Response to [REDACTED], P.E. pertaining to:

- Shoal Creek waterflow
- Mechanisms that prevent overtopping
- Sediment and gravel bar removal around bridge infrastructure
- Maintenance records
- Potential West Ave bridge watermain vulnerability
- In-person inspection of creek to finalize [www.austinshoalcreek.com](http://www.austinshoalcreek.com)

05/04/2026 by [austinshoalcreek.com](http://austinshoalcreek.com)

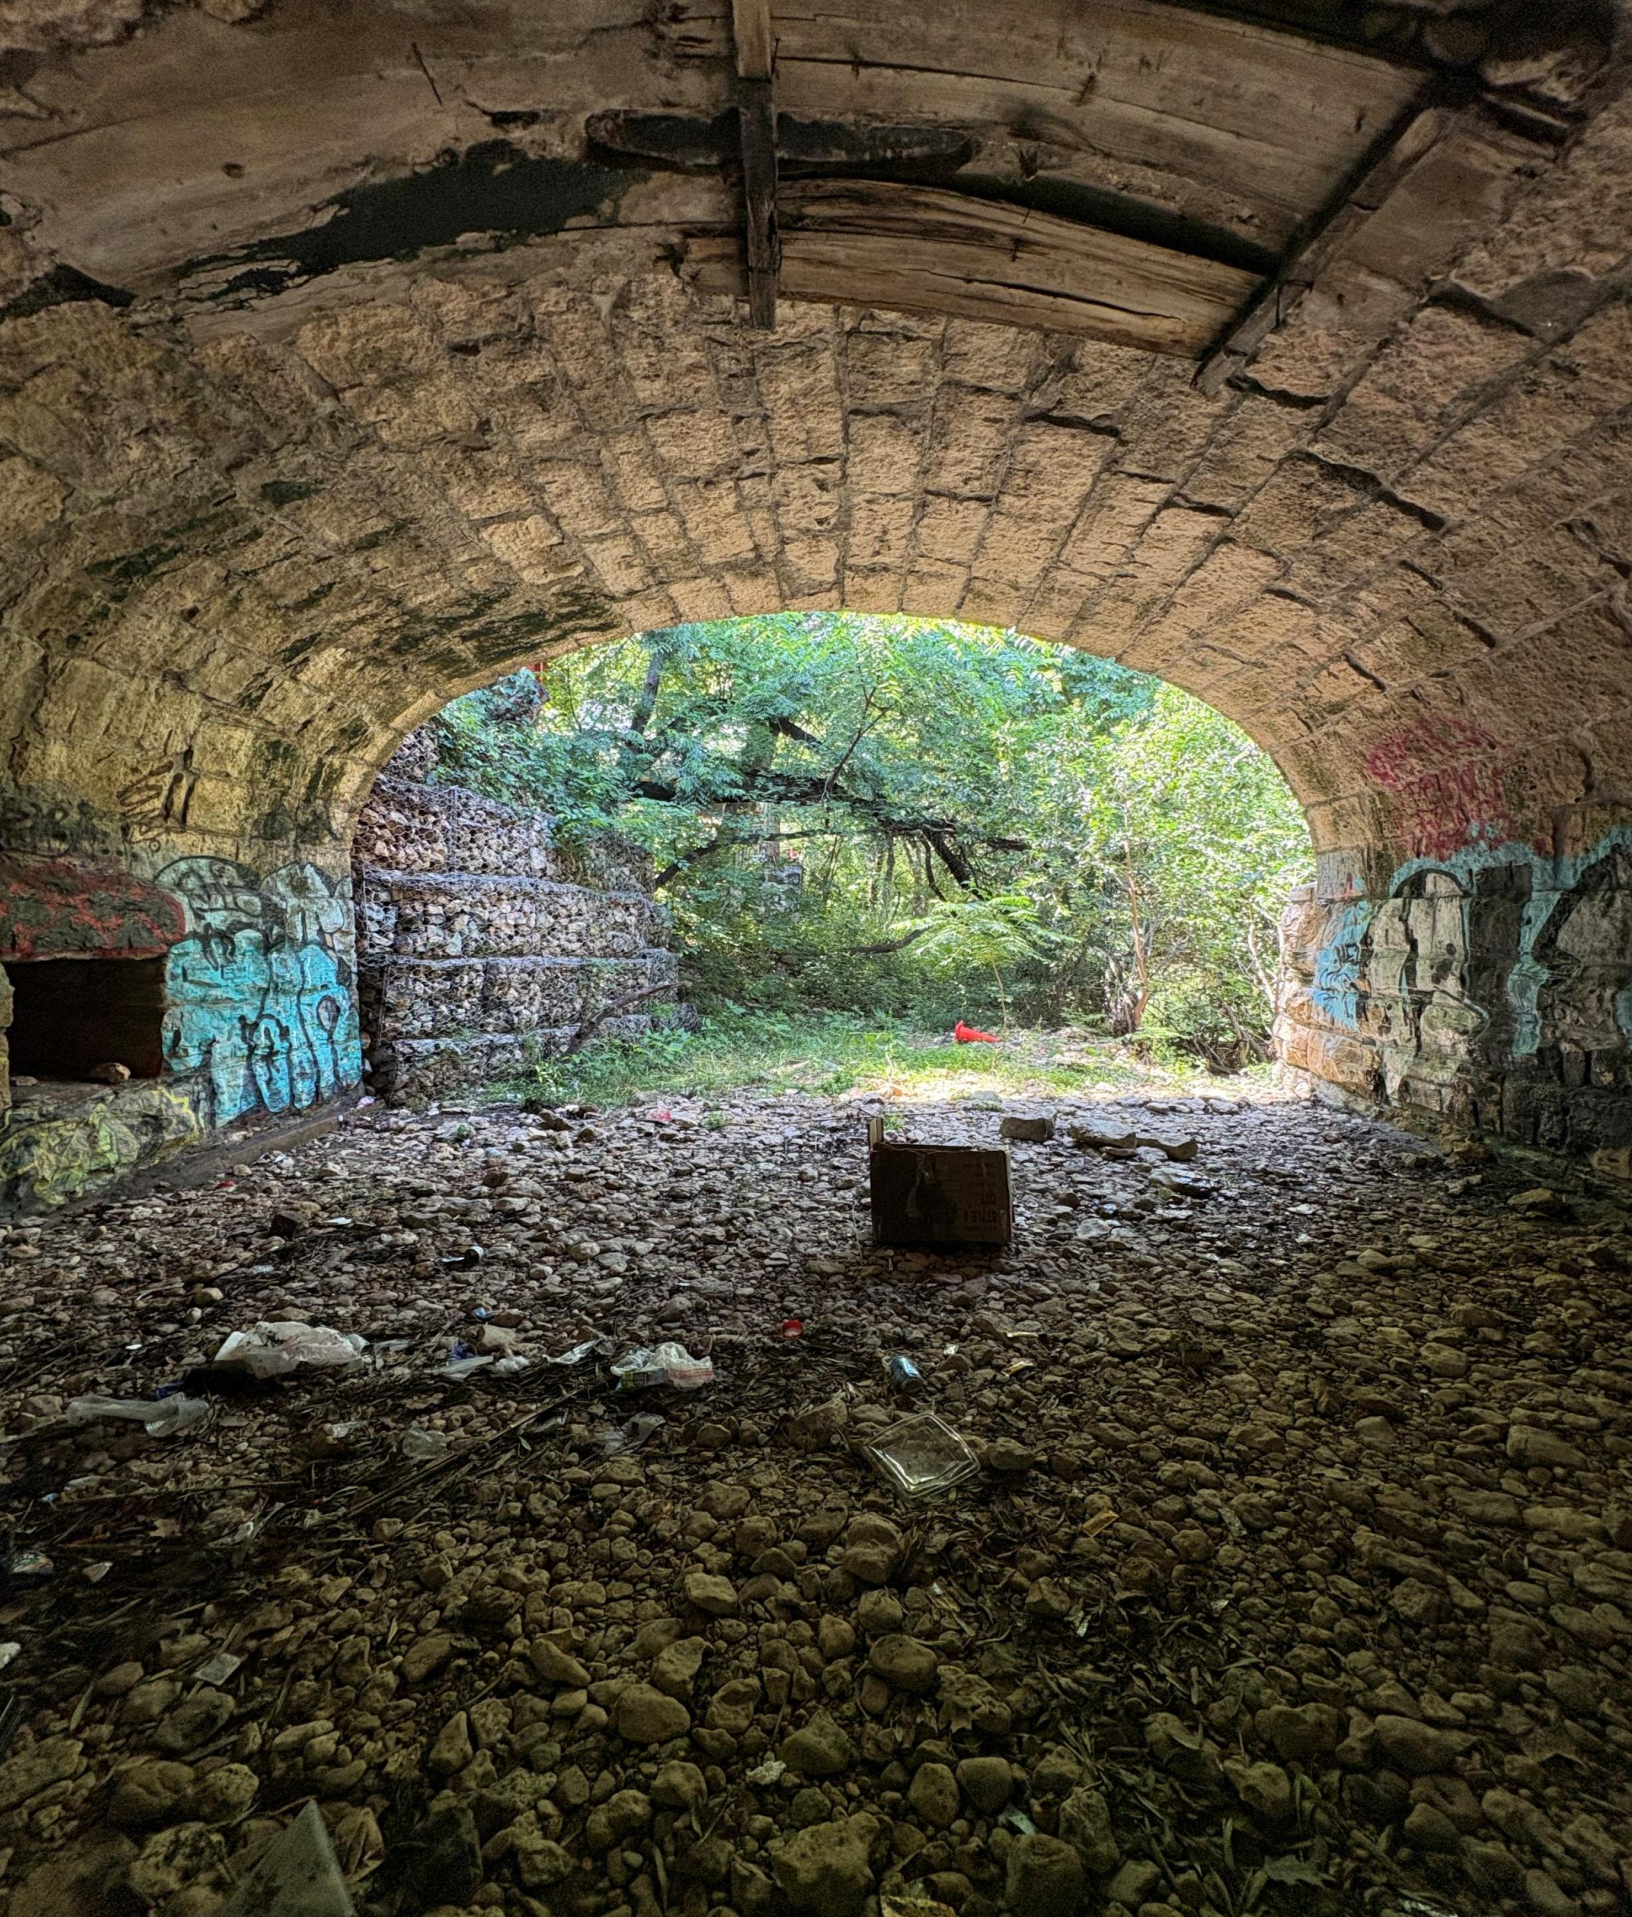
These photographs show how the east span of the W 6 St bridge feeds directly into the foundational areas of Sammie's (has partial erosion prevention measures in place) and Taquero Mucho (has no erosion prevention measures in place other than a reinforced foundation).

Erosion and obstruction may not be a concern here, despite appearing to be so. The erosion prevention measures in place across the creek on the west side (top left) look like an appropriate and needed remedy on the east side, from the layman's perspective.

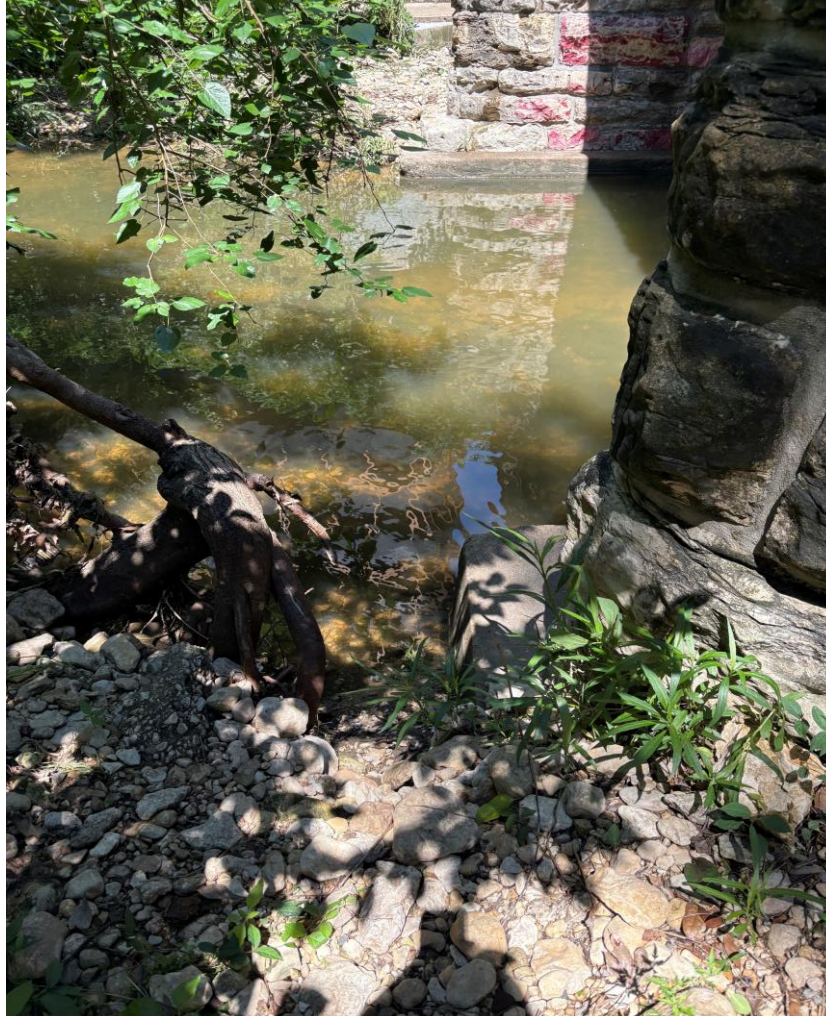
The photographs above and to the right form a pan of the creek by turning right (west) from downstream at Sammie's and returning upstream towards the east footer of the W 6 St bridge.

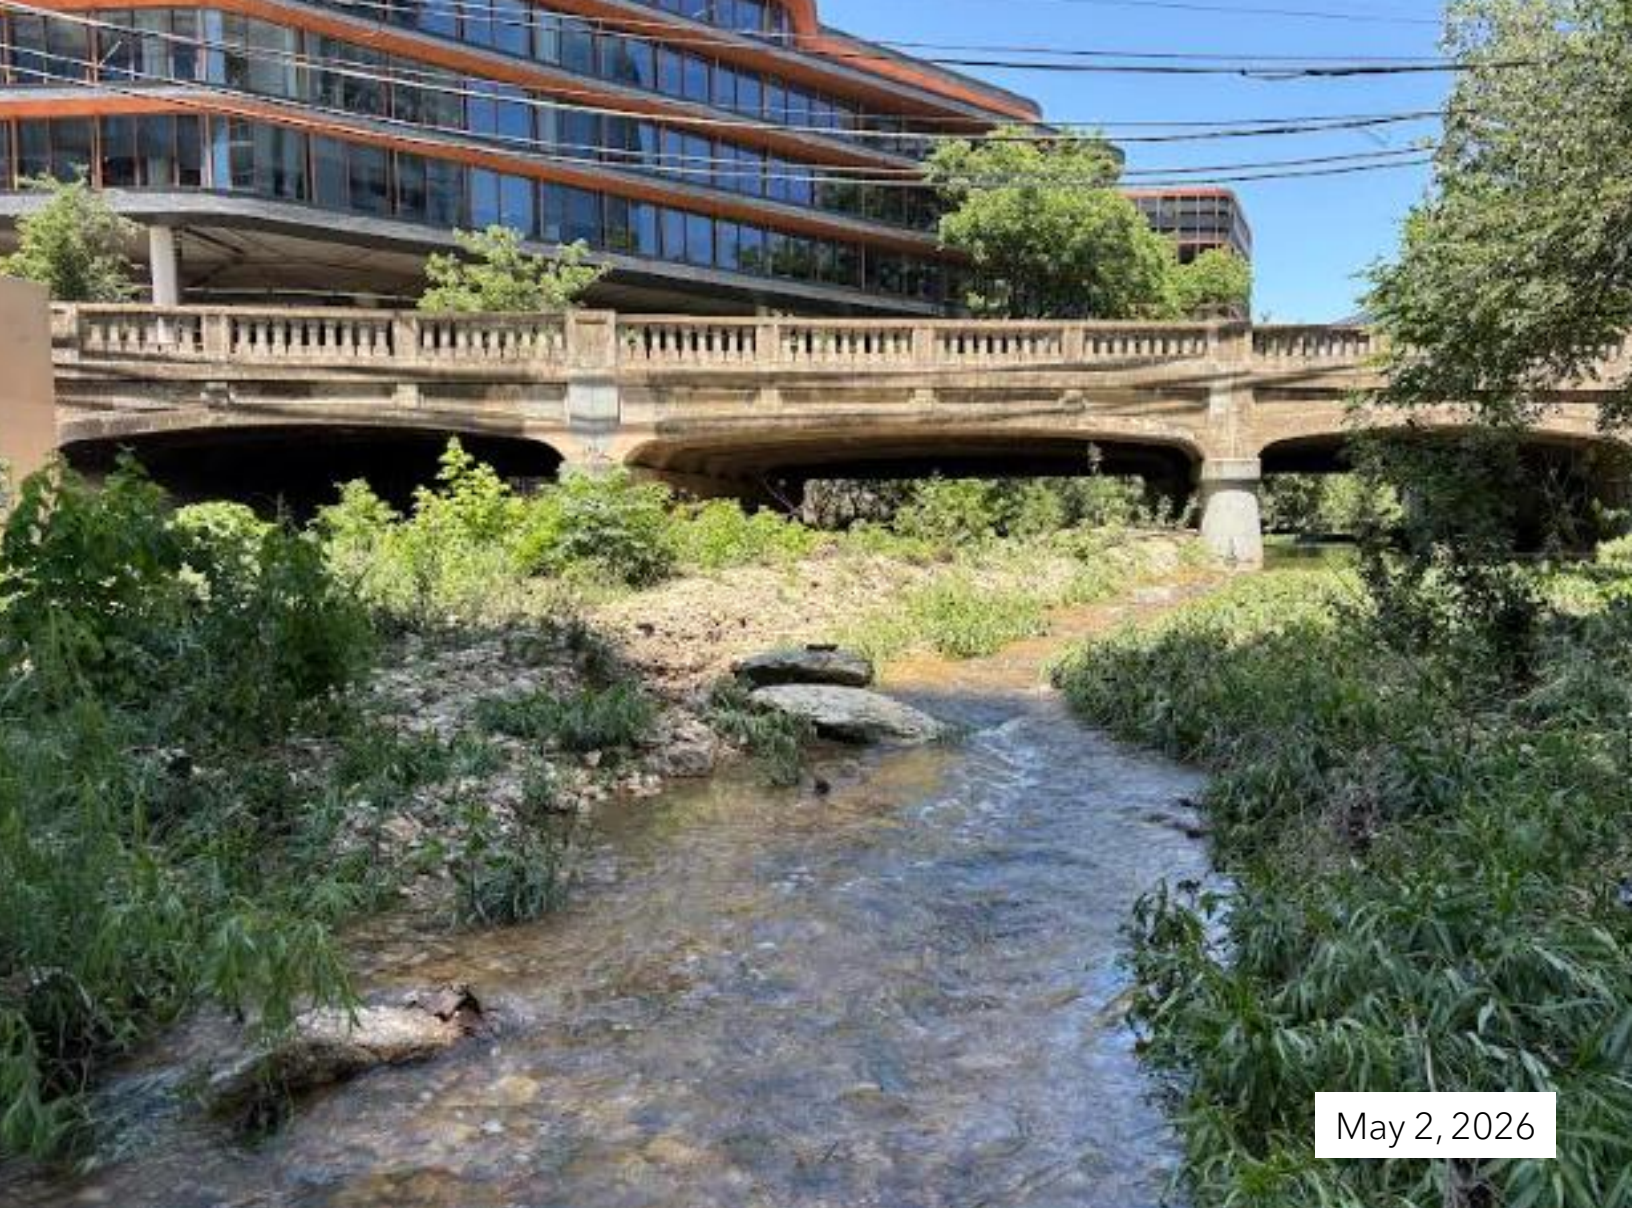
May 2, 2026

The 2016 study mentioned the need to monitor the W 5 St area, but if the gravel bar had been manually lowered/removed, as the 2008 photograph suggests, it is possible the people who conducted the 2016 field inspection were unaware of as much.

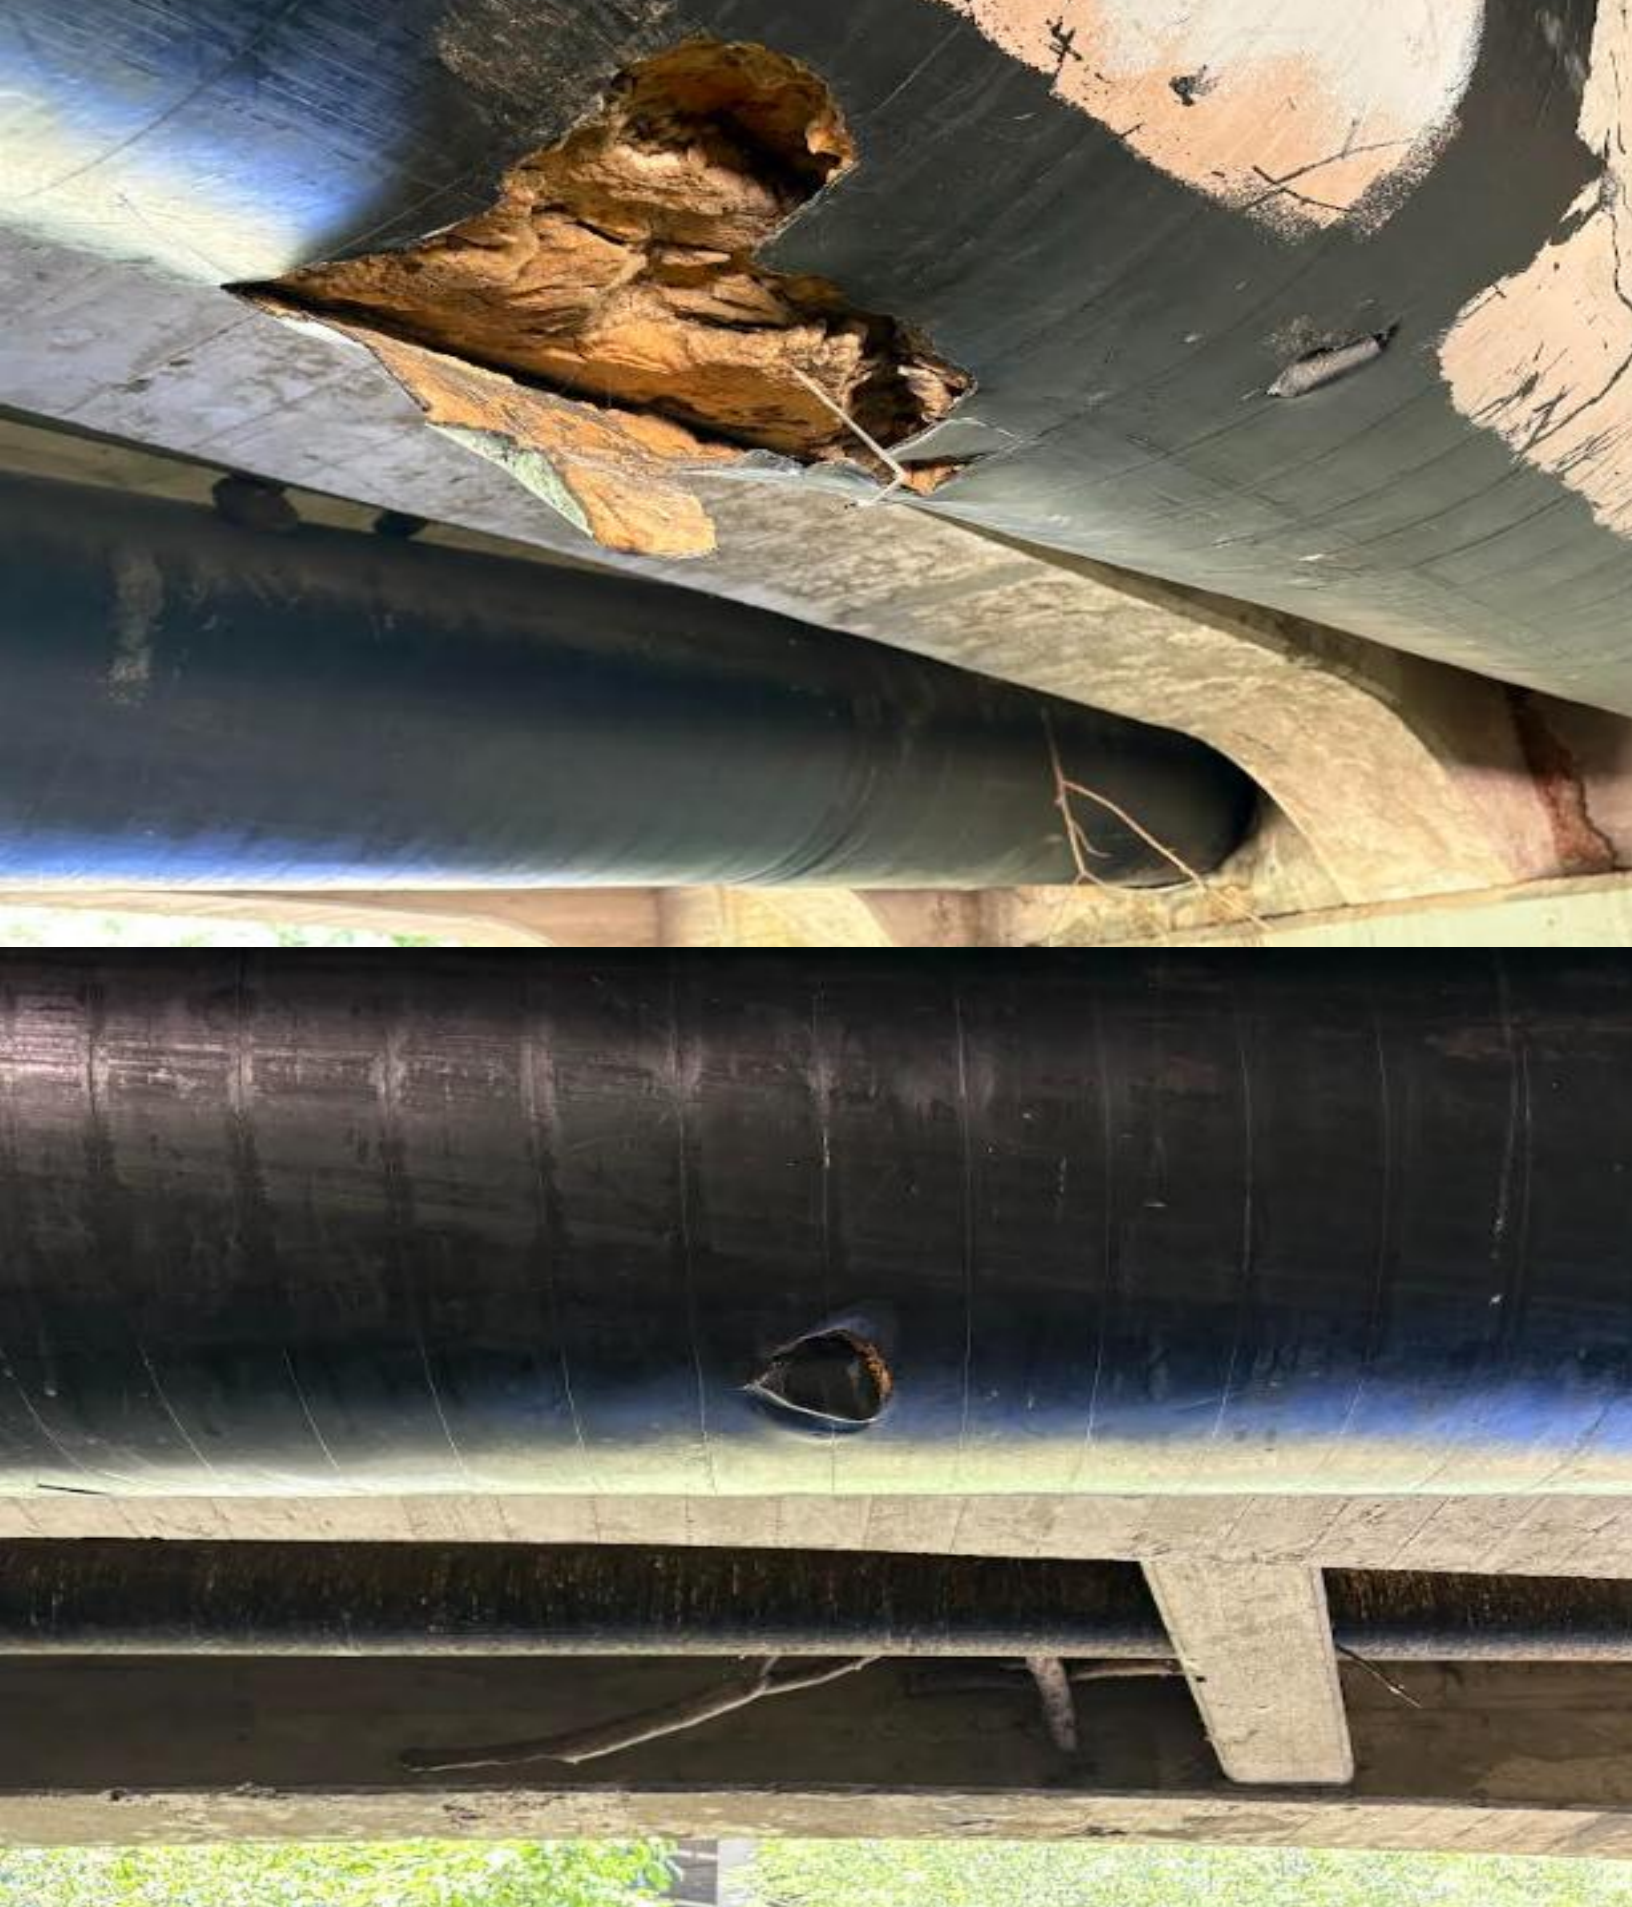
The damage to Austin Water utility pipes happens because, as indicated by snagged branches, waterflow in this area constantly reaches the height of the bridge spans, which have their designed capacity reduced by sediment and gravel.

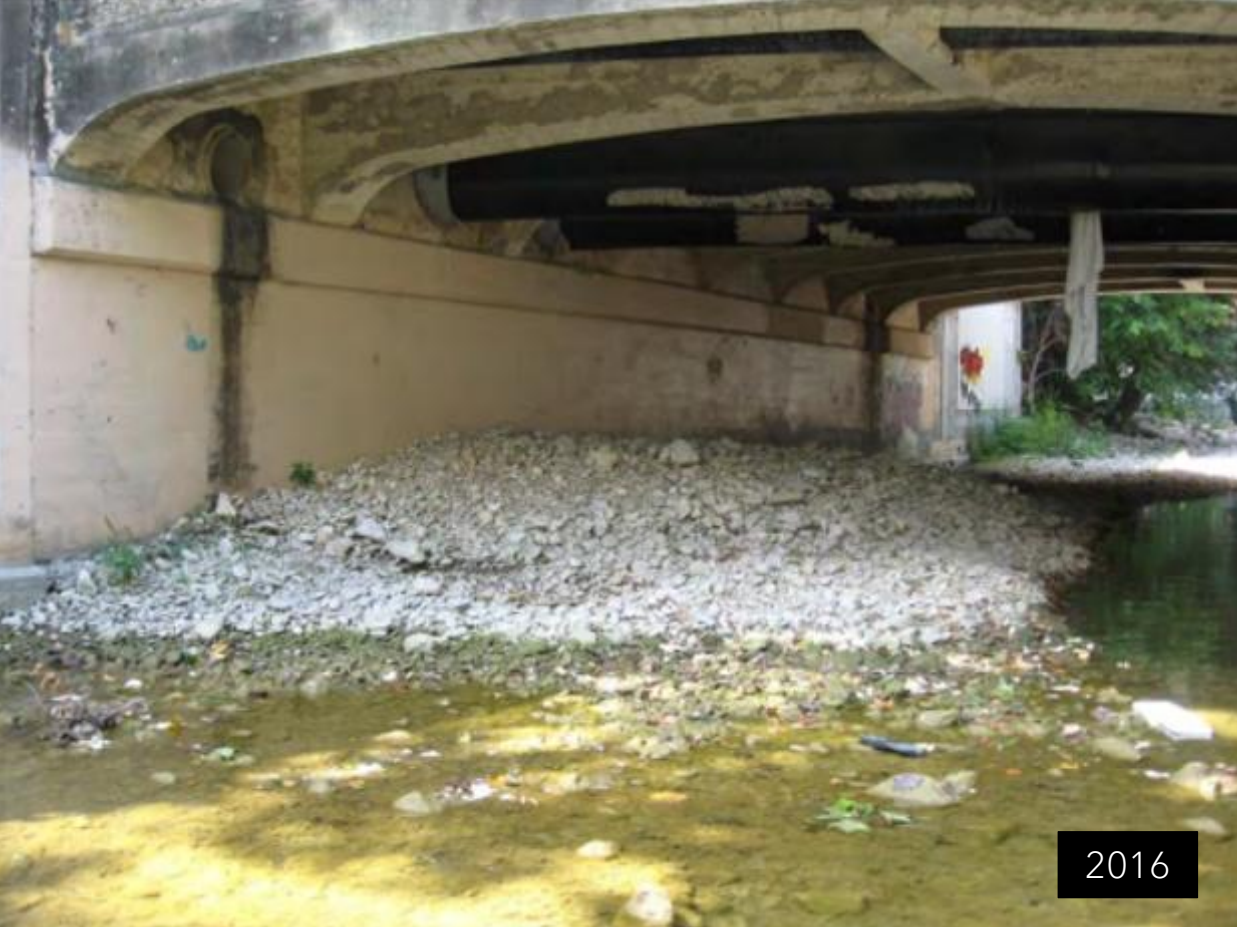
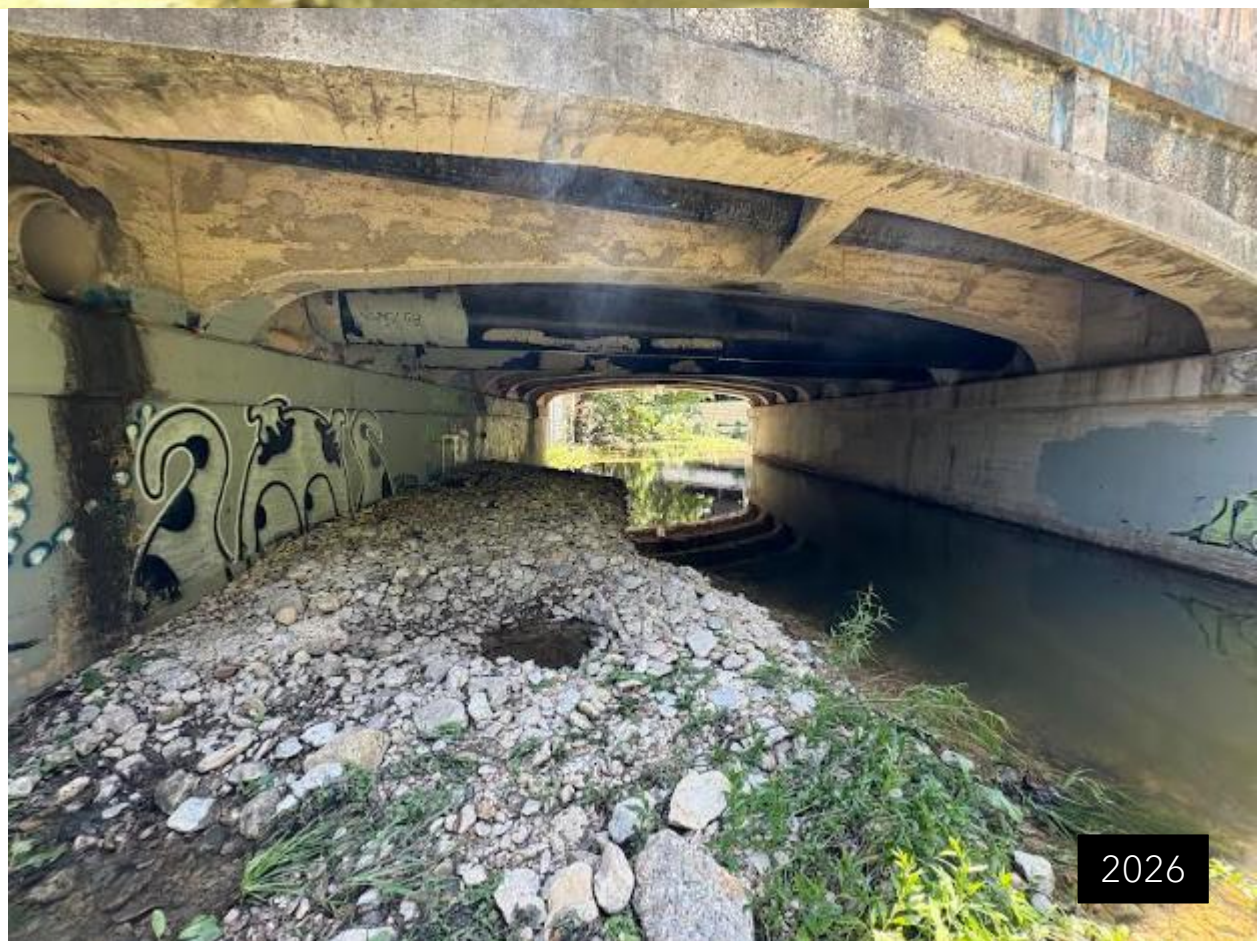
The gravel bar under the east span has grown slightly since 2016. Water is slow to drain downstream just past the span of the W 5 St bridge.

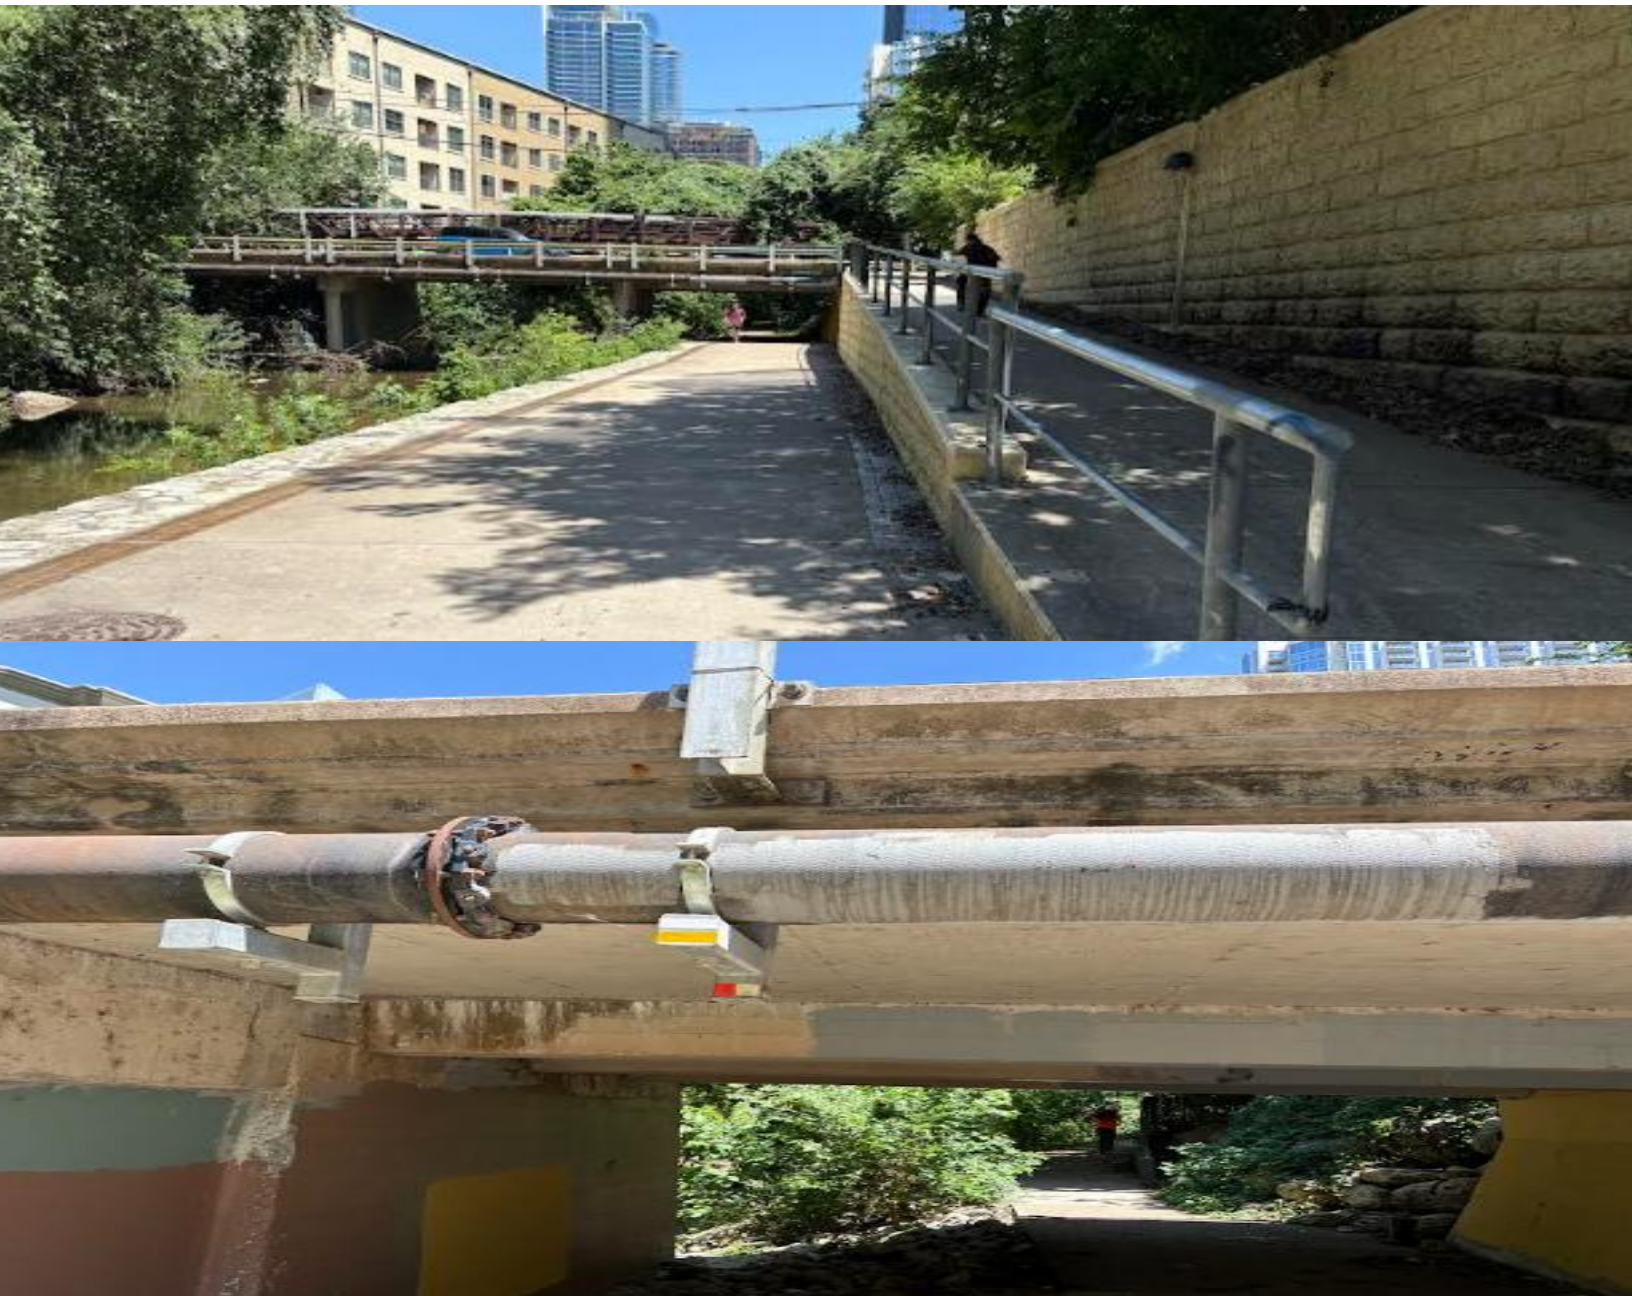
The bridge has what appears to be a pressurized utility drinking water pipe spanning directly in front of it. Based on what I've observed, the pipe could be susceptible to damage from flood debris.

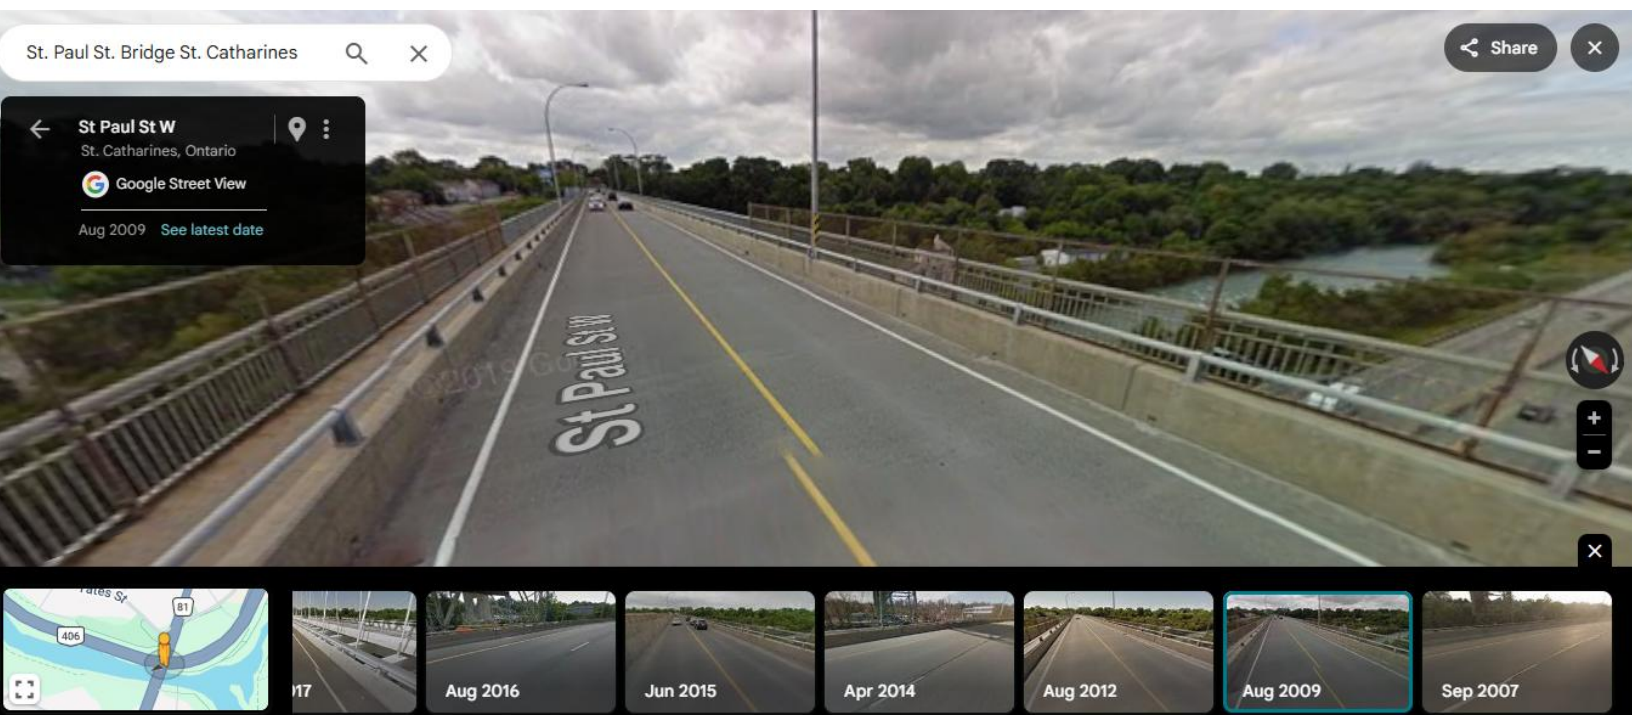
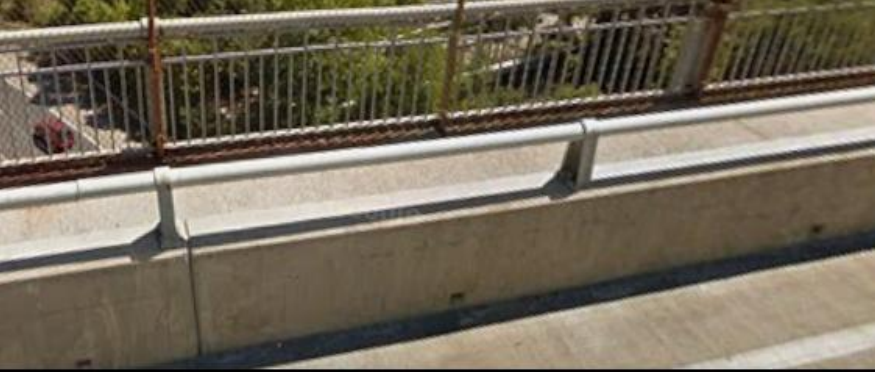
The top screen capture gives a better height perspective to show how the old St. Catharines bridge guardrail could reasonably protect people vs. the old W 6 St bridge highway styled guardrail.

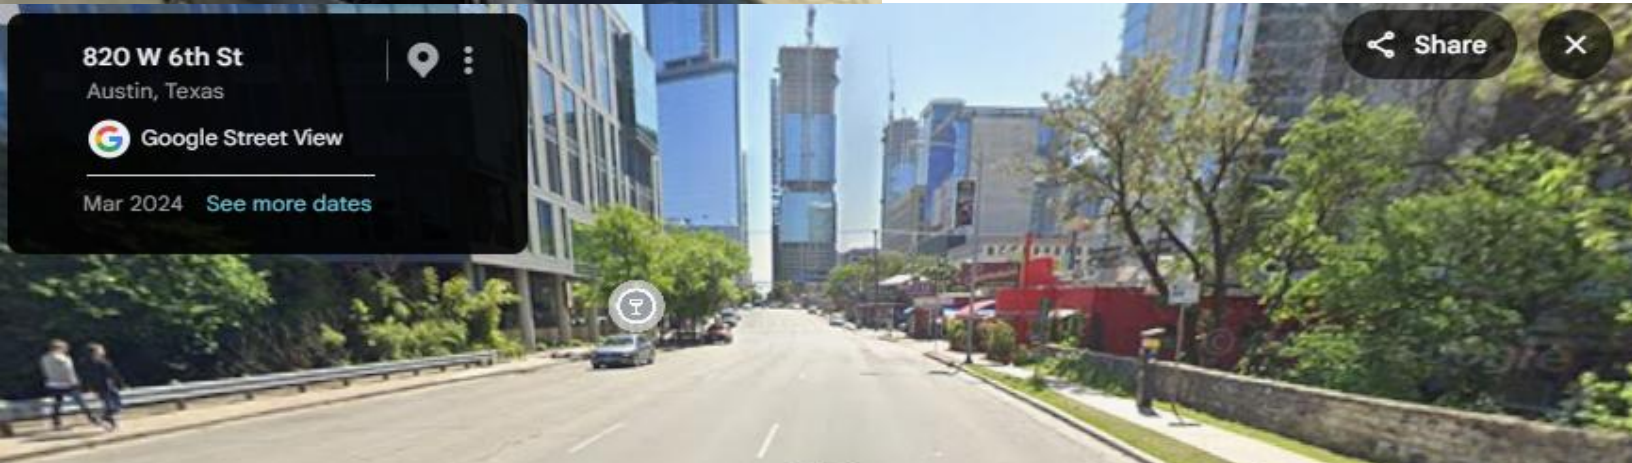
The bottom screen capture shows the height disparity between the north and south W 6 St bridge pedestrian safety measures.
