**AIRCRAFT  
ACCIDENT  
REPORT**  
**Trans World Airlines Flight 800**  
**Part I**  
**Consideration of Reasonable Probable Causes**

**Report on the accident to  
Trans World Airlines Flight 800  
Boeing 747-131, N93119  
Near East Moriches, New York  
July 17, 1996  
by John Barry Smith,  
Independent Aircraft Accident Investigator**

## **Part I: Consideration of Reasonable Probable Causes**

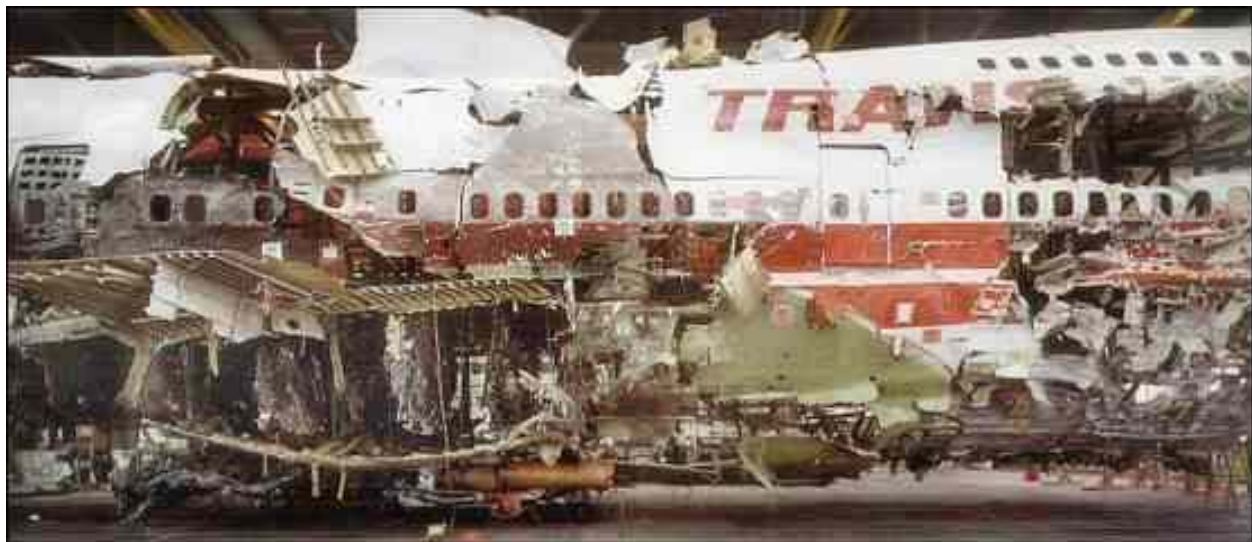
Right front and middle of Trans World Airlines Flight 800 revealing sharp sooted and non sooted cut in fuselage, nose to right.

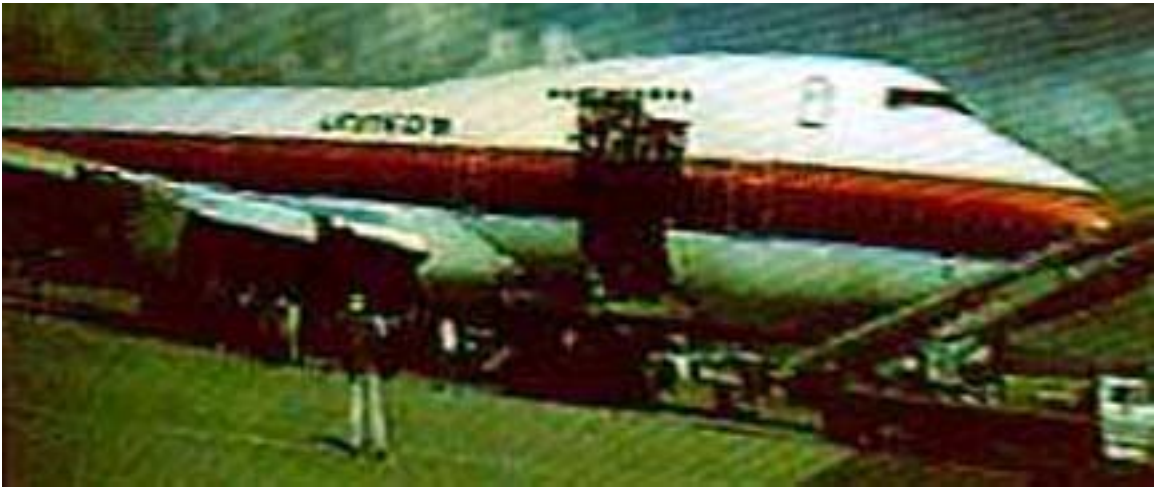
Photo of hole in United Airlines Flight 811 made by inadvertent opening of forward cargo door in flight. Note rectangular shape.

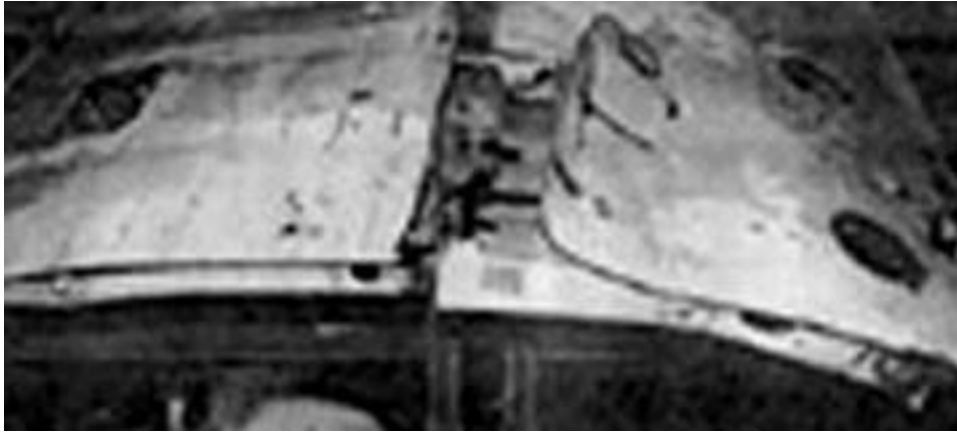
Closeup photo from NTSB AAR 92/02 for United Airlines Flight 811 showing bottom half of the retrieved door, the longitudinal split at midspan latches, and the peeled away skin from the aft midspan latch.

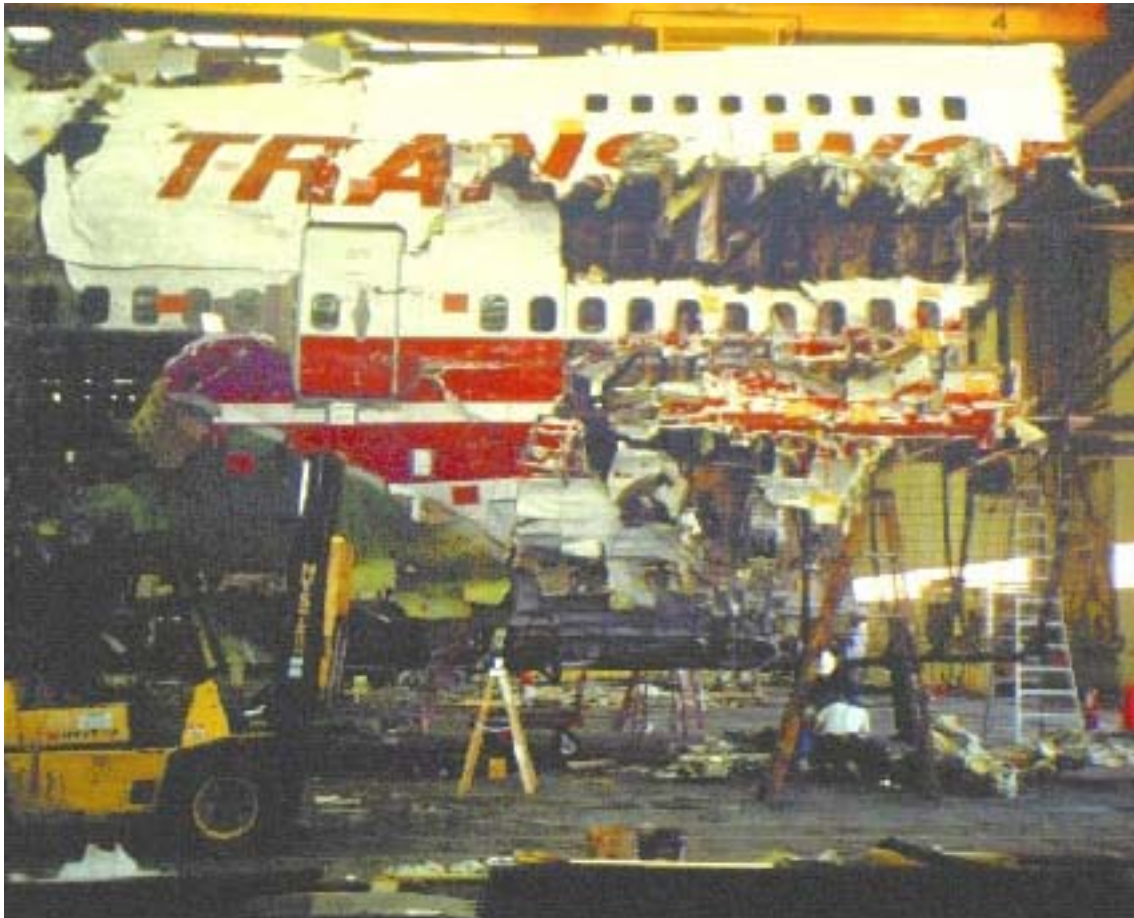
The right front of the reconstruction

Nose to right.
