# INSPECTION REPORT

For the Property at:  
**123 Leafy Lane**  
HASTINGS, ON

Prepared for: Mr & Mrs Twig  
Inspection Date: Sunday, March 14, 2021  
Prepared by: David Sharman

RE: Report No. 1366  
123 Leafy Lane  
Hastings, ON

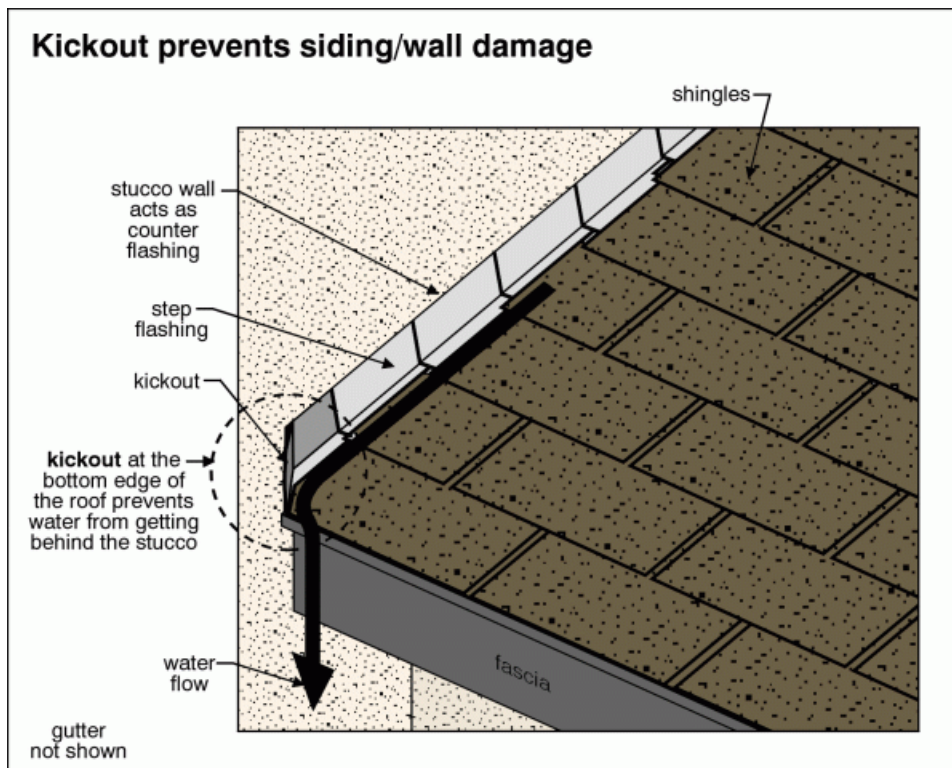
2. **Condition:** • [No kickout flashing](#)

**Implication(s):** Chance of water damage to contents, finishes and/or structure

**Task:** Improve

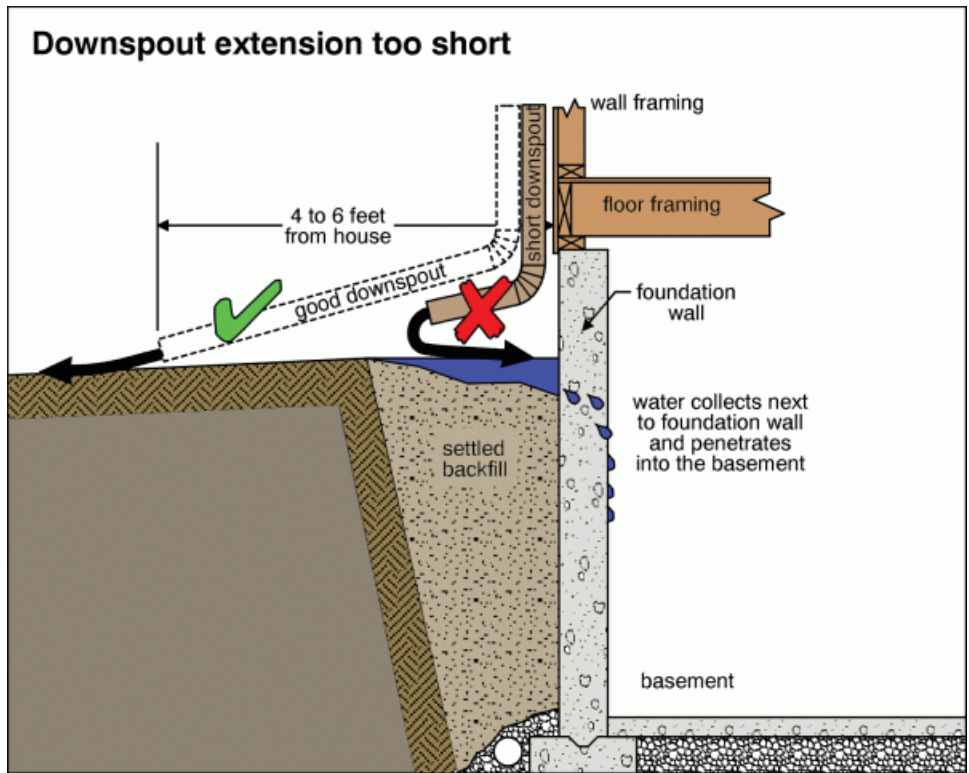
**4. Condition:** • [Downspouts end too close to building](#)

**Implication(s):** Chance of water damage to contents, finishes and/or structure

3. Downspout ends too close to building

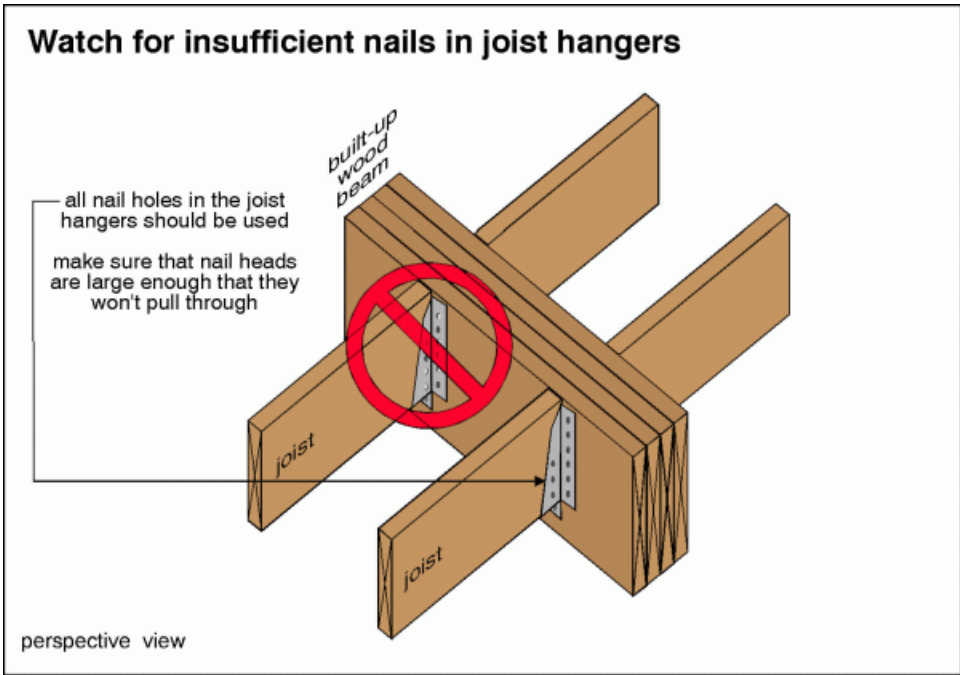
#### **5. Condition:** • [Fastener problems](#)

4. Poor end bearing, joist hanger connections

**Task:** Improve

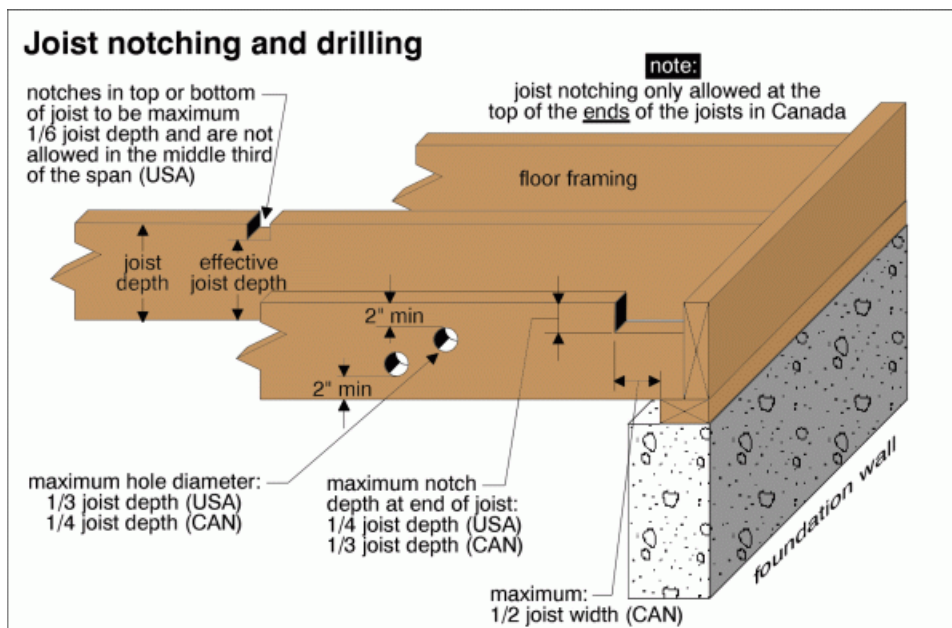
**6. Condition:** • [Notches or holes](#)

5. Joists are notched and weakened

**Task:** Repair

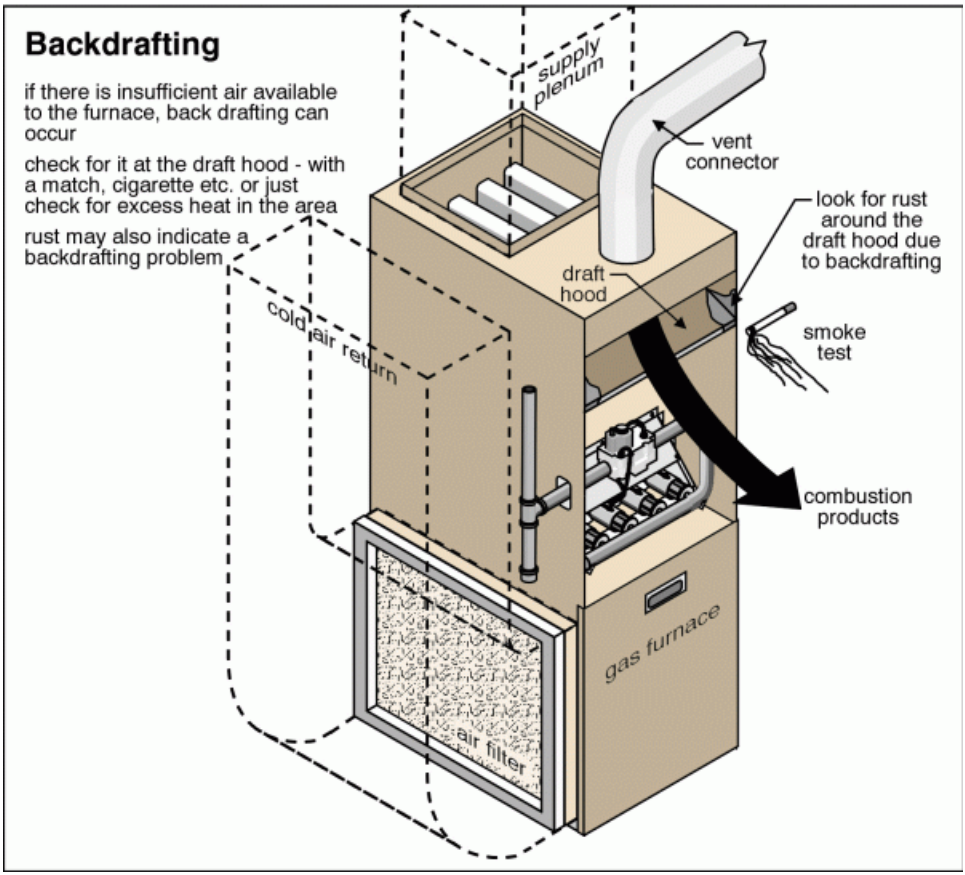
14. **Condition:** • [Draft hood spillage or backdraft](#)

A considerable amount of rust was noted on the front of the furnace.

**Implication(s):** Equipment not operating properly | Hazardous combustion products entering home

9. Rust at bottom of heat exchanger
