Solar PV String Inverter System Inspection Report

Project Name:	D. Jacobson & Sons Ltd	Contractors Name and Address
Installation Address:	Bacup Road, Rawtenstall, BB4 7PA	MBC Renewables Ltd 14 Fairview Drive Medomsley Edge Consett Co. Durham DH8 6QX
Tested by:	Michael Middlemast	Signature:
Project Reference:	JACOBSON001	
Commissioning Date:	2022	
Test Start Time:	29/05/2023 10:10 AM	
Test End Time:	30/05/2023 10:45 AM	
Rate kWp of plant:	100kWp

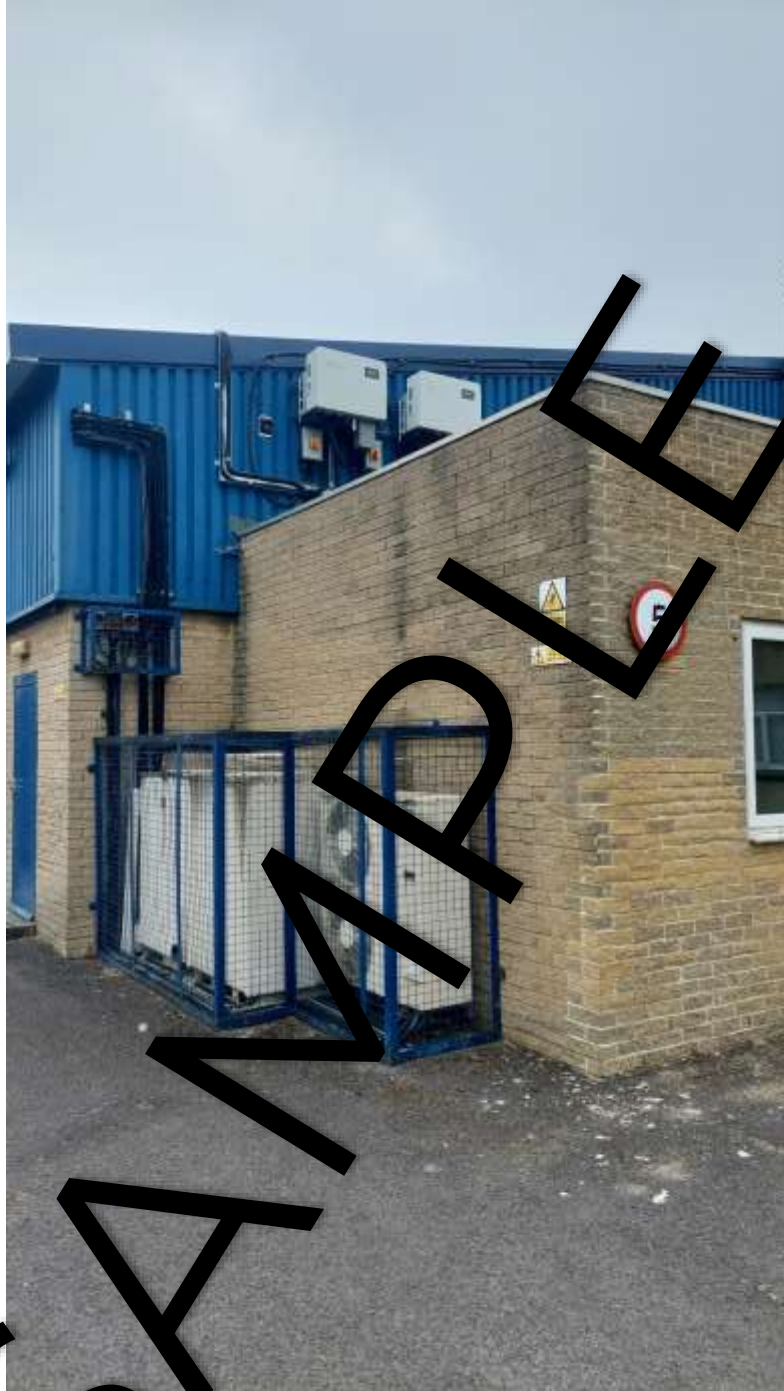
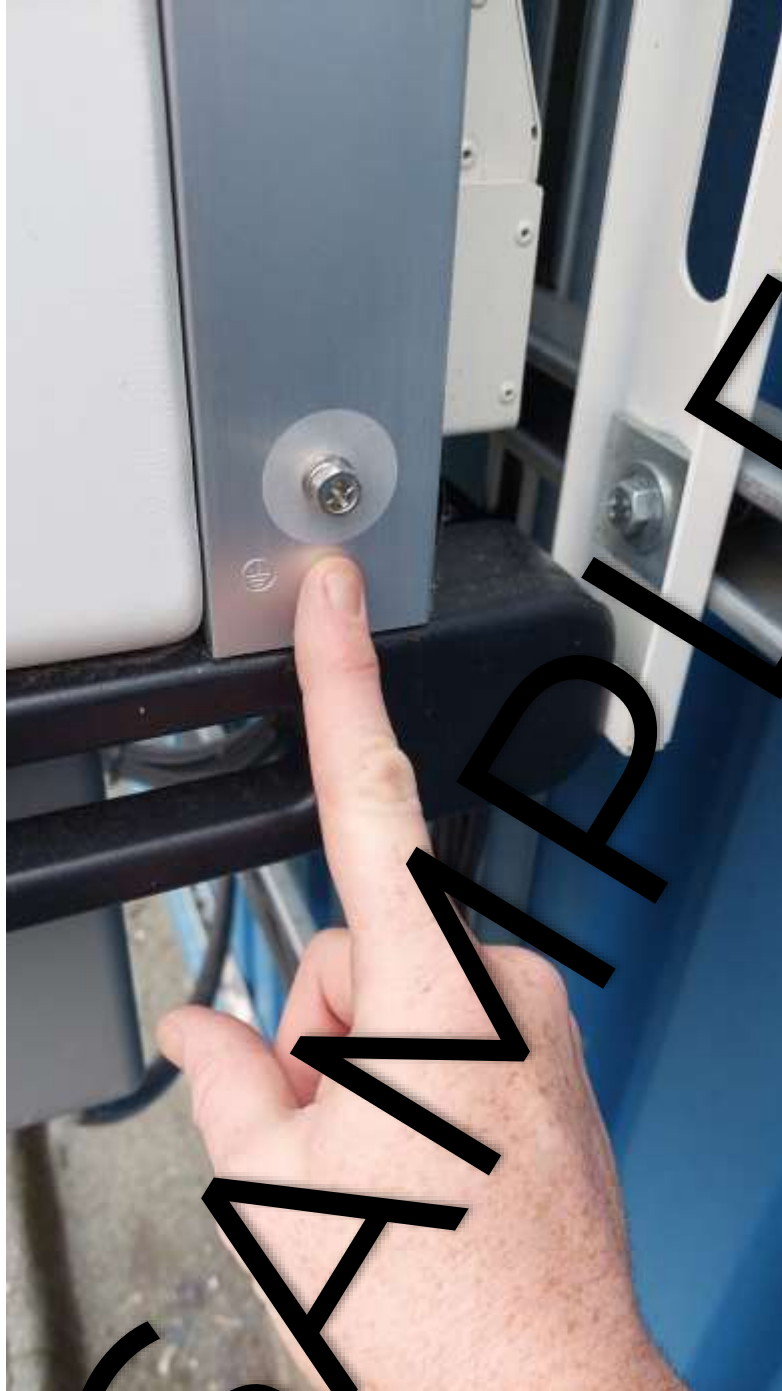
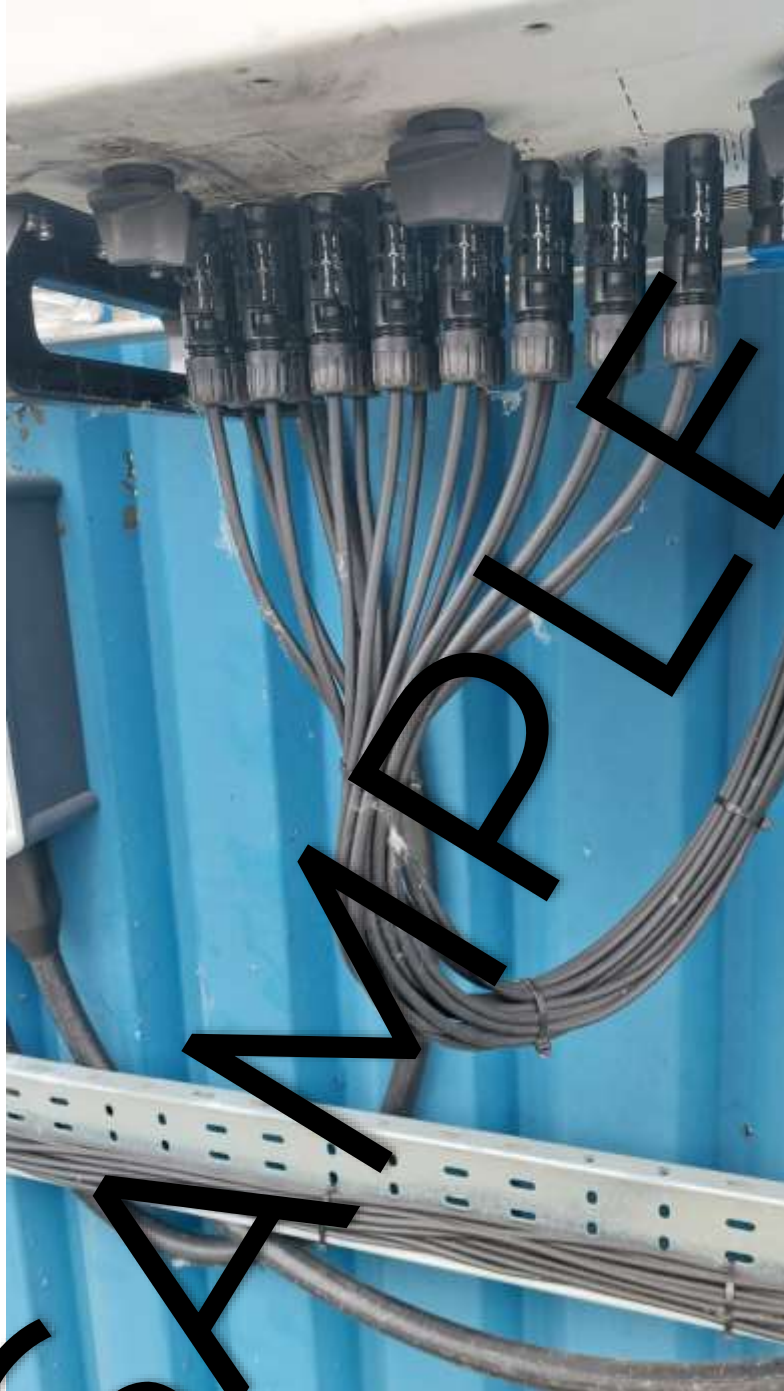
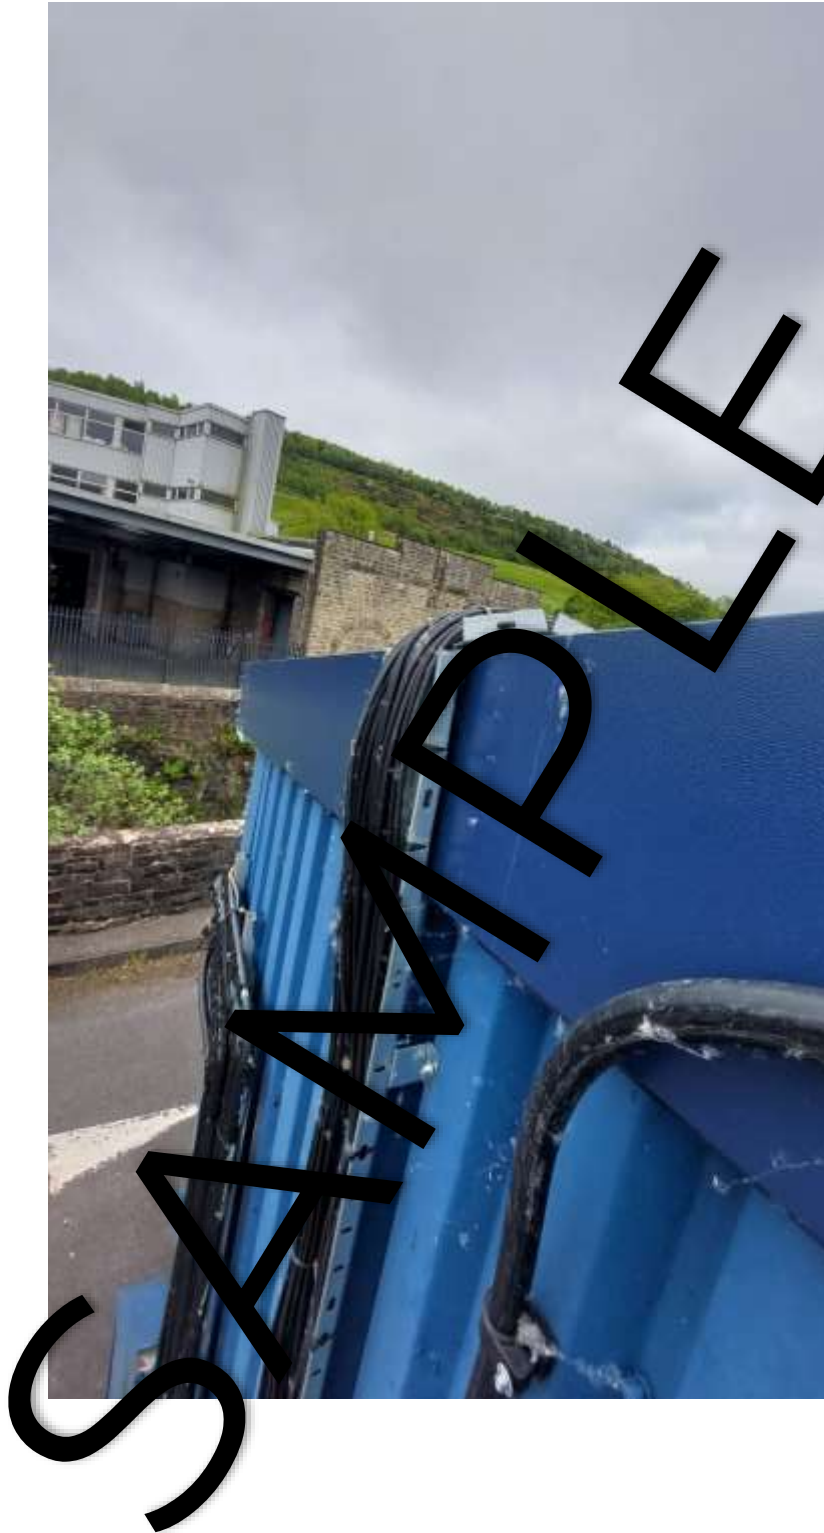
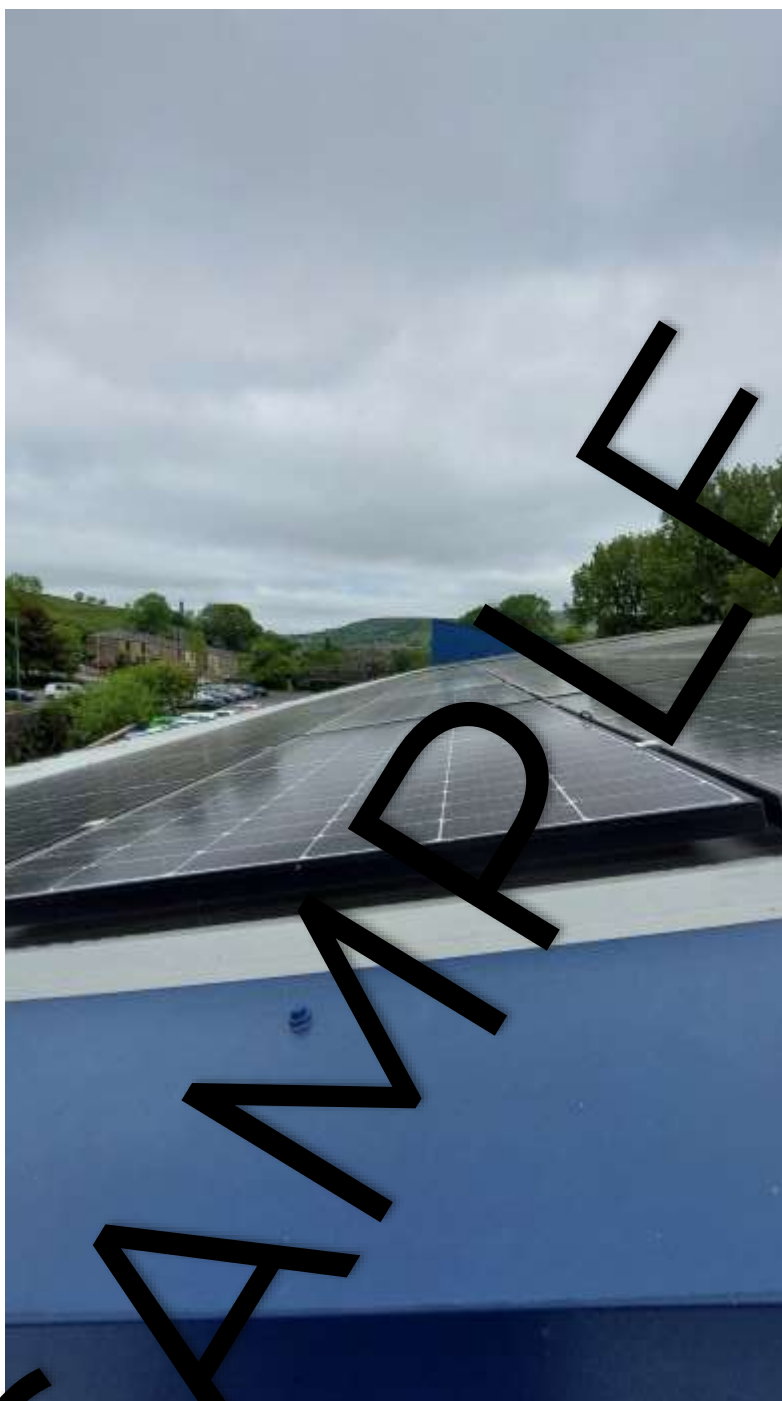
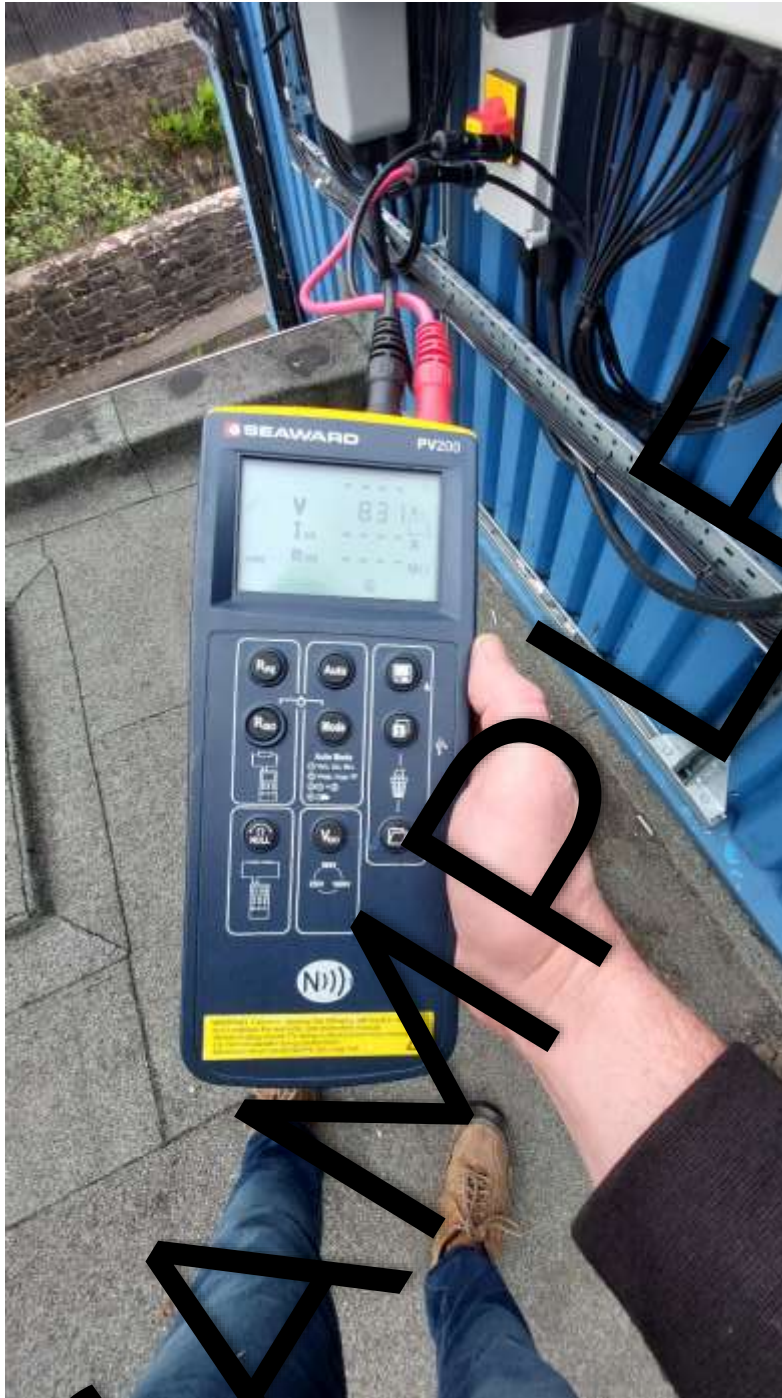
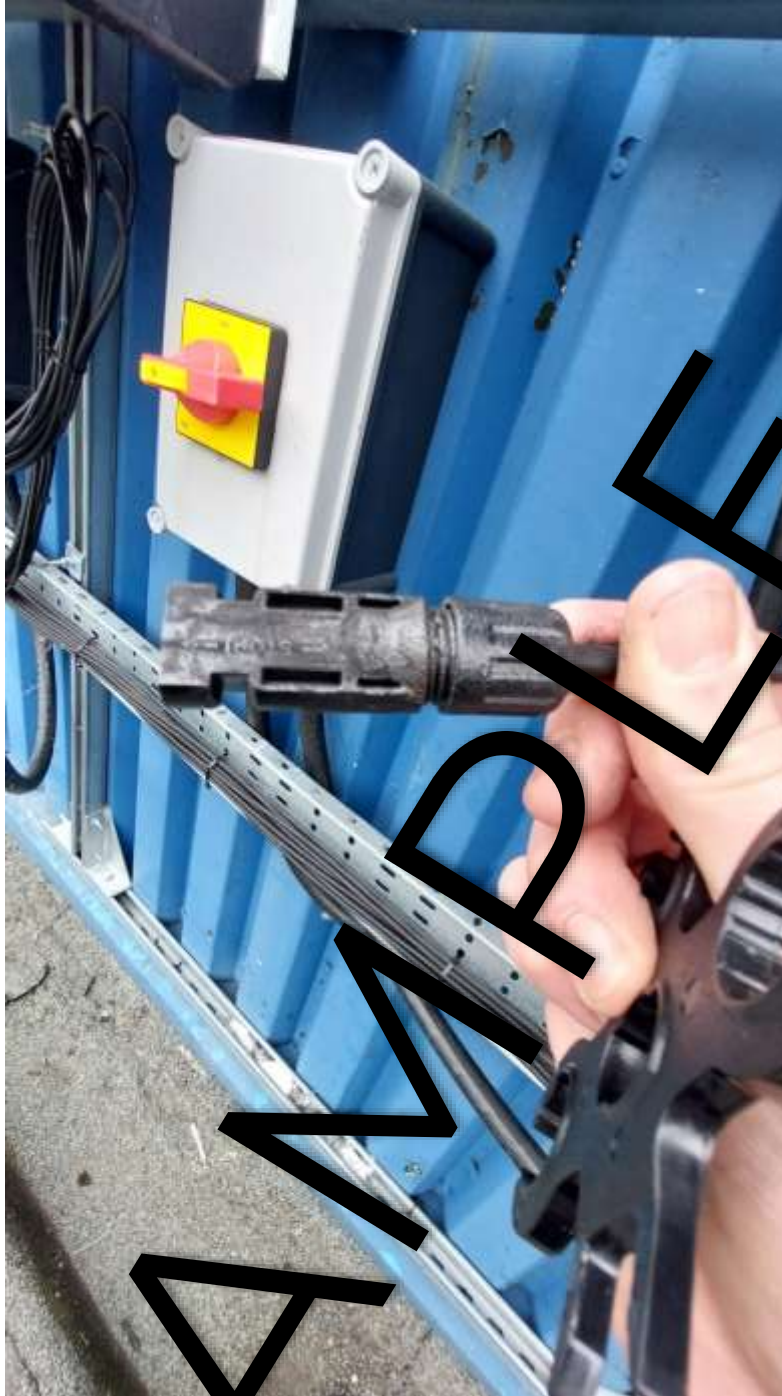
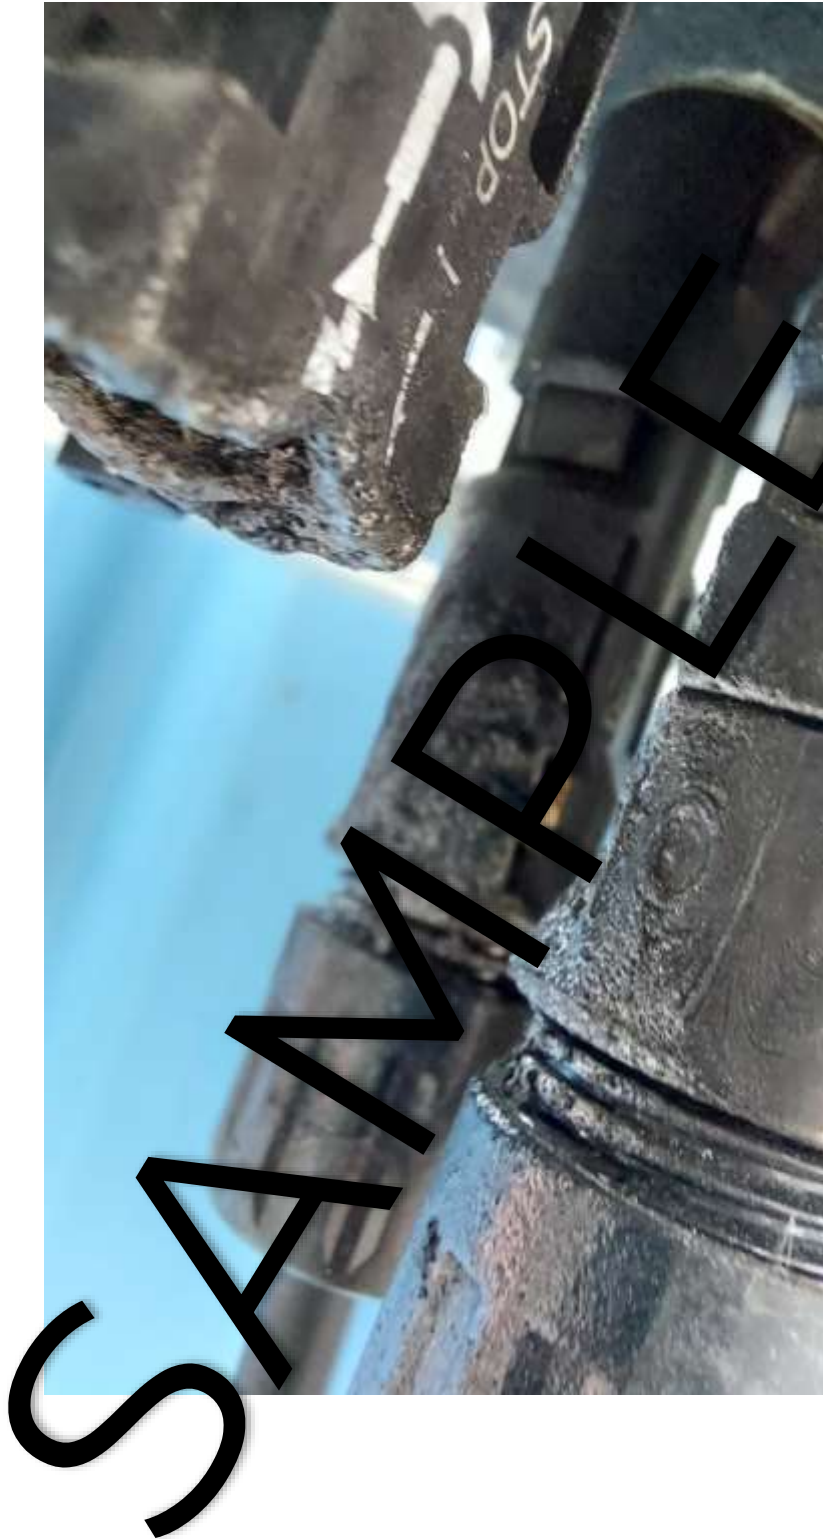
SAMPLE
SITE IMAGES

Loose cables can be seen from the top side of the array.

These loose cables are then subject to the elements and movement over time. This loosens connections causing the insulation faults on the array.

The full width of cable trays has not been utilised and TAPE has been used to hold cables together (*see images*) this is not in line with code.

Inverters are exposed to the elements and harsh environment. This is not in line with the manufacturer's suggested installation instructions and **will void any warranty**. Suggest installation of housing and protective cover.

System is not properly grounded (*see images*)

Around the installation is litter from the installation crew and old installation manuals (*see images*). This poses further fire risk and suggests "bad practice" culture amongst installers.

- Prepare correct PPE for works
- Perform pre-IEC62446 tests Category 1 and 2, record results
 - o Module level testing
 - o String level testing
- Modules cleaned, obstructions removed and inspect roof
- Install equipotential earth bonding
- Calculate and install correct size of cable for DC cable runs, 6mm not 4mm?
- Replace damaged inverters – check new inverter warranty status
- Correctly string the modules to inverters in line with code
- Re-run AC cabling to internal DB (*Approx 60/80M length*)
- Upgrade all switch gear
- Add Schematic, shut down procedure etc.
- Add inverter housing
- Perform post-IEC62446 test Category 1 and 2, record results
- Clear area of obstructions and litter
- Add Greenworld communications system for safety and monitoring
- Add avian deterrents, netting
- Perform annual visual inspection and IEC62446 testing
- Perform annual cleaning routine
