**Revised**  
**FULL RESERVE STUDY**  
**Sunset Lakes**  
**Homeowners' Association, Inc.**

**Merritt Island, Florida**  
**Inspected - February 23, 2021**  
**Revised - October 15, 2021**

Sunset Lakes Homeowners' Association, Inc.  
Merritt Island, Florida

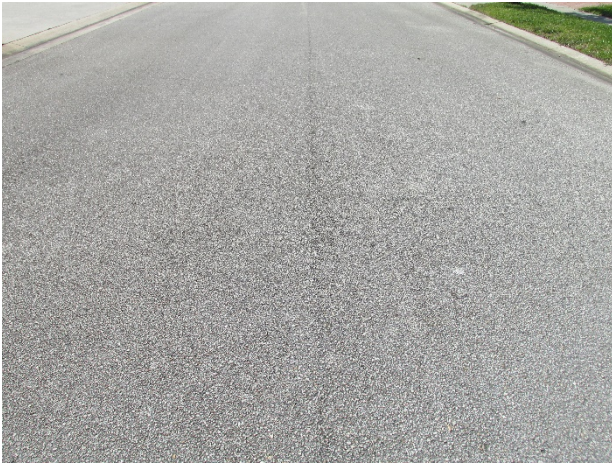
**Asphalt pavement on Tipperary Drive**

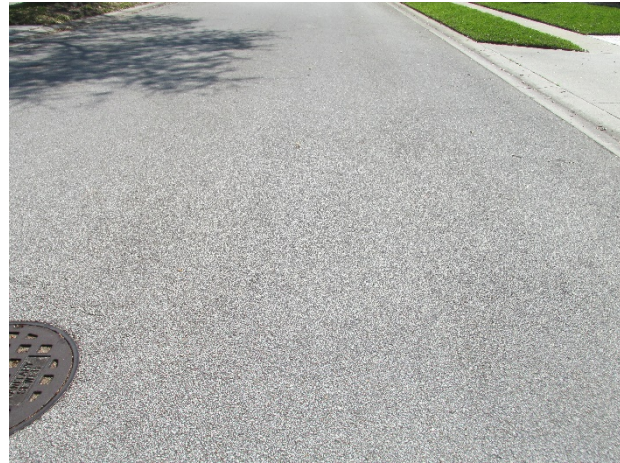
**Asphalt pavement on Limerick Drive**

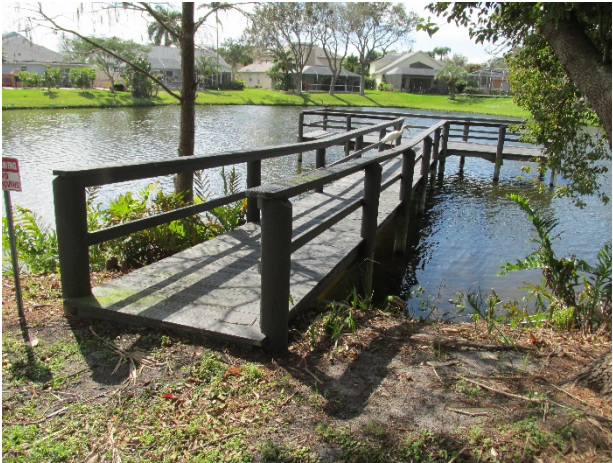
**Condition:** Fair overall with wood deterioration evident

**Wood dock overview**

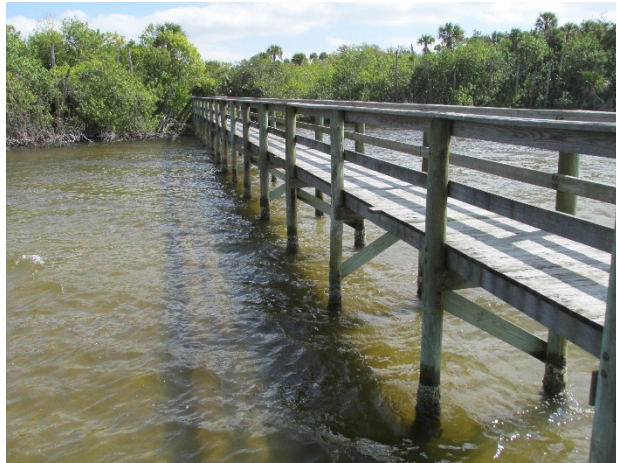
**Wood pier overview**

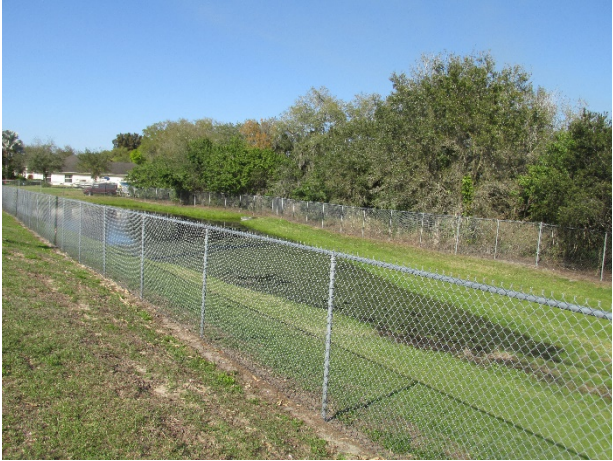
**Condition:** Fair overall with vegetation cover evident

Chain link fence

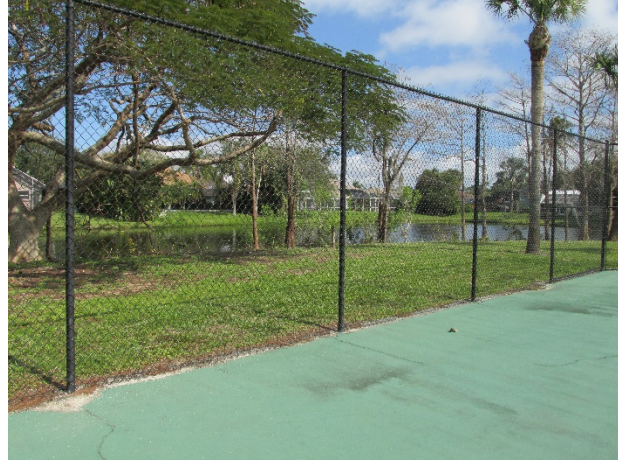
**Condition:** Good overall

**Tennis court fence**

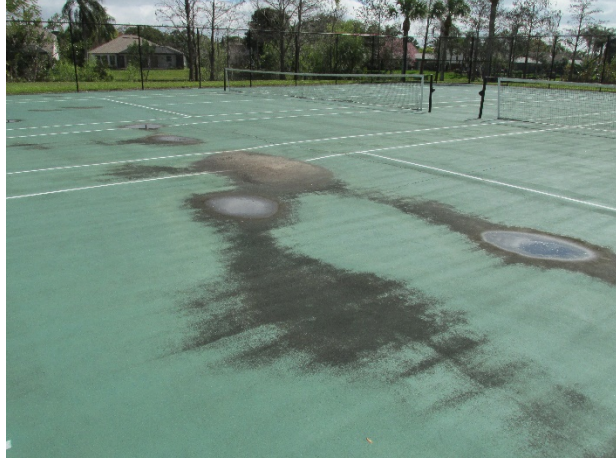
**Condition:** The tennis court is in poor overall condition with cracks and major settlement throughout, and the basketball court is in good to fair overall condition with cracks evident.

**Tennis court surface settlement evident**
