# Home Inspection Report

123 Main St  
Anytown, GA

# Premier Home Inspections

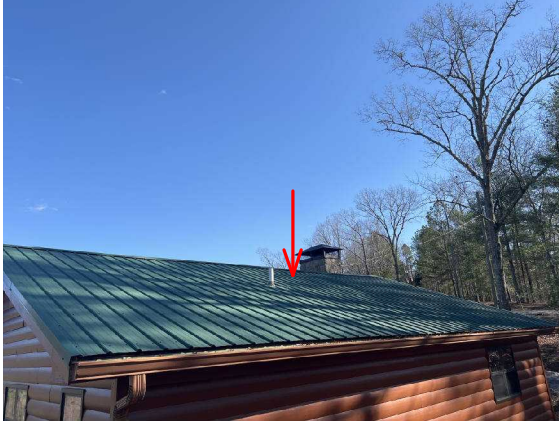
1. Method of Inspection: On roof
2. ☒ ☐ ☐ ☒ ☐ Material: Metal - There is a missing screw at the metal roof panel near the upper floor deck.  
The edge of this panel can easily be lifted by hand.

There is also a damaged area of metal roofing near the PVC event that is leaking. It appears this has been repaired with sealant, which will only be a temporary repair.

Recommend consultation with a roofer for further evaluation of the roof and to make any needed repairs.

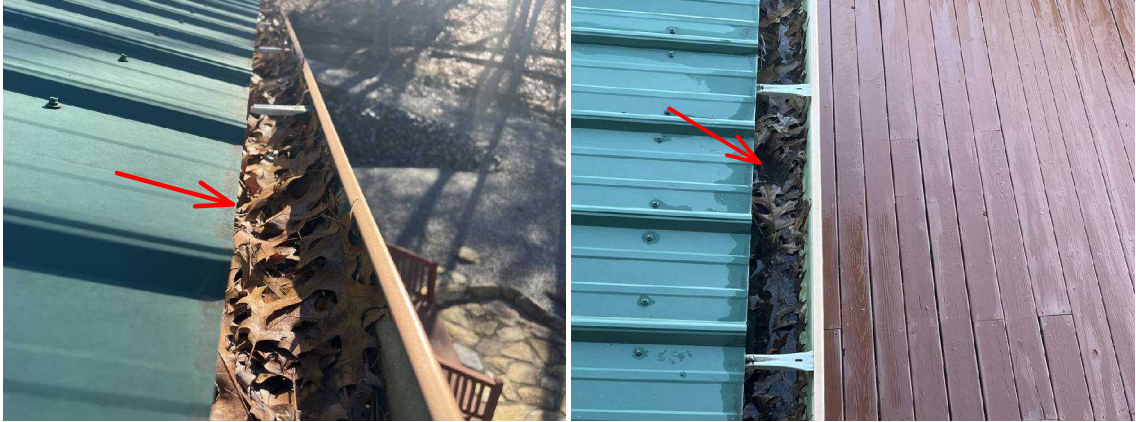
9. ☒☐☐☒☐ Gutters: Aluminum - The gutters are clogged with leaves and then to be cleaned.

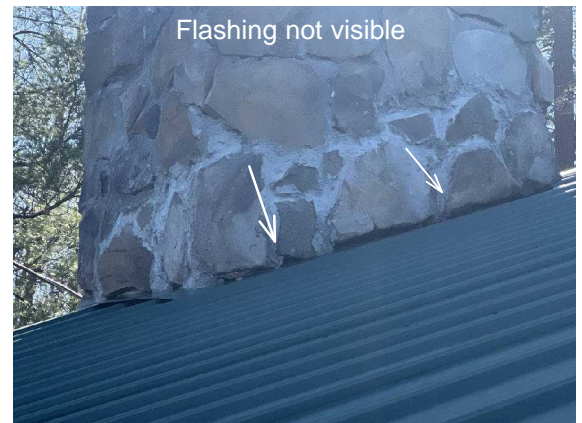
13. ☐☐☒☐☐ Chimney Flashing: While there was some flashing visible, much of the flashing was not visible and could not be inspected as it is covered by stone. This is the proper way to flash (under the stone), but it does prevent inspection.

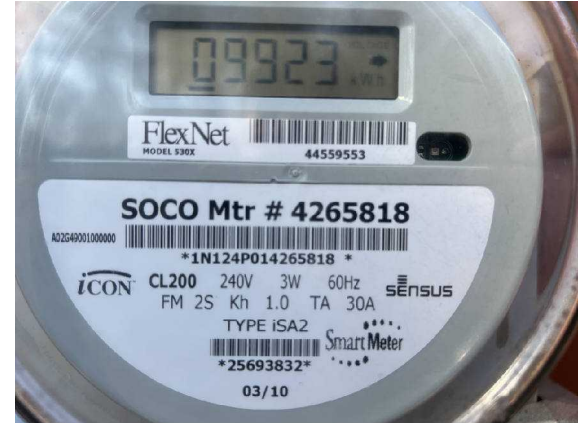
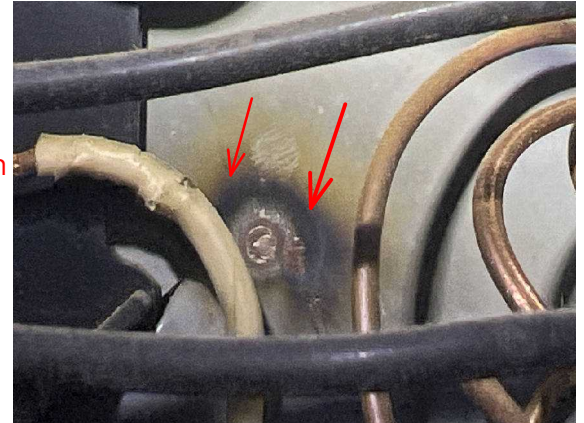
Bedroom Electric Panel

1. Service Size Amps: 200 Volts: 120-240 VAC
2. ☒☐☐☐☐ Service: Copper - Service provider and meter number
3. ☒☐☐☒☐ 120 VAC Branch Circuits: Copper - There is some evidence of some POSSIBLE arcing add the neutral wire in the panel. It is unknown if this is a current issue or occurred in the past. No arcing detected at time of inspection further evaluation by an electrician is suggested.
4. ☒☐☐☐☐ 240 VAC Branch Circuits: Copper
5. ☐☒☐☐☐ Aluminum Wiring:
6. ☒☐☐☐☐ Conductor Type: Romex
7. ☒☐☐☐☐ Ground: Rod in ground only

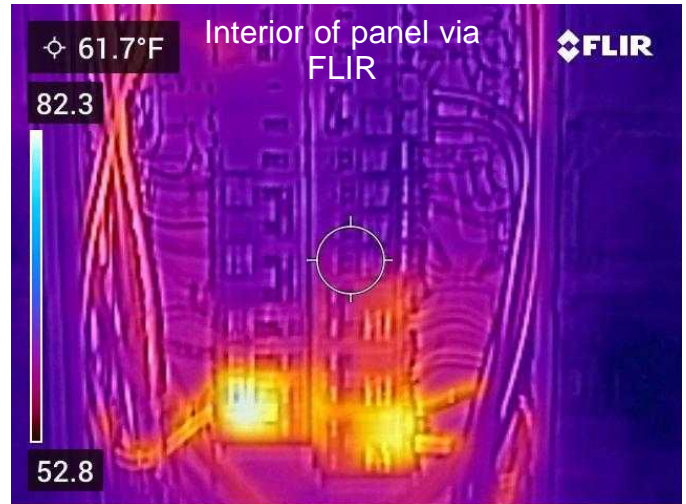
8. ☒☐☐☐☐ Manufacturer: Square D - There were no elevated heat levels per infrared photography. Although there may be yellow/orange present, the temperature indicator on left of photo indicates that none of these levels are elevated.

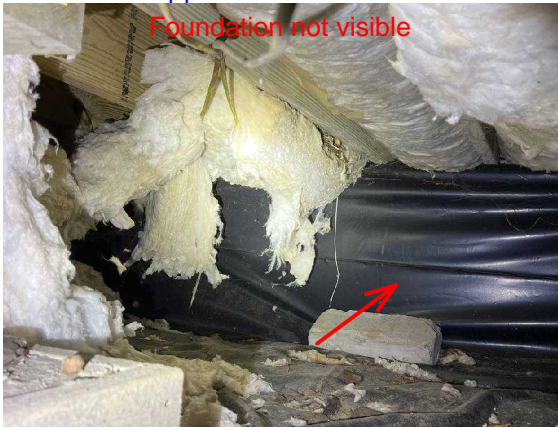
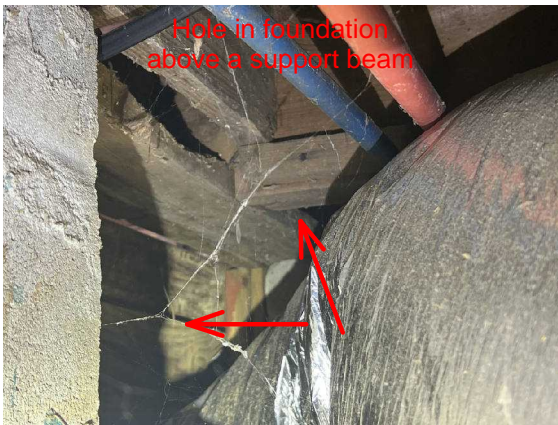
1. ☒ ☐ ☐ ☐ ☐ Structure Type: Wood frame
2. ☒ ☐ ☒ ☒ ☐ Foundation: Block - A large section of the foundation wall is not visible as inspectors view was blocked by a vapor barrier that is covering the wall. Consequently, this wall could not be observed.

However, there was a hole knocked in the foundation wall for the package HVAC unit ductwork. This is not uncommon. However, this is the same area that supports one of the support beams. Recommend consultation with a qualified contractor for further evaluation and to install additional support.

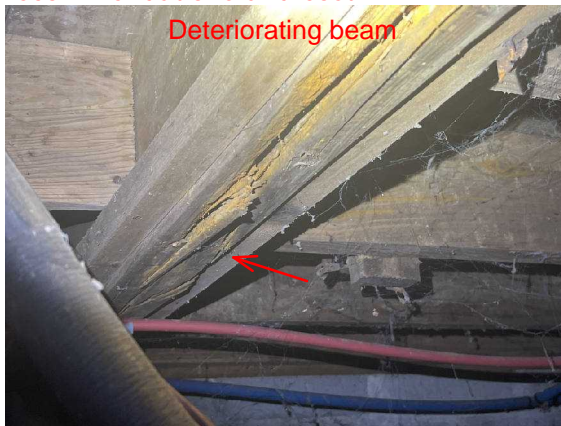
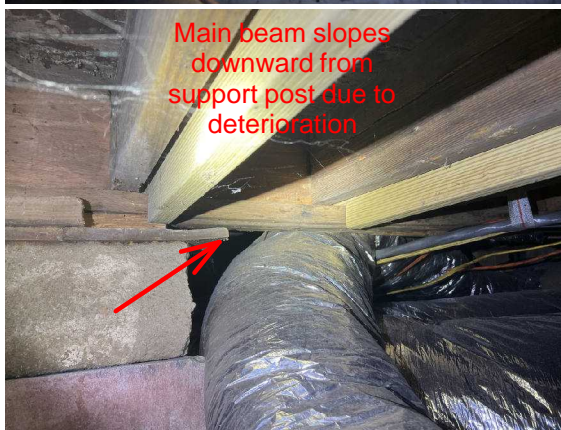
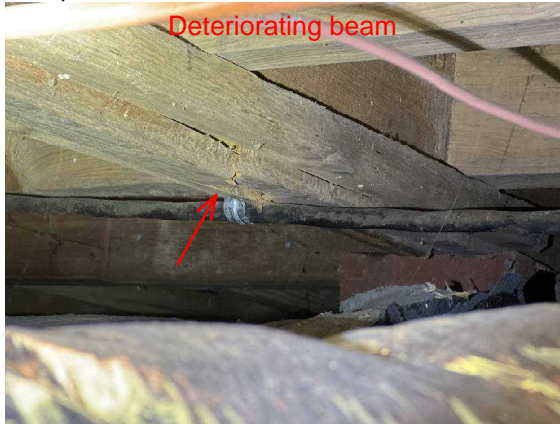
3. ☐ ☐ ☐ ☒ Beams: Solid wood - There is damage to several support beams under the laundry and bedroom areas of the main floor. This damage appears to be from moisture and also possible wood destroying organisms. There is also deterioration to the pieces of wood on top of block support posts that support the beam.

There has been a package heating and air unit installed, and a large hole was cut in the foundation wall. This is not unusual, however, a main support beam rest on the wall that was removed.

There has been a significant amount of repair work done in the crawlspace, however, some of these newer joists were attached to a beam that appears to be deteriorating.

This damage is possibly the cause of the sloping floors mentioned later in the report.

Recommend consultation with a qualified contractor for further evaluation and for repair recommendations and cost.

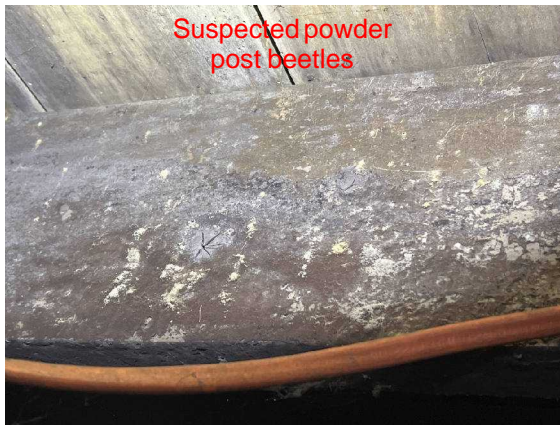
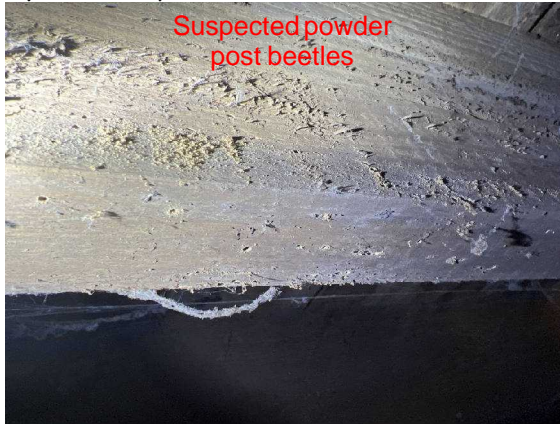
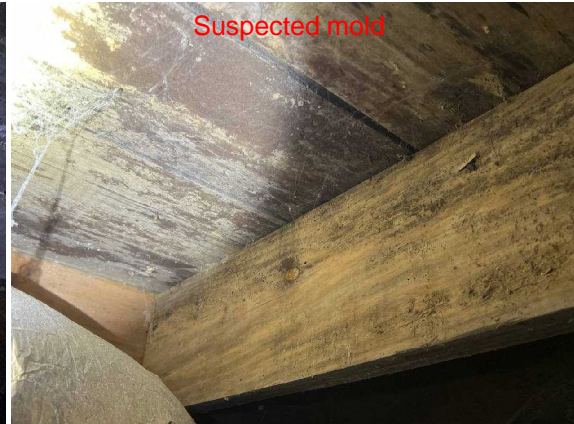
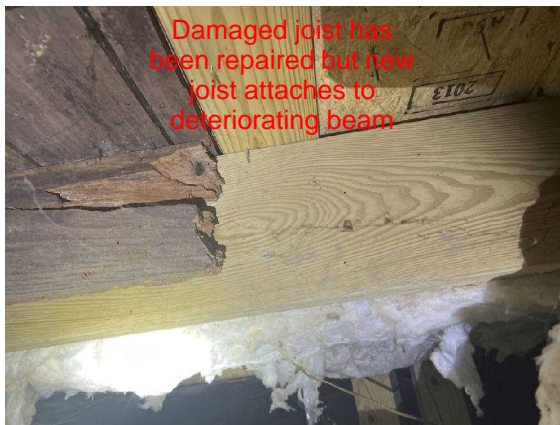
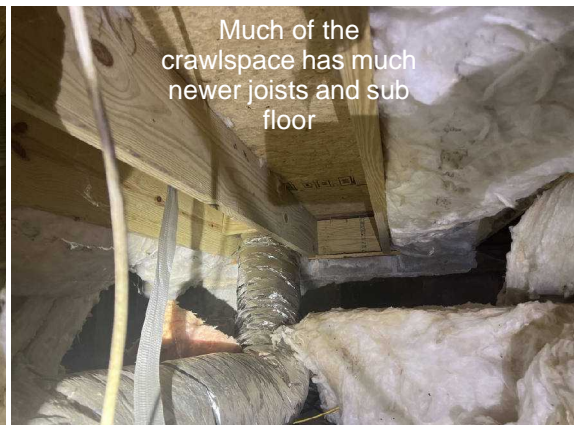
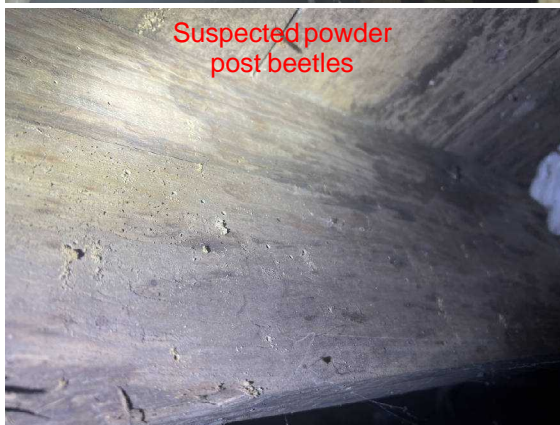
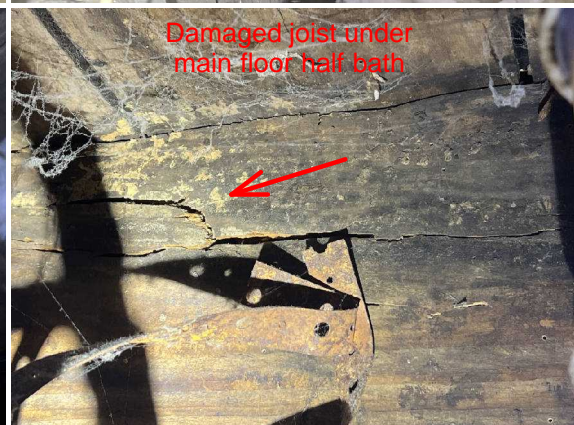
4. ☐ ☐ ☐ ☒ ☐ Joists/Trusses: 2x8 - There is evidence of powder post beetles on numerous joists and beams.

There is a cracked joist under the laundry room area that will need to be repaired.

Some of the newer joists have been attached the a deteriorating beam (see photos above).

Recommend further evaluation and repair by a qualified contractor. Also recommend consultation with a pest control company for treatment options.

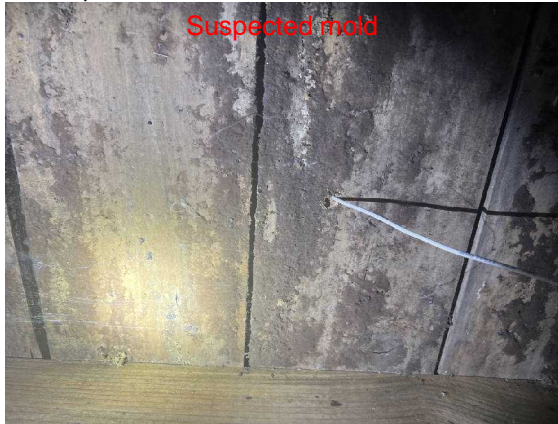
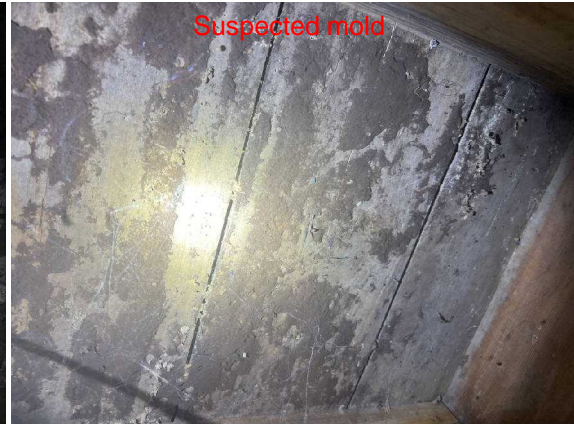
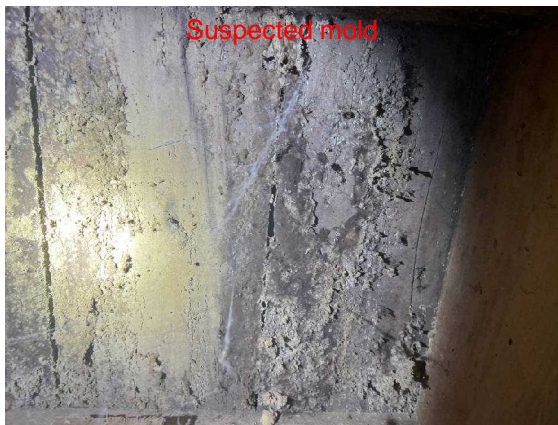
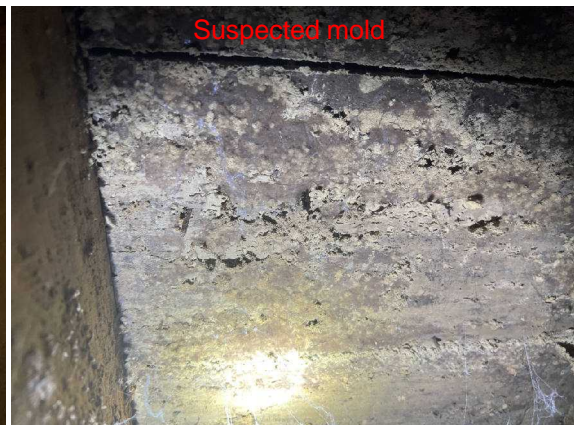
Subfloor: (continued)

7. ☐☐☐☒☐ Subfloor: Dimensional wood - The sub floor appears to have been replaced in some areas.

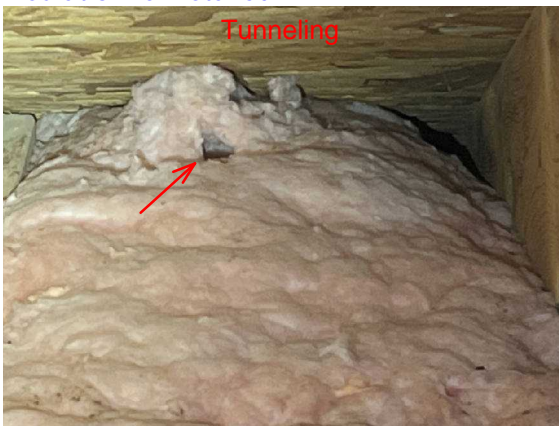
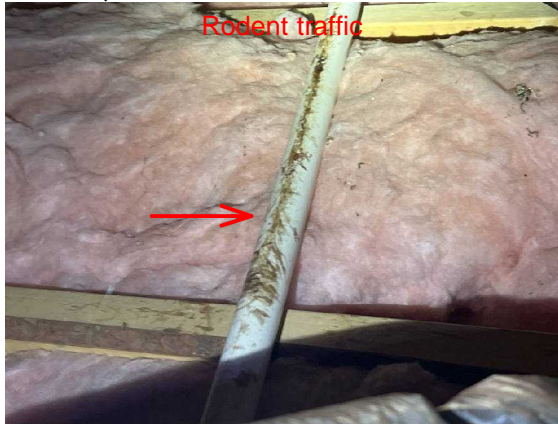
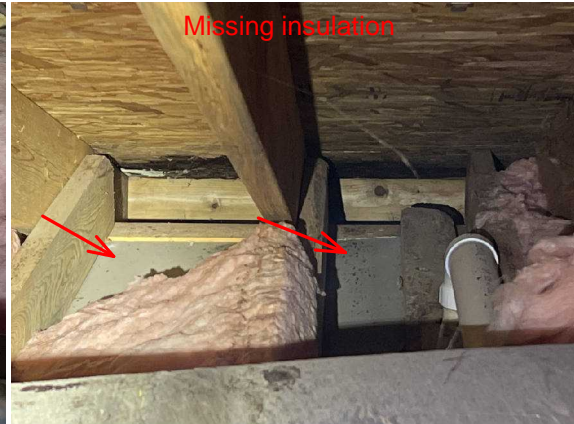
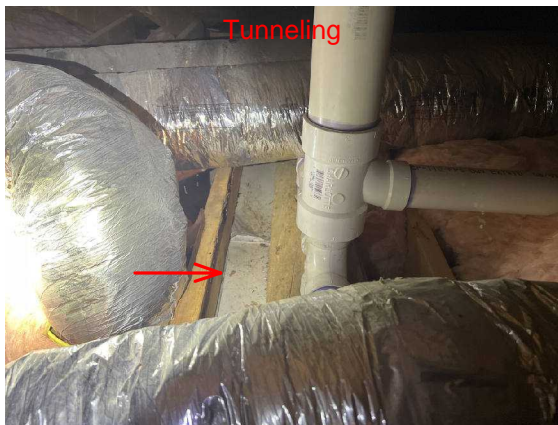
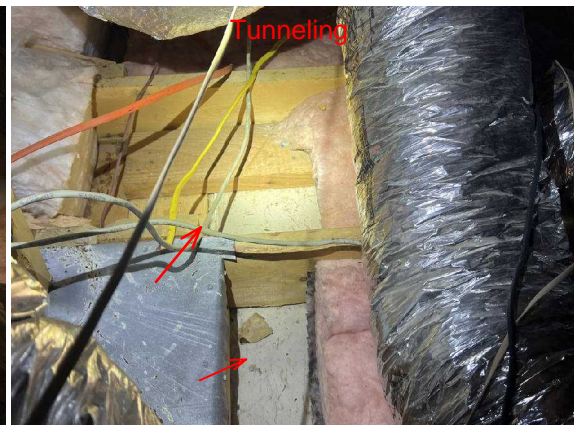
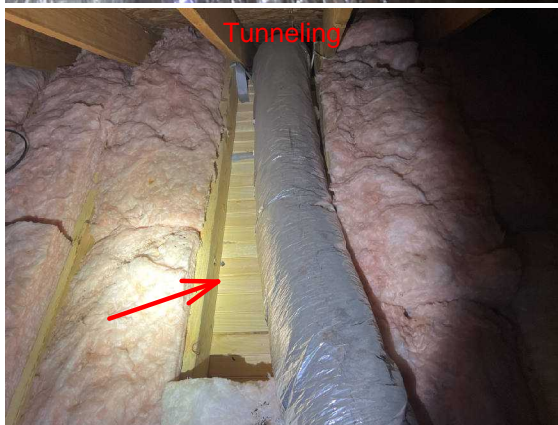
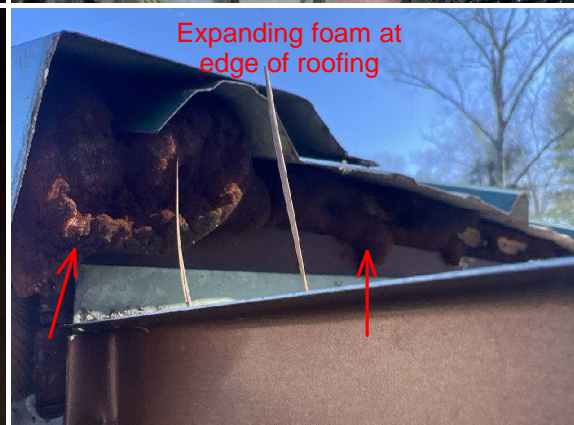
Insulation: (continued)

5. ☒ ☐ ☐ ☒ ☐ Insulation: Fiberglass - There were some signs of rodents in the attic. That was tunneling in the insulation and evidence of rodent traffic around the condensate line. It is unknown if this is a current problem or occurred in the past. Expanding foam insulation has been installed in an apparent attempt to keep the rodents out of the attic. However, rodents can chewed through foam insulation. Recommend consultation with a pest control company for further evaluation and recommendations (there may already be a contract on the house as there are commercial rodent bait stations on exterior-recommend asking seller).

There are also a few areas of missing insulation. Energy efficiency can be increased if additional insulation is installed.

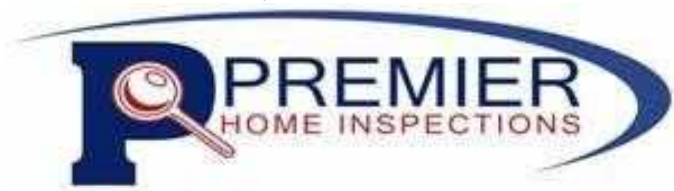
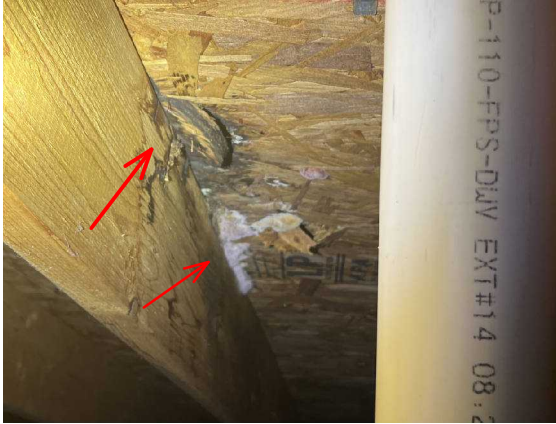
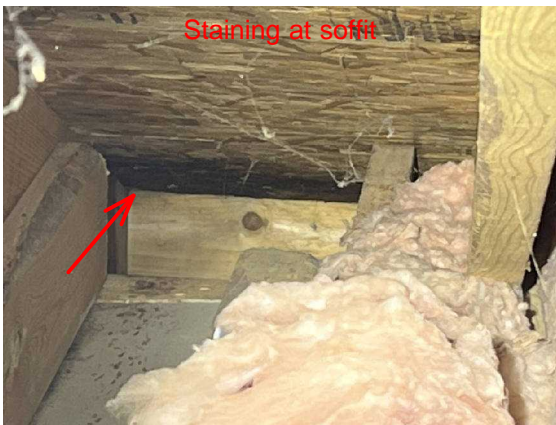
Moisture Penetration: (continued)

7. ☐☐☐☒ Moisture Penetration: Ongoing water penetration noted - There is an active roof leak above the second floor bathroom area. This area tested with elevated moisture levels per moisture meter and is likely the result of the staining in the ceiling in that bathroom mentioned later in the report. There is also some staining near the soffit. However, inspector is unable to reach this area due to lack of access to check to see if it is active per moisture meter.

Recommend consultation with a roofer for further evaluation of the roof and to make any needed repairs.

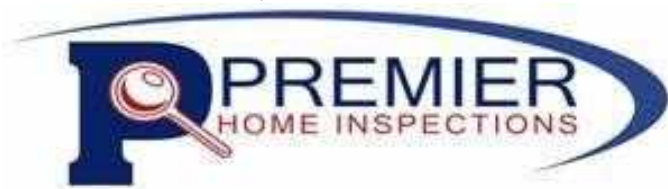
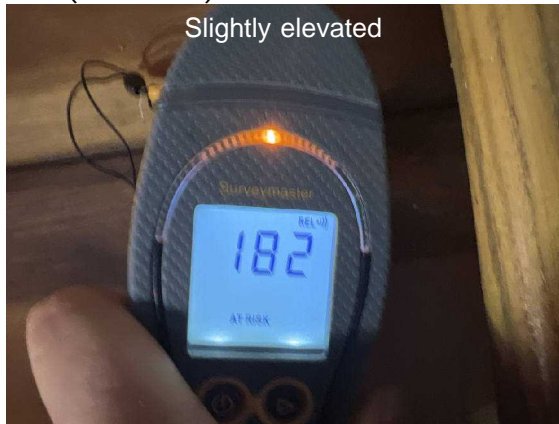
Moisture Location: (continued)

2. ☒ ☐ ☐ ☐ ☐ Walls: Concrete, Wood
3. ☒ ☐ ☐ ☐ ☐ Floor: Poured
4. ☒ ☐ ☐ ☐ ☐ Doors: Metal
5. ☒ ☐ ☐ ☐ ☐ Windows: Metal frame insulated
6. ☒ ☐ ☐ ☐ ☐ Electrical: 110 VAC outlets and lighting circuits
7. ☐ ☒ ☐ ☐ ☐ Smoke Detector:
8. ☒ ☐ ☐ ☐ ☐ HVAC Source: Heating and Cooling system register
9. ☒ ☐ ☐ ☐ ☐ Ventilation: Windows
10. ☒ ☐ ☐ ☒ ☐ Moisture Location: At foundation - There are some signs of moisture intrusion in the corner of the basement area.

This area test is slightly elevated with moisture contact. No obvious reasons noted, but possibly caused by clogged gutters (mentioned earlier in the report) causing water to overflow and fall at base of foundation. This is only a hypothesis and cannot be guaranteed.

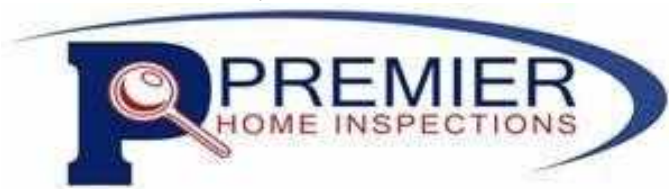
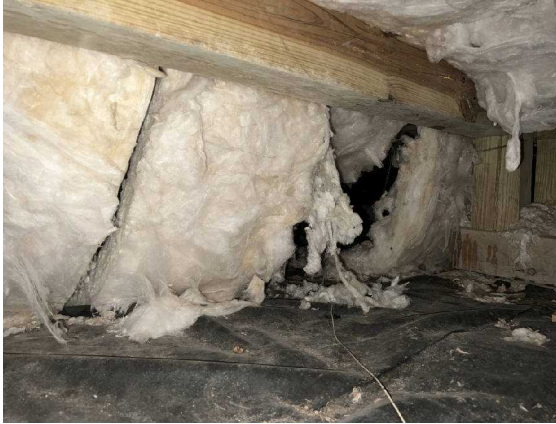
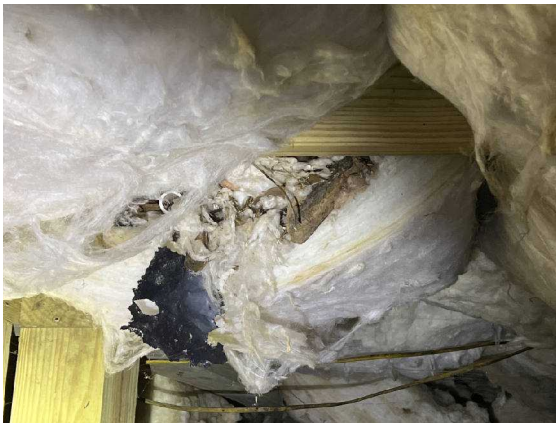
Insulation: (continued)

1. Method of Inspection: In the crawl space
2. ☒ ☐ ☐ ☐ ☐ Access: Door
3. ☐ ☒ ☐ ☐ ☐ Moisture Penetration:
4. ☐ ☒ ☐ ☐ ☐ Ventilation:
5. ☐ ☒ ☐ ☒ ☐ Insulation: Fiberglass - There is no insulation under the bedrooms and laundry room on the main floor.

However, there is insulation in the other (repaired areas with newer wood) areas of the crawlspace. However, this insulation is falling in numerous areas due to rodent activity.

There is evidence of rodent bait stations as well as hardware cloth that has been installed to help keep rodents away. It is unknown if this is a current problem or occurred in the past. Recommend asking seller about any rodent control they have in place and if a professional pest control company is servicing this house.

Recommend any falling insulation be replaced. The falling insulation did block view of some areas of crawlspace.

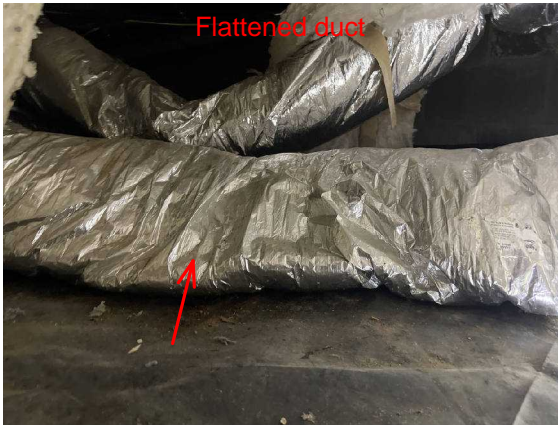
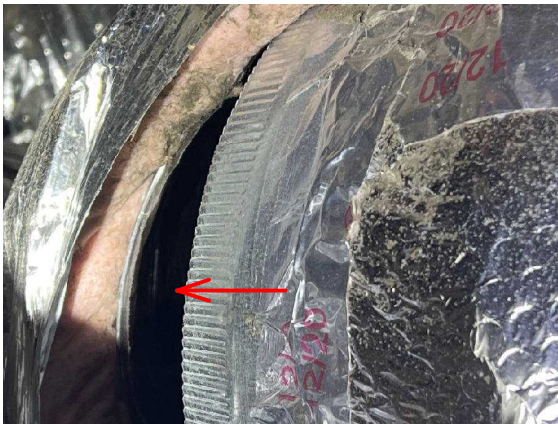
8. ☐☐☐☒☐ Distribution: Insulflex duct - There is some damage to the supply line duct in a few areas the crawlspace, allowing heated air to be vented into the crawlspace. There is also some damage to the ductwork likely caused by workers in the crawlspace. This duct has been flattened.

Recommend consultation with an HVAC contractor for repair.

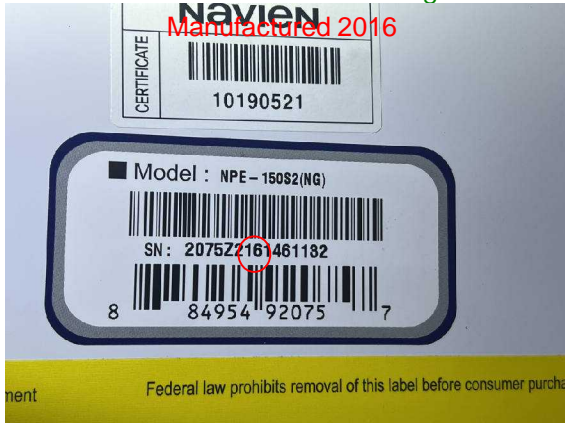
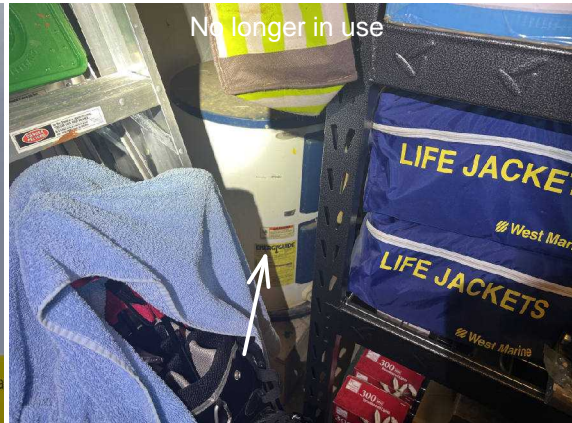
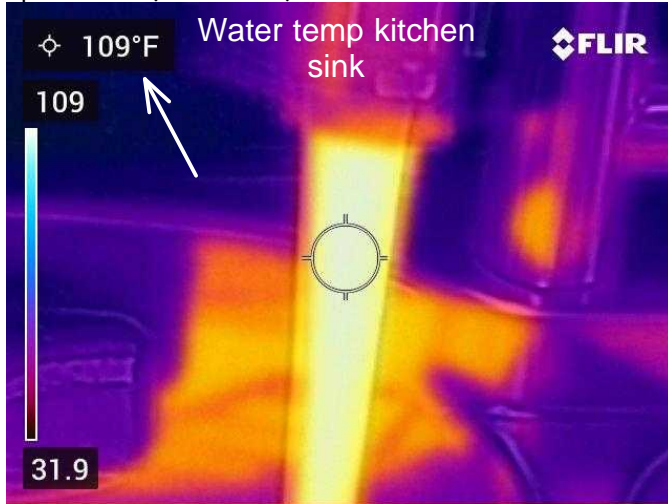
Water Heater Operation: (continued)

6. ☒☐☐☐☐ Water Heater Operation: Functional at time of inspection - The water heater is functional at time of inspection and is 6 years old.

The older water heater is no longer in use.

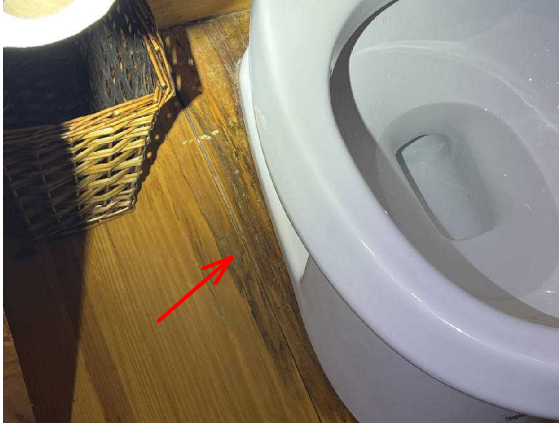
Floor: (continued)

- 1. ☒ ☐ ☐ ☐ ☐ Closet:
- 2. ☒ ☐ ☐ ☐ ☐ Ceiling: Wood
- 3. ☒ ☐ ☐ ☐ ☐ Walls: Wood
- 4. ☒ ☐ ☐ ☒ ☐ Floor: Wood - There is some minor damage to the floor around the toilet. This area tested slightly elevated with moisture. This toilet is loose and this may be resulting in some minor leak. Recommend this toilet have a new wax ring installed and the toilet reset and properly secured.

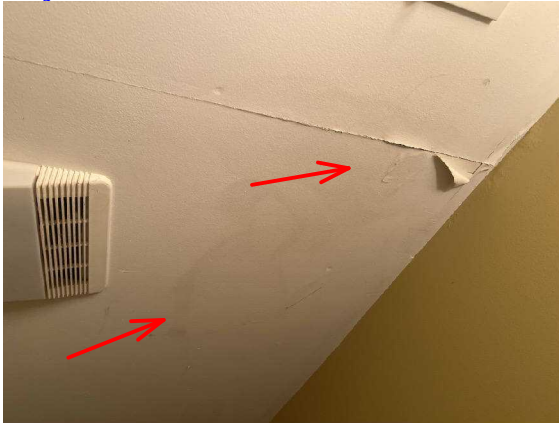
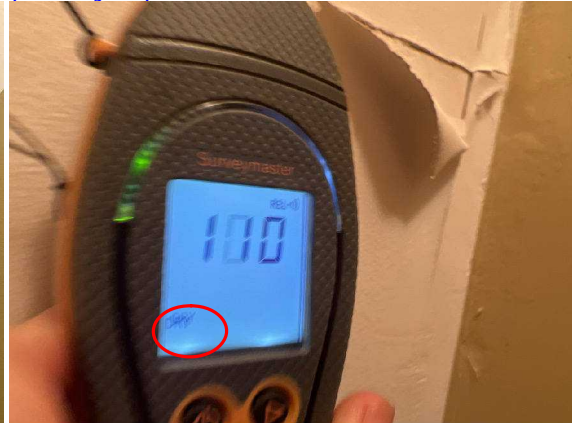
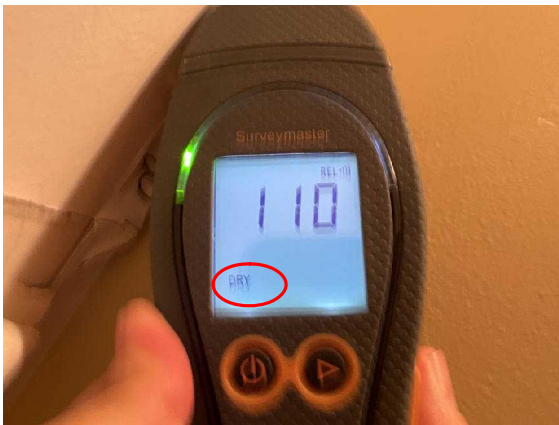
42. ☐☐☐☒☐ Ceiling: Painted drywall - There is some staining and separation at the drywall seam in the ceiling. This is likely the result of the leak in attic mentioned earlier in the report. This area tested within normal limits of the moisture meter, but the leak is still active and this staining may have occurred before the leak was temporarily repaired.

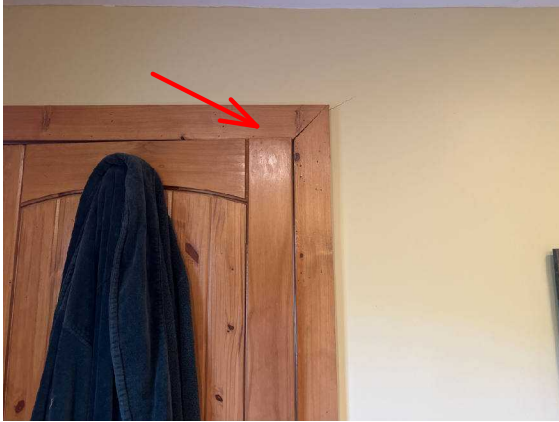
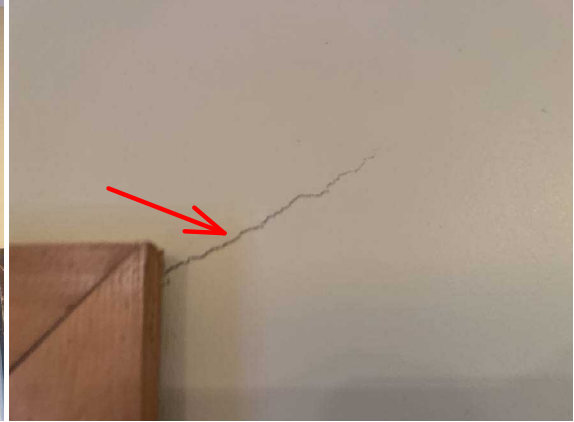
55. ☐☒☐☐☐ Closet:  
56. ☒☐☐☐☐ Ceiling: Painted drywall  
57. ☒☐☐☐☐ Walls: Painted drywall  
58. ☒☐☐☐☐ Floor: Tile  
59. ☒☐☐☒☐ Doors: Wood - The door into the master bathroom will not shut properly and rubs the frame. There is cracking in the drywall at this store, which indicates some possible minor settlement. Possibly the result of the problems mentioned earlier in the report. Recommend the door be adjusted.

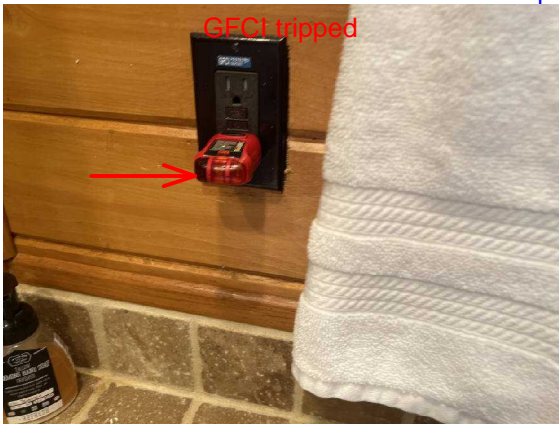
61. ☒ ☐ ☐ ☒ ☐ Electrical: 110 VAC outlets and lighting circuits, 110 VAC GFCI - The GFCI receptacle in the master bathroom is tripped and will not reset. This is likely the reason that the lights in the shower also do not work. Recommend repair.

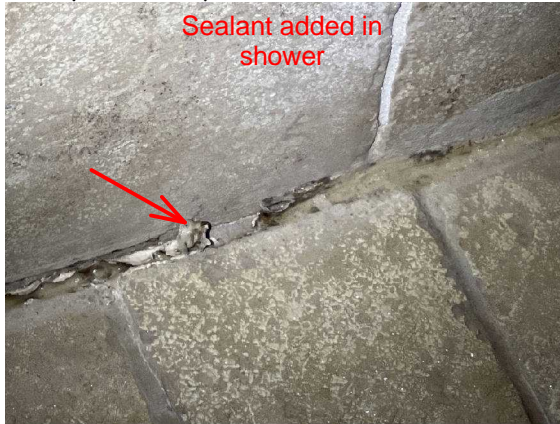
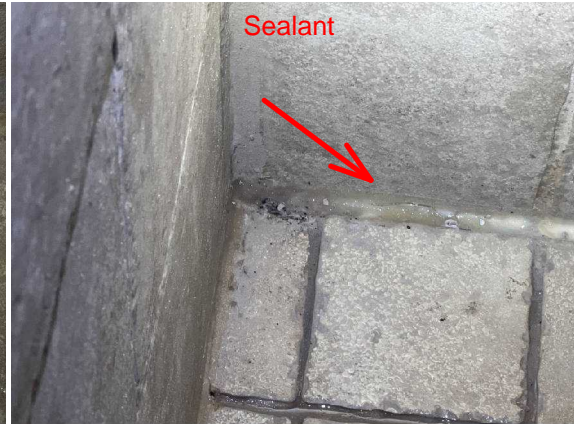
64. ☐ ☐ ☐ ☒ ☐ Shower/Surround: Tile - There is evidence that additional sealant has been installed at the shower, floor and wall. It is suspected that this may be the result of settlement mentioned in the report. This type of sealant is only a temporary repair, and any leaking could result in damage to sub floor and ceiling below. Recommend consultation with a qualified contractor for further evaluation, and to make a more permanent repair.

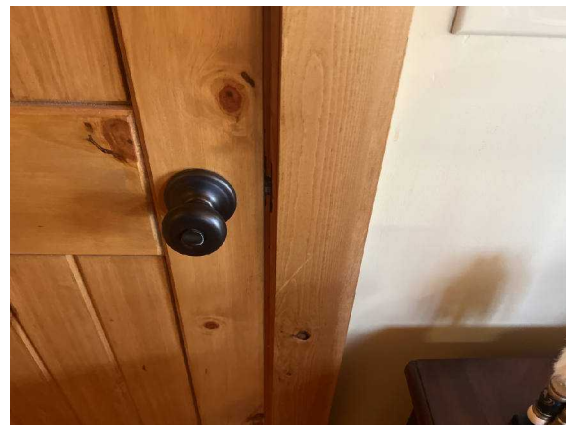
23. ☒☐☐☒☐ Doors: Wood - Lockset(s) not latching-requires adjustment

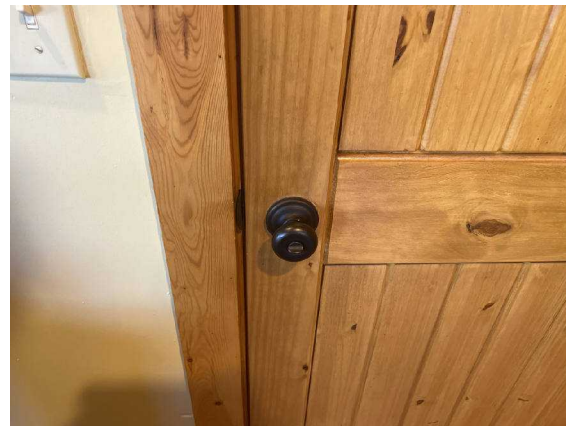
28. ☒☐☐☐☐ Closet: Single  
29. ☒☐☐☐☐ Ceiling: Wood  
30. ☒☐☐☐☐ Walls: Wood, Painted drywall  
31. ☒☐☐☐☐ Floor: Wood  
32. ☒☐☐☐☐ Doors: Wood - Lockset(s) not functioning-requires adjustment.

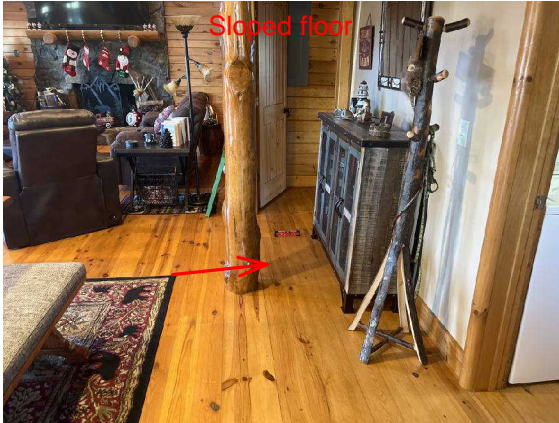
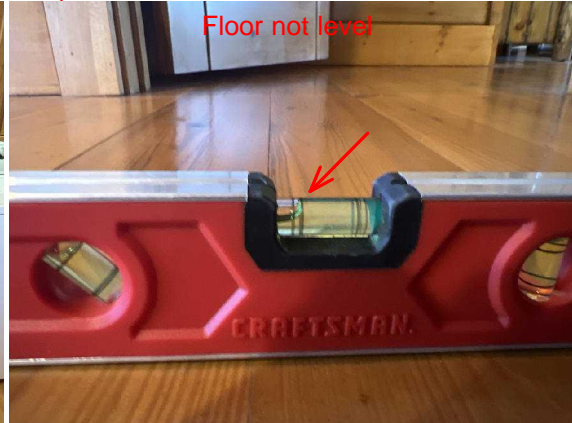
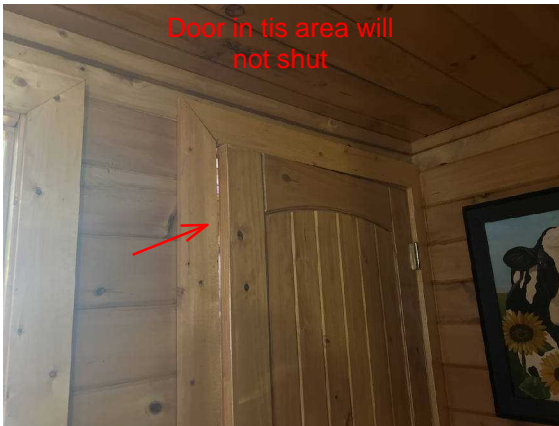
4. ☐☐☐☒☐ Floor: Wood - There is a downward slope to the floor near the entrance to the bedroom and laundry room areas. The door into the bedroom will not shut properly. This is likely the result of the structural issues mentioned earlier in the report.

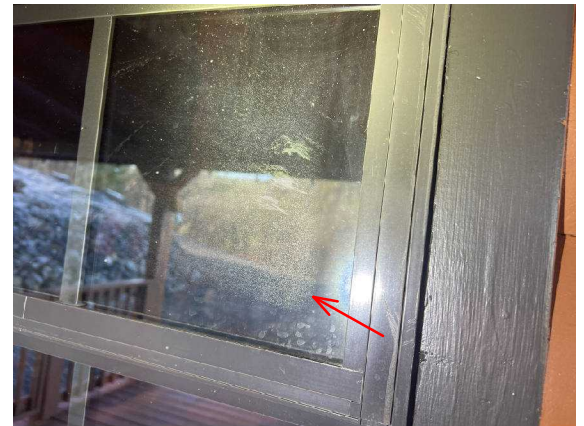
5. ☒☐☐☐☐ Doors: Wood  
6. ☒☐☐☒☐ Windows: Metal frame insulated - There is some minor fogging between the panes of glass on a few of the windows. This is not unusual over time with insulated windows.

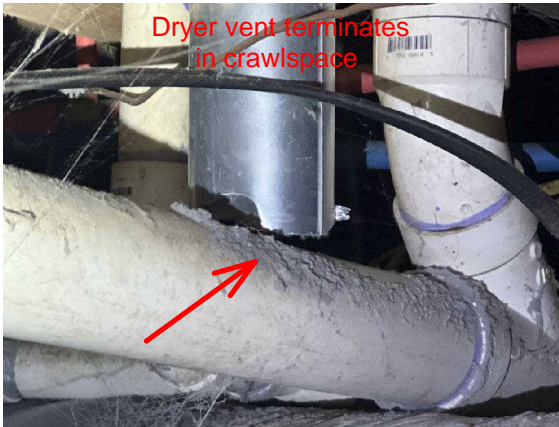
13. ☐☐☐☐☒ Dryer Vent: Rigid metal - The dryer vent terminates in the crawlspace. This has resulted in lint and moisture being blown into the crawlspace. This can lead to increase chances of mold and wood destroying organisms. Recommend this dryer vent be extended to the exterior and any lint cleaned as lint is flammable.

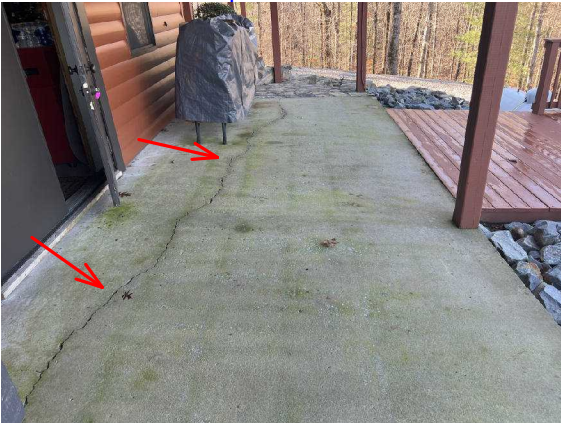
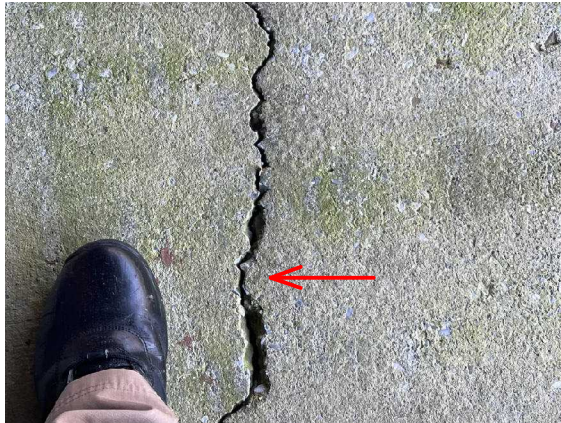
1. Patio: Concrete - There has been some settlement at the patio. This settlement has resulted in a crack of about 1/4 inch with some slight displacement. This is likely resulted in some minor settlement of the deck support post. It is unknown if this patio will continue to settle. Recommend sealing crack and monitoring. Should condition continue to worsen then recommend consultation with a qualified contractor for further evaluation and repair.

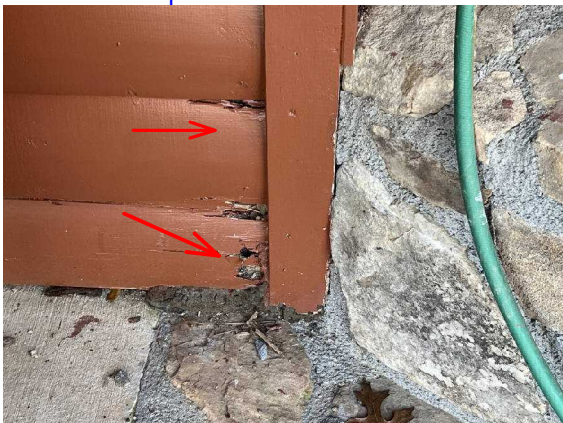
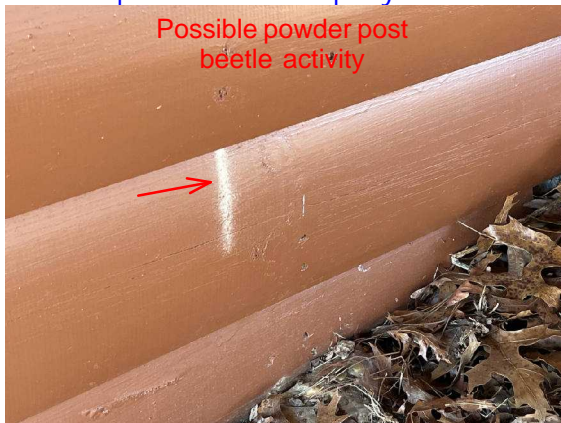
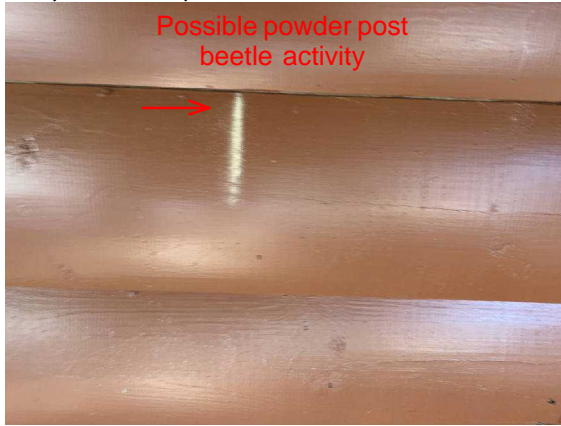
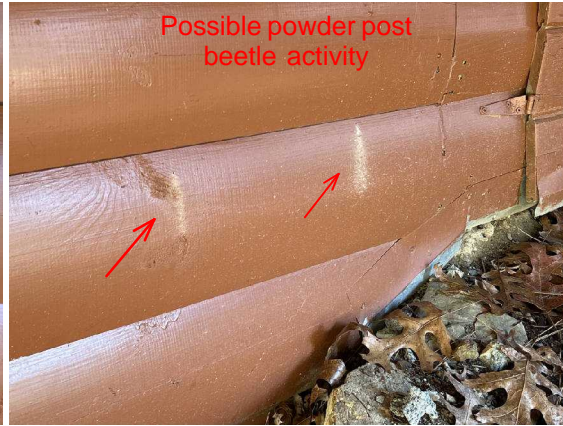
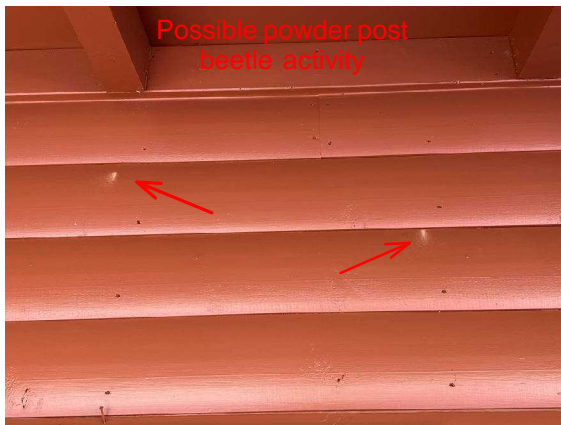
2. Exterior siding Exterior Surface Type: Wood - There is some deterioration to the siding near the rear right retaining wall. It is possible this was the result of wood destroying organisms. Recommend consultation with a pest control company for further evaluation. Recommend any deteriorating siding be replaced.

There is also evidence of suspected powder post beetles in the siding near the entrance to the crawlspace area and at front porch. Recommend consultation with a pest control company for further evaluation and treatment.

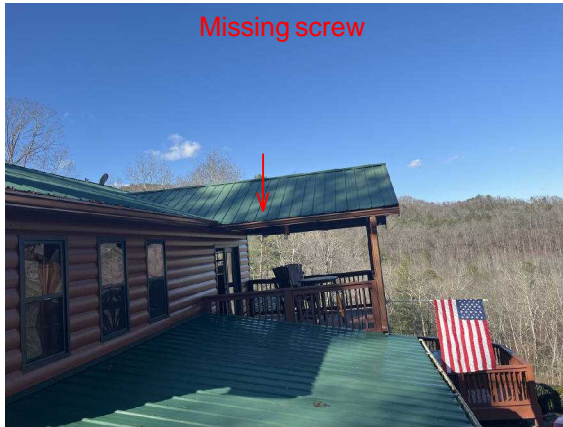
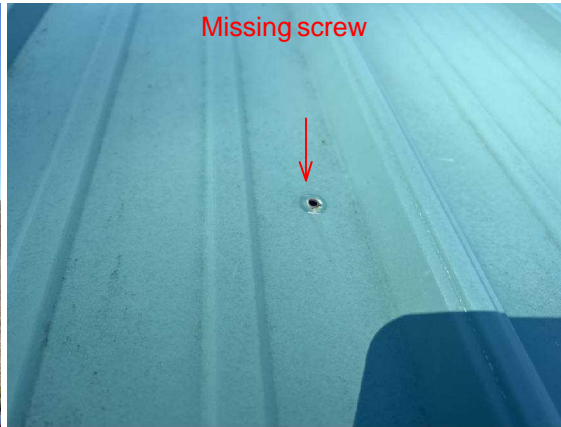
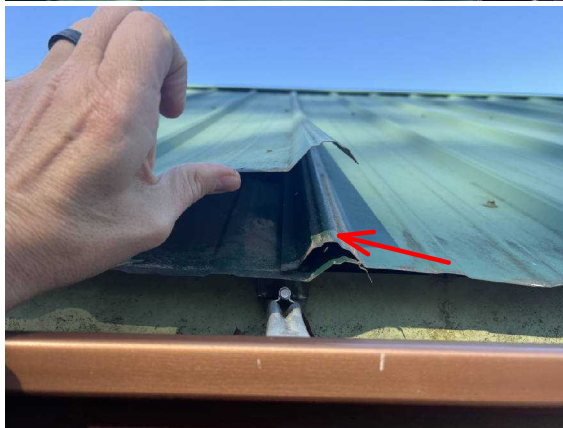
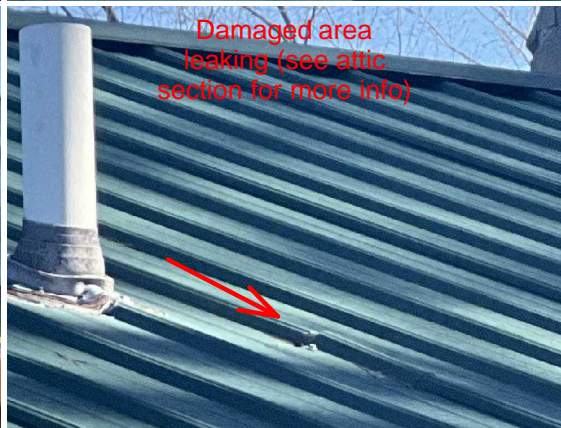
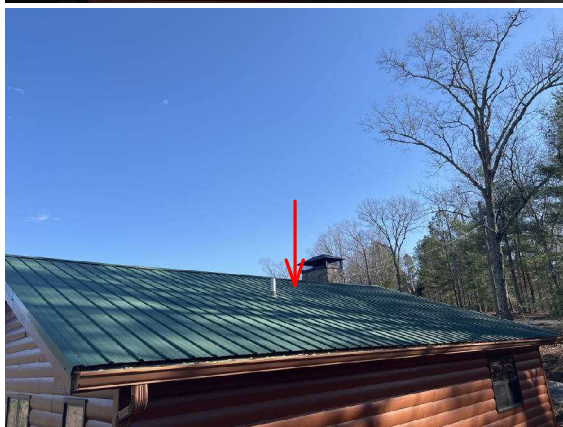
4. Main Roof Surface Material: Metal - There is a missing screw at the metal roof panel near the upper floor deck. The edge of this panel can easily be lifted by hand.

There is also a damaged area of metal roofing near the PVC event that is leaking. It appears this has been

repaired with sealant, which will only be a temporary repair.

Recommend consultation with a roofer for further evaluation of the roof and to make any needed repairs.

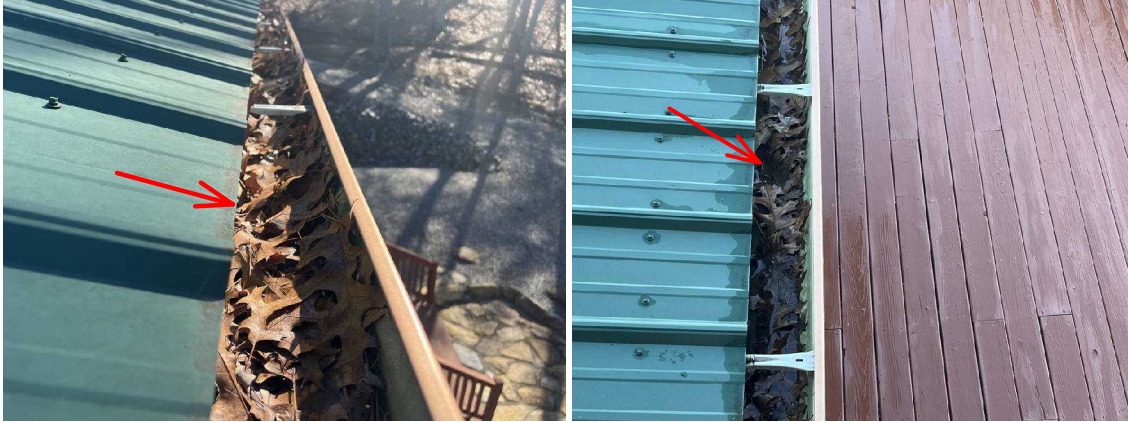
5. Gutters: Aluminum - The gutters are clogged with leaves and then to be cleaned.

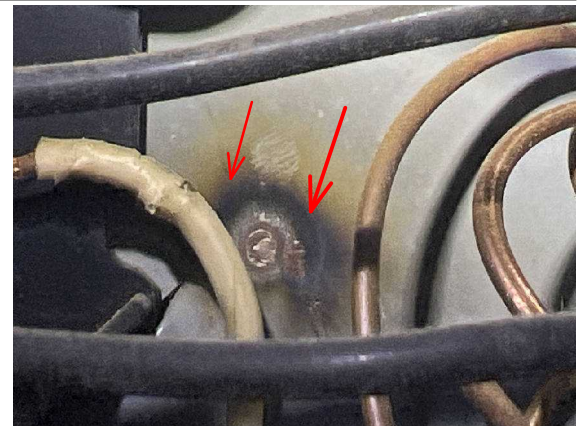
6. 120 VAC Branch Circuits: Copper - There is some evidence of some POSSIBLE arcing add the neutral wire in the panel. It is unknown if this is a current issue or occurred in the past. No arcing detected at time of inspection further evaluation by an electrician is suggested.

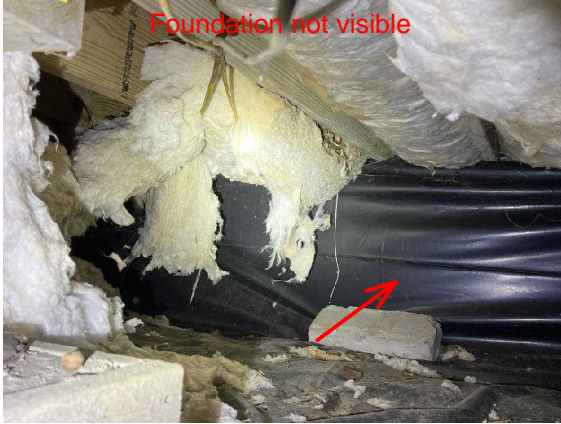
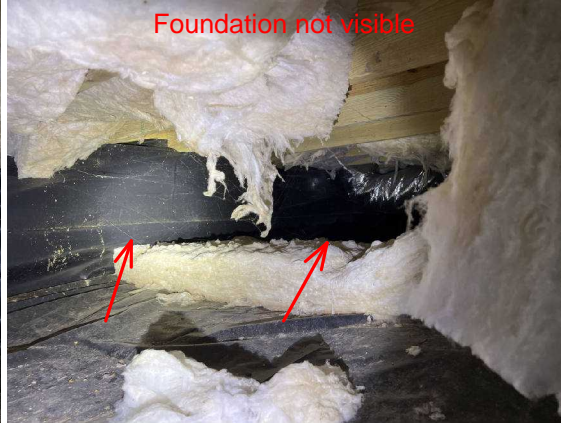
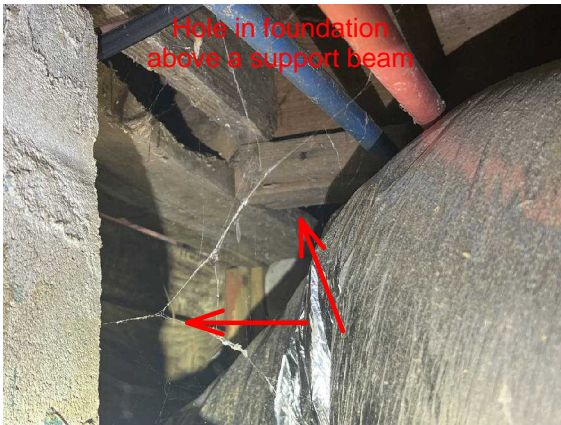
9. Foundation: Block - A large section of the foundation wall is not visible as inspectors view was blocked by a vapor barrier that is covering the wall. Consequently, this wall could not be observed.

However, there was a hole knocked in the foundation wall for the package HVAC unit ductwork. This is not uncommon. However, this is the same area that supports one of the support beams. Recommend consultation with a qualified contractor for further evaluation and to install additional support.

Some of the newer joists have been attached the a deteriorating beam (see photos above).

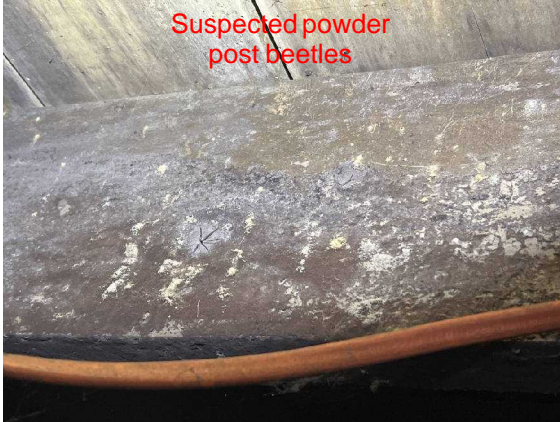
10. Joists/Trusses: 2x8 - There is evidence of powder post beetles on numerous joists and beams.

Suspected powder  
post beetles

Recommend further evaluation and repair by a qualified contractor. Also recommend consultation with a pest control company for treatment options.

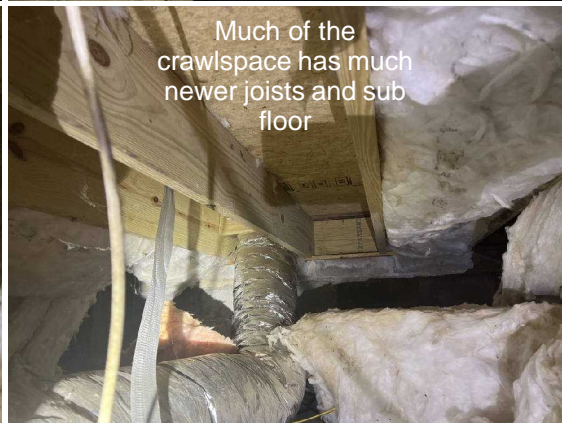
Damaged joist has  
been repaired but new  
joist attaches to  
deteriorating beam

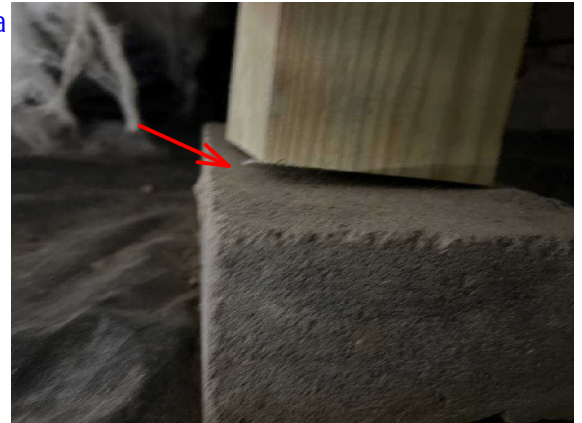
11. Piers/Posts: Wood - The wood support post near the fireplace area is no longer touching the footer. Recommend repair.
