# Home Inspection Report

123 Main St  
Anytown, GA

# Premier Home Inspections

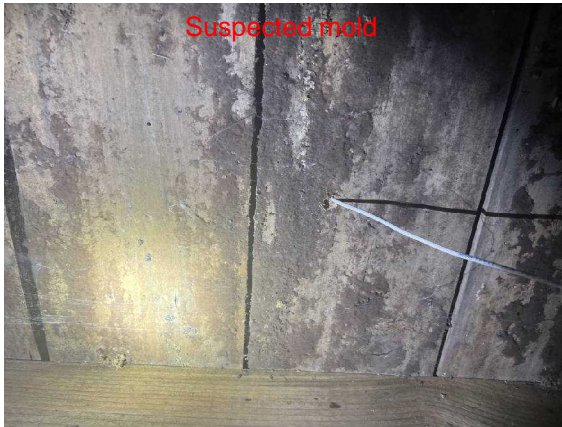
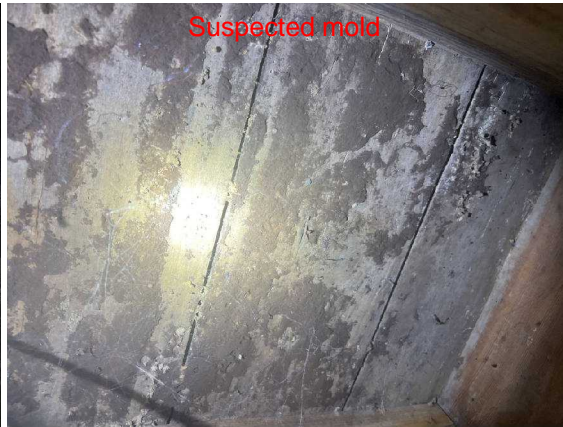
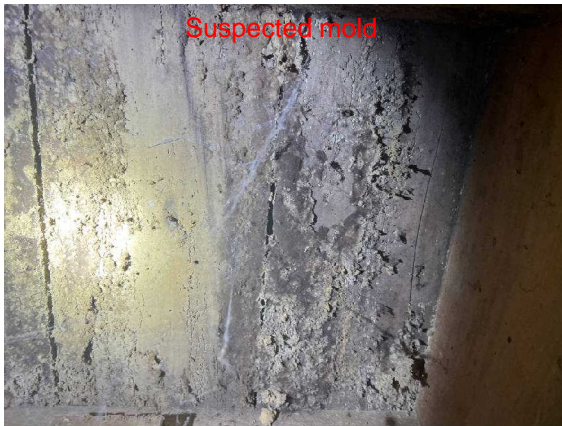
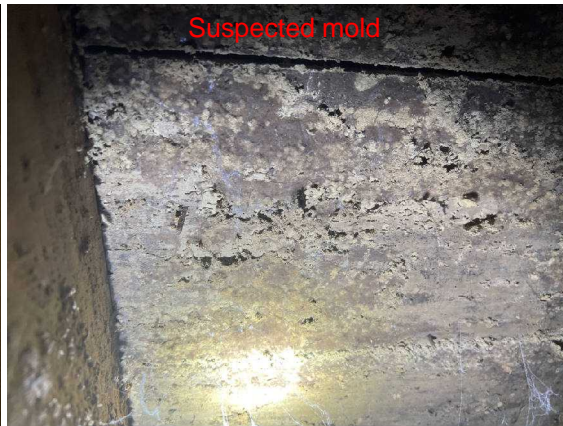
13. Subfloor: Dimensional wood - The sub floor appears to have been replaced in some areas.

This mold will need to be cleaned. Inspector is certified to do air quality testing and can return to do the testing for an additional charge of \$350 as there are equipment and lab fees involved.

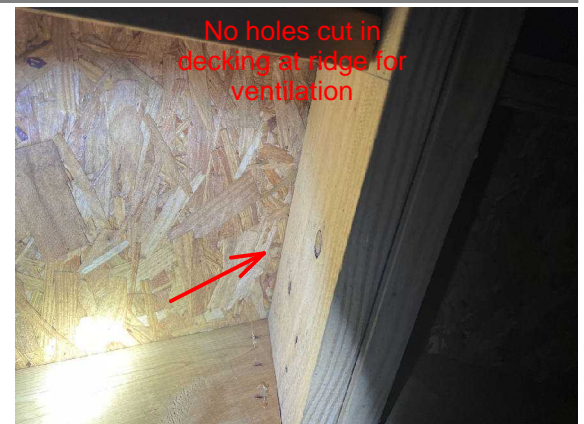
14. Main Attic Ventilation: There was no ventilation in the attic. Any soffit vents are blocked by insulation and the decking for the ridge vent was not properly cut to allow for air to escape. Recommend consultation with the roofer for further evaluation and to install proper ventilation.

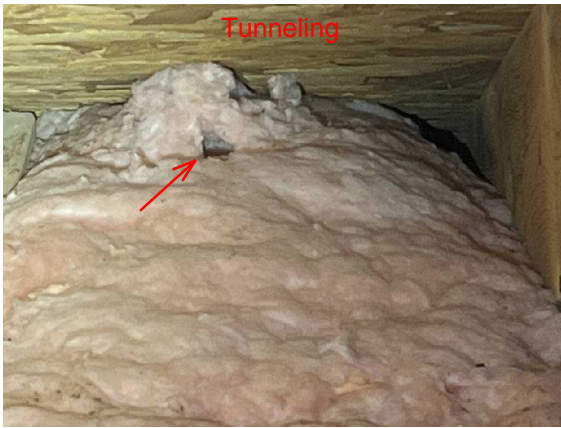
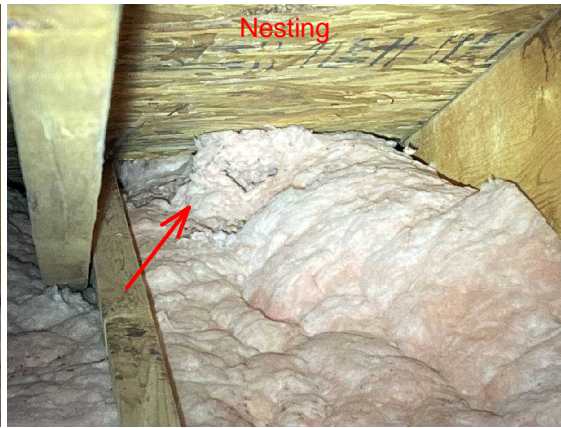
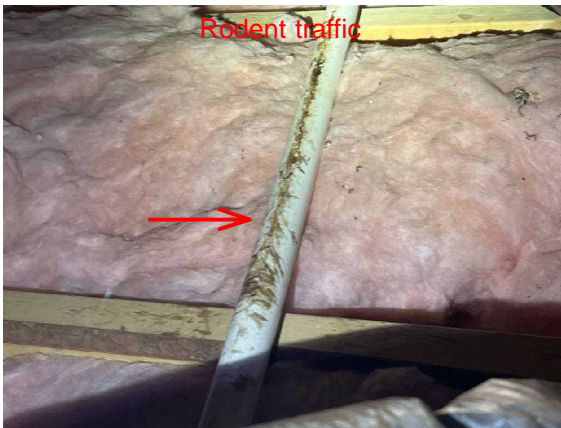
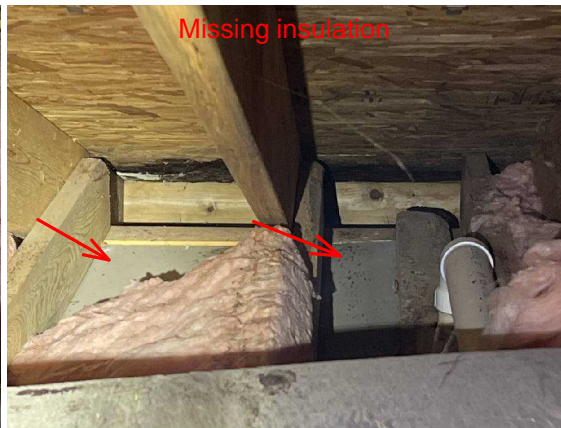
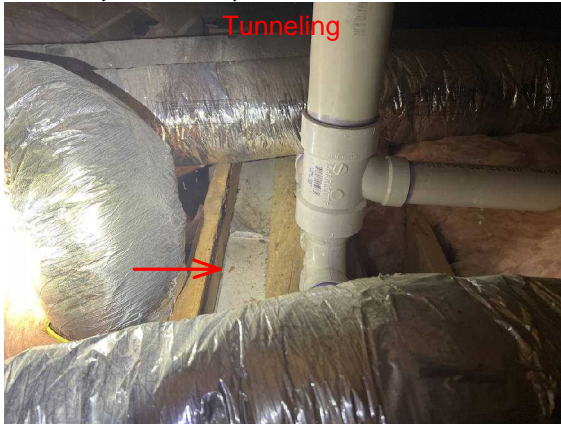
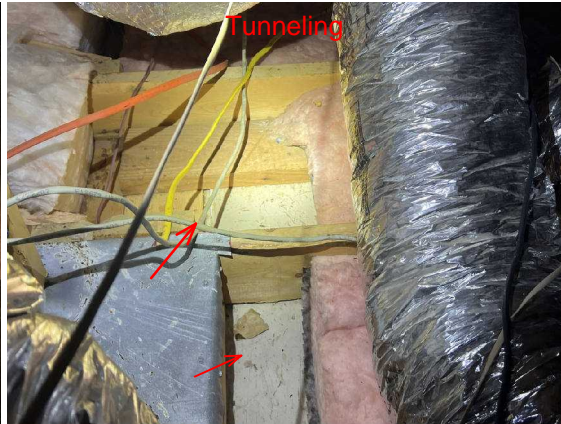
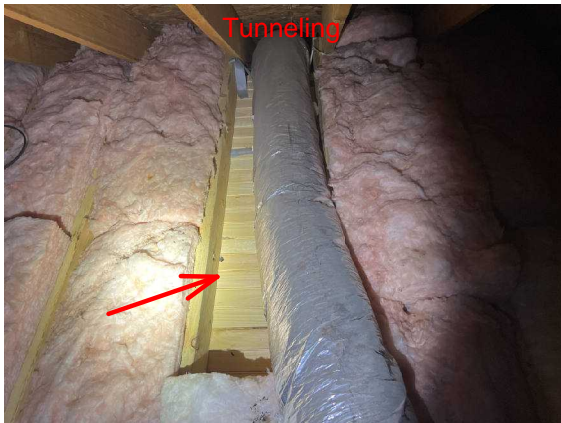
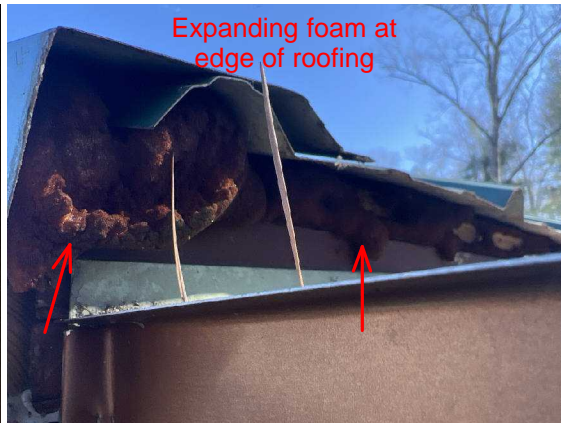
15. Main Attic Insulation: Fiberglass - There were some signs of rodents in the attic. That was tunneling in the insulation and evidence of rodent traffic around the condensate line. It is unknown if this is a current problem or occurred in the past. Expanding foam insulation has been installed in an apparent attempt to keep the rodents out of the attic. However, rodents can chewed through foam insulation. Recommend consultation with a pest control company for further evaluation and recommendations (there may already be a contract on the house as there are commercial rodent bait stations on exterior-recommend asking seller).

There are also a few areas of missing insulation. Energy efficiency can be increased if additional insulation is installed.

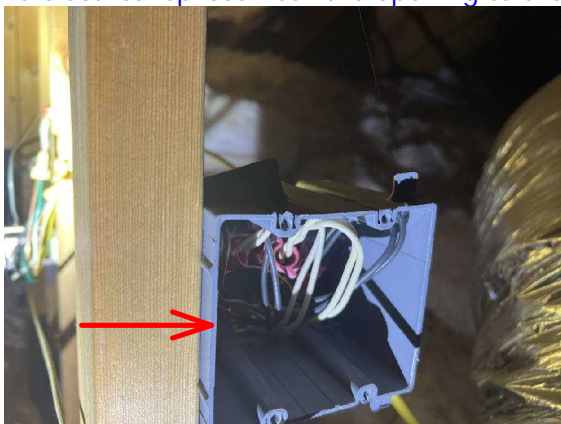
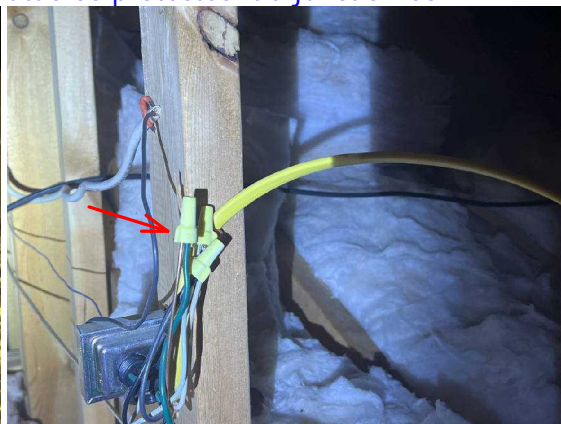
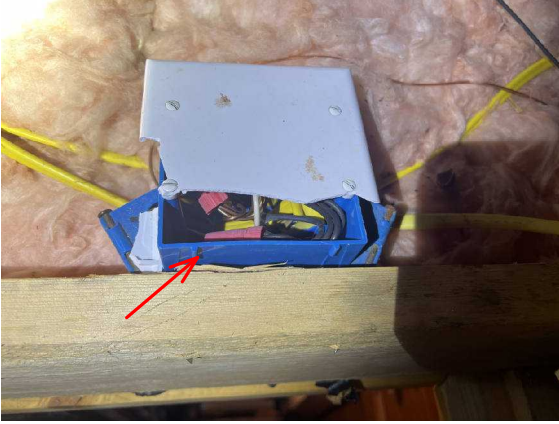
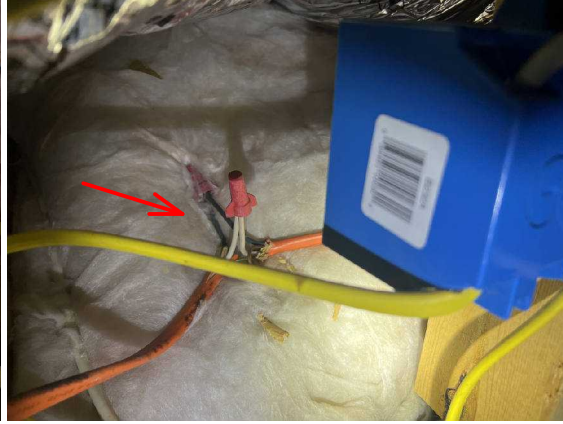
16. Main Attic Wiring/Lighting: 110 VAC - Recommend all junction boxes have covers installed. Also, recommend the electrical splices near the opening to the attic be protected it a junction box.

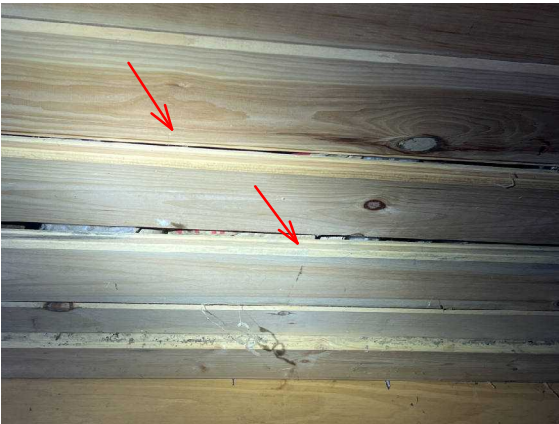
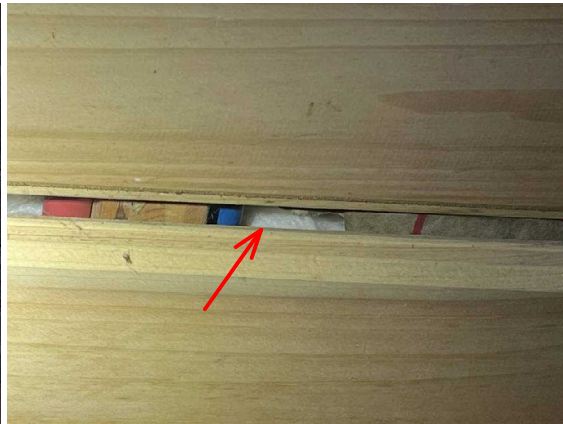
17. Main Basement Ceiling: Wood - The tongue and groove ceiling in basement is pulling away in a few areas and needs to be re-secured.

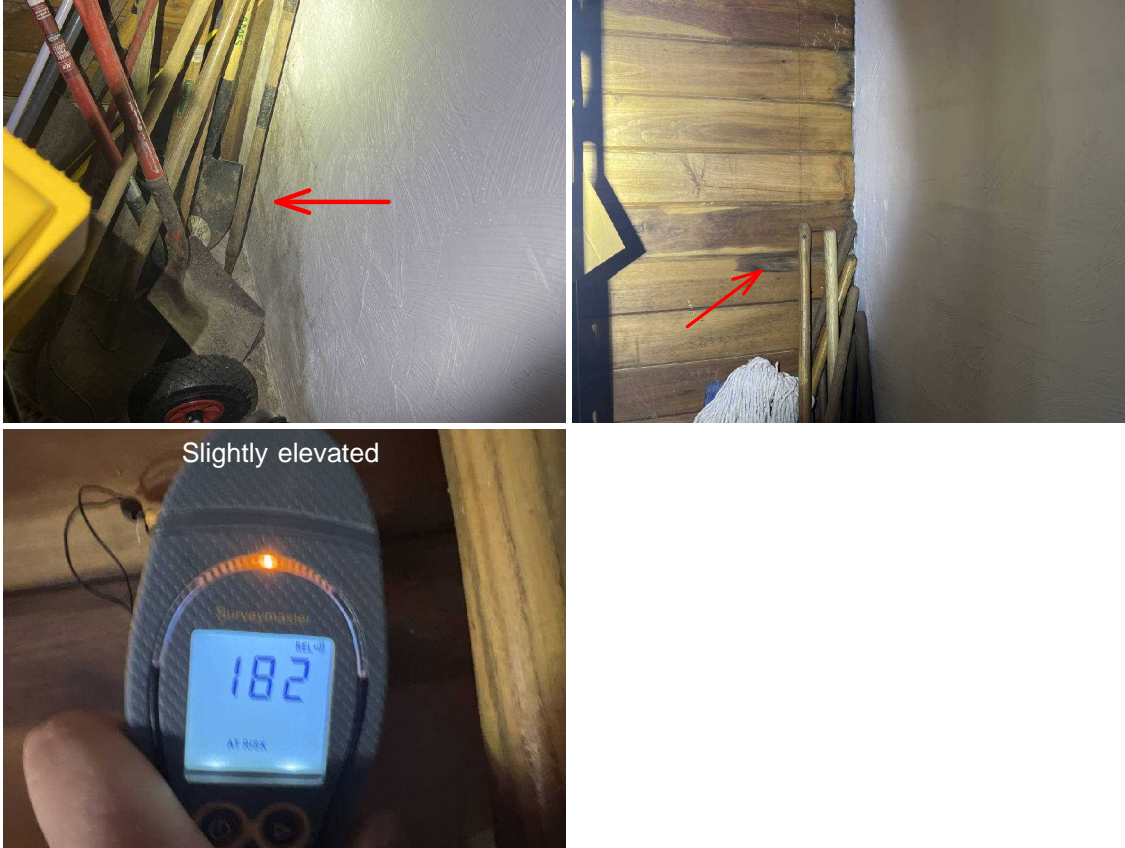
18. Main Basement Moisture Location: At foundation - There are some signs of moisture intrusion in the corner of the basement area.

This area test is slightly elevated with moisture contact. No obvious reasons noted, but possibly caused by clogged gutters (mentioned earlier in the report) causing water to overflow and fall at base of foundation. This is only a hypothesis and cannot be guaranteed.

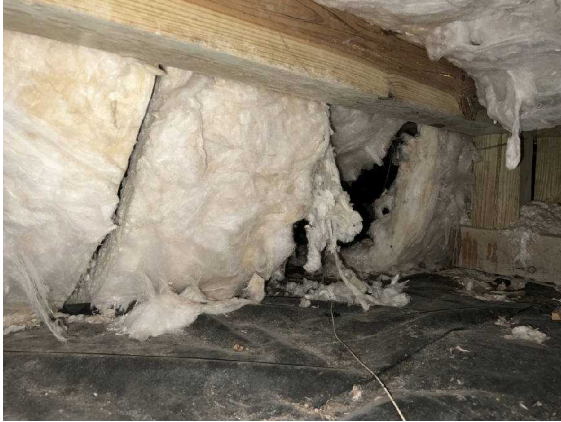
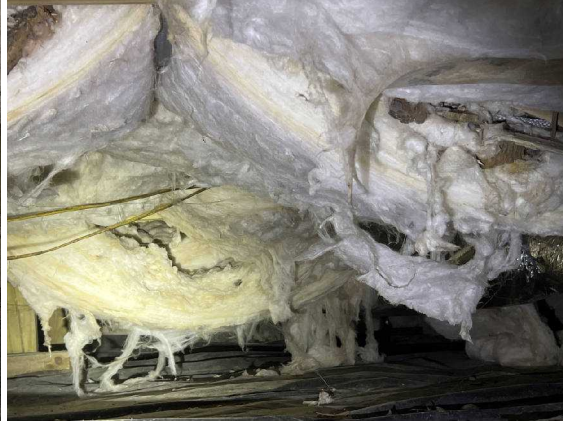
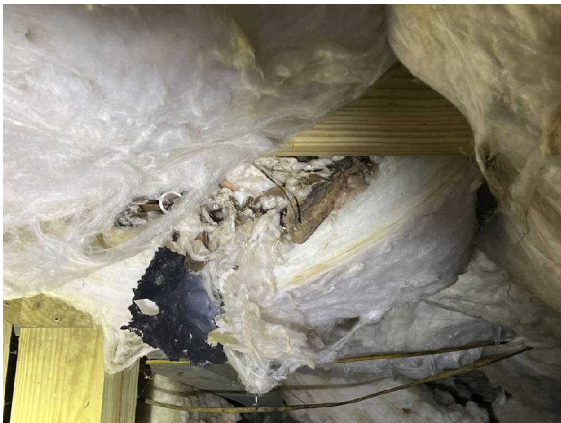
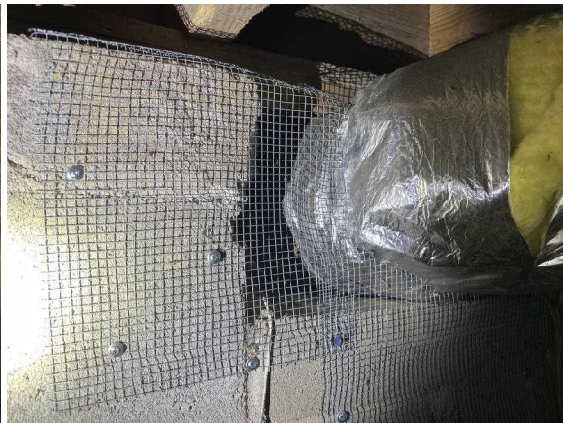
19. Main Crawl Space Insulation: Fiberglass - [There is no insulation under the bedrooms and laundry room on the main floor.](#)

[However, there is insulation in the other \(repaired areas with newer wood\) areas of the crawlspace. However, this insulation is falling in numerous areas due to rodent activity.](#)

[There is evidence of rodent bait stations as well as hardware cloth that has been installed to help keep rodents away. It is unknown if this is a current problem or occurred in the past. Recommend asking seller about any rodent control they have in place and if a professional pest control company is servicing this house.](#)

[Recommend any falling insulation be replaced. The falling insulation did block view of some areas of crawlspace.](#)

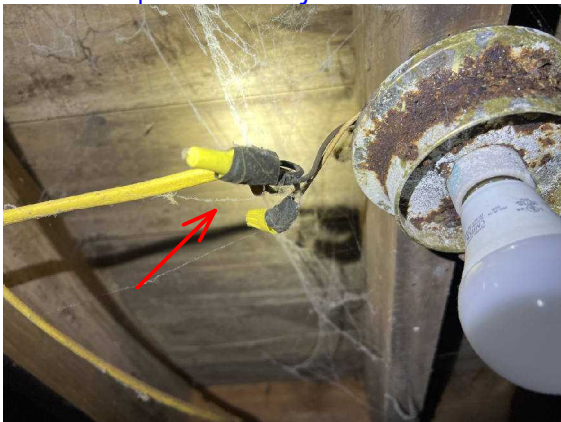
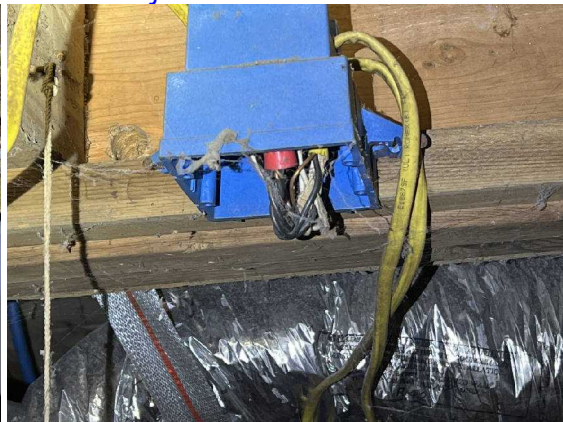
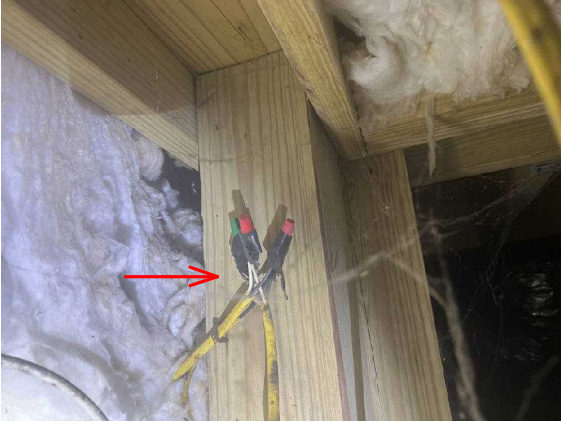
20. Main Crawl Space Electrical: 110 VAC/220 VAC - There are several electrical splices in the crawlspace that need to be protected in junction boxes. Recommend all junction boxes have covers installed

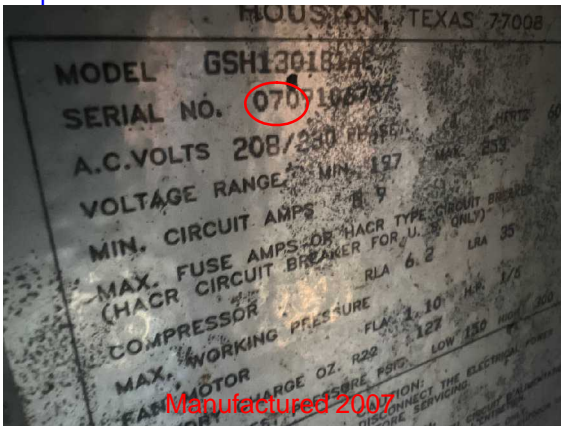
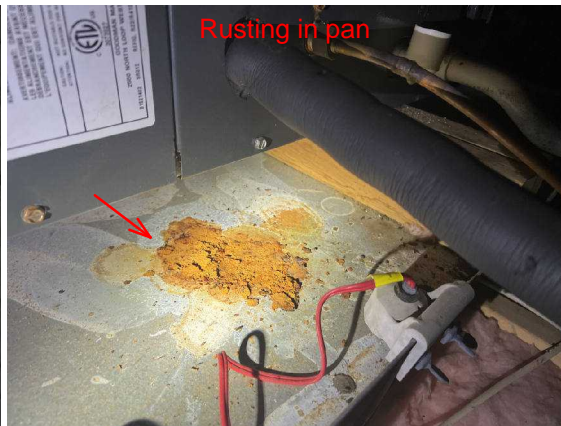
21. Second floor AC System A/C System Operation: Not inspected - Due to an exterior temperature below 60 degrees, and to avoid damage to the unit, the AC could not be operated. However, this AC system is 15 years old and nearing end of expected life.

Due to the age, and the rusting on the drip pan in the attic at the condensate line, recommend service by an HVAC company. Since AC could not be operated it is unknown if this is a current leaking problem or occurred in the past.

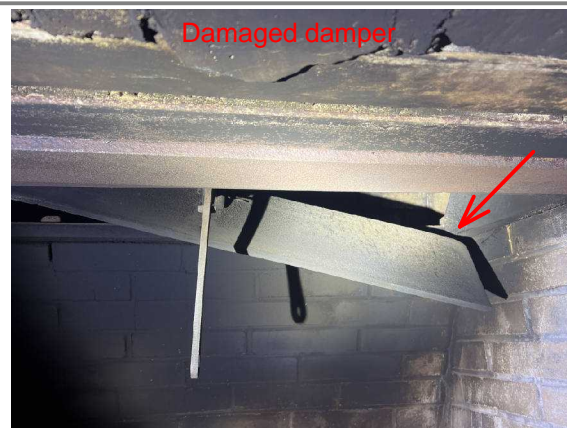
22. Living Room Fireplace Damper: Metal - The damper is no longer properly attached. Recommend consultation with a qualified contractor for repair so that the damper works properly.

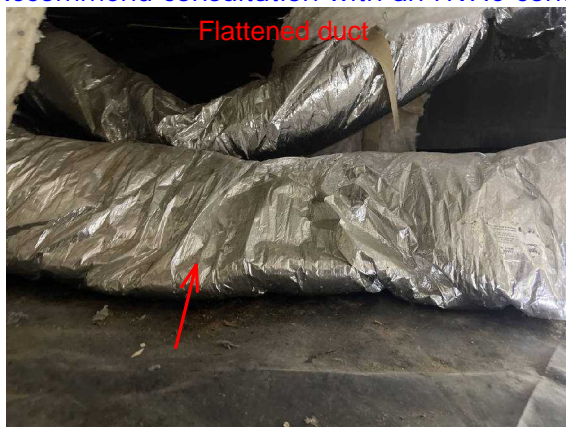
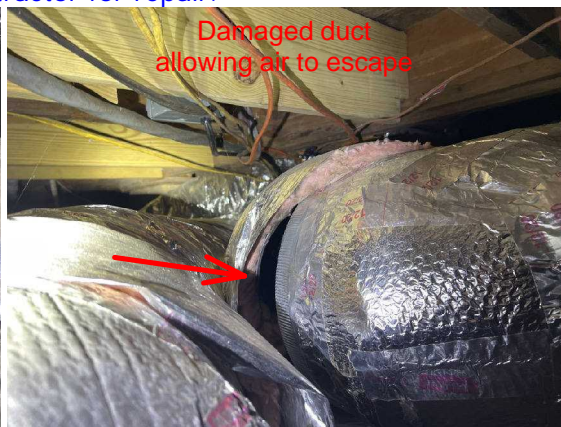
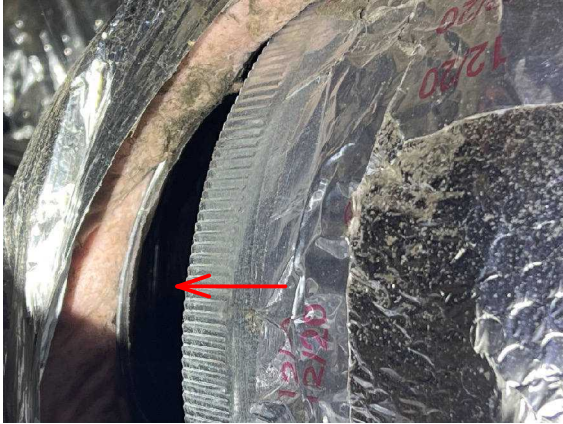
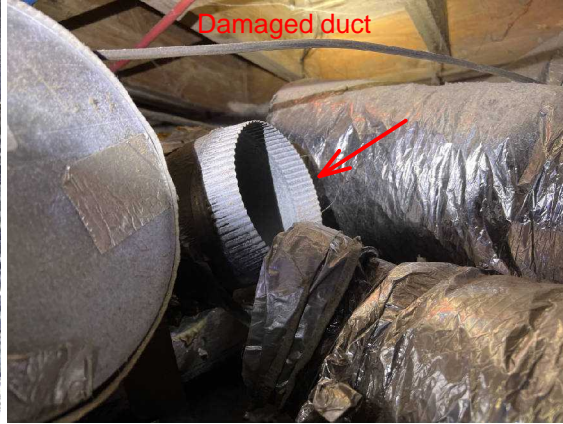
23. Main Heating System Distribution: Insulflex duct - There is some damage to the supply line duct in a few areas the crawlspace, allowing heated air to be vented into the crawlspace. There is also some damage to the ductwork likely caused by workers in the crawlspace. This duct has been flattened.

Recommend consultation with an HVAC contractor for repair.

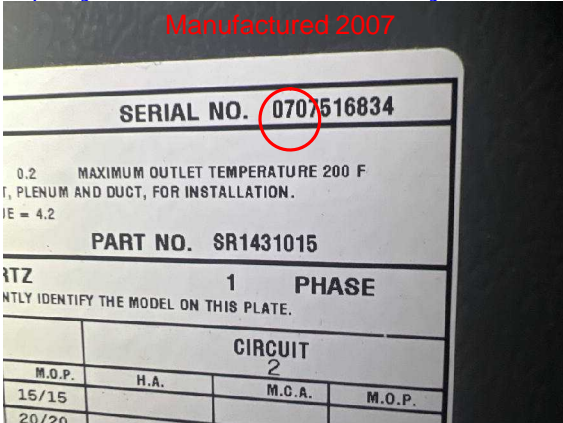
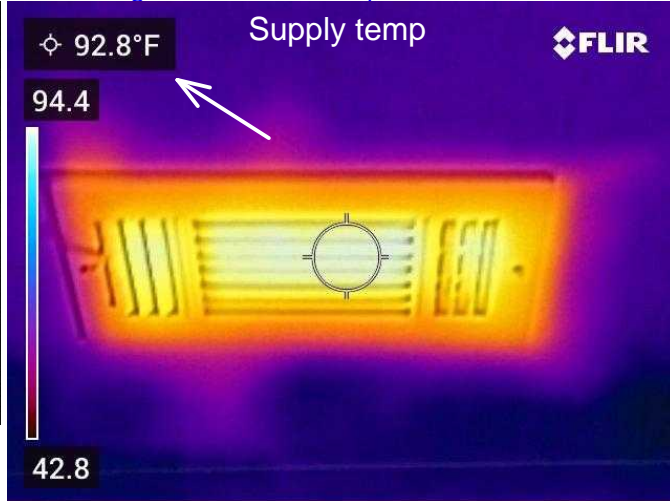
24. Attic Heating System Heating System Operation: Functional - The attic heat pump system was working properly. However, this unit is 15 years old and nearing the end of its expected life.

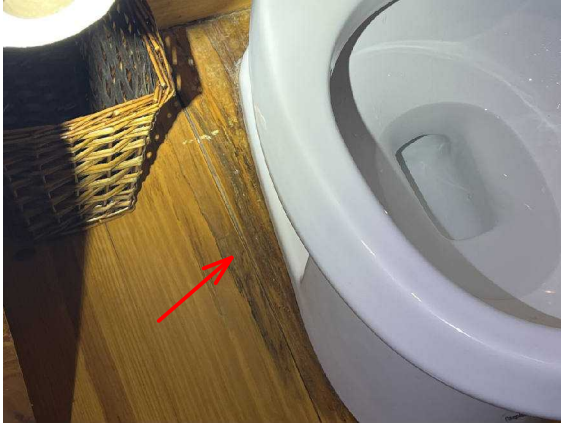
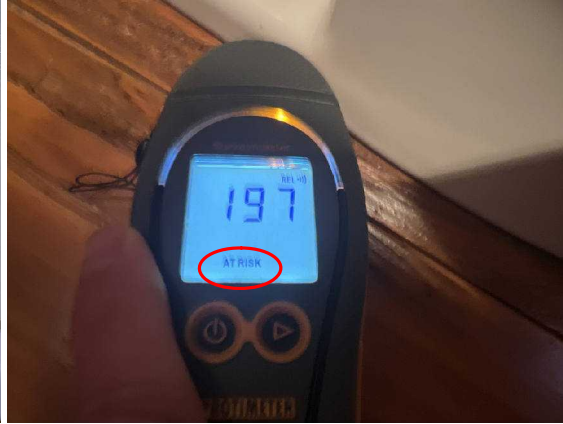
26. 1st floor half bath Bathroom Floor: Wood - There is some minor damage to the floor around the toilet. This area tested slightly elevated with moisture. This toilet is loose and this may be resulting in some minor leak. Recommend this toilet have a new wax ring installed and the toilet reset and properly secured.

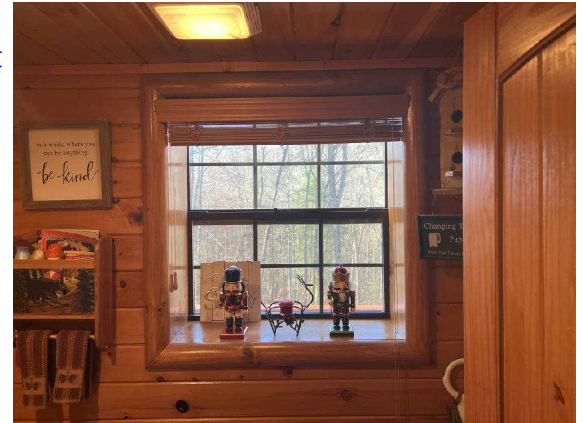
27. 1st floor half bath Bathroom Windows: Metal frame insulated - This window will not open with normal pressure. Inspector does not force windows for fear of breaking them. Recommend window be made to be operable.

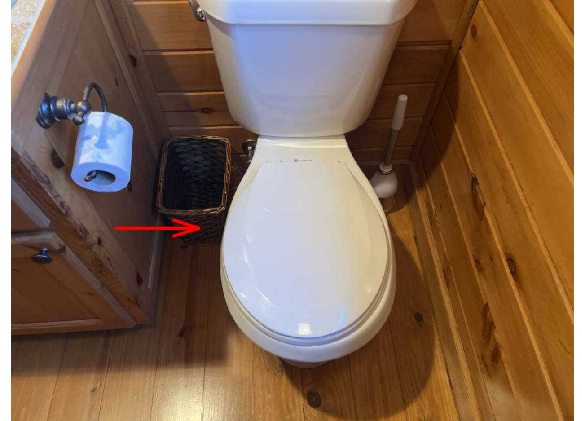
29. 1st floor half bath Bathroom Toilets: Glacier Bay - The toilet is loose and possibly leaking slightly. Recommend a new wax ring be installed and the toilet properly secured

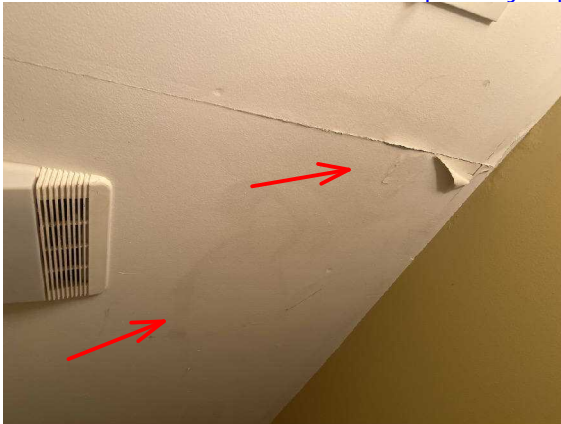
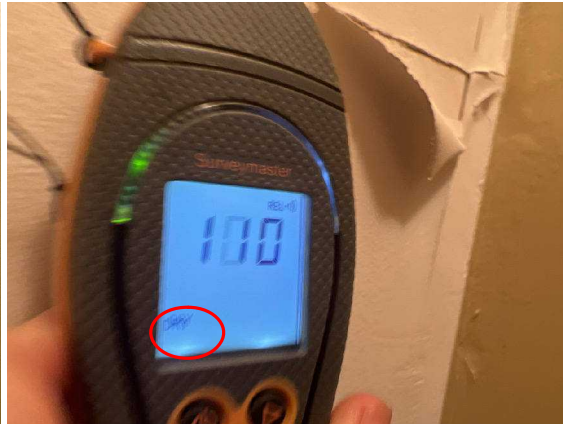
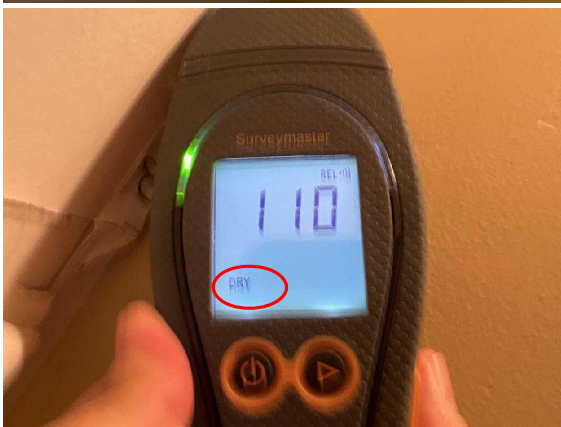
30. 2nd floor rear left bedroom bath Bathroom Ceiling: Painted drywall - There is some staining and separation at the drywall seam in the ceiling. This is likely the result of the leak in attic mentioned earlier in the report. This area tested within normal limits of the moisture meter, but the leak is still active and this staining may have occurred before the leak was temporarily repaired.

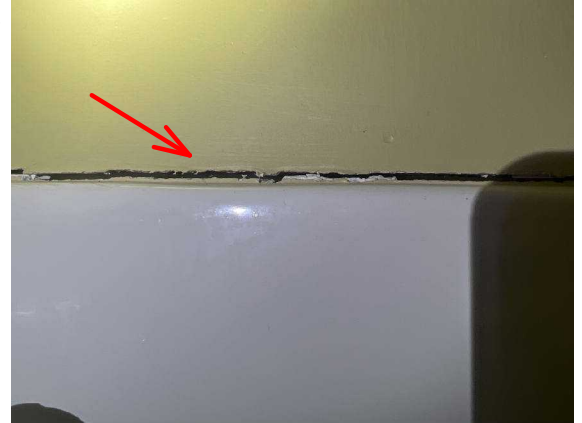
31. 2nd floor rear left bedroom bath Bathroom Walls: Painted drywall - Recommend caulking the crack at the drywall at the top of the shower. This will help prevent water intrusion. This possibly the result of some settlement due to structural issues mentioned earlier in the report.

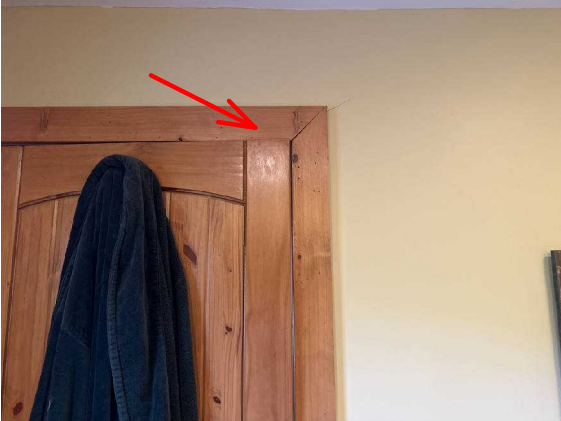
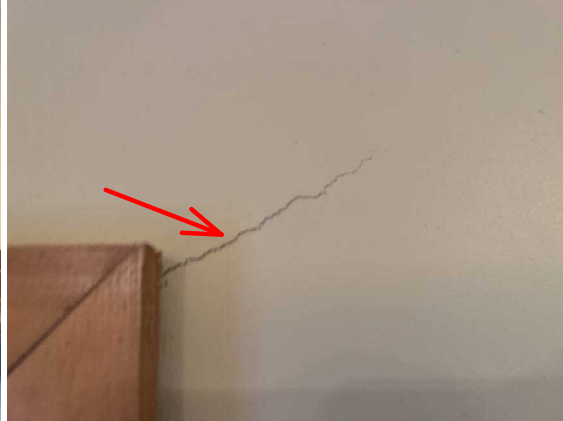
32. Master Bathroom Doors: Wood - The door into the master bathroom will not shut properly and rubs the frame. There is cracking in the drywall at this store, which indicates some possible minor settlement. Possibly the result of the problems mentioned earlier in the report. Recommend the door be adjusted.

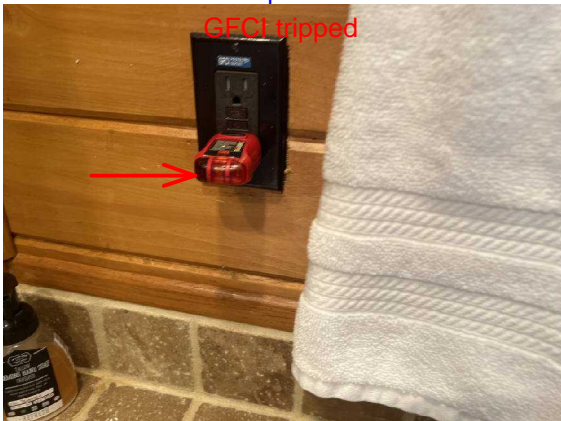
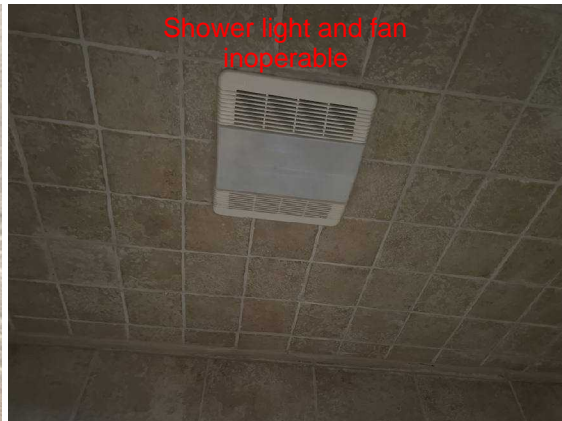
33. Master Bathroom Electrical: 110 VAC outlets and lighting circuits, 110 VAC GFCI - The GFCI receptacle in the master bathroom is tripped and will not reset. This is likely the reason that the lights in the shower also do not work. Recommend repair.

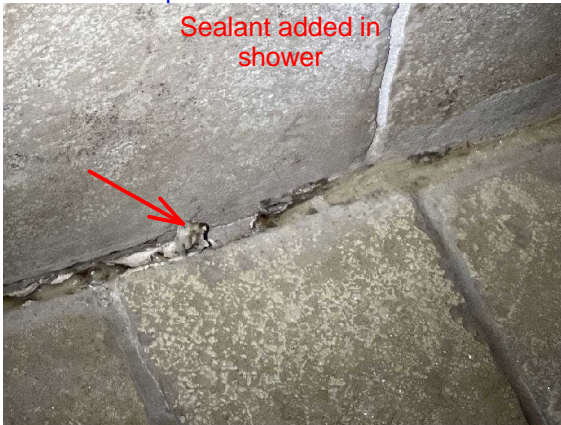
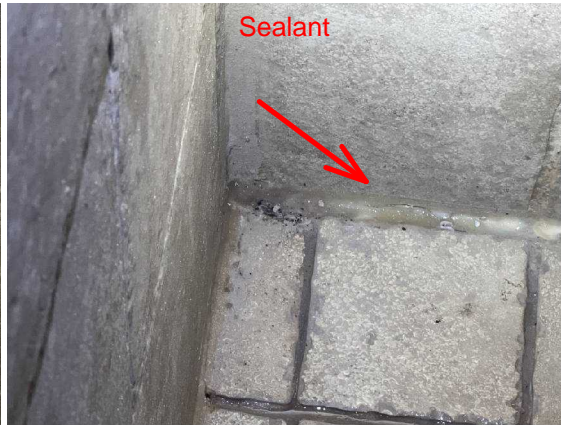
34. Master Bathroom Shower/Surround: Tile - There is evidence that additional sealant has been installed at the shower, floor and wall. It is suspected that this may be the result of settlement mentioned in the report. This type of sealant is only a temporary repair, and any leaking could result in damage to sub floor and ceiling below. Recommend consultation with a qualified contractor for further evaluation, and to make a more permanent repair.

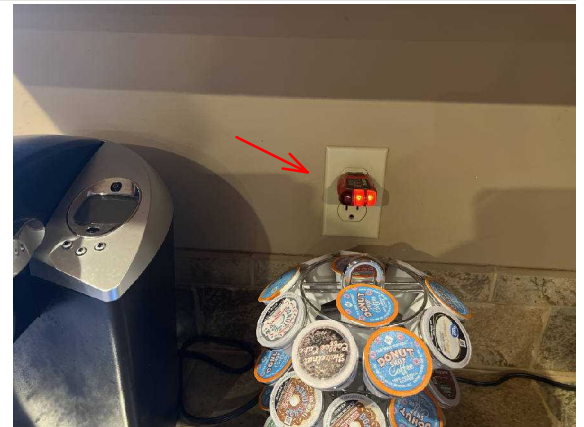
35. 1st Floor Kitchen Electrical: 110 VAC outlets and lighting circuits - The receptacles are non-GFCI protected. Although this was not a requirement when this home was constructed, installation of GFCI protected receptacles can increase safety and this is recommended.

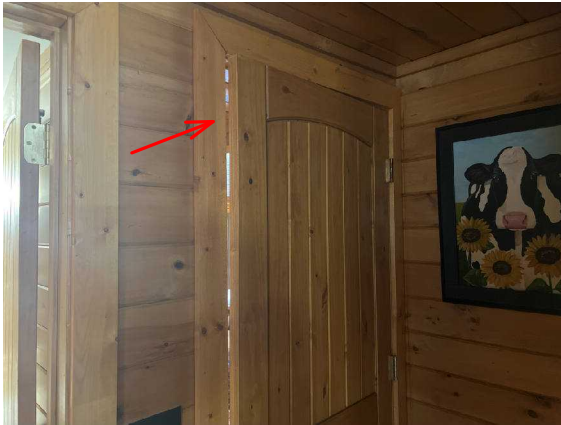
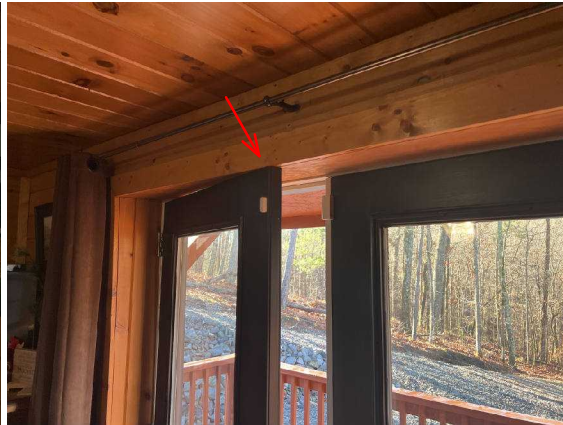
The door leading to the exterior rubs the door frame opening one operated. Recommend door be adjusted.

These issues may be the result of the structural issues mentioned earlier in the report.

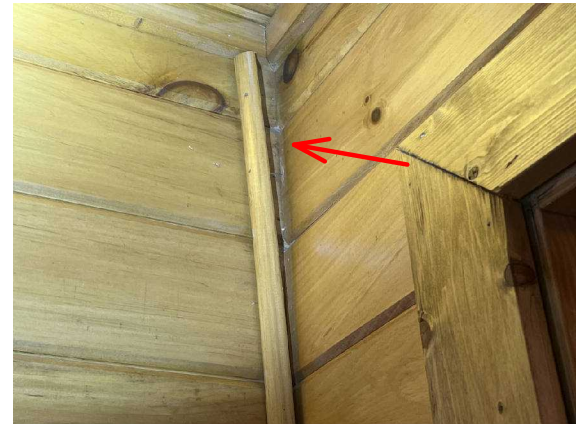
38. 2nd Floor rear left Bedroom Walls: Wood - The corner trim is no longer properly secured. This is possibly the result of some minor settlement. Recommend is trim piece be adjusted and reinstalled.

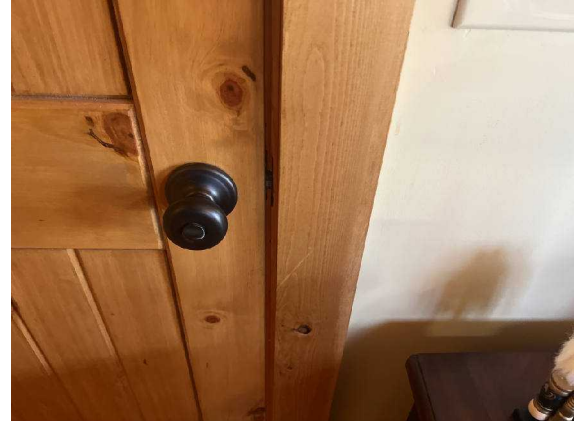
39. 2nd Floor rear left Bedroom Doors: Wood - Lockset(s) not latching-requires adjustment

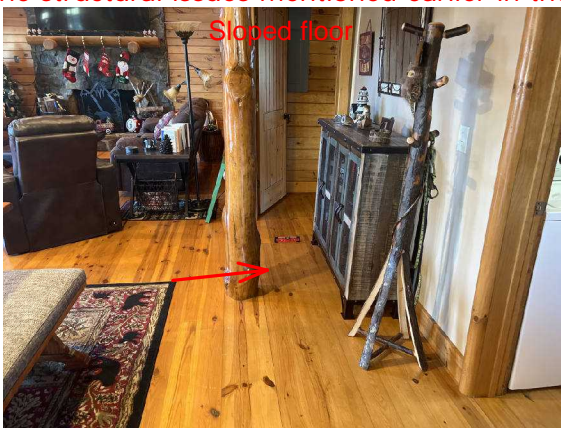
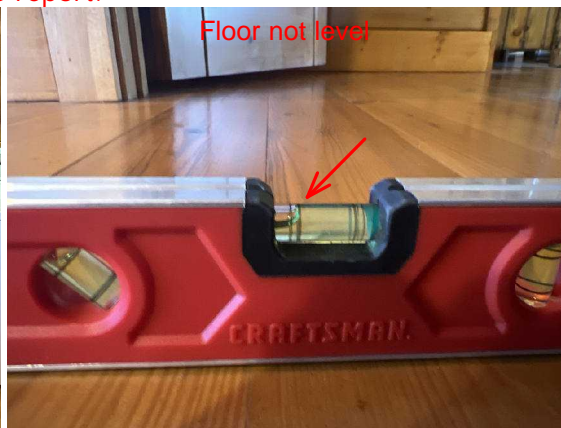
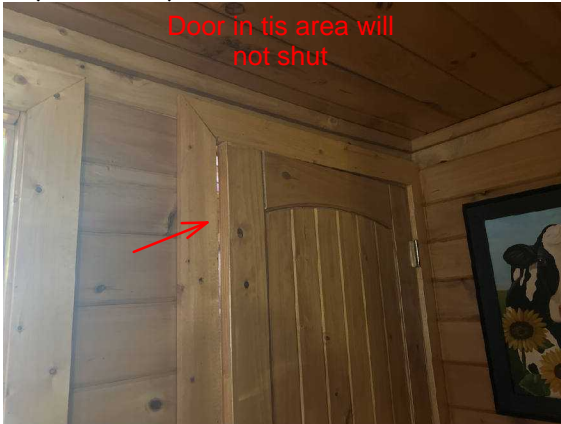
41. Living Room Living Space Floor: Wood - There is a downward slope to the floor near the entrance to the bedroom and laundry room areas. The door into the bedroom will not shut properly. This is likely the result of the structural issues mentioned earlier in the report.

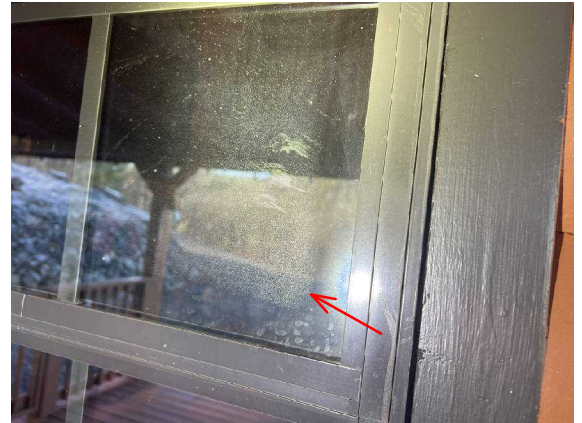
42. Living Room Living Space Windows: Metal frame insulated - There is some minor fogging between the panes of glass on a few of the windows. This is not unusual over time with insulated windows.

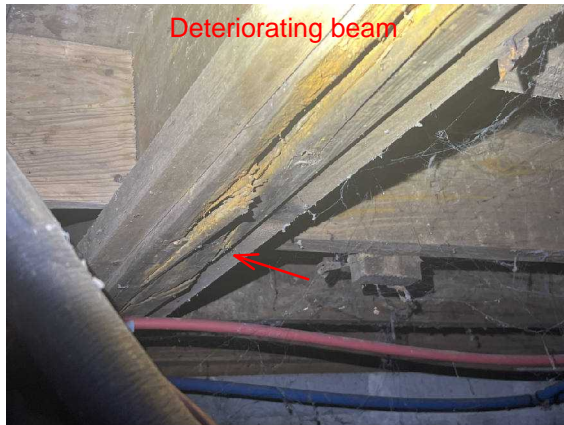
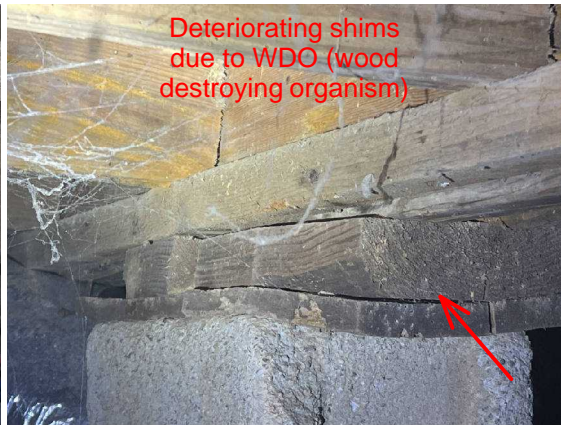
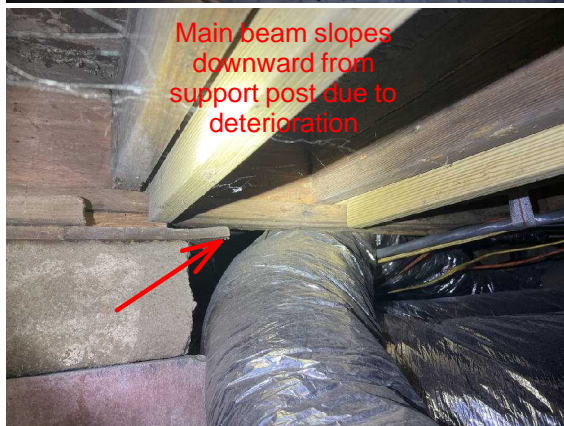
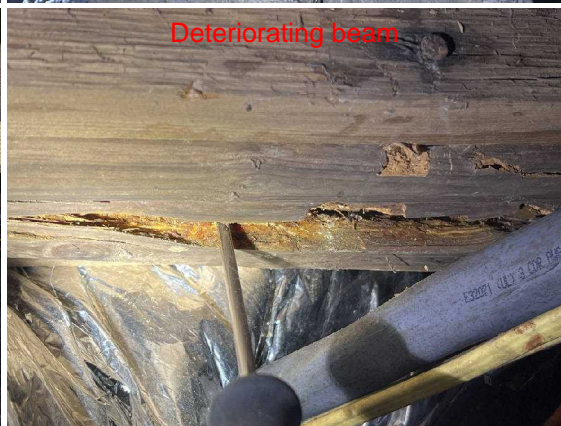
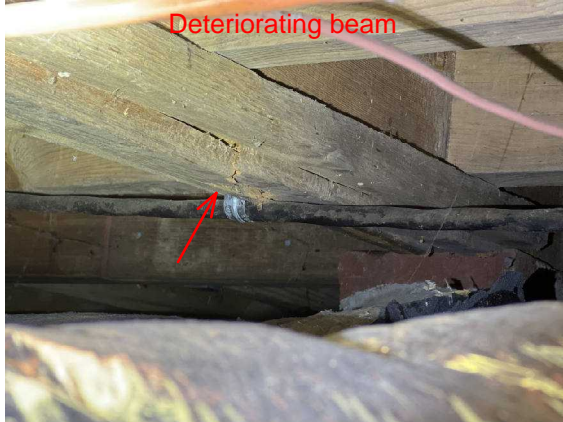
Damaged joist has  
been repaired but new  
joist attaches to  
deteriorating beam

1. Beams: Solid wood - There is damage to several support beams under the laundry and bedroom areas of the main floor. This damage appears to be from moisture and also possible wood destroying organisms. There is also deterioration to the pieces of wood on top of block support posts that support the beam.

There has been a package heating and air unit installed, and a large hole was cut in the foundation wall. This is not unusual, however, a main support beam rest on the wall that was removed.

There has been a significant amount of repair work done in the crawlspace, however, some of these newer joists were attached to a beam that appears to be deteriorating.

This damage is possibly the cause of the sloping floors mentioned later in the report.

Recommend consultation with a qualified contractor for further evaluation and for repair recommendations and cost.

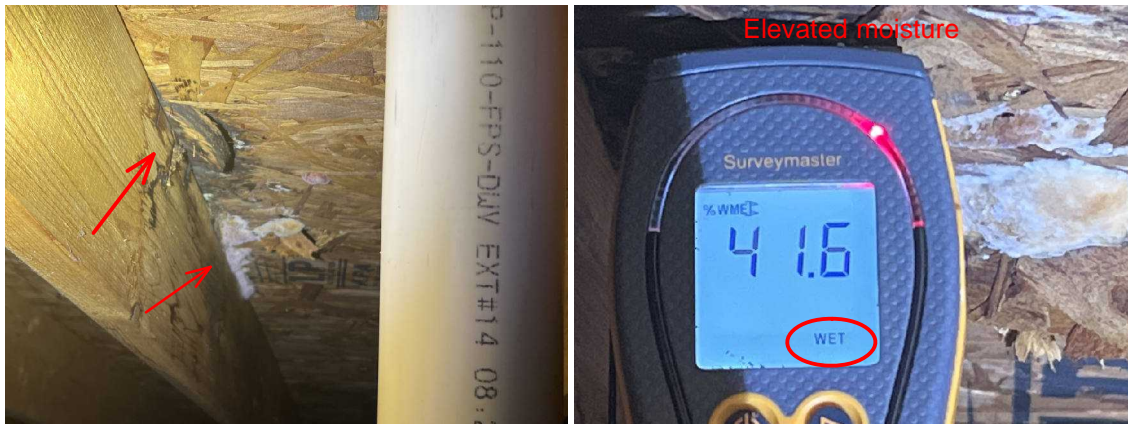
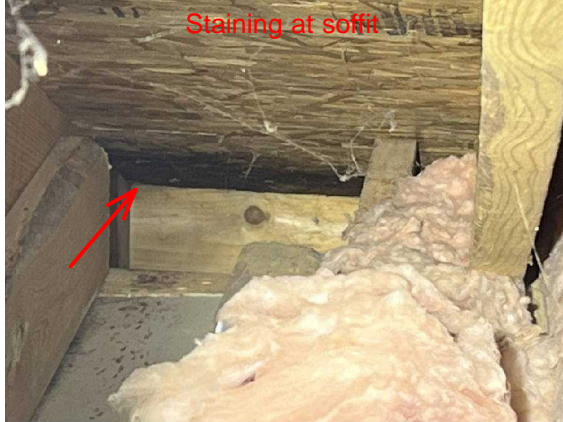
2. Main Attic Moisture Penetration: Ongoing water penetration noted - There is an active roof leak above the second floor bathroom area. This area tested with elevated moisture levels per moisture meter and is likely the result of the staining in the ceiling in that bathroom mentioned later in the report. There is also some staining near the soffit. However, inspector is unable to reach this area due to lack of access to check to see if it is active per moisture meter.

Recommend consultation with a roofer for further evaluation of the roof and to make any needed repairs.

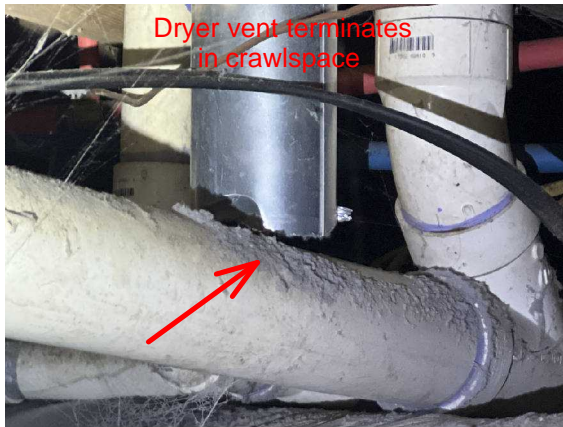
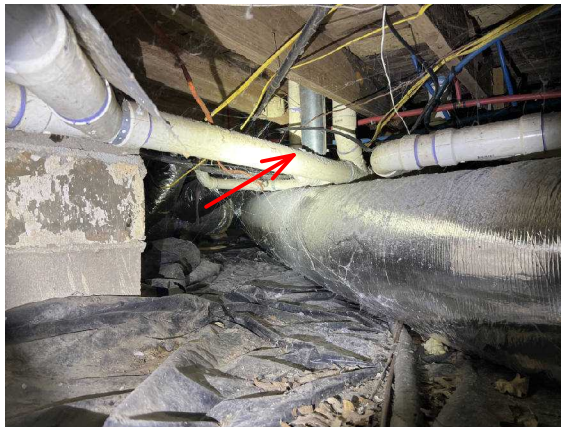
3. 1st Floor Laundry Room/Area Dryer Vent: Rigid metal - The dryer vent terminates in the crawlspace. This has resulted in lint and moisture being blown into the crawlspace. This can lead to increase chances of mold and wood destroying organisms. Recommend this dryer vent be extended to the exterior and any lint cleaned as lint is flammable.
