SUMMARY

This Summary outlines potentially significant issues from a cost or safety standpoint. This section is provided as a courtesy and cannot be considered a substitute for reading the entire report. Please read the complete document.

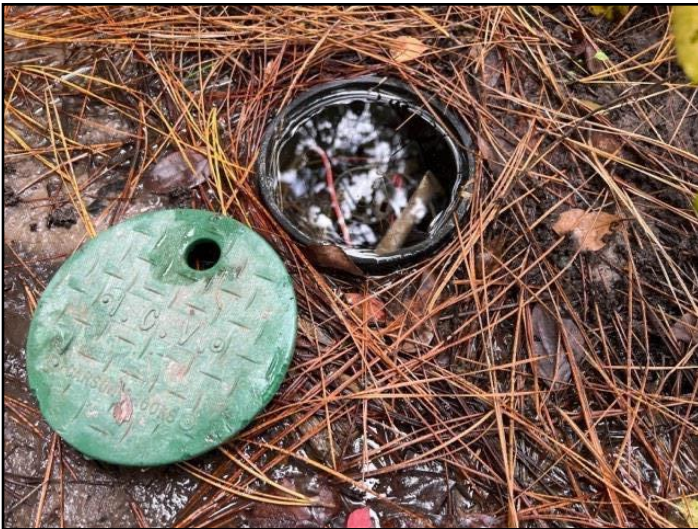
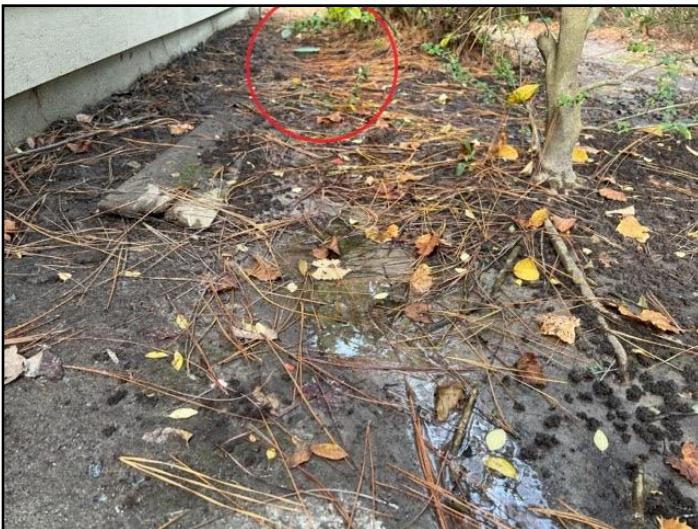
8. Water inside ICV for sprinkler

10. Ponding of water near ICV

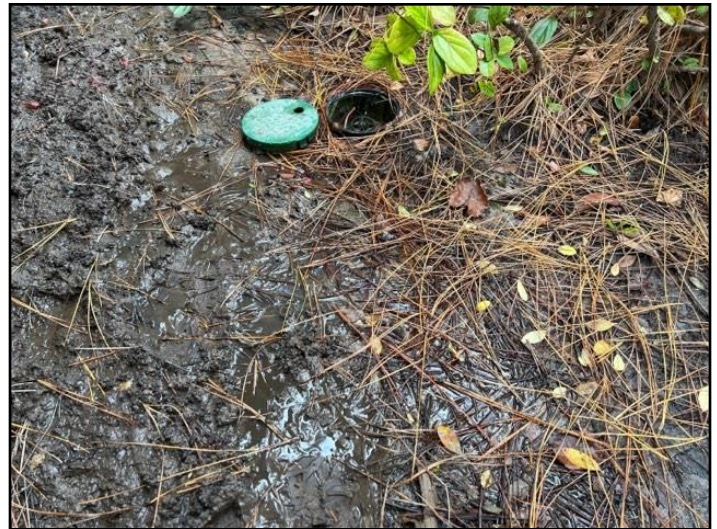
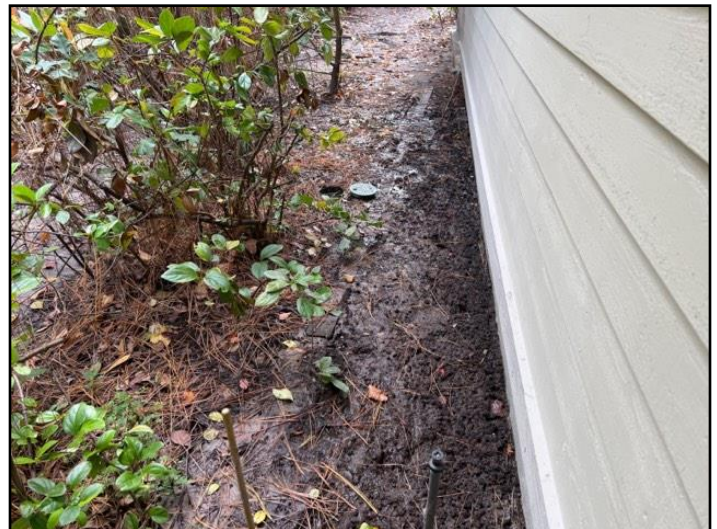
9. Ponding of water along garage wall

11. Ponding of water along garage wall

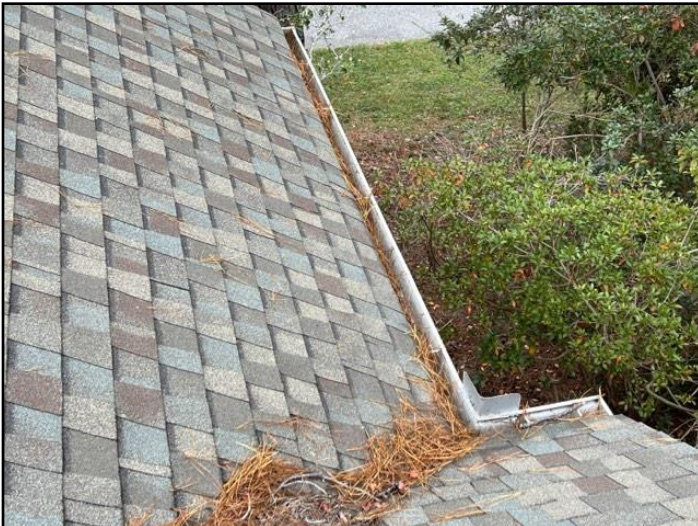
Observed clogged gutters on front and rear portion of home. Recommend cleaning.

25. Clogged gutters, front

Task: Clean

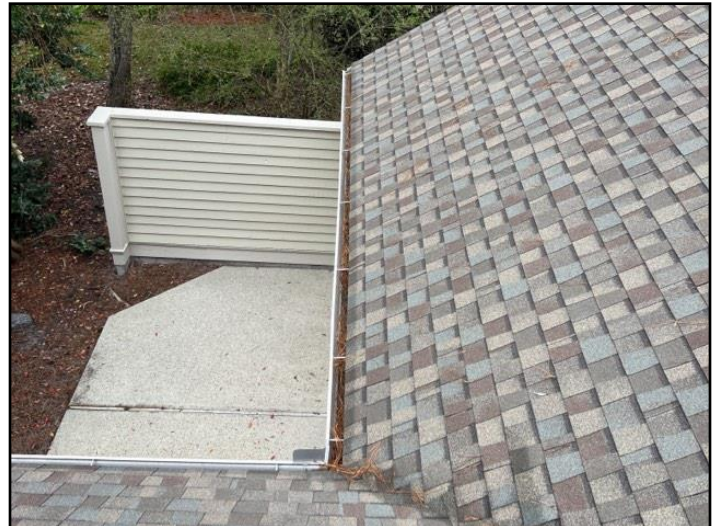
26. Clogged gutters, rear

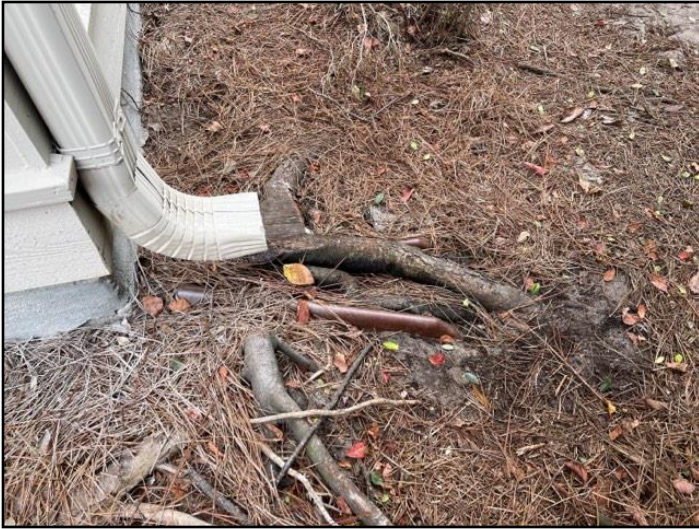
Observed gutter downspouts on rear portion of home discharging close to building. Observed one gutter discharge having minor soil erosion washing away old tree roots. The other discharge pipe is covered with pine needles and debris. Recommend improving and provide gutter extension to keep water away from the building.

27. Minor soil eroding below gutter discharge

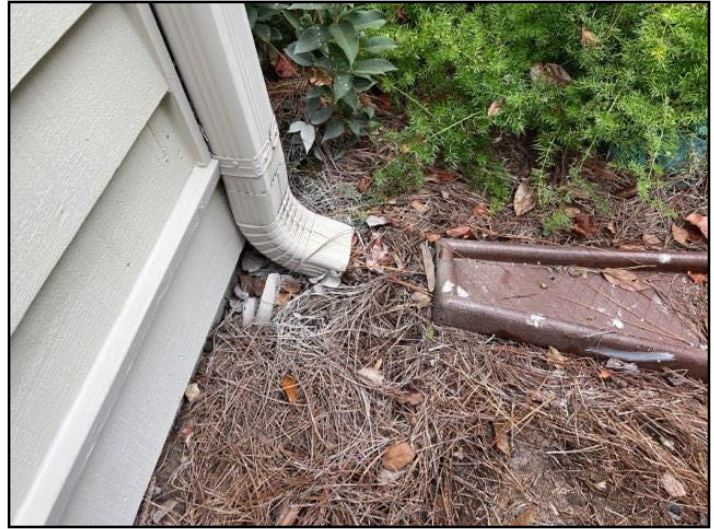
28. Discharge covers with debris

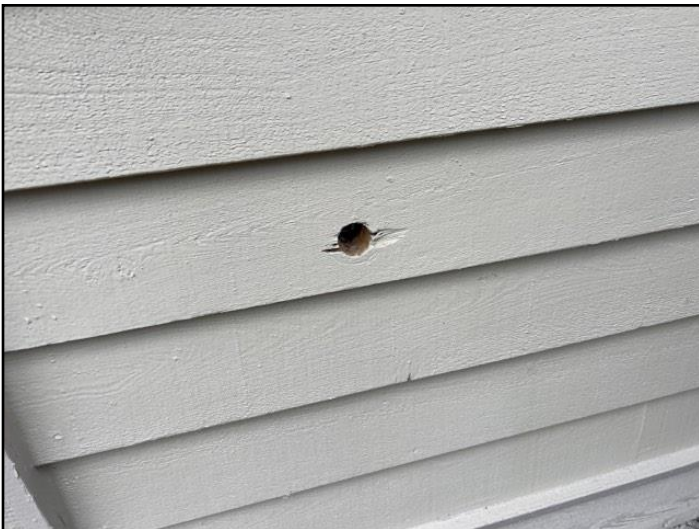
Observed open penetration on front left side of entryway along garage wall. Possibly old hose bib was at that location. Recommend sealing opening.

29. Open gap in siding

Task: Improve/ seal

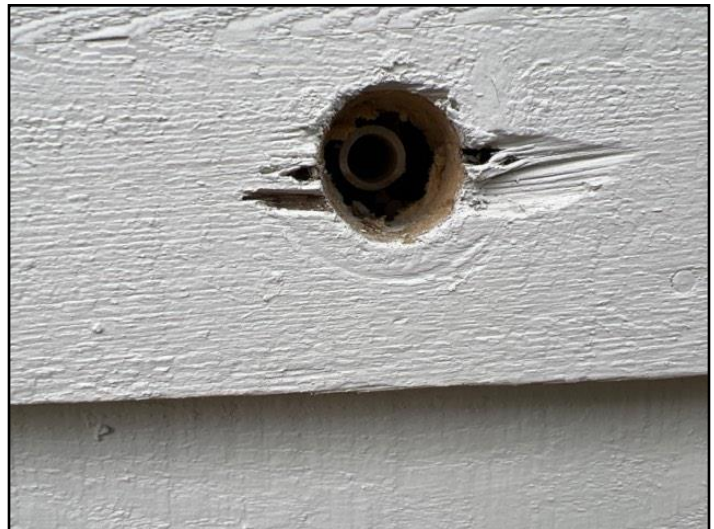
30. Open gap w/ old piping

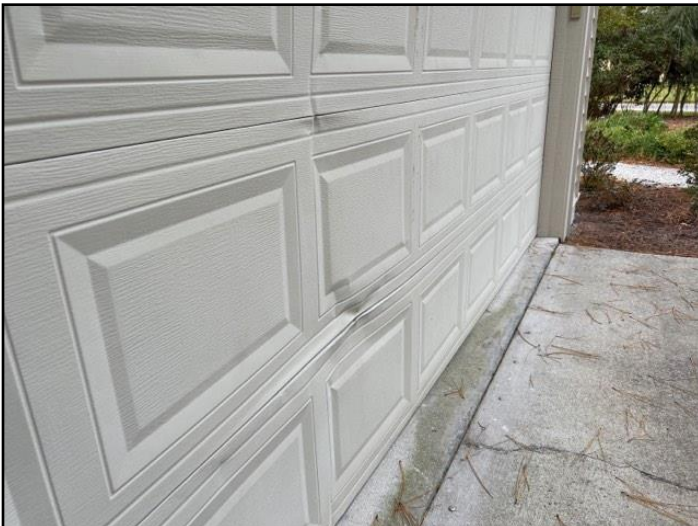
46. Dented garage door

Task: Monitor/ or Improve

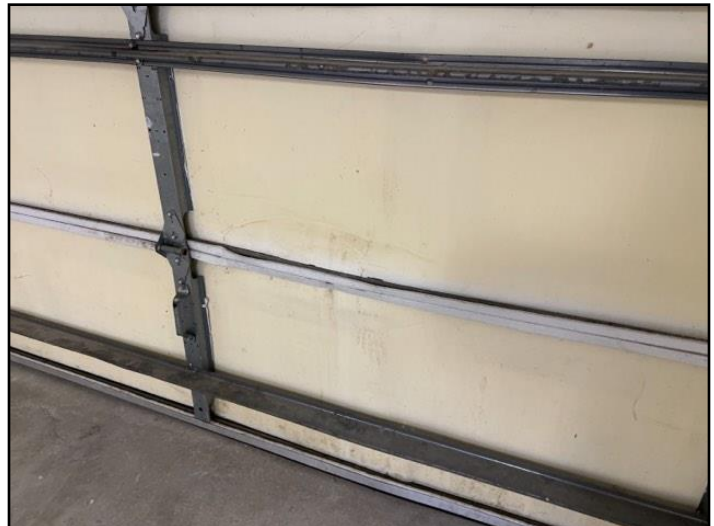
47. Dent viewed from inside garage

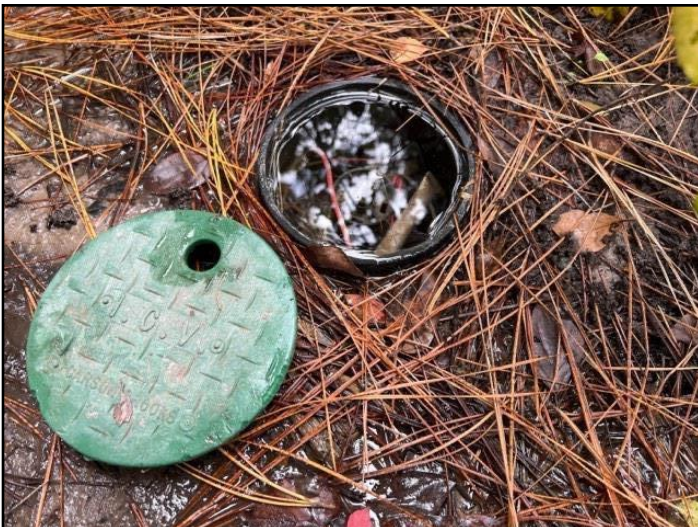
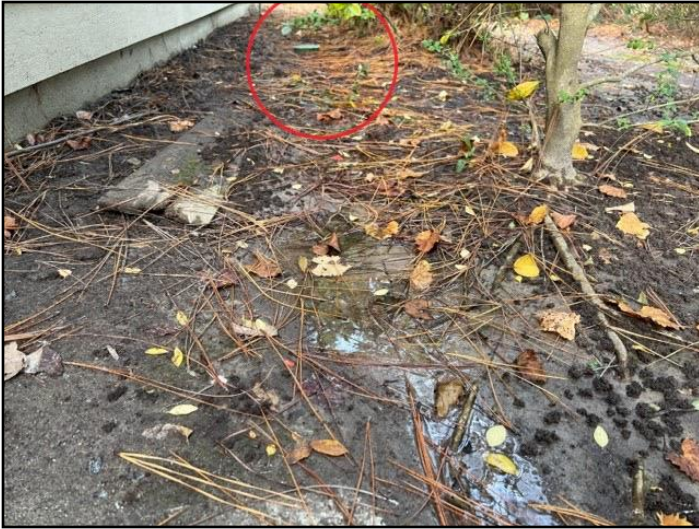
50. Water inside ICV for sprinkler

52. Ponding of water near ICV

Task: Further evaluation

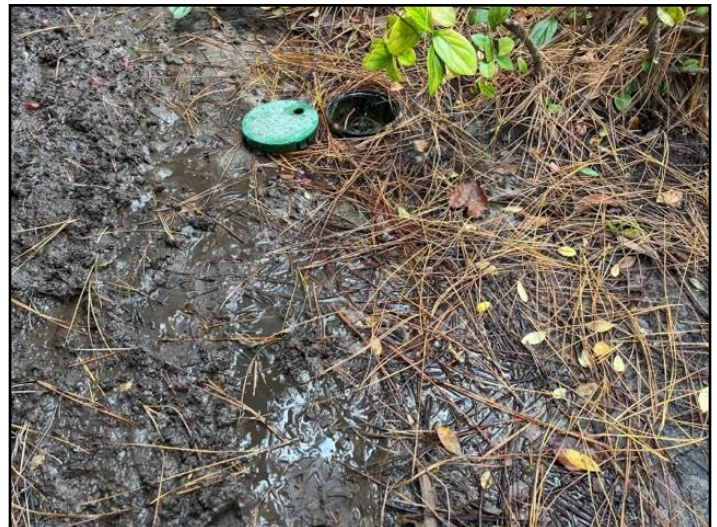
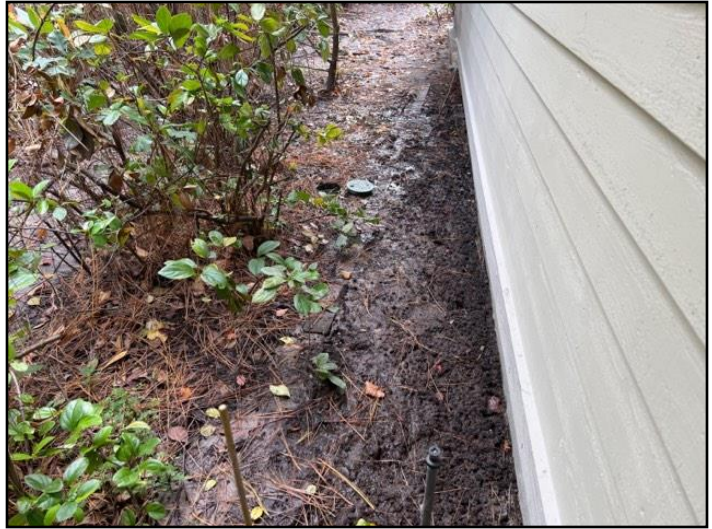
51. Ponding of water along garage wall

53. Ponding of water along garage wall

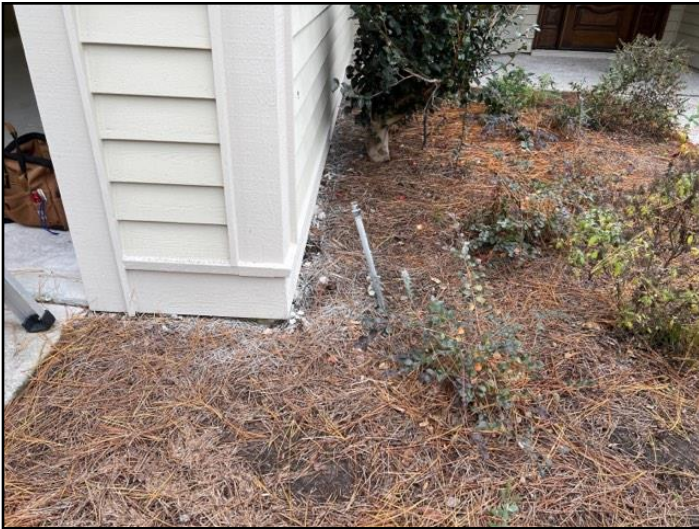
54. Tilted sprinkler heads

Task: Monitor

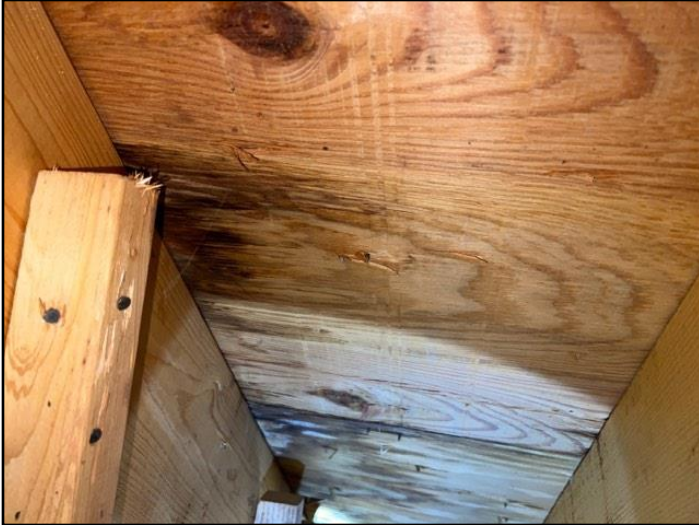
64. Water stains on door sheathing, garage

Task: Monitor

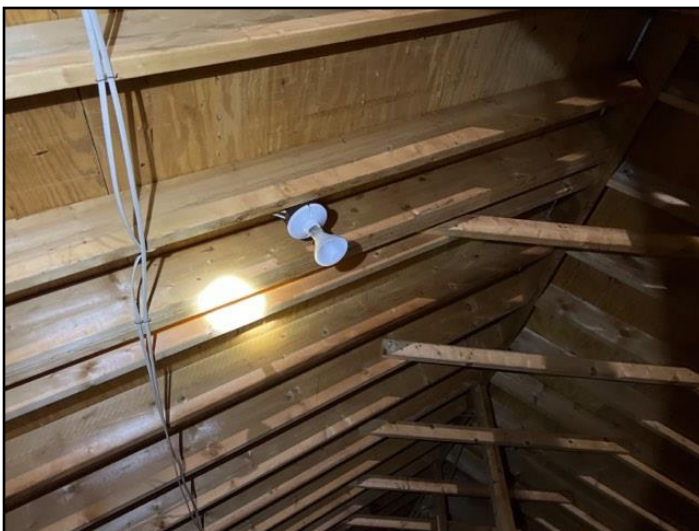
90. Inoperative lights in attic

Task: Improve

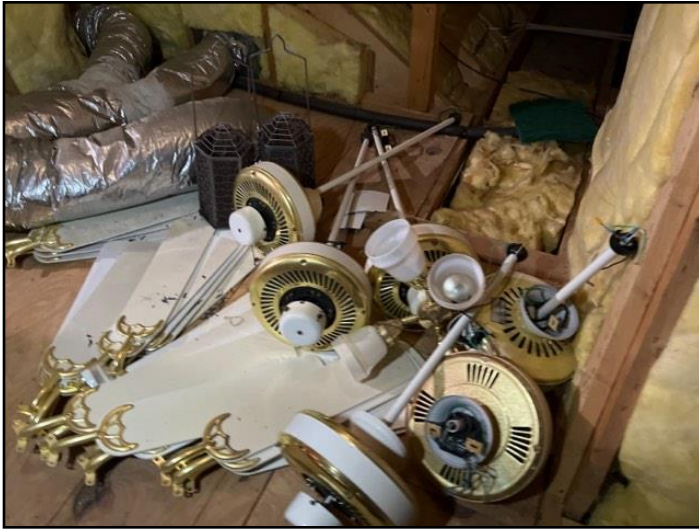
121. Debris in main attic

Task: Clean

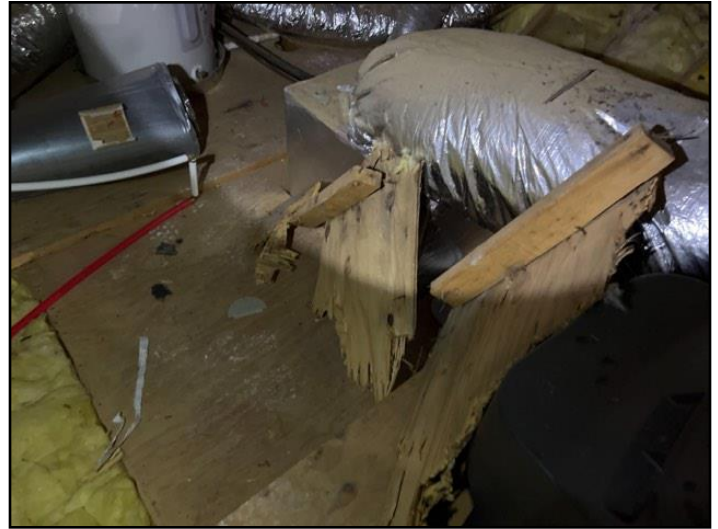
122. Debris in attic

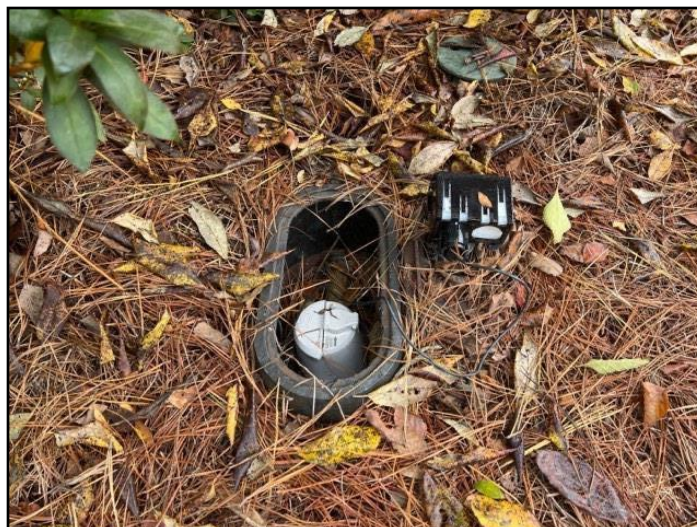
At meter on left side of driveway. Observed no cover at meter.

124. Meter on left side of property

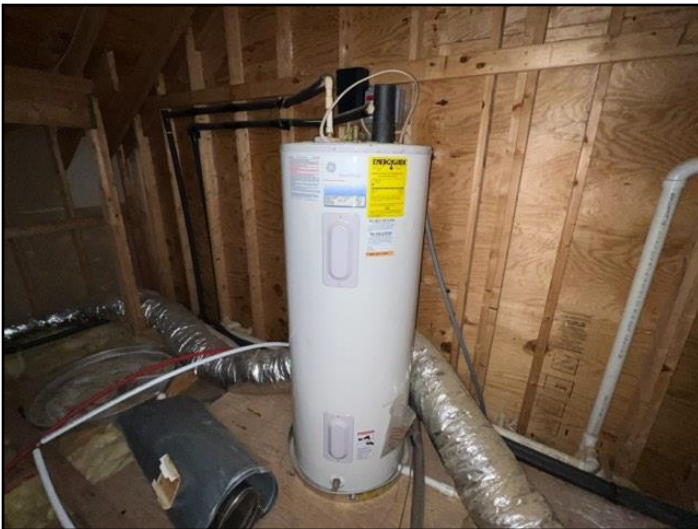
GE water heater on left side of attic over kitchen /laundry area. 50 gallons 2007. Water valve shut off at GE water heater. Unable to get hot water at fixtures throughout home.

126. General Electric water heater

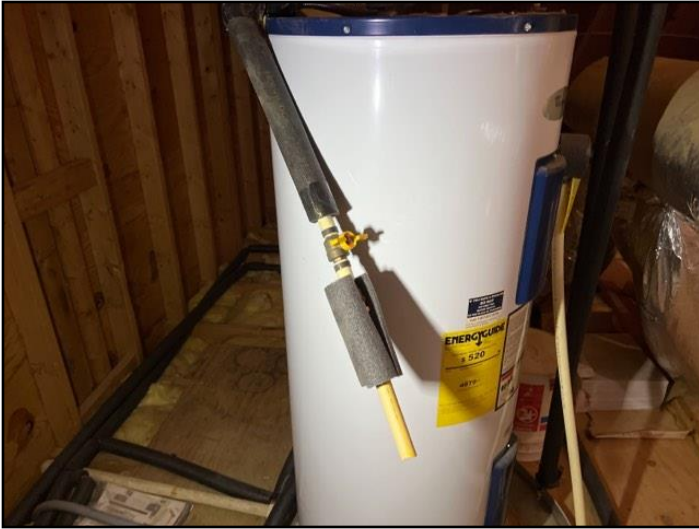
Observed a whirlpool 50 gallon water heater, 2012' on right side of home over bedrooms. Water heater possibly inoperative. No supply lines attached to piping at water heater. Electricity to water heater is live. Request disclosure.

132. No water supply attached

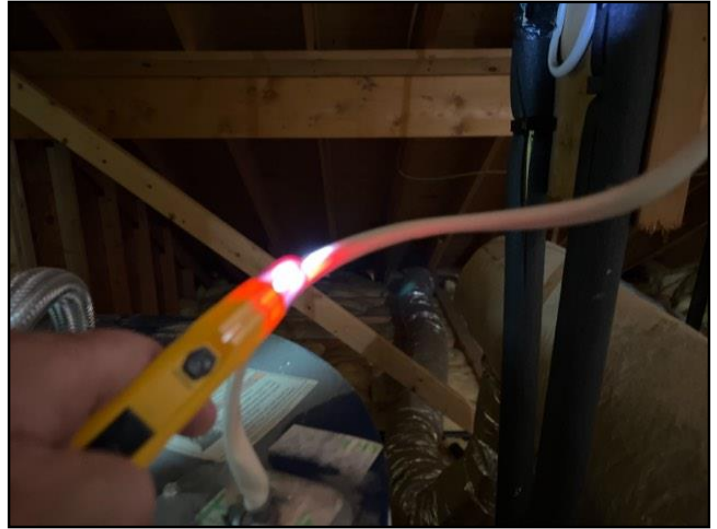
133. Live wire to water heater.

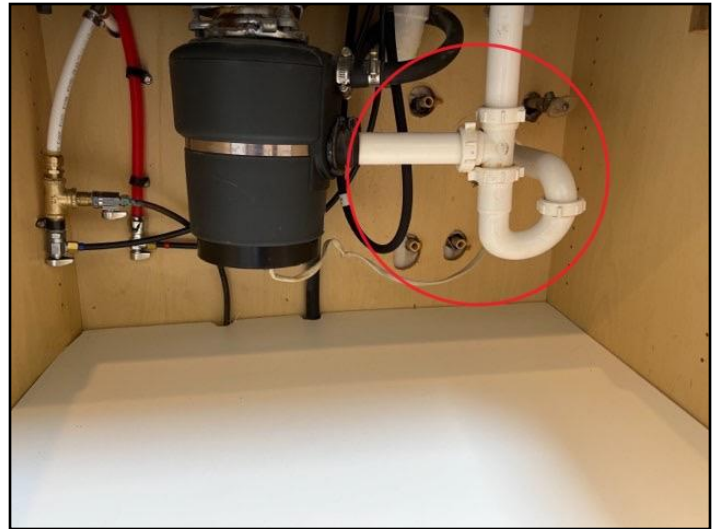
40. Condition: • Observed abandoned supply plumbing under kitchen sink. Recommend monitoring.

142. Older abandoned supply lines

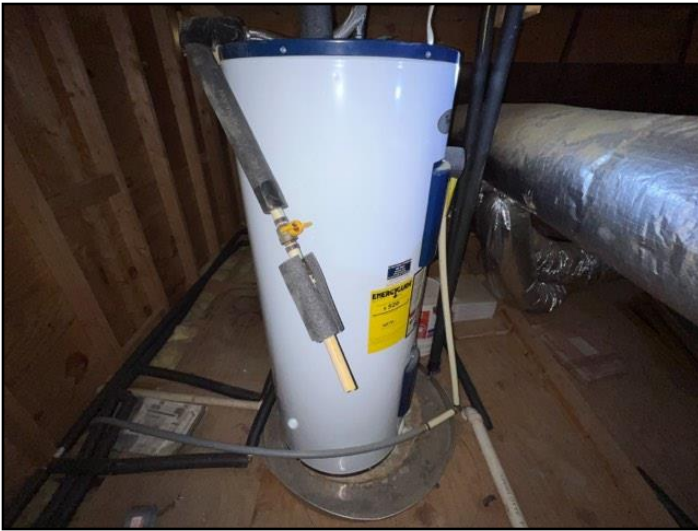
41. Condition: • Inoperative

Observed abandoned Whirlpool water heater in attic that is not attached to supply plumbing. Electrical connections still attached to component that are live . Recommend further evaluation and request disclosure.

143. Inoperative water heater

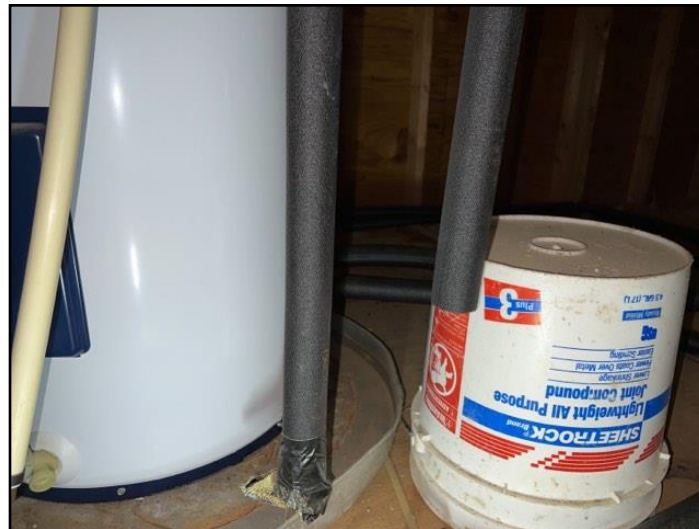
145. Cut supply piping

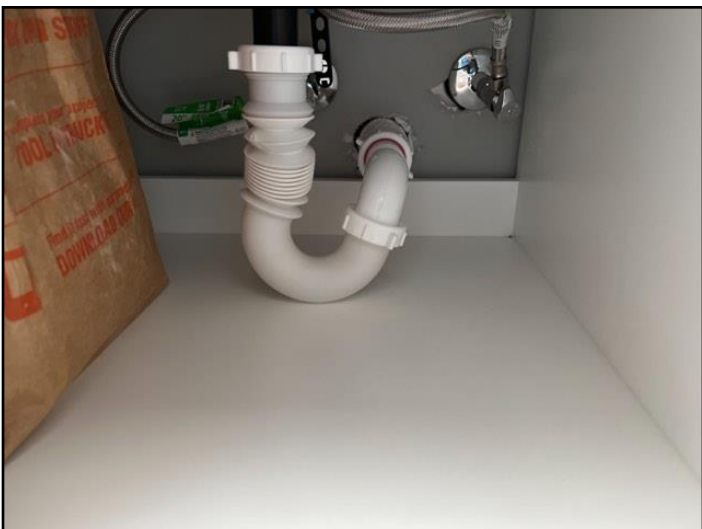
.....Observed flexible accordion type waste plumbing at P-traps below both sinks in primary bathroom and under sink in middle bathroom. No leaks present. Recommend replacing.

148. Flexible accordion waste piping

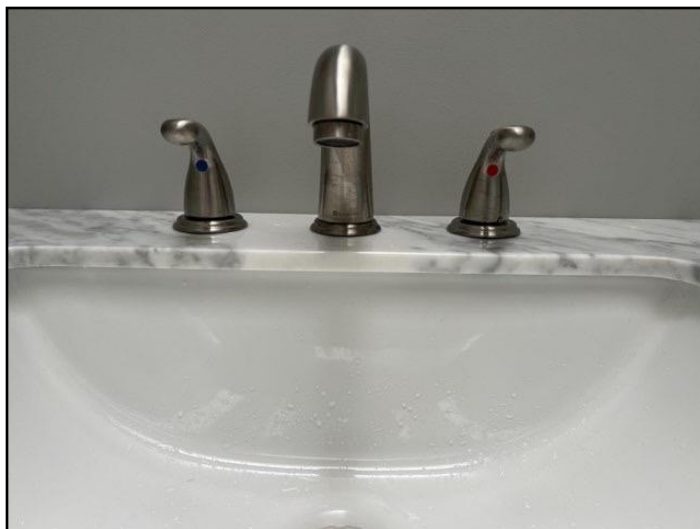
44. Condition: • Hot and cold reversed

150. Hot and cold reversed, middle bathroom

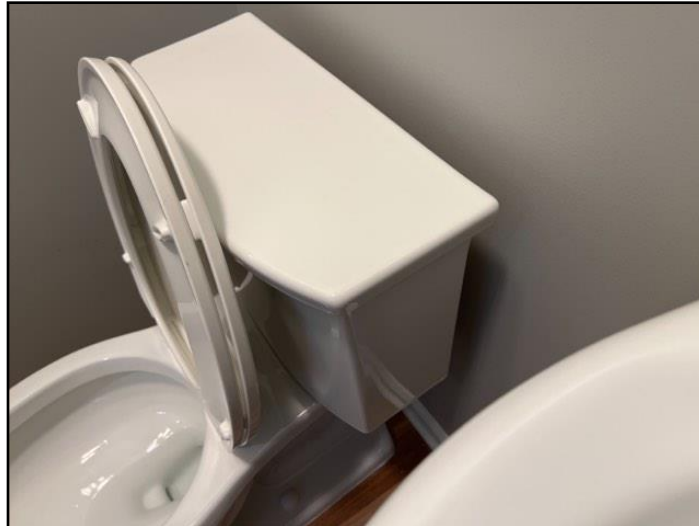
45. Condition: • Loose

Tank has a slight wobble on top of the toilet base . Observed no leaking. Toilet operational. 1/2 Bathroom. Recommend securing.

151. *Loose tank on top of toilet base*

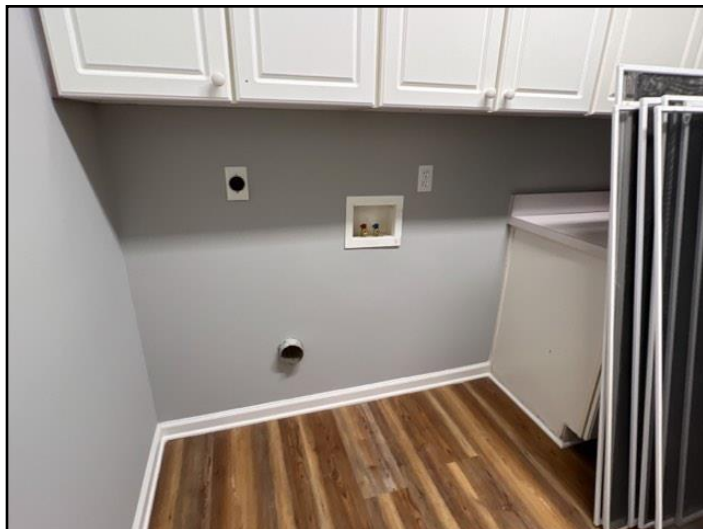
Inventory Washing Machine: • Observed no washer or dryer in home.

161. No washer or dryer in laundry room.

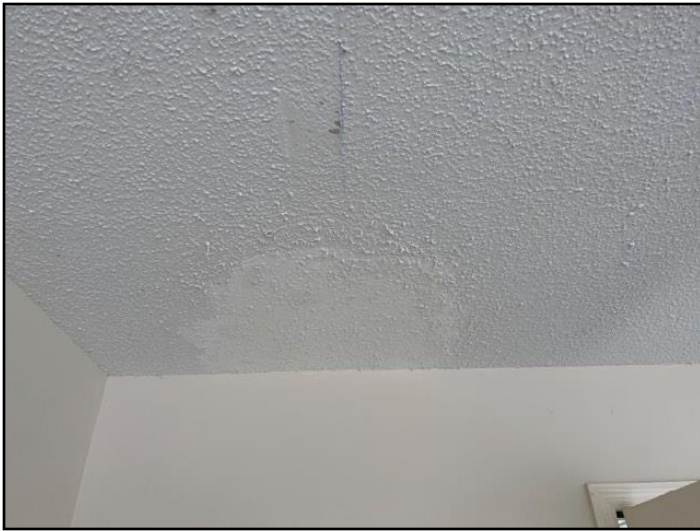
46. Condition: • Patched

Observed several patched areas on drywall ceiling in the garage. No moisture present when tested. Recommend disclosure of repair

167. Patched ceiling in garage

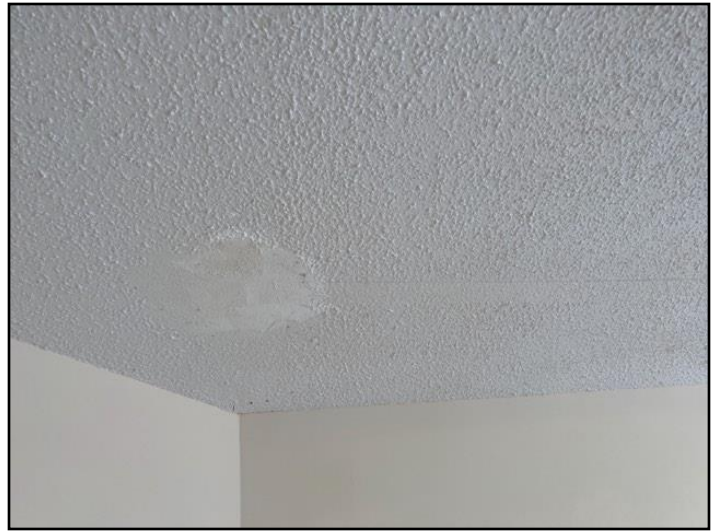
168. Patched garage ceiling

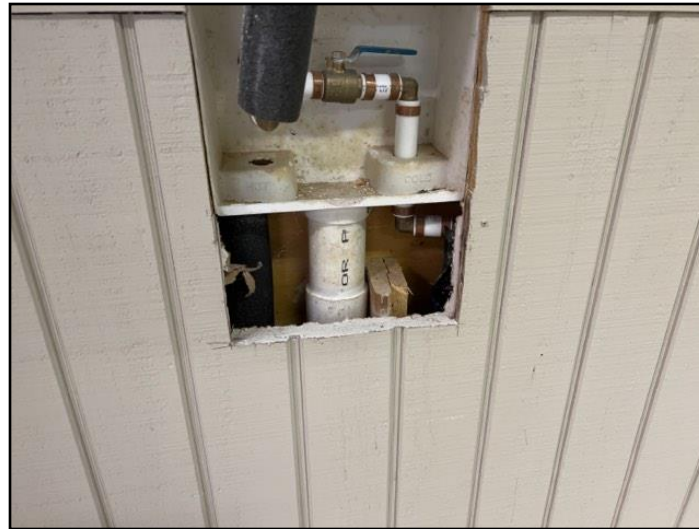
47. Condition: • Observed small open section at wood wall in garage. Possibly to access plumbing below water shut off. Monitor /Replace

170. Open wall for access to plumbing

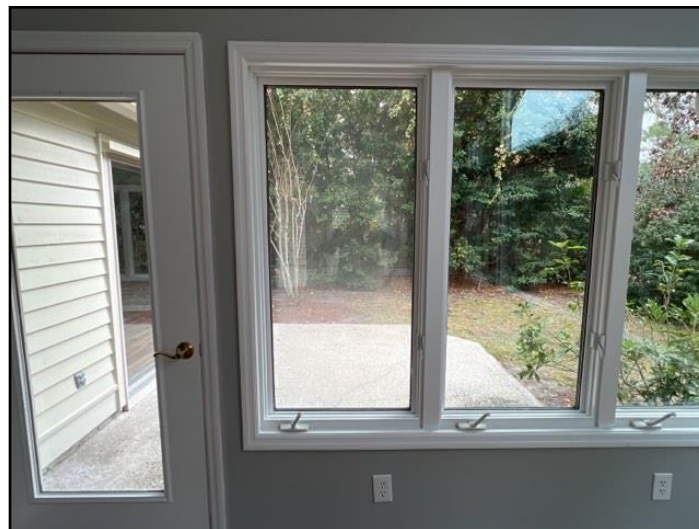
48. Condition: • Fogged Glass/Failed thermal Seals

Observed slight fogging at left side window in sunroom. Monitor.

171. Fogged Glass on window in sunroom

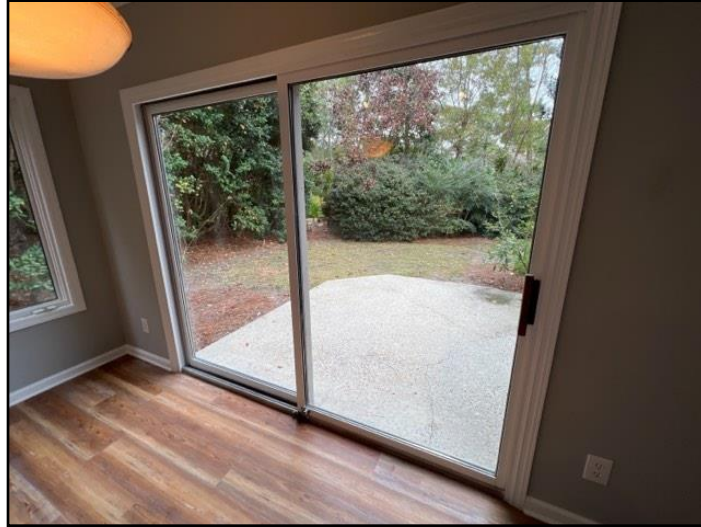
51. Condition: • Difficult to open

Rear glass slider off of Kitchen difficult to operate. It does open with some effort. Observed dirt and debris in lower track. Recommend cleaning track and rollers.

175. Glass slider difficult to open
