FULL RESERVE STUDY

Whittier Towers Apartments Association, Inc.

**Lauderdale By The Sea, Florida
October 11, 2021**

Reference: 211064

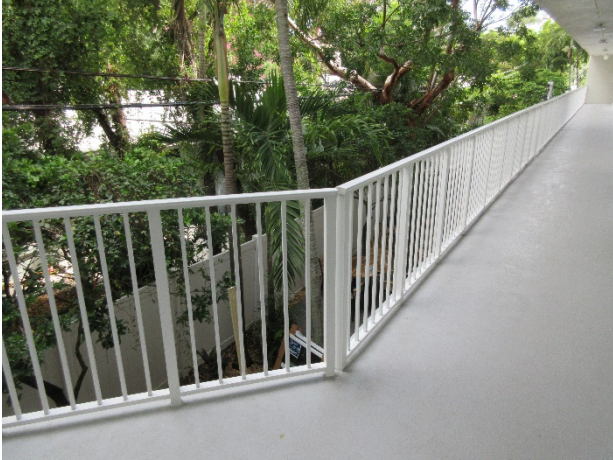
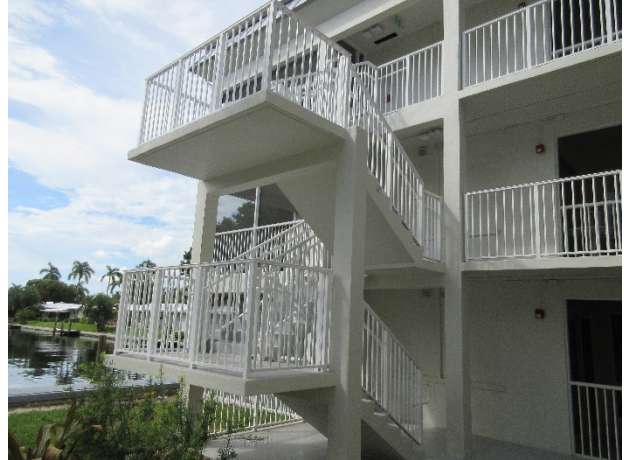
Aluminum railings overview

Condition: Good overall

Useful Life: Replacement up to every 40 years and paint finishes and capital repairs every 15- to 20-years.

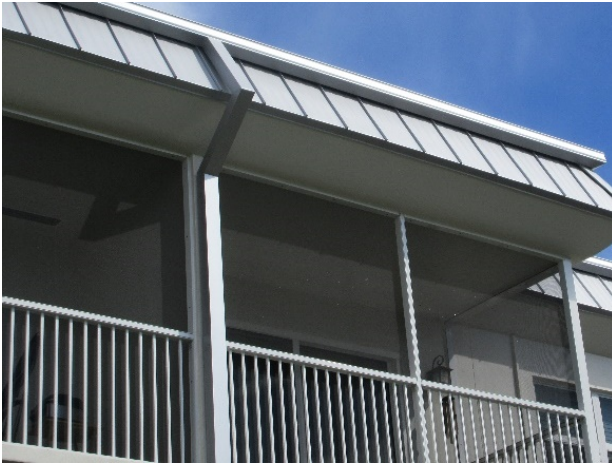
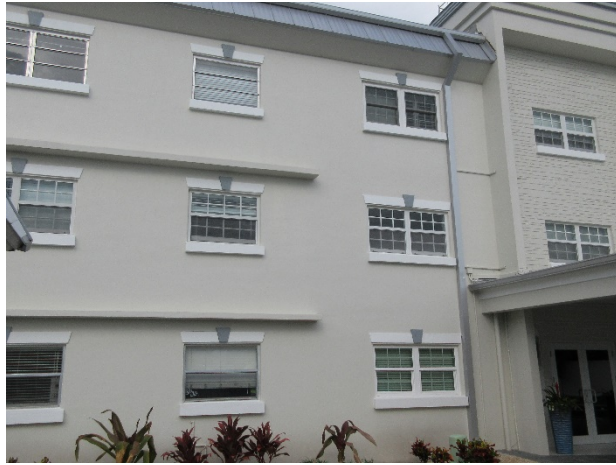
Metal gutter and downspout assembly

Condition: Good overall

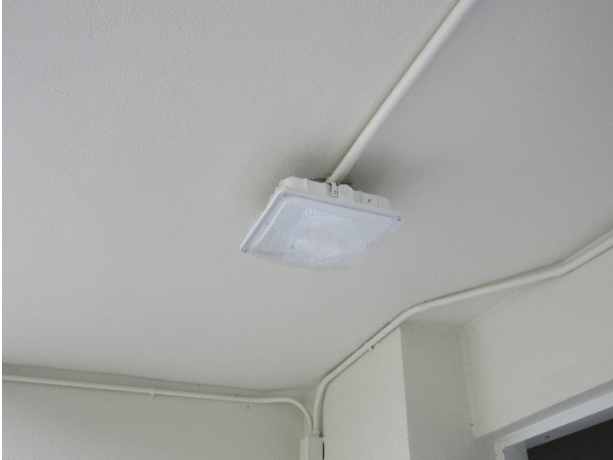
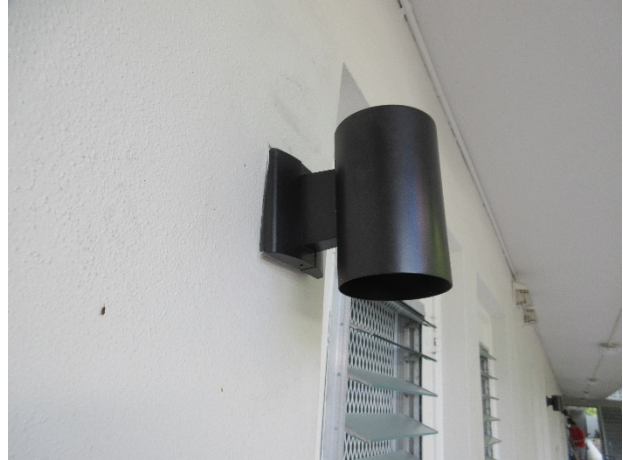
Breezeway ceiling light fixture overview

Breezeway wall light fixture overview

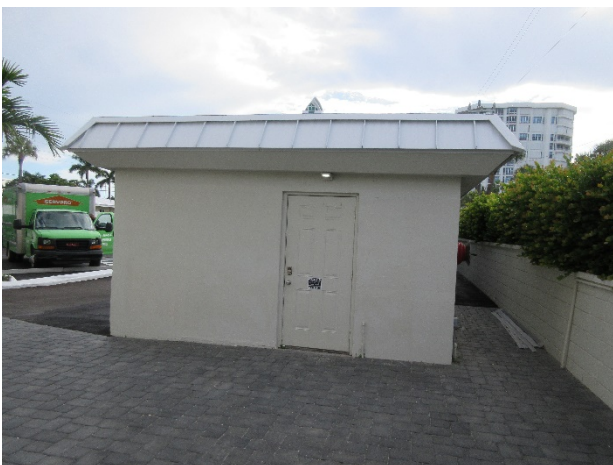
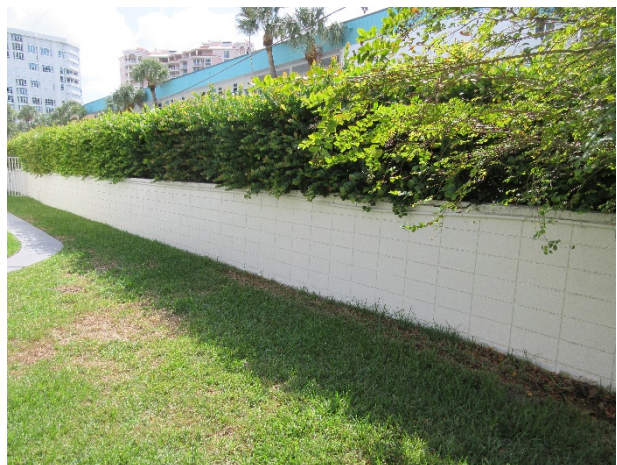
Carport concrete façade

South perimeter wall concrete façade

Useful Life: We recommend concrete facade inspections, paint finishes and repairs every five- to seven-years.

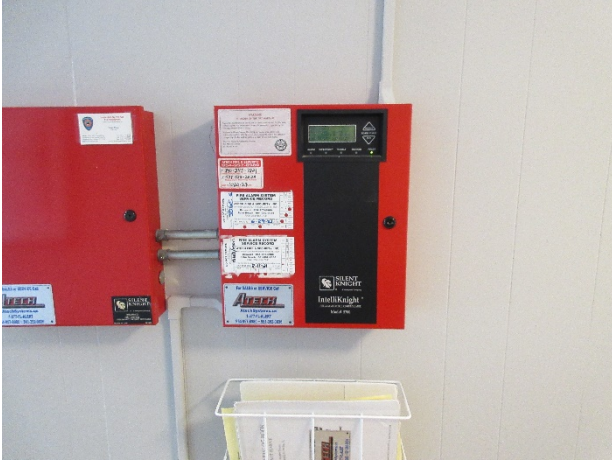
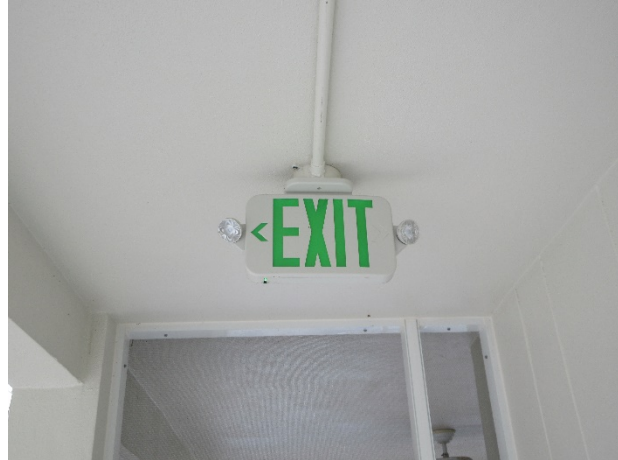
Conditions: Reported satisfactory

Life safety system control panel overview

Life safety system emergency device

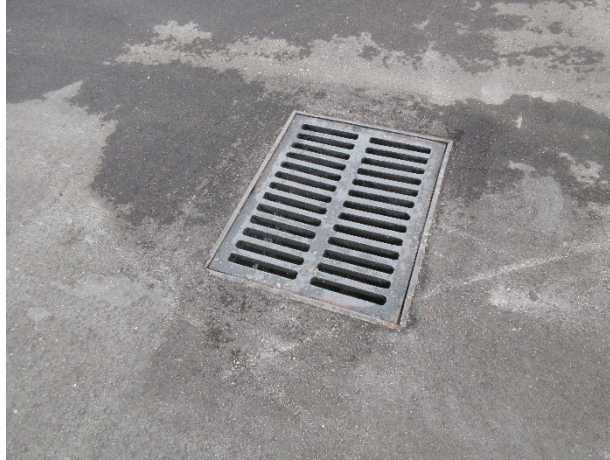
Condition: Good overall without settlement visually apparent

Catch basins overview

Useful Life: The useful life of catch basins is up to 65 years. However, achieving this useful life usually requires interim capital repairs or partial replacements every 15- to 20-years.

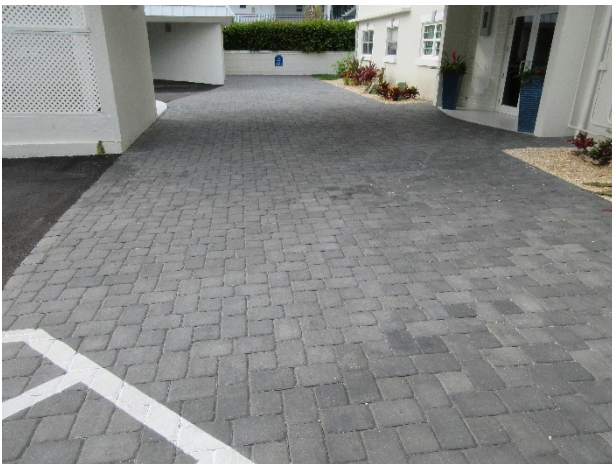
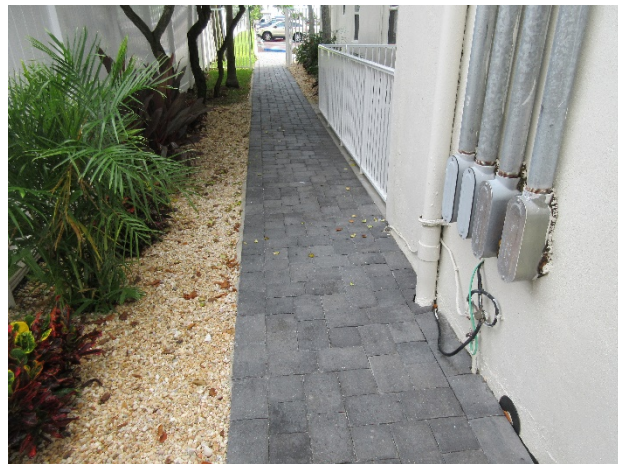
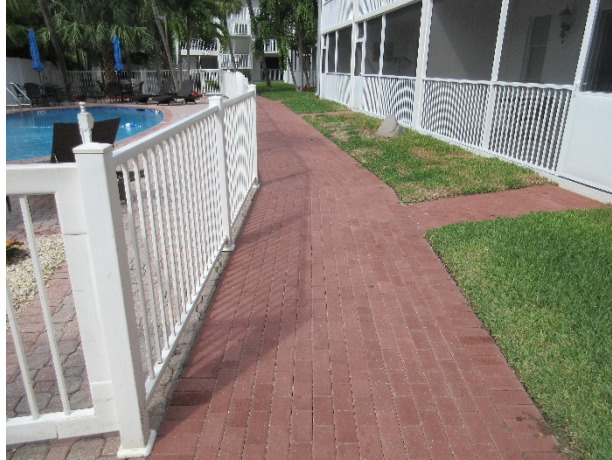
Condition: Good overall

Masonry pavers overview

Expenditure Detail Notes: Expenditure timing and costs are depicted in the **Reserve Expenditures** table in Section 3. Our cost is based on information provided by the Association. We suggest the Association conduct interim resetting and replacement of minor areas of pavers as normal maintenance, funded from the operating budget.

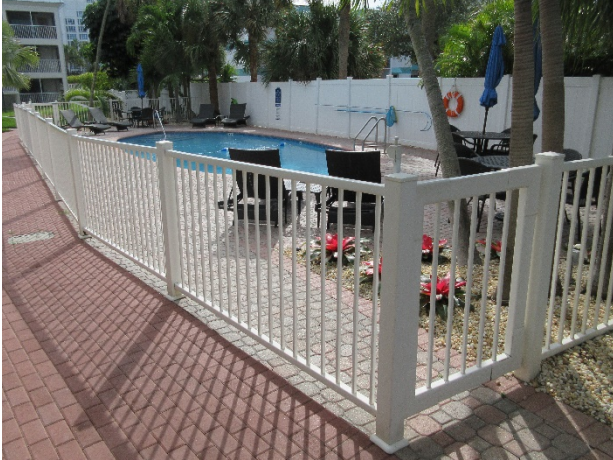
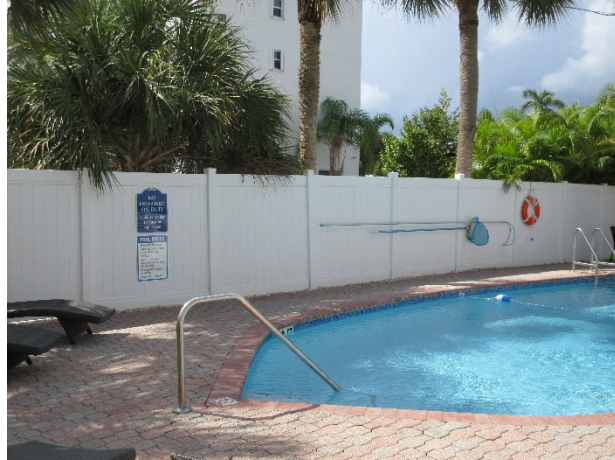
Condition: Good overall

Vinyl fence overview

- Annually:
 - Inspect and repair loose fasteners or sections, and damage
 - Repair leaning sections and clear vegetation from fence areas which could cause damage

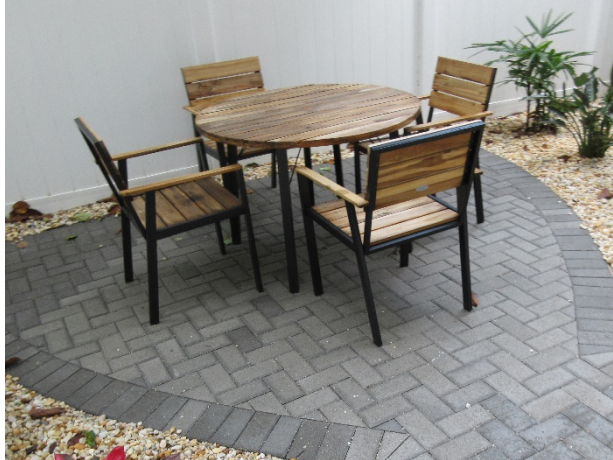
Condition: Good overall

Site furniture overview

Expenditure Detail Notes: Expenditure timing and costs are depicted in the **Reserve Expenditures** table in Section 3. We recommend interim re-strapping, refinishing, cushion replacements, reupholstering and other repairs to the furniture as normal maintenance to maximize its useful life.

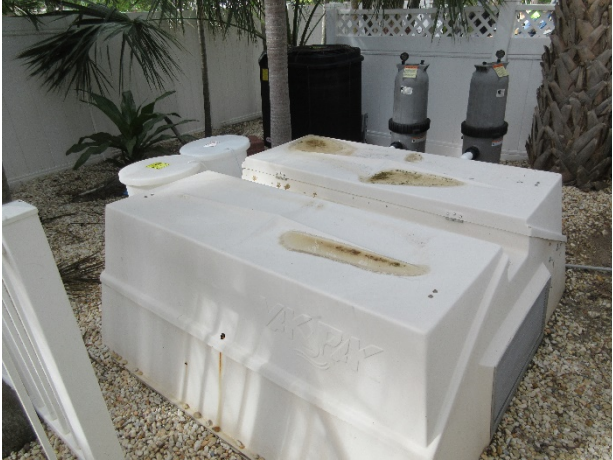
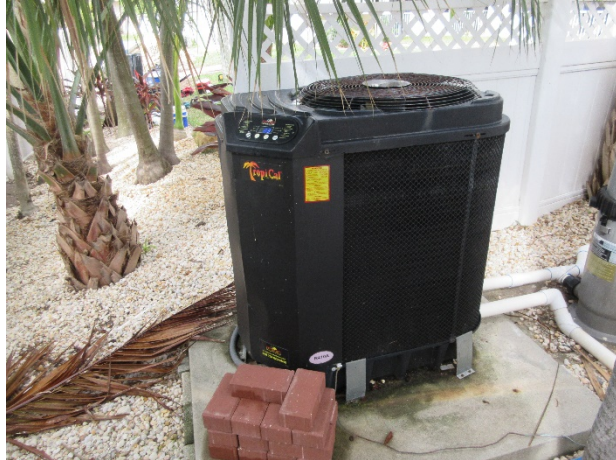
Condition: Reported satisfactory

Pool mechanical equipment overview

Preventative Maintenance Notes: We recommend the Association maintain a maintenance contract with a qualified professional and follow the manufacturer's specific recommended maintenance and local, state and/or federal inspection guidelines.

Expenditure Detail Notes: Expenditure timing and costs are depicted in the **Reserve Expenditures** table in Section 3. Failure of the pool mechanical equipment as a single event is unlikely. Therefore, we include replacement of up to fifty percent (50%) of the equipment per event. We consider interim replacement of motors and minor repairs as normal maintenance.

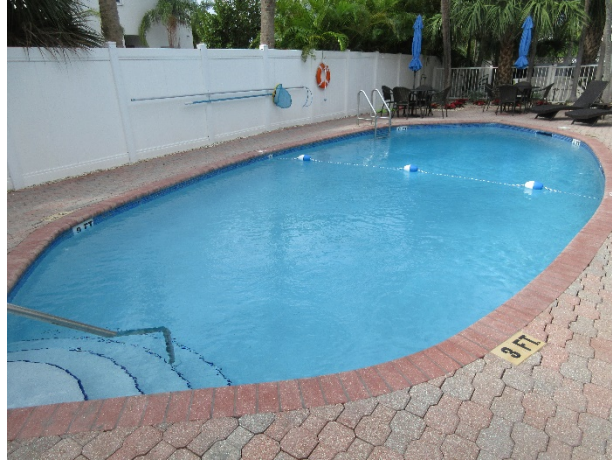
Condition: Good overall

Pool overview

- Semi-annually:
 - Inspect and patch areas of significant plaster delamination, coping damage and structure cracks
 - Inspect main drain connection and anti-entrapment covers, pressure test circulation piping and valves
 - Test handrails and safety features for proper operation

Expenditure Detail Notes: Expenditure timing and costs are depicted in the **Reserve Expenditures** table in Section 3. We recommend the Association budget for full tile and coping replacement every other plaster replacement event. Removal and replacement of the finish provides the opportunity to inspect the pool structures and to allow for partial repairs of the underlying concrete surfaces as needed. To maintain the integrity of the pool structures, we recommend the Association budget for the following:

- Removal and replacement of the plaster finishes
- Partial replacements of the scuppers and coping as needed
- Replacement of tiles as needed
- Replacement of joint sealants as needed
- Concrete structure repairs as needed

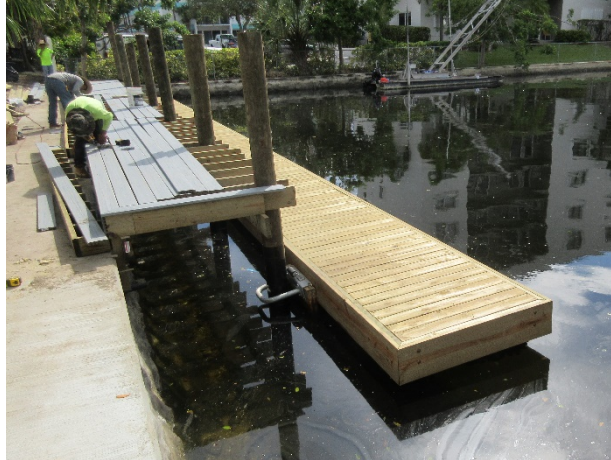
Condition: Good overall

Wood and composite dock overview

Expenditure Detail Notes: Expenditure timing and costs are depicted in the **Reserve Expenditures** table in Section 3. Our estimate of cost is based on information provided by the Association and we recommend Whittier Towers fund interim replacements of utilities prior to replacement of the docks and annual repairs to displaced pilings through the operating budget.
