Sample Report

D.C Building Inspectors

Pest And Building Inspection

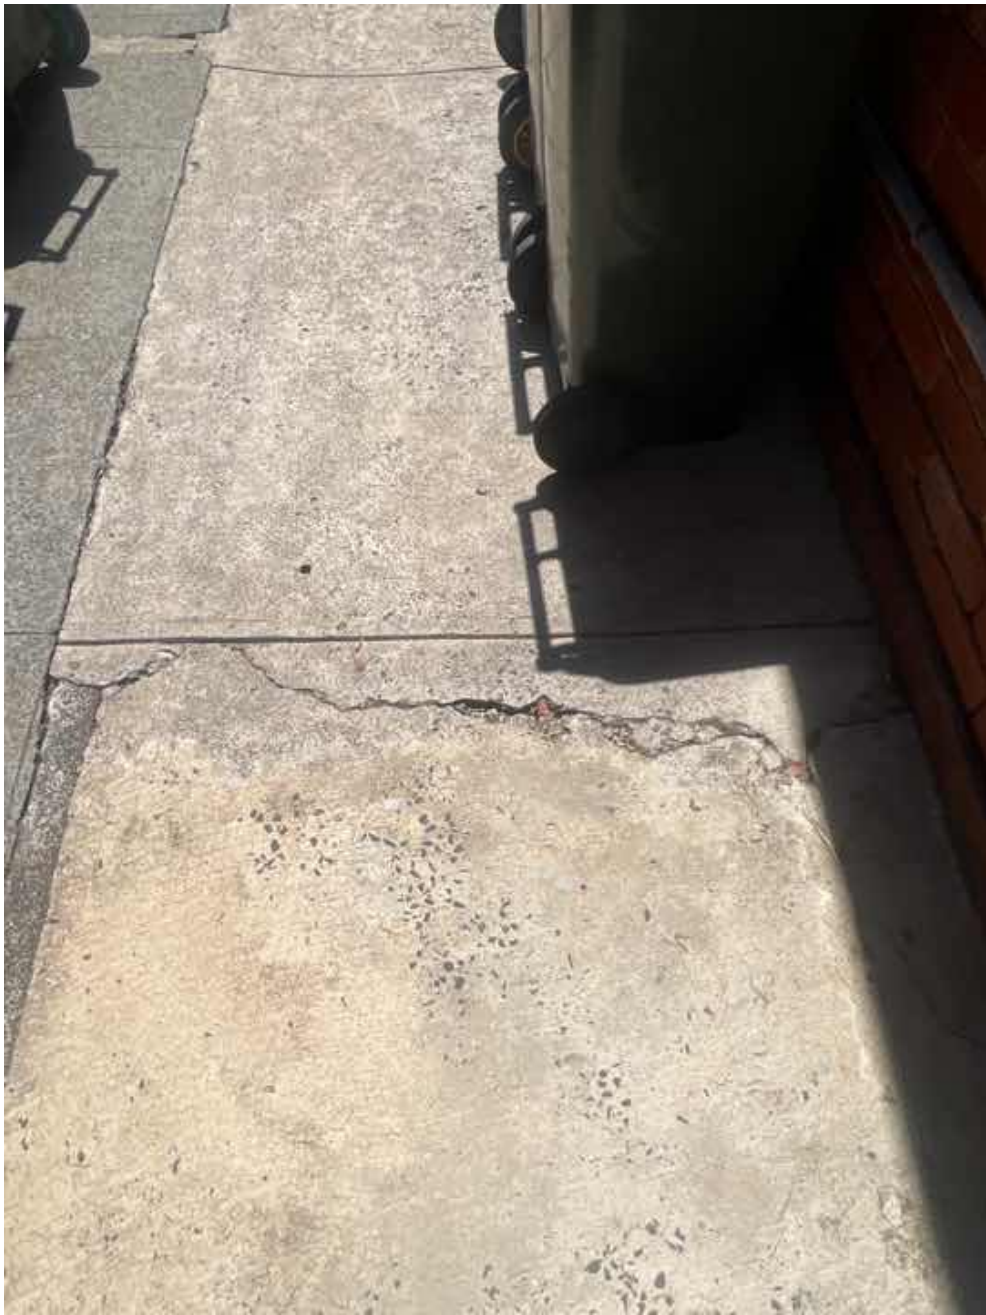
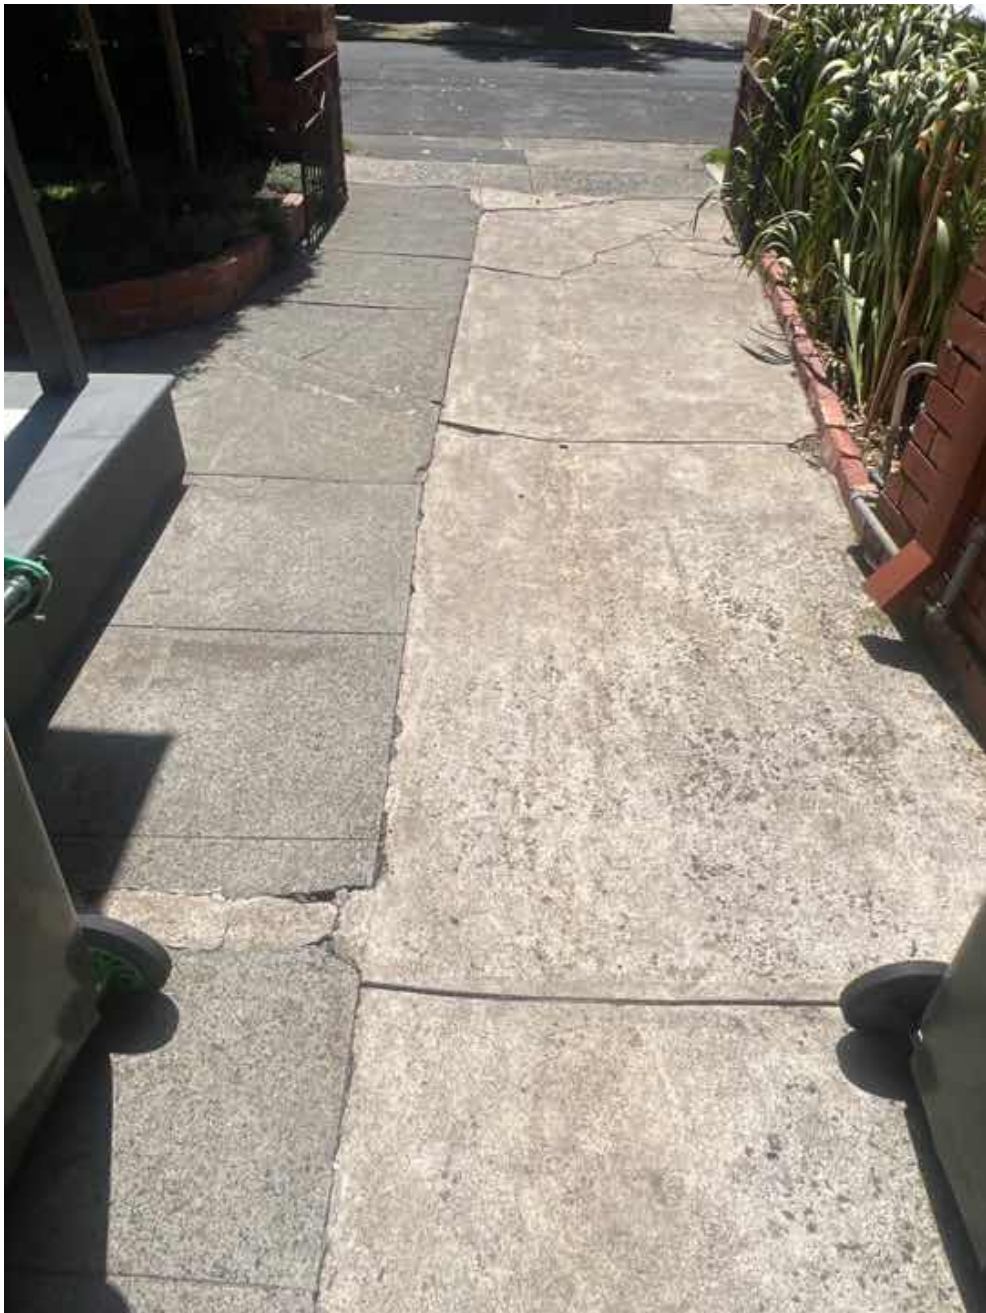
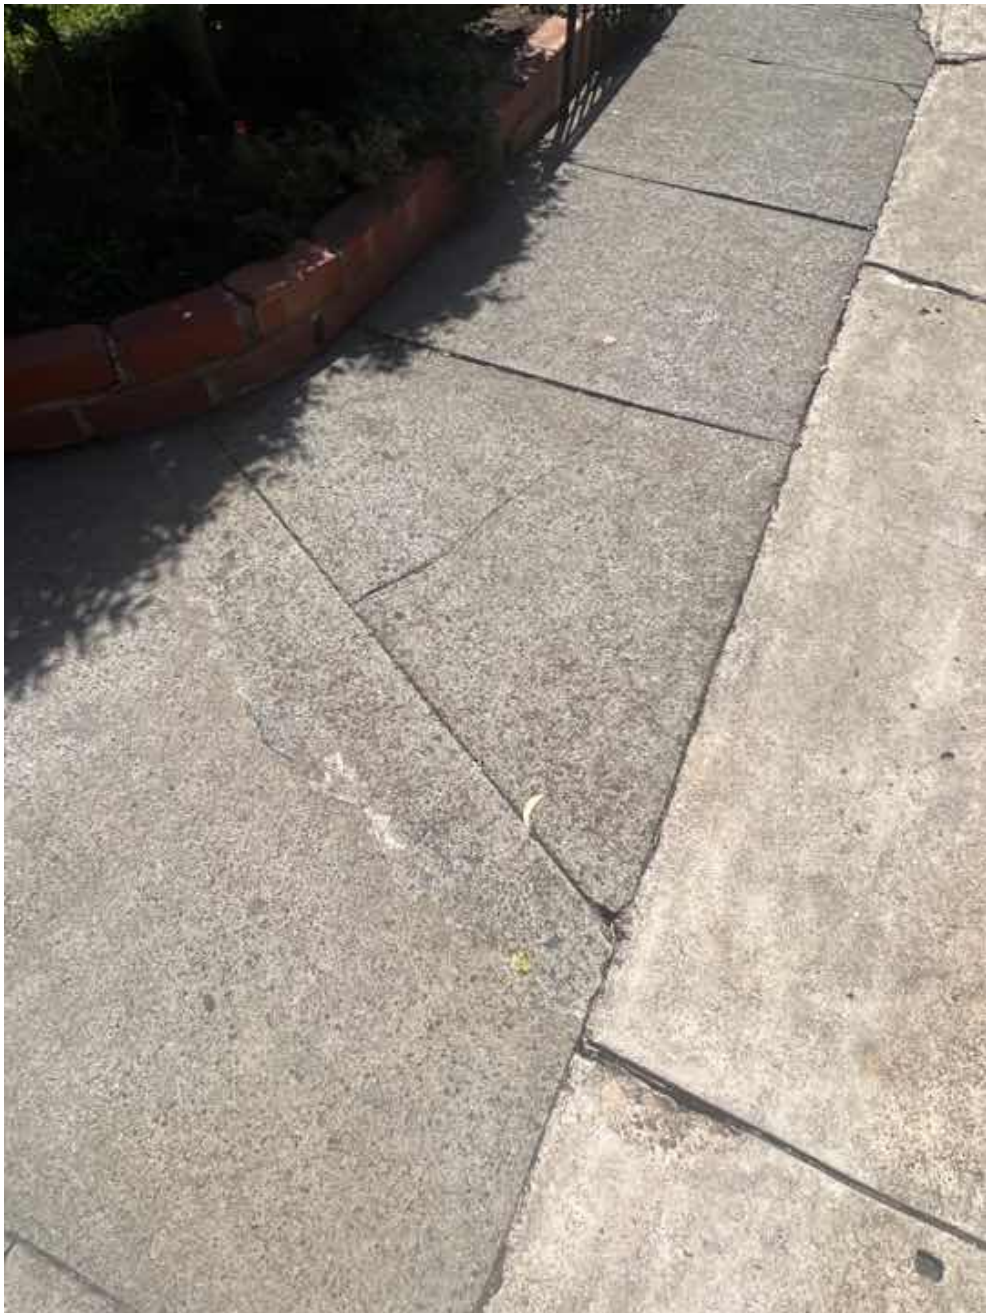
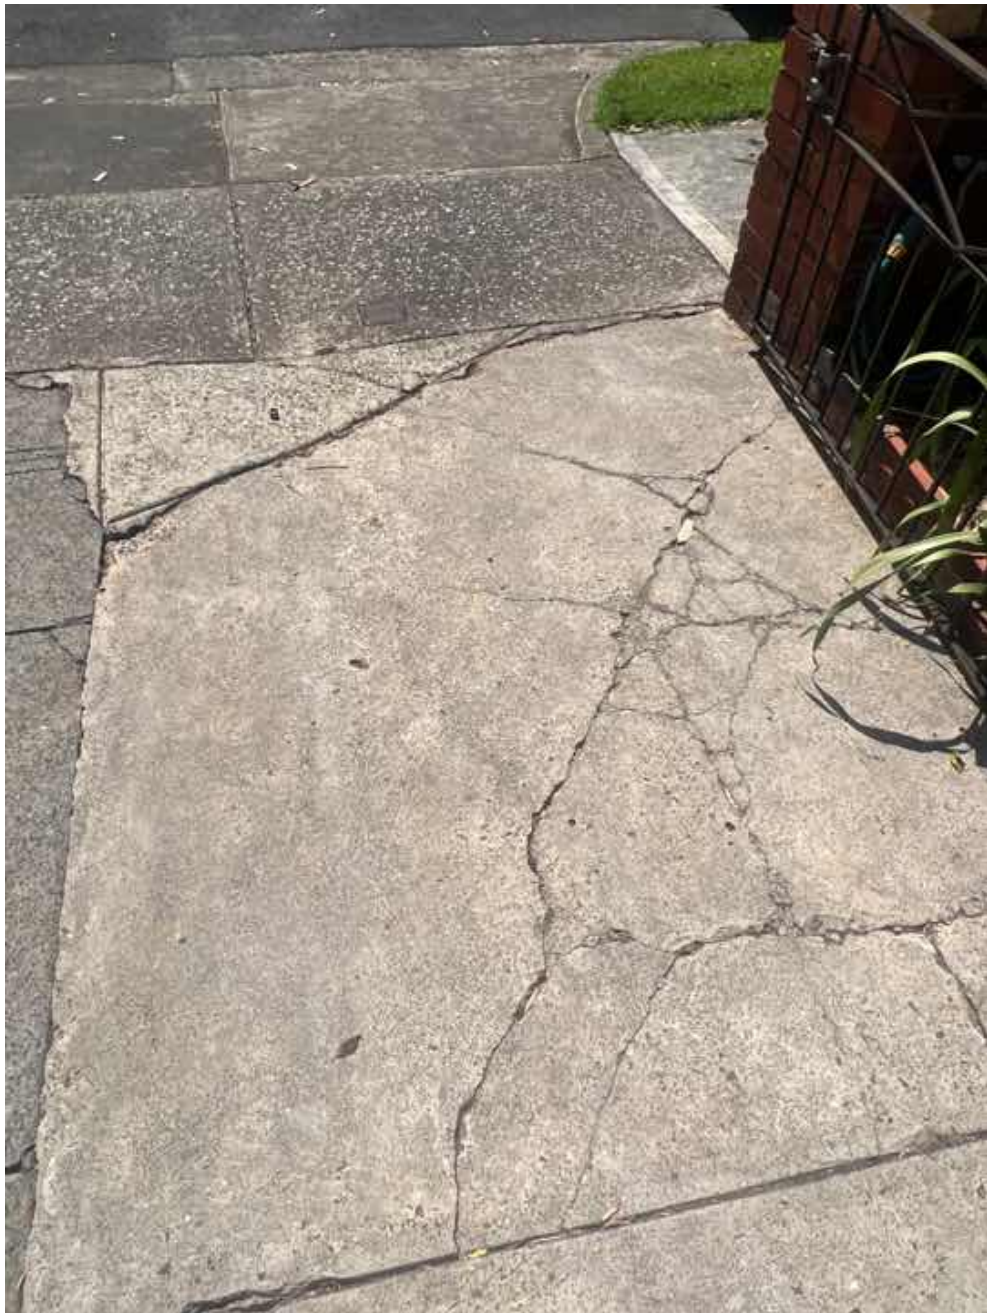
Driveway Condition

The driveway is in poor condition to some areas and replacement is recommended. Contact a qualified concreter for a quotation prior to a decision to purchase.

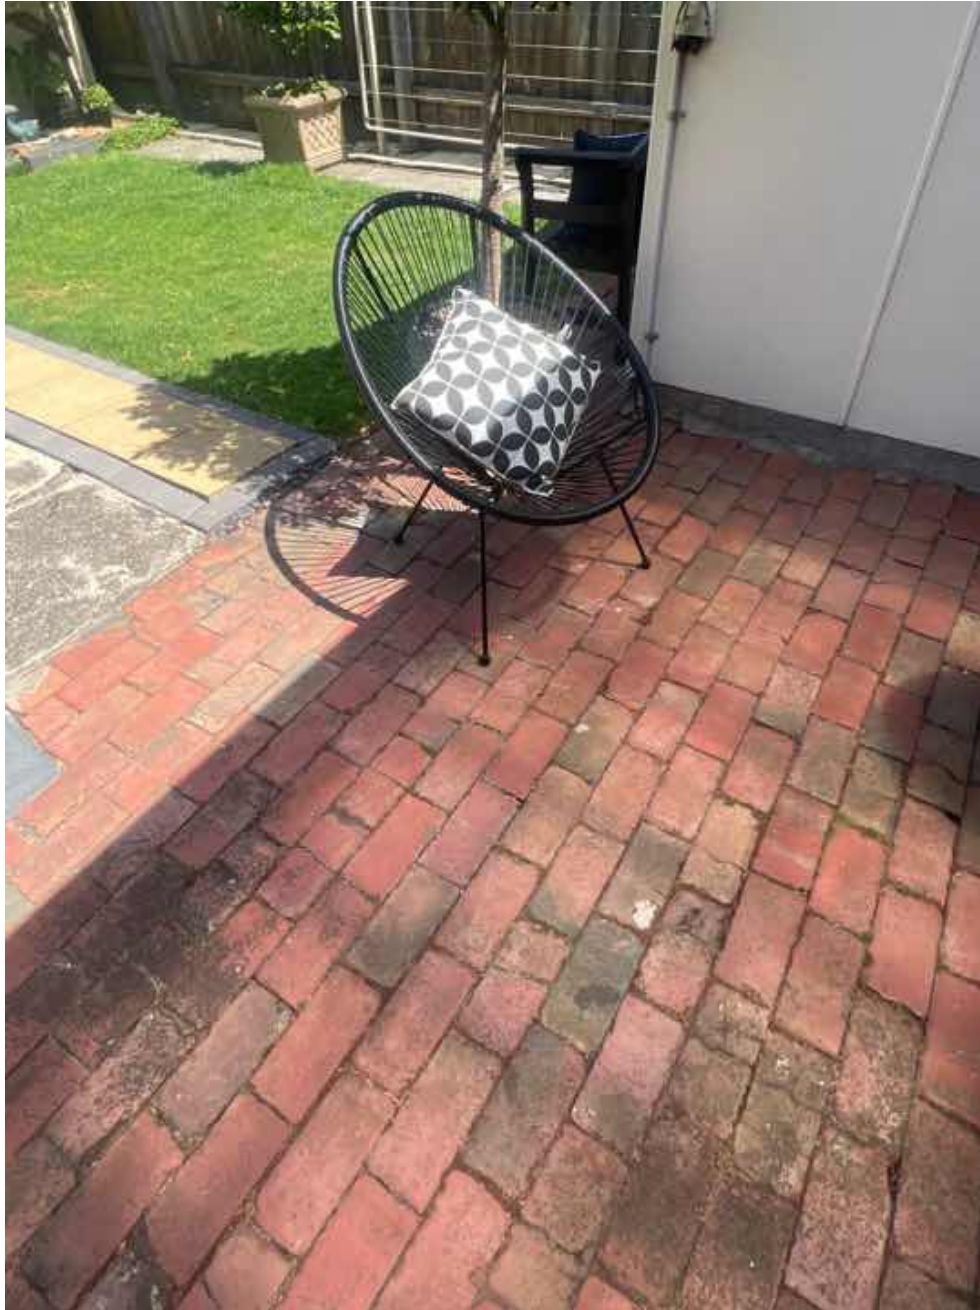
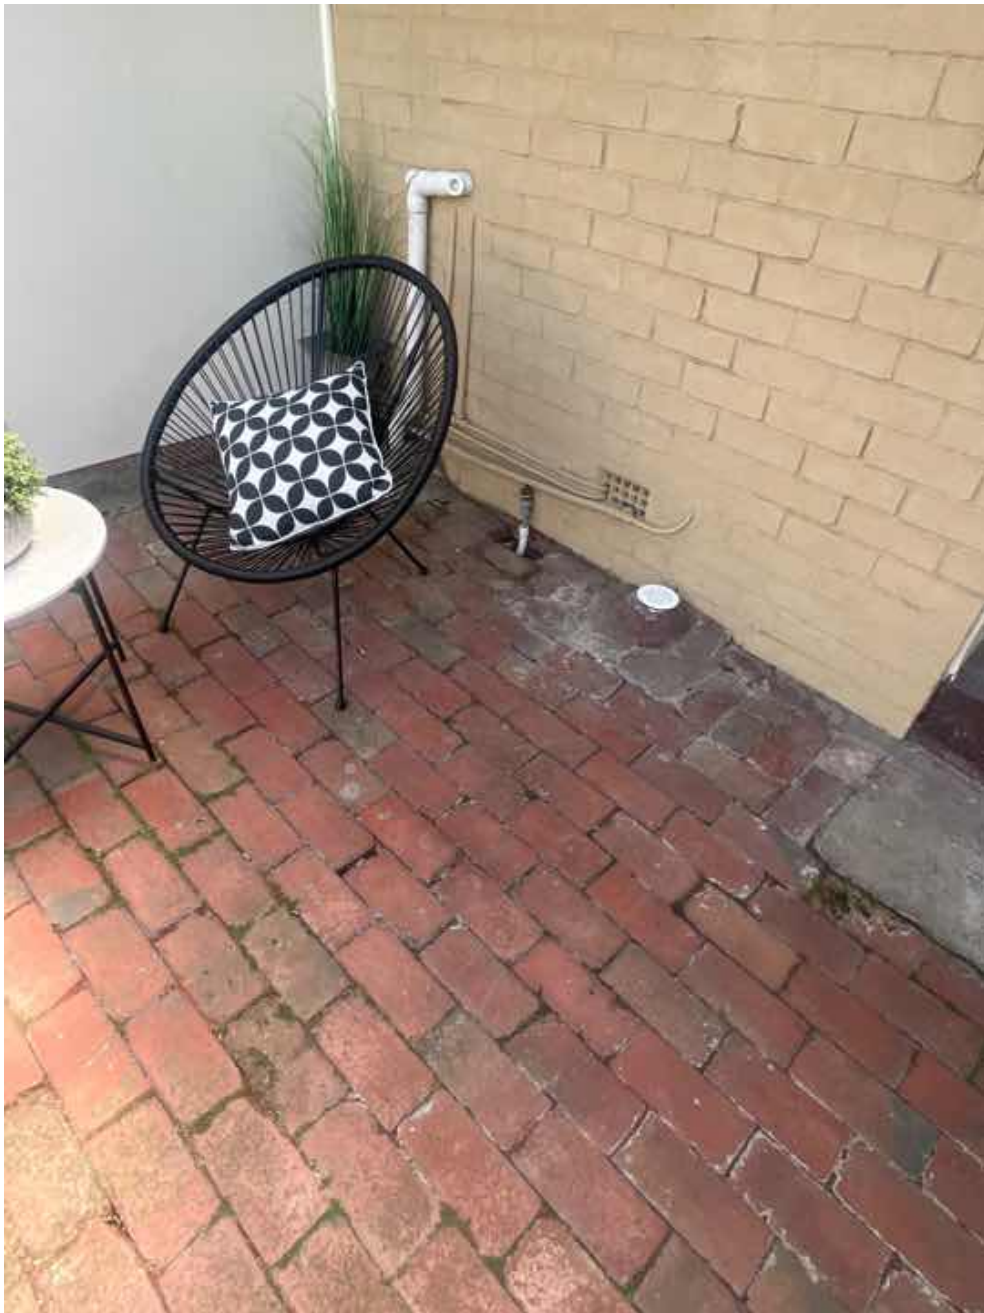
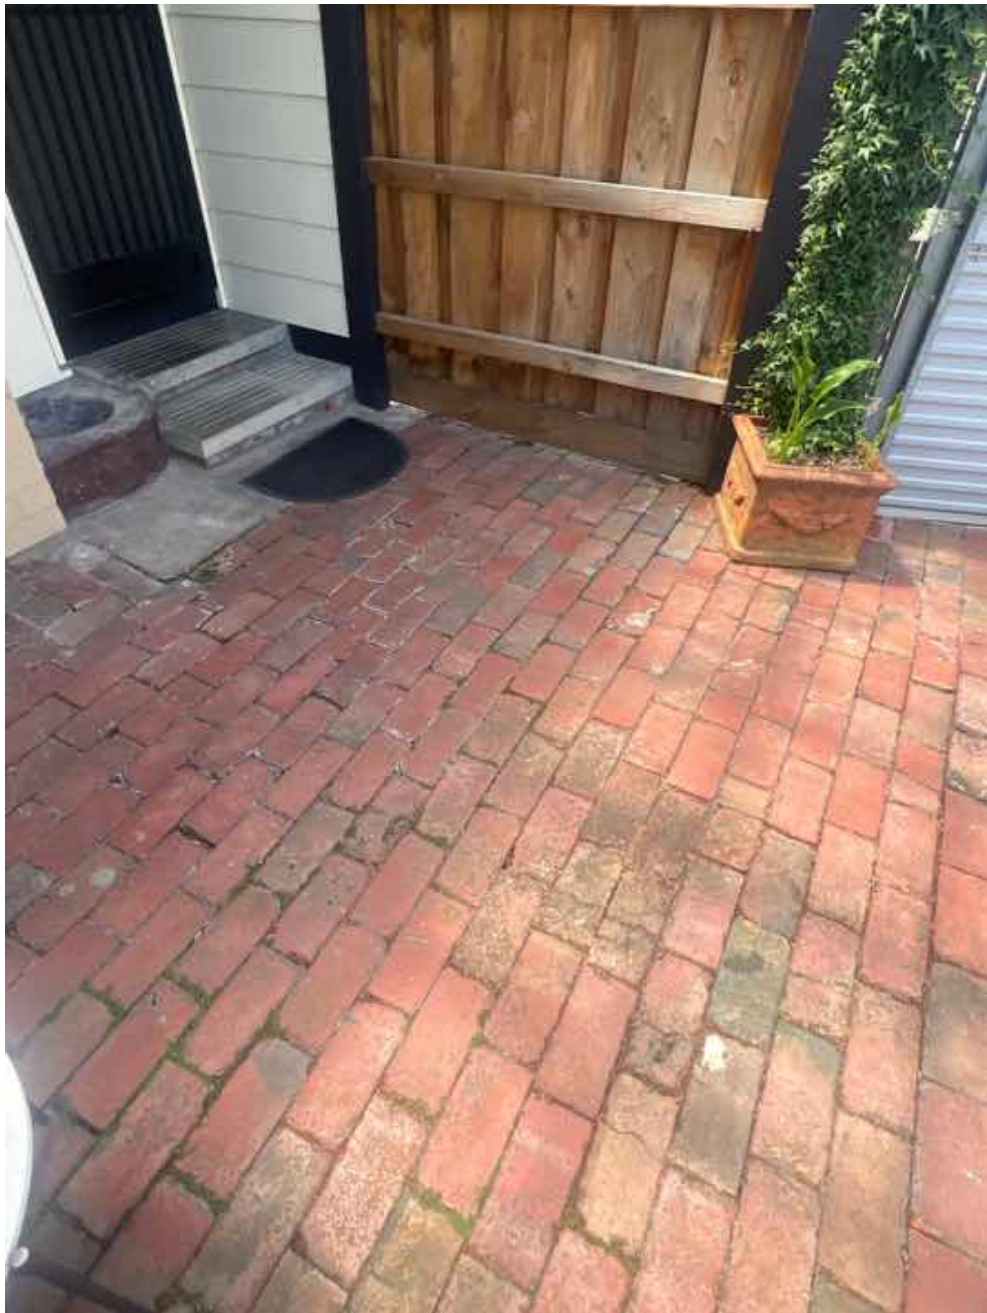
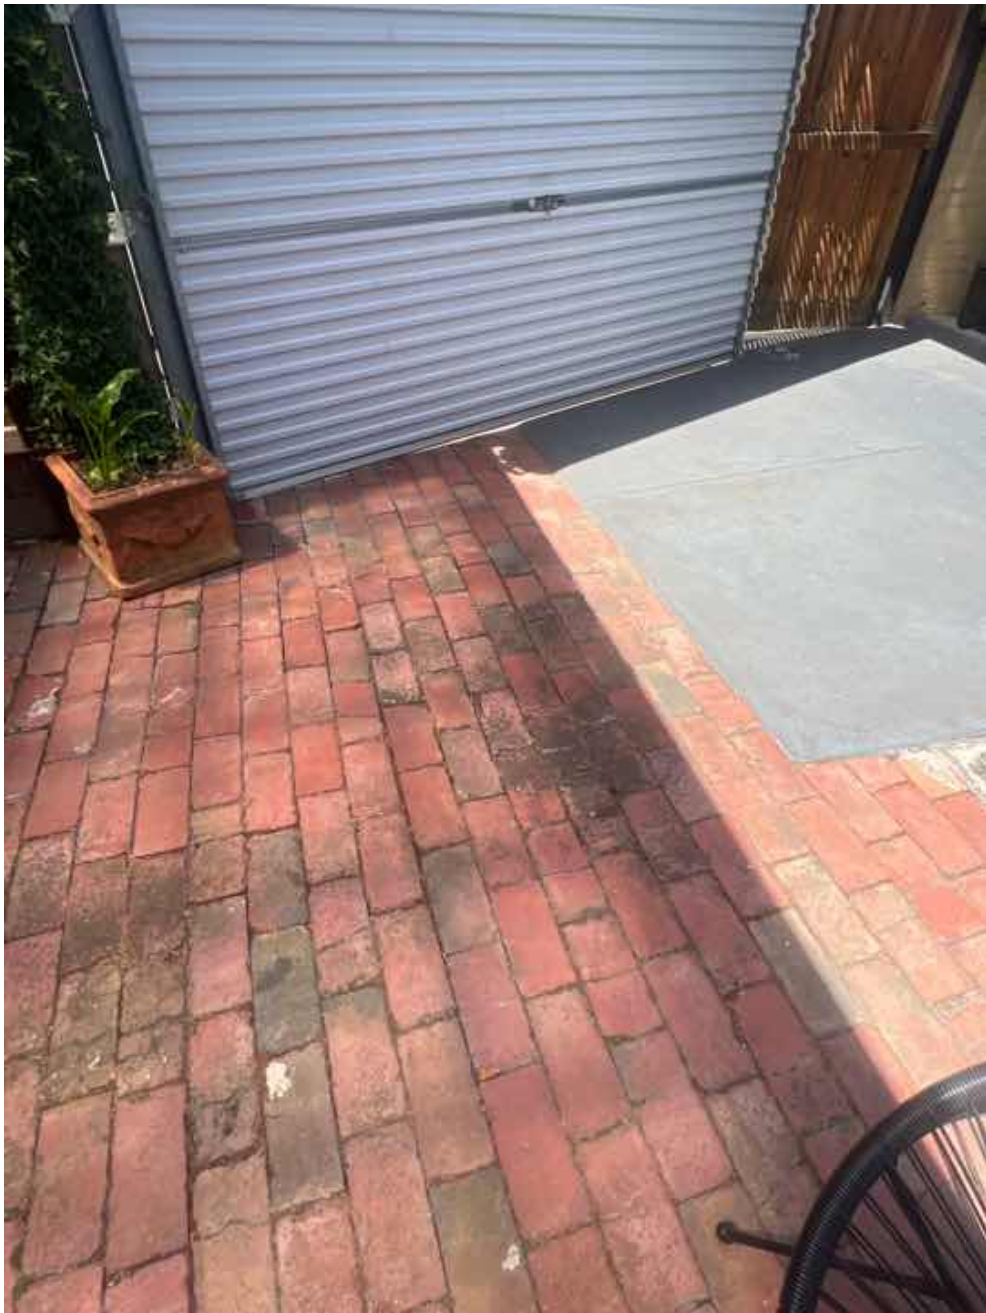
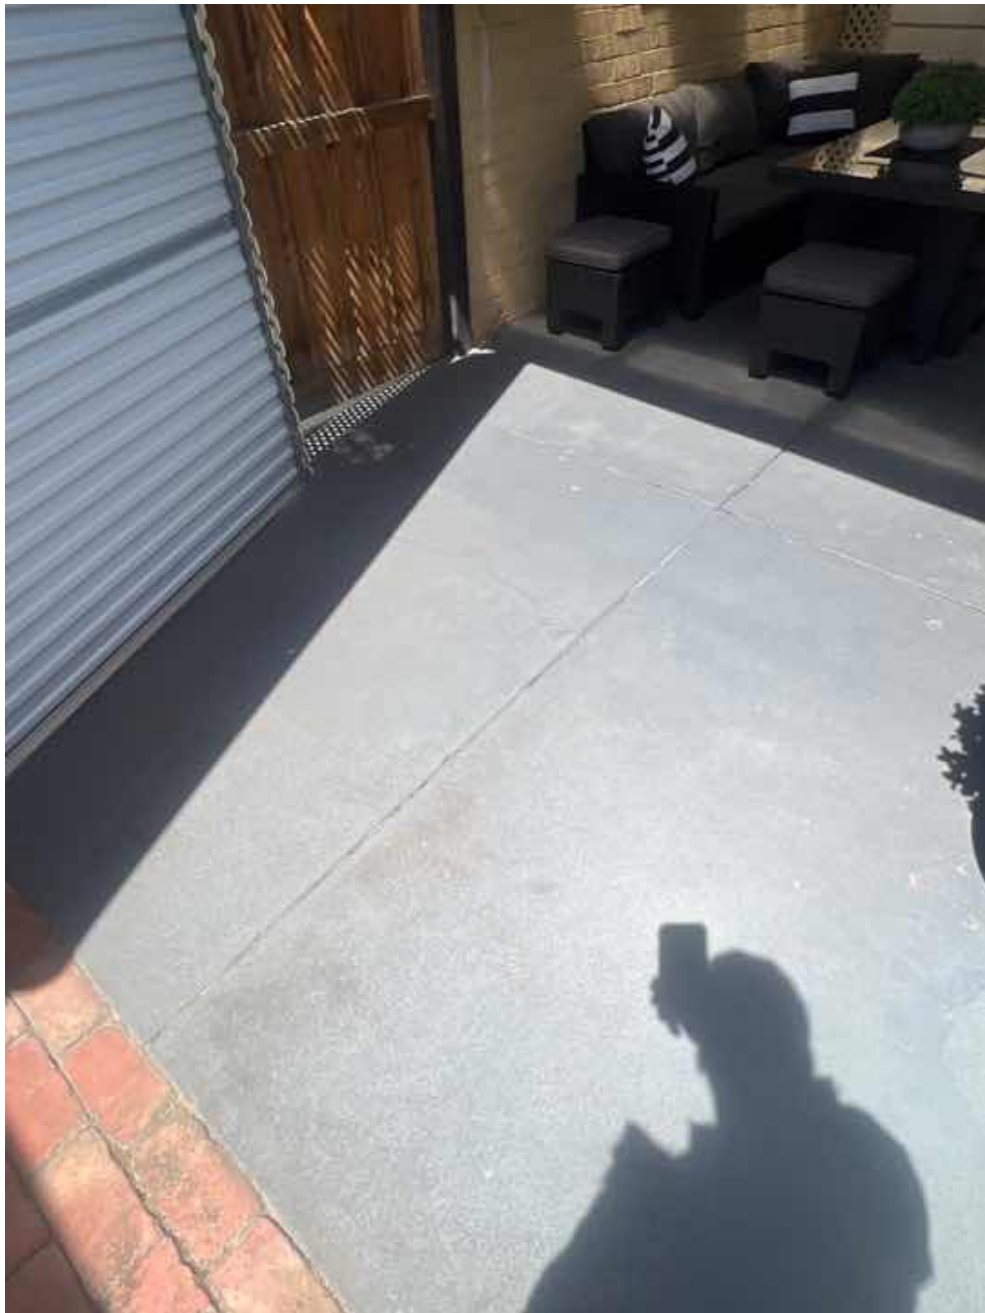
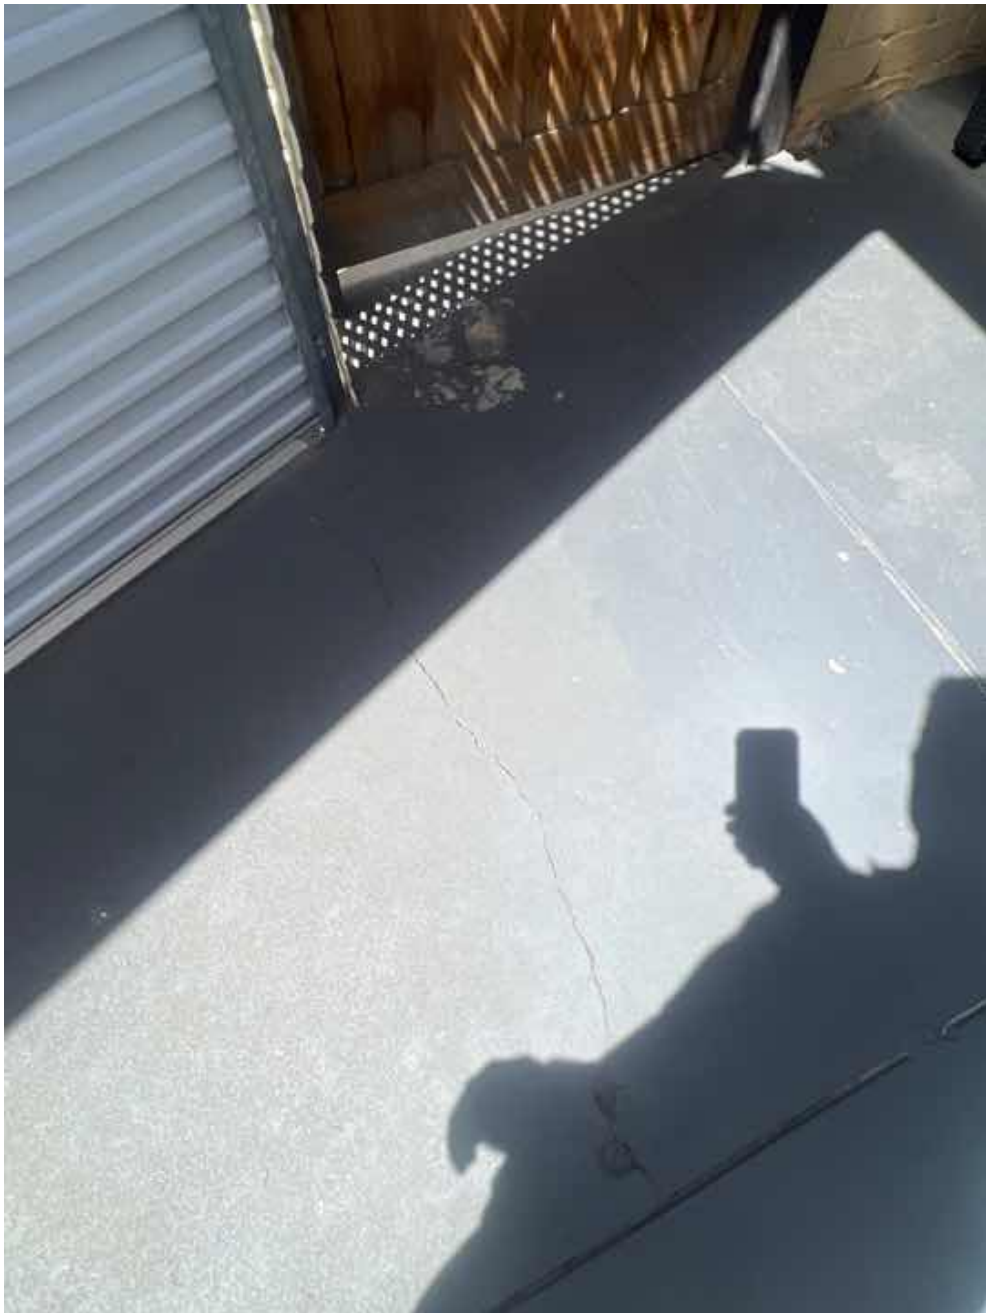
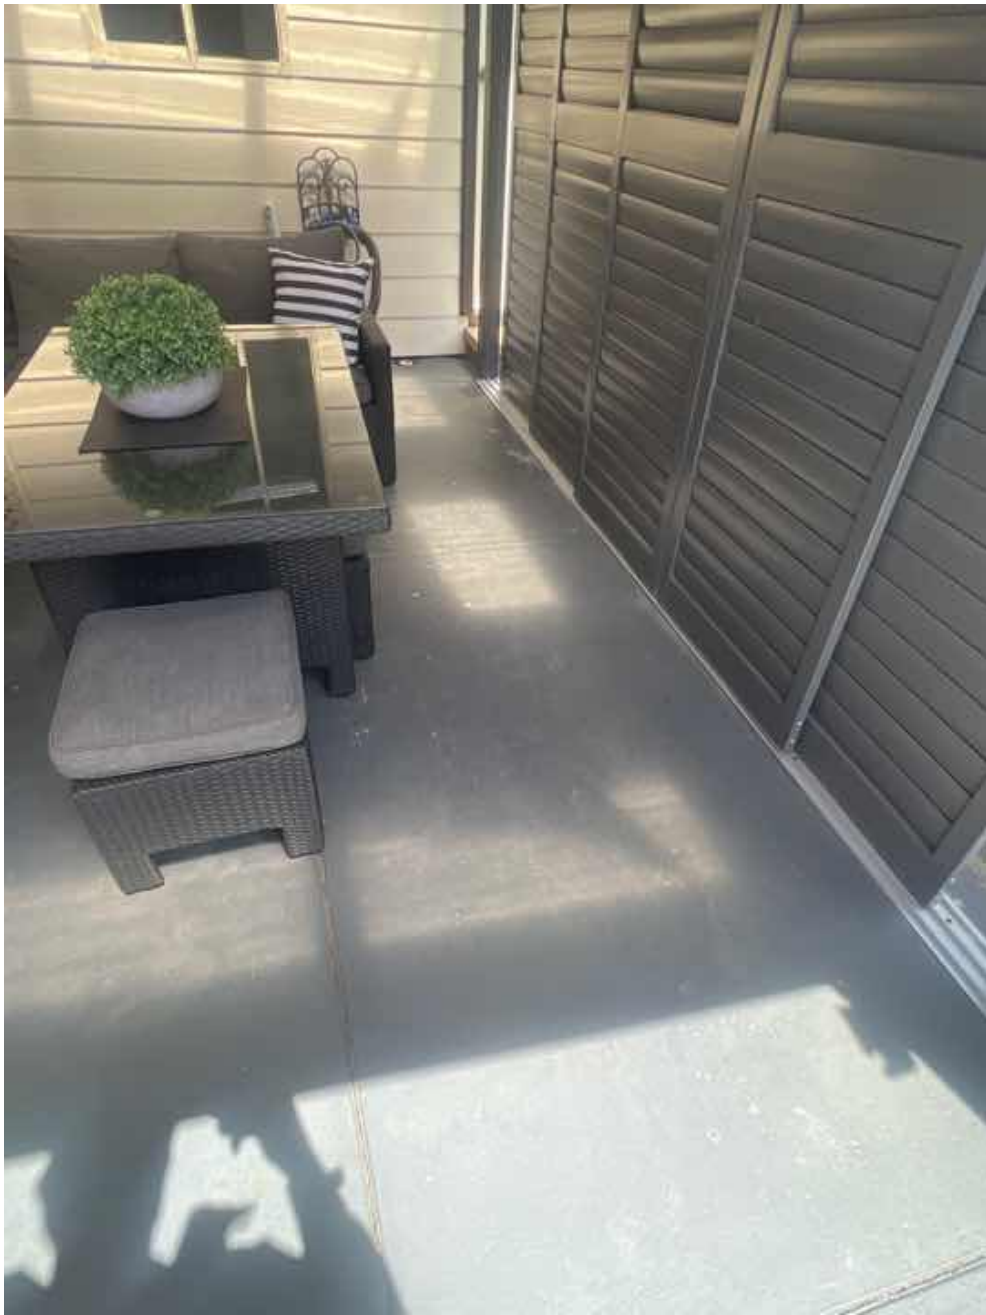
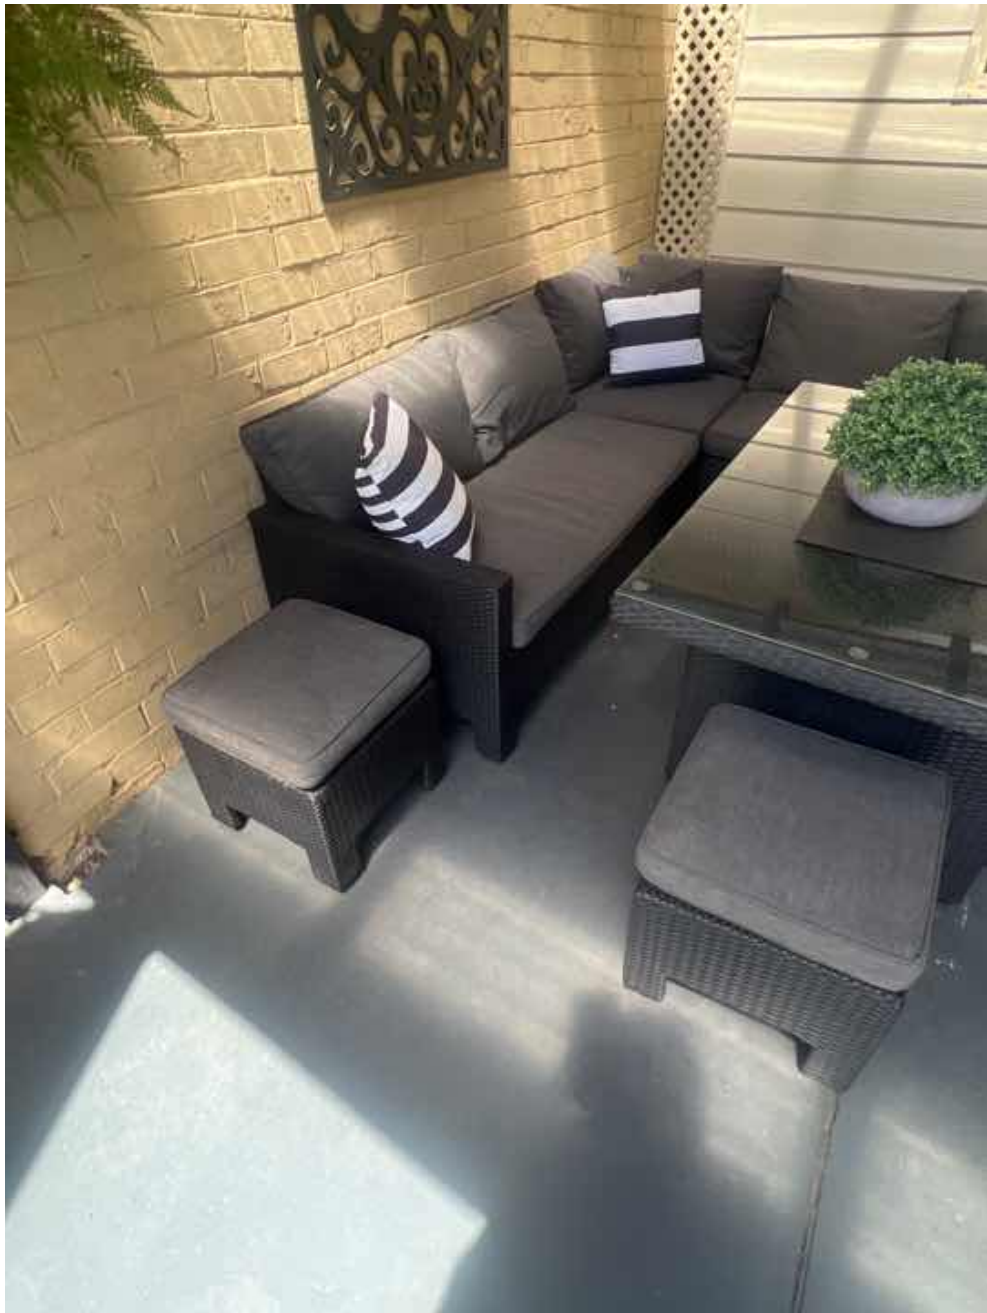
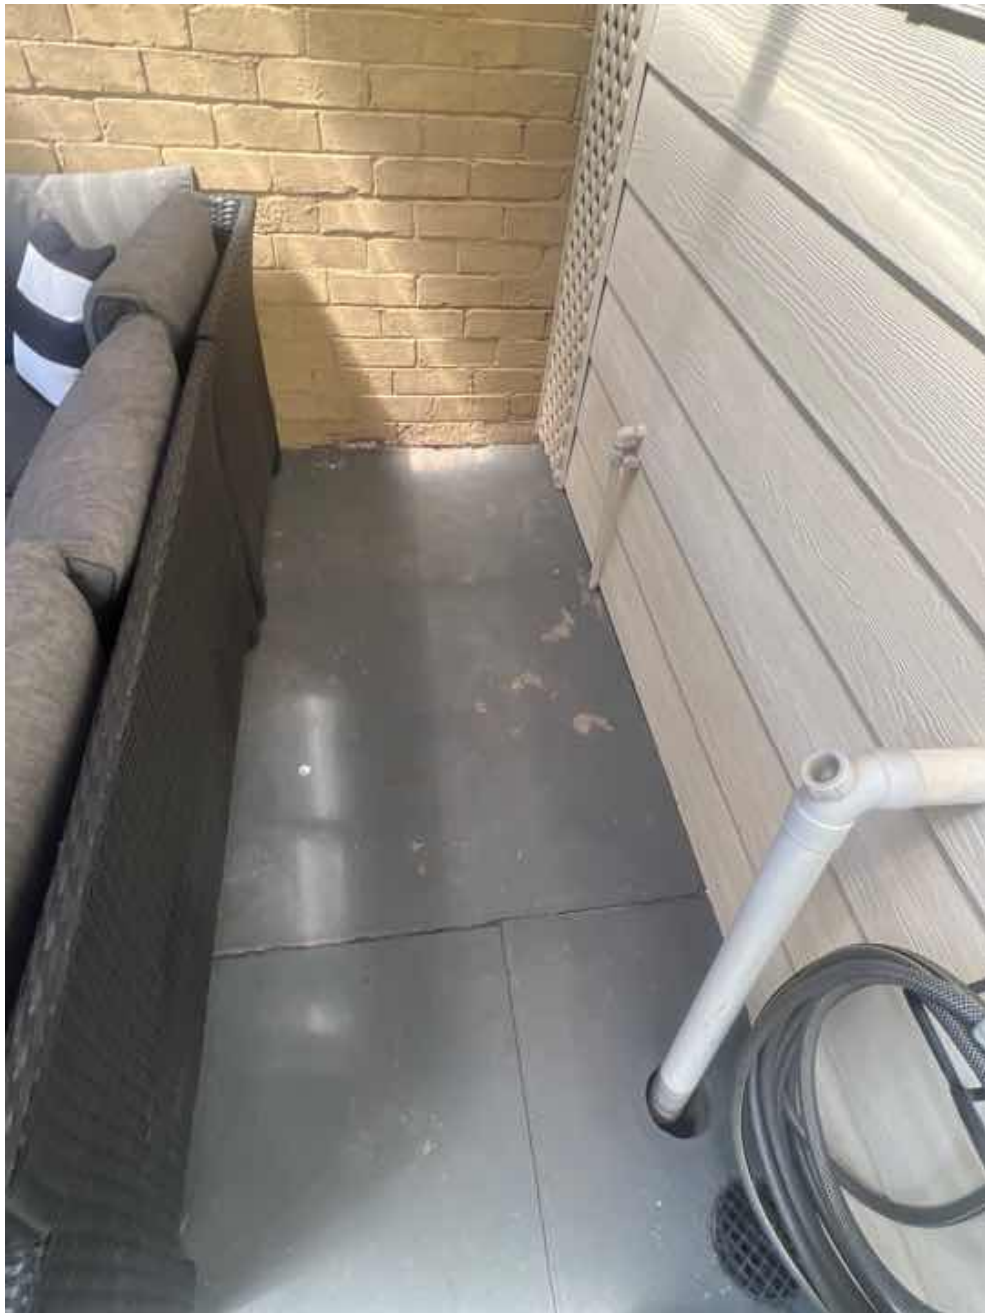
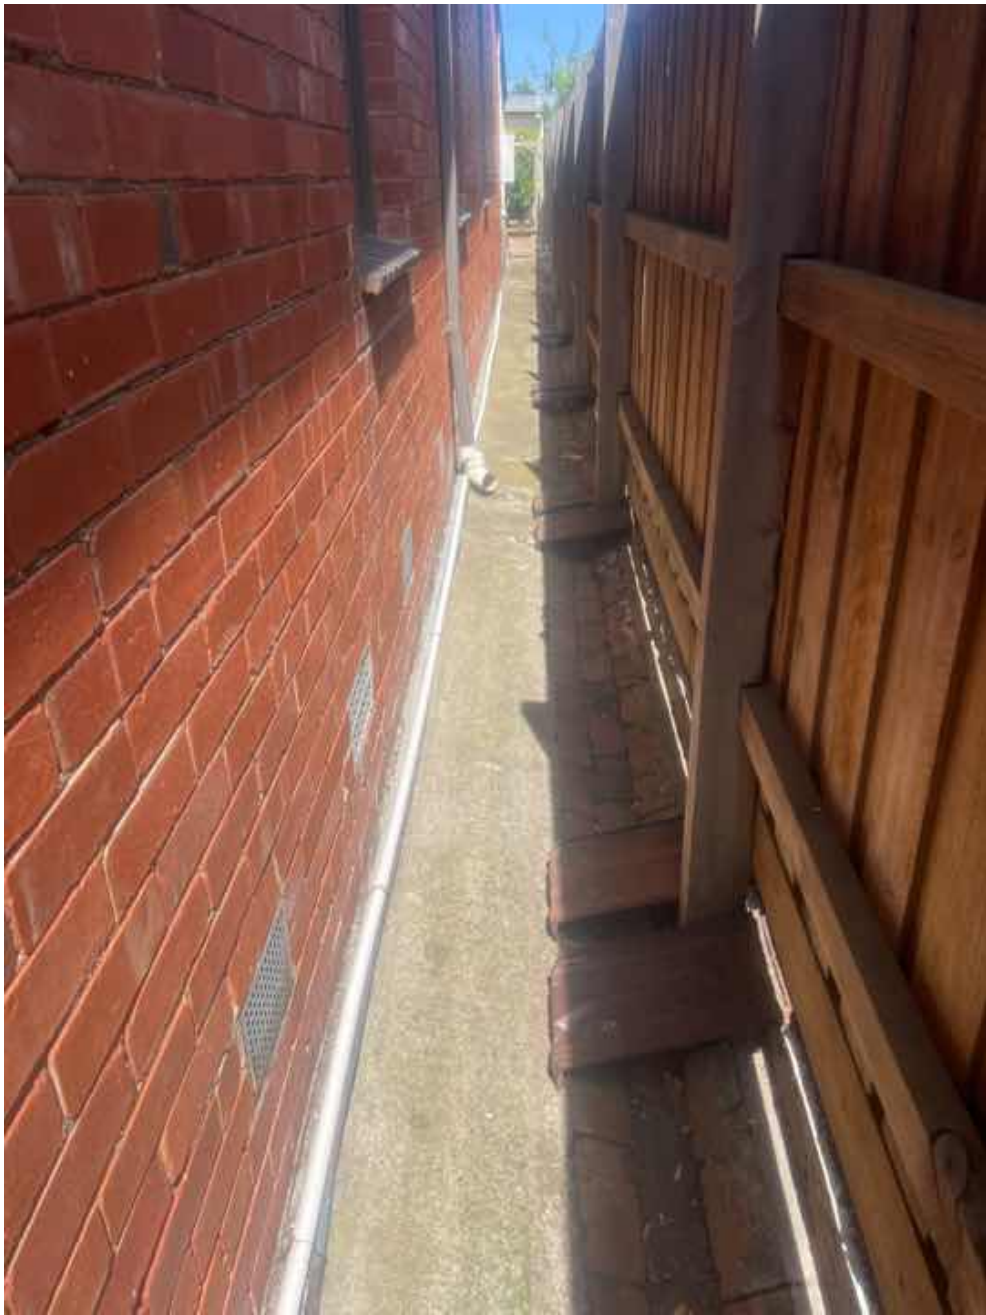
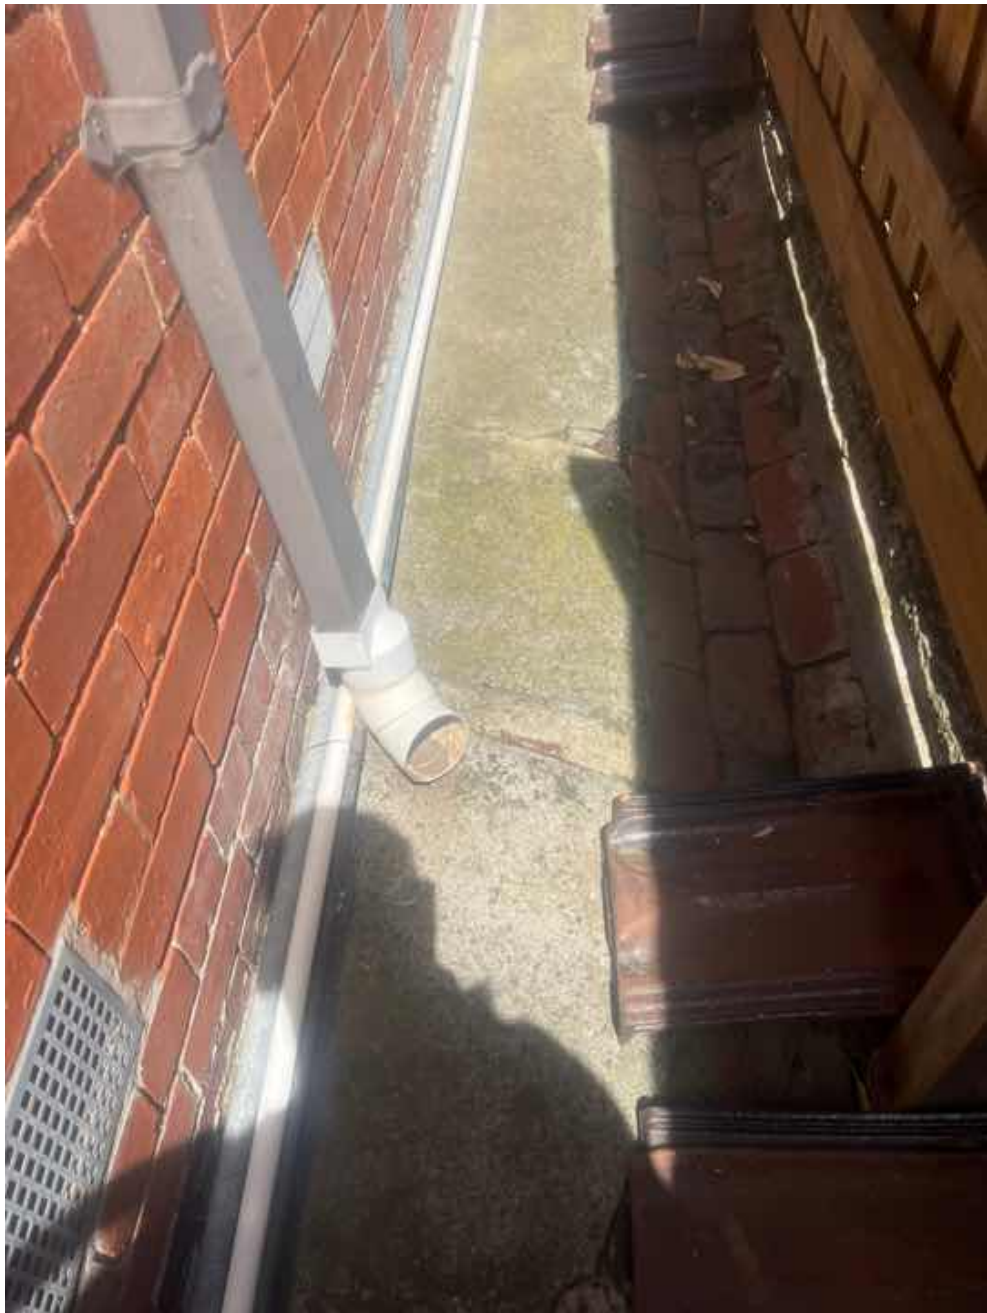
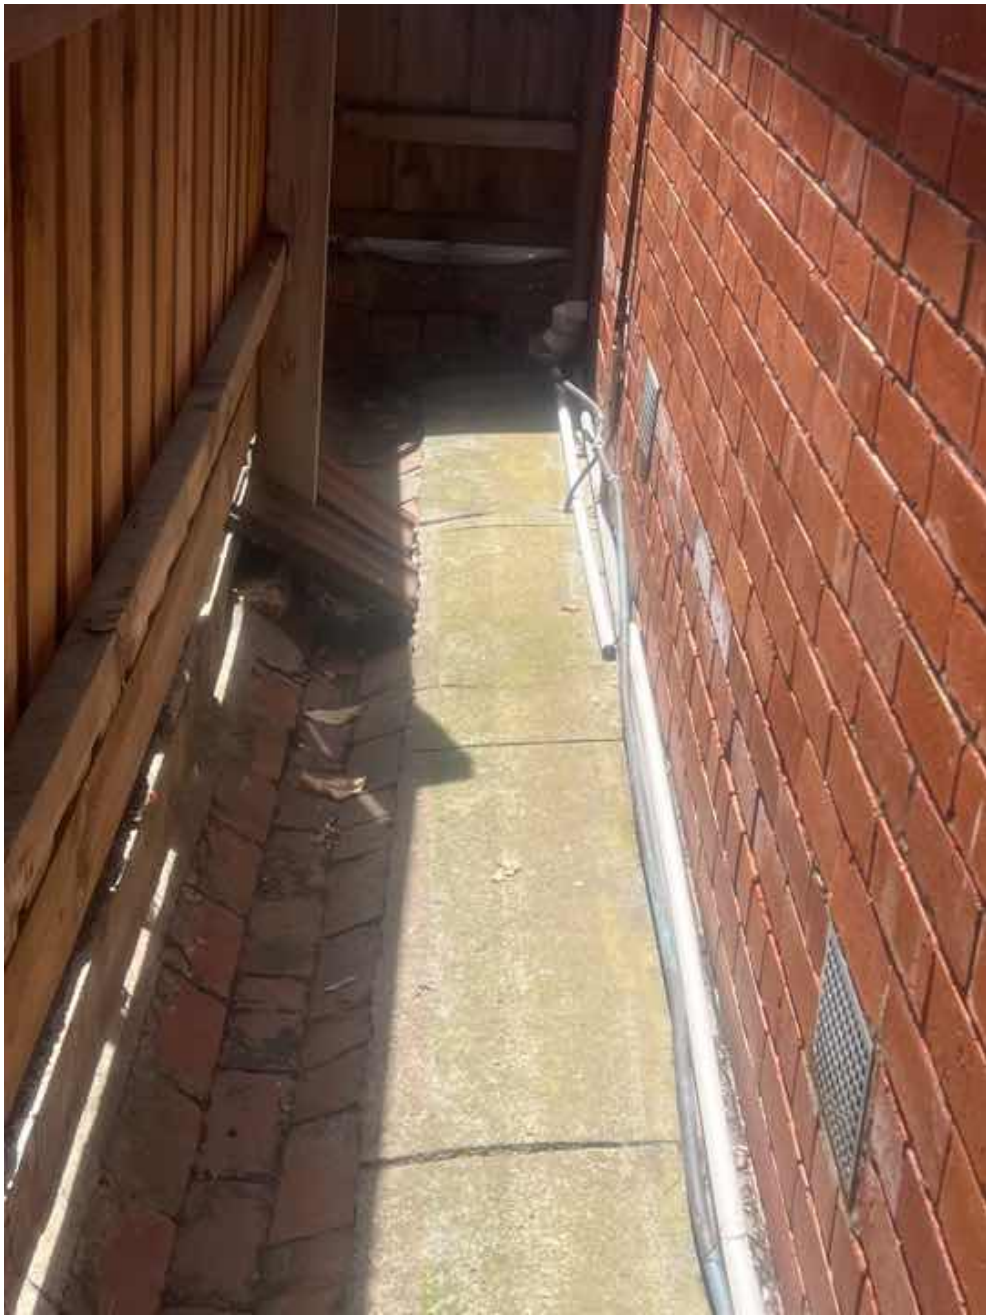
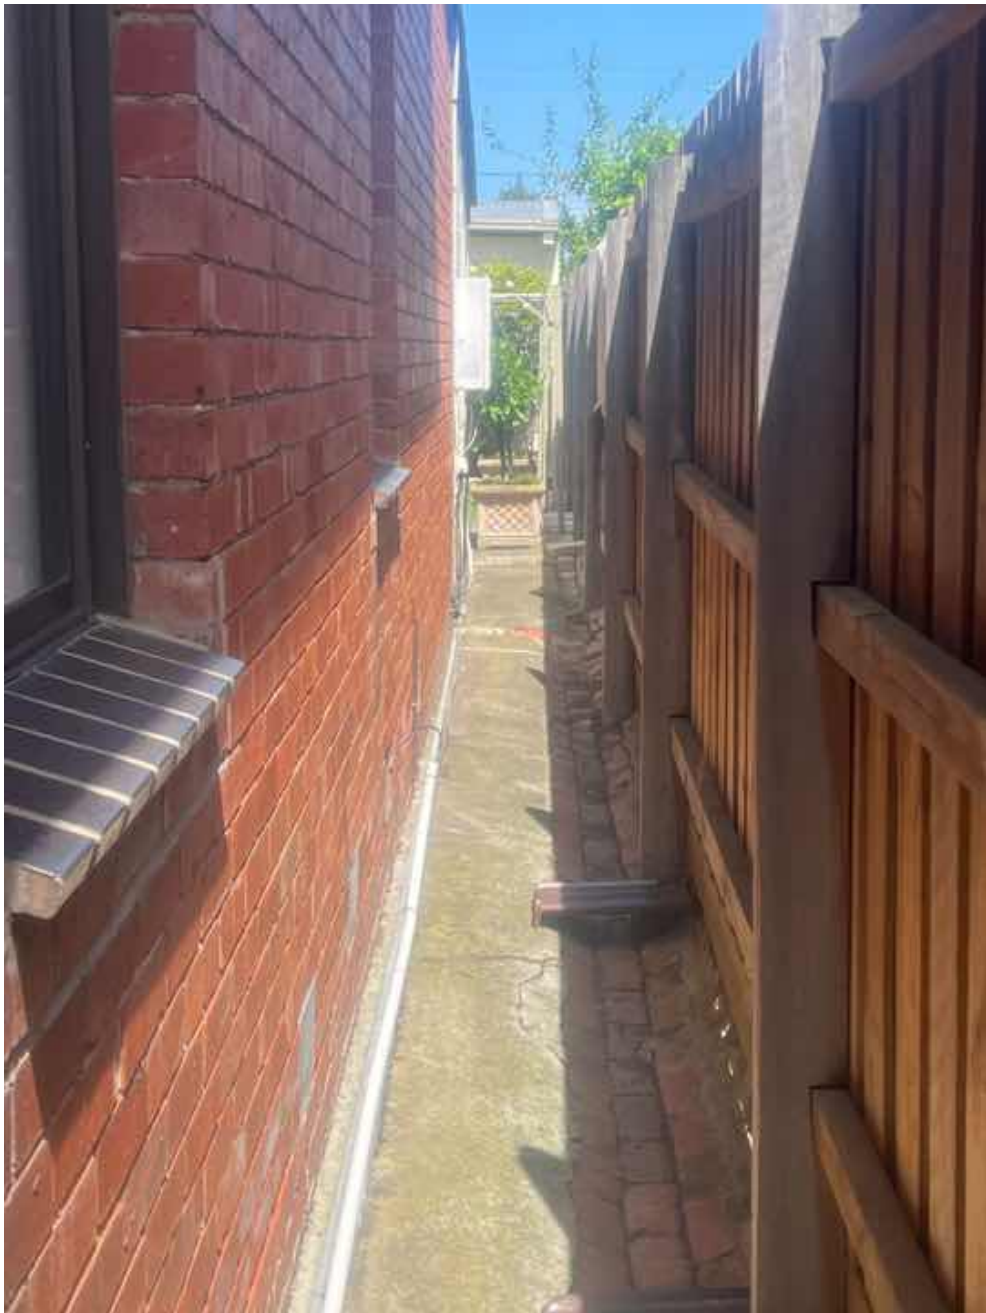
Pathways Condition

Common cracks and settlement were observed on paths. Whilst these cracks appeared to be typical at the time of inspection, we strongly recommend you monitor these cracks and if worsening occurs contact a concreter for further advice.

The concrete path is in poor condition replacement recommended. Contact a qualified concreter for repairs. Surface raised and settled in some areas. This can cause water ponding. Relaying recommended.
