Sample Report

D.C Building Inspectors

Pest And Building Inspection

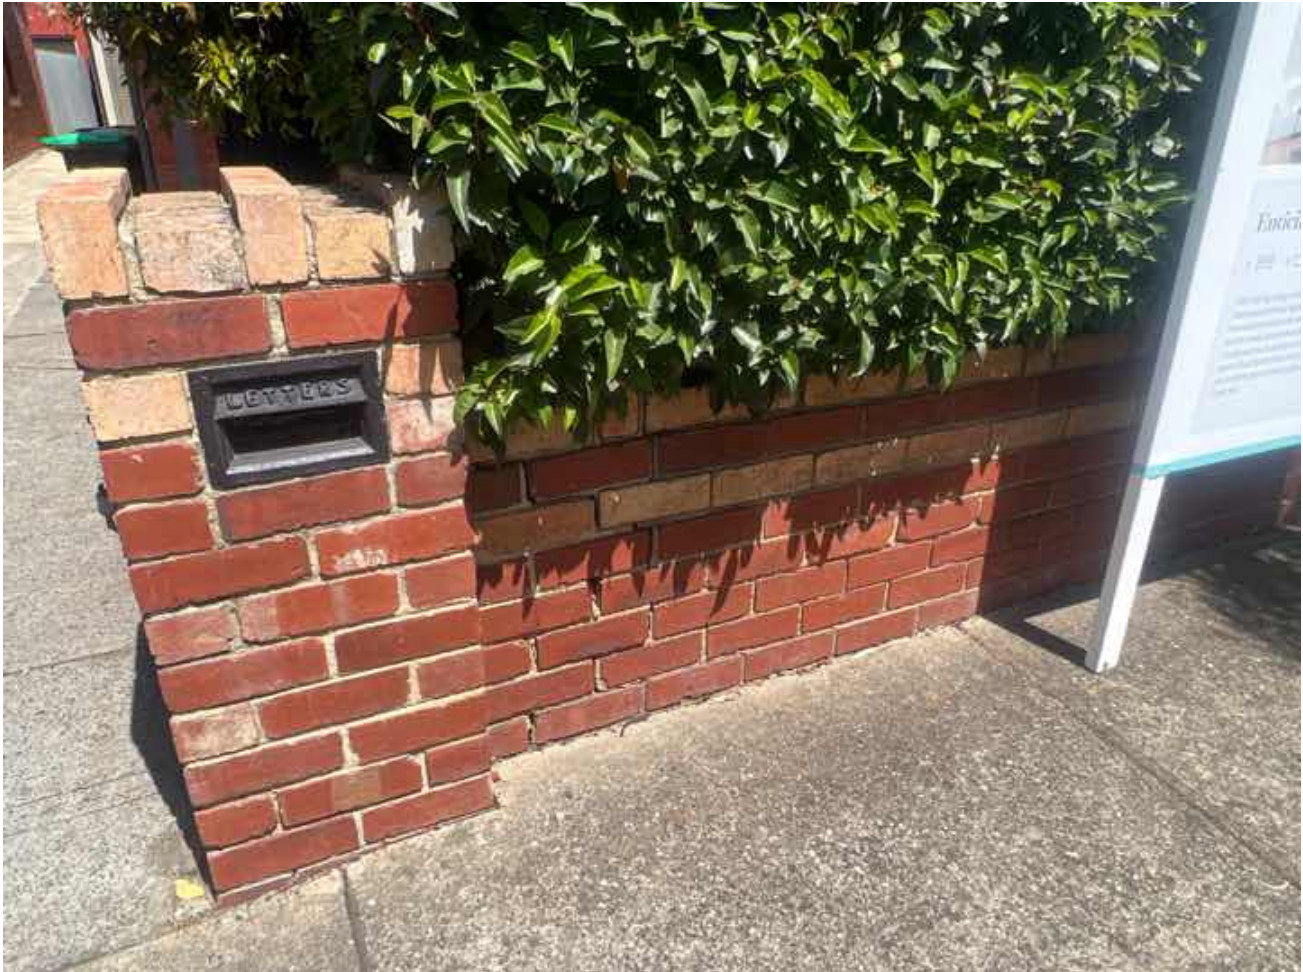
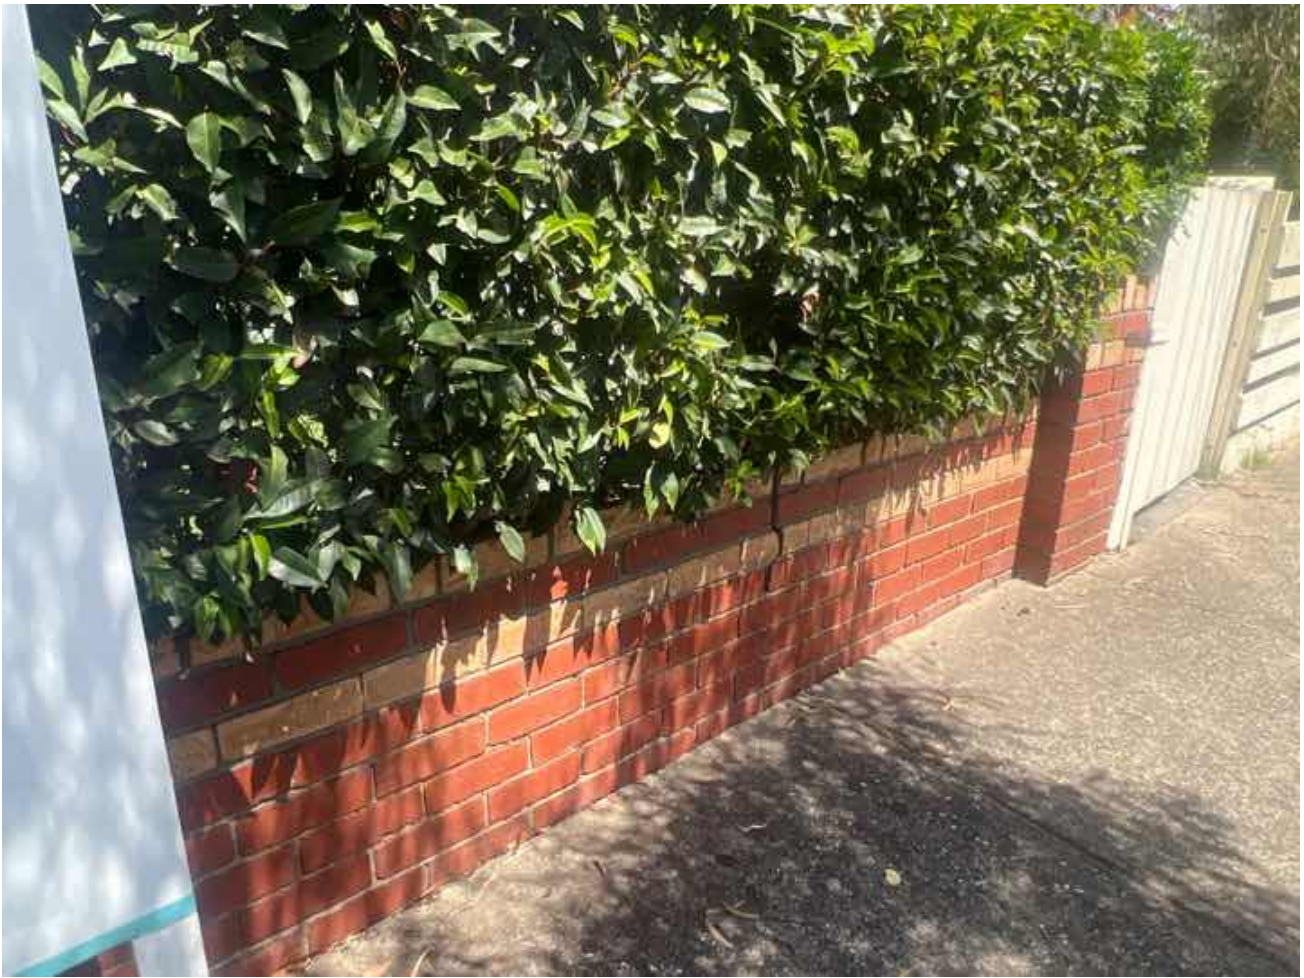
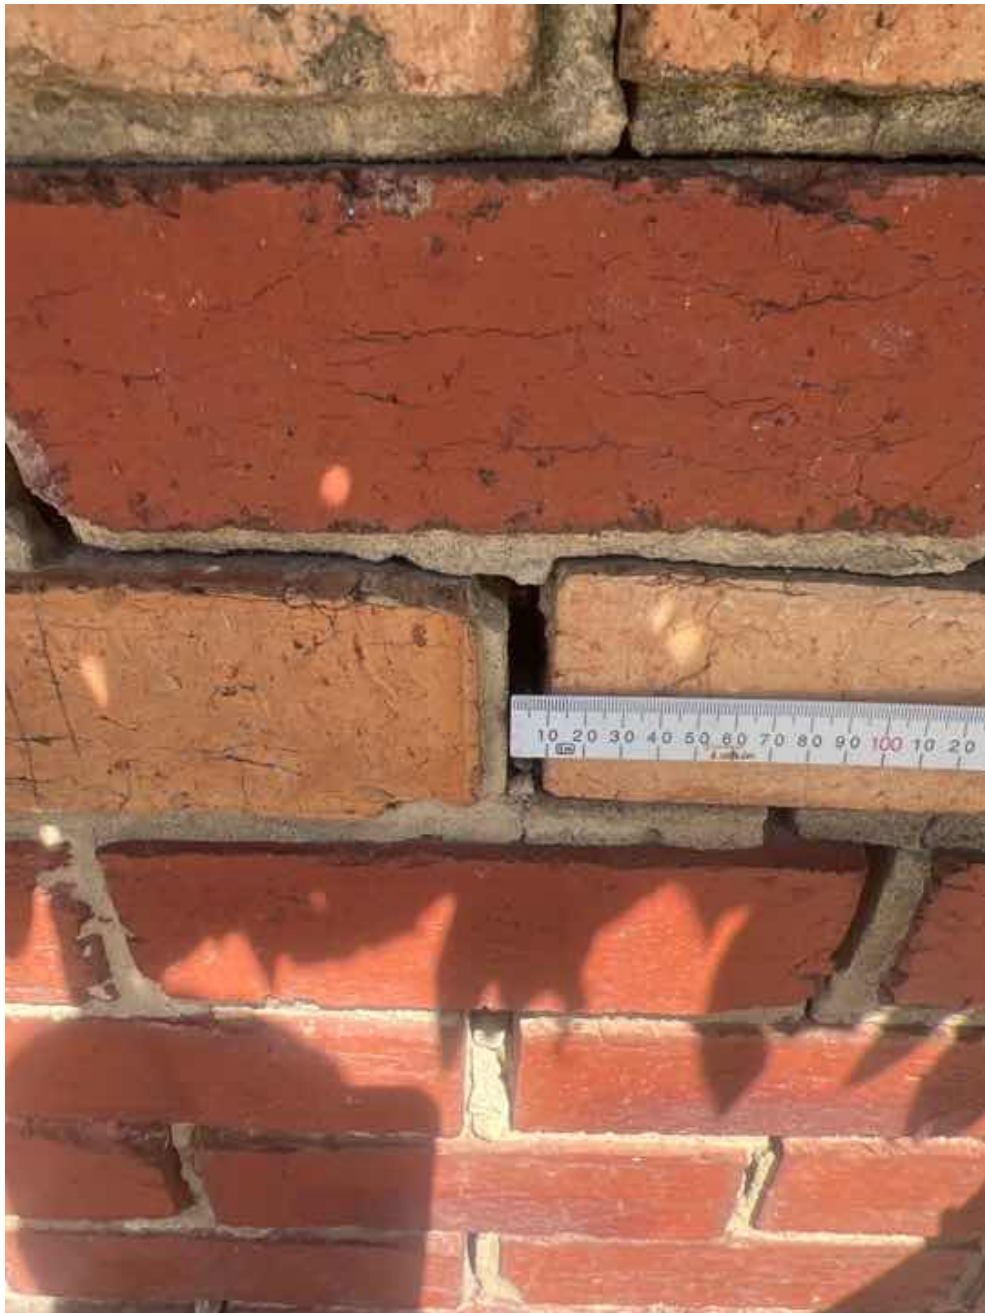
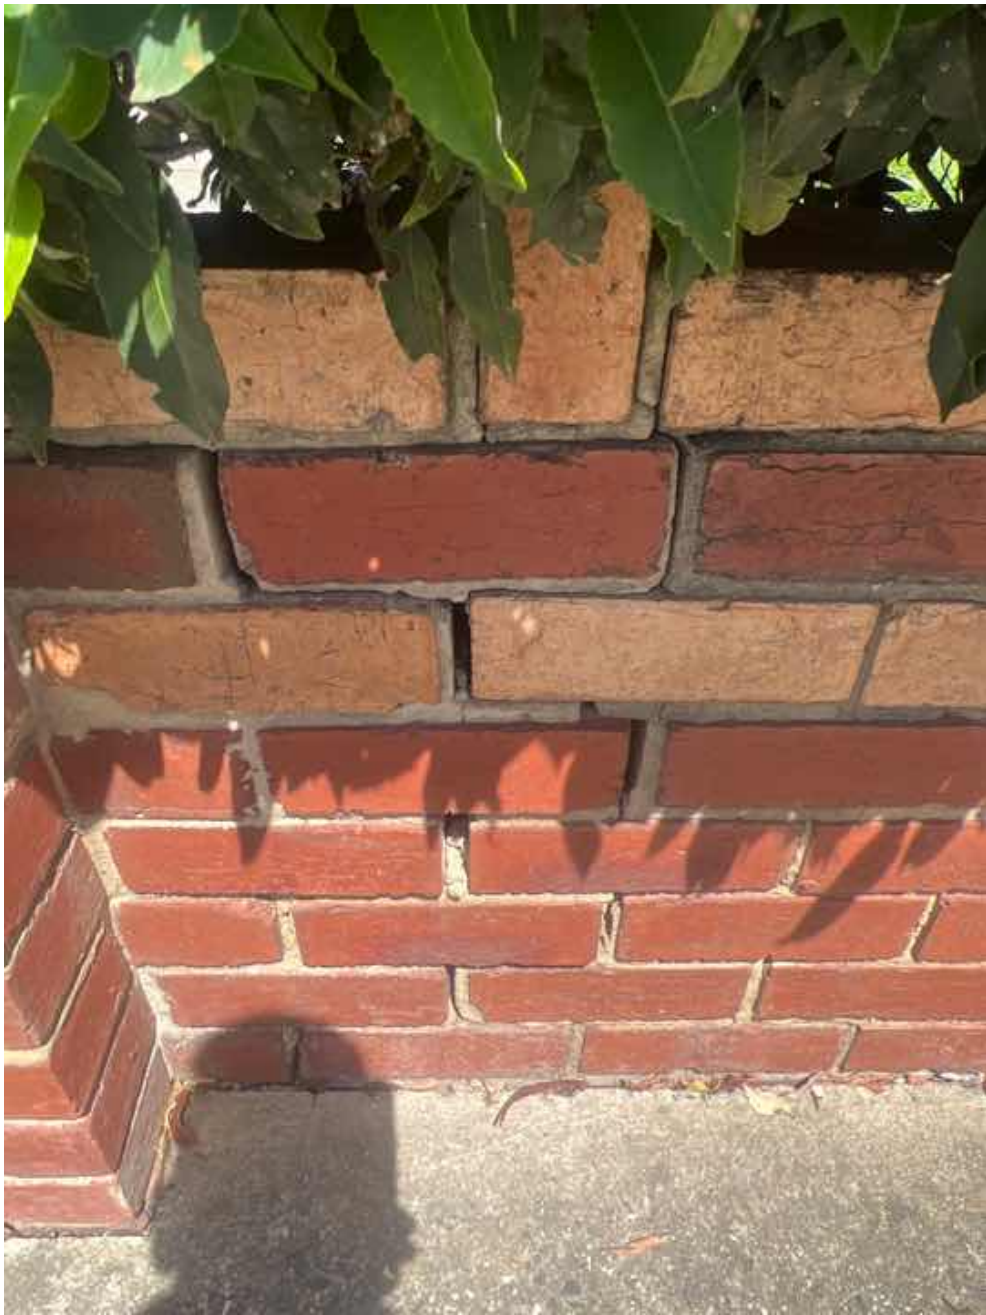
Overall Condition (Front Brick)

On inspection, defects were present that will require further accessing and recommendations by licensed and qualified trades persons.

The front brick fence has settlement/movement cracks. This may be a potential safety hazard. A qualified brick layer should be engaged for repairs.

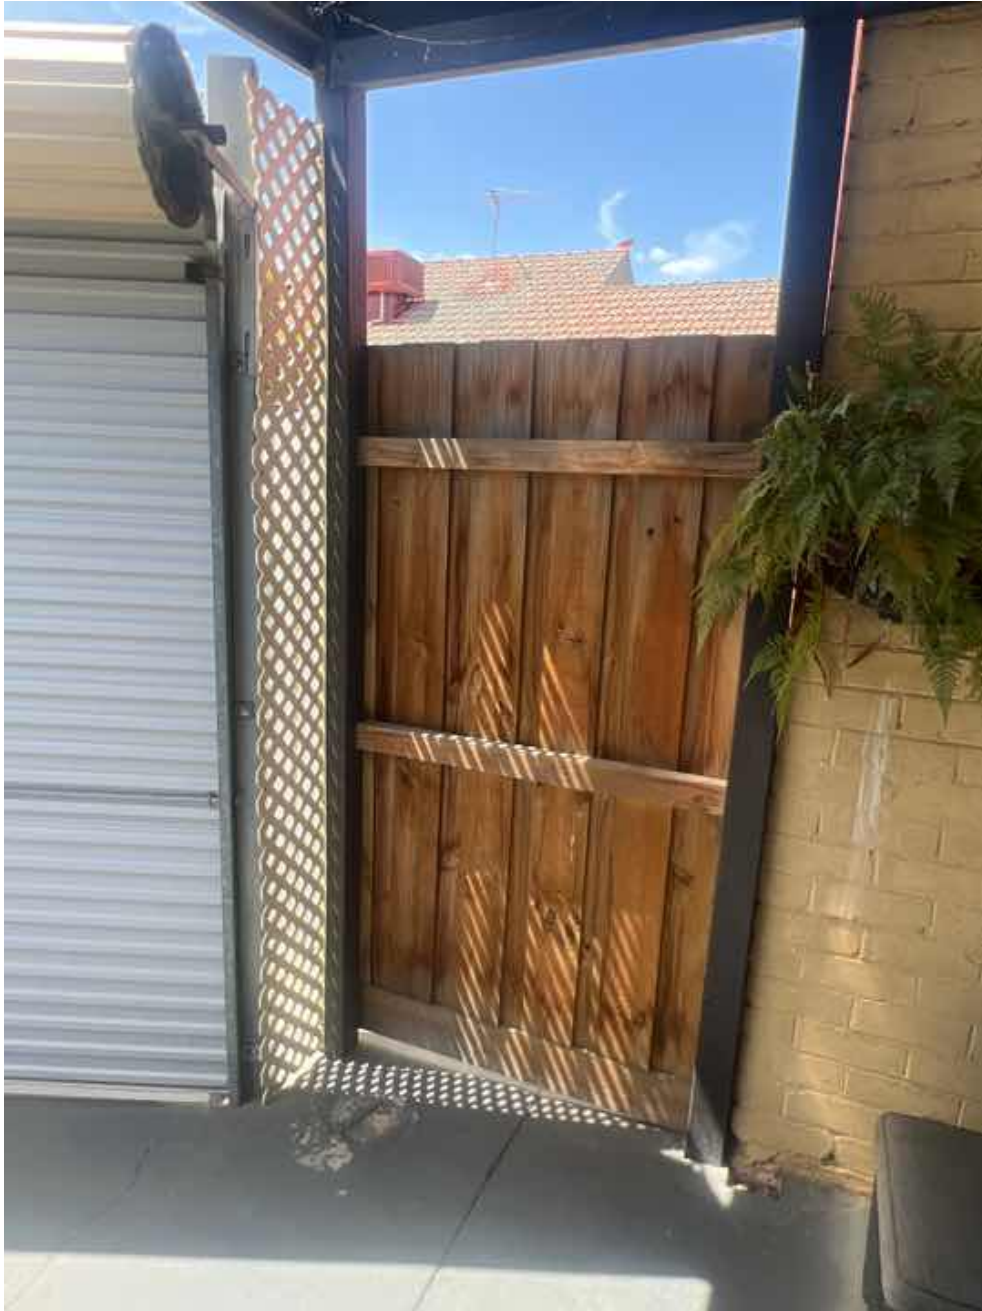
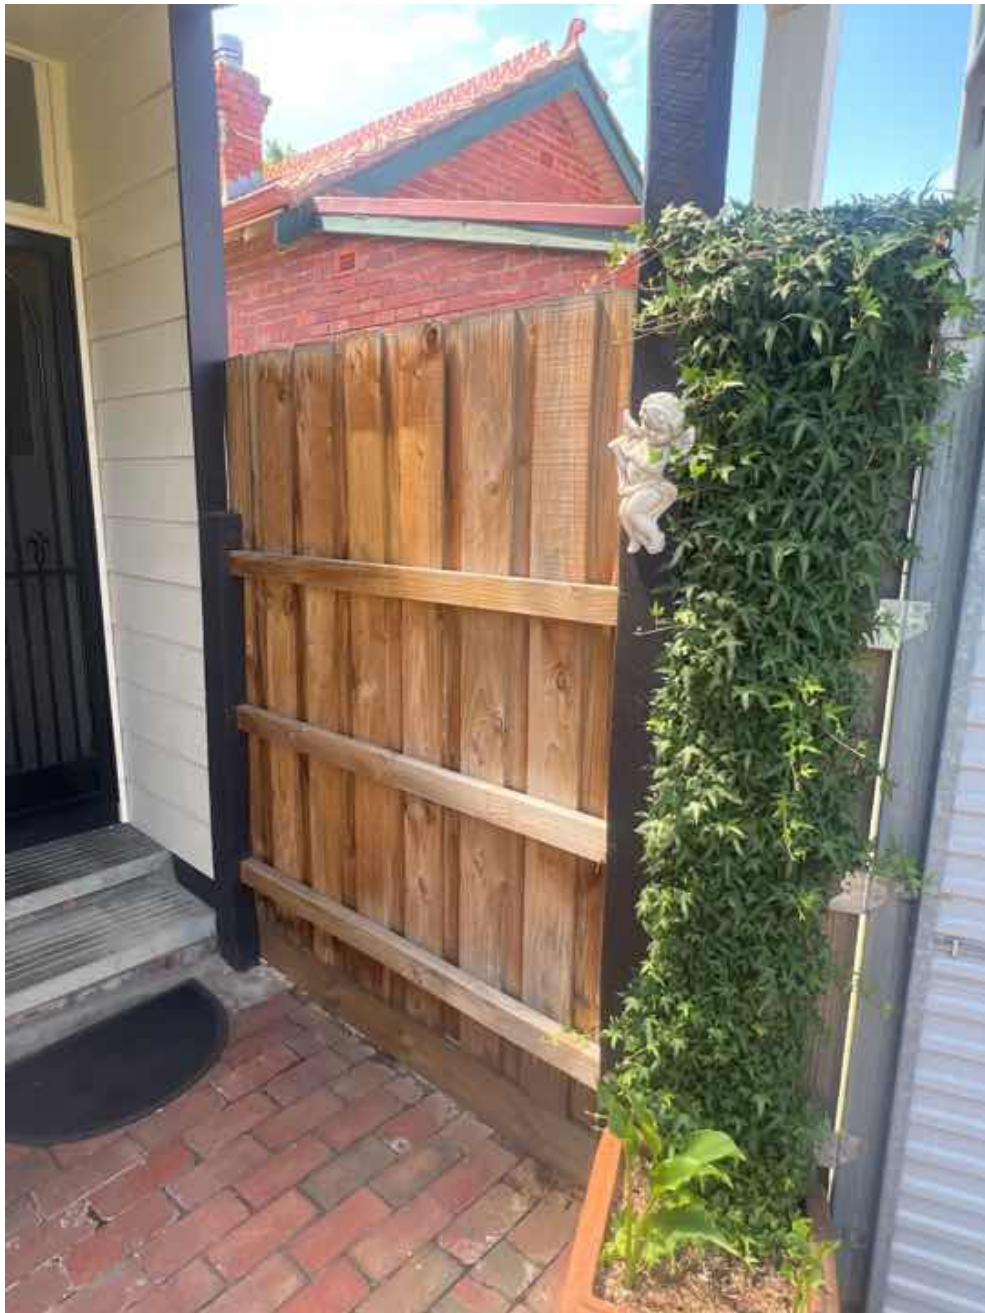
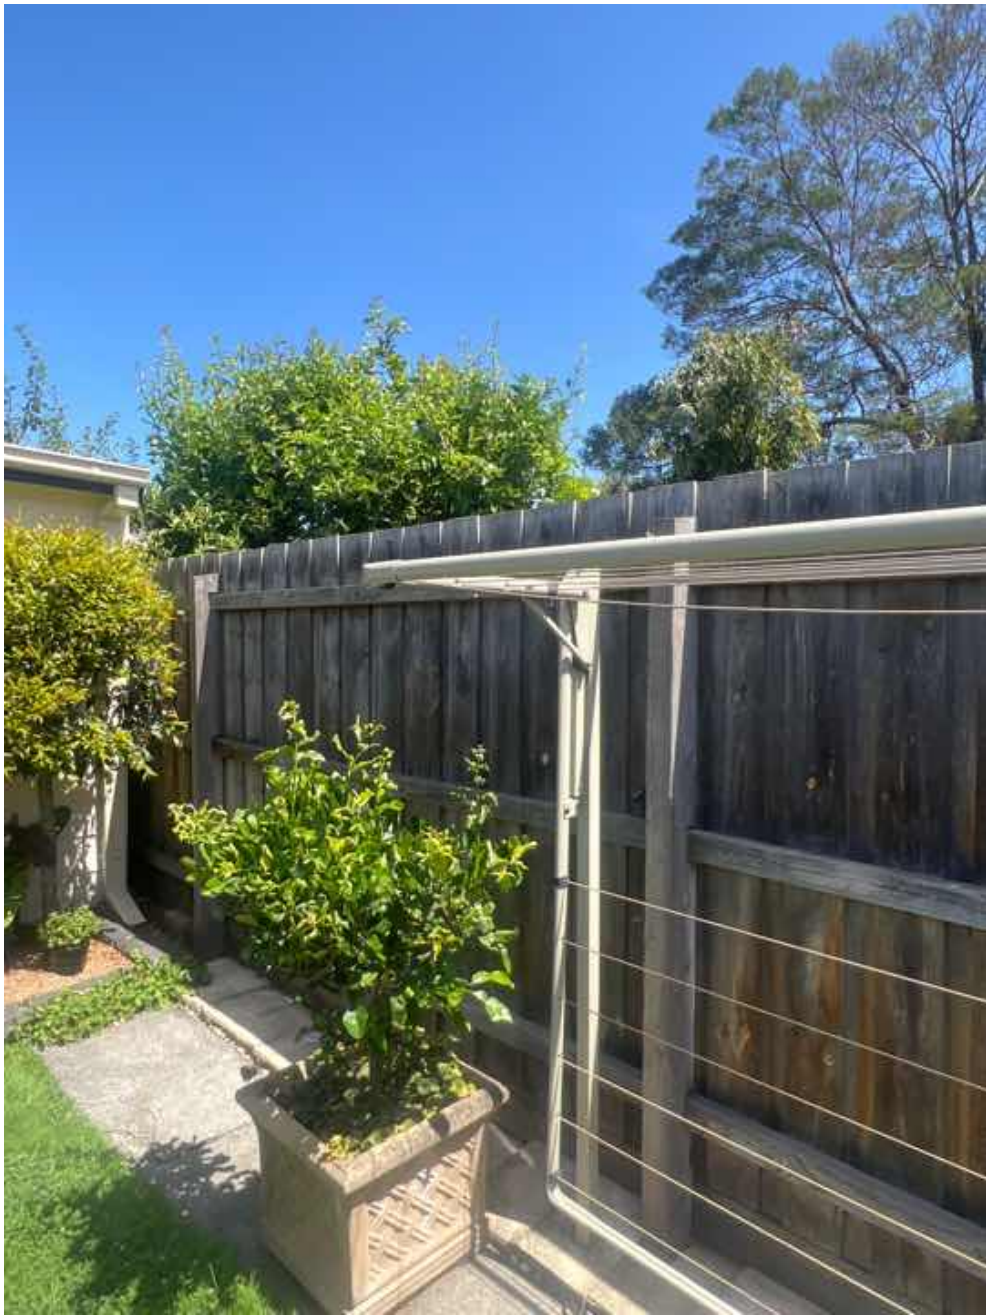
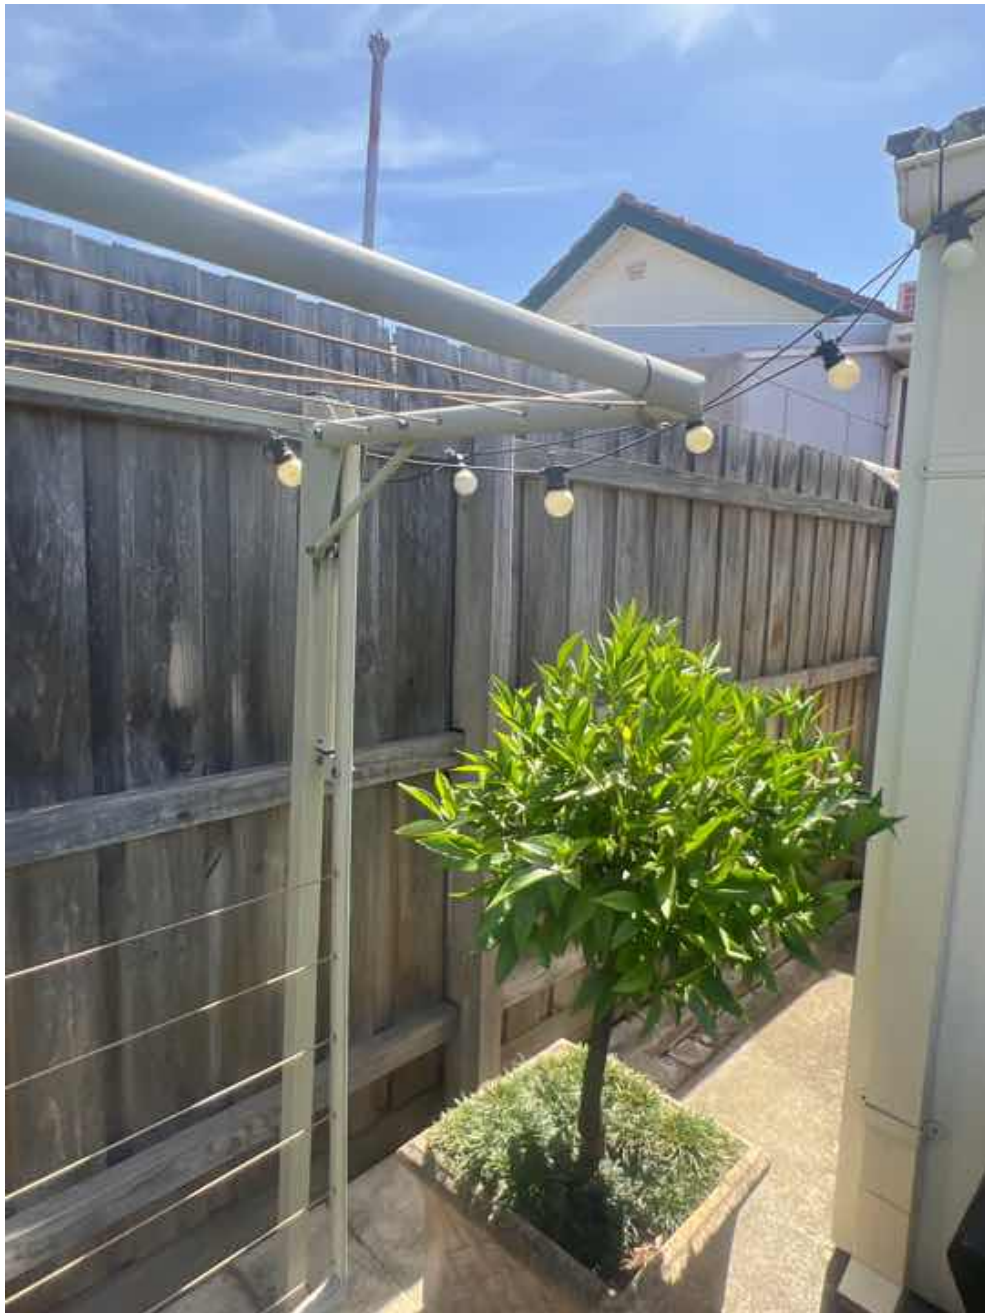
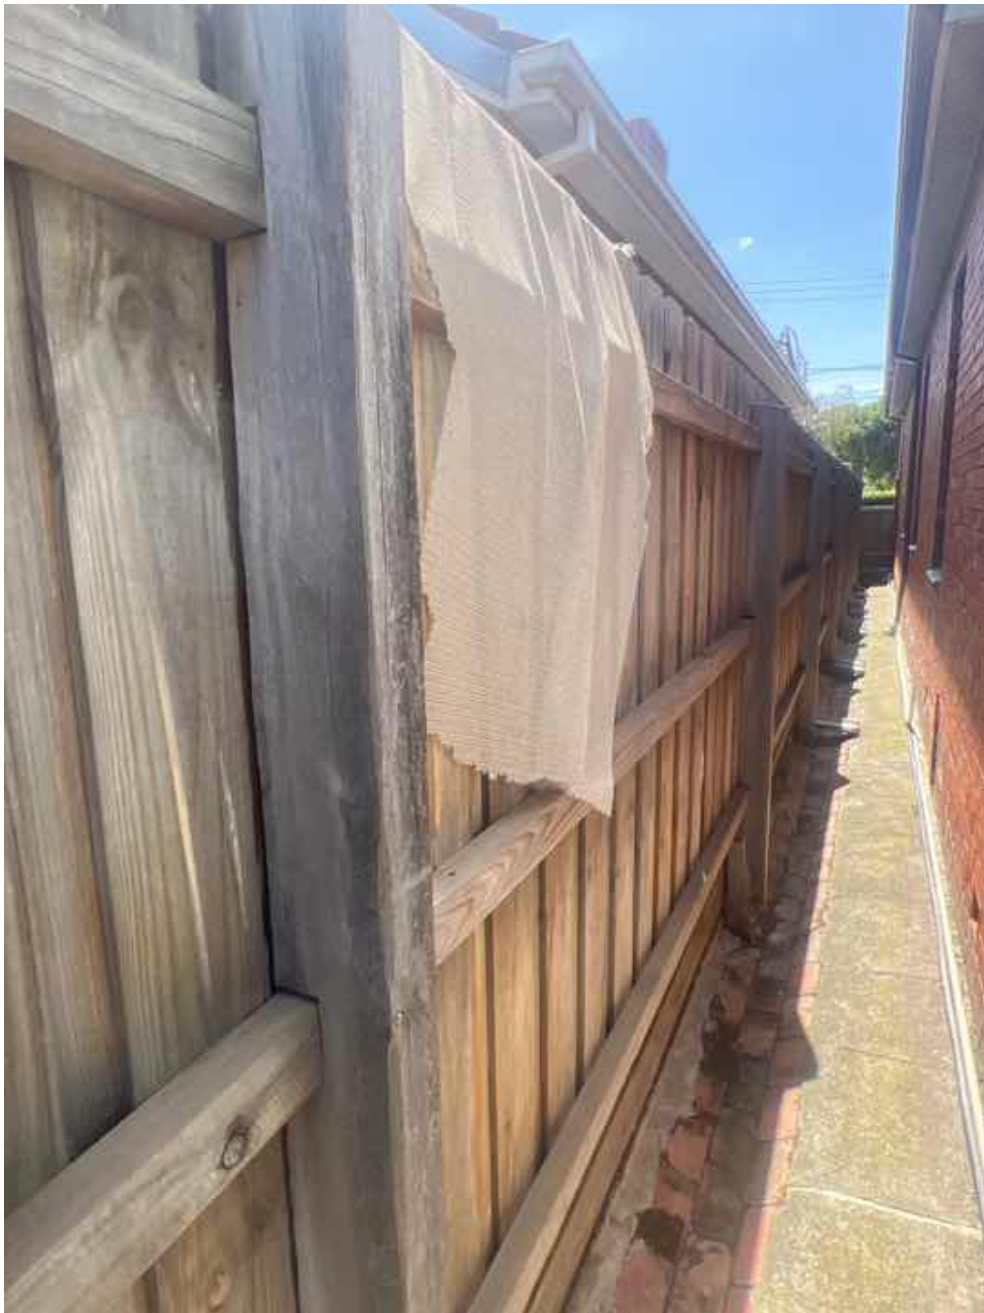
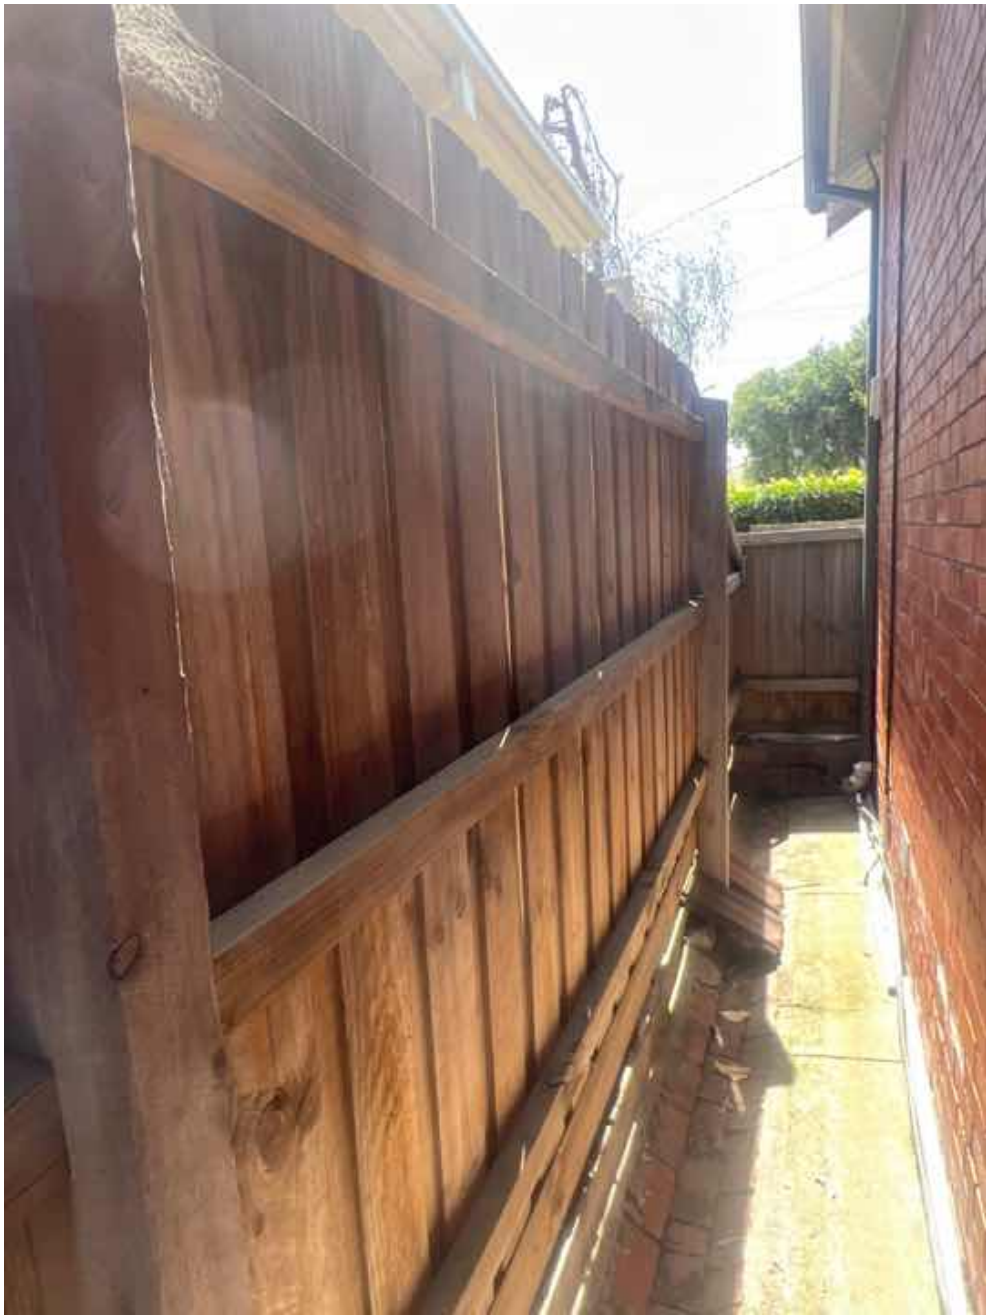
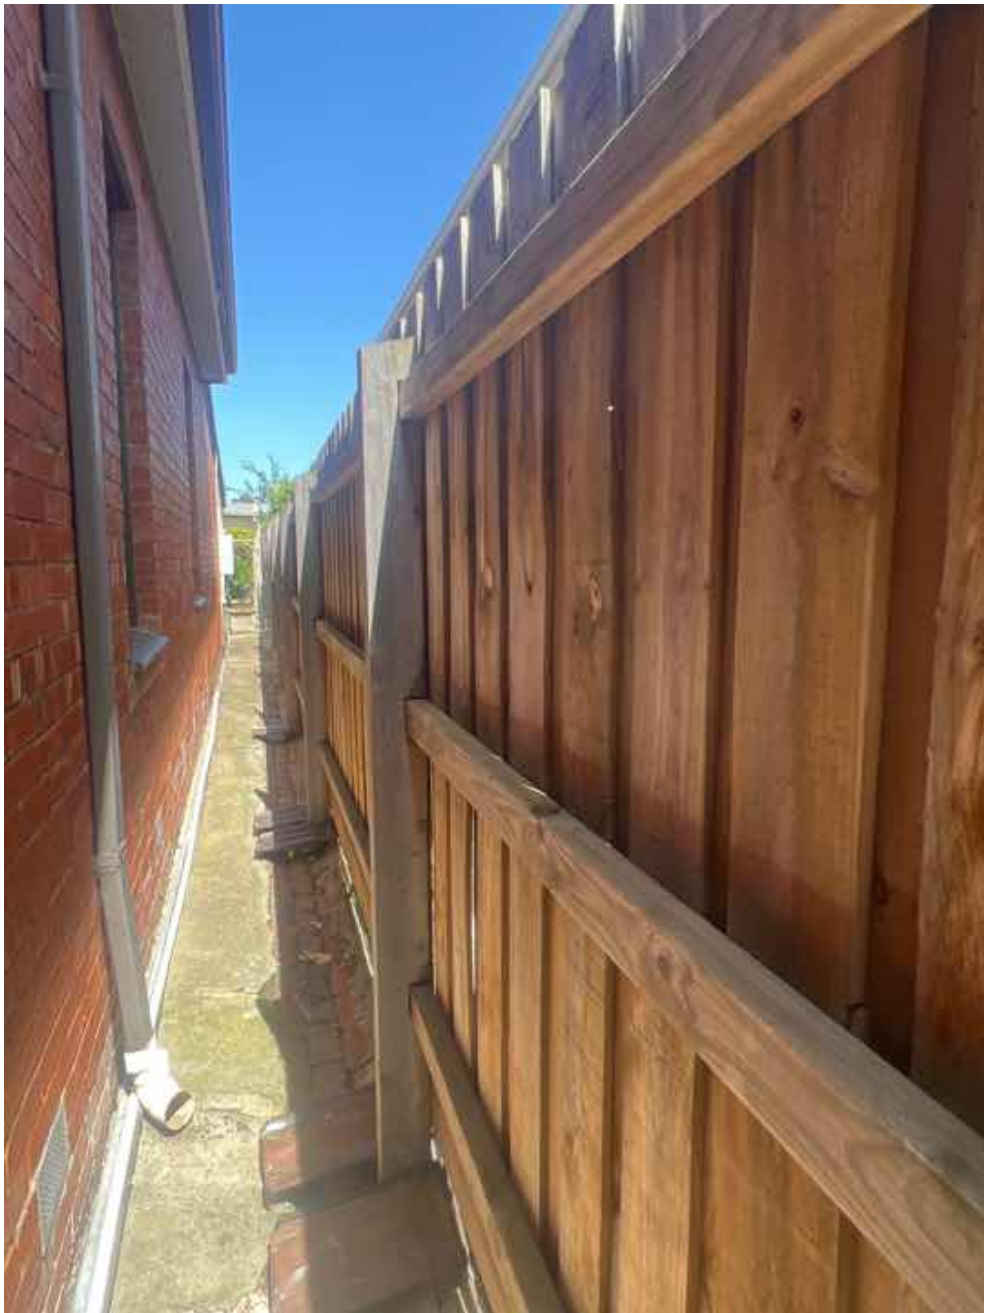
Overall Condition (Timber)

Of the visible areas, the general condition of the fences and gates is serviceable for the age of dwelling.

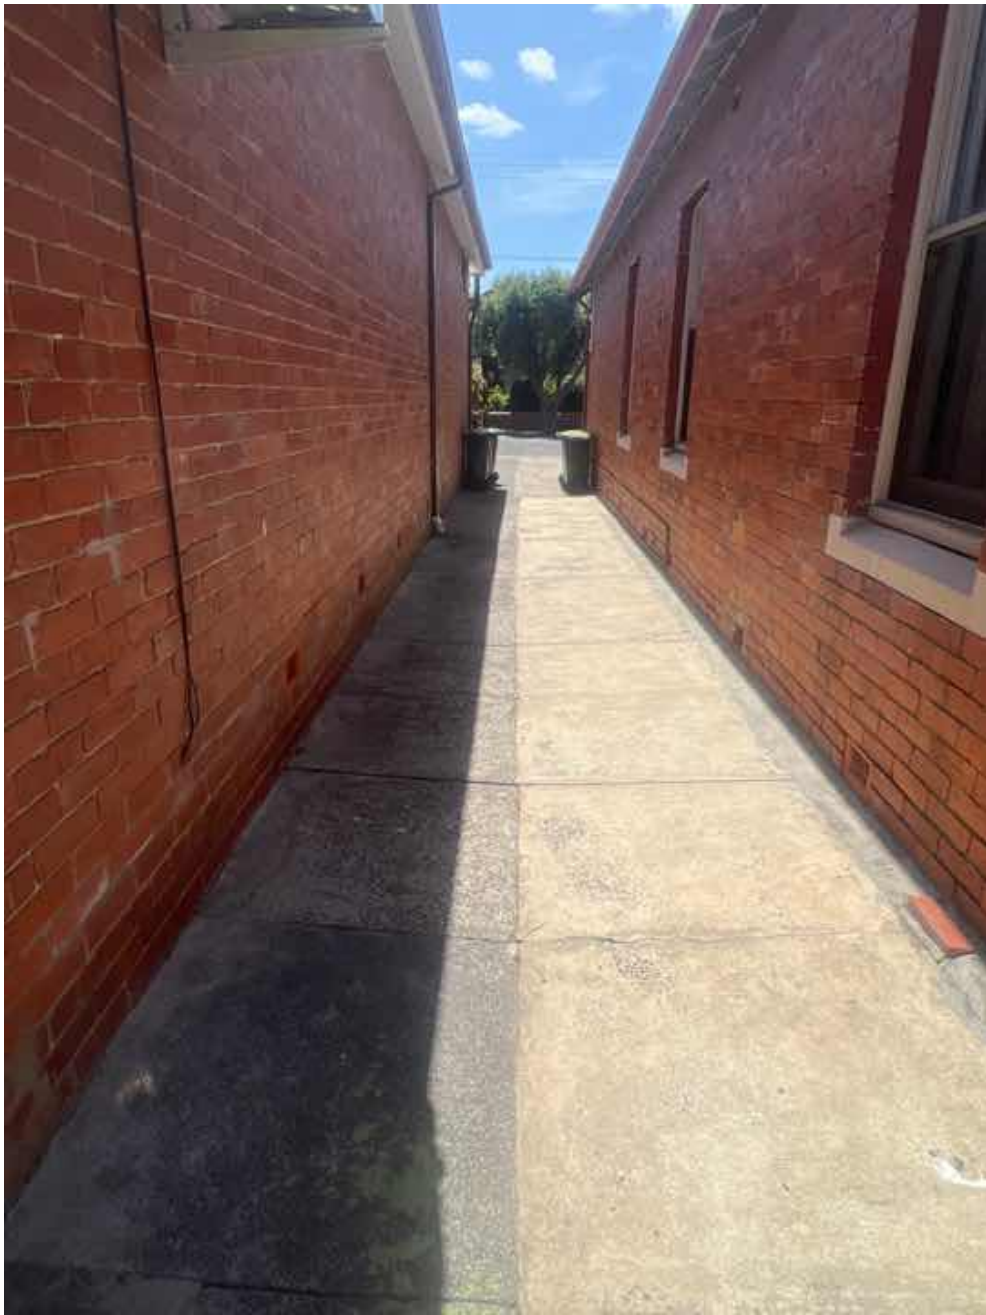
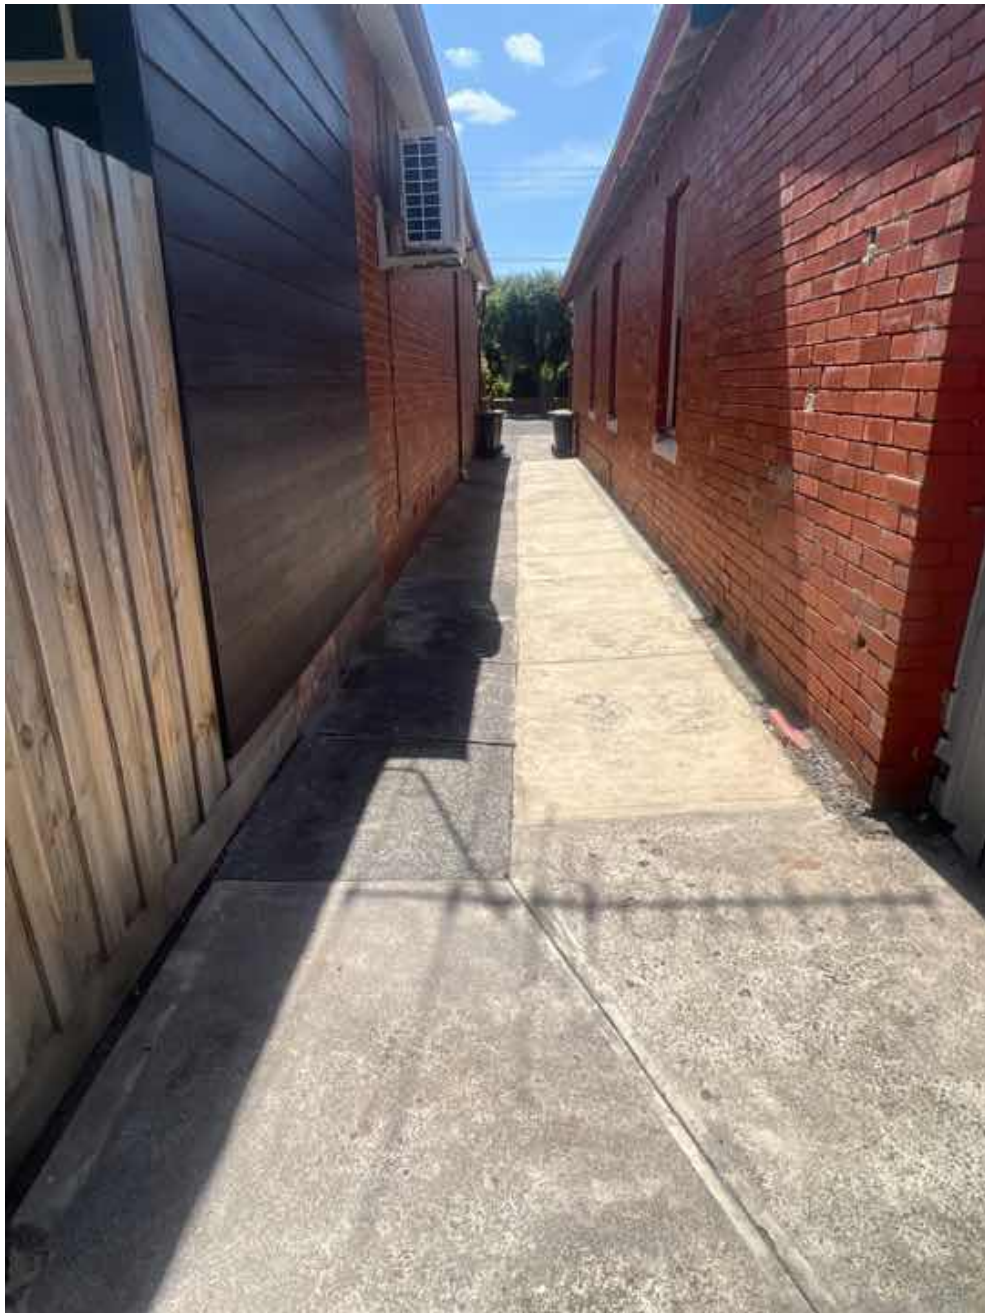
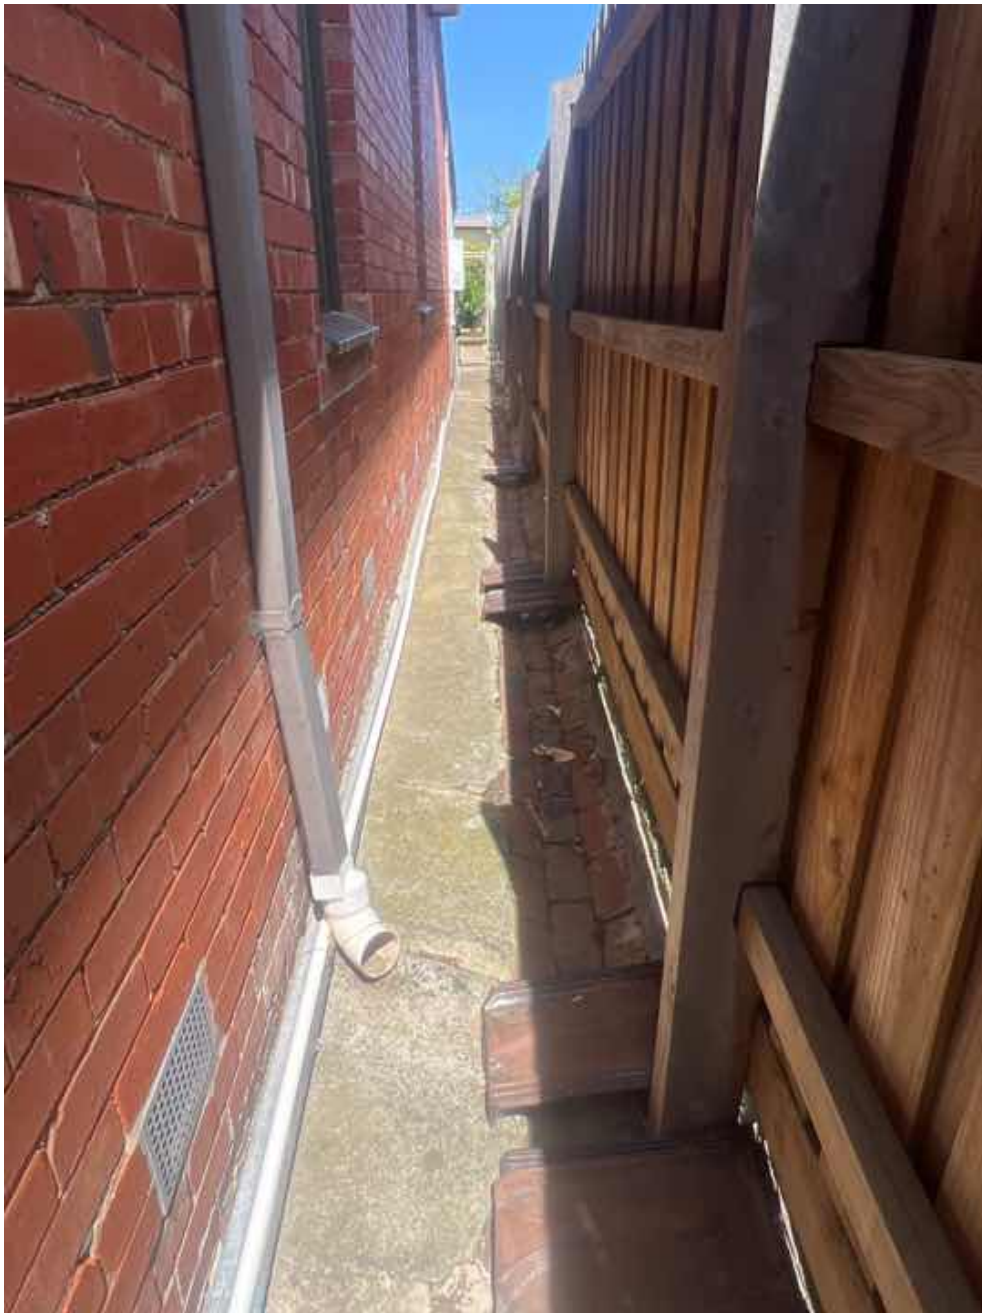
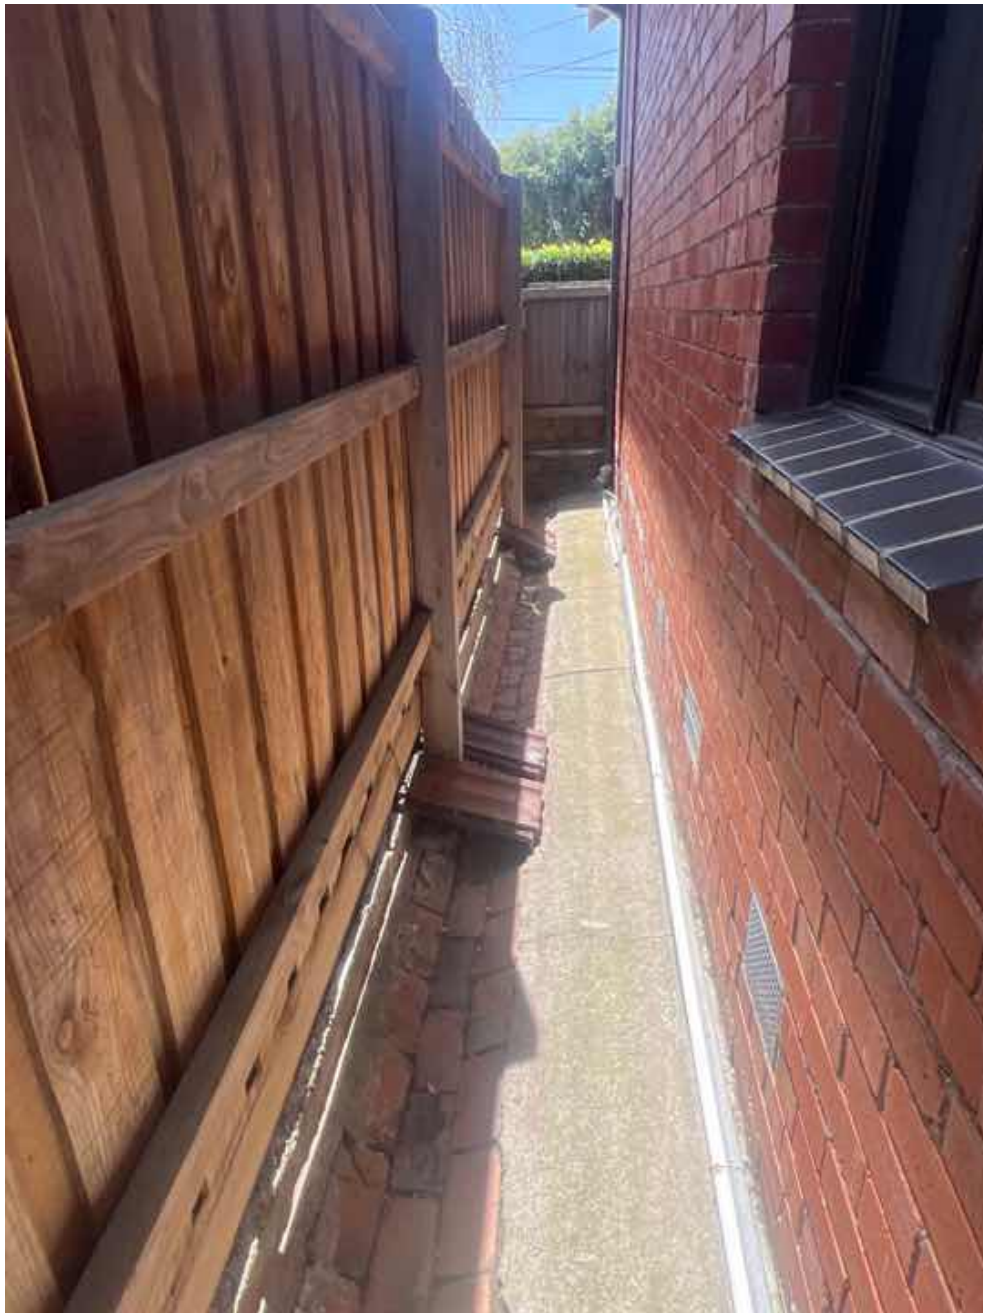
Drainage Findings

The ground levels along the perimeter walls of the home did not appear to fall away from the property walls sufficiently due to the natural landscape and contour. This will need to be assessed during a periods of rainfall and if surface water appears to be entering the sub floor if applicable or ponding against the perimeter walls, engage a plumber or landscaper to assess and rectify as required. All drains should be regularly checked by a plumber and kept clean of debris to allow surface water to be carried away from the dwelling.

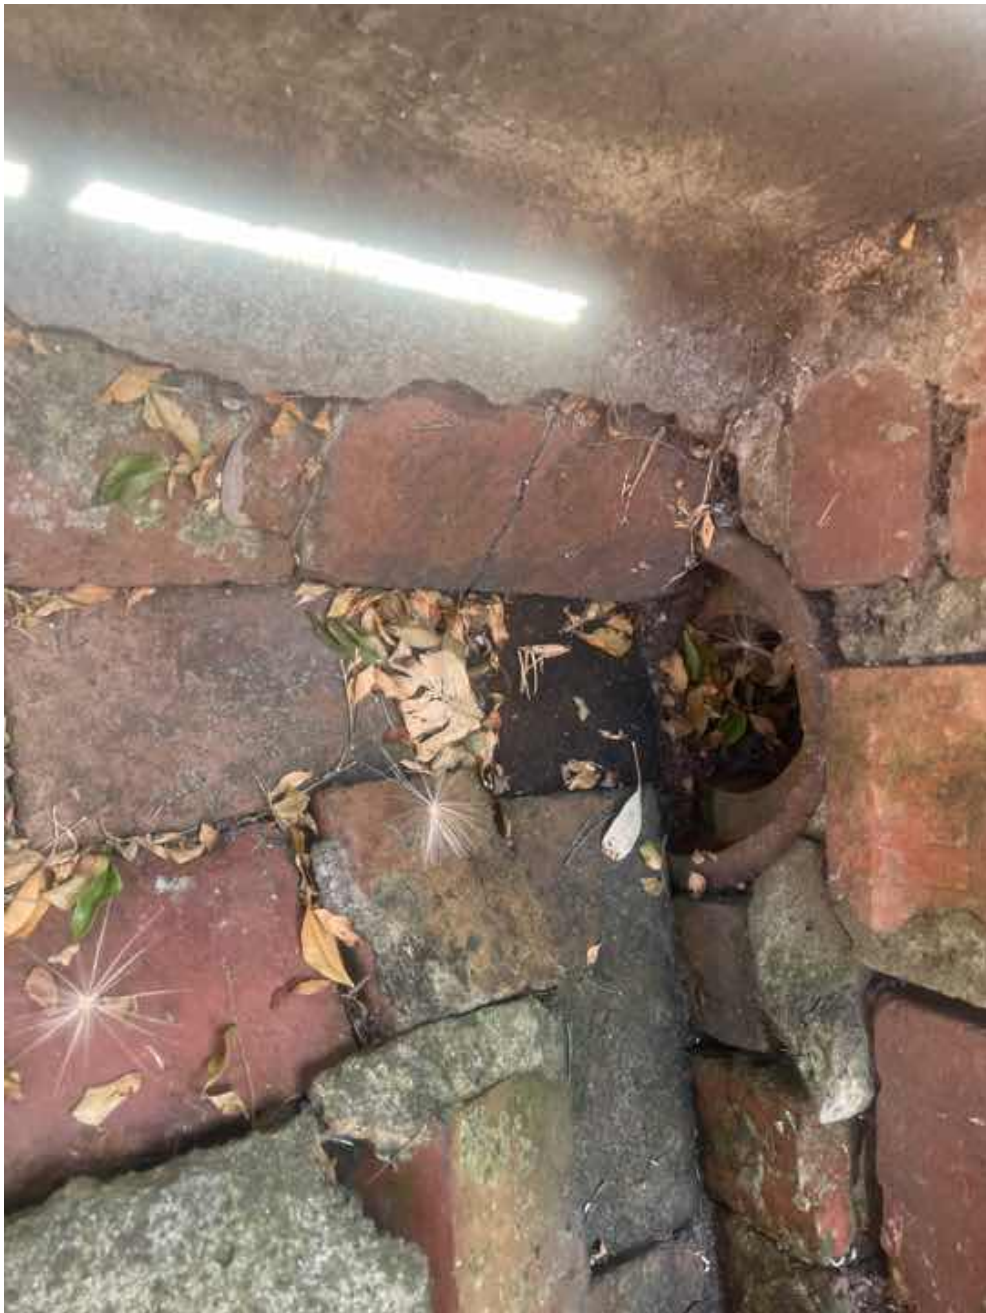
Drains

Debris evident in/around drains - Requires cleaning out.
