Sample Report

D.C Building Inspectors

Pest And Building Inspection

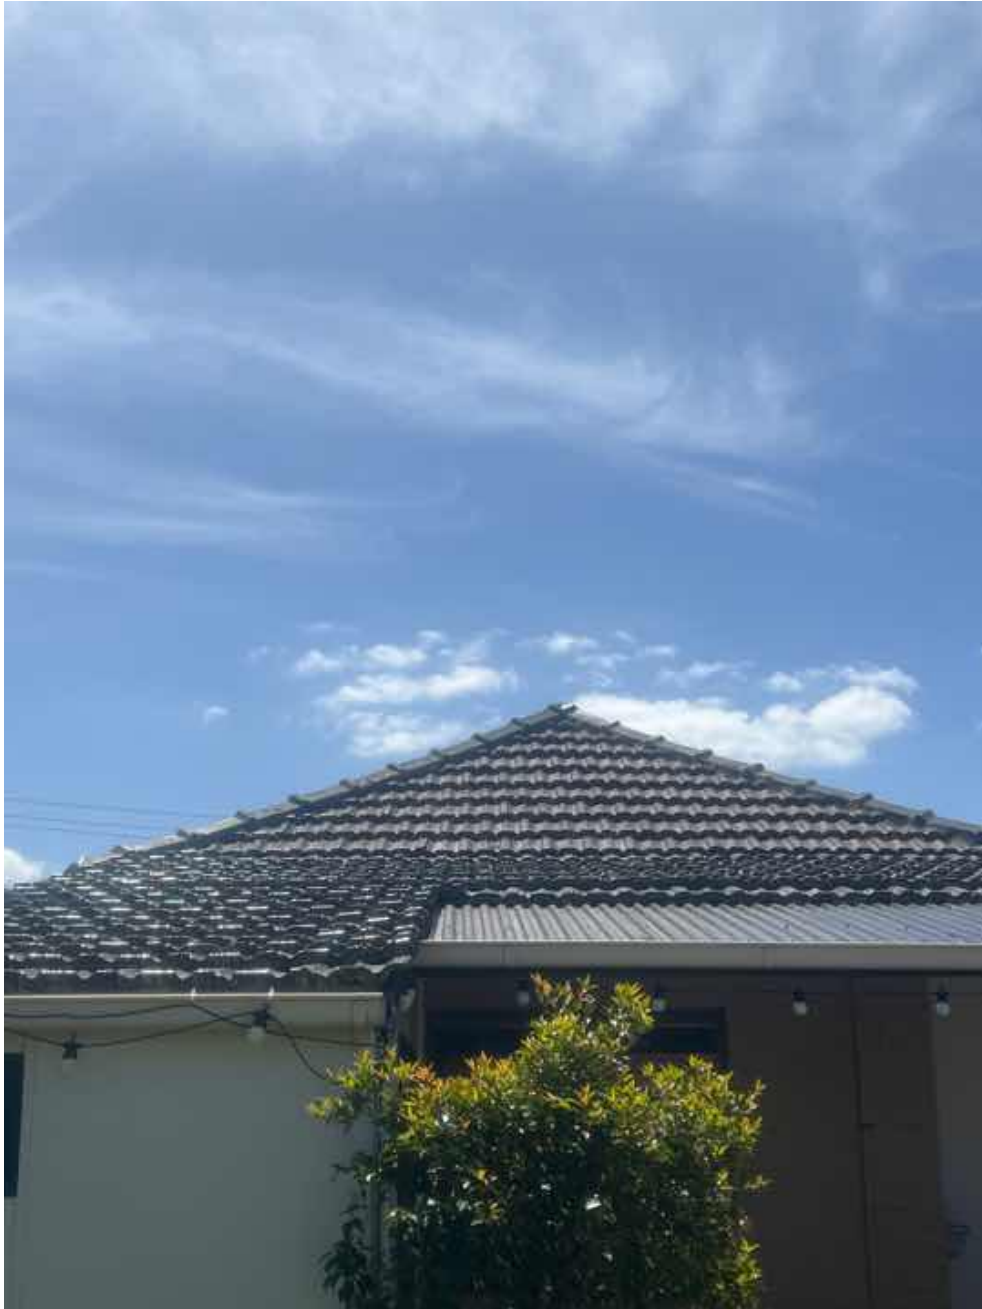
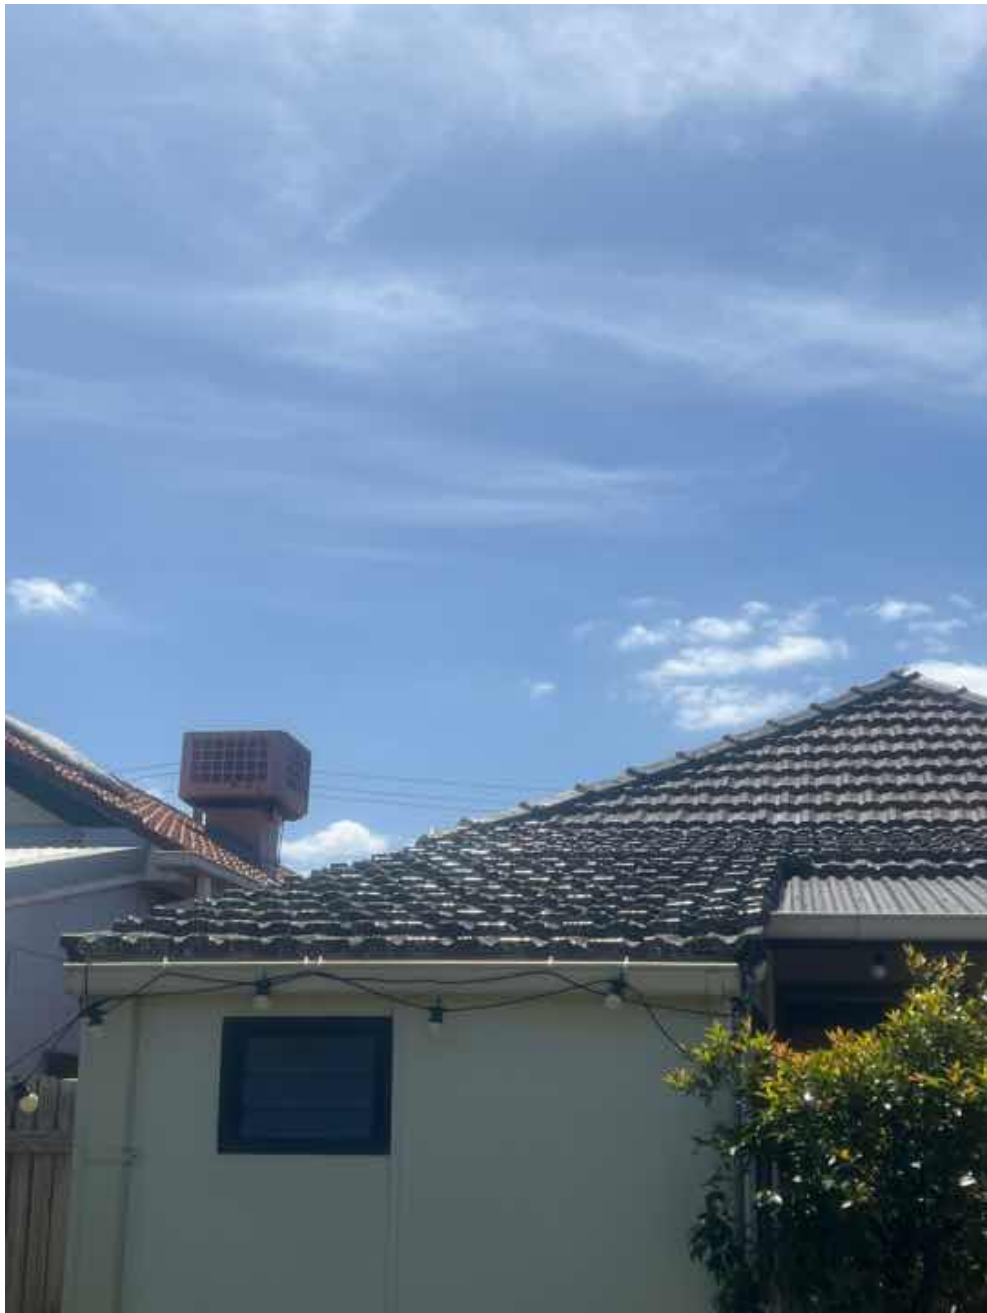
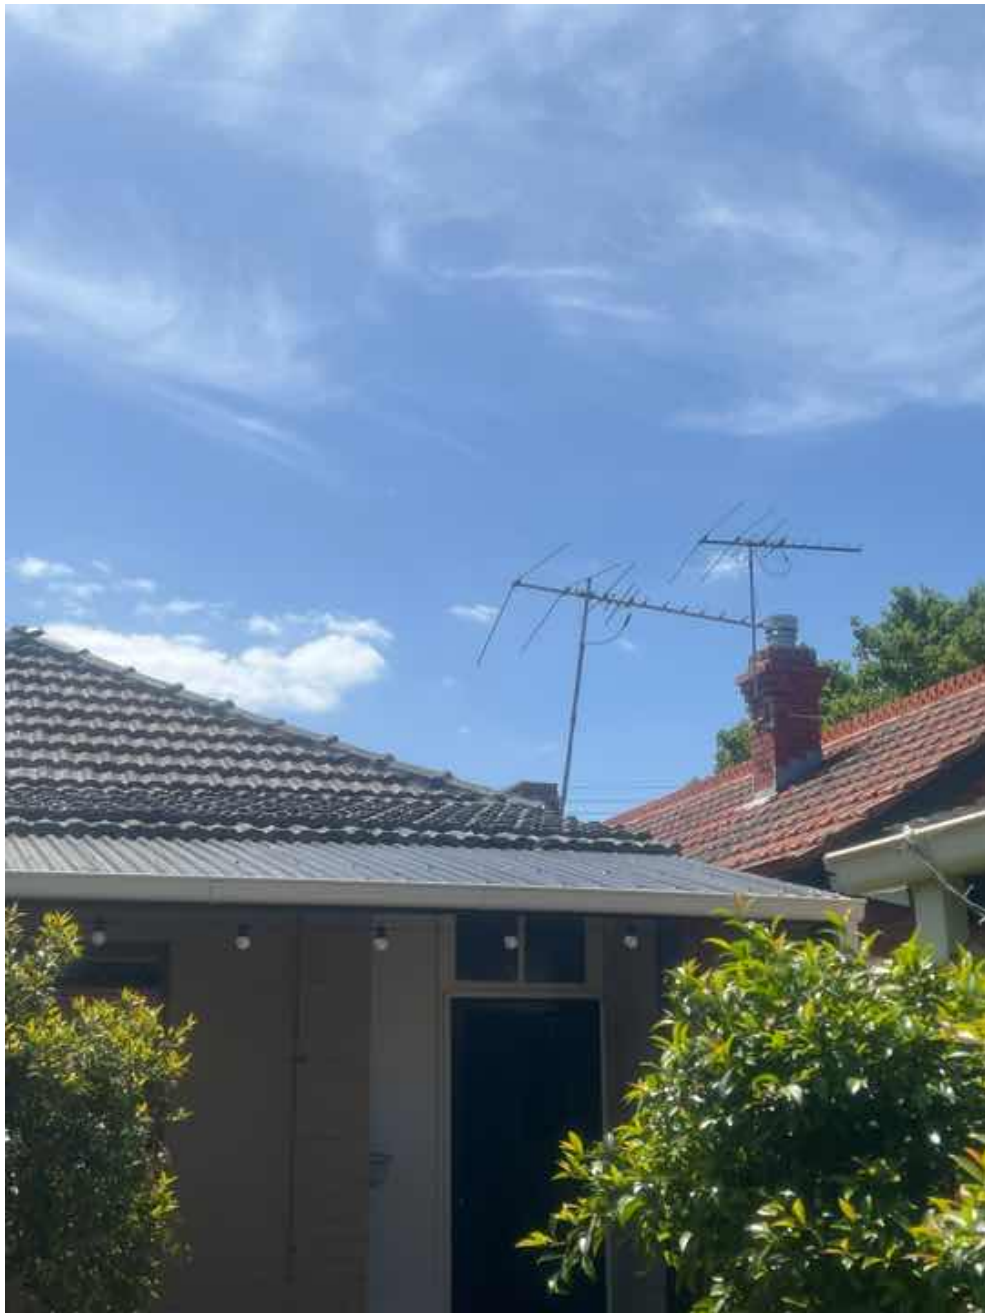
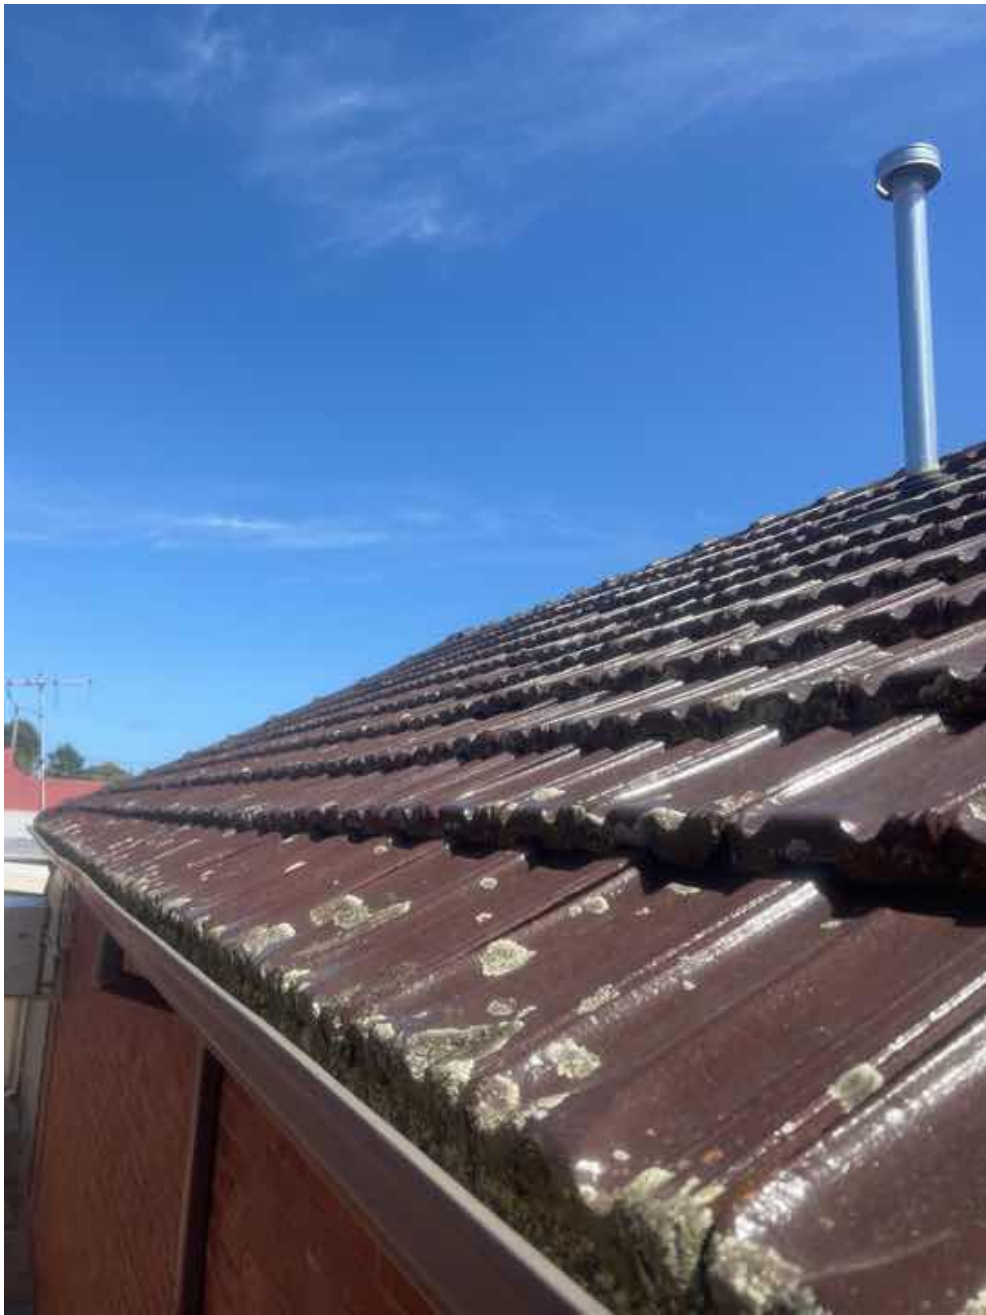
Overall Condition

On inspection, defects were noted that may require further assessment and recommendations by licensed roofer.

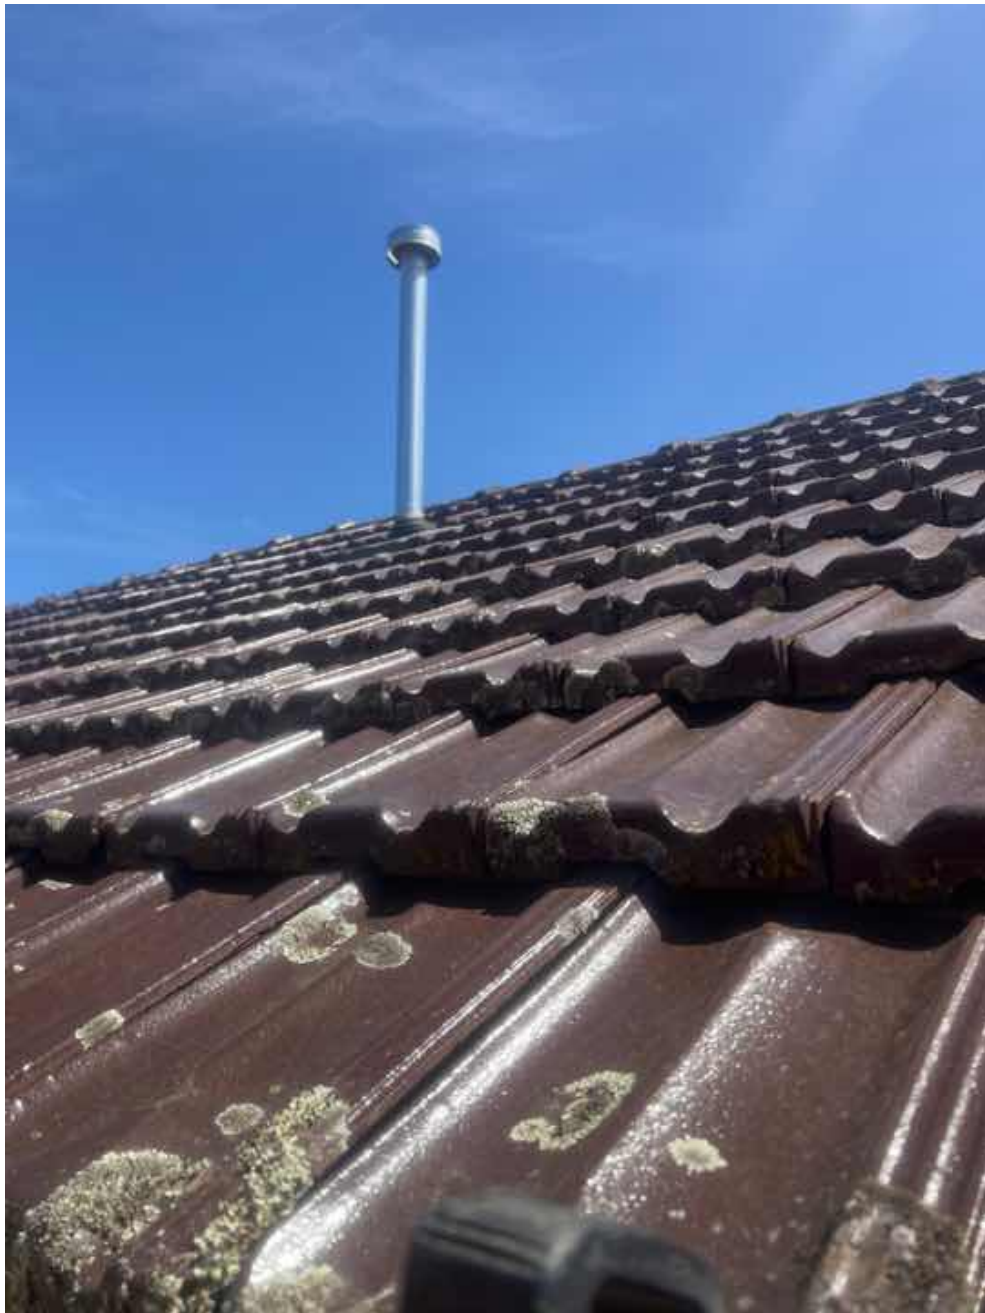
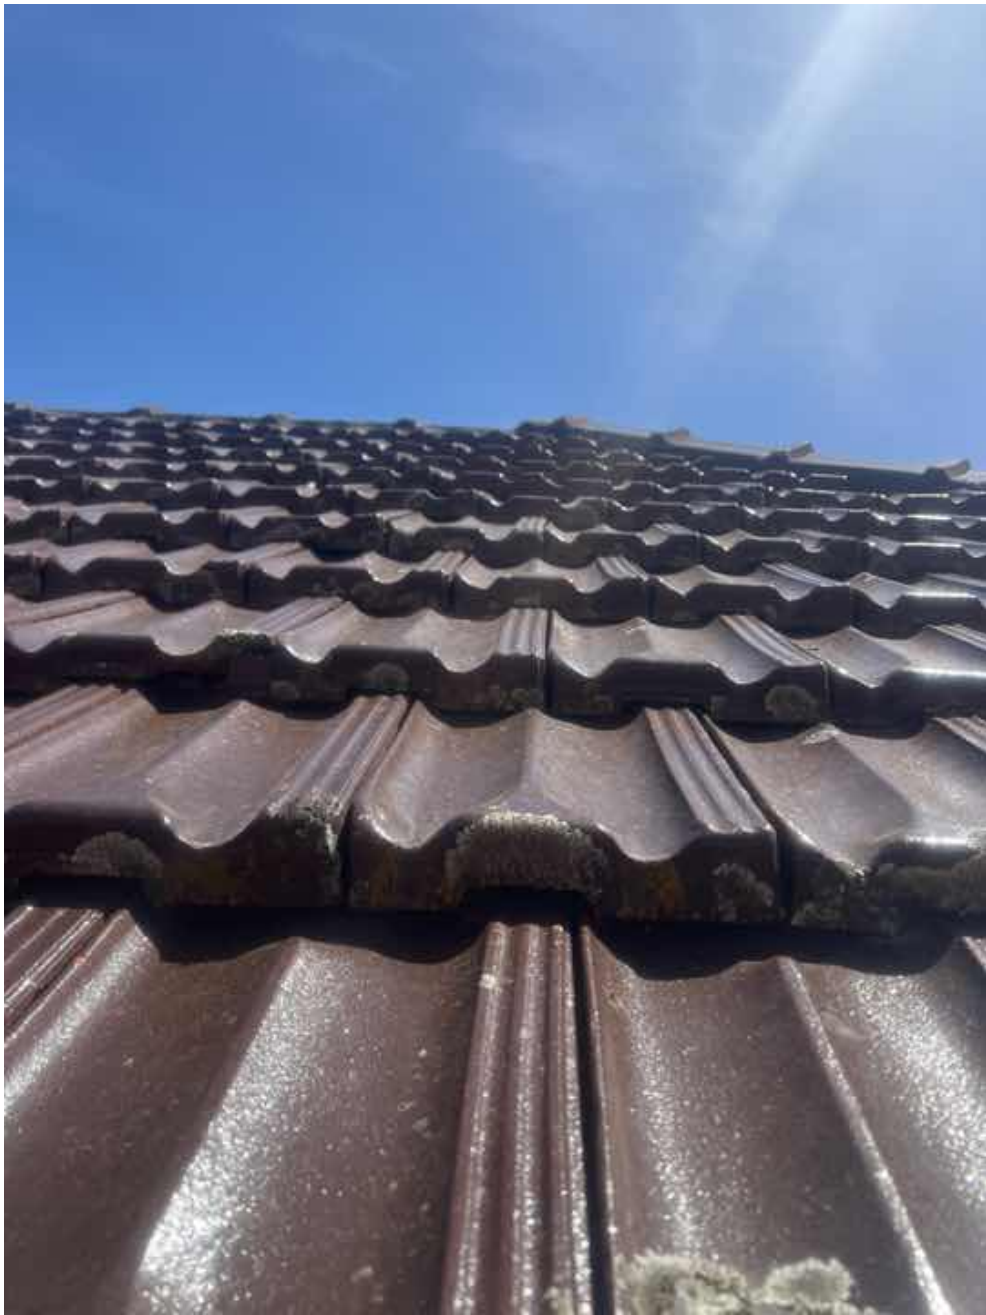
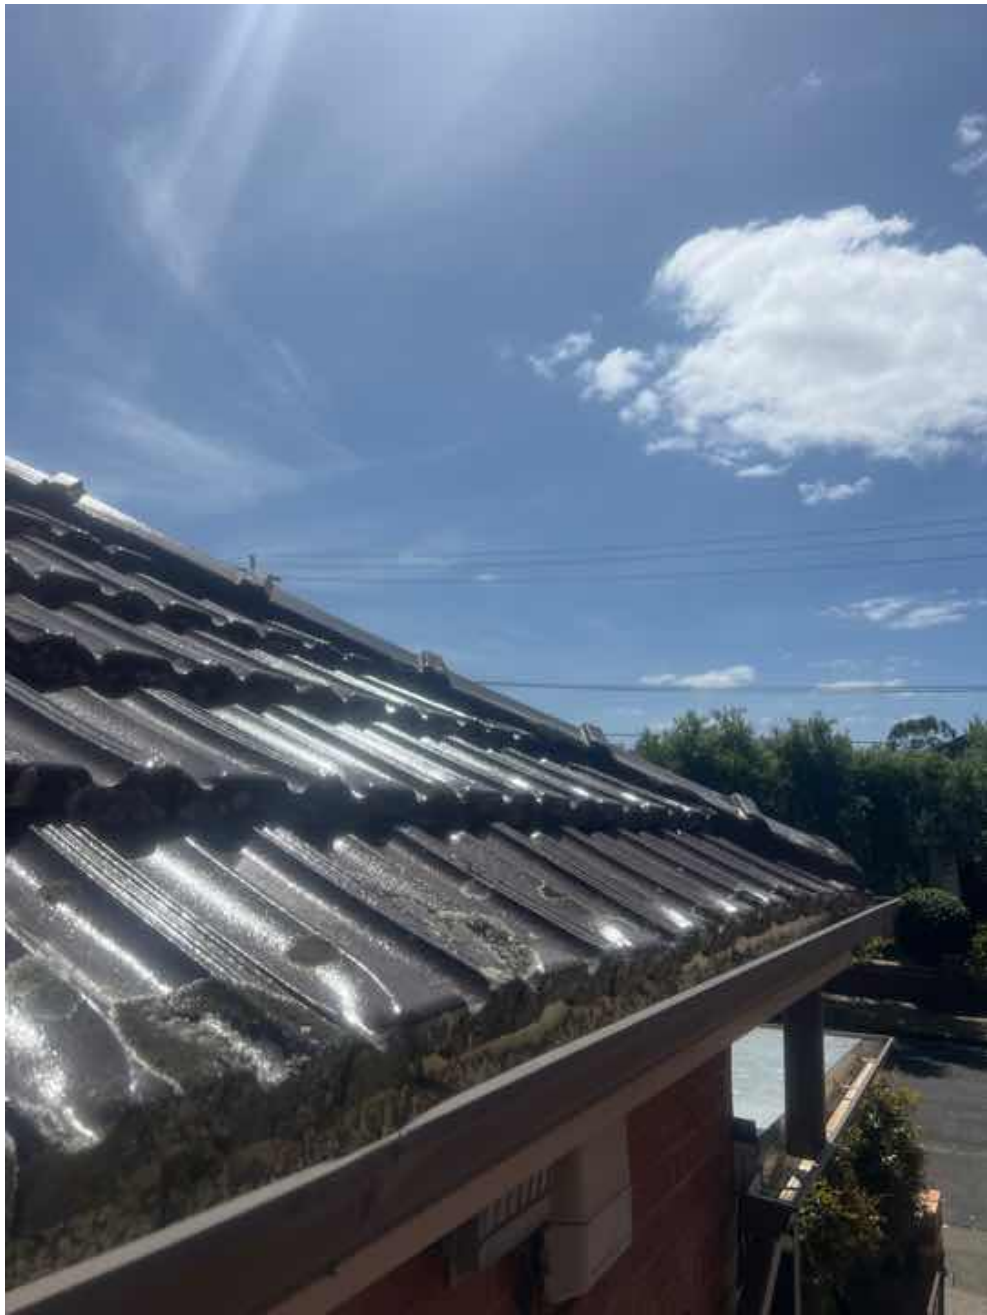
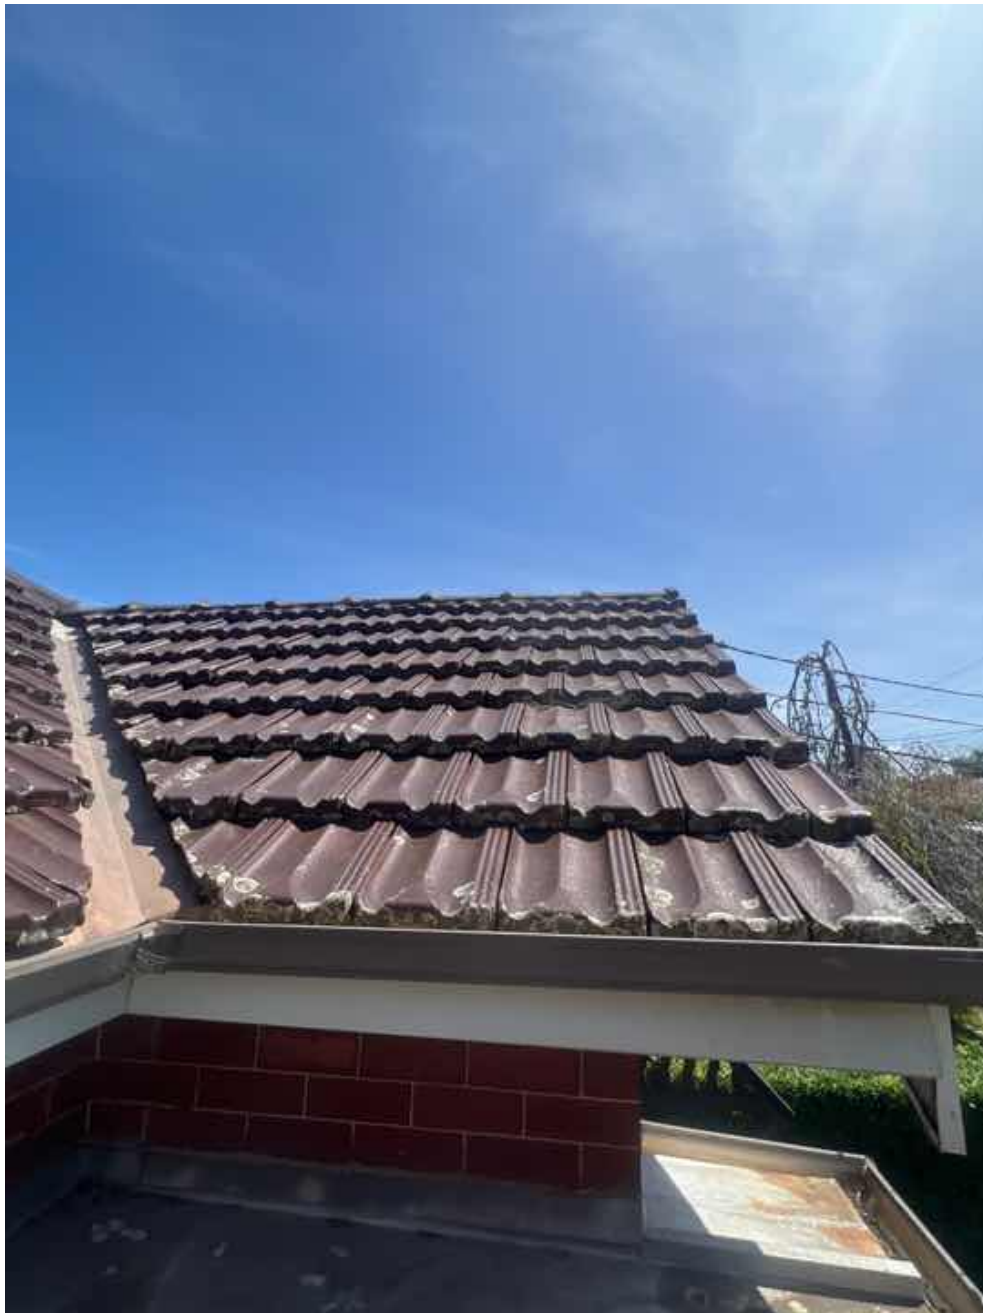
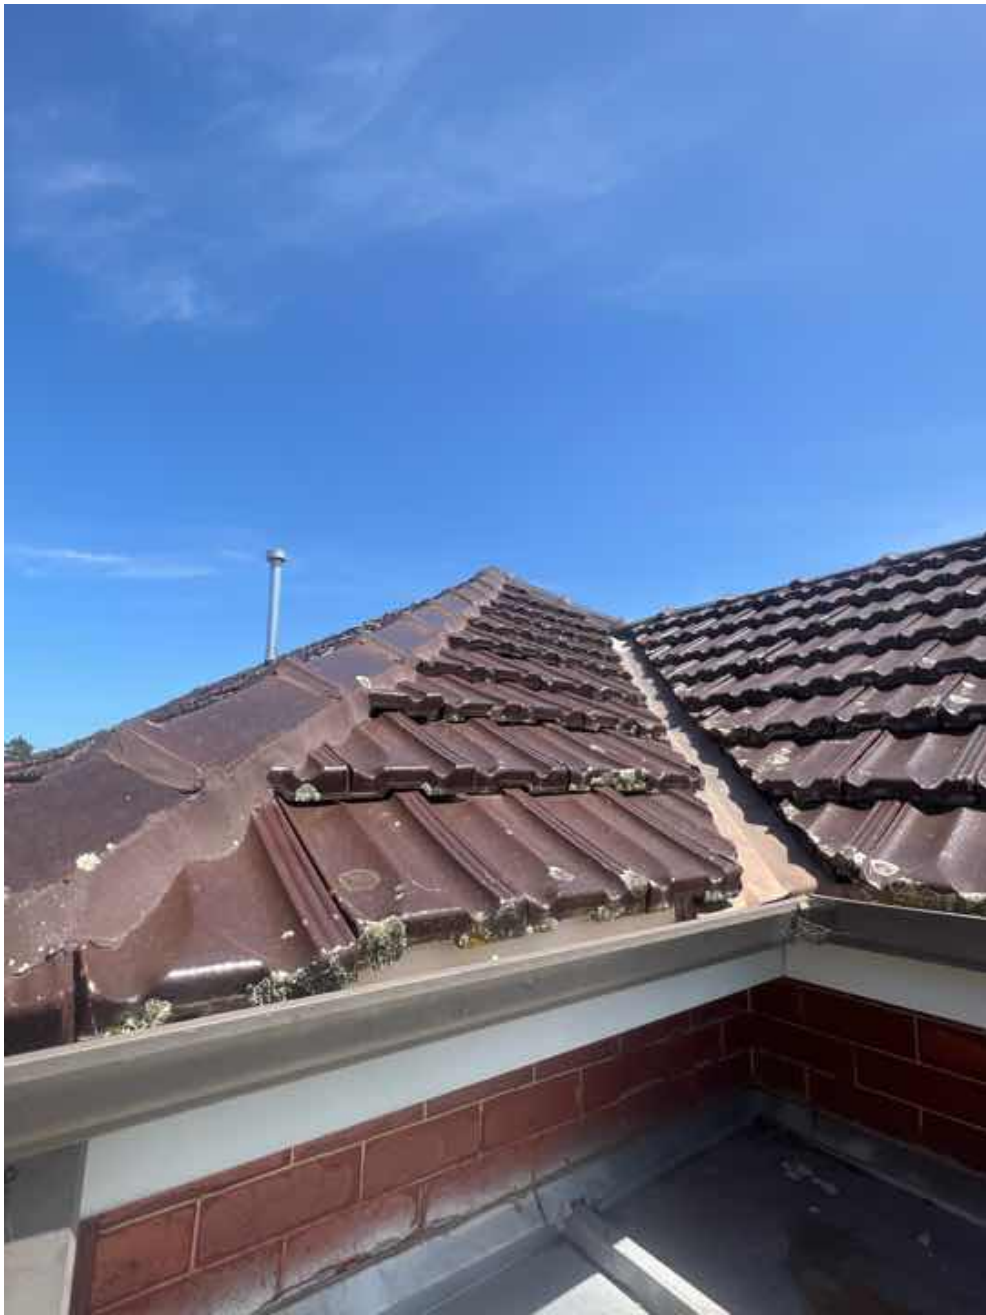
Metal roof is rusting and requires or replacement as the may lead to water ingress into the roof cavity. Contact a qualified roofing contractor for immediate repairs.

Moss has built up on the tiles over time. It is preferable to have removed / cleaned to prevent deterioration.

Recommendations: A qualified roof restoration contractor should be engaged for advice and recommendations.

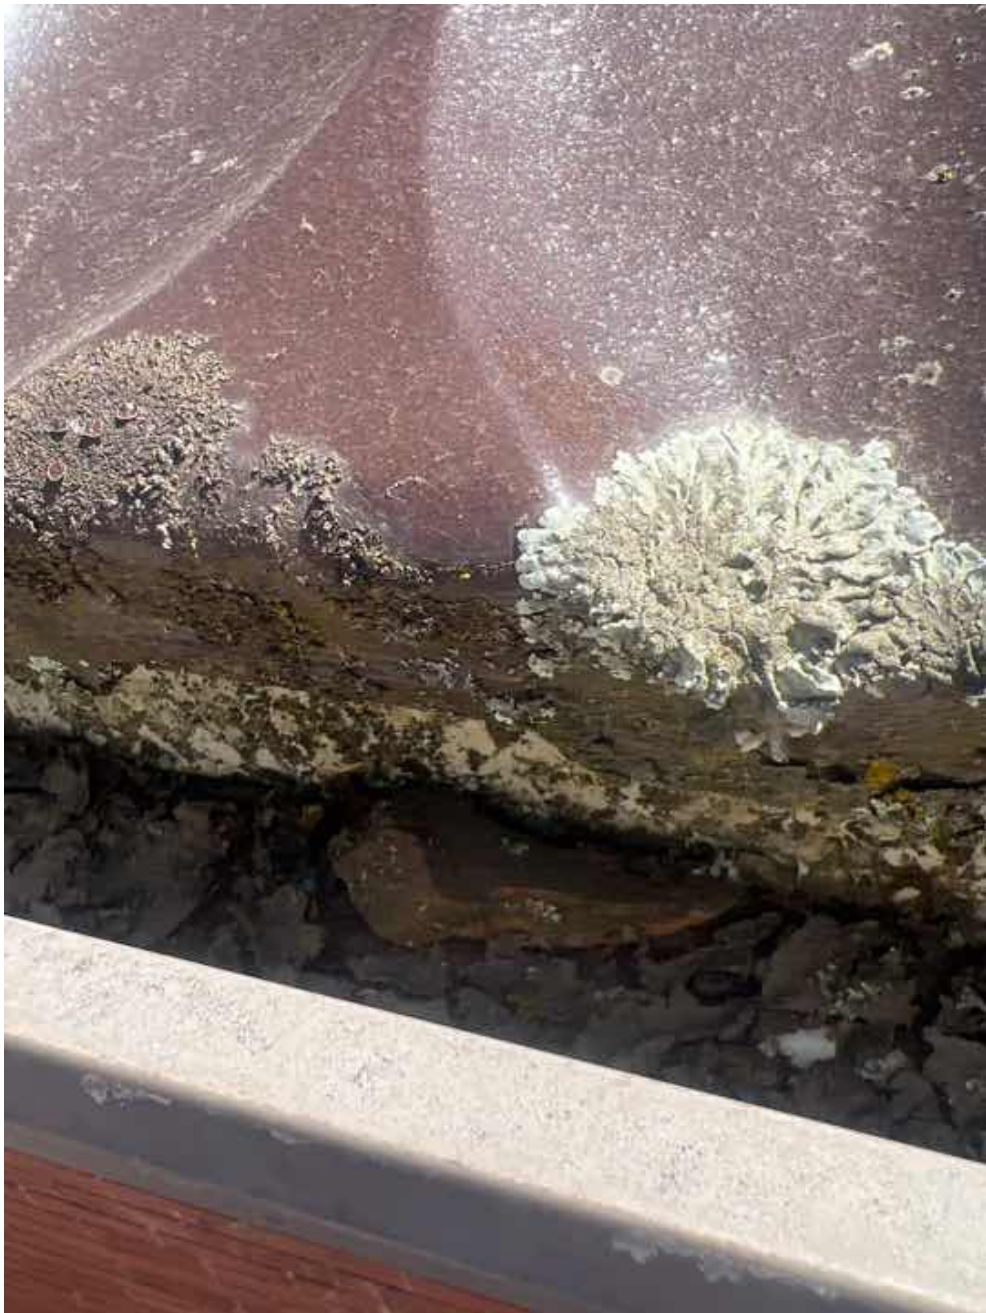
Debris in guttering areas- this requires cleaning out to prevent blocking of downpipes and leaking into eaves and fascia. Have gutters cleaned and assessed by a plumber for adequate fall. Regularly clean to prevent ponding. Ponding water will contribute to rust.

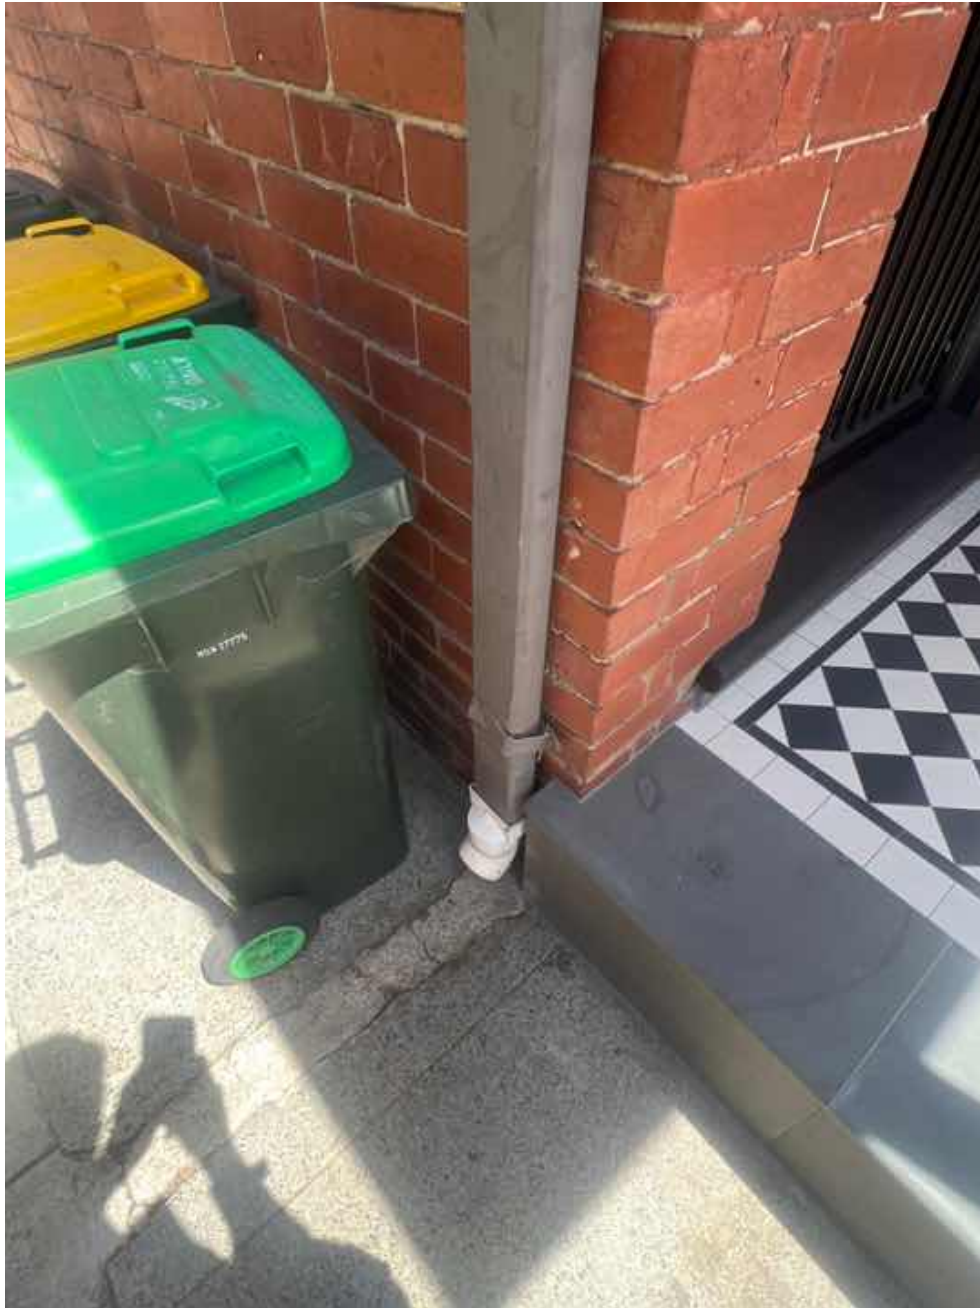
The downpipe/s wall clips is detached or missing. Although minor and easily rectifiable, we recommend a licensed roof plumber be engaged for repairs.

Leaking downpipe joins visible. This can be conducive to termite infestation and cause water damage to cladding over time. A qualified roof plumber should be engaged to repair.

Downpipe/s not connected to storm water discharge - Downpipes not connected to storm water have the potential to cause differential settlement to the footings, cause rising damp and is also conducive to termite infestation. A qualified roof plumber should be engaged for advice and recommendations.

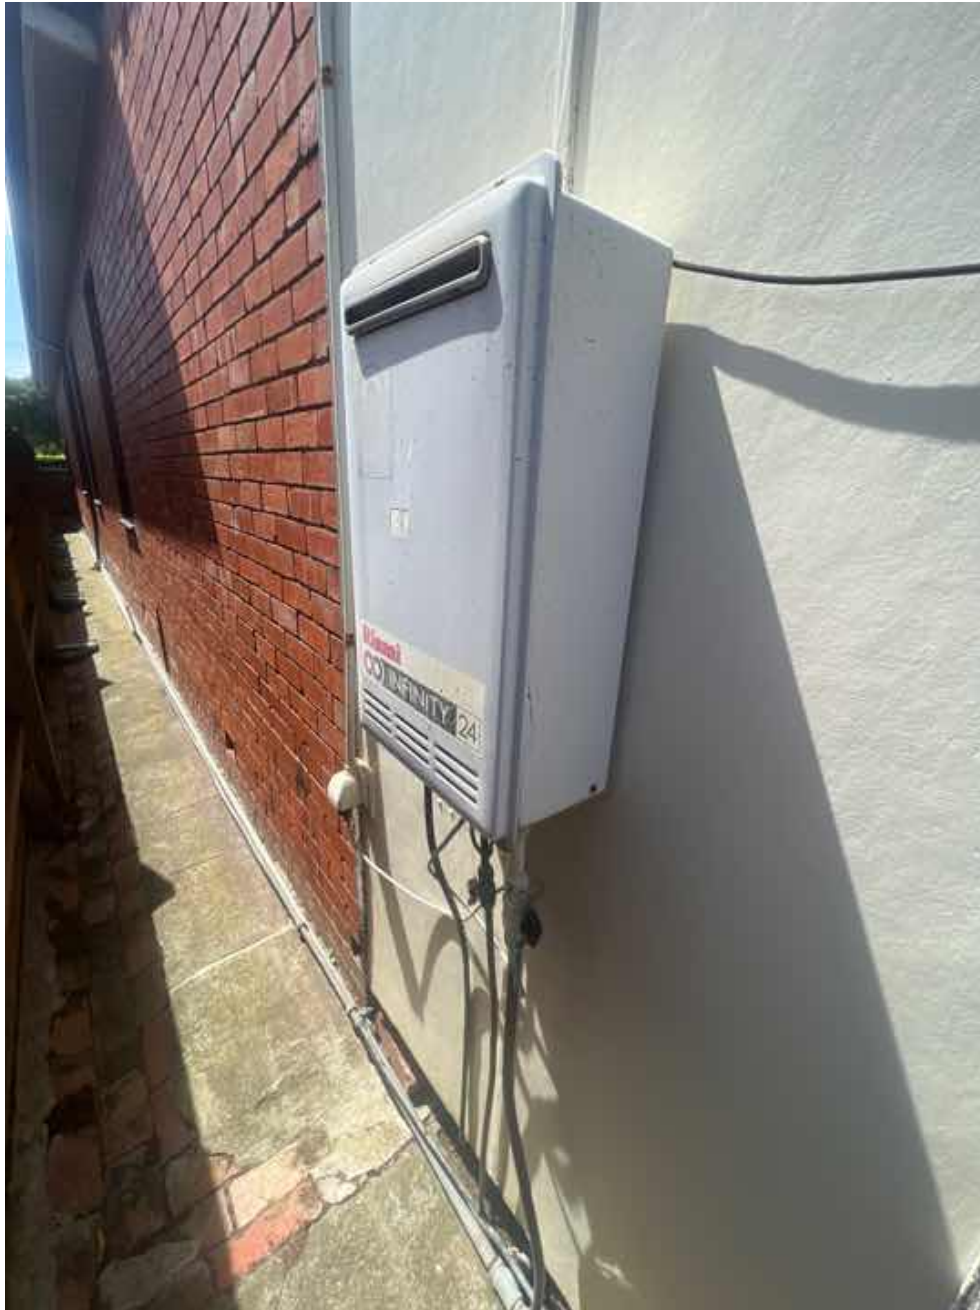
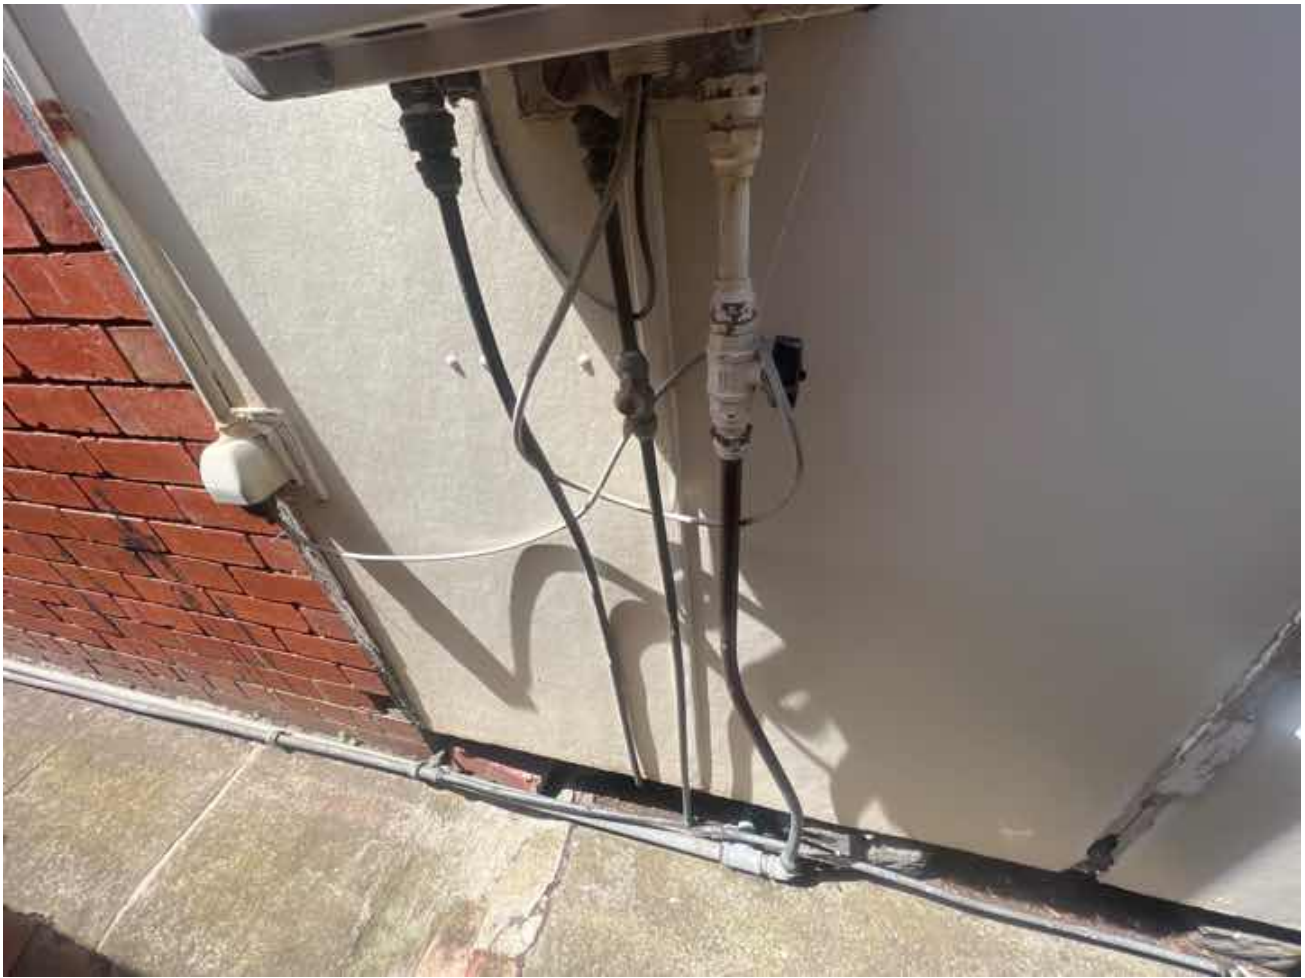
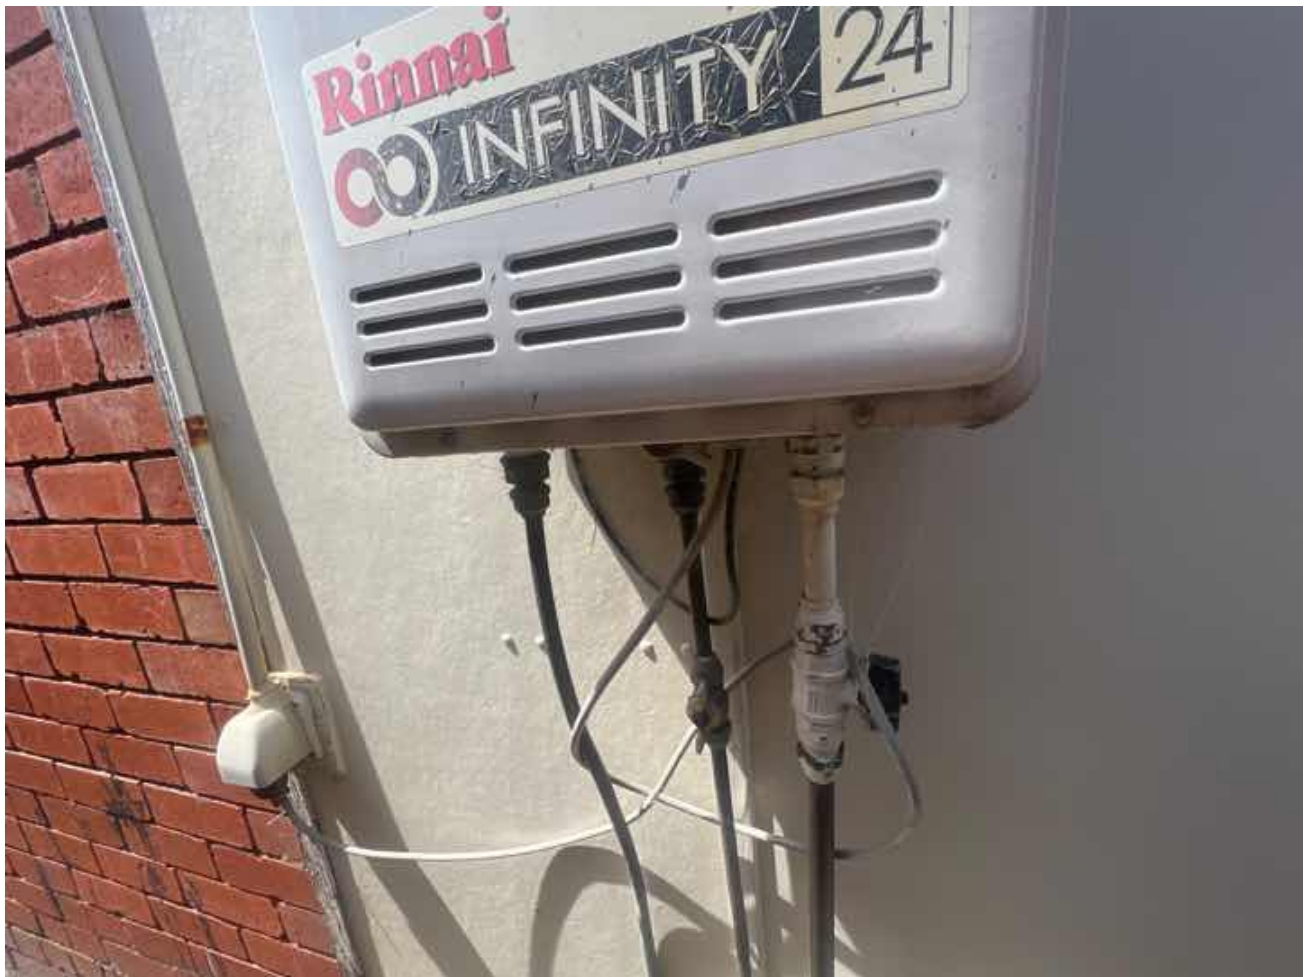
The hot water system appears to be in a serviceable condition. No specific tests other than running the hot water from a tap was carried out. No determination has been made as to the suitability or adequacy of the hot water system in relation to capacity or otherwise.
