Sample Report

D.C Building Inspectors

Pest And Building Inspection

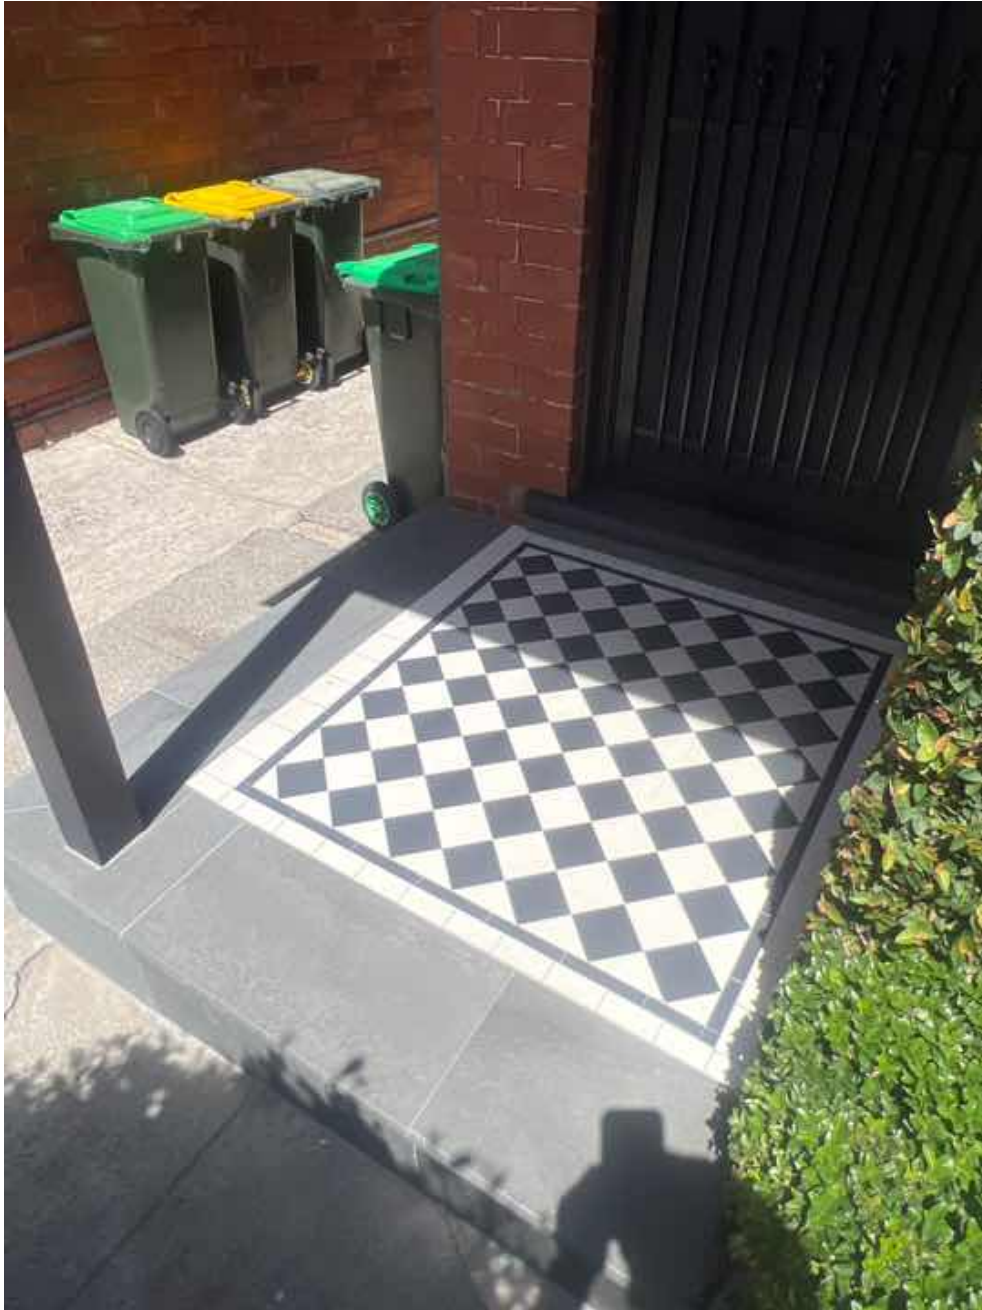
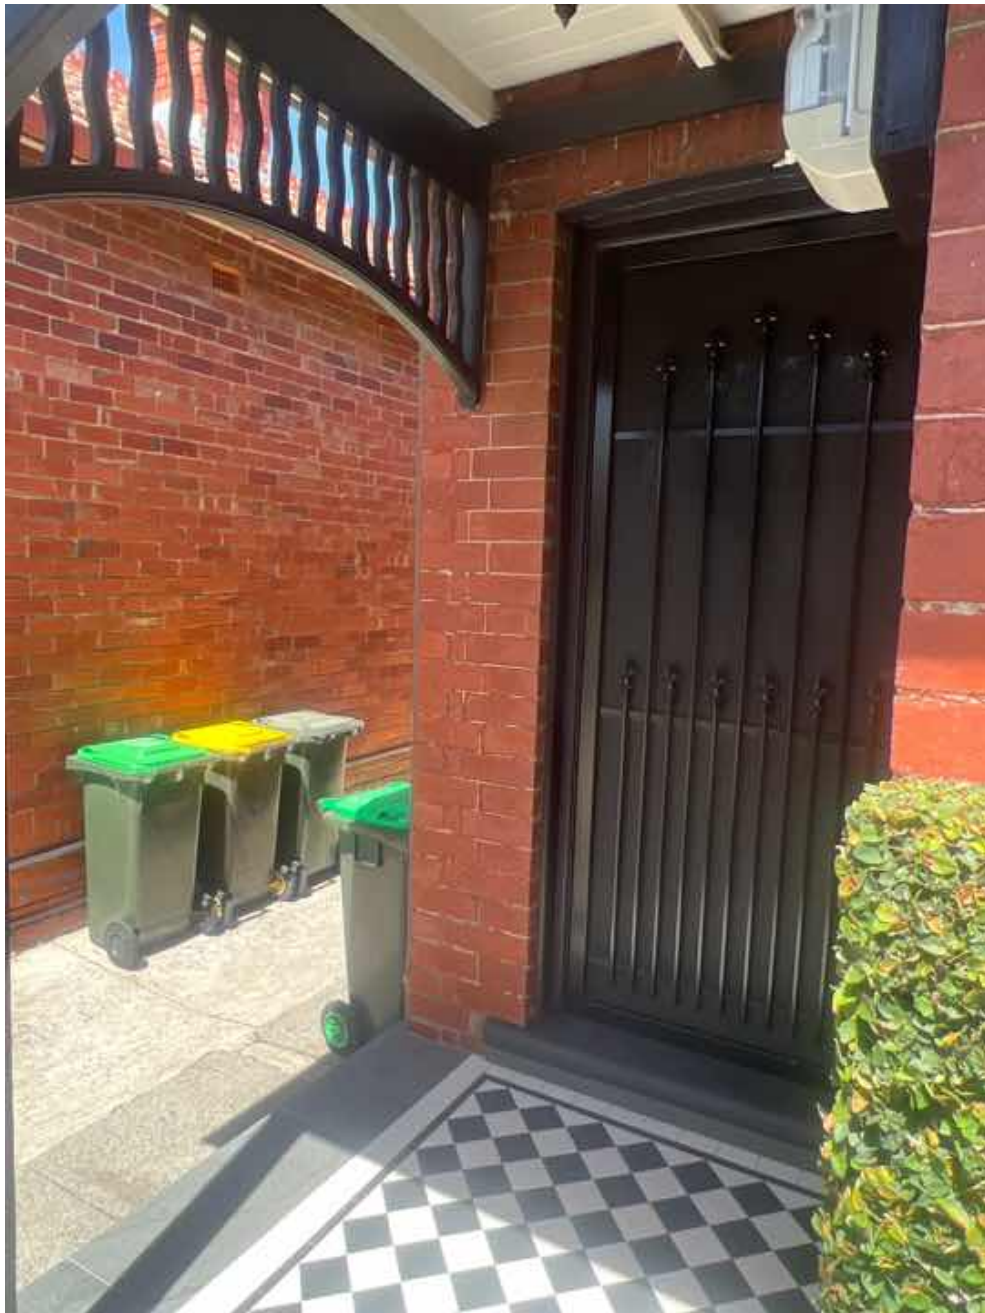
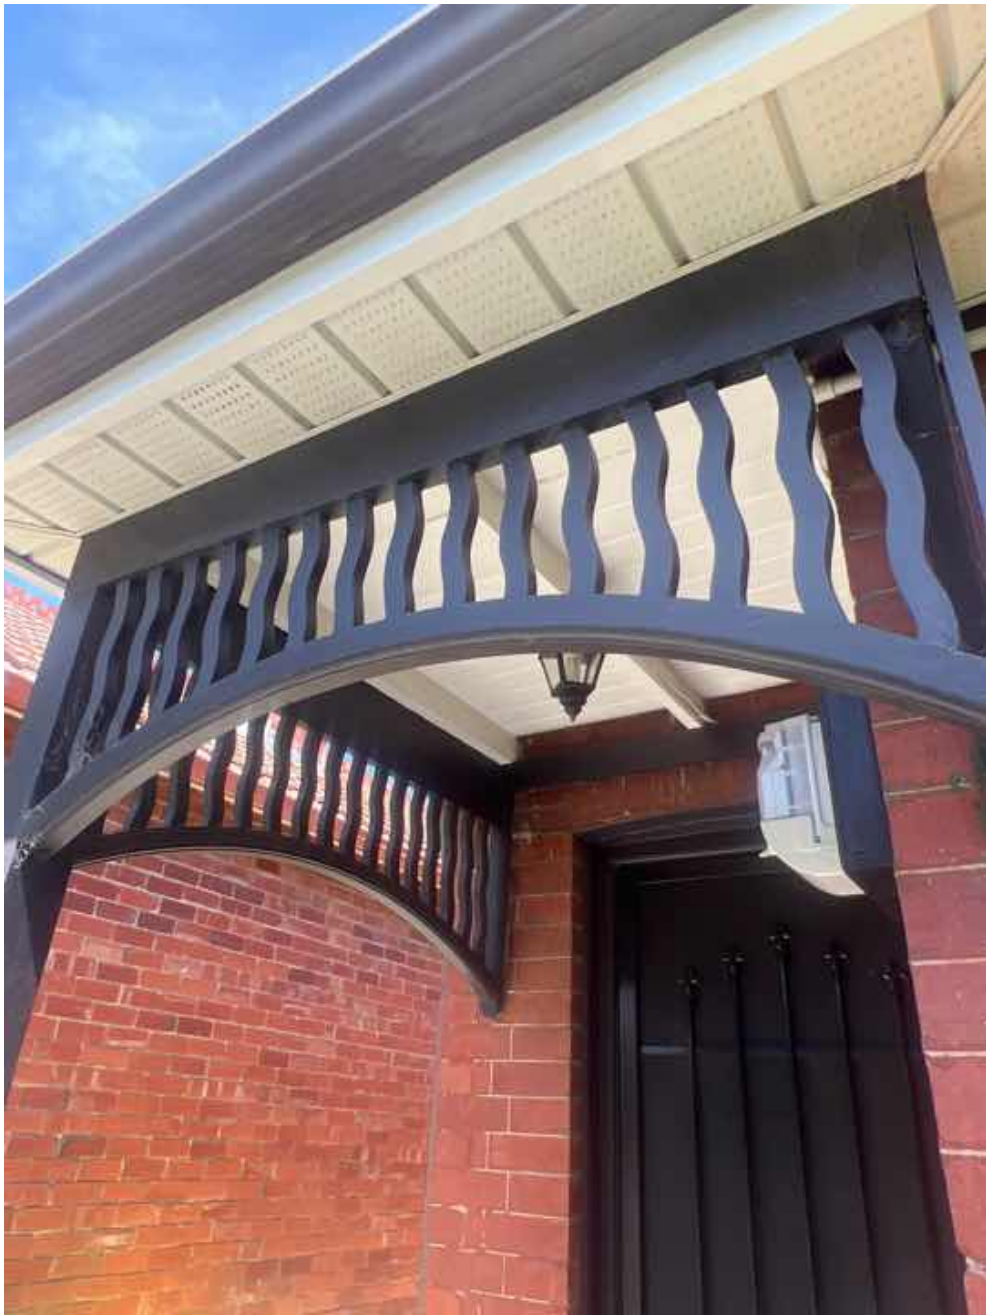
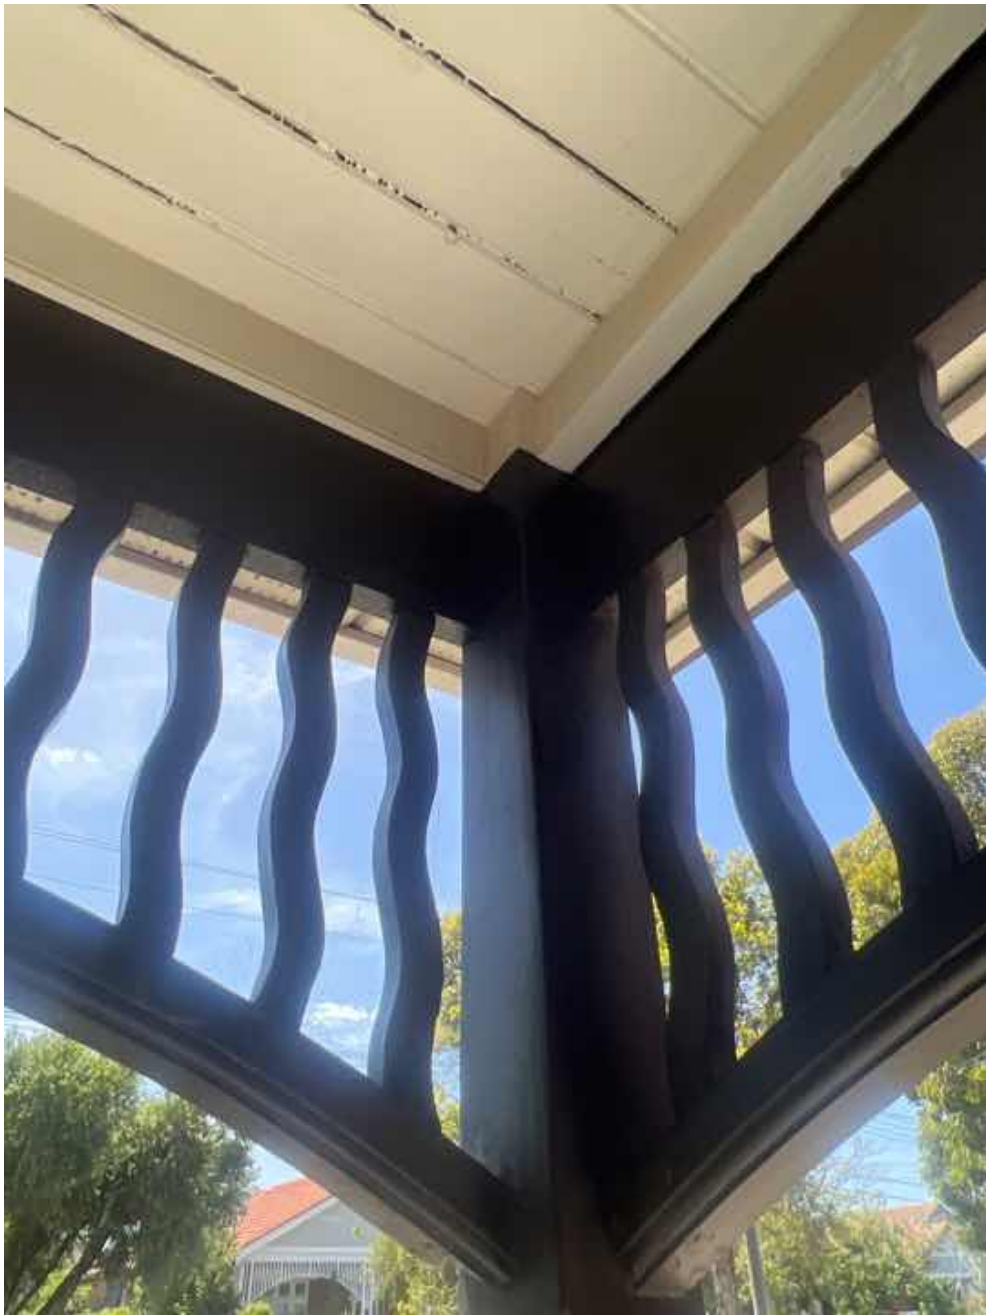
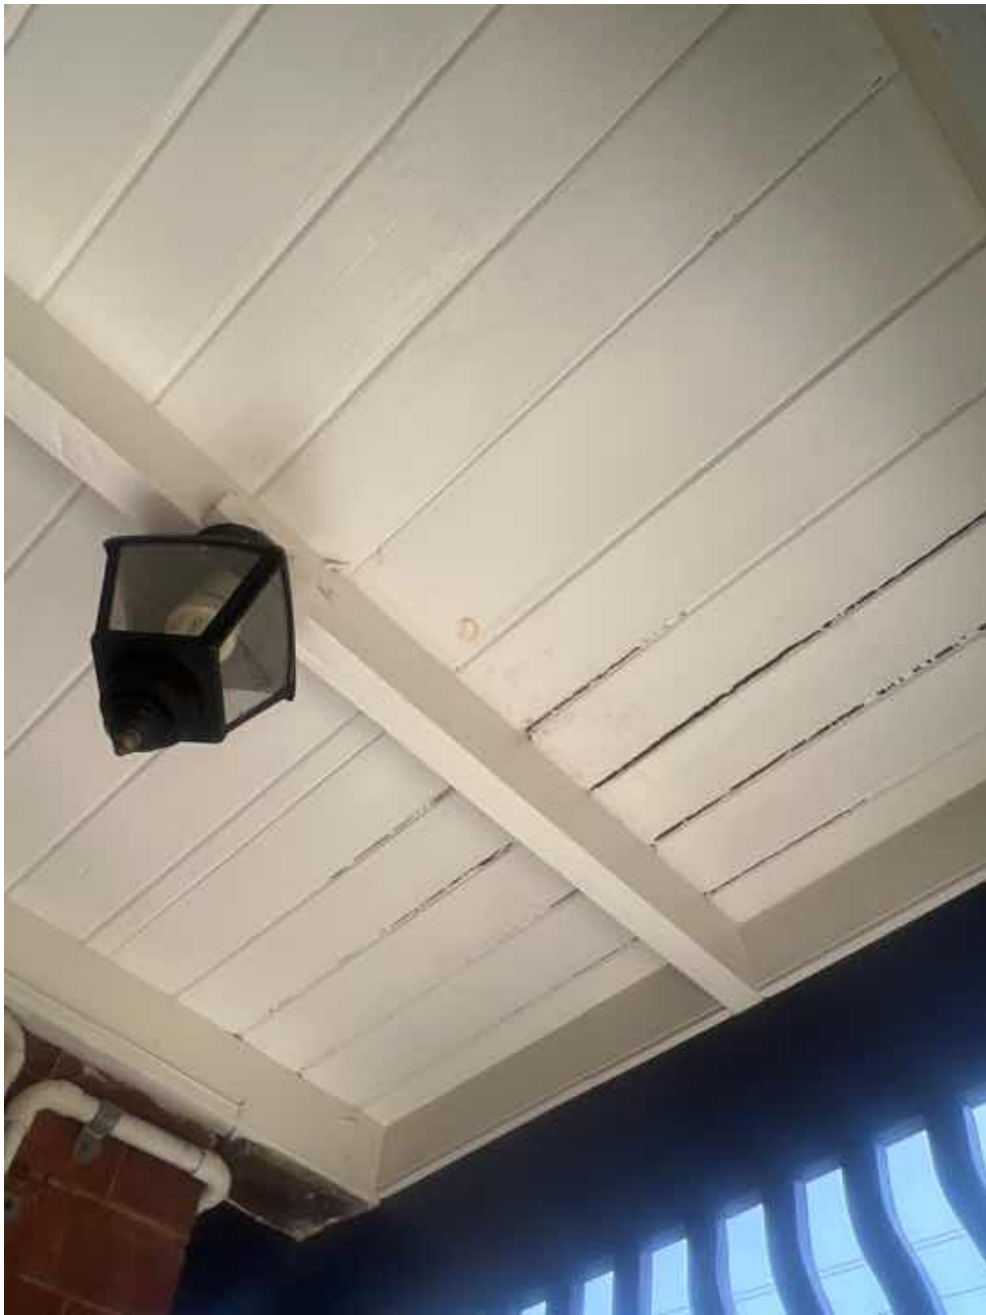
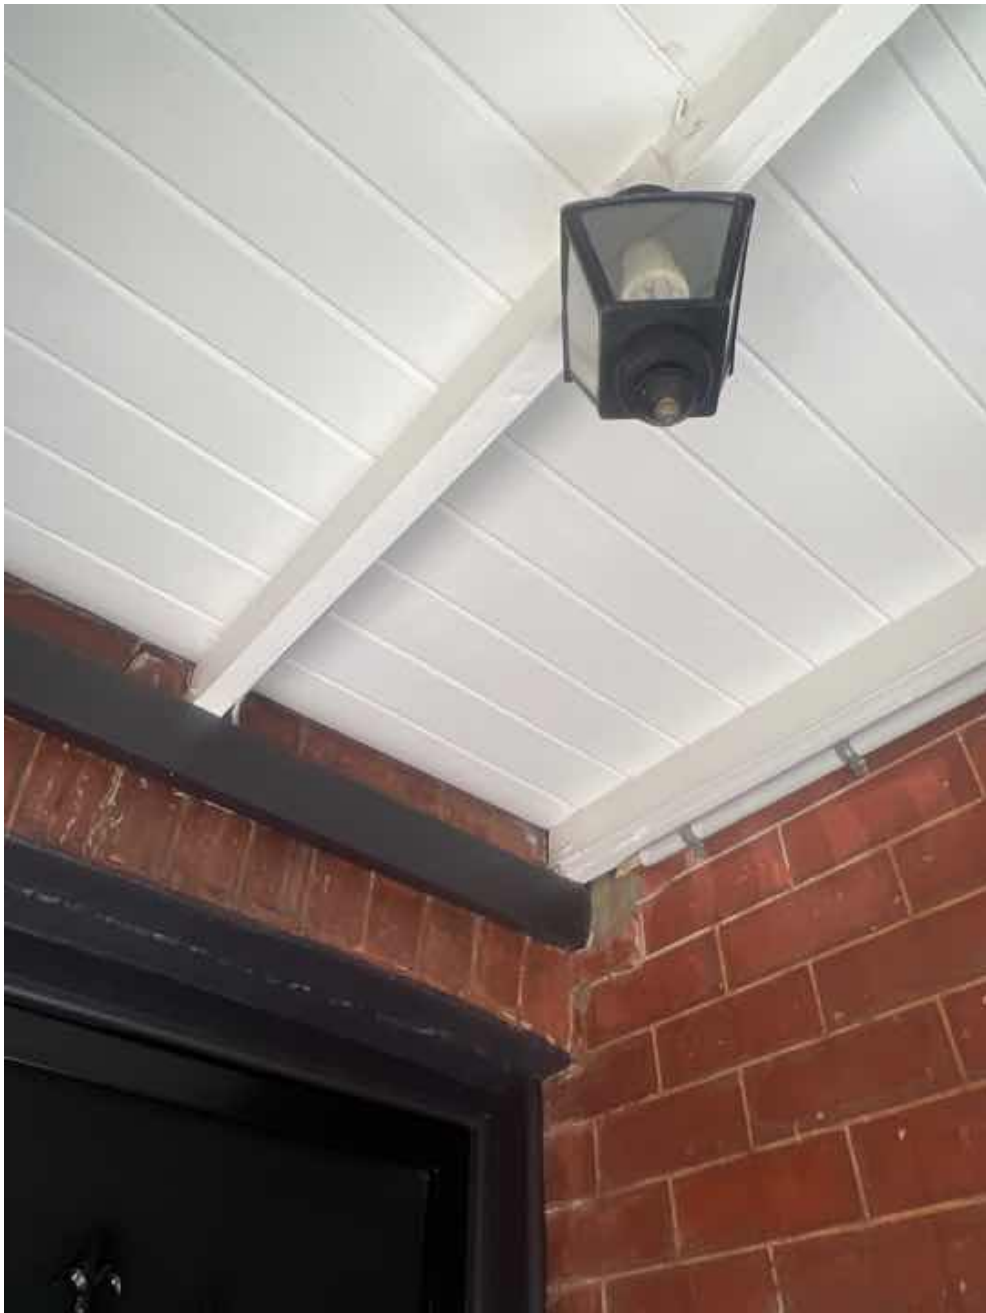
The entry porch serviceable or in reasonable or condition for the age of this dwelling.

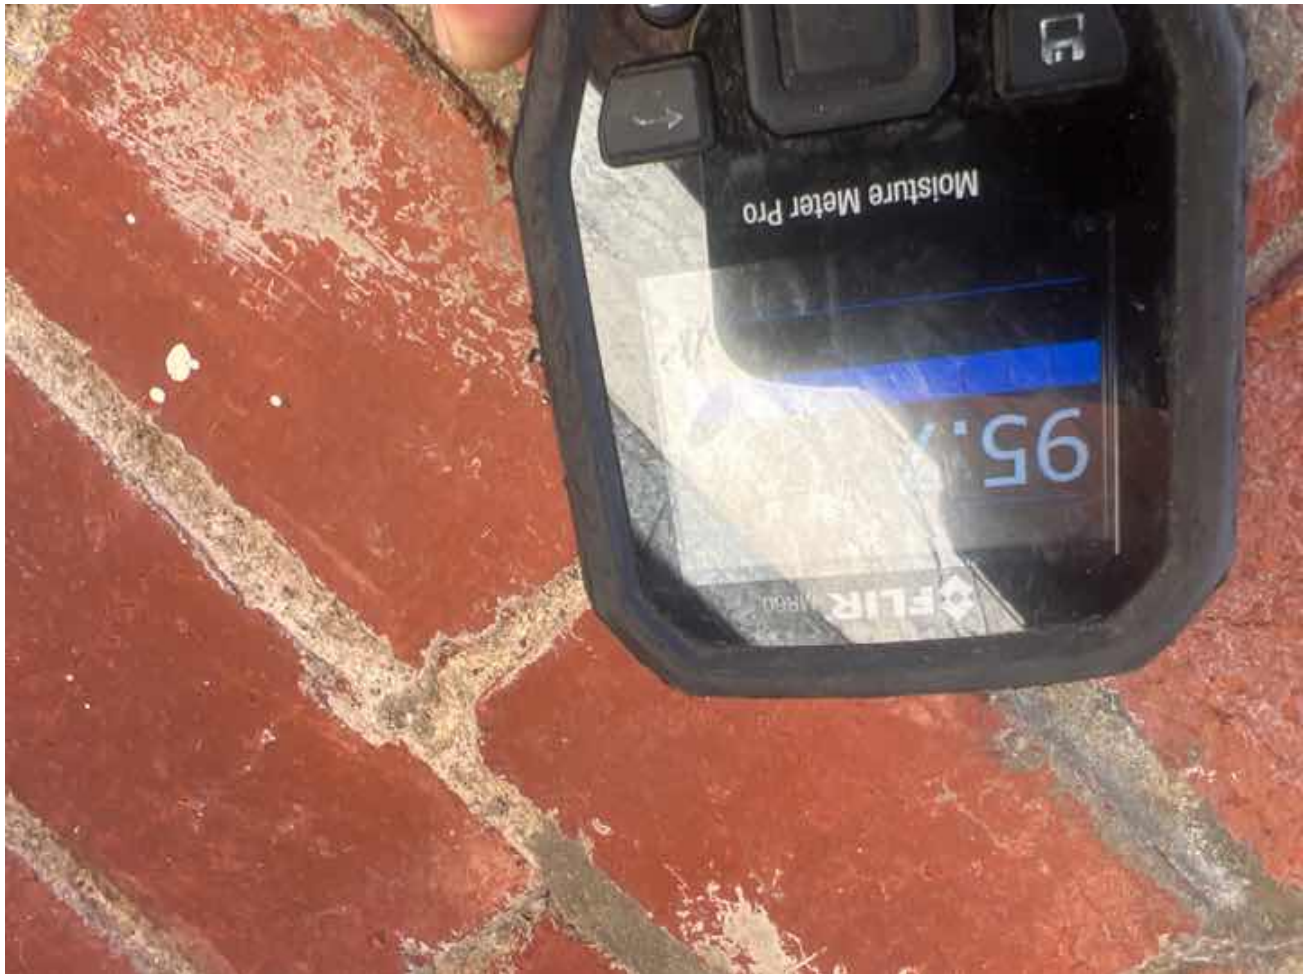
High moisture readings were to the exterior walls. We recommend specialist in this field be engaged for further evaluation and repairs.

Salt residue & brick mortar deterioration on lower wall visible. Further investigation required. A specialist in this field should be engaged for advice and recommendations.

Though under Damp proof course, minor fretting to brickwork observed. Overtime the salts in the uptake of moisture breaks the bricks down to powder form. Have checked by a qualified brick layer for advice and recommendations.

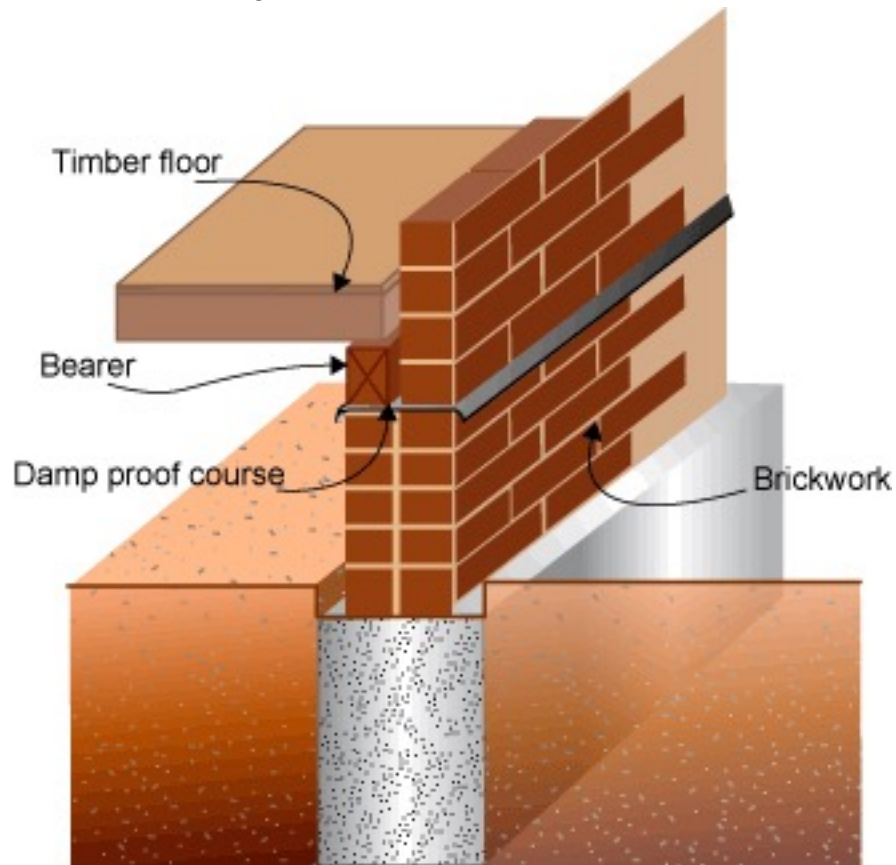
Damp Proof Course

A damp proof course is not visible or could not be visually identified. This may cause rising damp issues. Contact a specialist in this field to further investigate and make recommendation.
