Sample Report

D.C Building Inspectors

Pest And Building Inspection

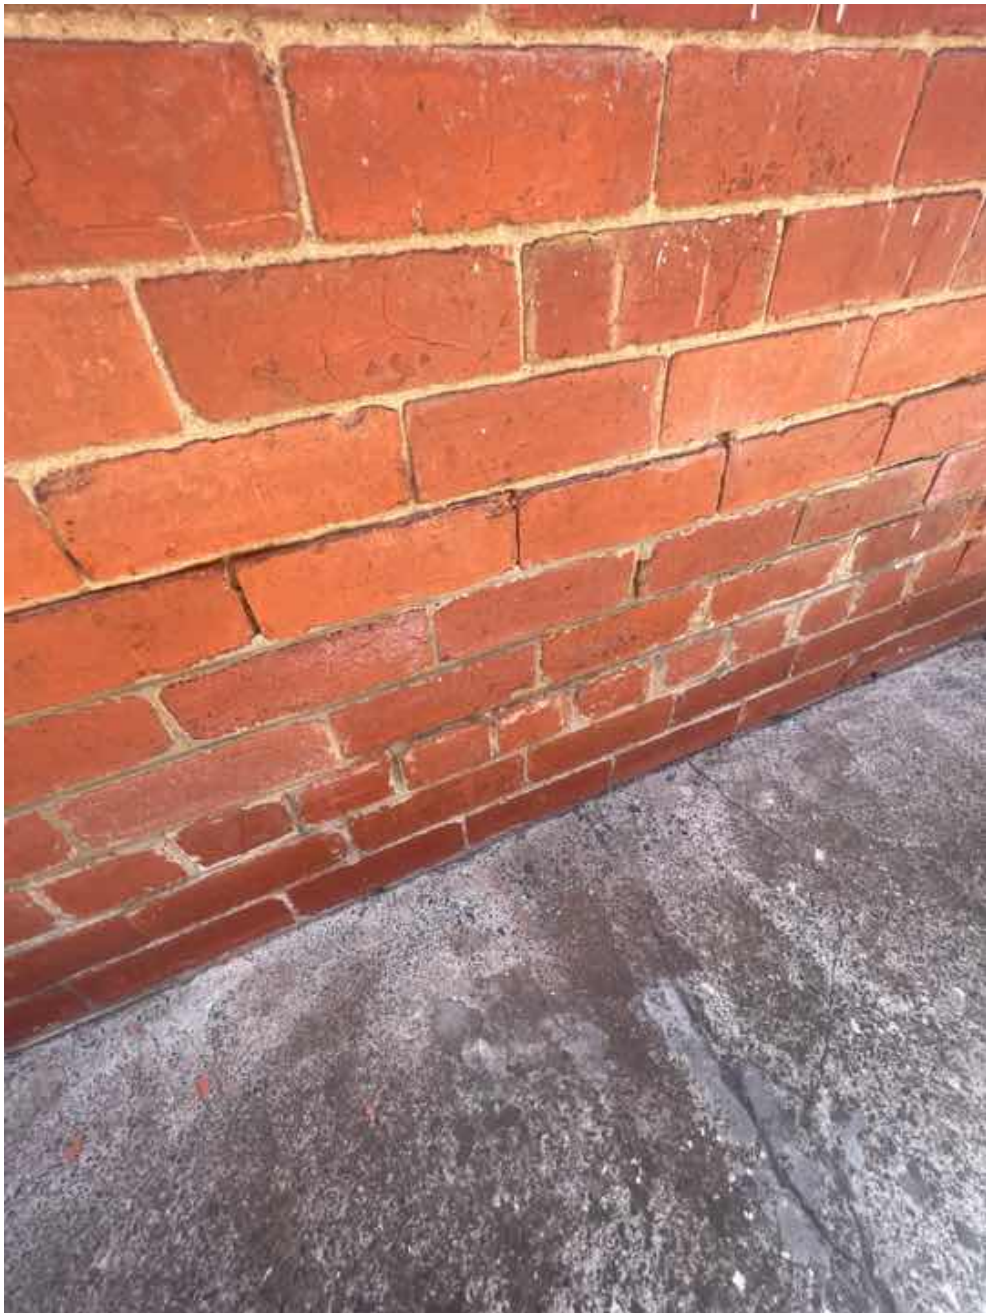
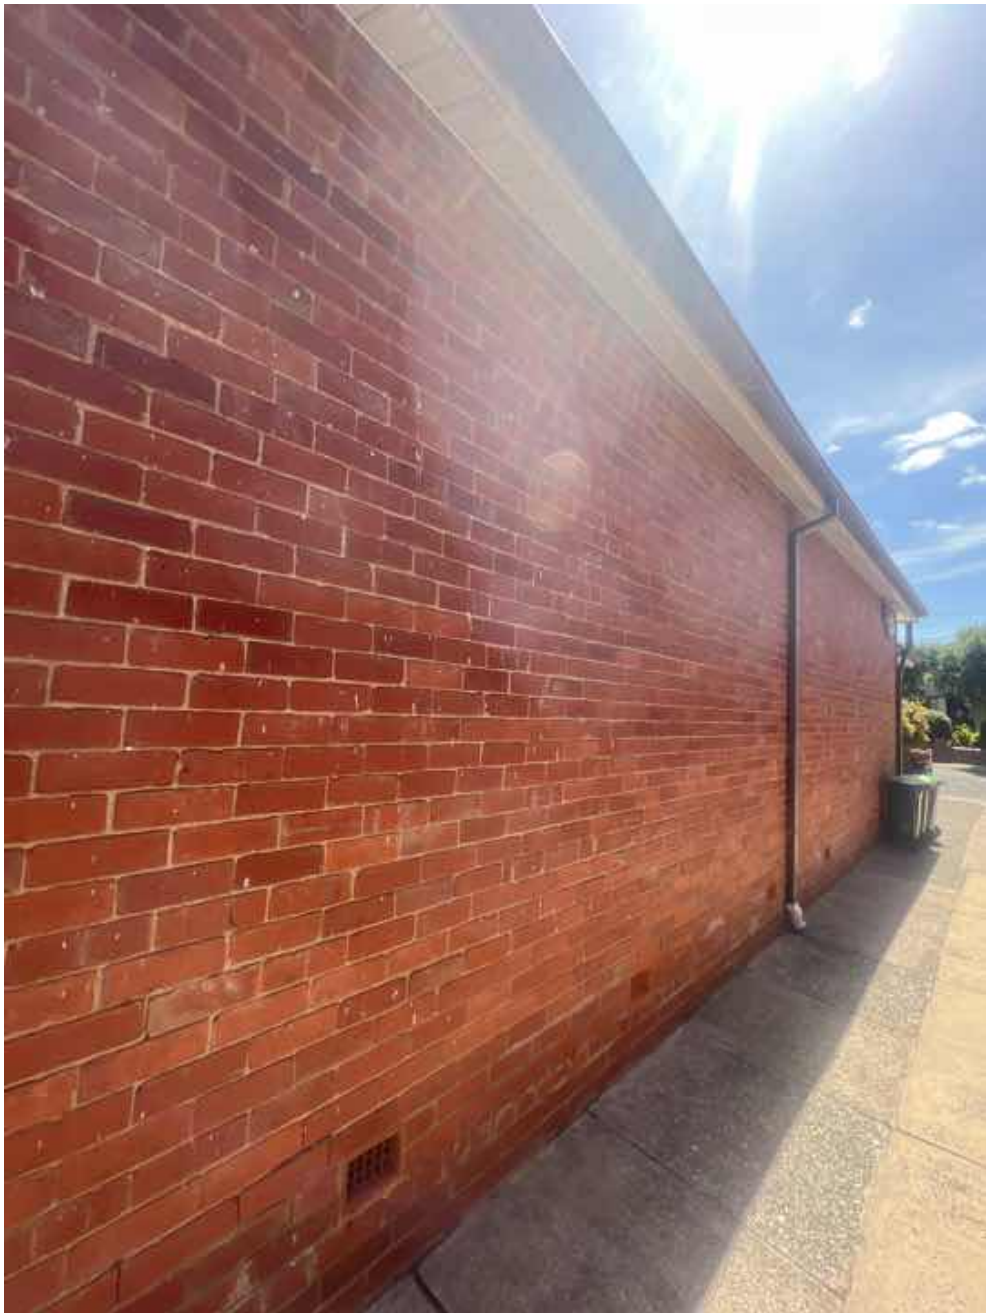
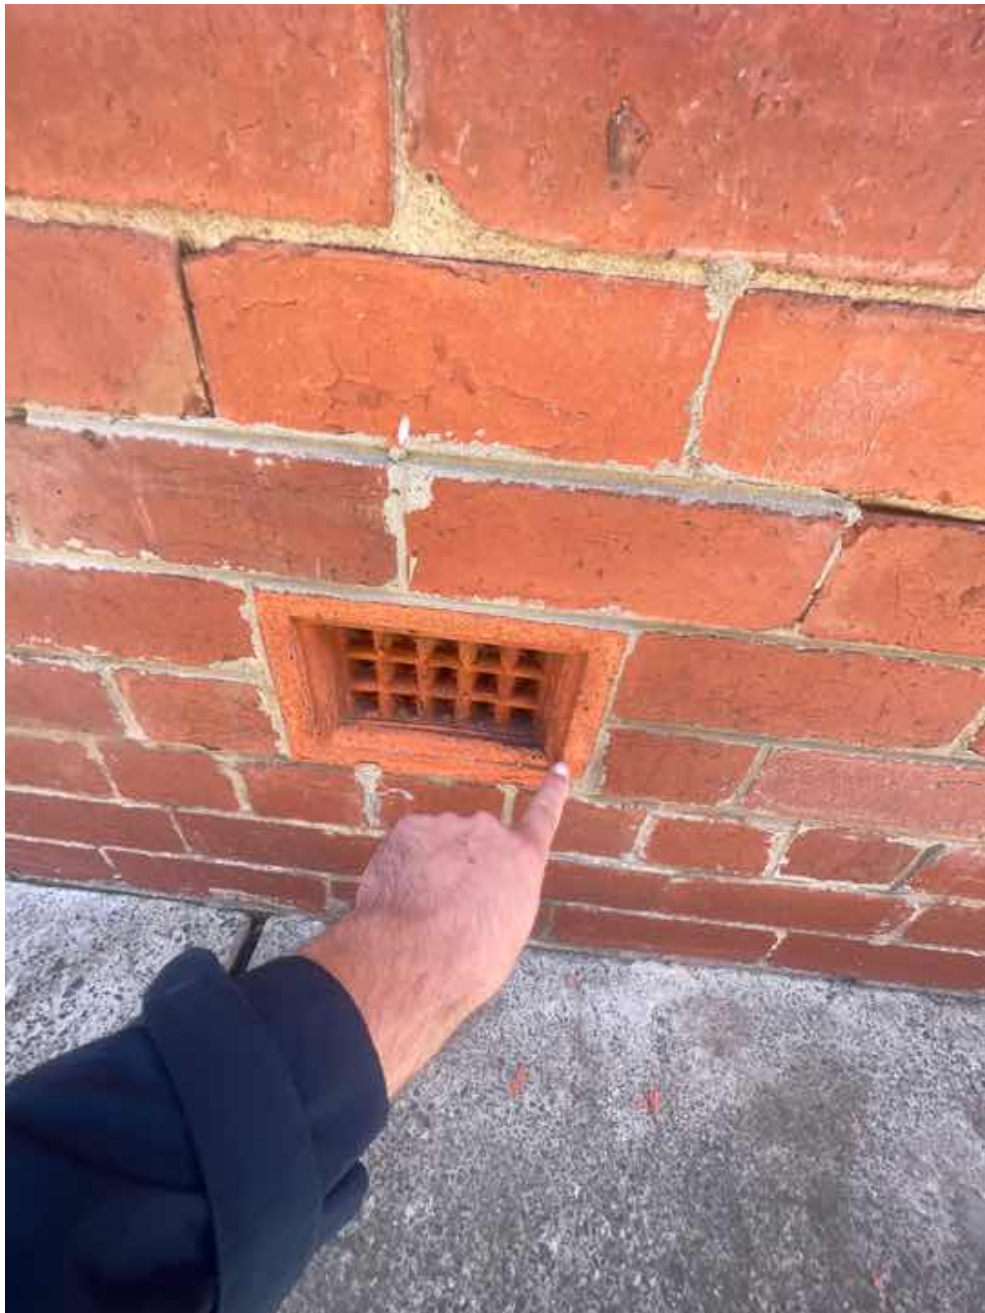
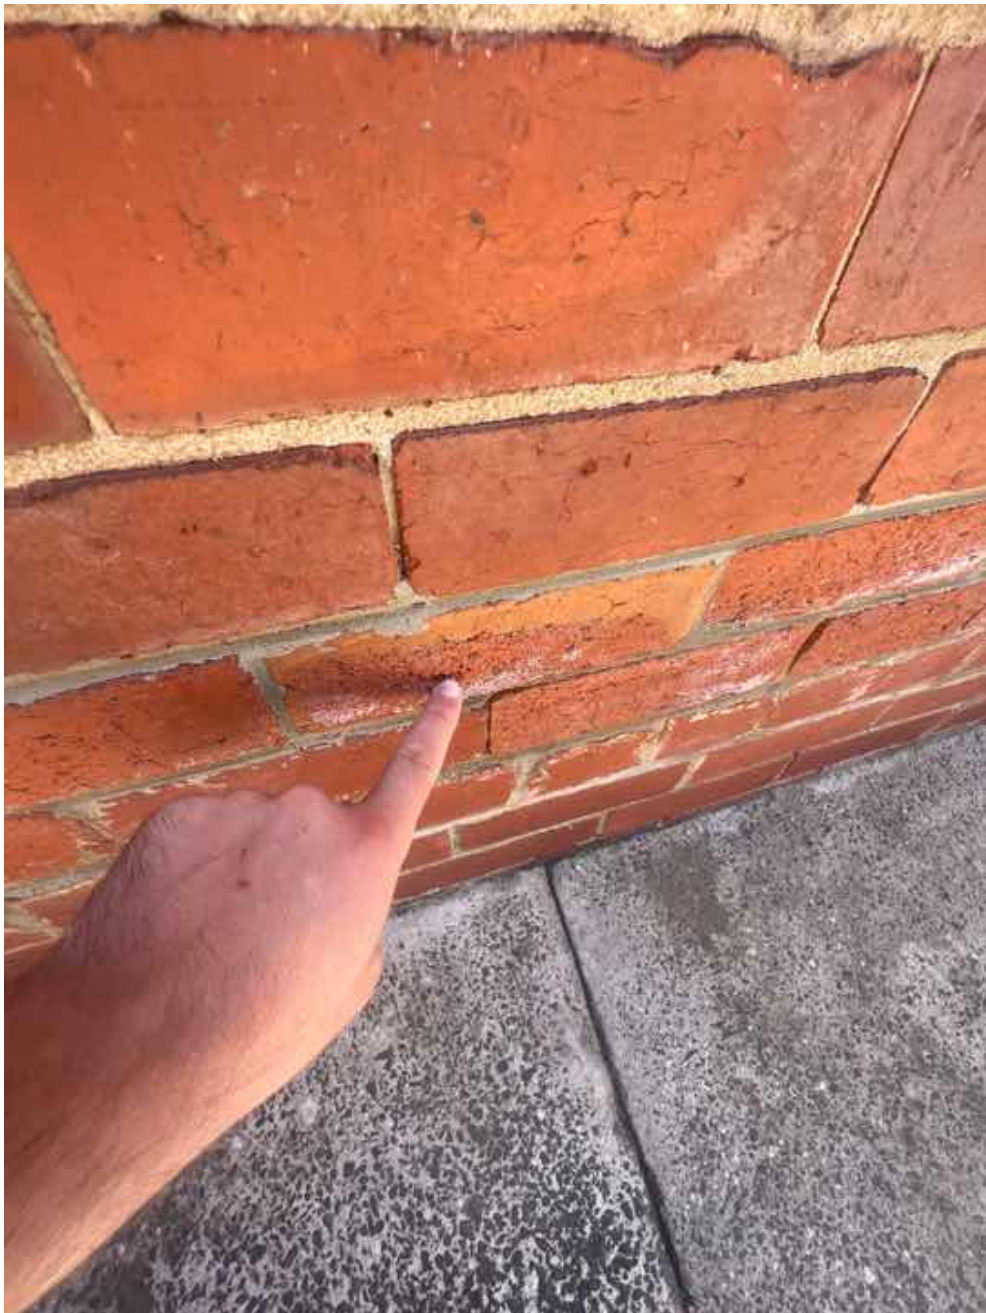
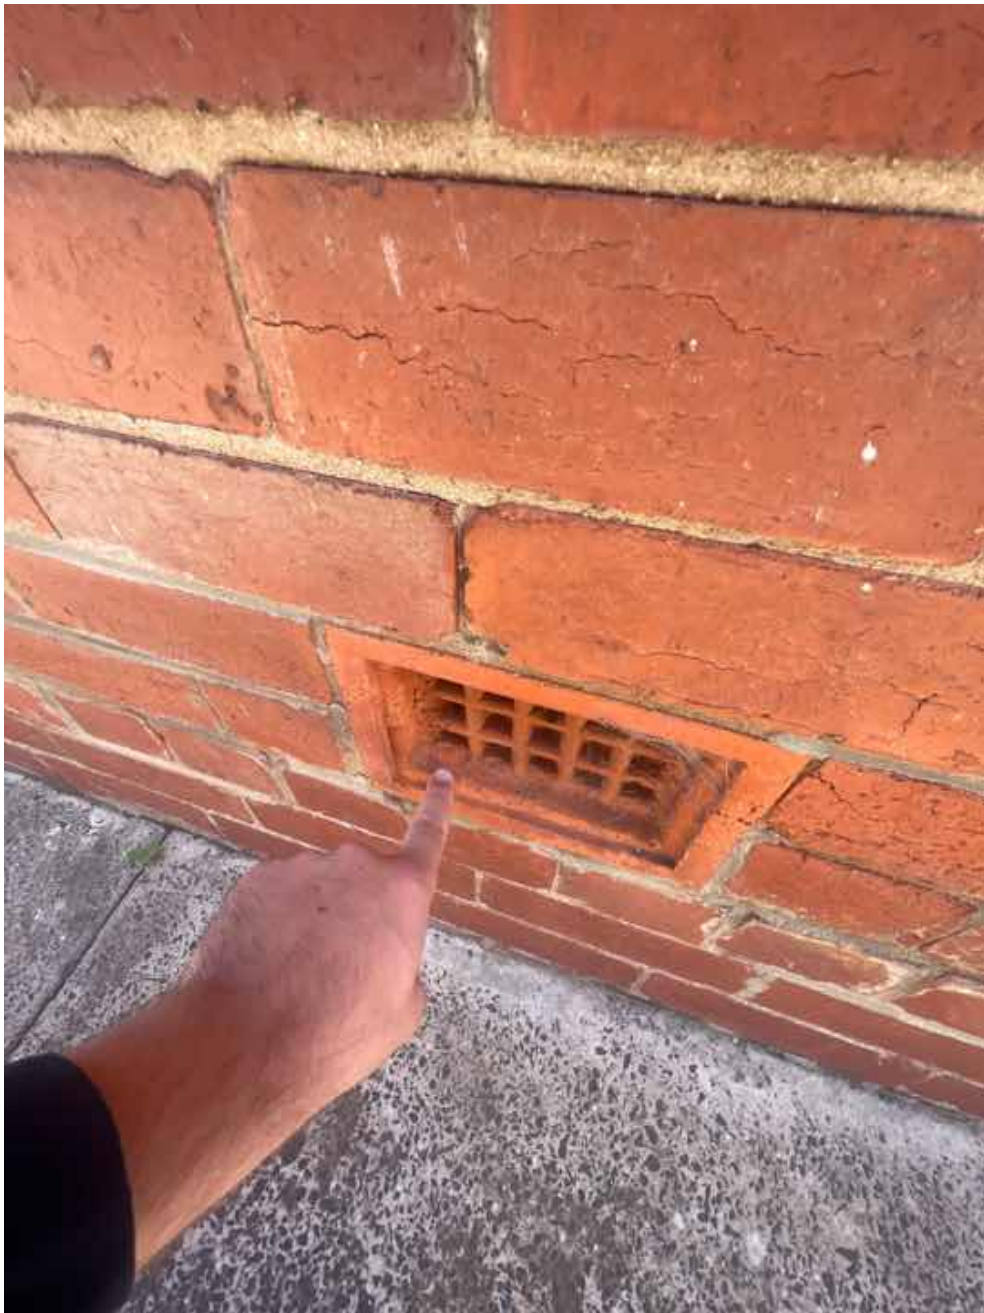
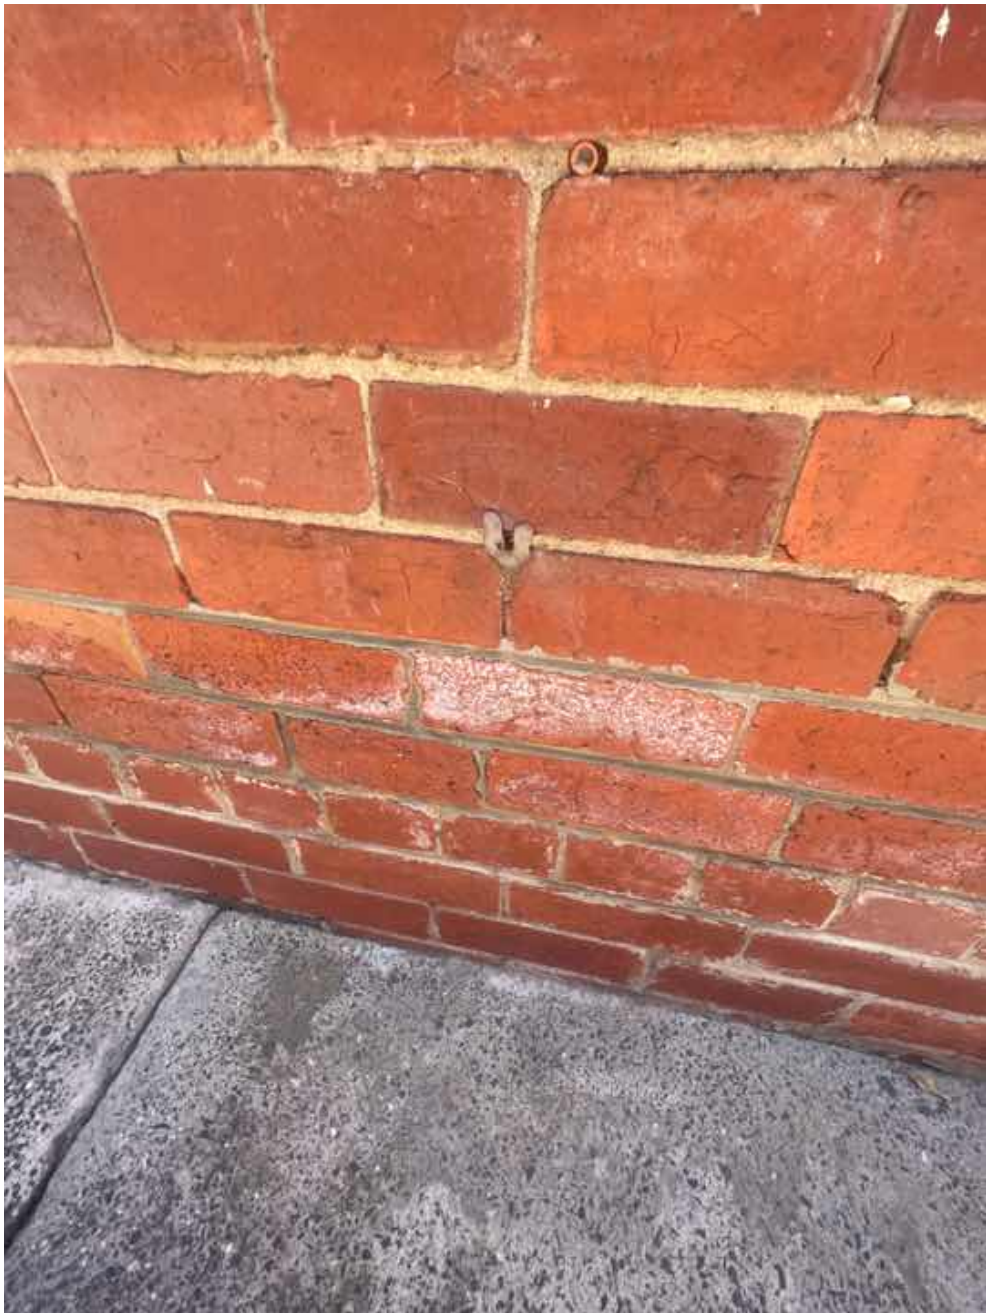
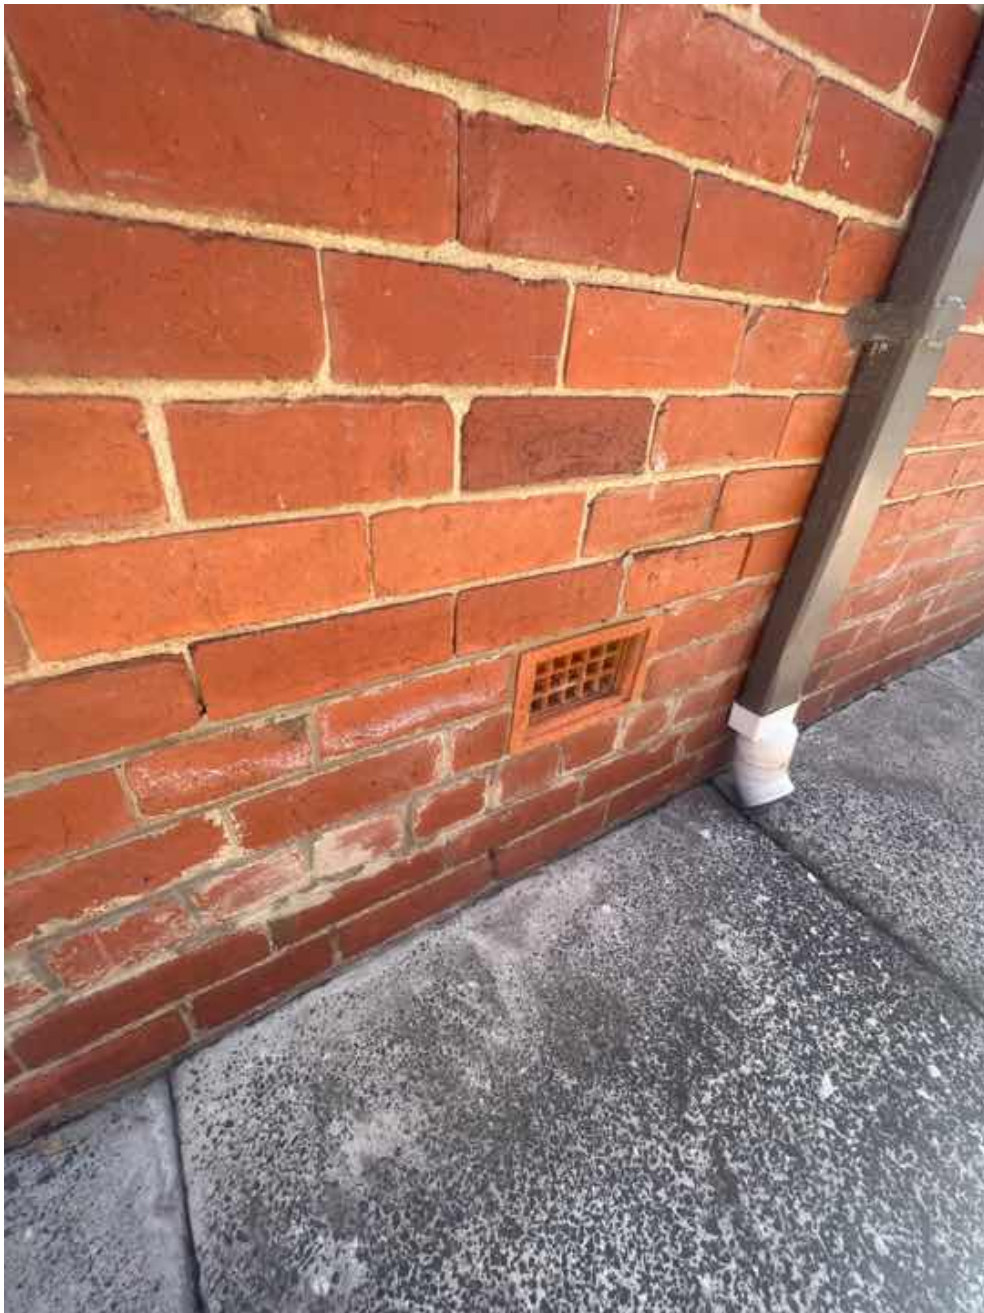
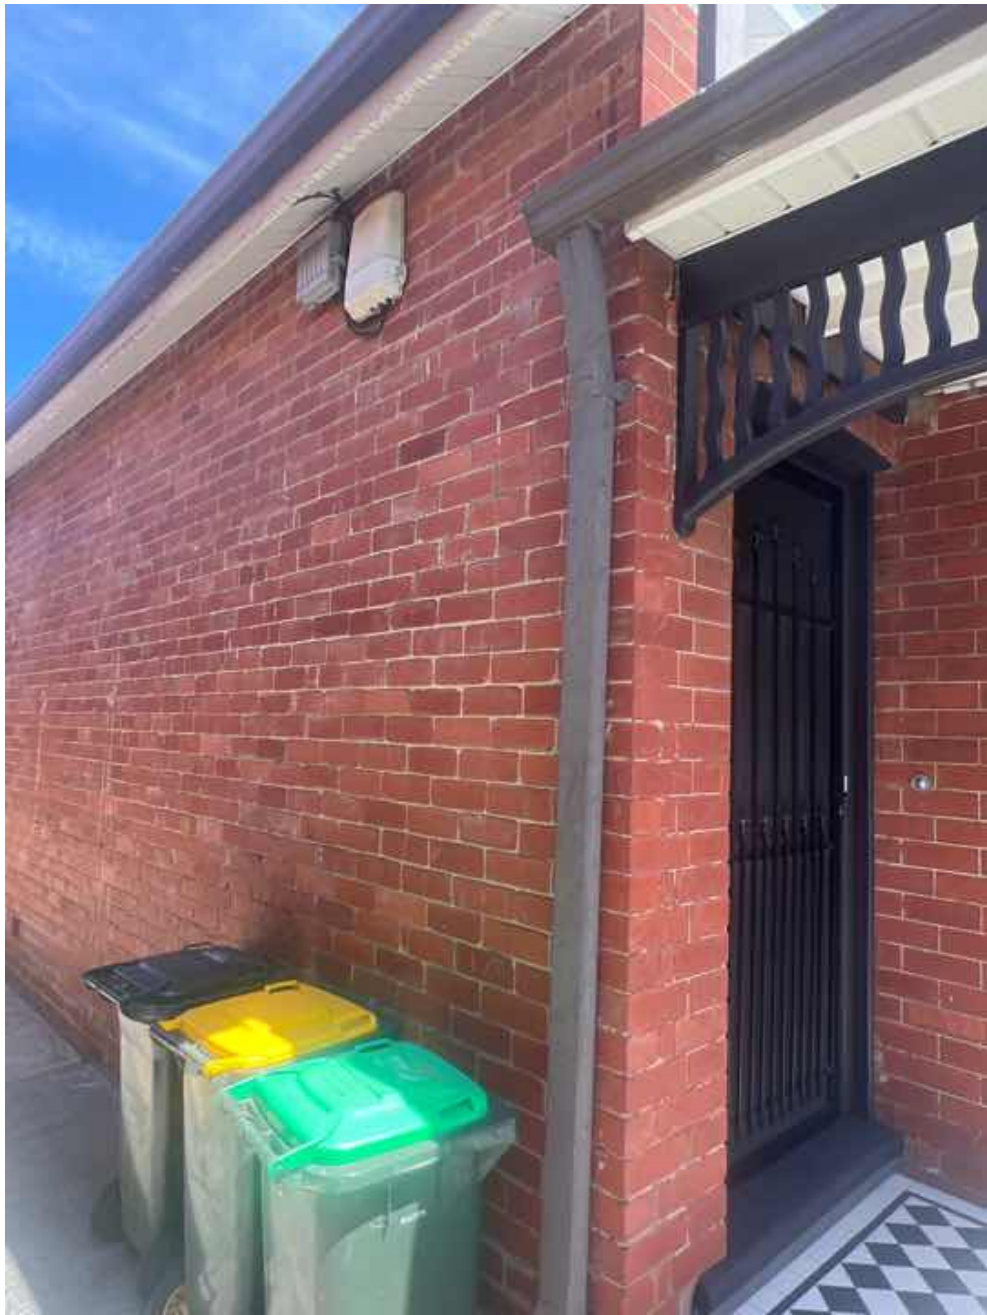
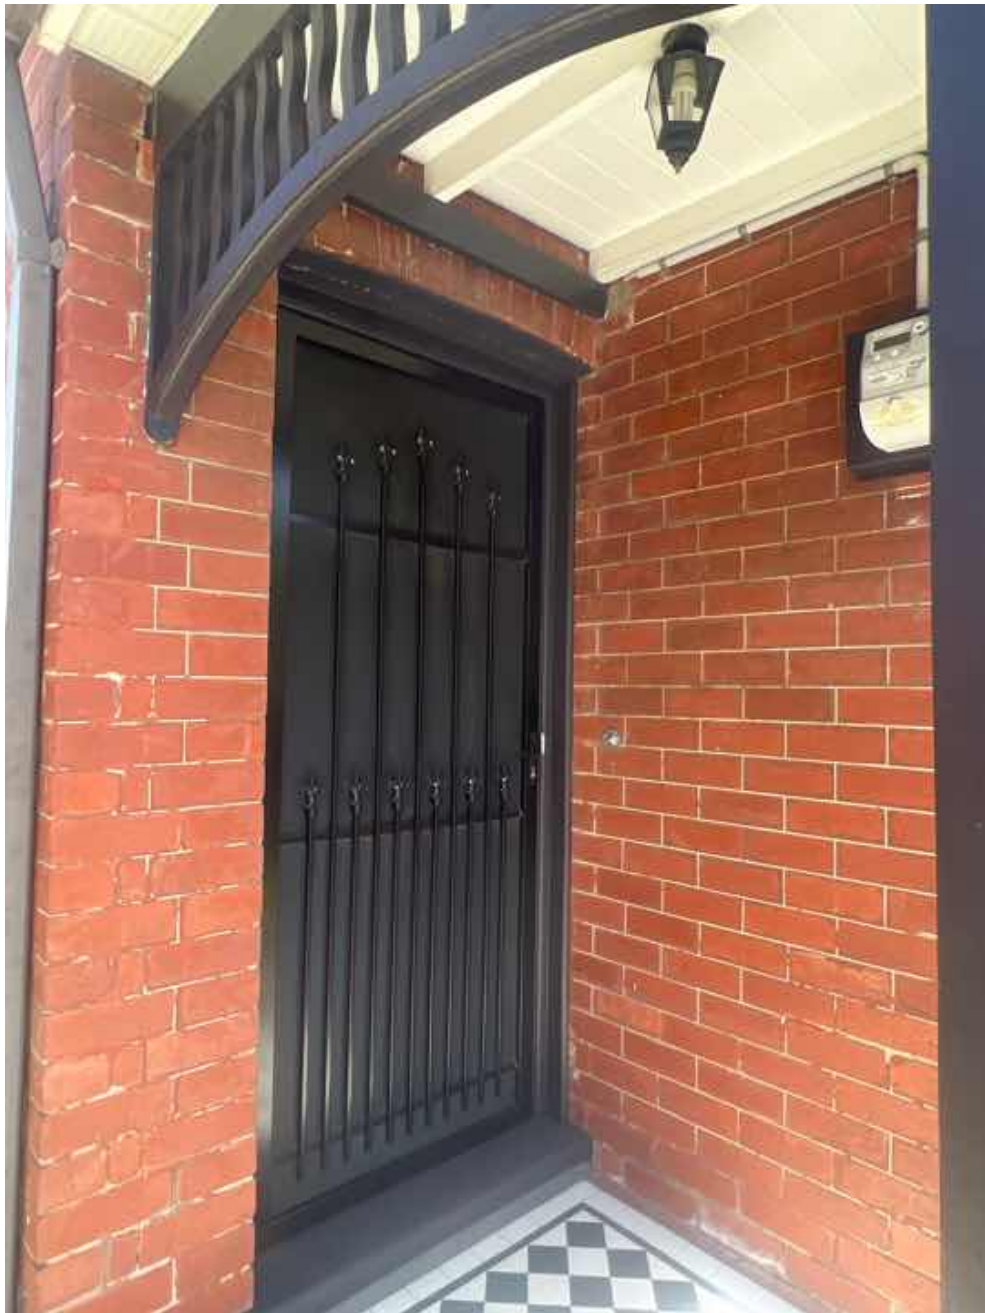
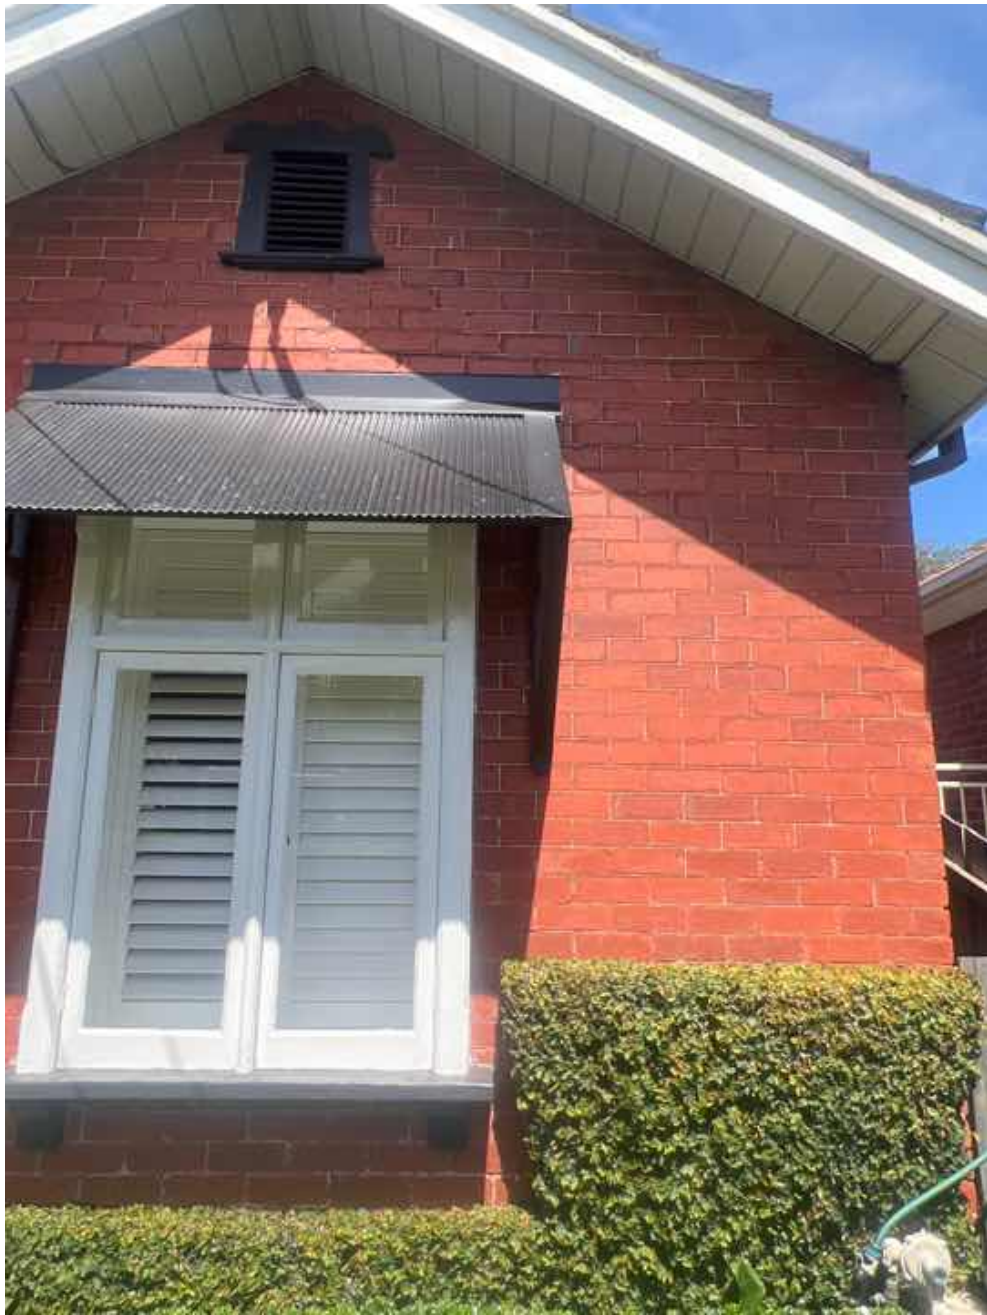
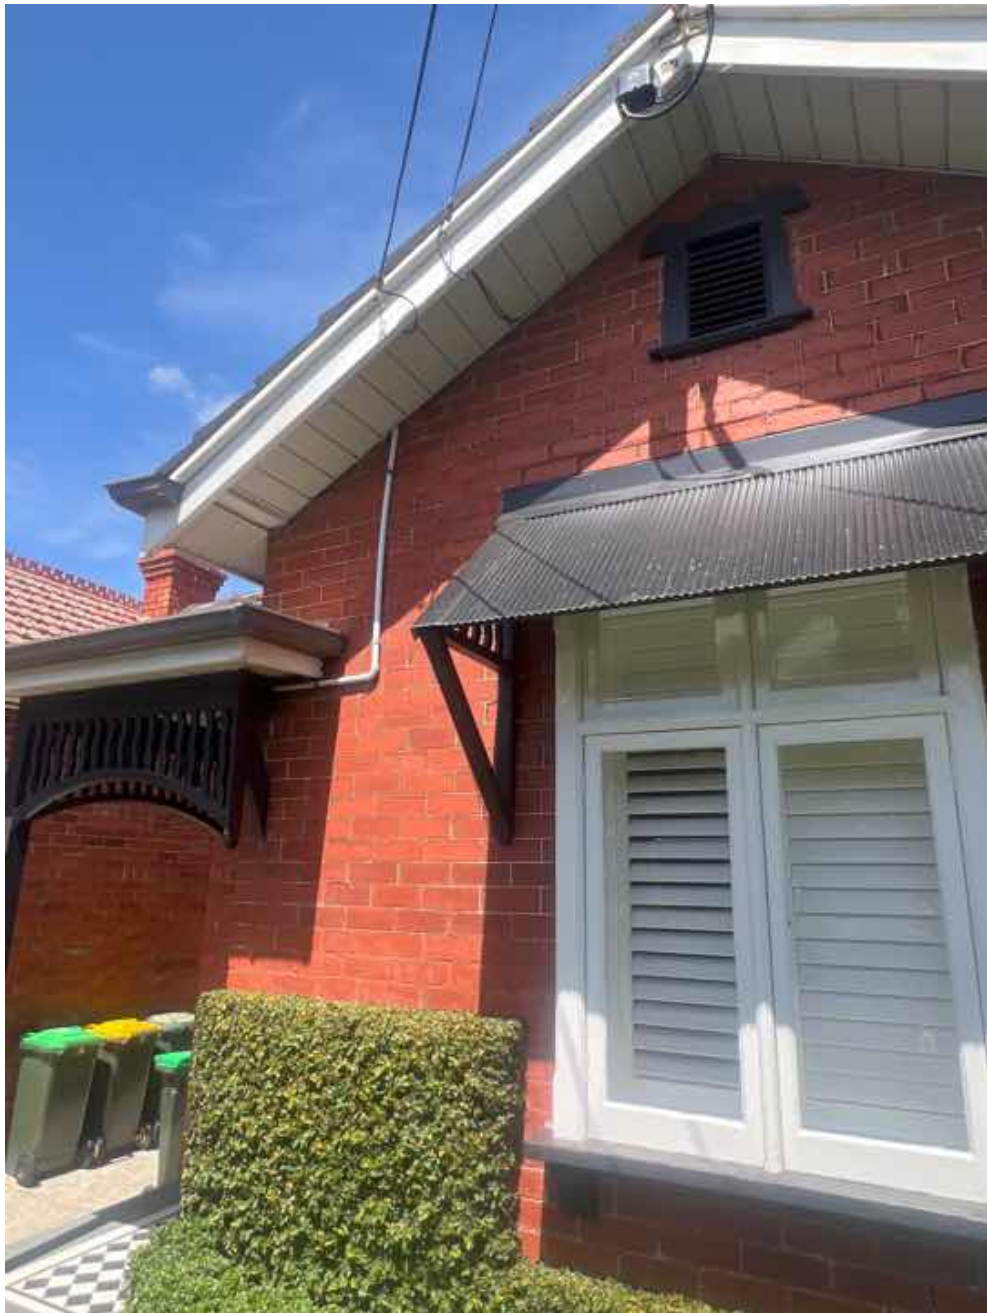
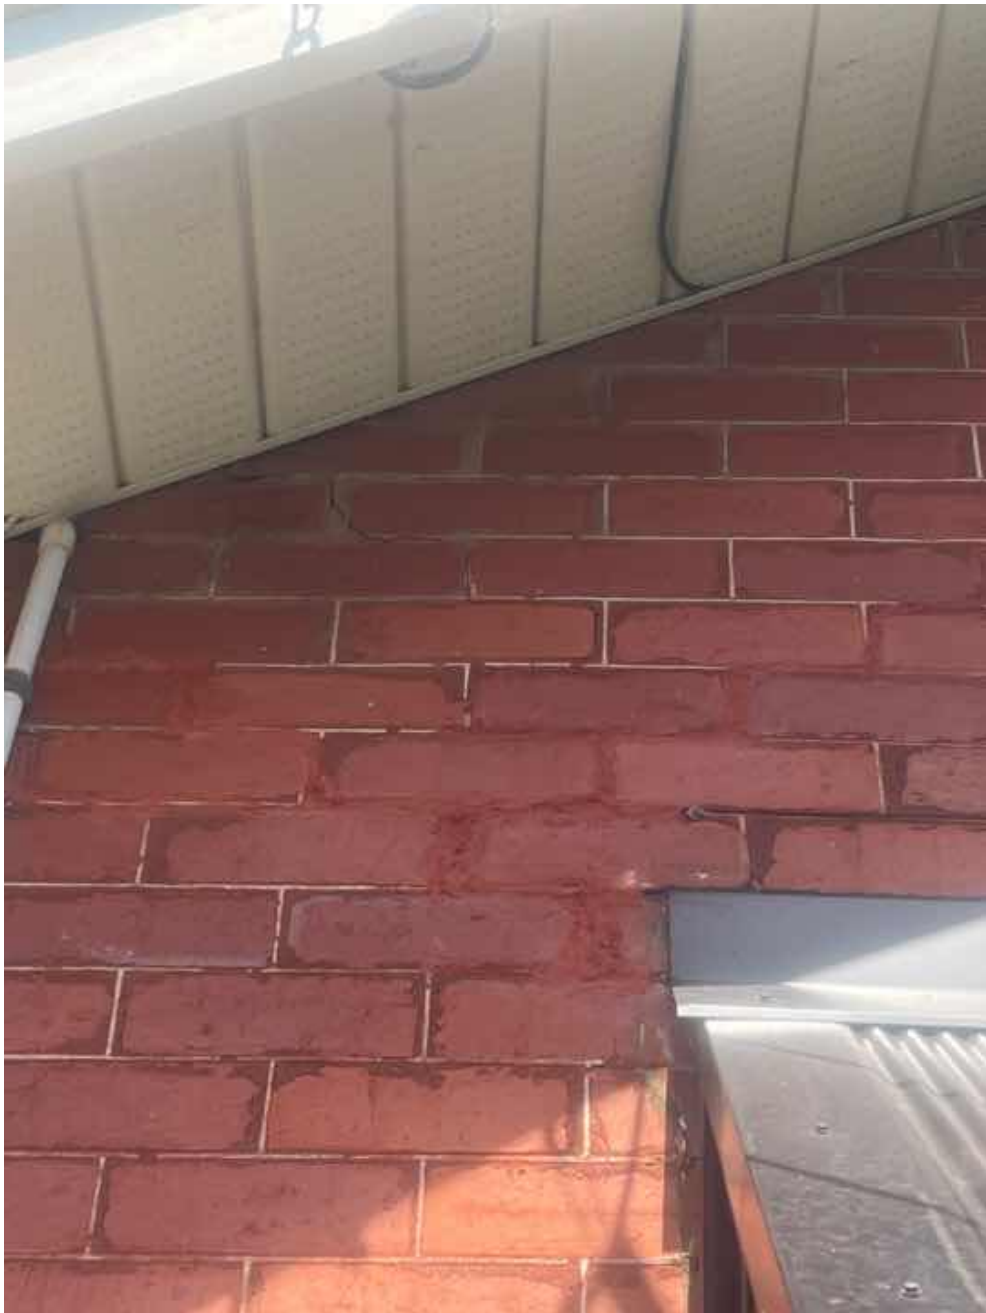
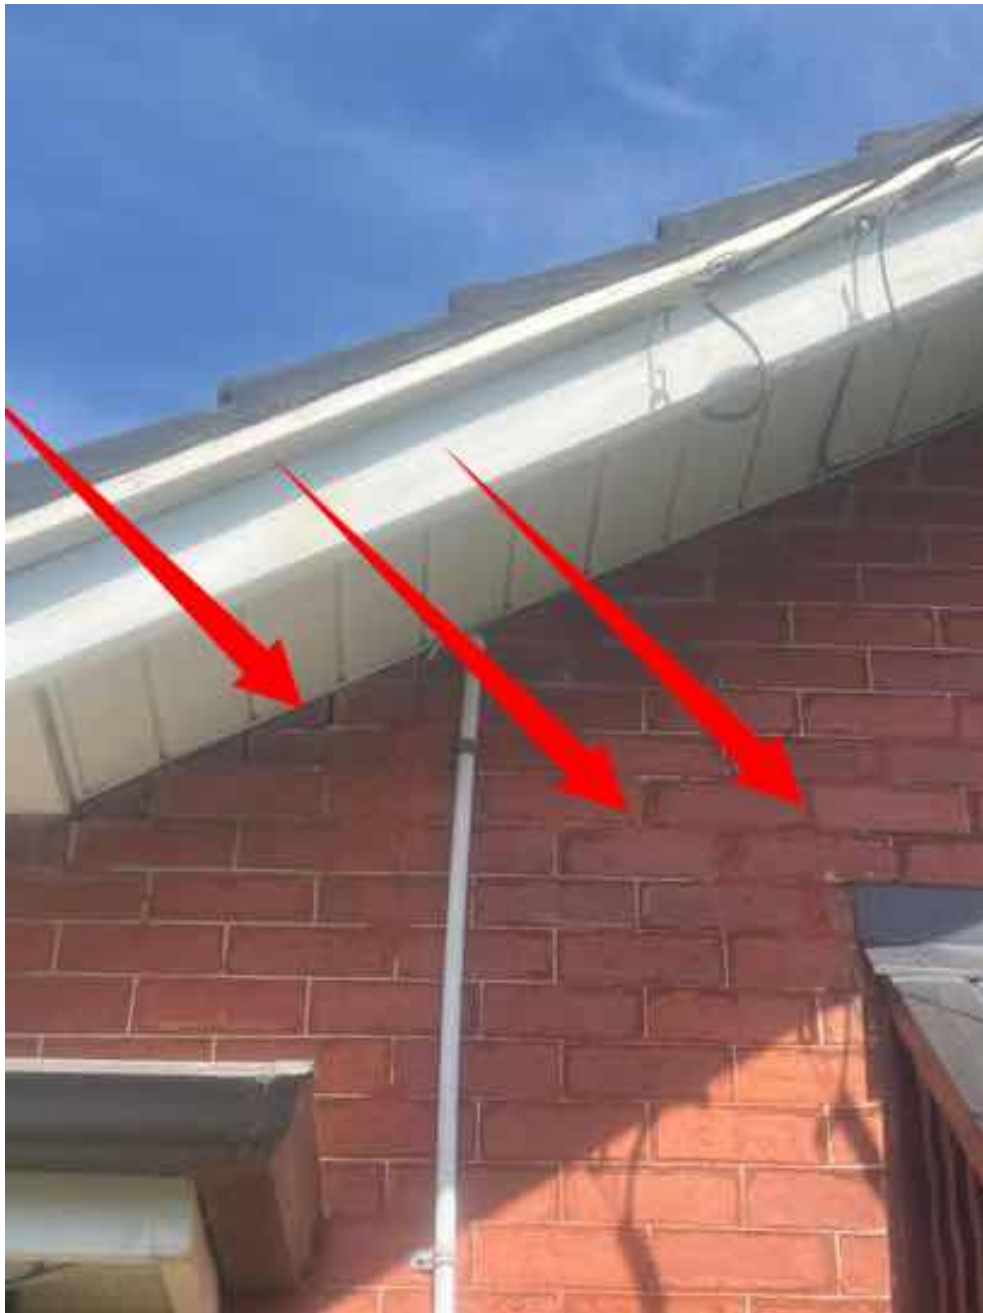
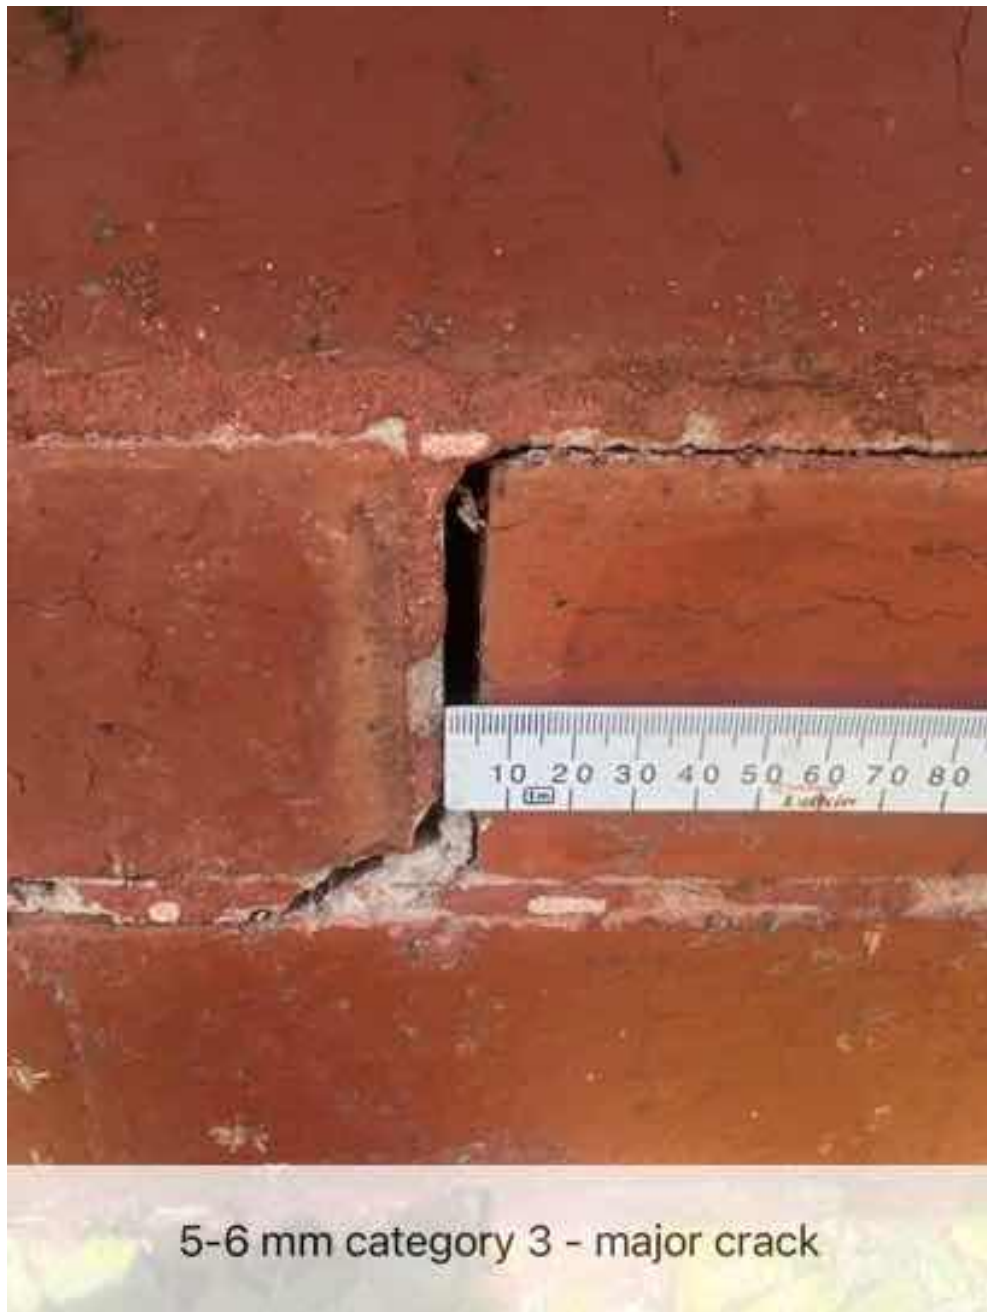
Brick fretting to brickwork observed. Overtime the salts in the uptake of moisture breaks the bricks down to powder form. Contact a qualified bricklayer for repairs.

Cracks noted (Damage Category 3 to 4)

Possible causes may be foundation movement. Support structure deflection. Thermal movement and moisture uptake or loss, failure under external loads. In the inspectors opinion these cracks require further assessment. A structural engineer should be consulted for further evaluation and advice.

Sections of the masonry brick wall/s have been repointed. This is where cracks have developed and mortar inserted into same. Monitoring advised and if further opening occurs engage a qualified structural engineer for advice and recommendations.

Rising damp detected. A qualified damp proof specialist should be engaged for advice and recommendations. Accurate diagnosis of the cause and extent of the damp problem is very important. It is strongly advised that you have this issue assessed prior to purchasing the dwelling as can be quite costly if a damp proof course has to be reinstated.

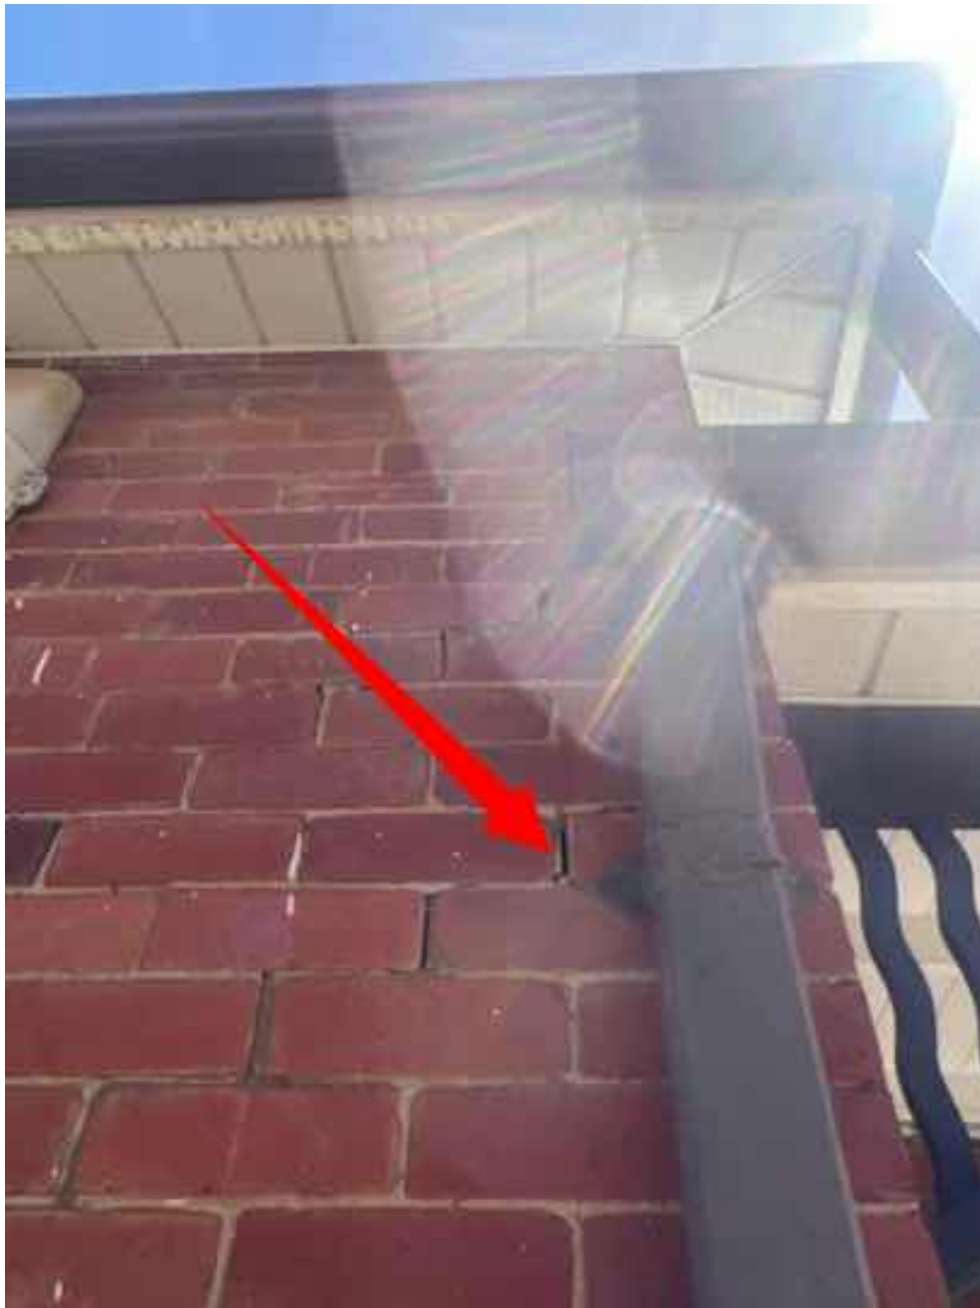
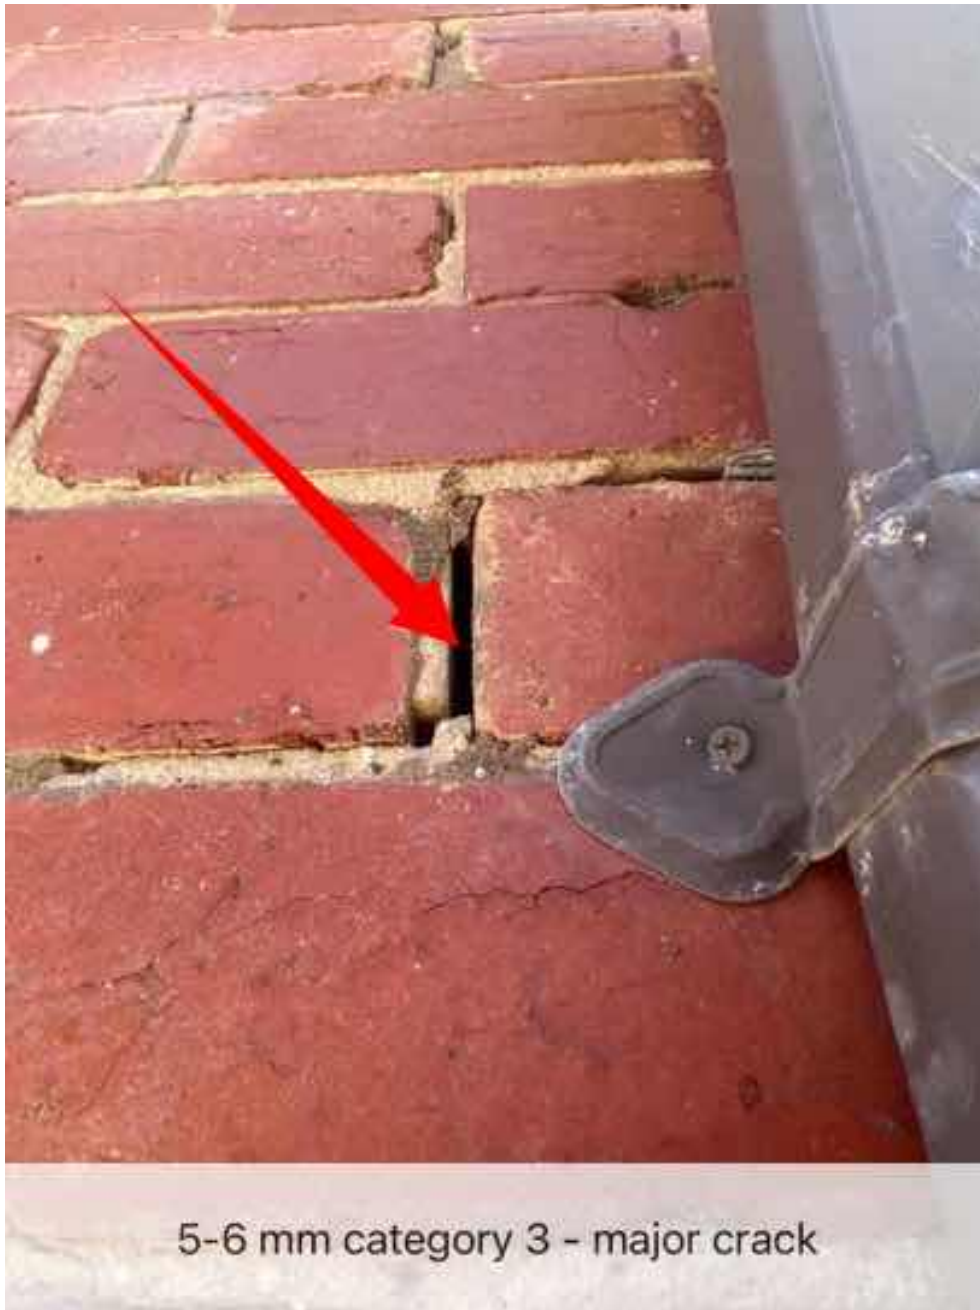
Cracks noted (Damage Category 3 to 4)

Possible causes may be foundation movement. Support structure deflection. Thermal movement and moisture uptake or loss, failure under external loads. In the inspectors opinion these cracks require further assessment. A structural engineer should be consulted for further evaluation and advice.

5-6 mm category 3 - major crack
