Sample Report

D.C Building Inspectors

Pest And Building Inspection

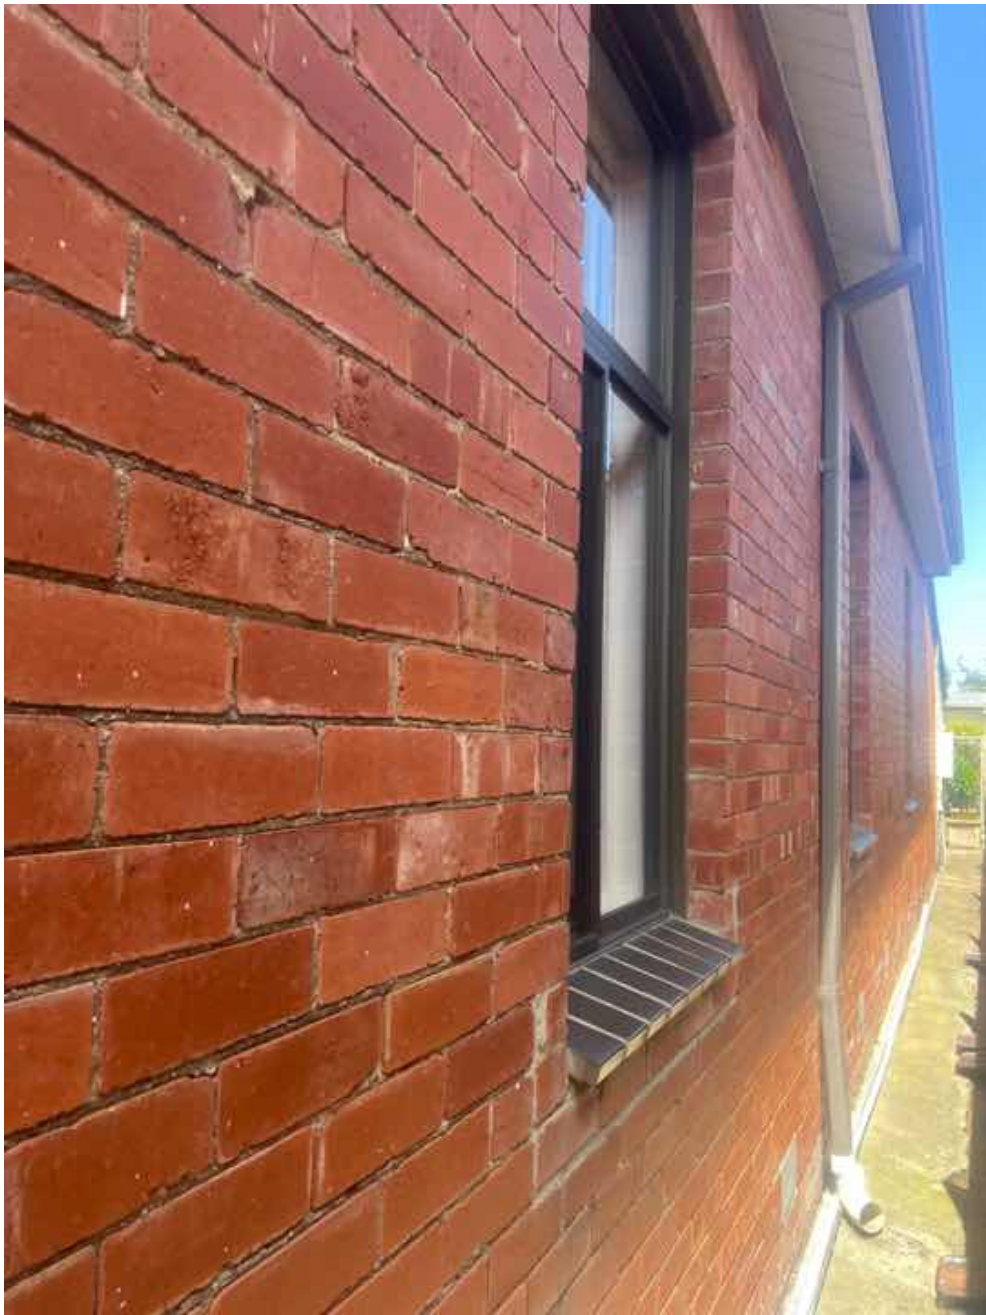
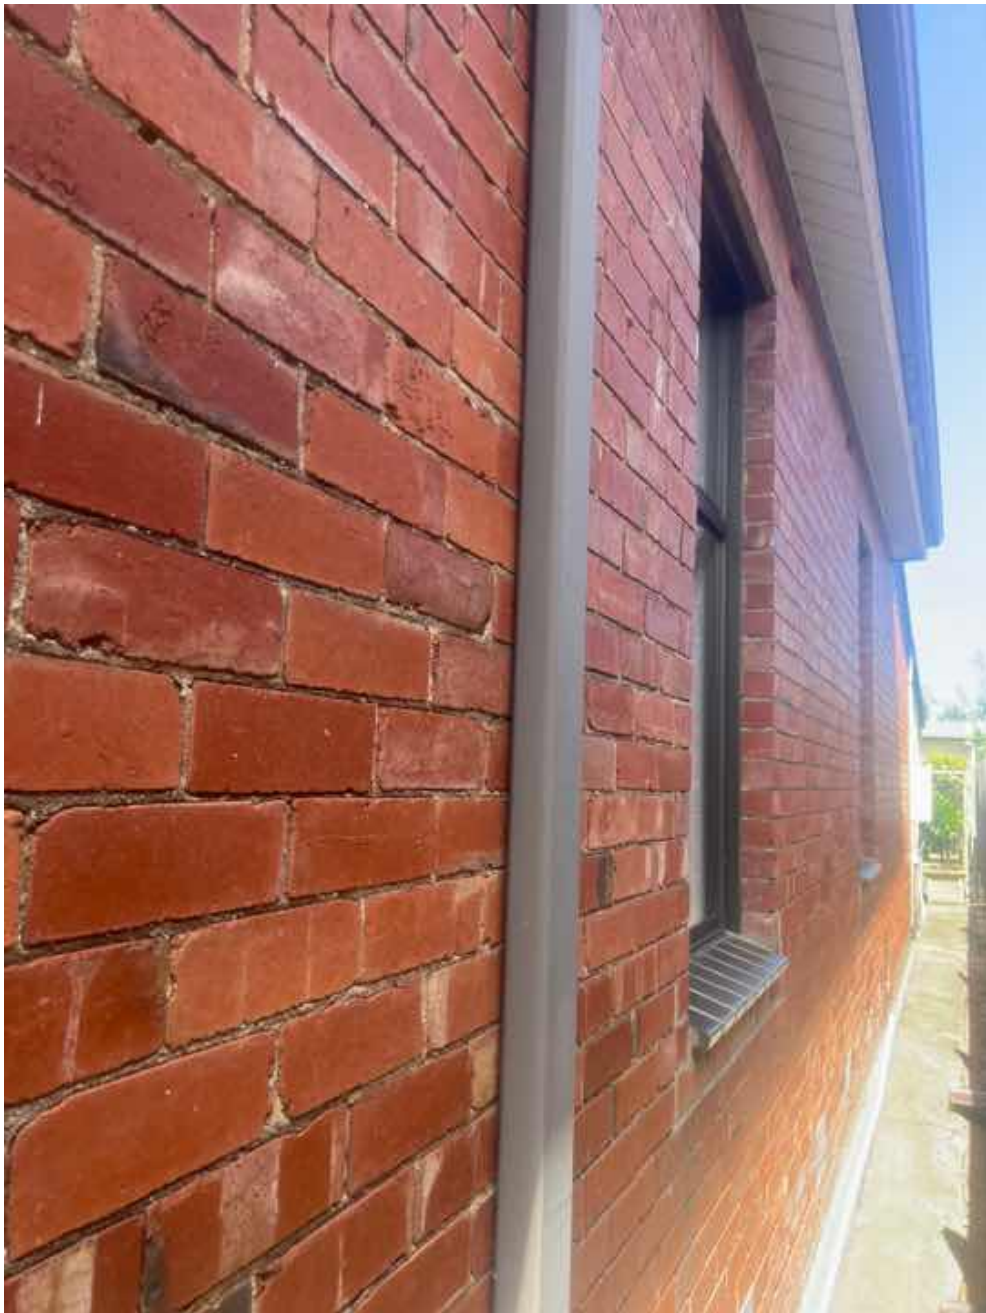
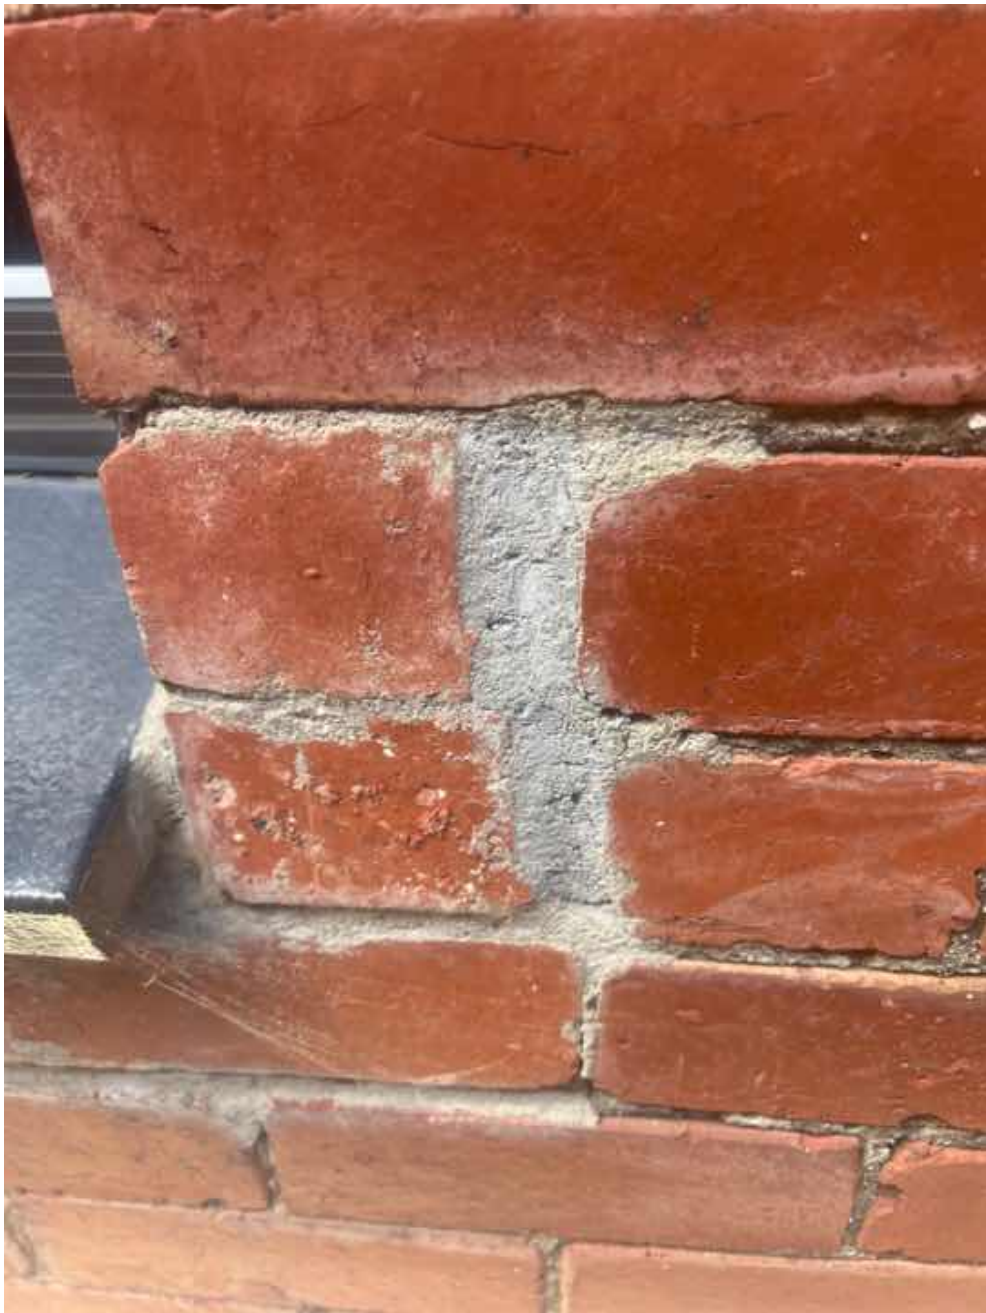
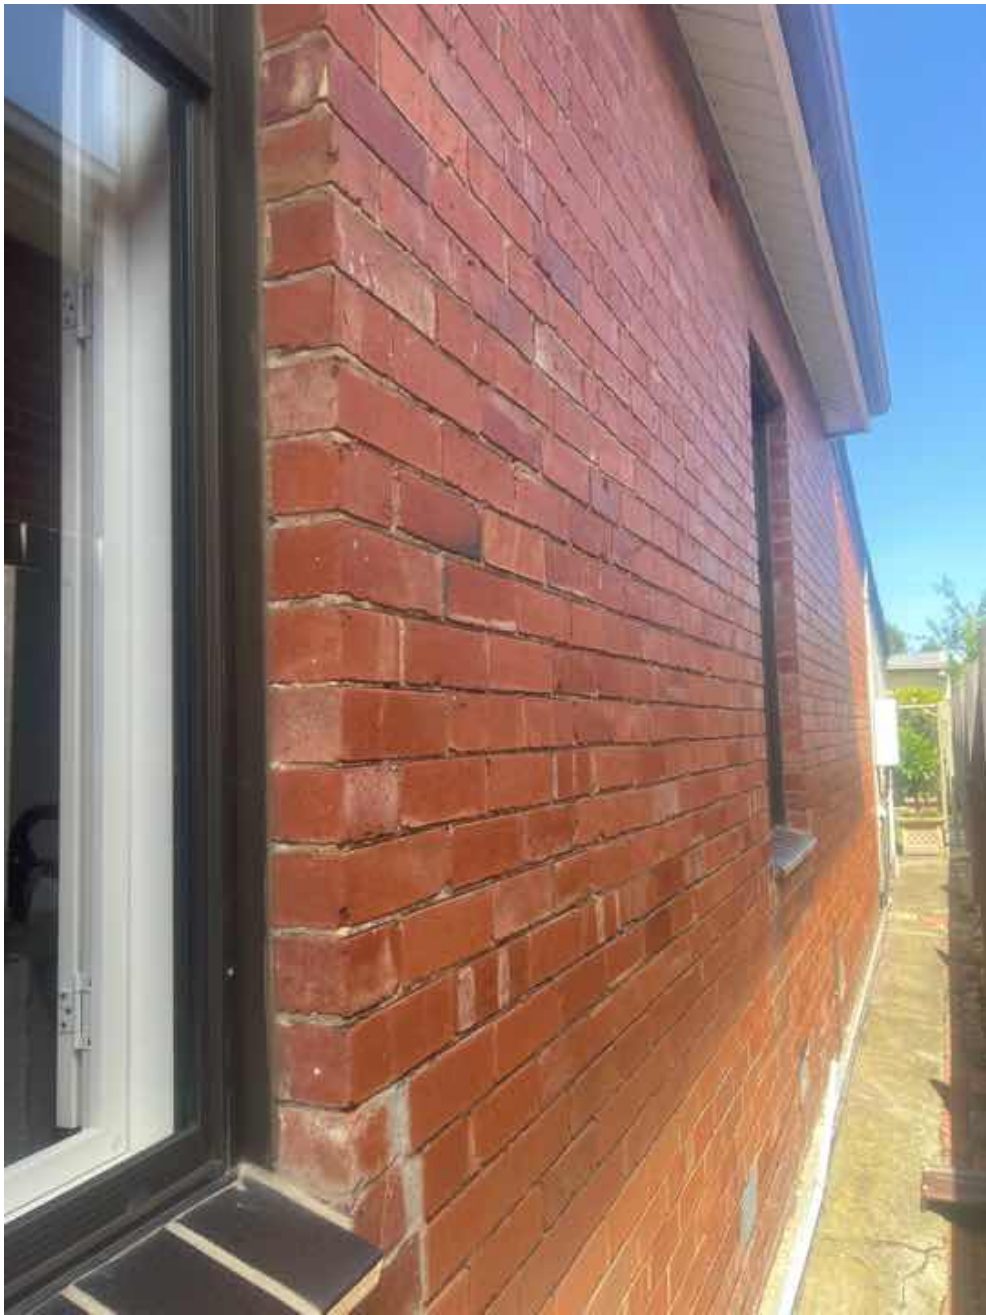
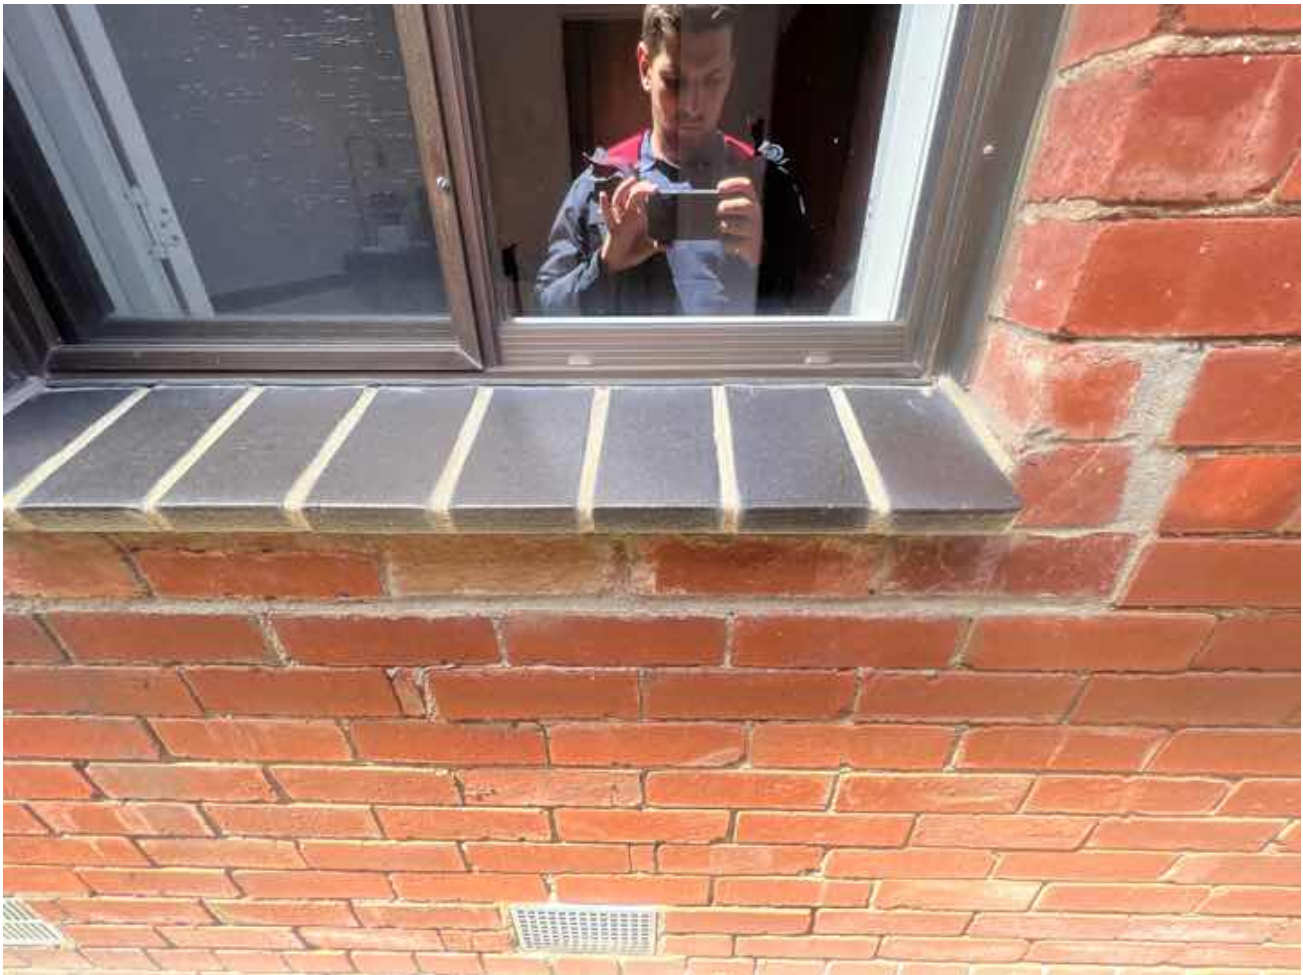
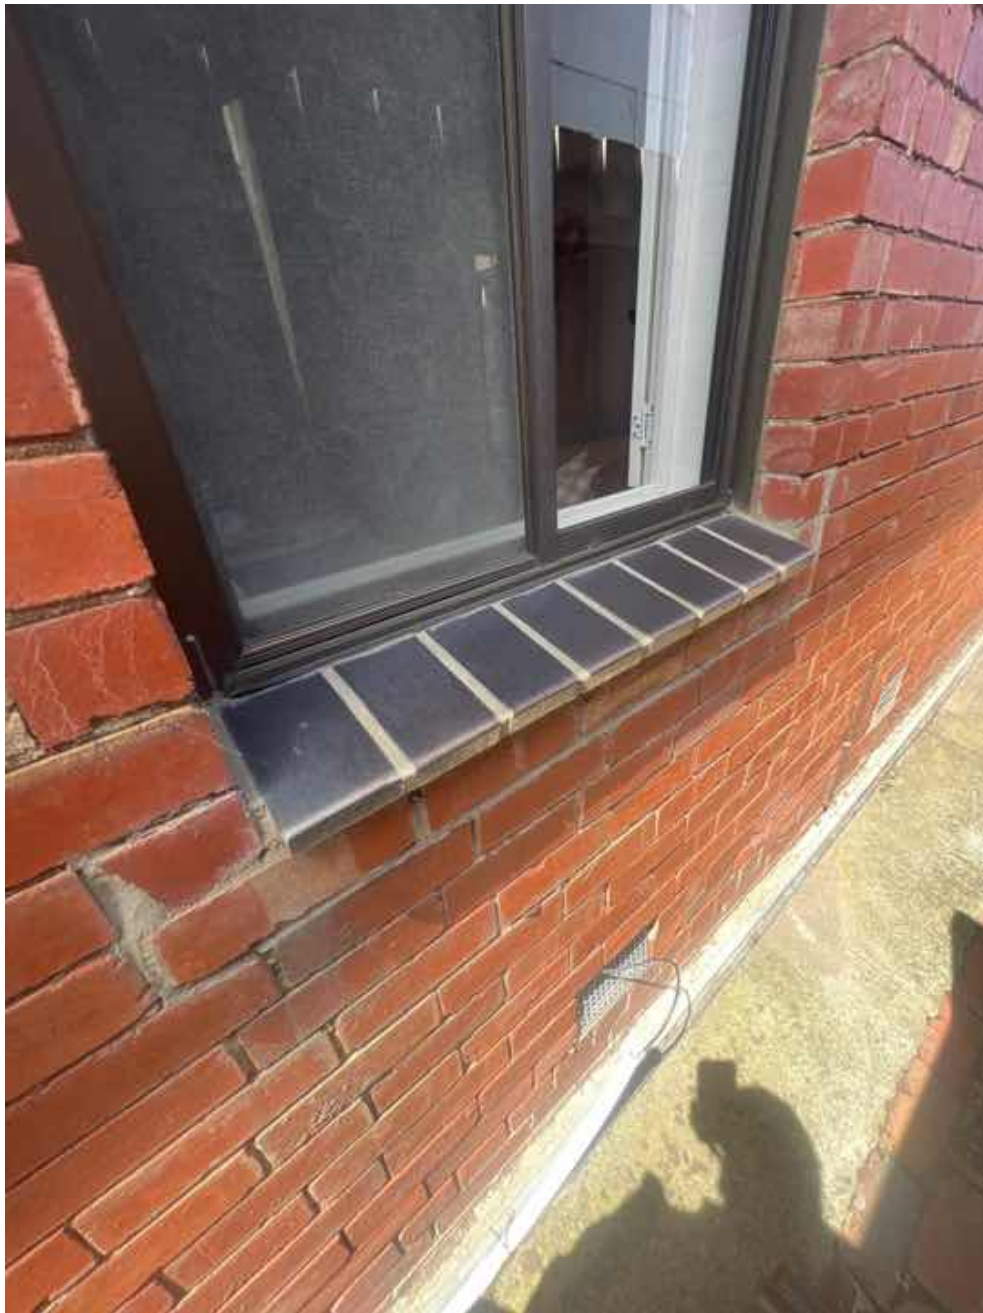
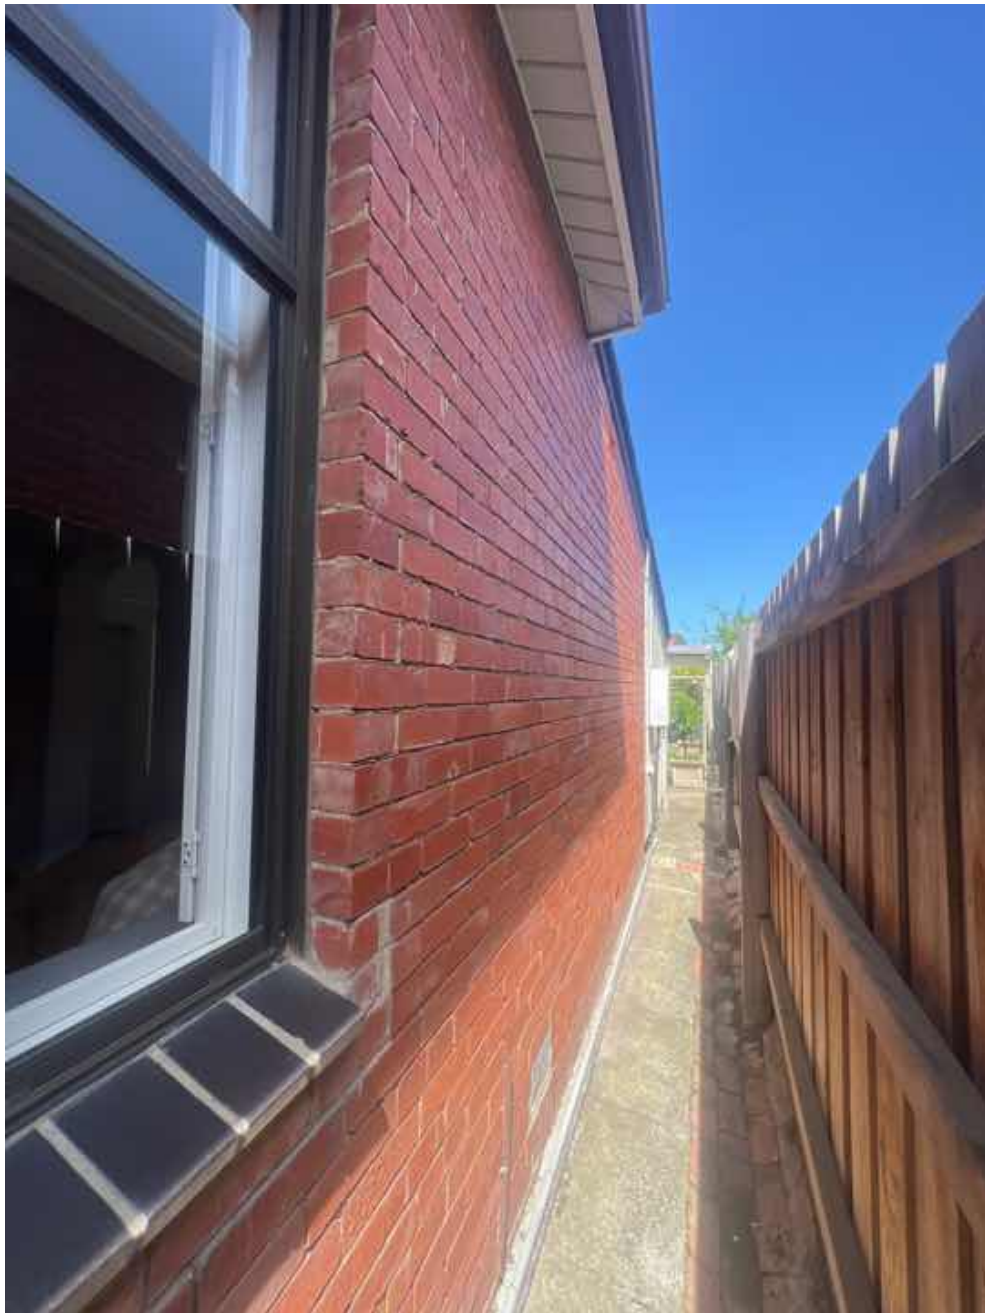
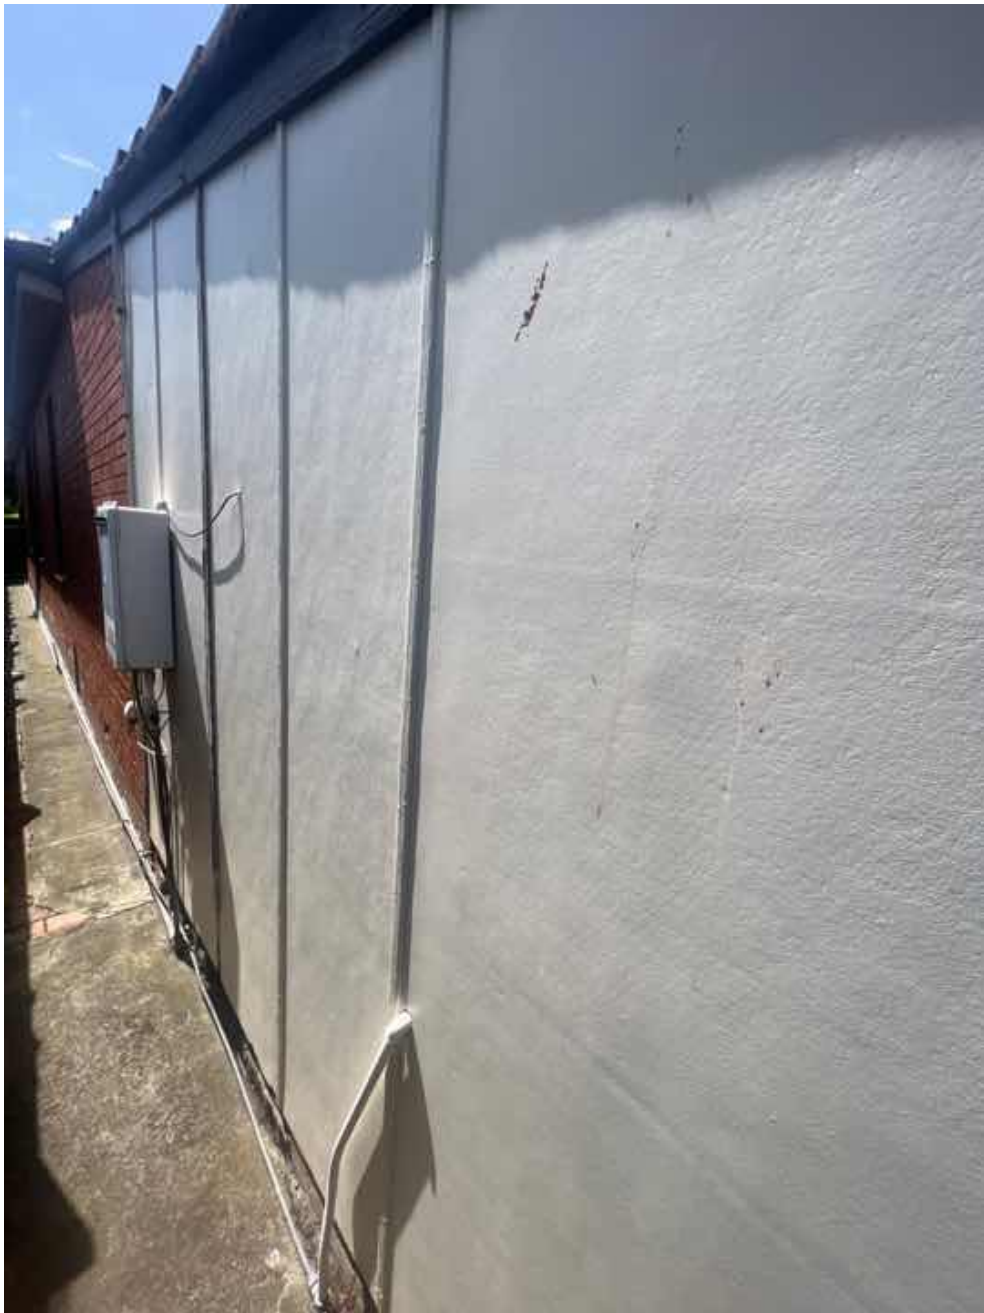
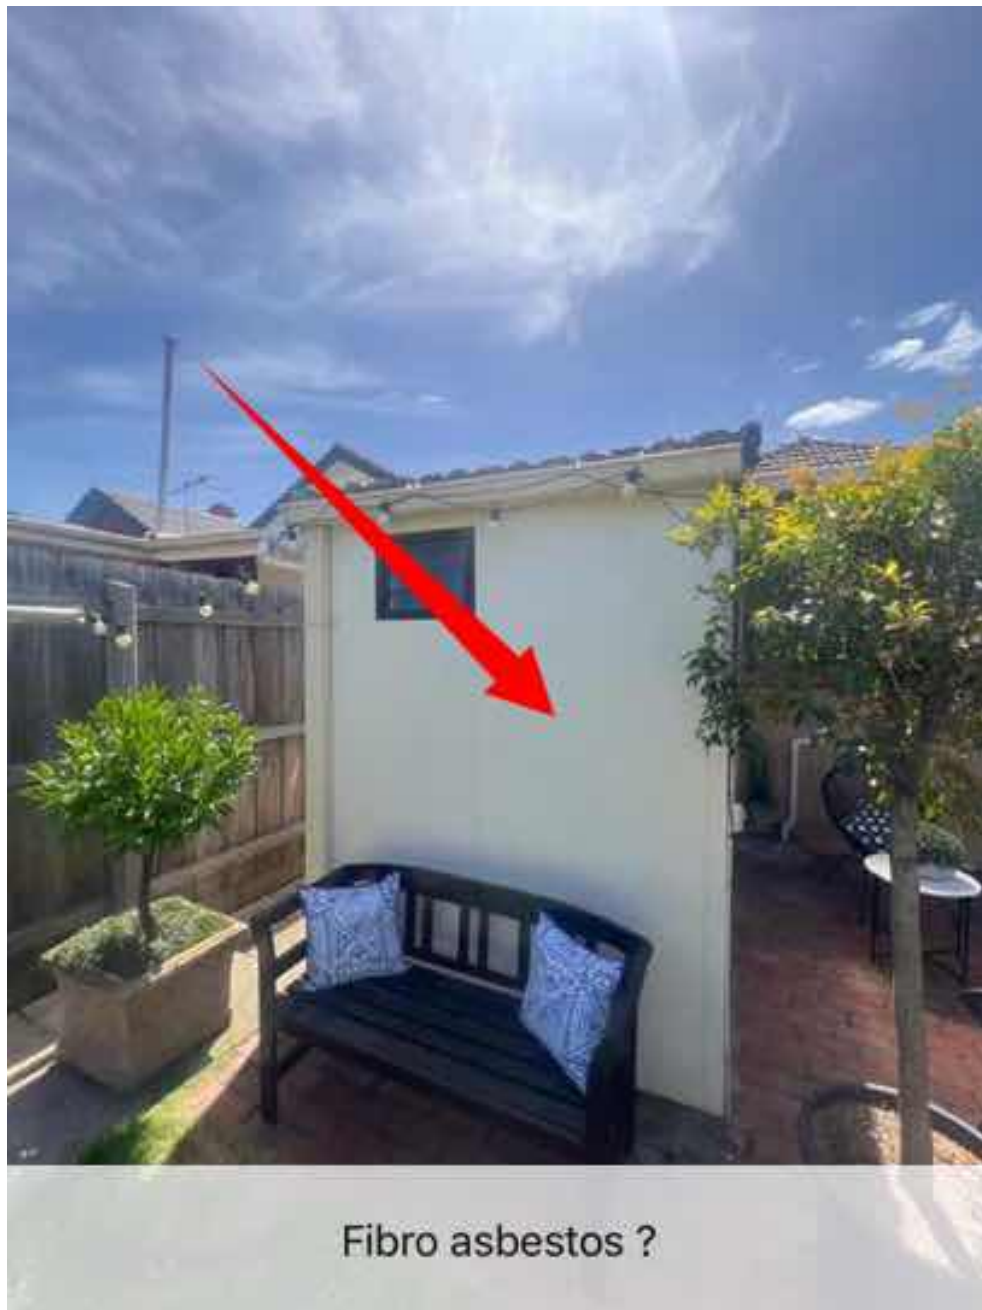
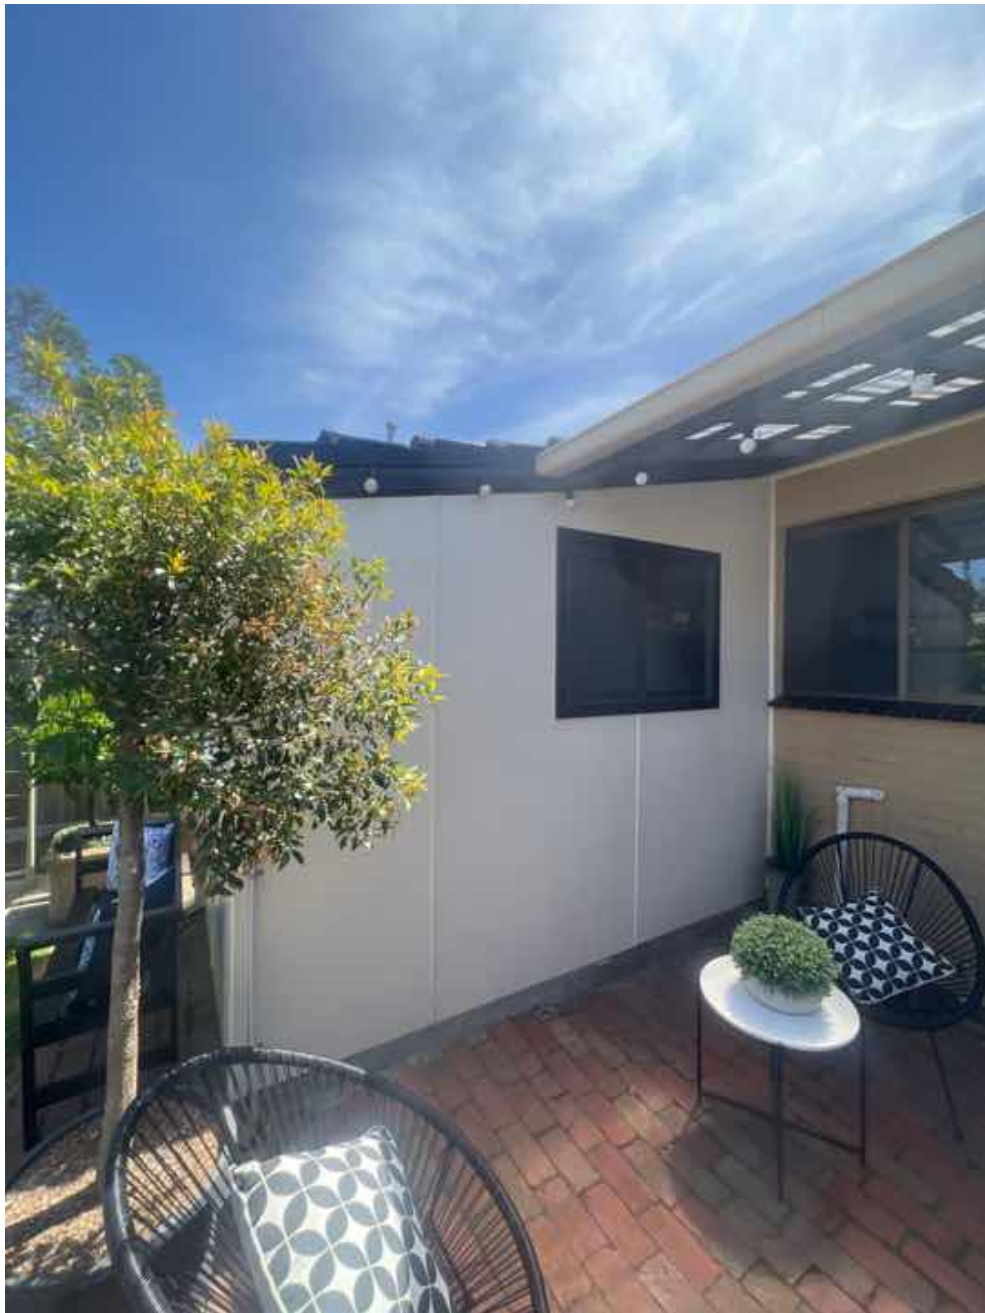
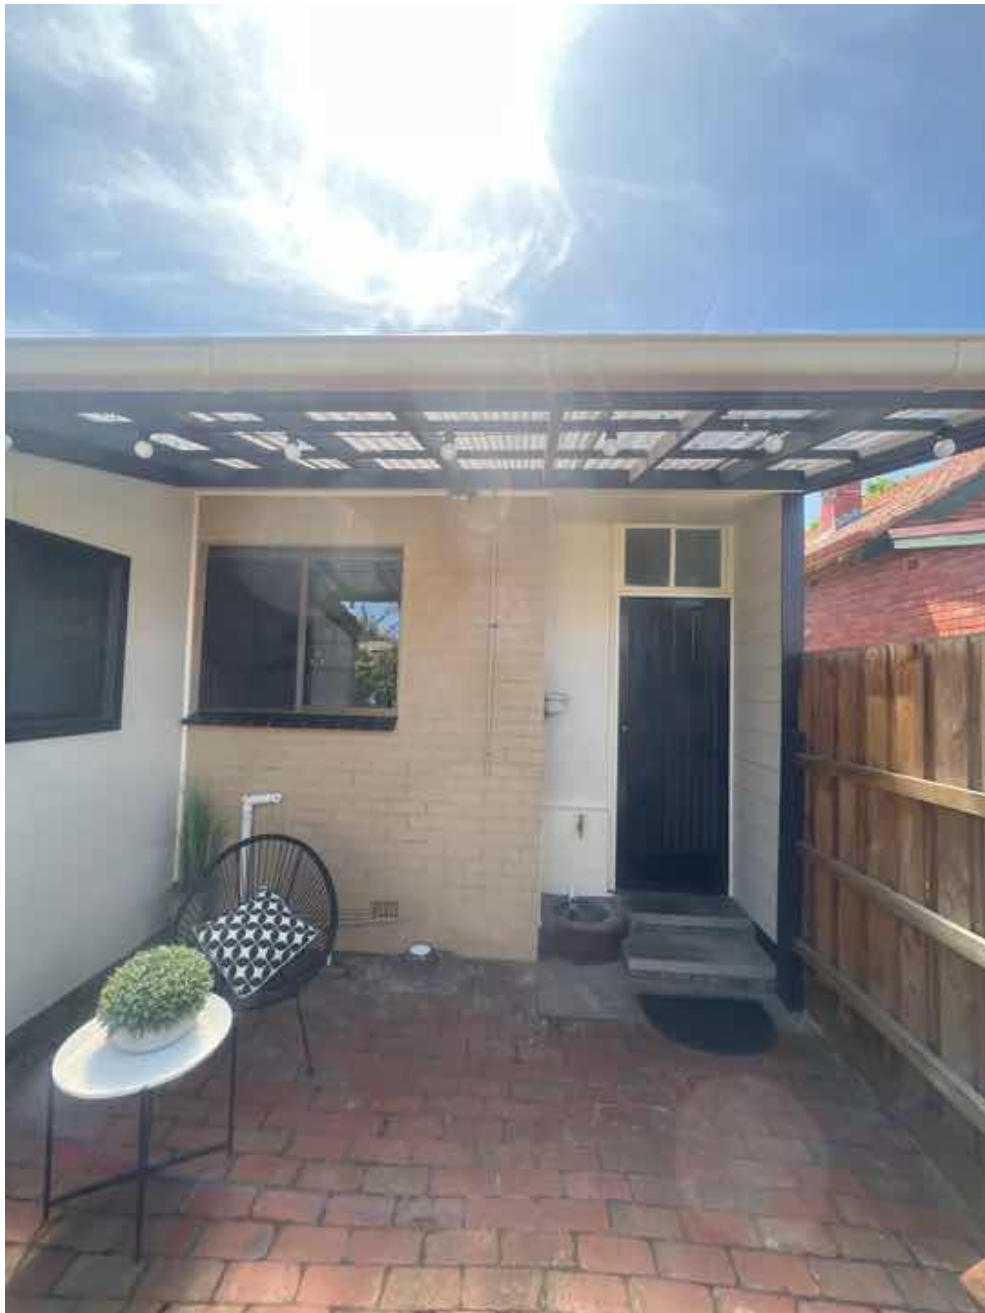
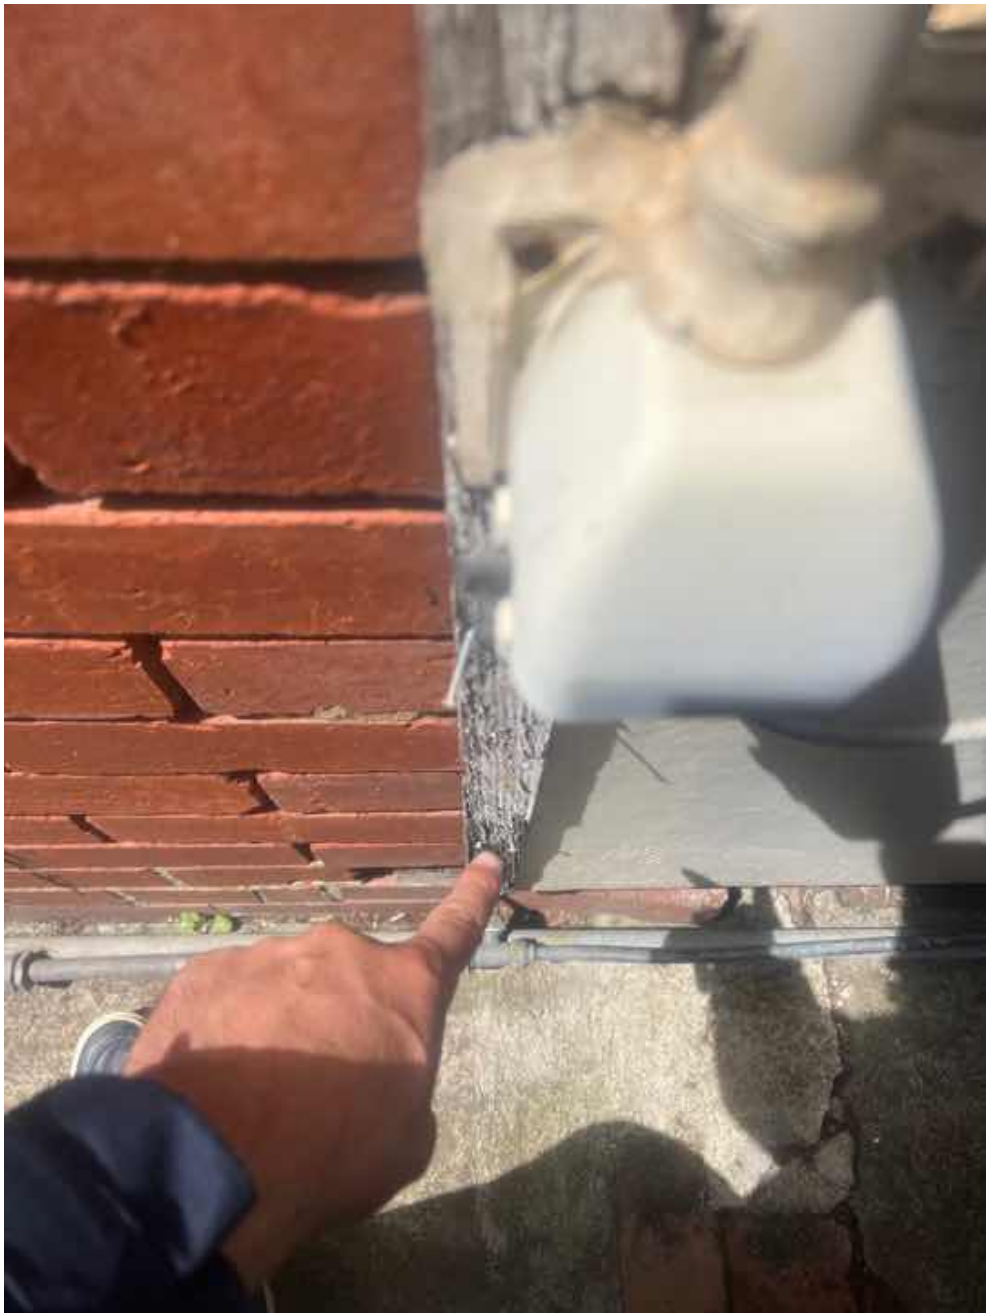
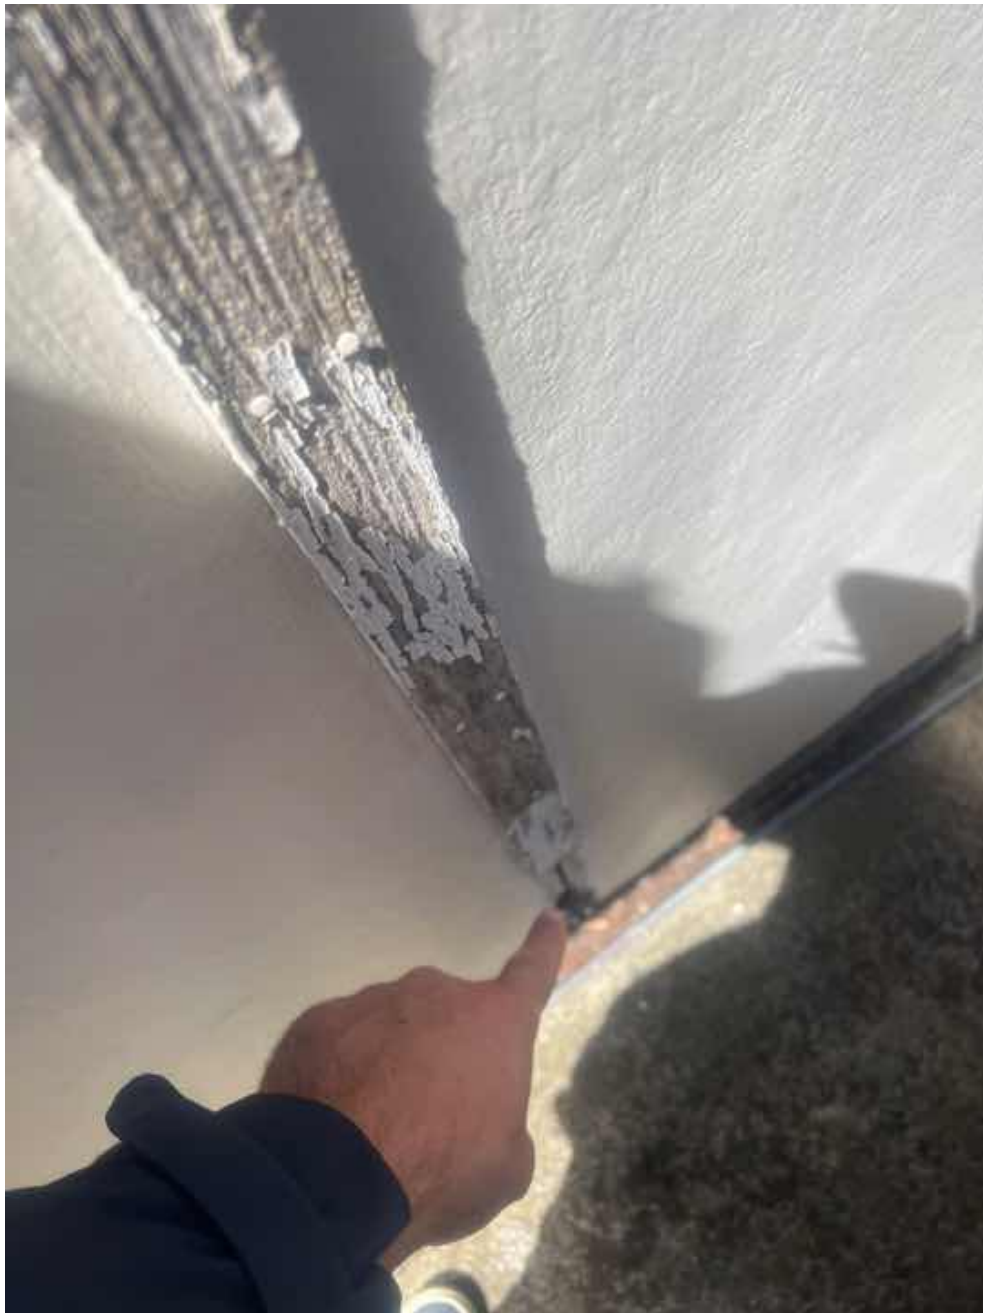
Mortar erosion between the brickwork is eroded. Contact a qualified bricklayer for repairs.

Minor decay was noted to the external wall lining. We recommend replacement of all affected timbers.

Minor cladding damage observed. This should be repaired so as to avoid moisture ingress and pests entry.

The walls are fibro and may contain Asbestos. Have an Asbestos inspection conducted prior to a decision to purchase.
