Sample Report

D.C Building Inspectors

Pest And Building Inspection

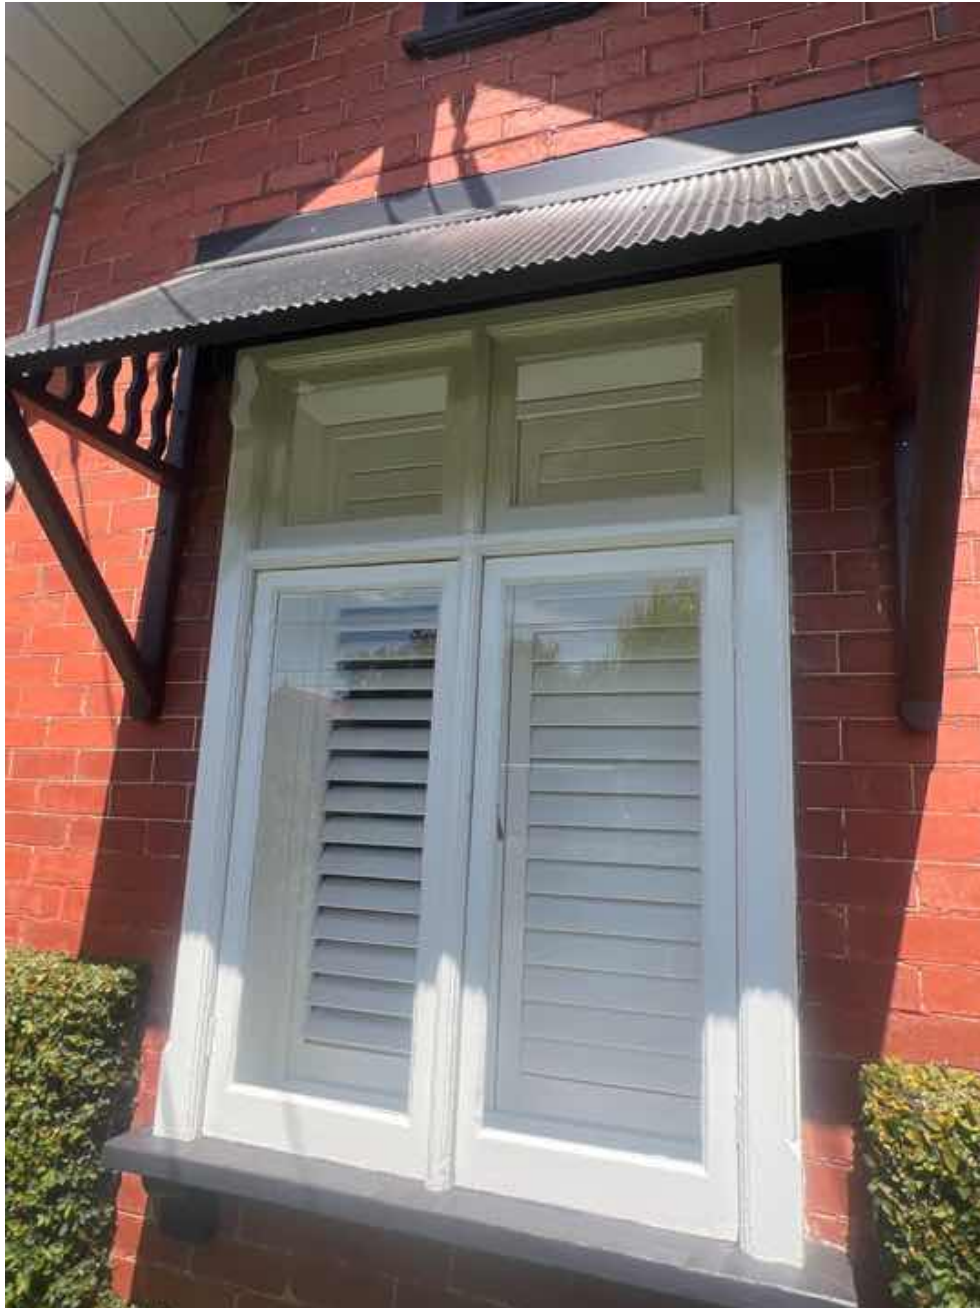
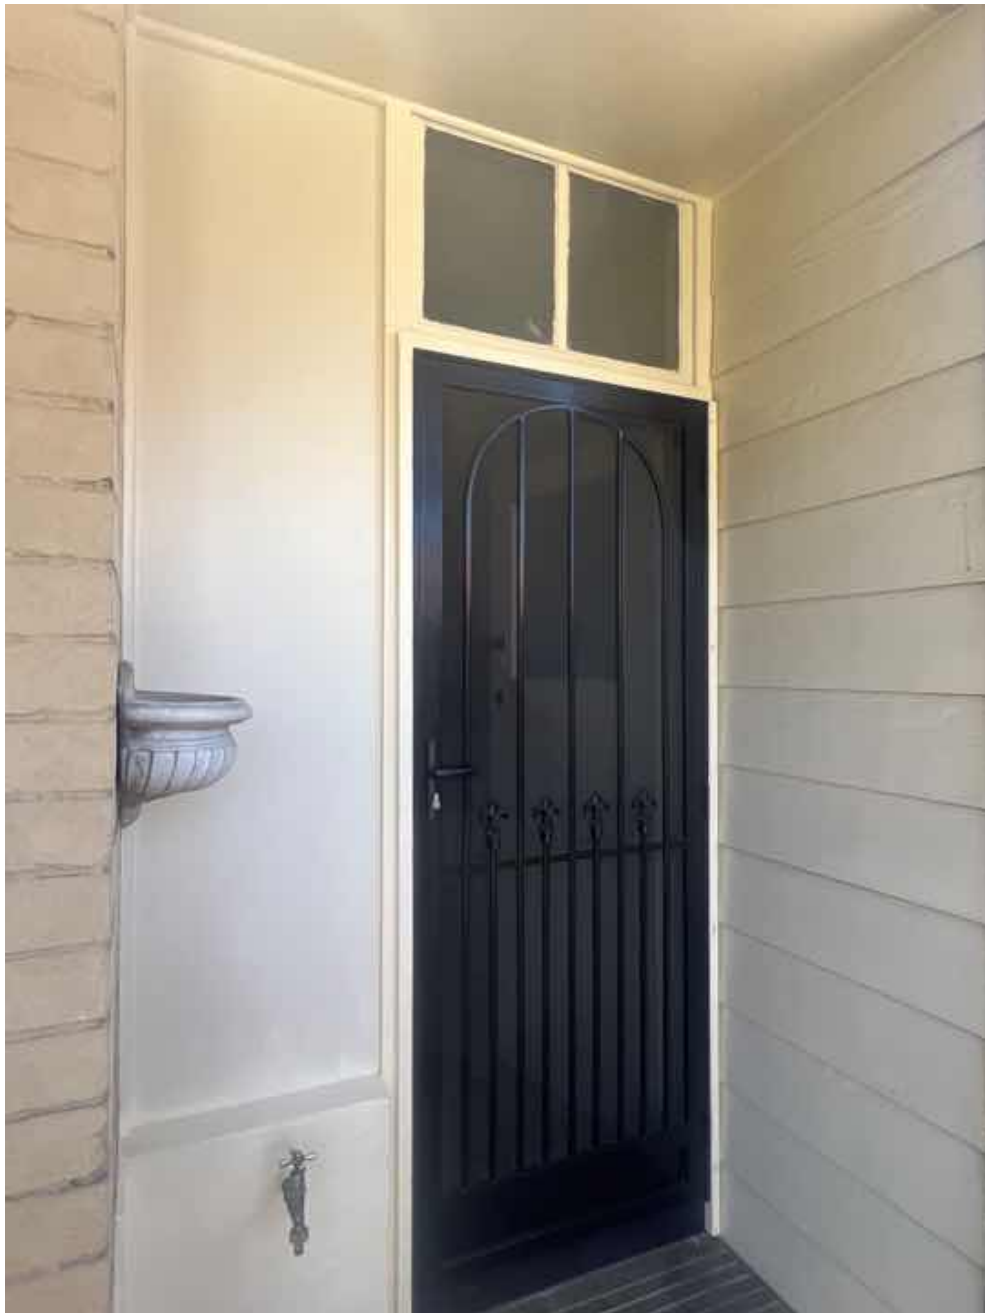
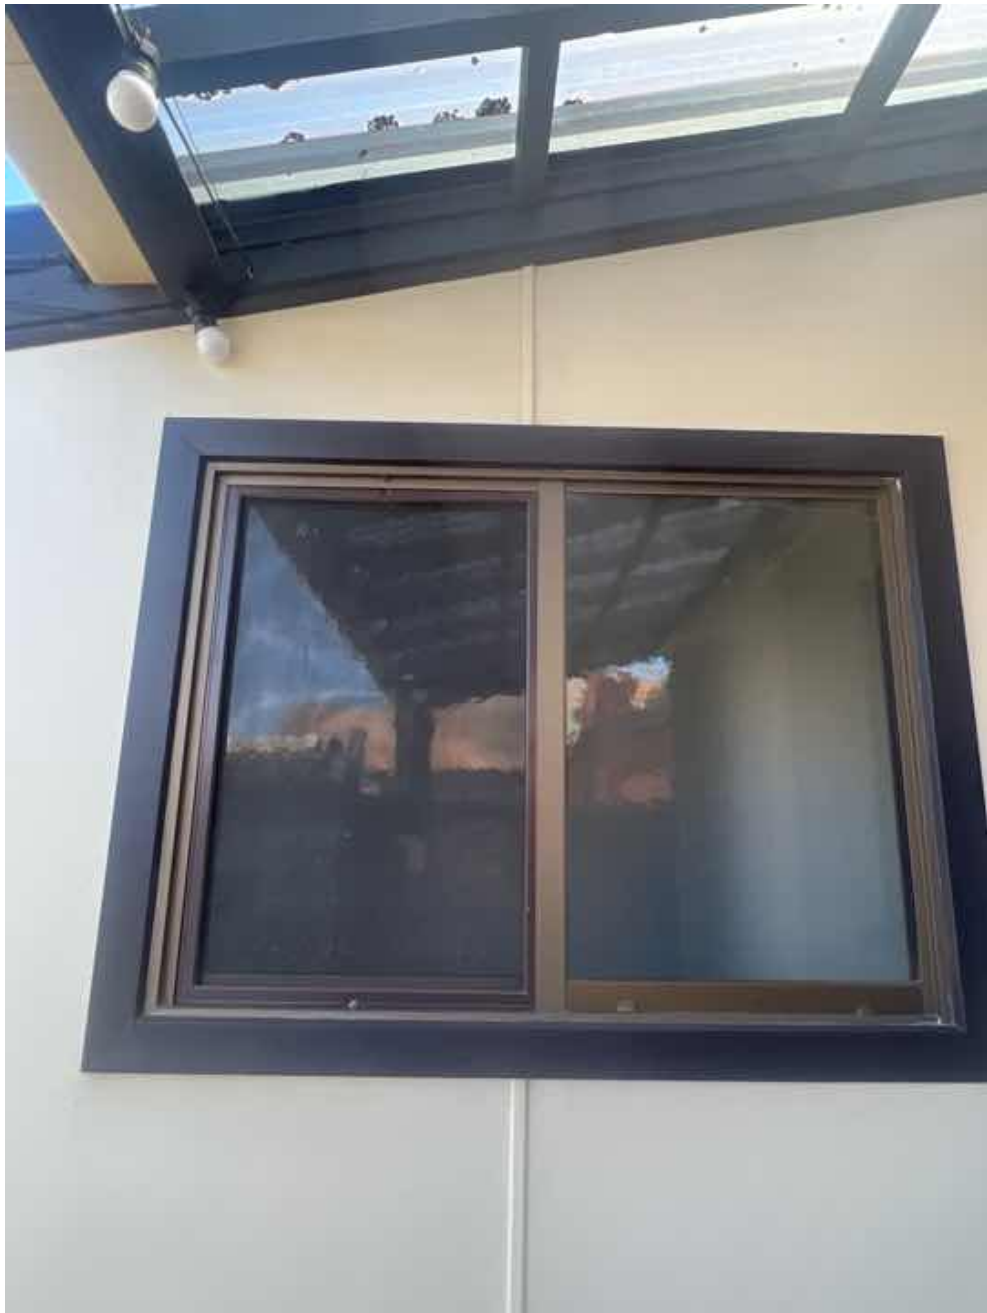
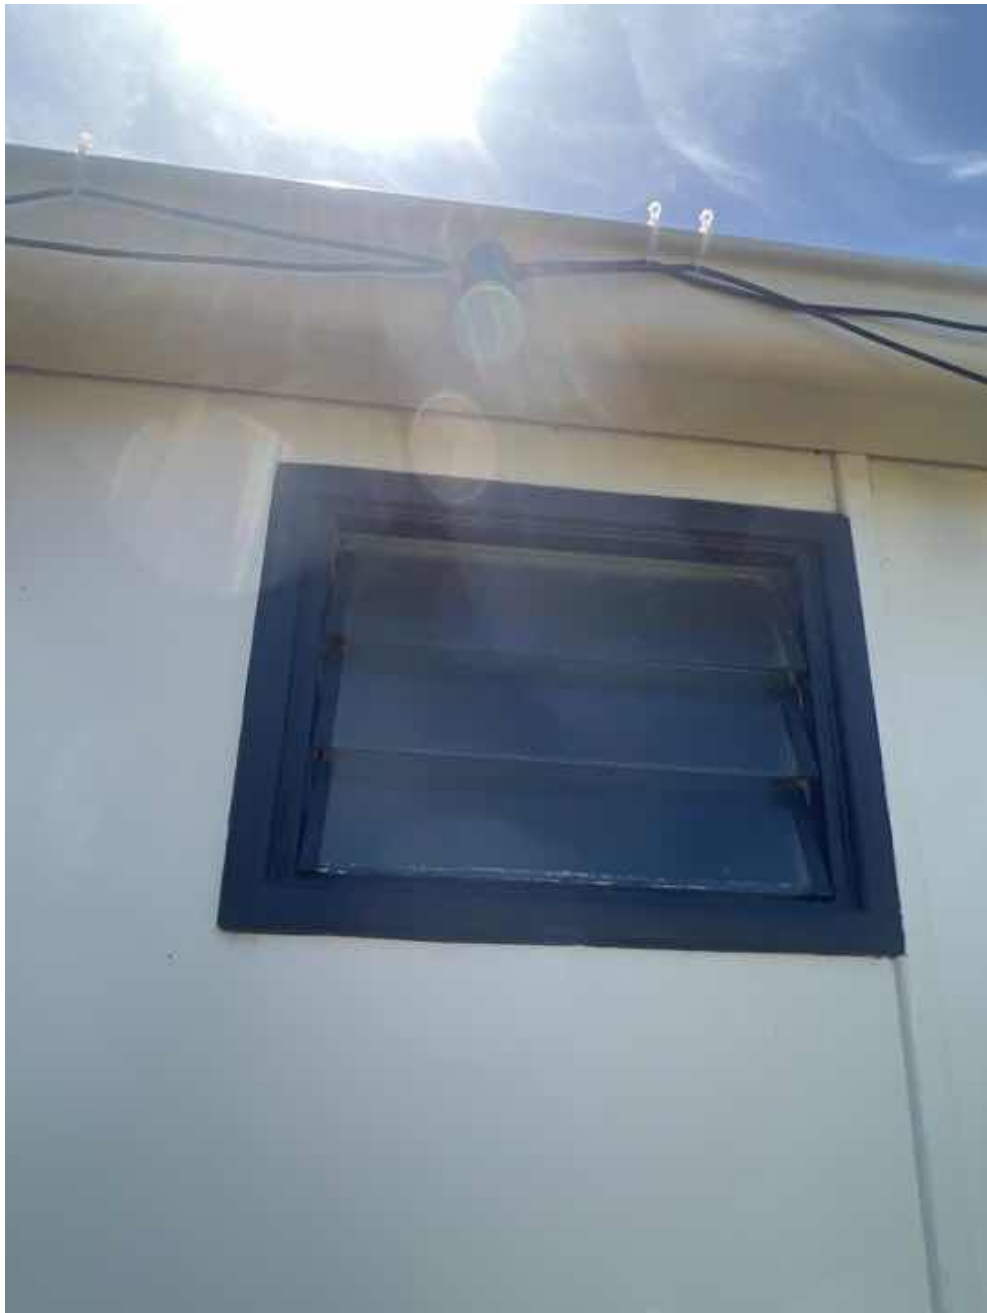
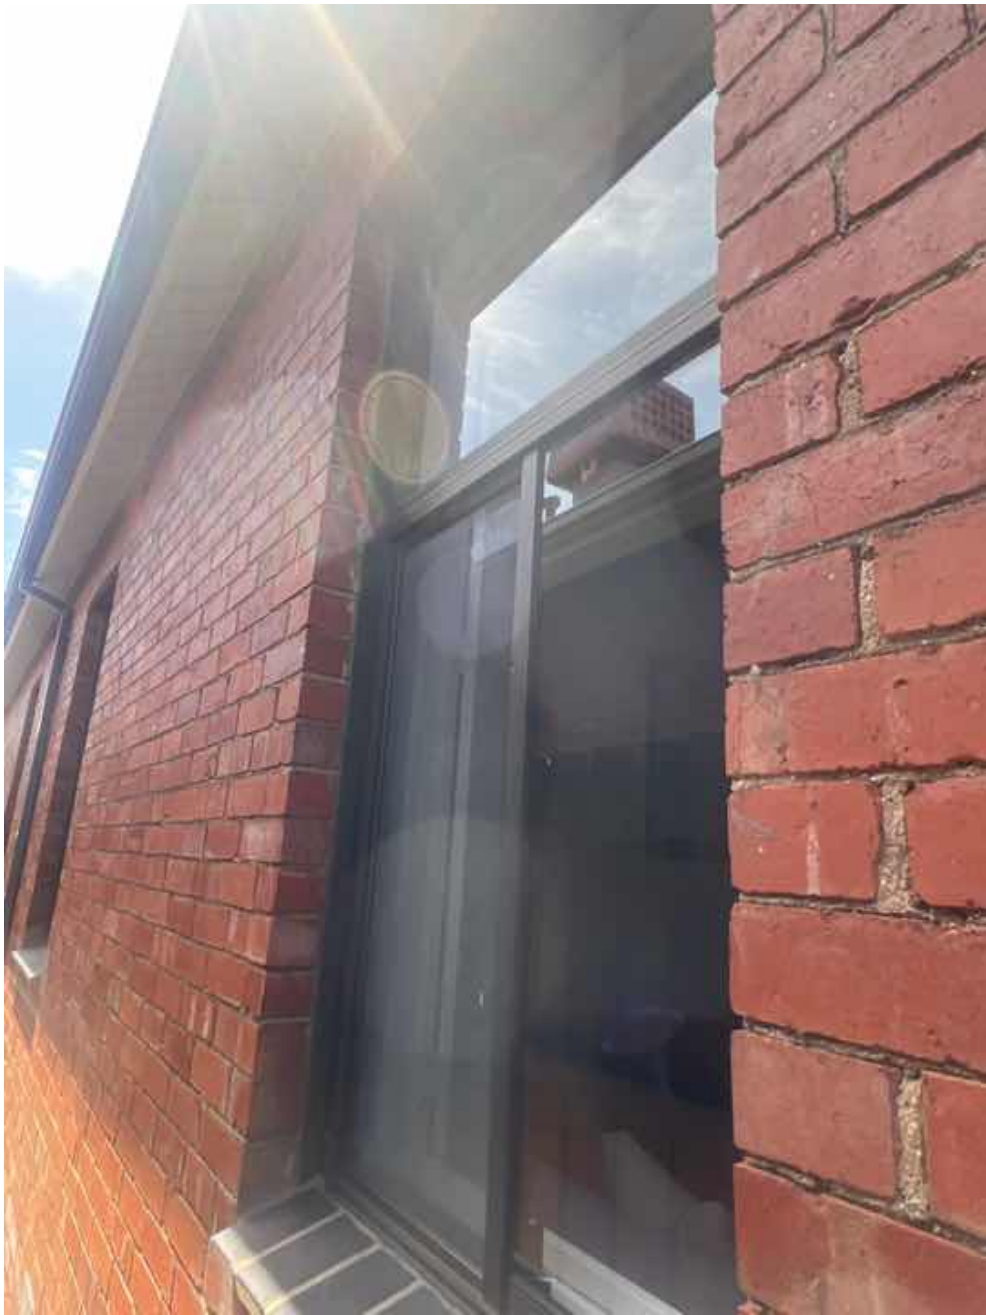
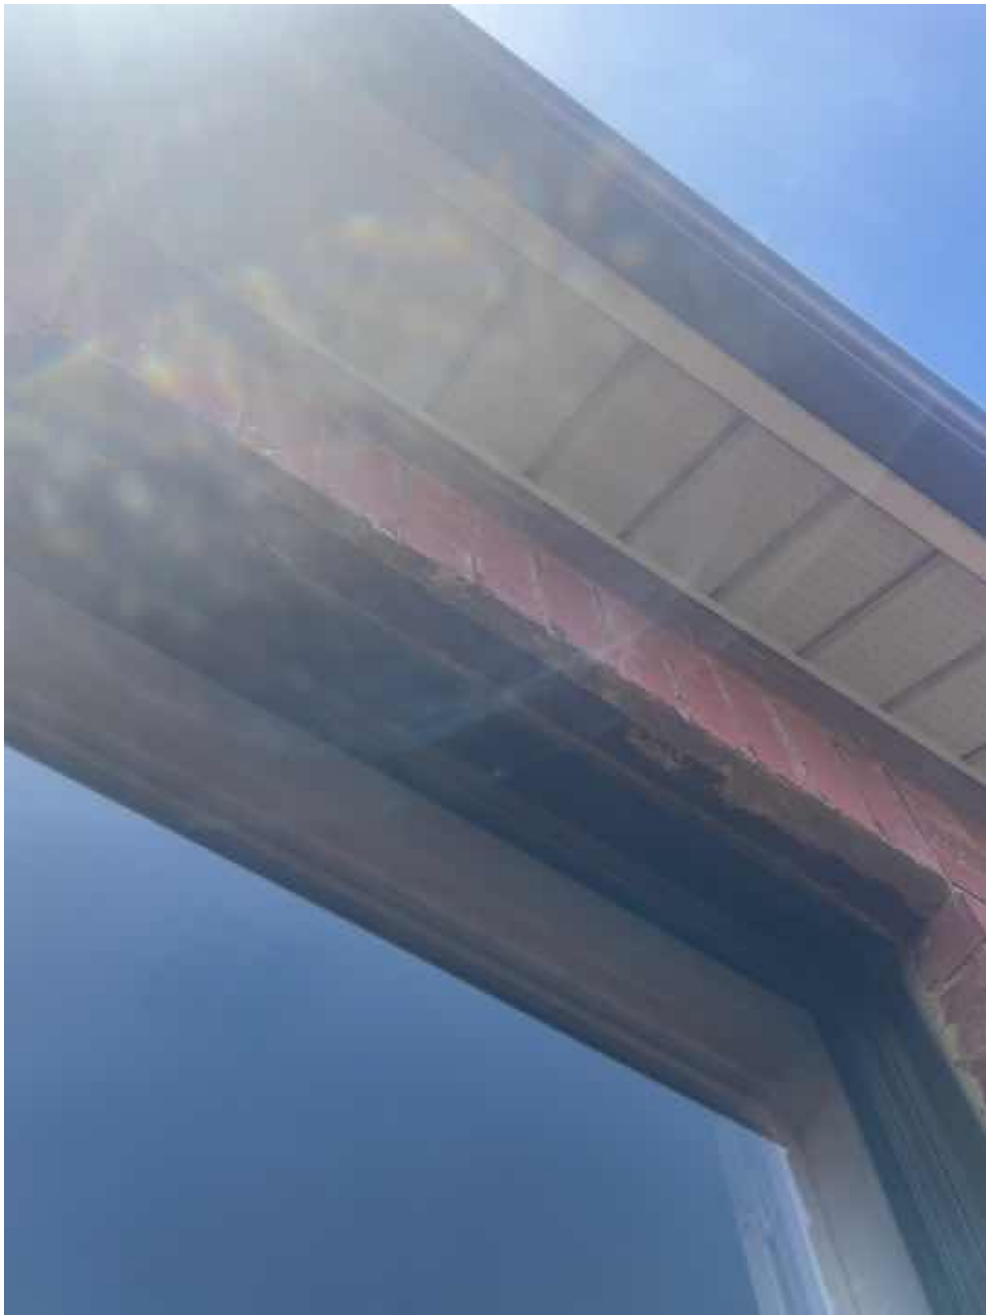
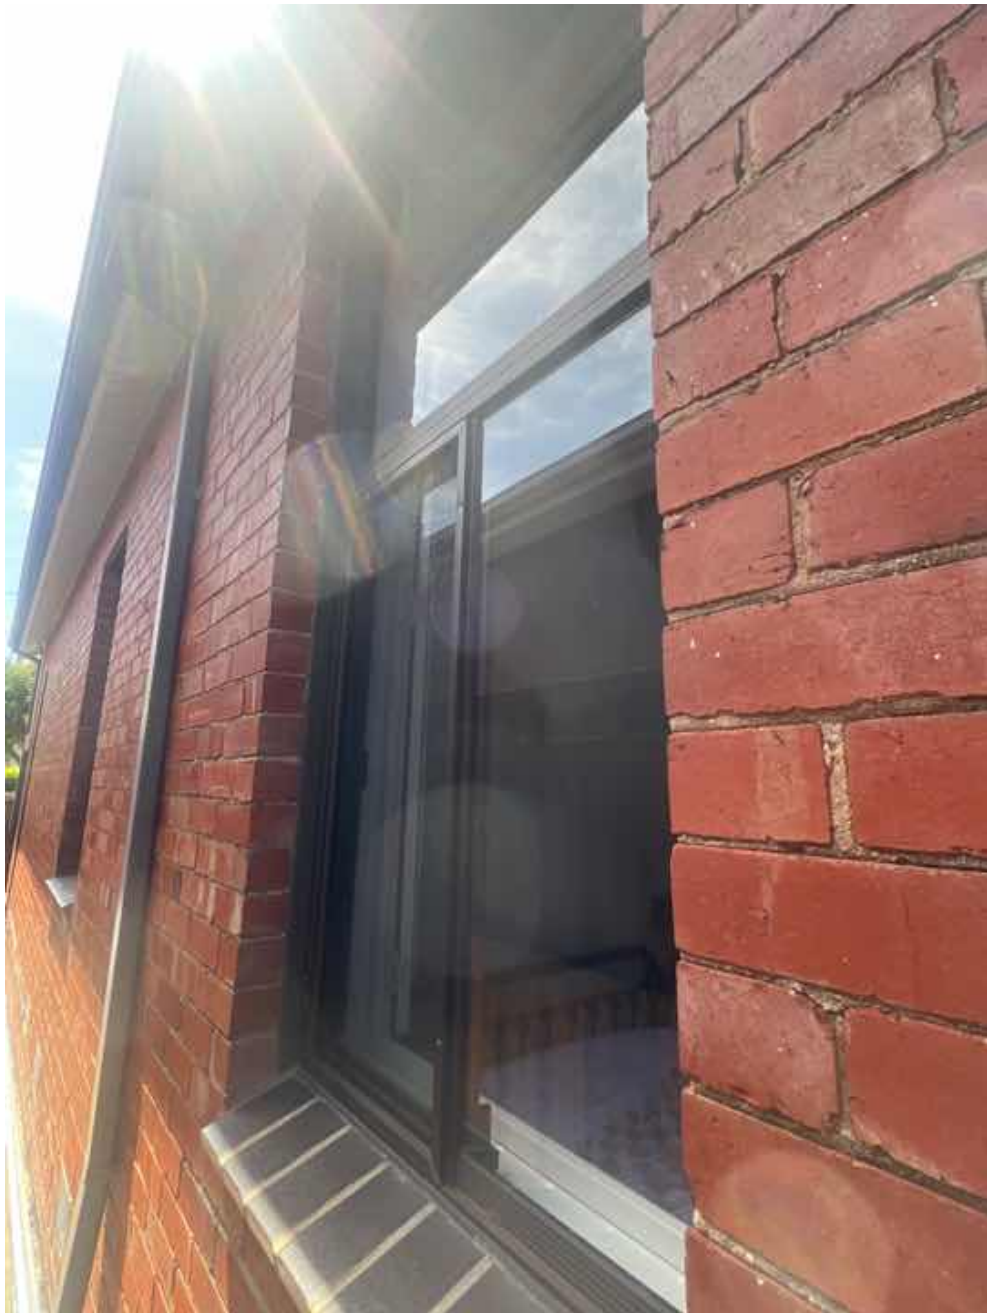
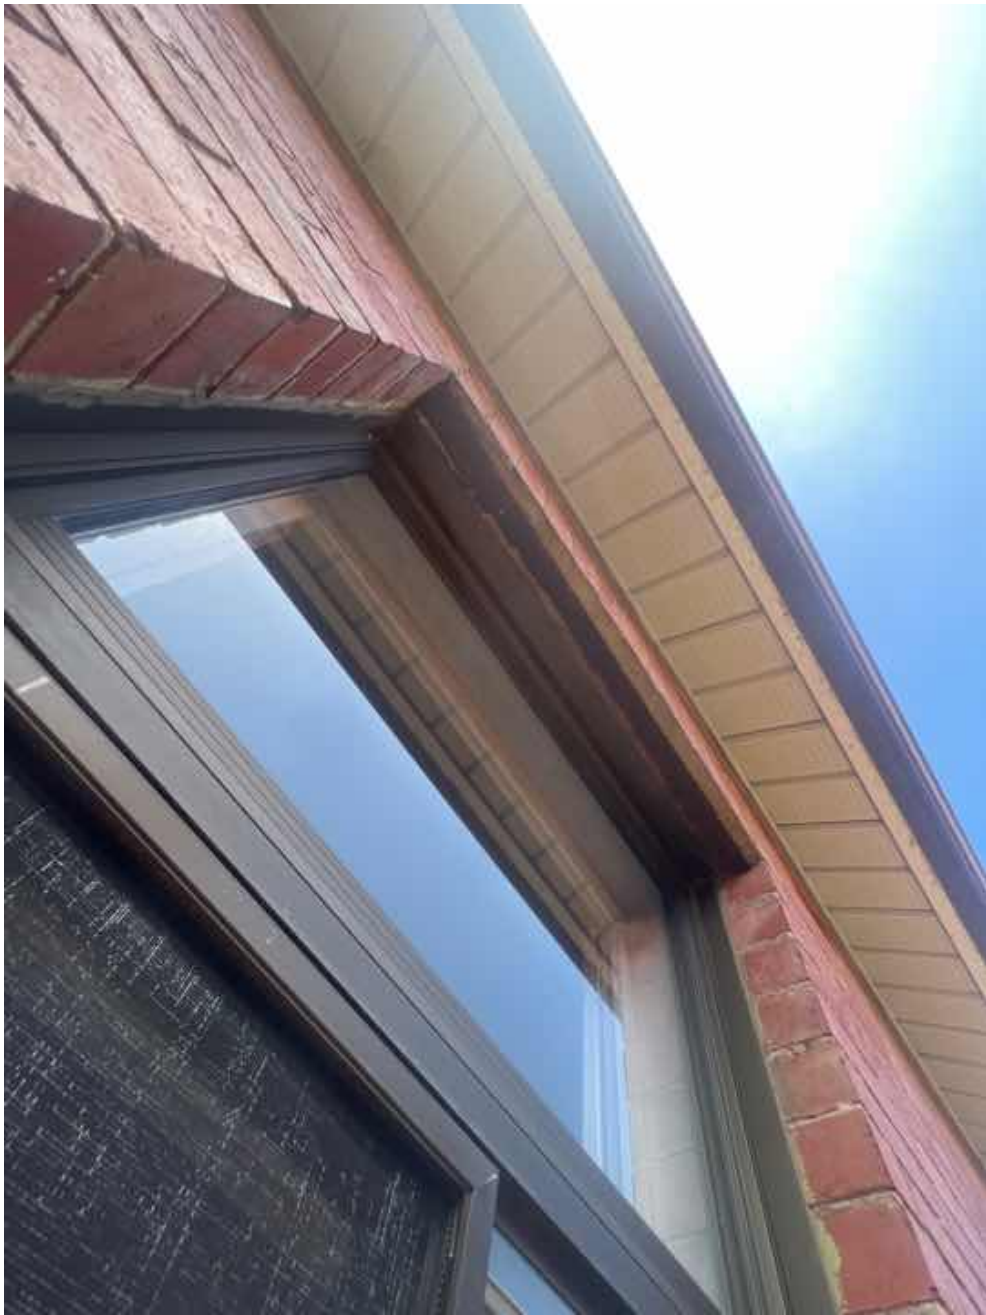
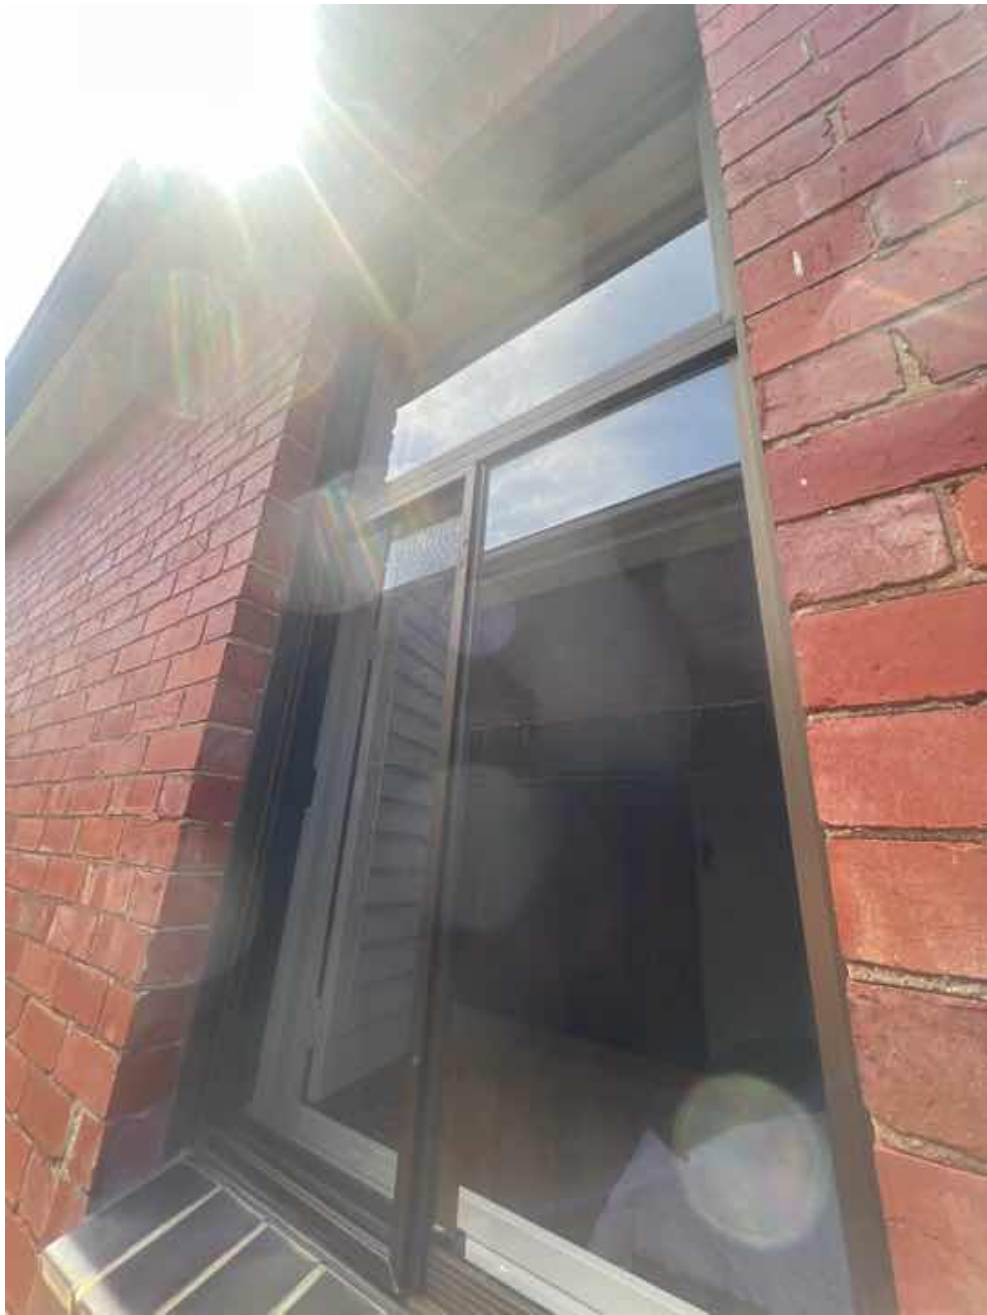
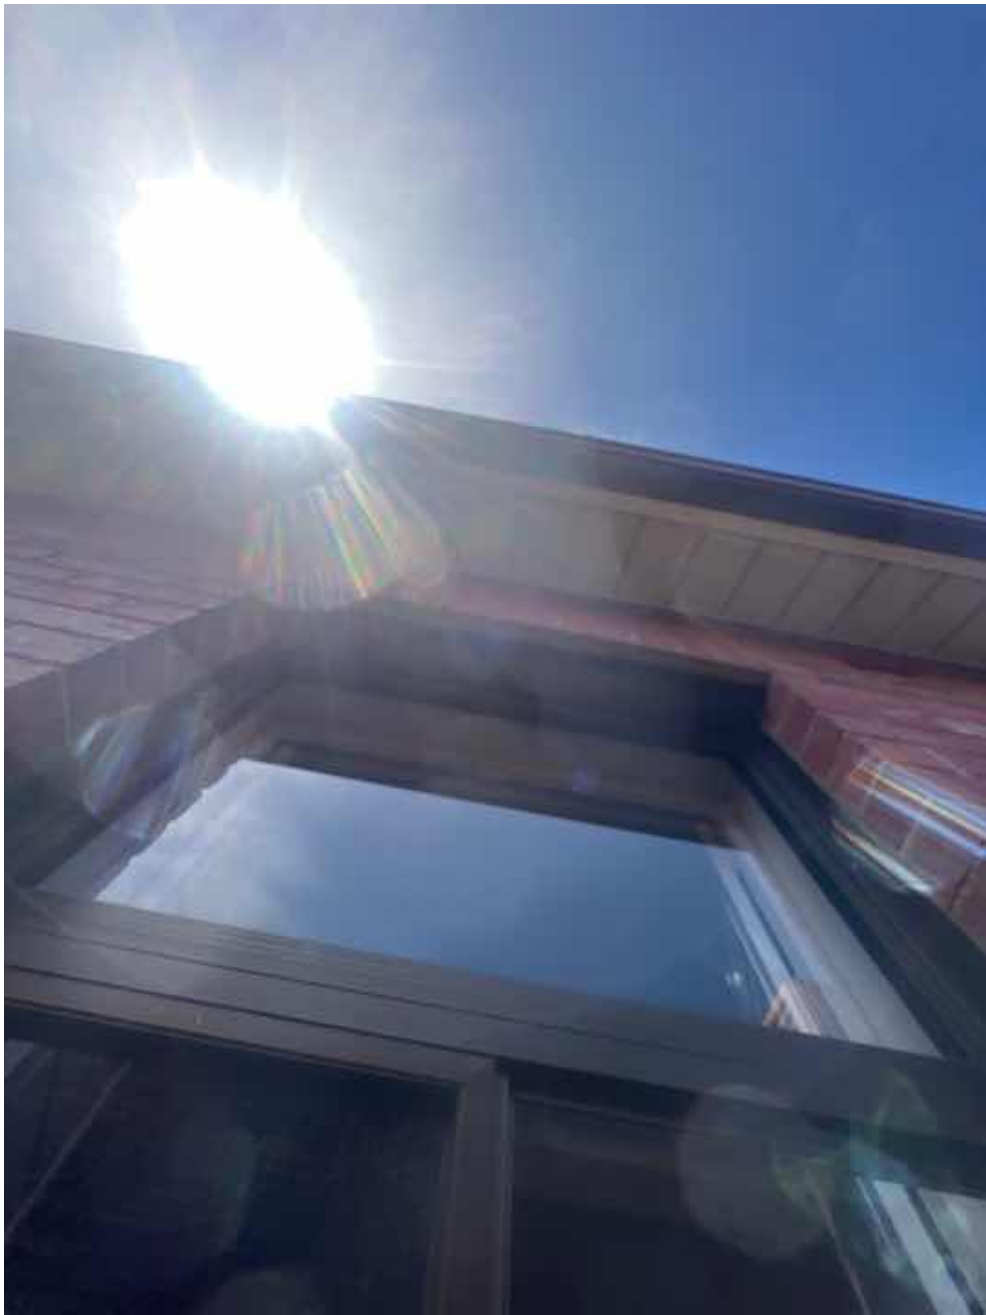
General age/damage has occurred to window components. Recommendations: Restoration work recommended. A qualified carpenter should be engaged for advice and recommendations.

Lintel rust in sections. This may cause cracking in wall linings above the window. A qualified brick layer should be engaged for advice and recommendations.

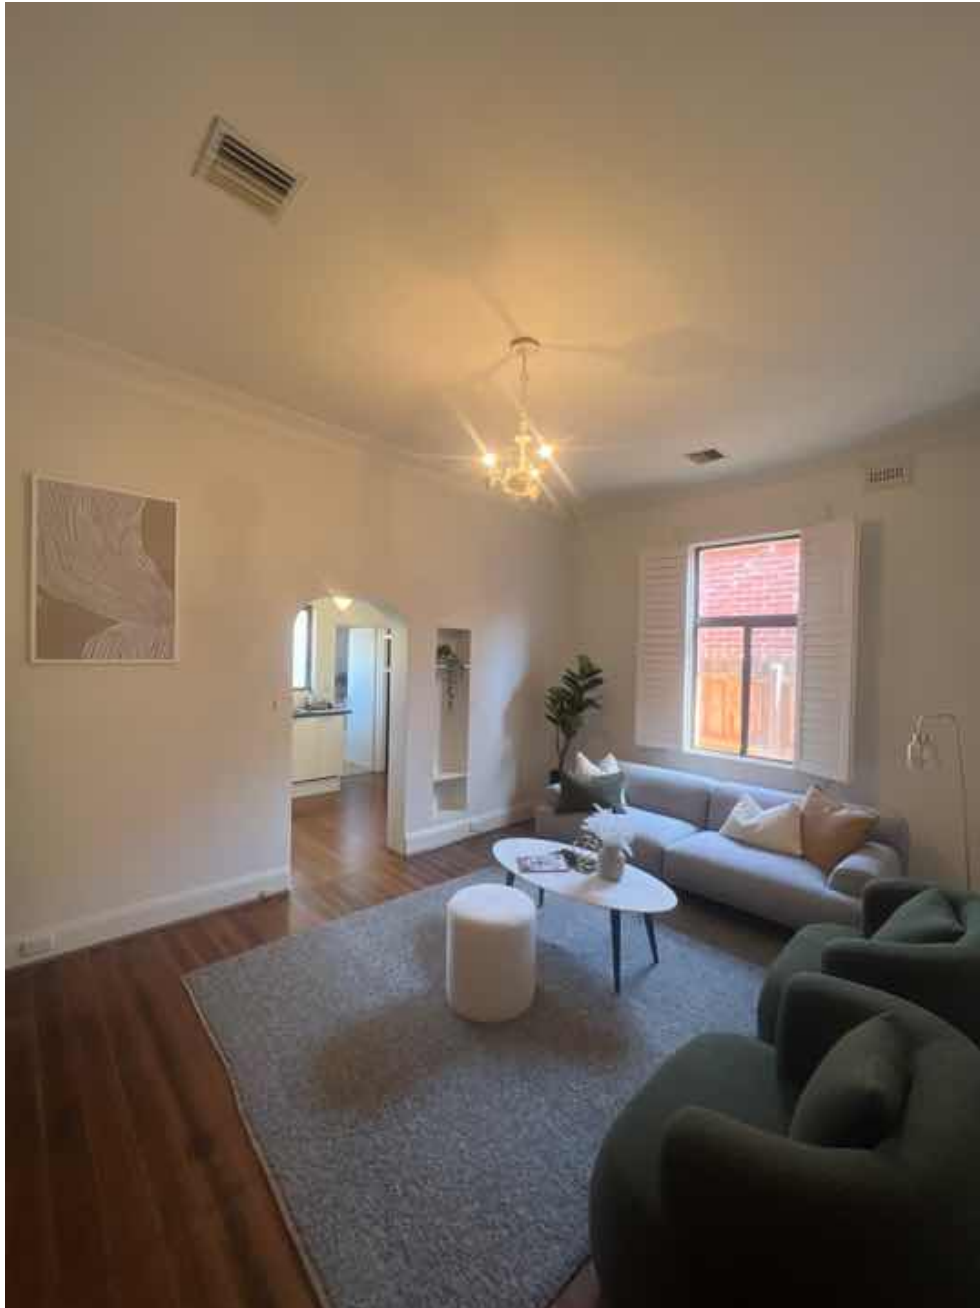
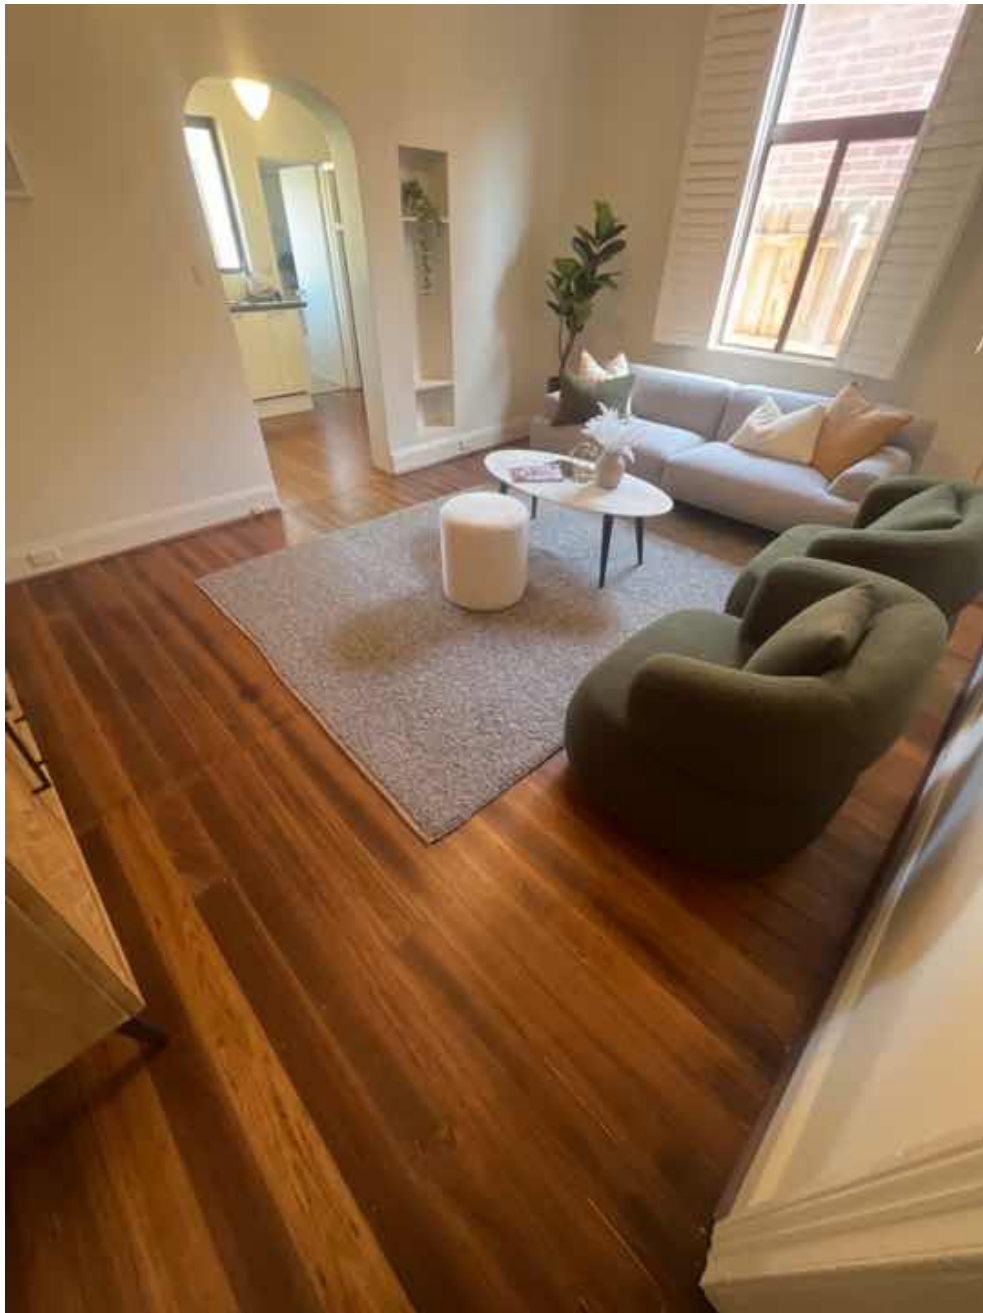
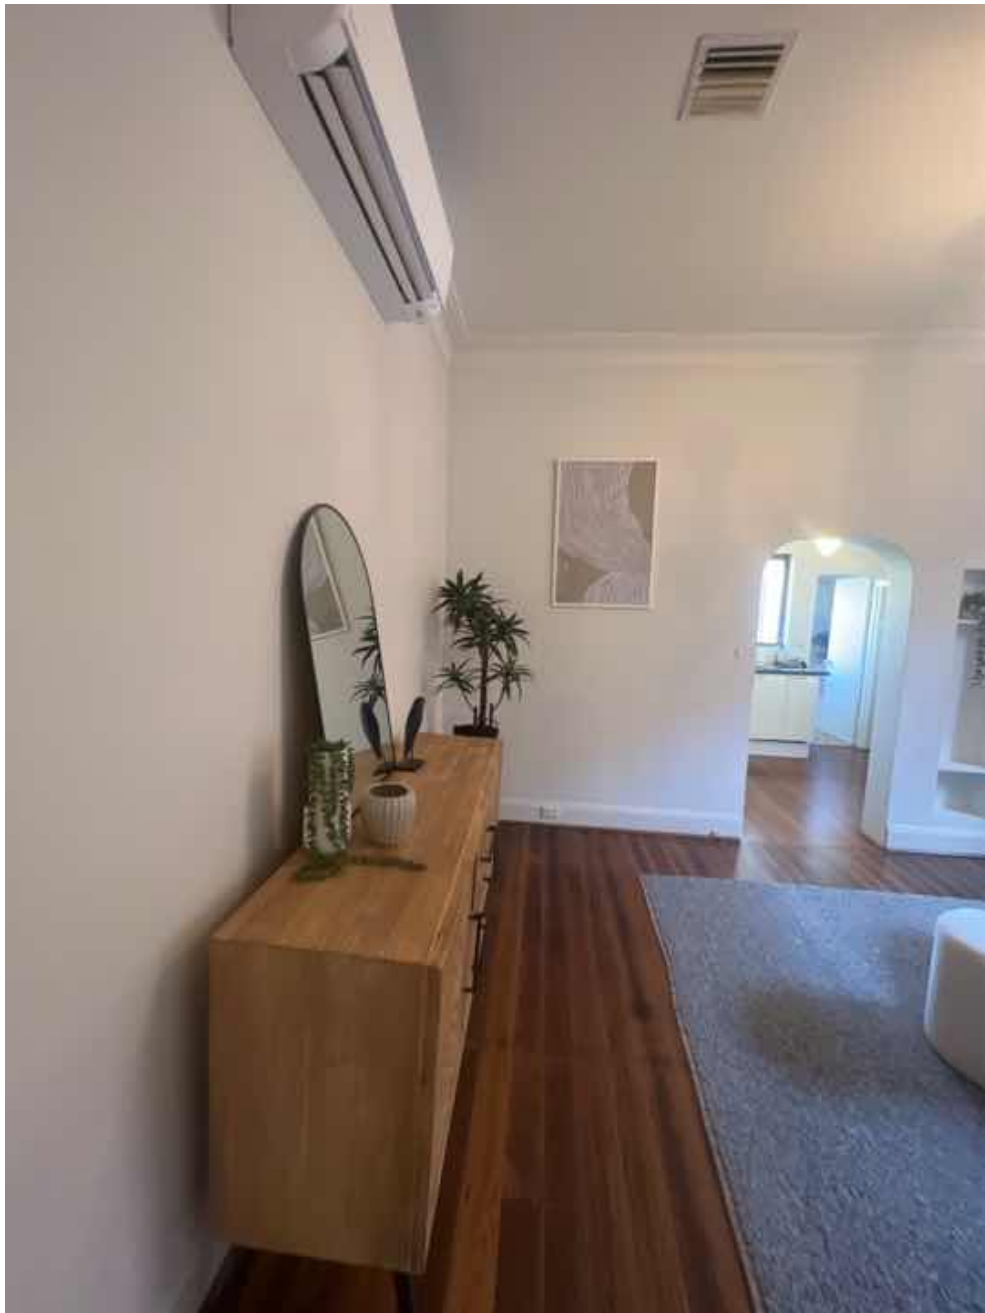
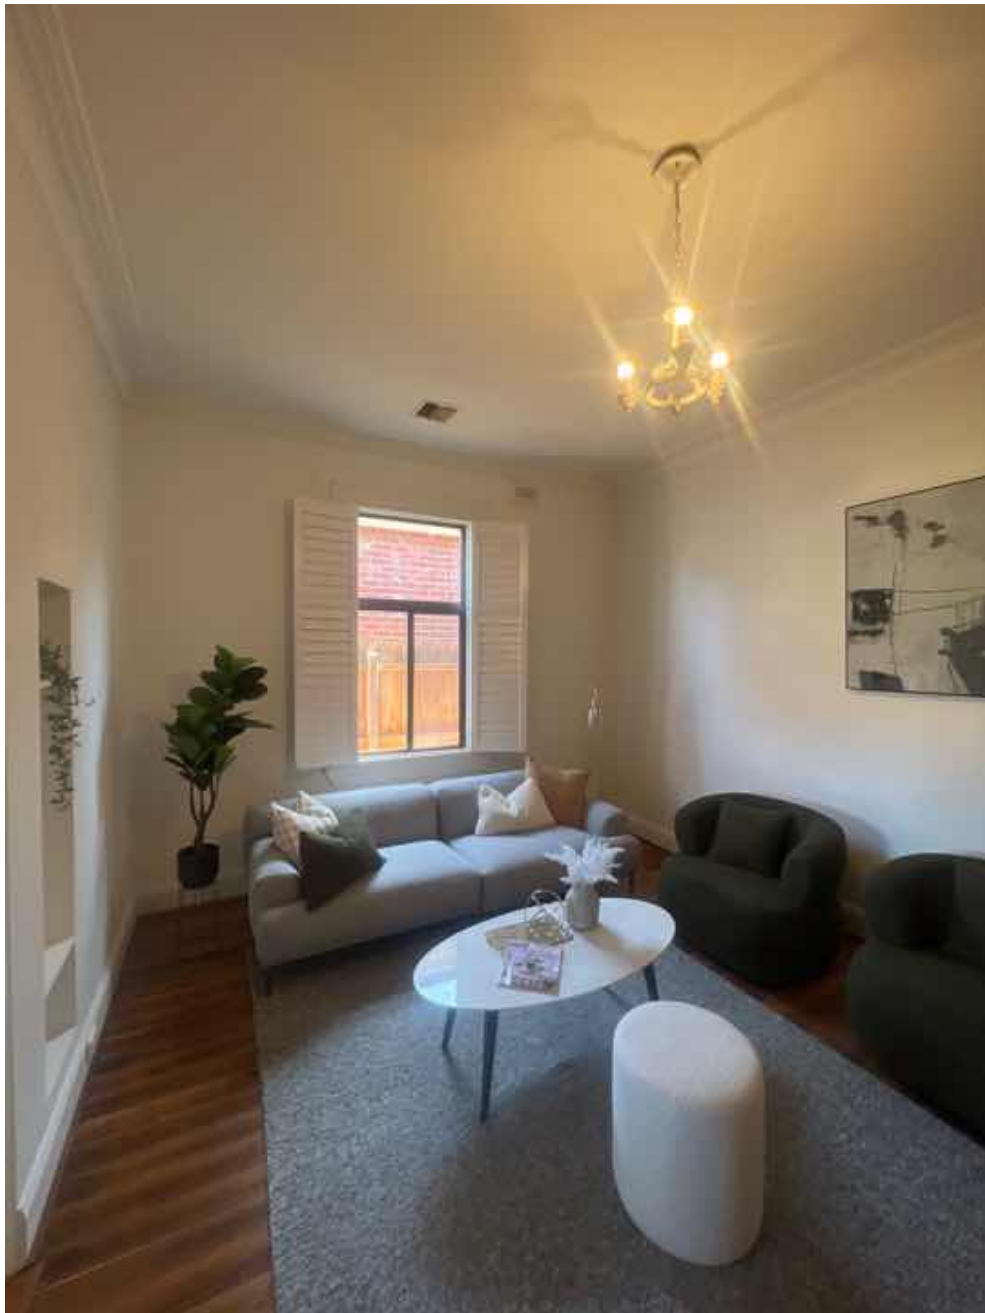
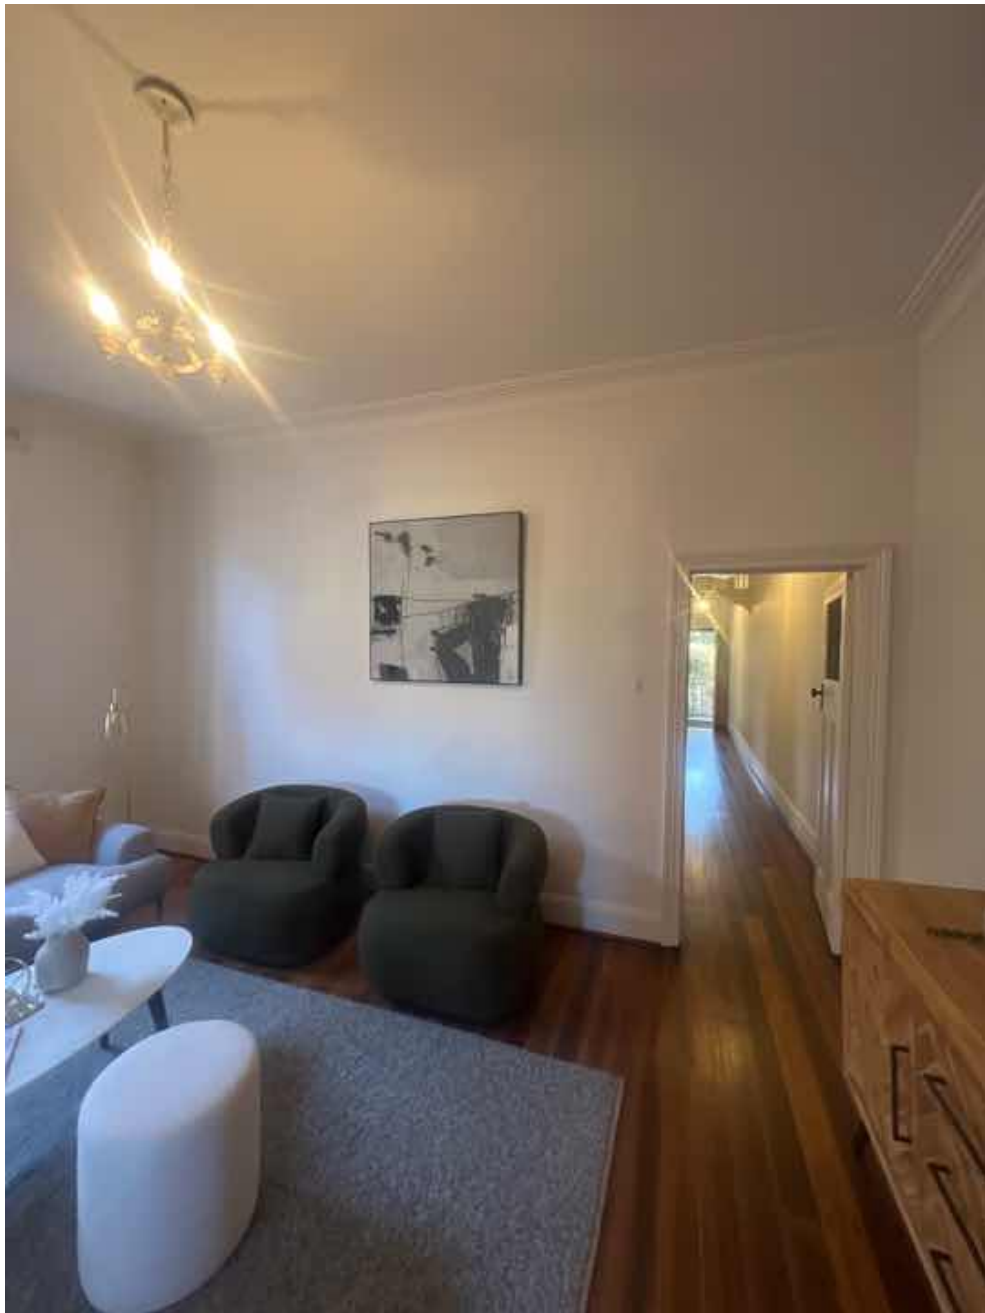
Patched wall cracks visible - Recommendations: Engage a plasterer to assess for further advice and repairs - I am unable to guarantee that these patched areas will not re-open in the future. If further opening occurs the affected areas may require re-assessment by a suitably qualified contractor.
