Sample Report

D.C Building Inspectors

Pest And Building Inspection

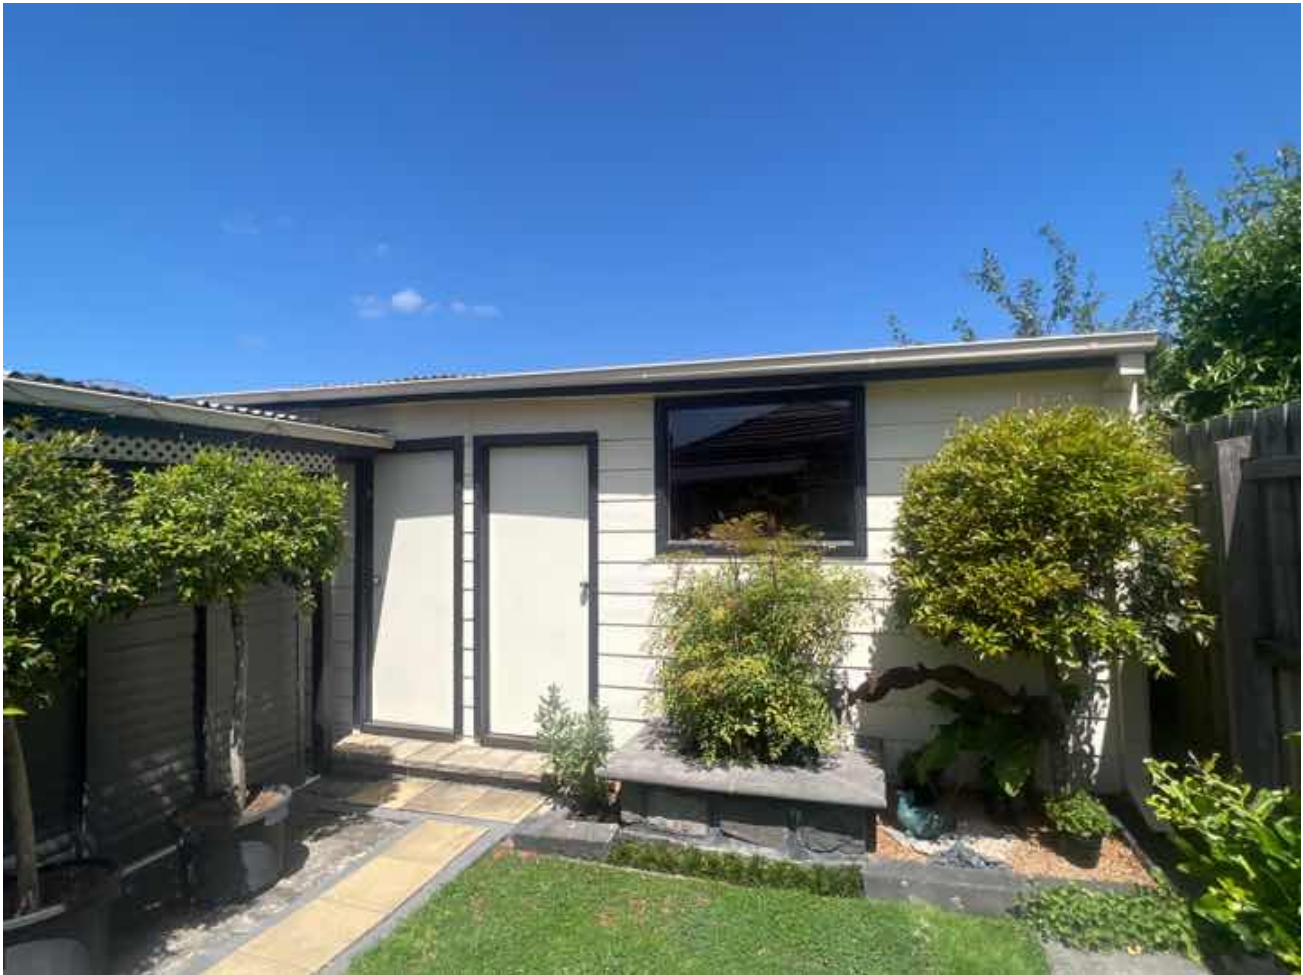
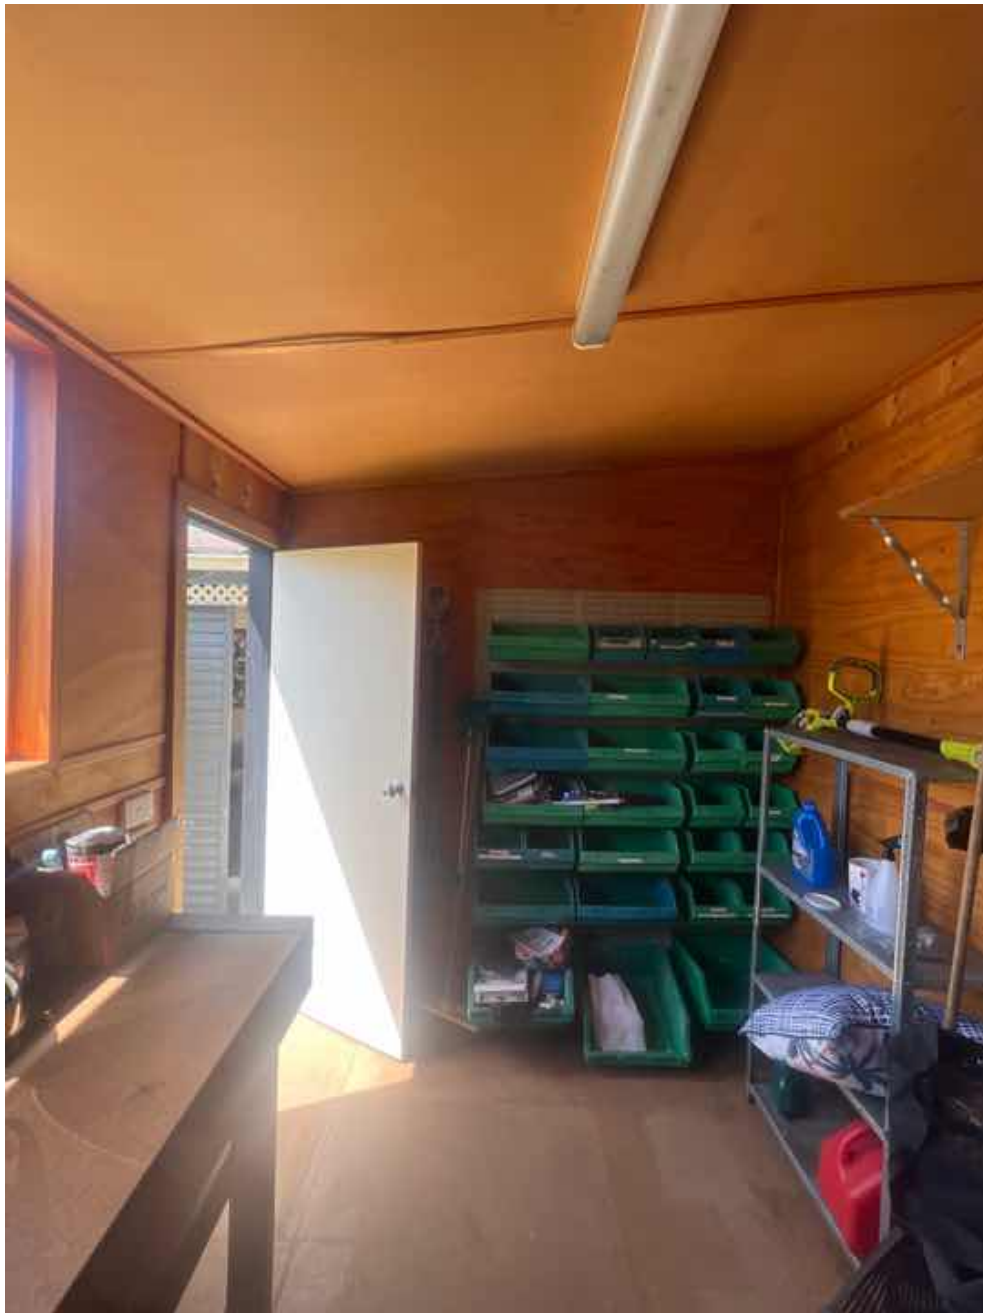
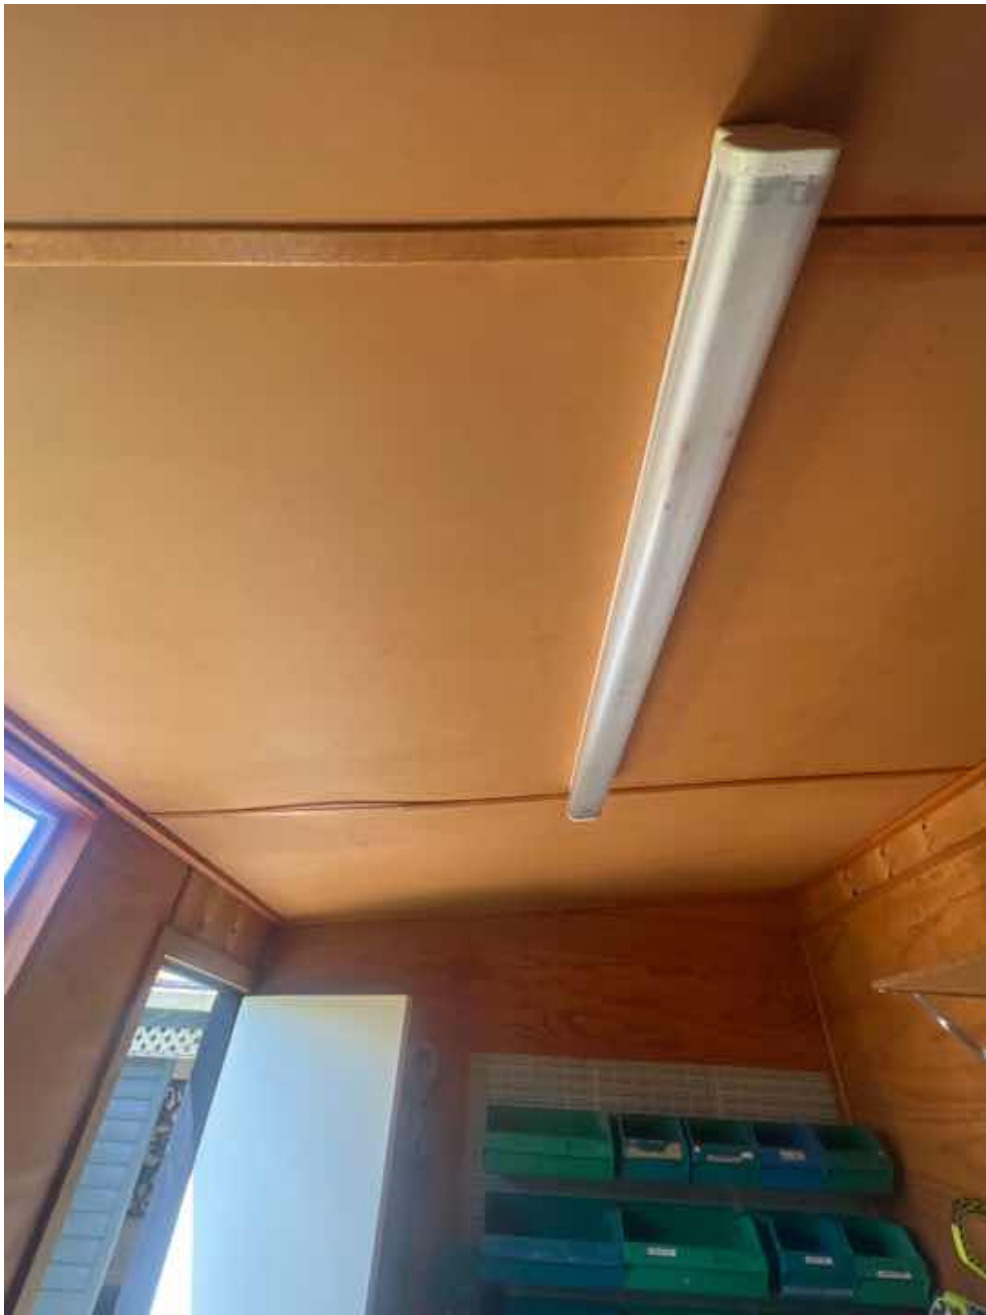
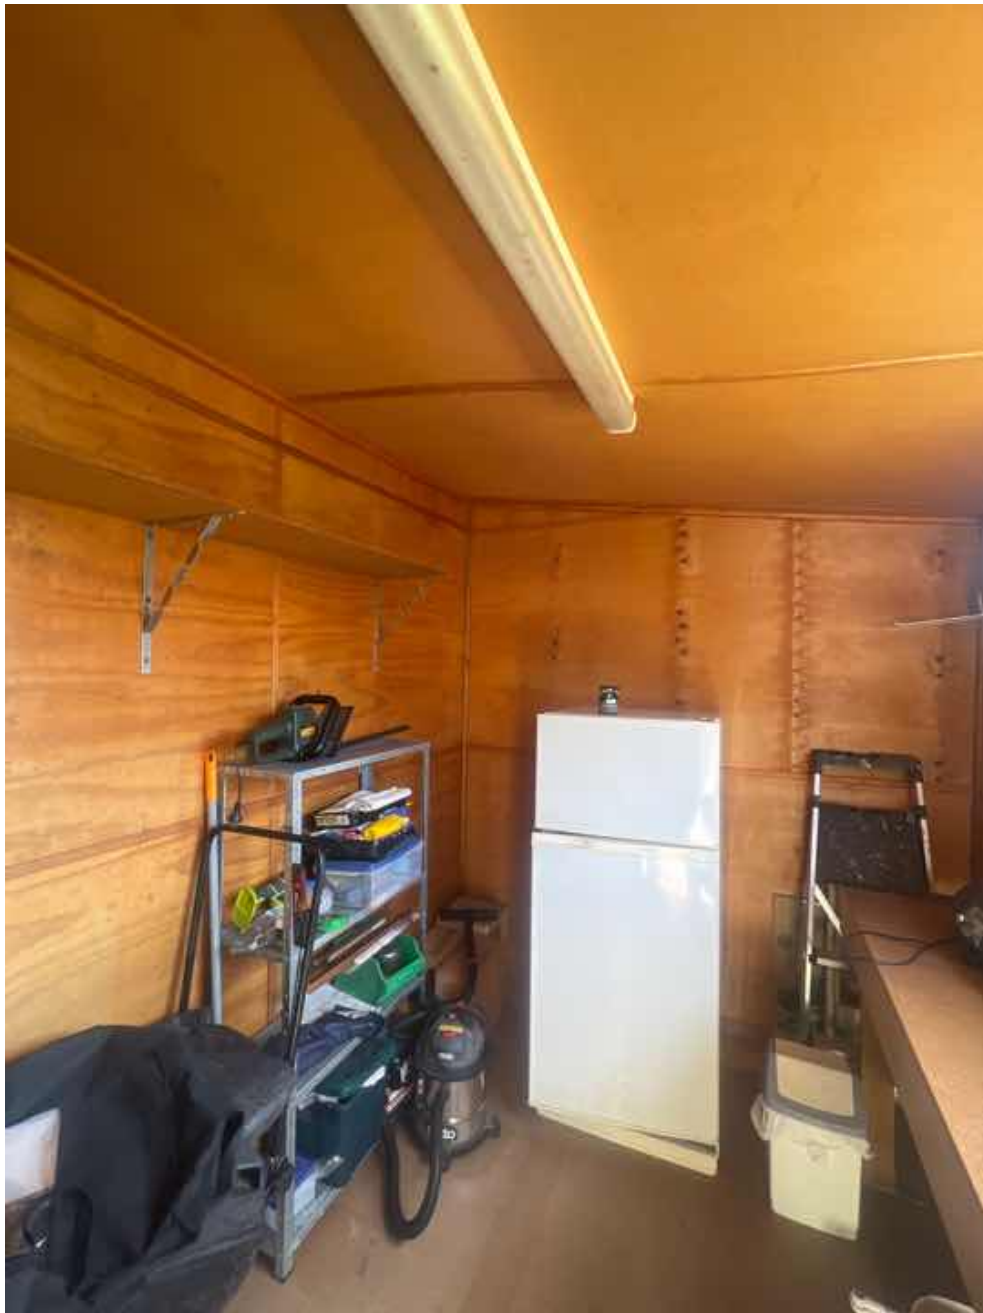
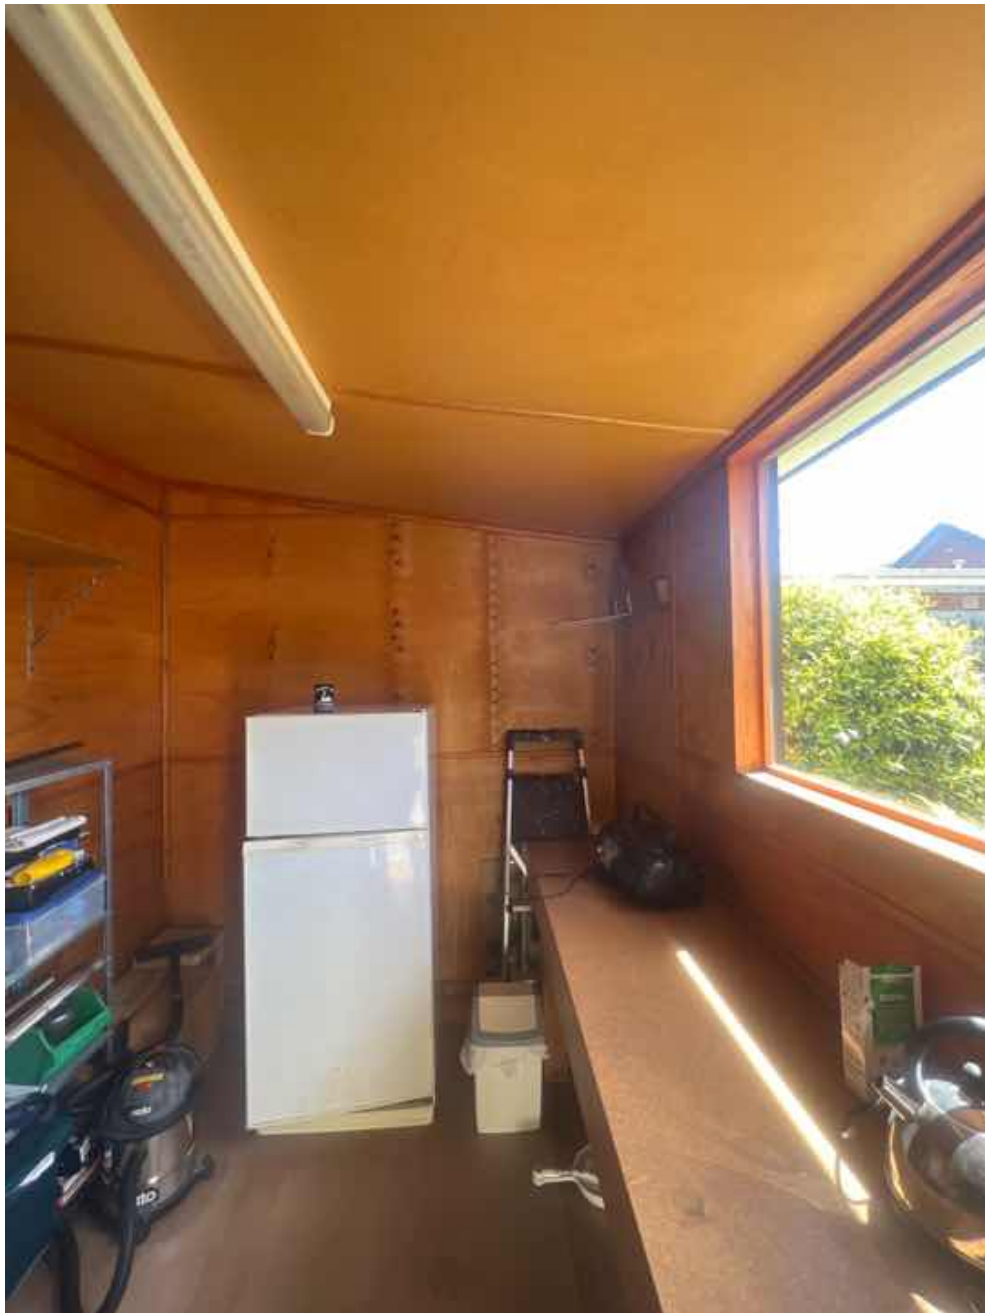
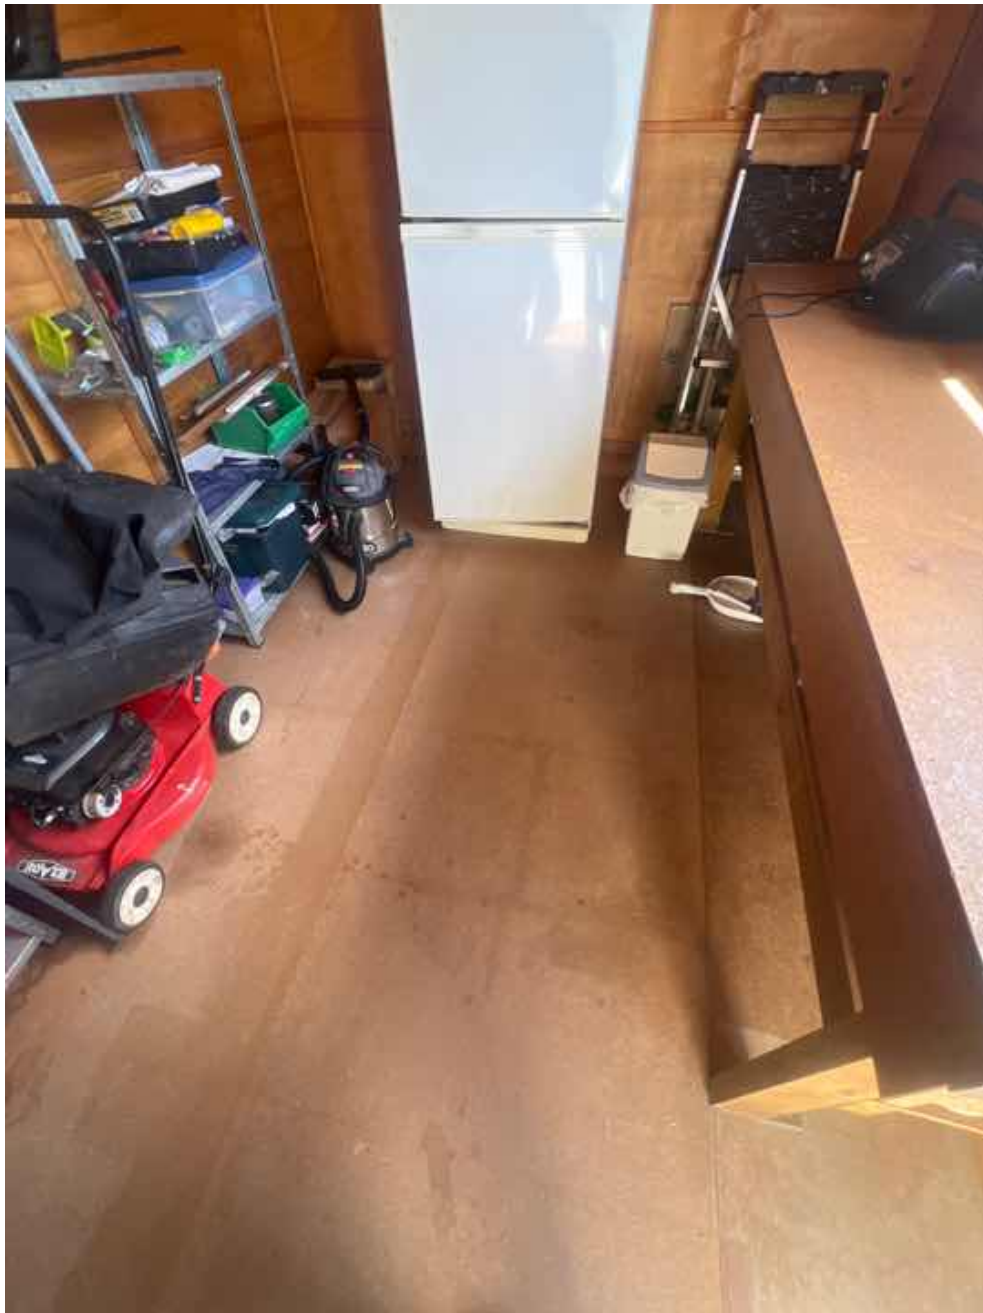
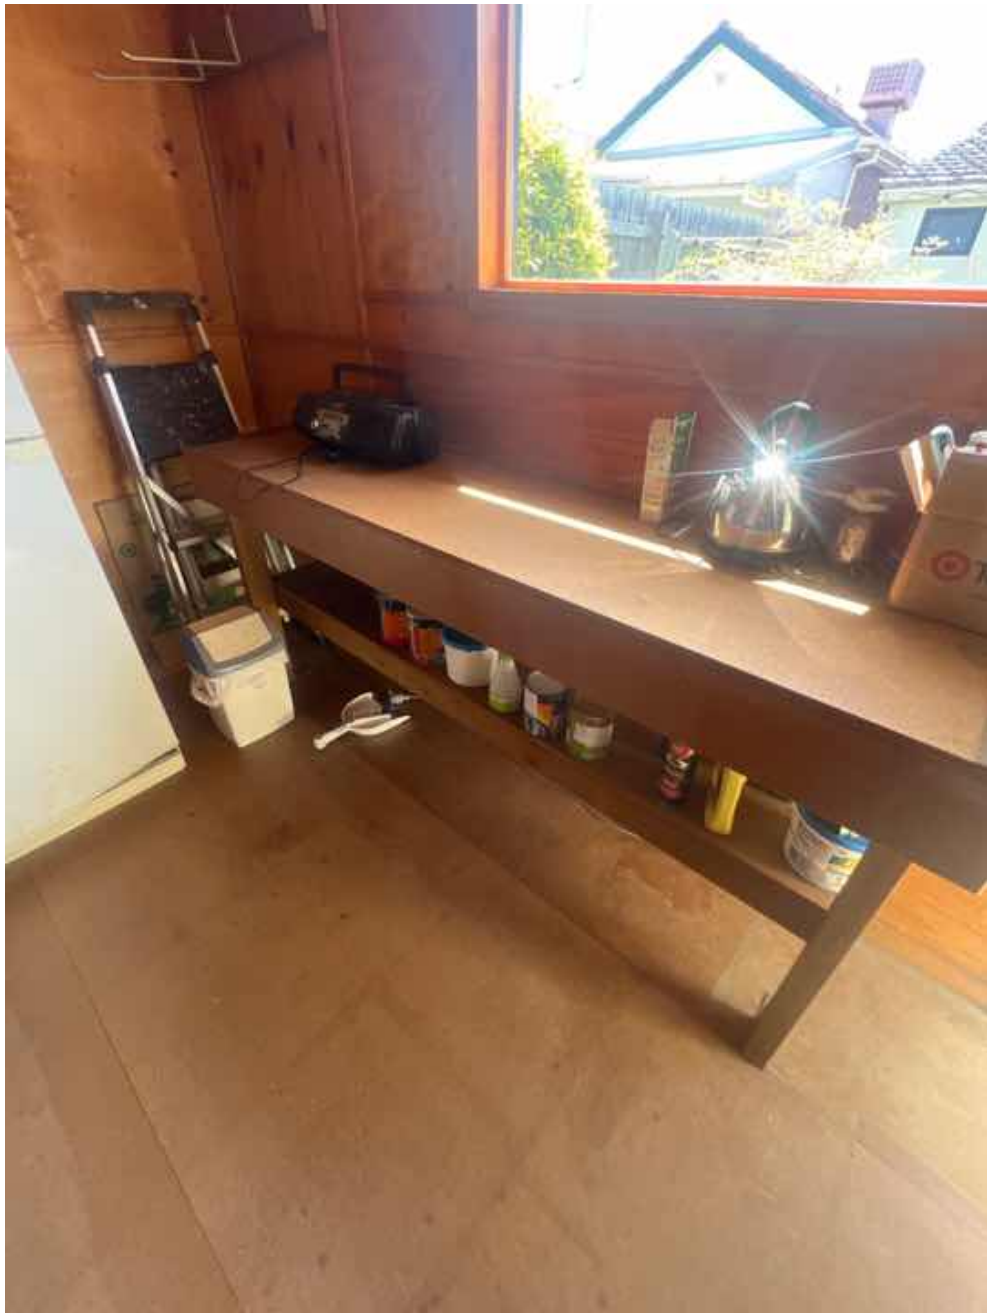
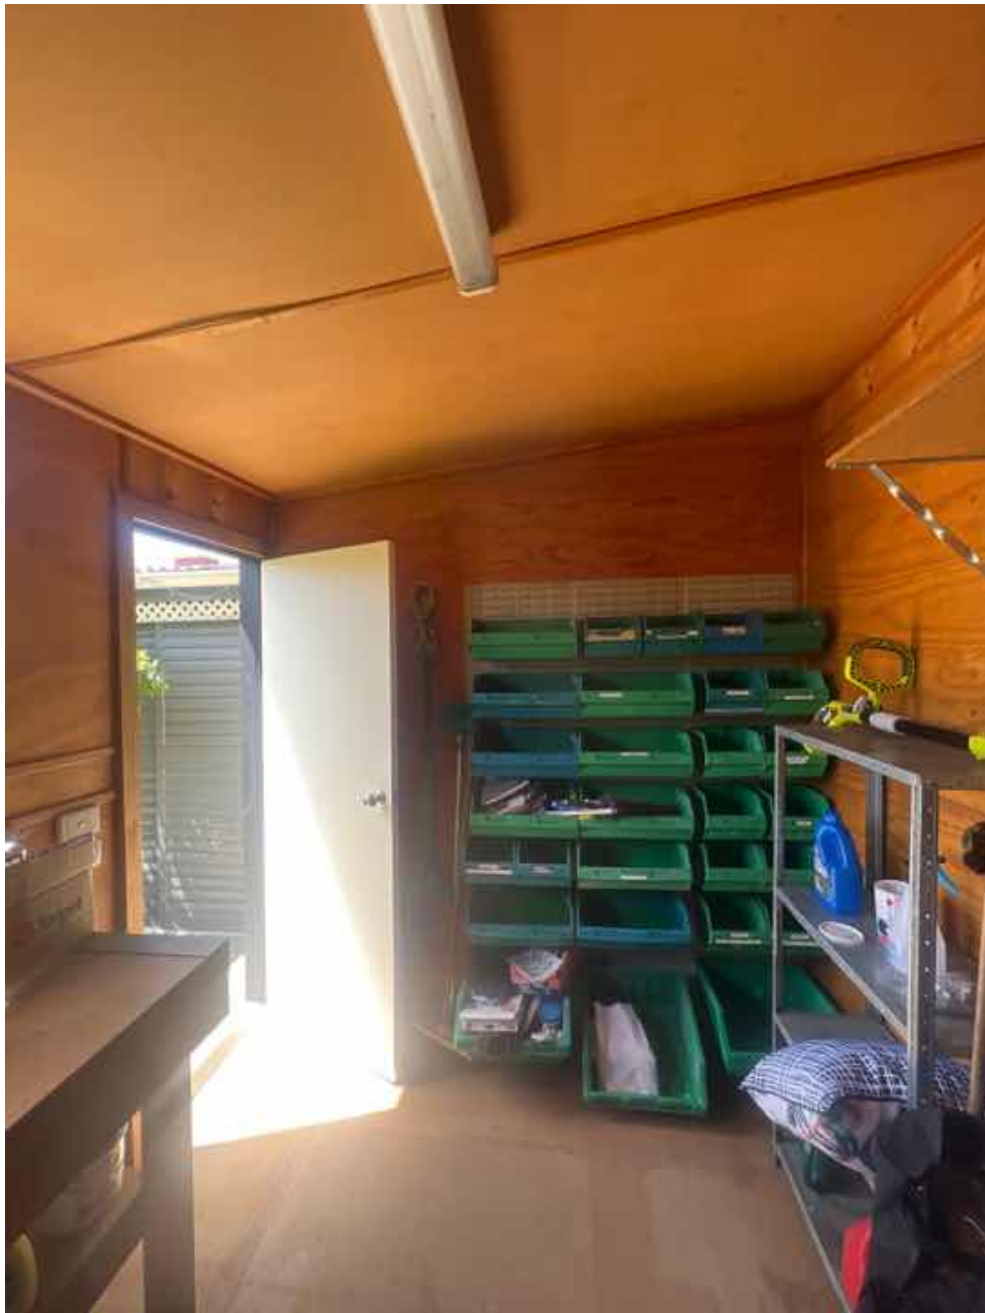
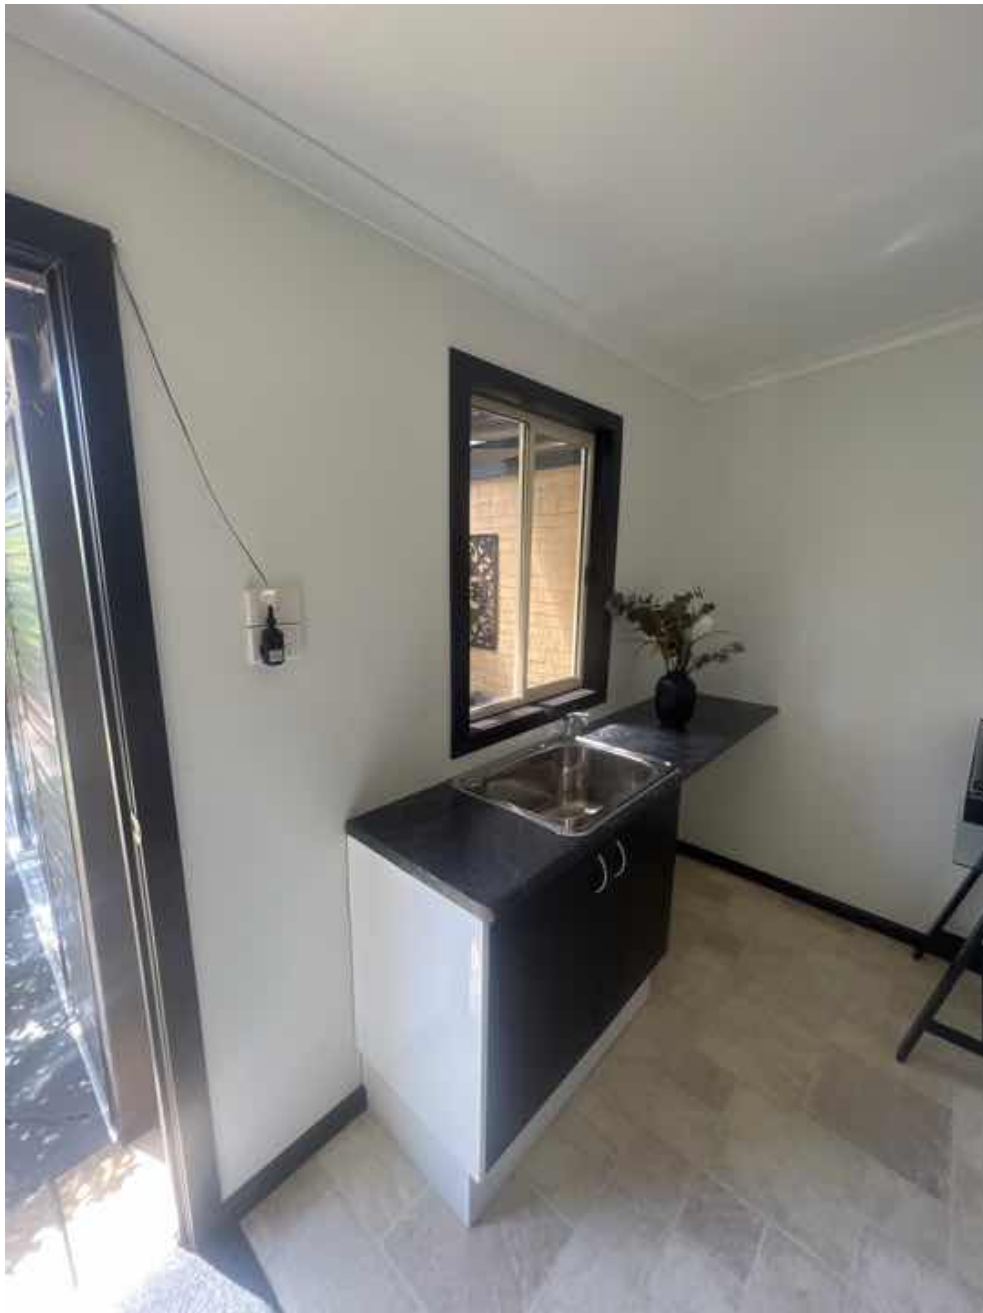
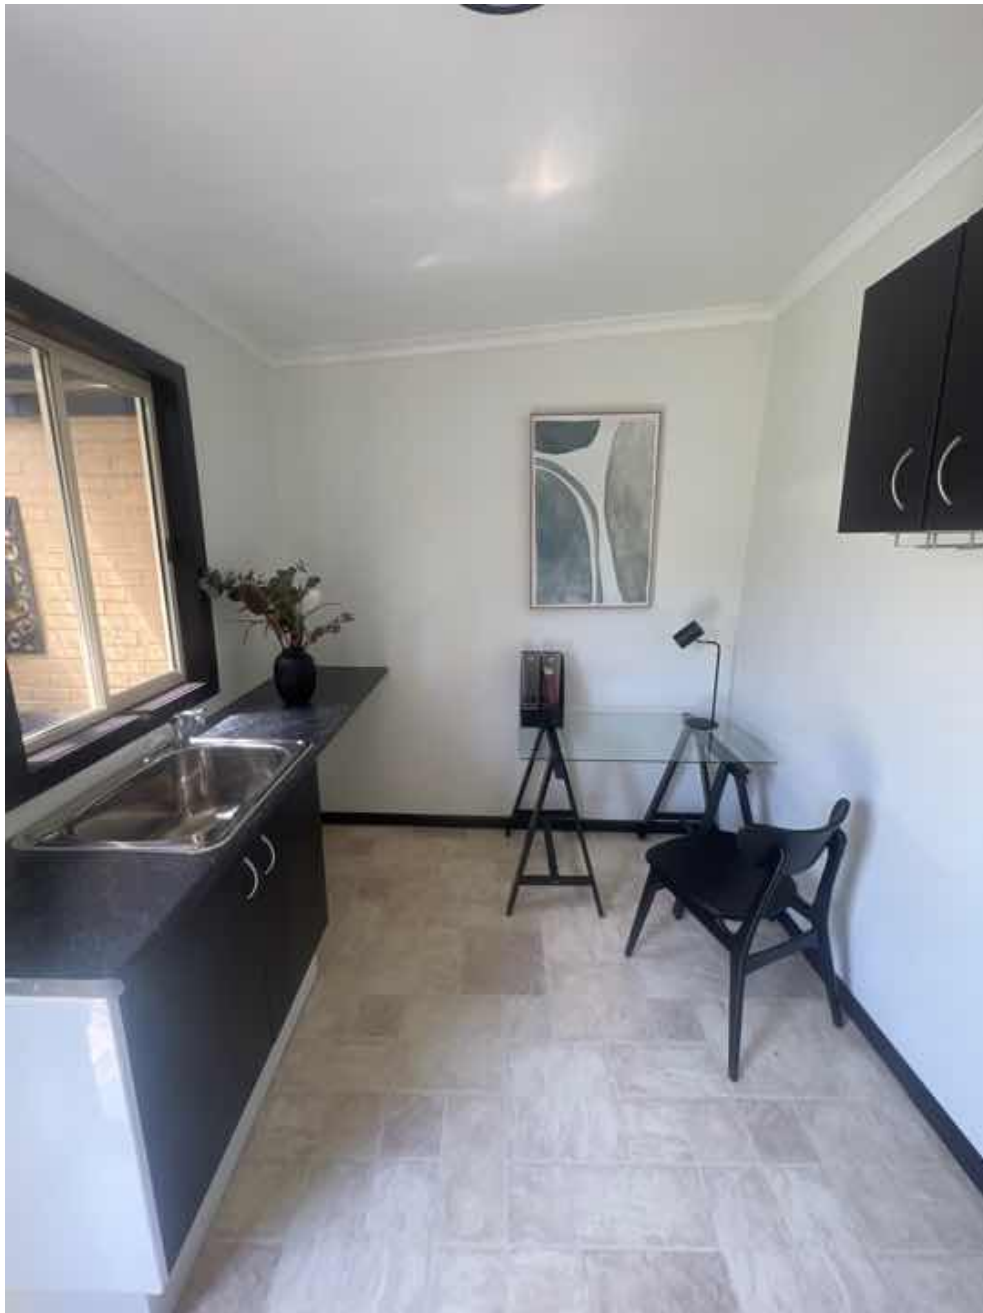
Settlement Cracks Noted. These are typical and generally patch and paint will suffice, however monitoring these cracks is advised for 12 months and if they become worse, further investigation by a suitably qualified professional is advised.

Decay noted to the timber floor. It is strongly recommended that all affected timbers be replaced. This presents a Safety Hazard. Contact a qualified carpenter for repairs.

Unevenness visible in floor. Possibly due to poor workmanship or excessive movement/settlement. A qualified carpenter should be engaged for advice and recommendations re levelling.

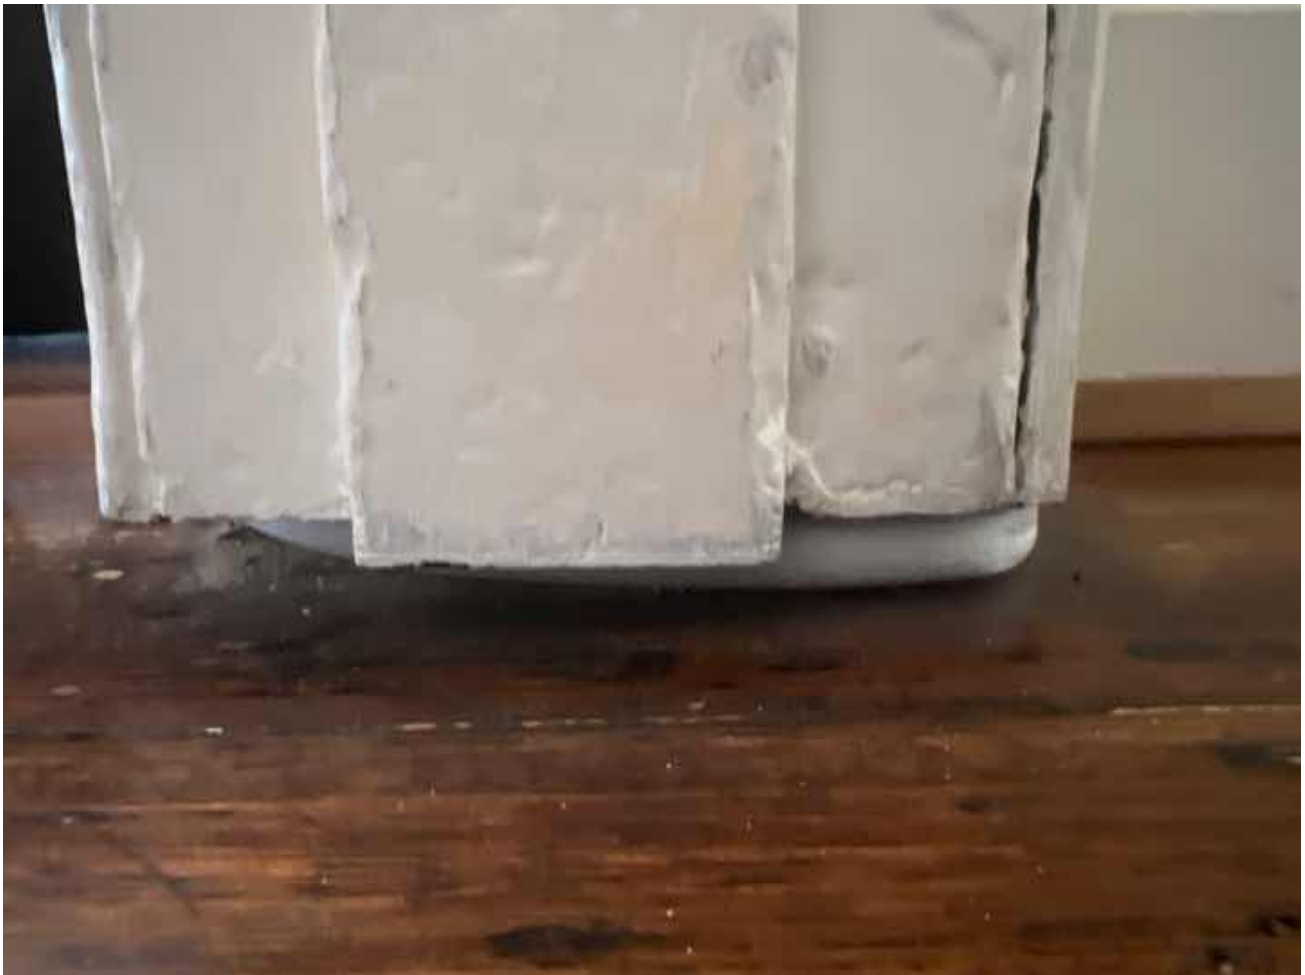
Flooring

Unevenness visible in floor. Possibly due to poor workmanship or excessive movement/settlement. A qualified carpenter should be engaged for advice and recommendations re levelling.

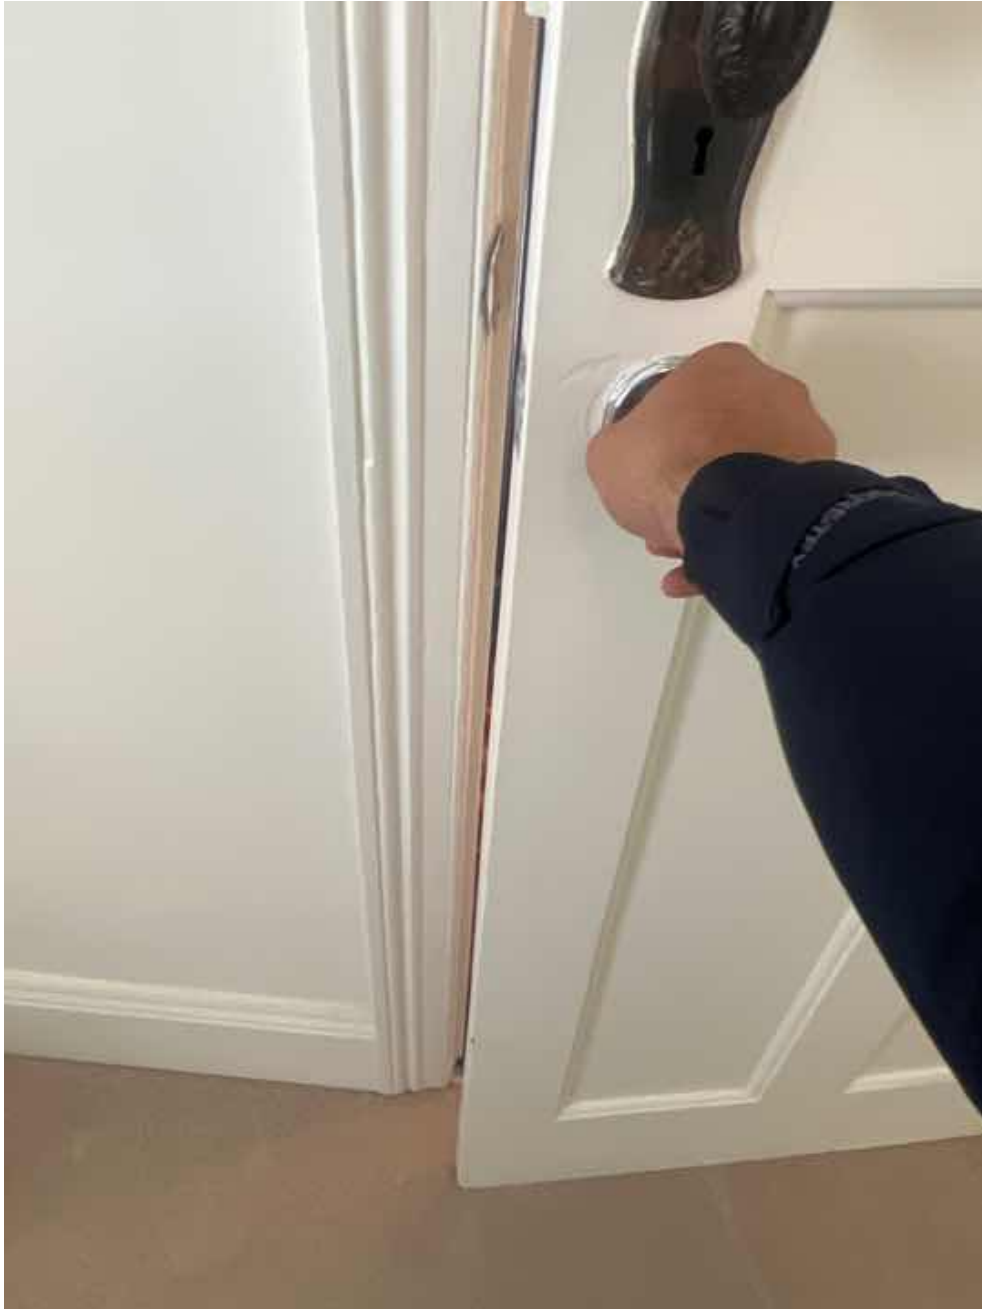
Door

Uneven / out of square door causing binding. A qualified carpenter should be engaged to refit.

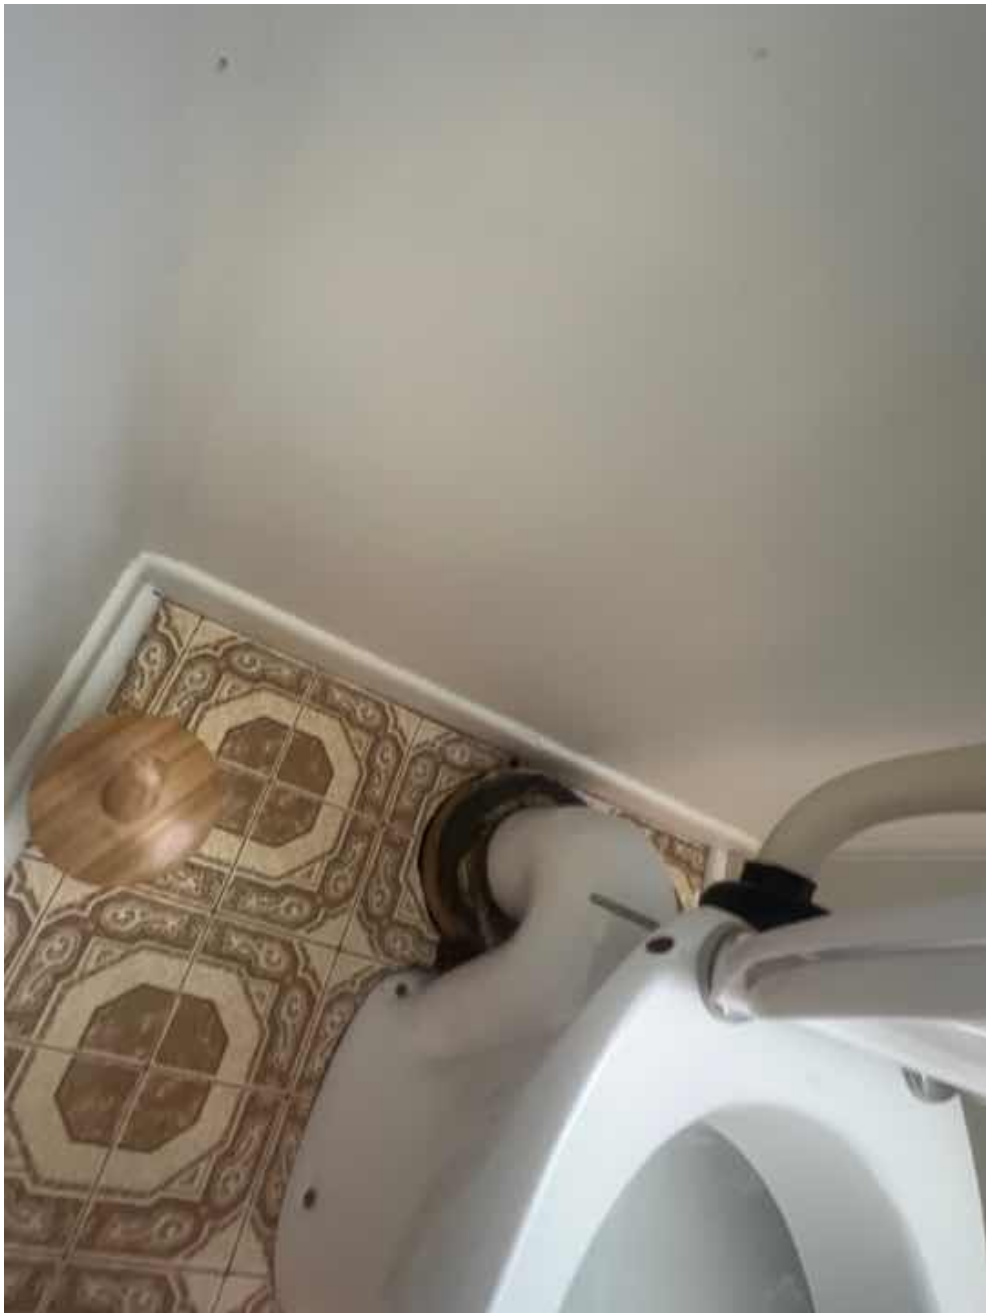
Toilet

The seal is deteriorated causing water to continuously run. Though a maintenance issue I recommend you contact a qualified plumber for repairs.

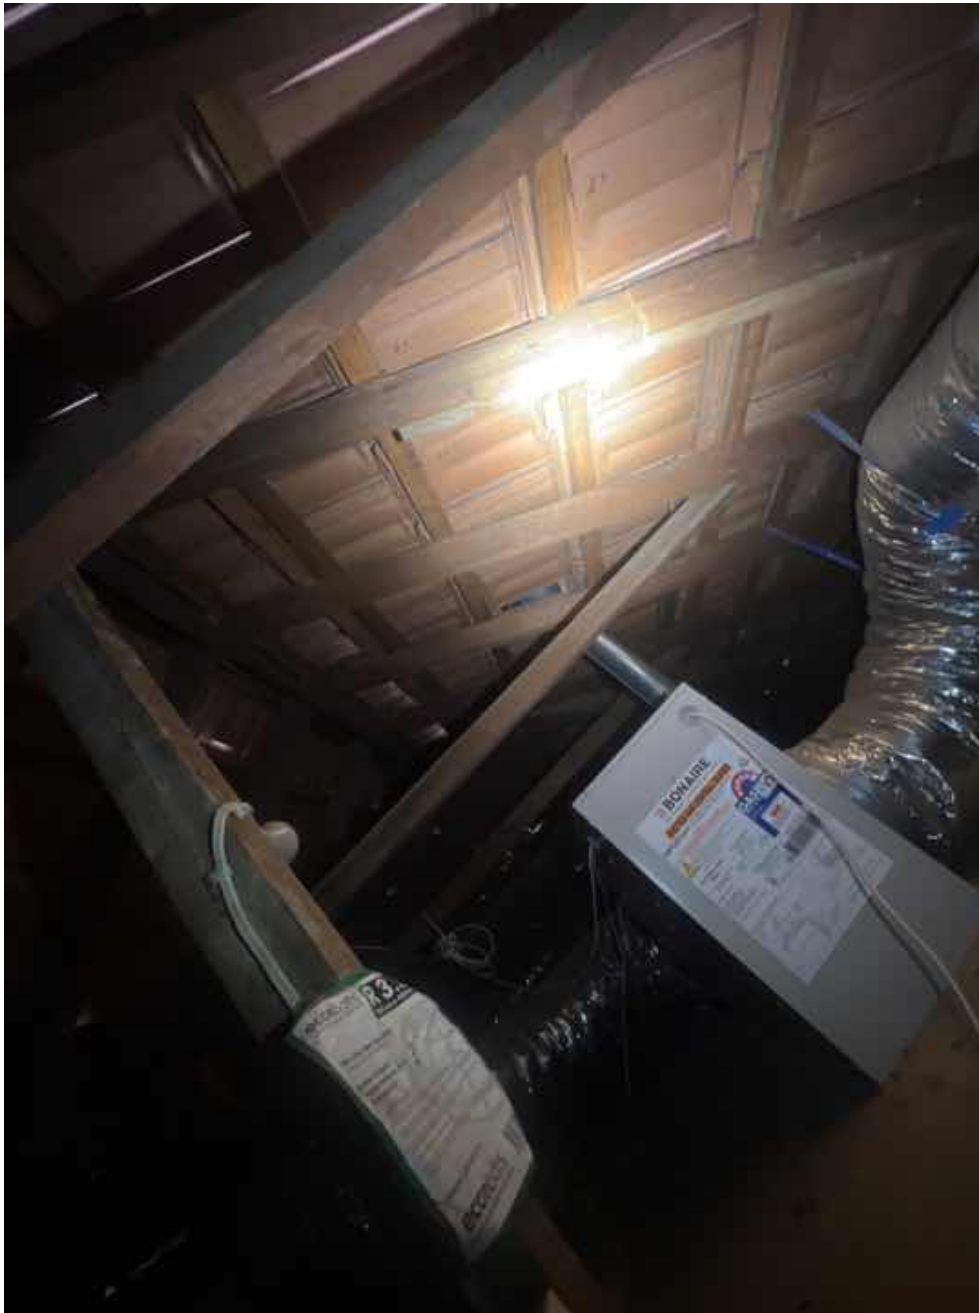
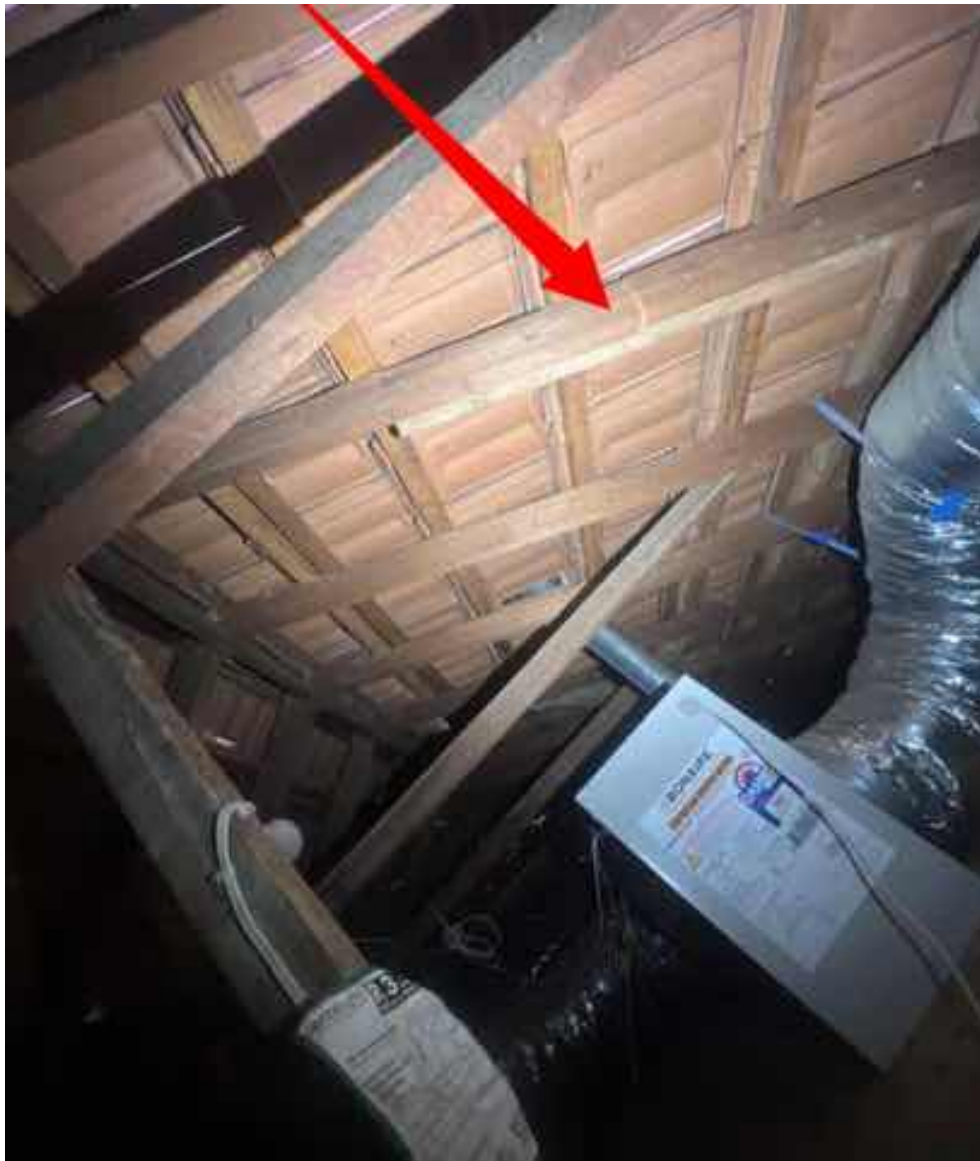
Cut rafter

We note a timber rafter has been cut and appears to have been repaired. We cannot comment on the structural integrity of this repair therefore we recommend a structural engineer is engaged to provide recommendations and advice regarding the adequacy of this repair. This is a potential major structural defect and we recommend further investigation prior to a decision to purchase.
