Gotham City Home Inspections, Inc.

123 Anywhere St, NYC, NY 10449
Inspection prepared for: Sample Report
Date of Inspection: 6/8/2019 Time: 10:00 AM
Age of Home: Built pp. 1930 Size: 900
Weather: Sunny
Order ID: 6892

Inspector: Anthony (Tony) Castoro
License # 16000054820
355 Wilson Avenue, Staten Island, NY 10312
Phone: (718)360-1868
Email: tonyc@abrooklynhomeinspection.com
www.gothamcityhomeinspections.com

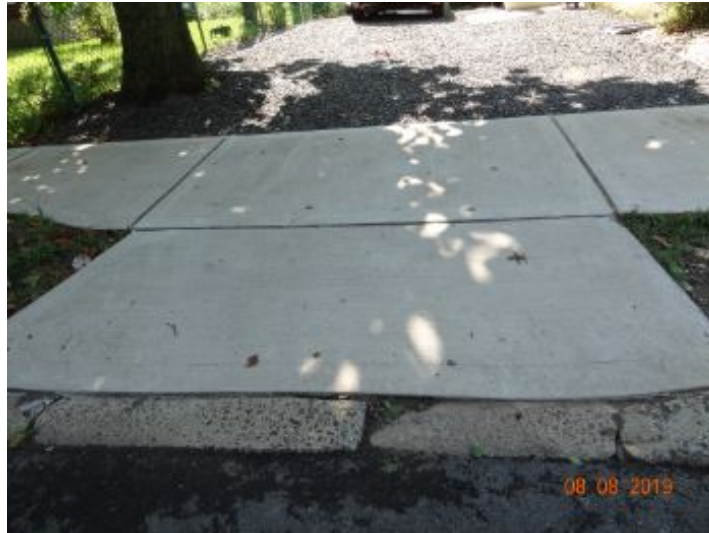
Driveway

Observations: Functional

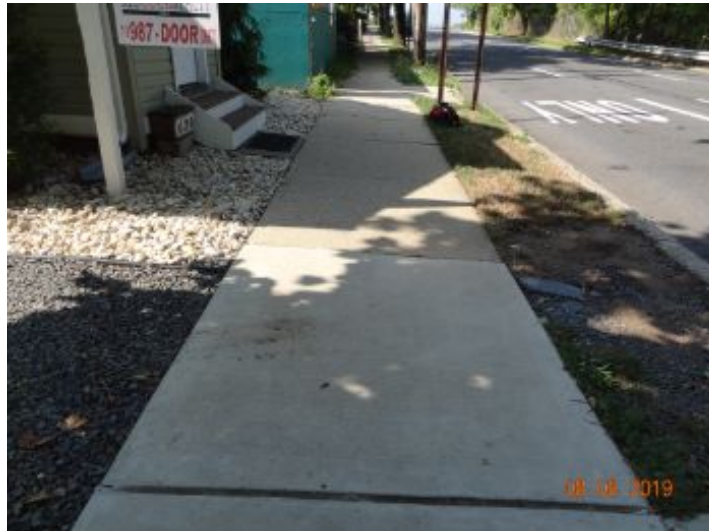
Public Walkway

- Visible walkways are serviceable.

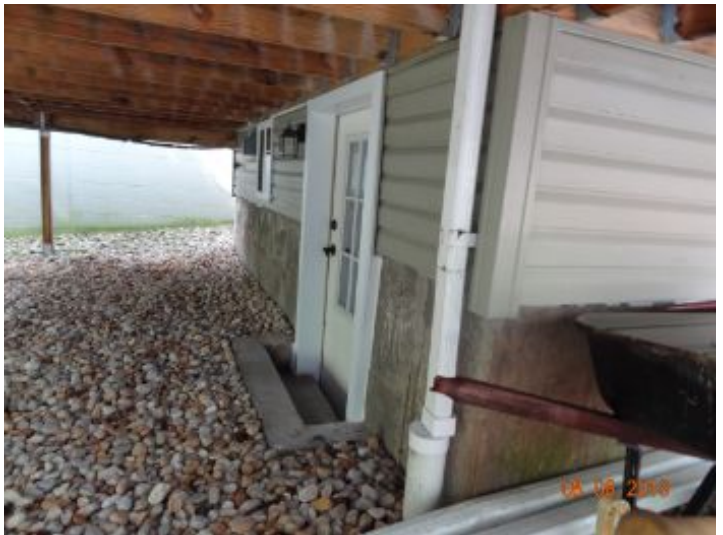
- Poor weather seal observed at front entrance door at the top of the frame. Water staining observed at the base of the rear basement entry door frame, the base of this door is water rotted. There is no means of drainage at this area. the deadbolt does not lock at the rear basement entrance door.

rear basement entry

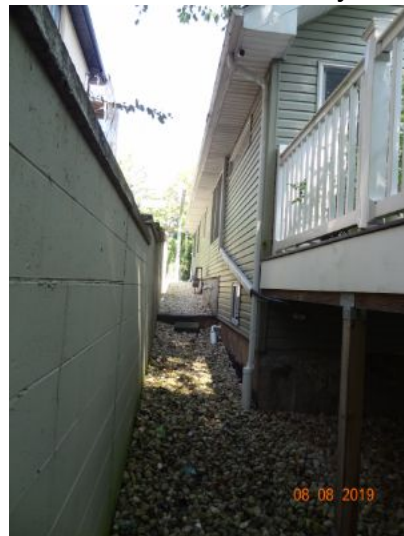
right side of houser

Page 9 Item: 12	Vegetation Affecting Structure	<ul style="list-style-type: none"> Tree branches overhanging/contacting House structure at the right side, trim/prune/remove as needed.

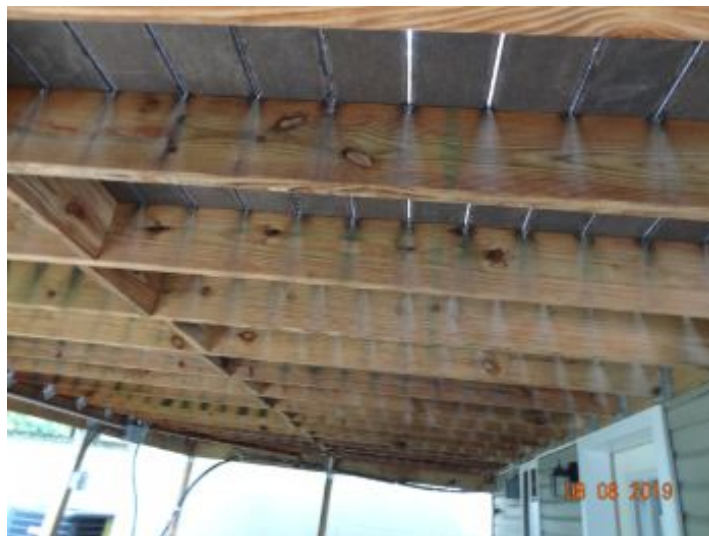
below deck structure

Observations: Appears in serviceable condition.

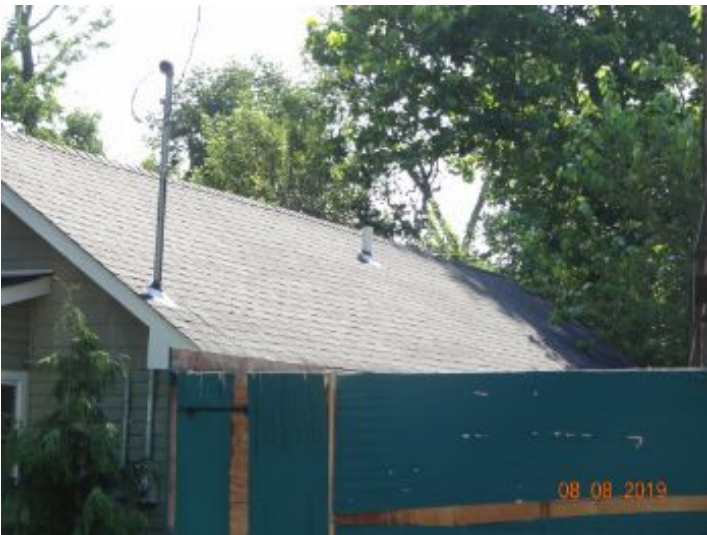
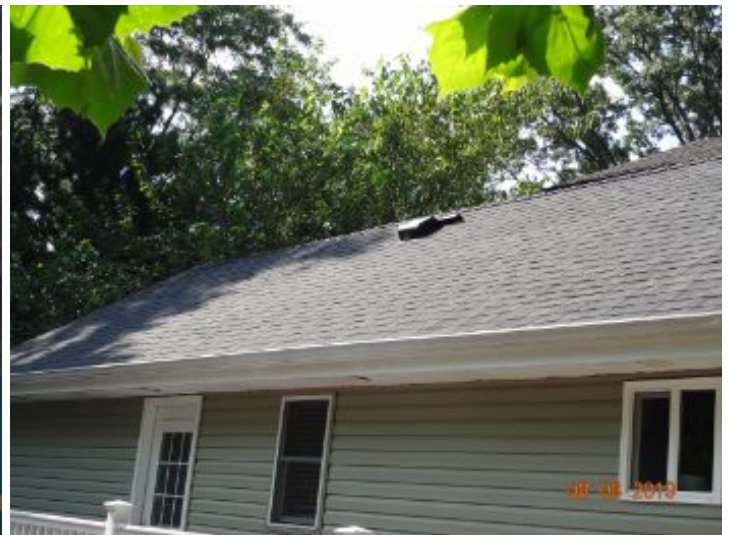
Roof Covering

- Visible areas of the roof appeared serviceable at time of inspection, except where noted. No prediction of future performance or warranties can be offered.

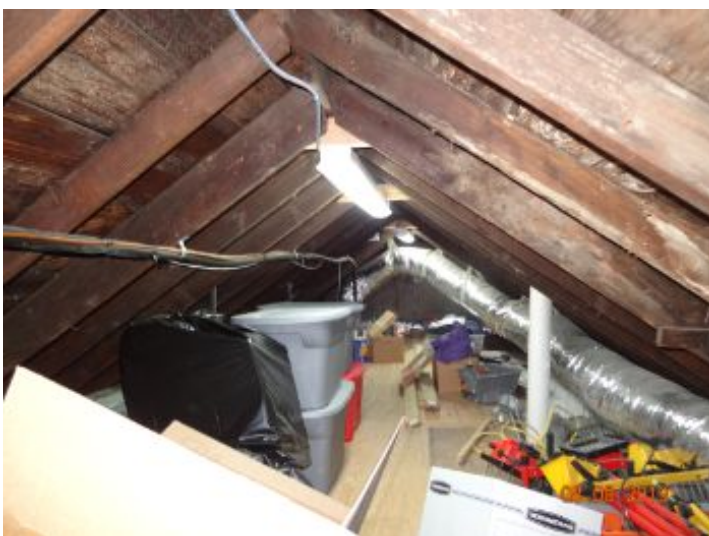
Attic

- Limited review of roof structure due to vaulted ceilings at the extension. Limited review of ceiling structure do refinishing materials.
- One cracked rafter and one damage rafter observed at the left side of the roof structure.
- FYI: Roof rafters have been reduced in size from 2 x 6 to 2 x 4 at the rear section of the attic.

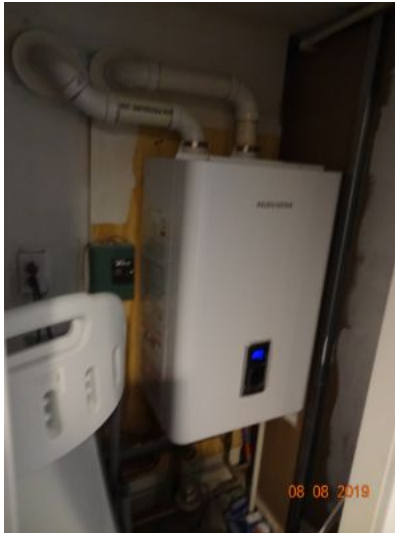
tankless boiler/water heater

- Functional at time of inspection.

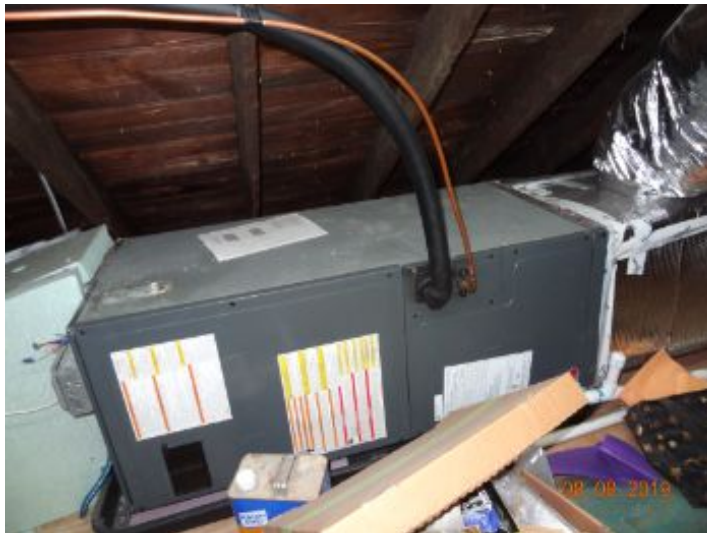
Interior a/c unit in the attic

- Functional at time of inspection
- The PTAC A/C unit(s) were operating within normal performance range. A temperature differential of 14 degrees was observed. 14 to 22 degrees is considered normal performance.
- FYI: There is no central a/c in the basement.

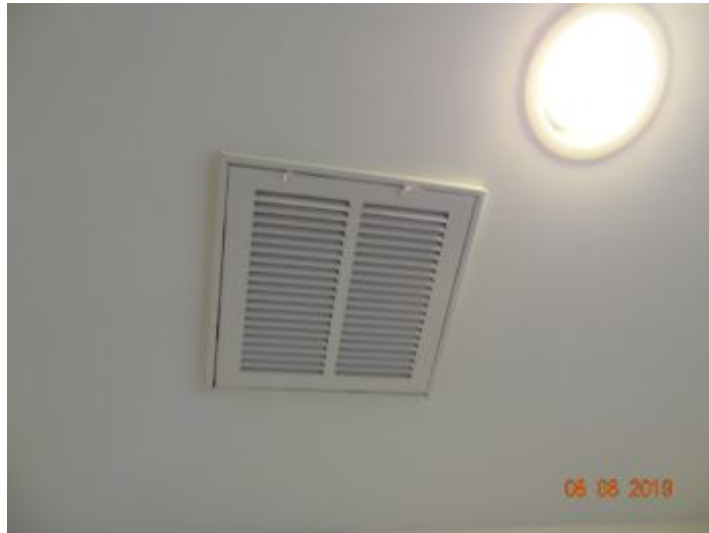
central a/c returns/air filters

- No deficiencies noted.
- **MAINTENANCE:** The air filter(s) should be inspected at least monthly and cleaned or replaced as required.

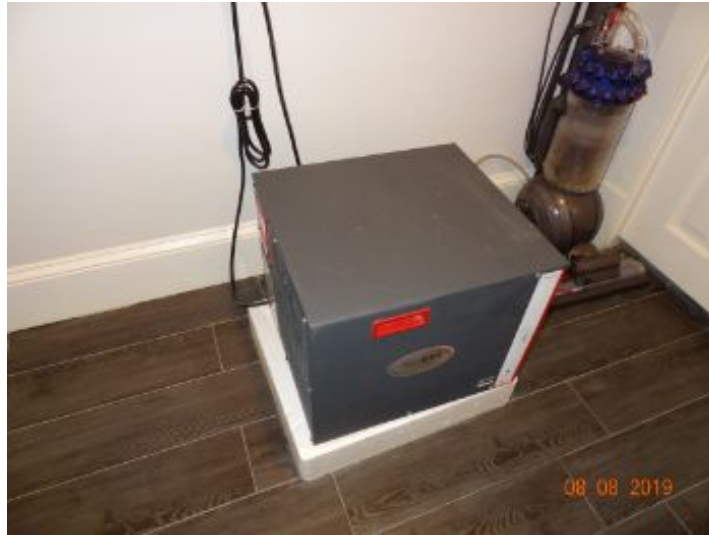
- FYI: there is a dehumidifier present in the cellar, it is connected to a condensate pump to dispose of the water.
