Home Inspection Report

123 Brick Rd
Sample, IL 12345

Inspected By: Erich Rohloff IL License
450.011661 Expires 11/30/2026

Brick by Brick Inspections Inc.
(708) 261-4467
brickbybrickinspections.com

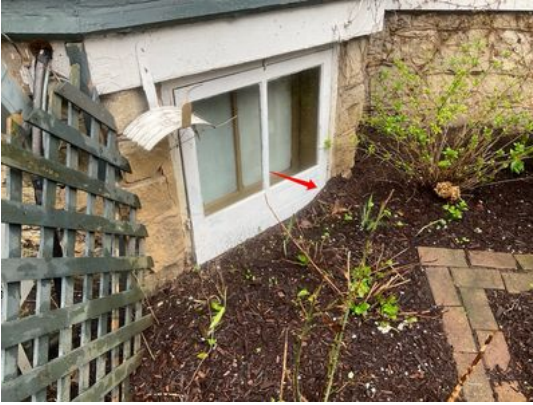
Soil/mulch in contact with the exterior wood storm windows. Recommend moving the soil back from the exterior of the house so it is not in contact with the wood trim or storm windows.

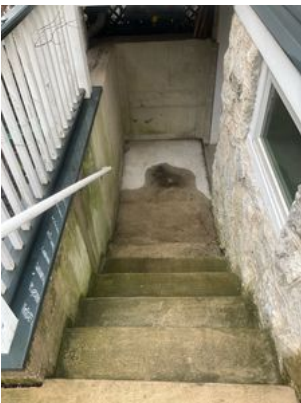
Comment 5

Recommend keeping the drain at the base of the stairwell cleared to keep water from entering the basement.

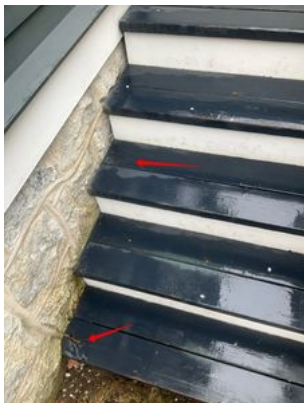
Comment 6

Deteriorating stair treads located at the rear staircase. Recommend replacement of the deteriorating stair treads.

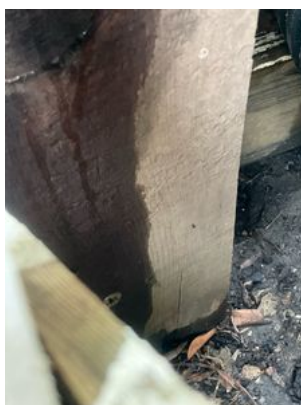
Comment 7

The supporting post on the rear deck are set slightly below grade. This can allow for the wood posts to slowly deteriorate, causing settlement of the deck.

The ledger board is not bolted to the homes exterior but appears to be nailed. The supporting board should be bolted it the homes exterior. Recommend monitor for movement or settlement of the deck. Future repairs should be made by a licensed contractor.

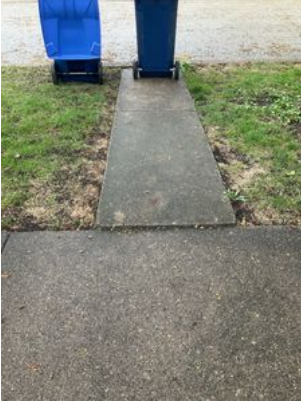
Comment 8

The walkway is uneven leading to the street and is a potential tripping hazard.

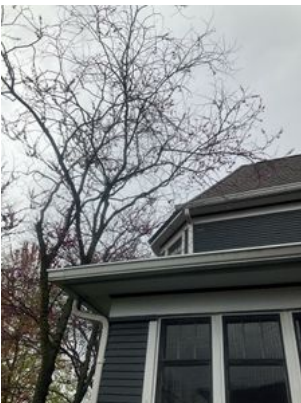
Comment 9

Tree hanging over the front of the house may require periodic maintenance to keep the branches from coming in contact with the roof or exterior of the home.

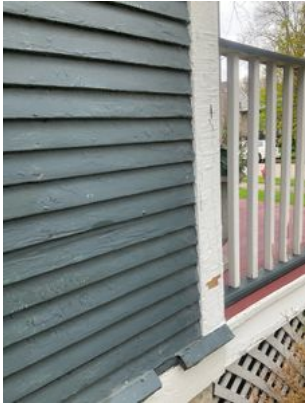
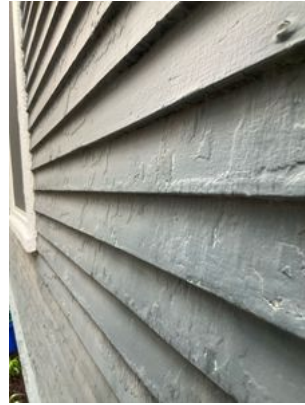
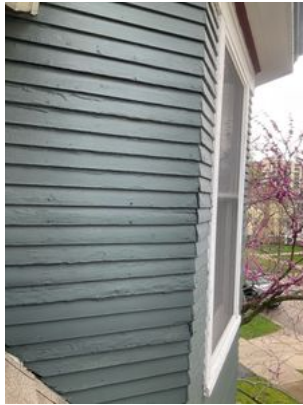
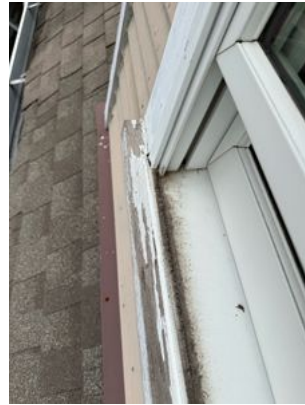
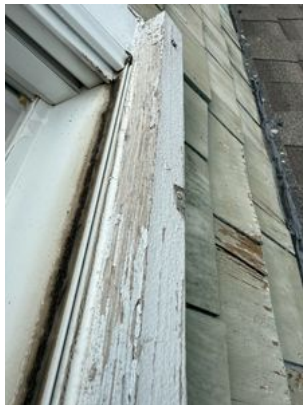
Peeling paint noted along the home exterior wood siding, trim, and railings. Multiple layers of paint over the original sections of the house. It is recommended that a professional painter further evaluate and make recommendations for painting the home exterior.

Continued moisture exposure to the exterior wood siding and trim can begin to cause deterioration of the wood. It is recommended that the exterior be repaired and painted in the near future.

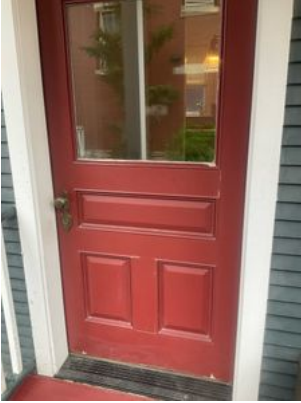
Peeling paint noted on the side entry door. Recommend scraping and repainting the entry door.

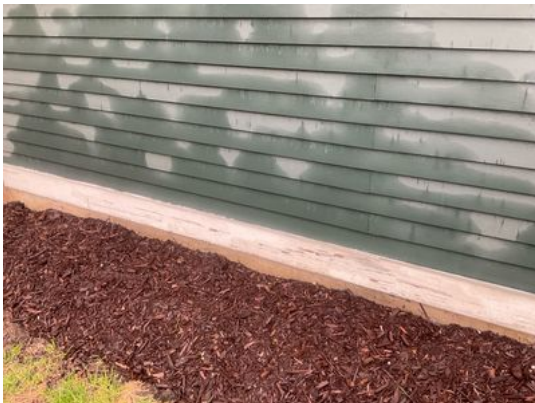
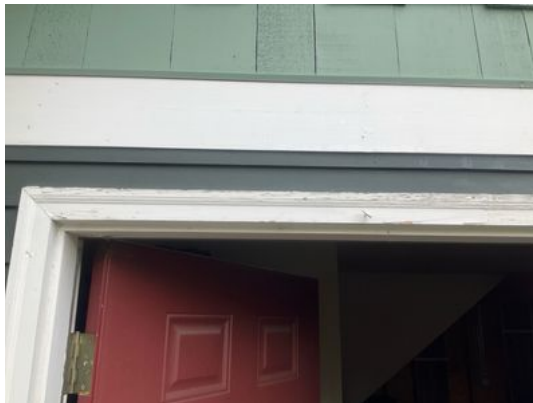
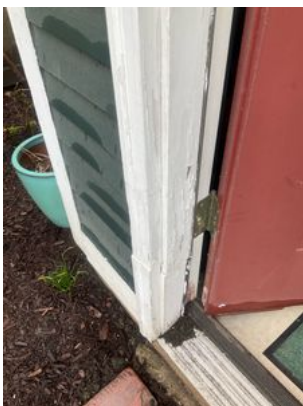
Peeling paint noted around the garage is wood trim, and door casings. Recommend repairing any damaged or deteriorated wood and repainting the wood exterior trim.

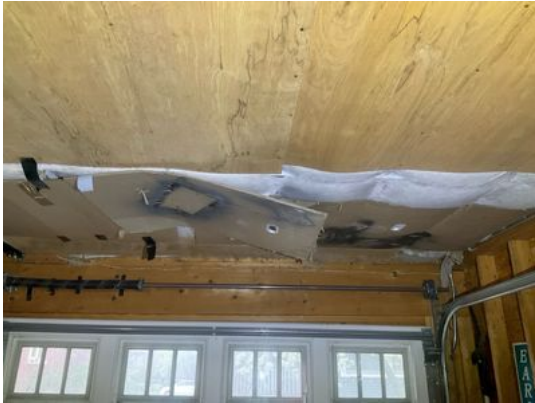
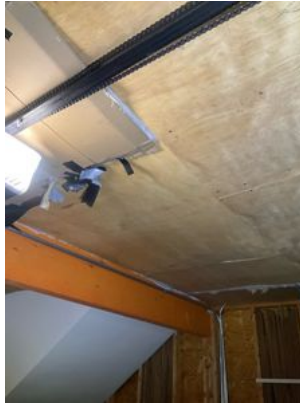
Recommend replacement of the quarter inch plywood and cardboard ceiling in the garage with 5/8 inch drywall. Drywall is recommended as a fire barrier between the occupied space above the garage. Recommend that the garage be sealed off completely from the living space above.

A sufficient fire barrier door with an auto closing feature is installed on the staircase, leading to the second floor.

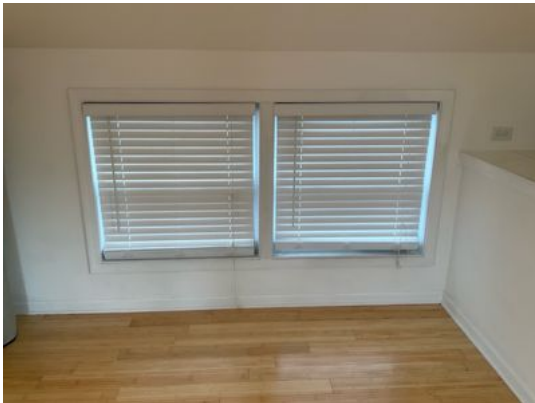
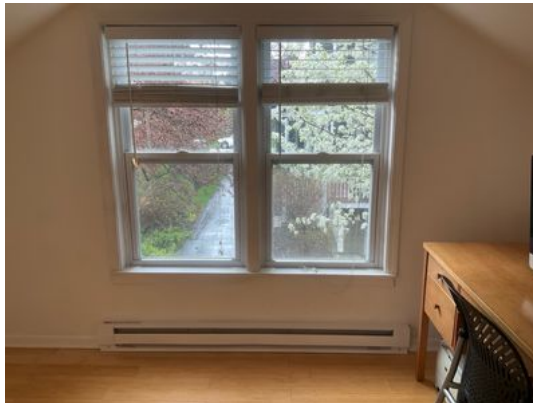
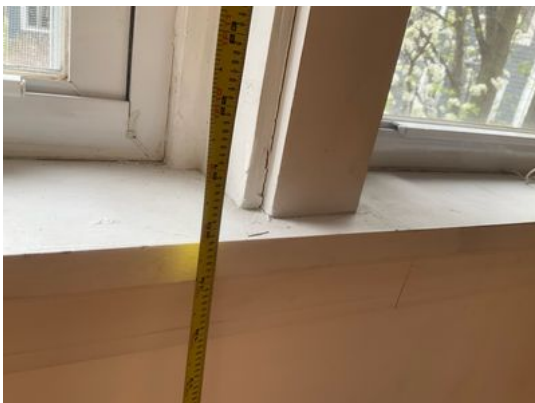
The base of the windows are close to the floor. The minimum recommended window height from the floor is 24". Low windows should have a locking system so the windows do not fully open and tempered glass should be installed. Open windows can be a safety hazard for children.

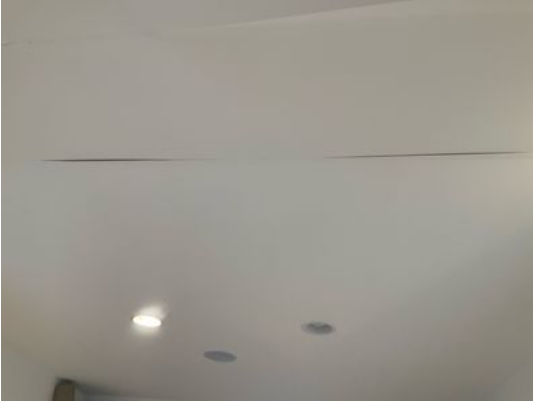
Drywall tape separating/cracking, this is common and can be repaired.

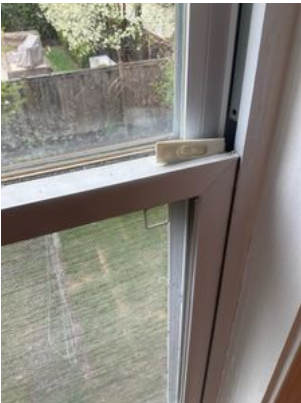
The side lock on the west facing window is broken.

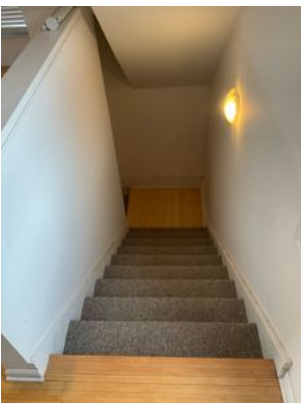
Recommend installing a graspable handrail along the garage staircase to the second floor.

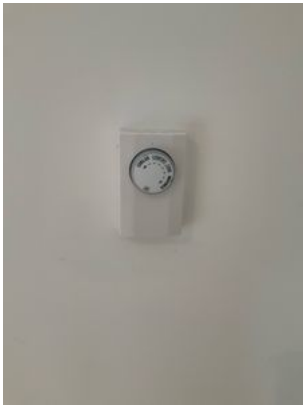
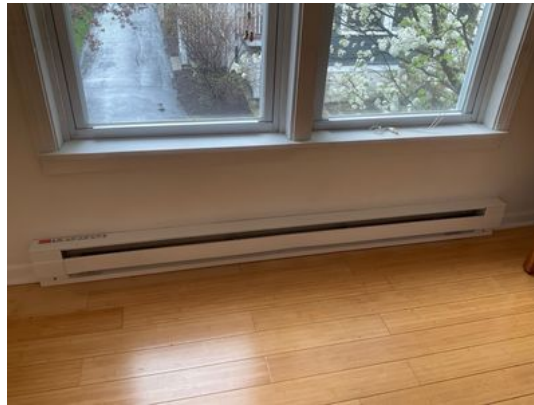
Electric baseboard heater installed along the south wall of the second floor. The electric baseboard heat is controlled using the thermostat. The heater was tested and was operational.

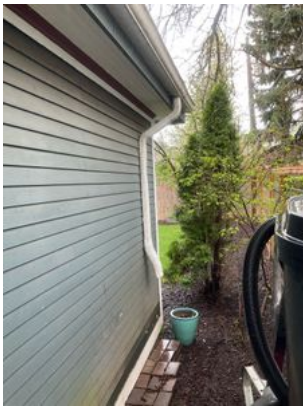
Recommend repairing the downspout at the rear of the garage and extending the drainage a minimum of 4 feet away from the structure.

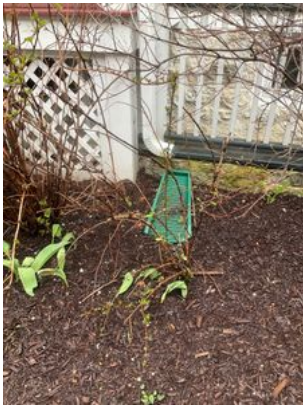
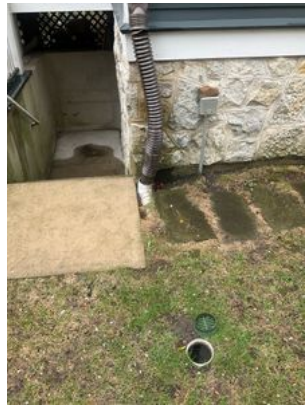
The downspouts are draining along the exterior but not moving water far enough from the home. All downspouts should discharge water 4-6 feet away from the structure, preferably where the water can run off and drain. Recommend extending downspouts and underground drainage away from the foundation.

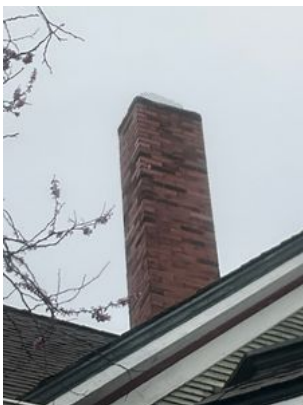
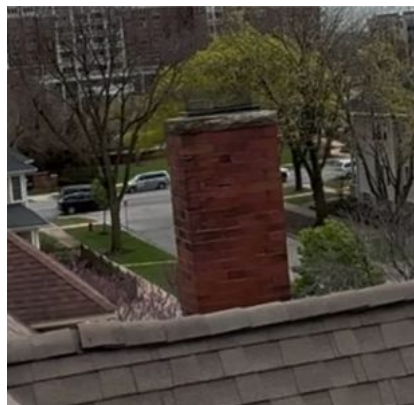
No rain cap installed on the chimney. A mesh has been installed over the chimney to prevent birds or small animals from entering the chimney. It is recommended that a rain cap be fixed to the top of the chimney to stop moisture penetration down the chimney flue.

The fireplace and the water heater share the same chimney. It is recommended that a qualified HVAC contractor or a professional chimney contractor inspect the chimney flue and install a rain cap.

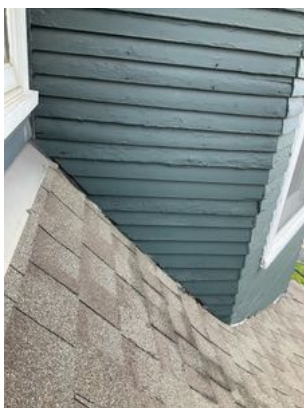
The wood exterior siding is in contact with the roofing shingles, this has caused the wood trim and siding to deteriorate around the corners of the home. A minimum of a 1" gap should be present between the siding and the roofing shingles.

A metal flashing should be installed behind the siding and under the roofing shingles where the roof meets the exterior walls, this was not visible in some corners of the home but appears to be installed.

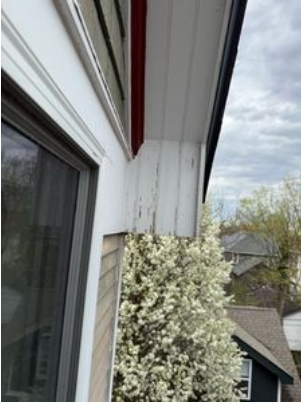
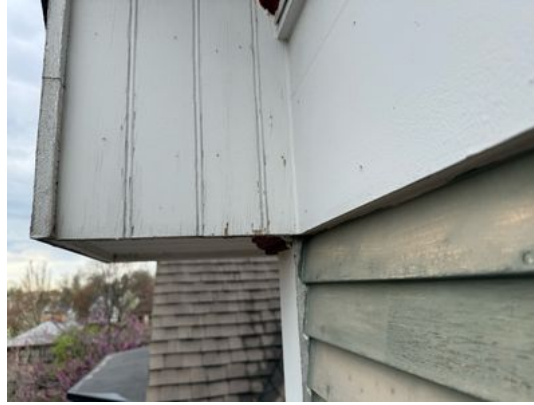
Portions of the wood soffit have peeling paint. Recommend that the soffits be scraped and repainted to protect the wood from moisture exposure.

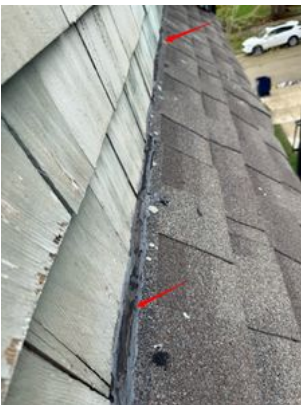
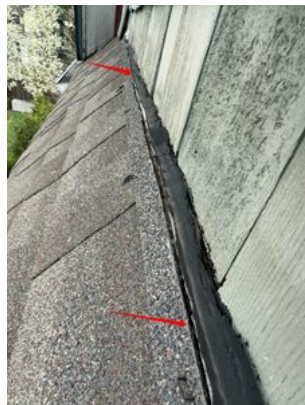
The roofing shingles between the 1st and 2nd floors along the west side of the home do not have a proper flashing installed between the exterior siding and the roofing shingles. The seam has been sealed using a caulking or roofing tar, there is visible separation between the shingles and the exterior siding. Recommend that a licensed roofing contractor repair by installing a flashing under the exterior siding that covers the gap where the roofing shingles start.

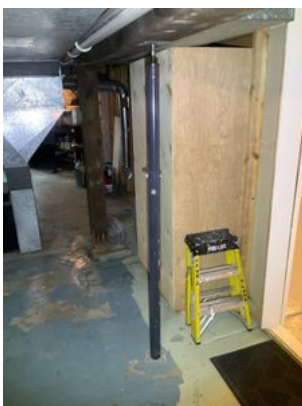
The supporting posts used in the basement utility room are meant to be used as temporary supports. It appears that the post has been installed as a permanent support. It is recommended that a licensed contractor further evaluate and replace the temporary support with a permanent supporting post including a concrete footing and mechanical fasteners to the structure.

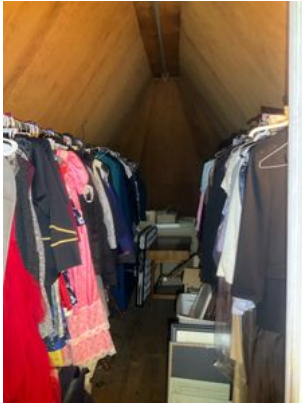
Portions of the attic were not inspected. No attic access. The roofing structure, roof decking, ventilation and installed insulation was not visible for inspection.

The only original section of the house which may have been part of an attic space was the rear closet pictured above.

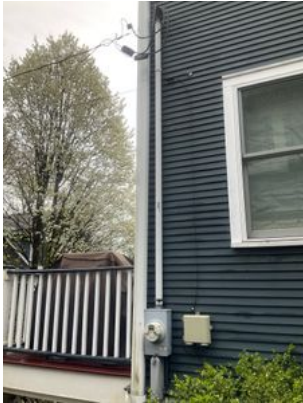
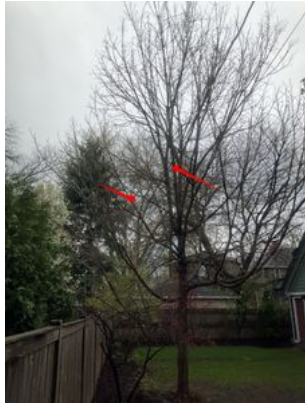
Main electrical service connection at the rear of the home. The electrical service line is in contact with trees in the yard. Recommend that a professional arborist cut back the branches that are in contact with the electrical service line.

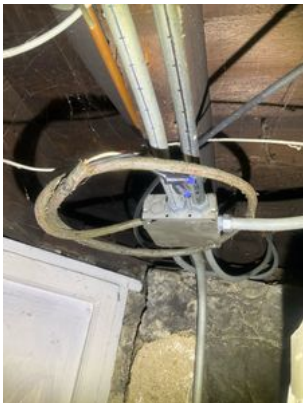
Comment 37

Non metallic shielded electrical wiring that has been capped up along the basement ceiling over the utility sink. Recommend that the wiring be removed by a licensed electrician.

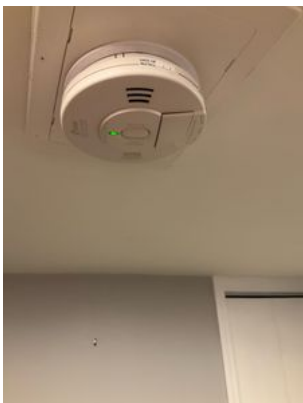
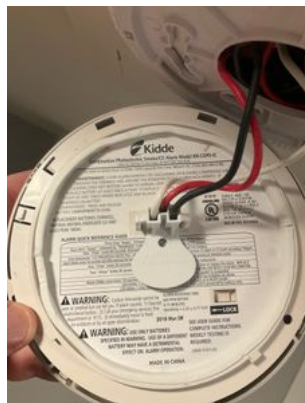
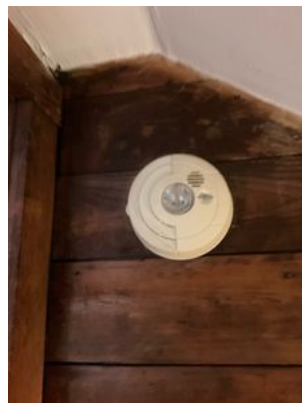
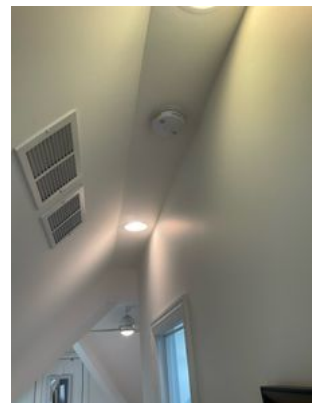
Comment 39 Deficiency

Smoke and carbon monoxide detectors installed in the home dated 2019. Some older smoke detectors were present that were over 10 years old.

Smoke and carbon monoxide detectors installed in the home on the 2nd and 3rd floors. Recommend adding a combination smoke and carbon monoxide detector near the 2nd floor rear bedroom and in the basement near the furnace and water heater. Adding individual smoke detectors to each bedroom is also recommended.

Illinois law requires that new smoke and carbon monoxide detectors be hard wired and powered OR have a 10 year sealed battery.

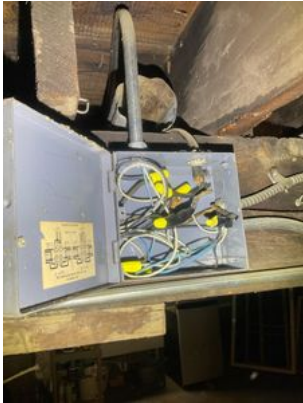
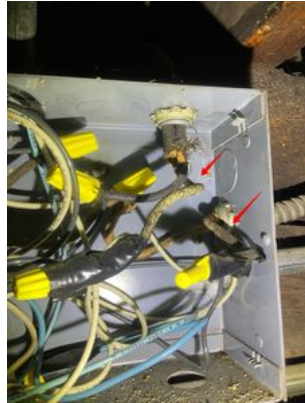
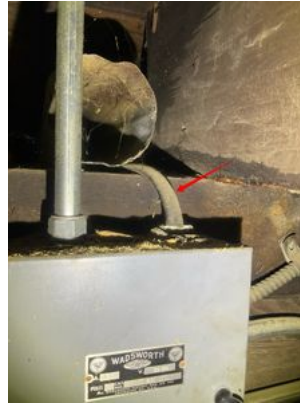
Comment 40 Deficiency

Older fuse box has been abandoned, several electrical connections have been made inside the fuse box. Recommend that the fuse box be sealed closed.

Older, cloth insulated wiring was present. This wiring insulation can wear down or can become brittle and break. Non metallic shielded wiring extending from the fuse panel. Recommend that the wiring be replaced by a licensed electrician.

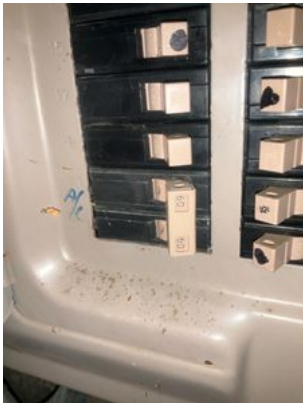
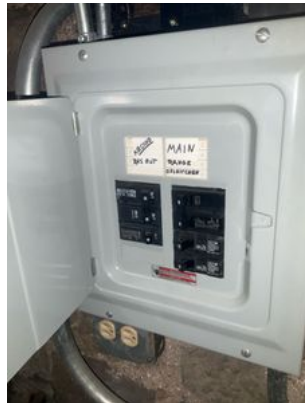
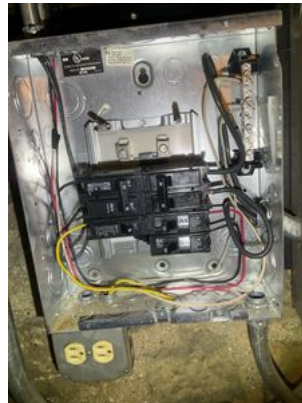
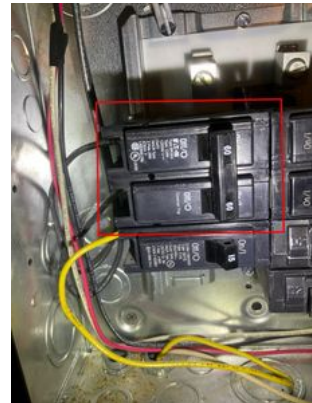
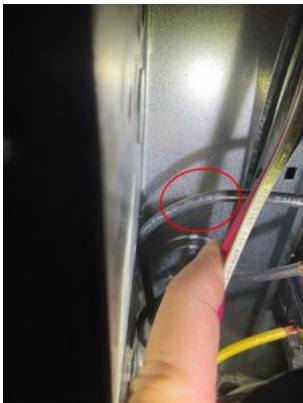
60 amp breaker in the sub panel (older panel) is the disconnect for the 2nd sub panel.

10 AWG wiring connected to a 60 amp breaker in the 2nd sub panel. The circuit wiring is undersized for the 60 amp breaker and poses a safety hazard. Recommend repair by a licensed electrician.

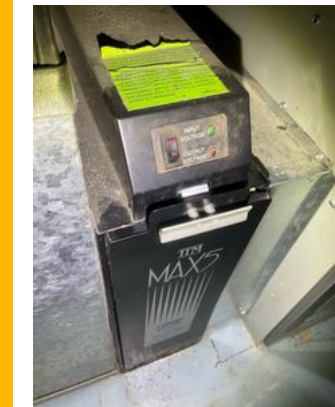
Comment 45
Deficiency

The older electric filter was no longer in use. The cover where the disposable filter is installed does not fully close and latch.

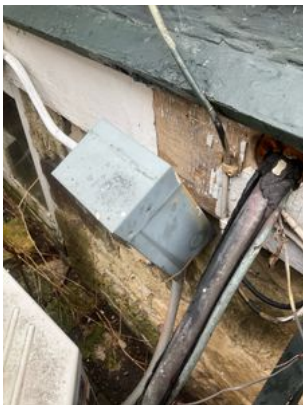
Comment 47

The electrical disconnect box for the air-conditioning condenser is not secured to the home exterior. Recommended a qualified contractor secure the electrical disconnect box to the exterior of the home.

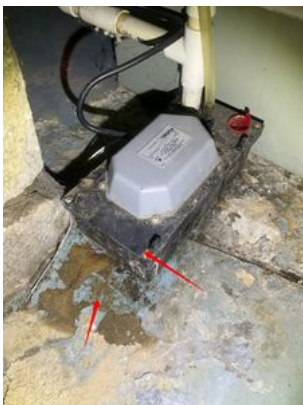
Comment 48

The condensation pump on the furnace appears to be leaking. Recommend repair or replacement of the condensation pump by a qualified HVAC contractor.

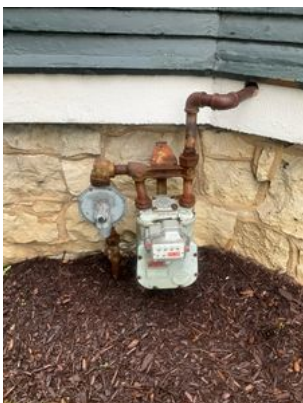
Gas meter and main shut off located at the side of the home.

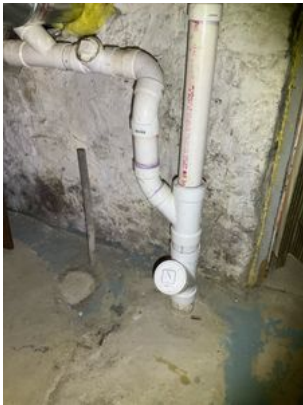
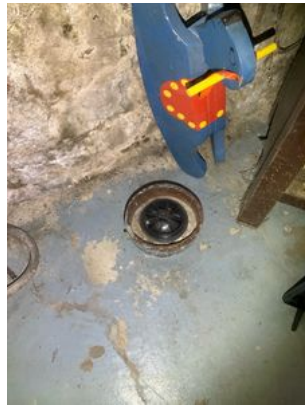
Comment 54 **Information**

Main waste line and clean out.

Only a visual inspection is performed to note the access for the main waste line, a licensed plumber can perform a sewer scope to determine the condition of the waste system drainage (not part of the inspection).

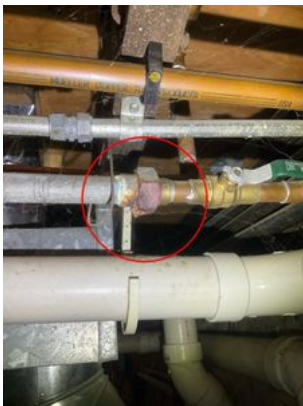
Comment 55 **Deficiency**

Corrosion at a water supply union connection indicates a water leak. This is located above the basements water heater. Recommend repair by a licensed plumber.

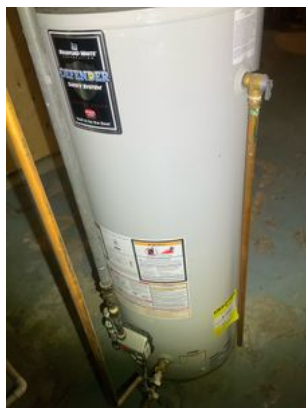
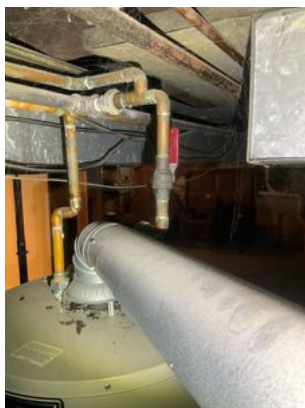
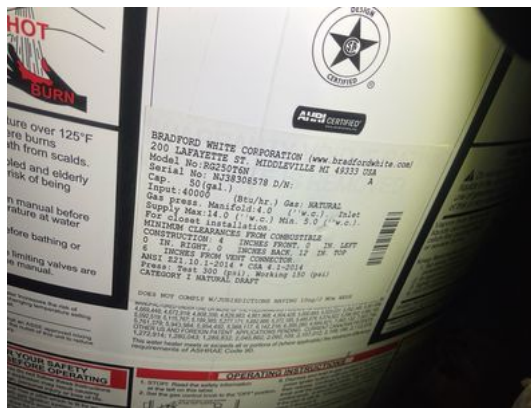
Water heater appears to be operating properly. Water and gas valves noted in photos.

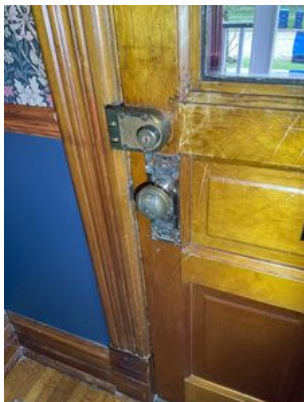
Keyed lock on the front entry door. This can create a safety hazard in the event of a fire or other emergency if the door cannot be opened. Recommend replacing with a standard deadbolt lock.

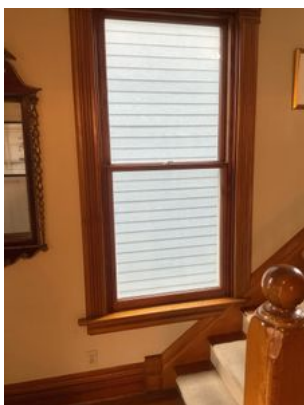
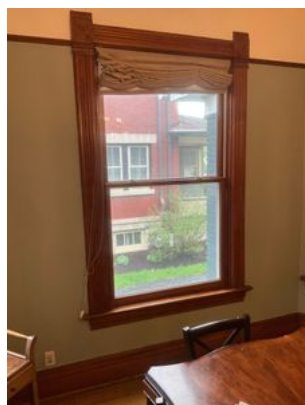
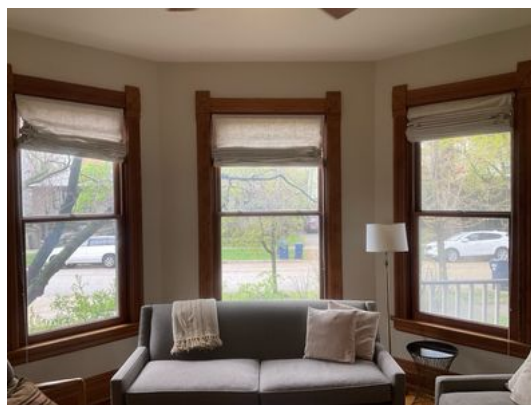
Comment 60

The lower window sashes in the entryway, living room (3 windows) and the dining room do not stay open and fall closed. The window must be propped open. Recommend repair by a licensed contractor.

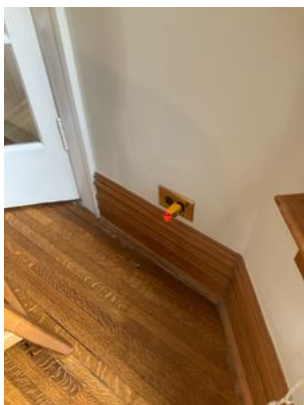
The interior outlet has reversed polarity (hot and neutral reversed). Recommend repair by a licensed electrician.

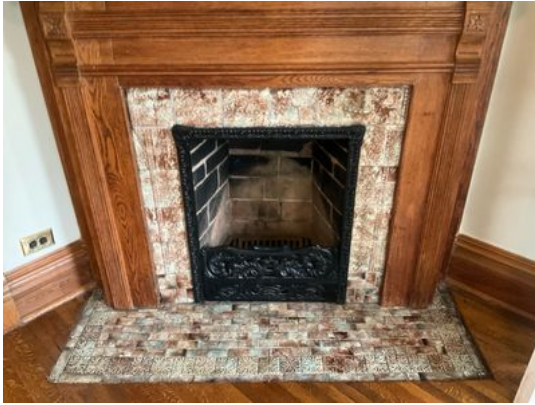
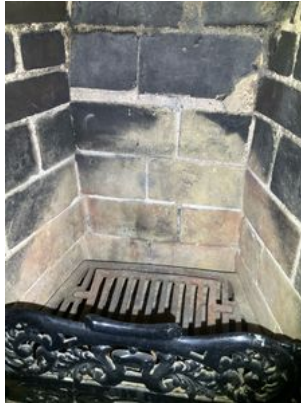
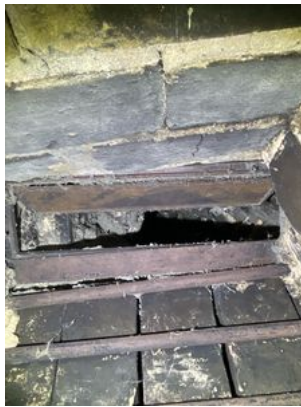
Comment 63

Masonry wood burning fireplace. The flue was functional. There is missing mortar between the bricks in the firebox that should be repaired. Recommend having the fireplace inspected by a professional chimney contractor prior to use.

The full condition of the chimney flue is not available, the entire chimney was not visible during the inspection. Further evaluation of the chimney by a professional chimney contractor or chimney sweep can determine the condition of the chimney flue.

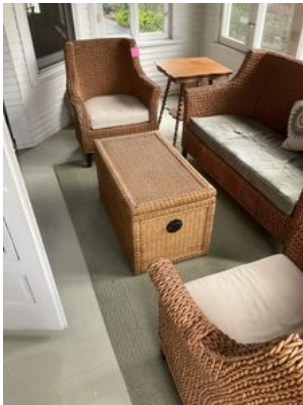
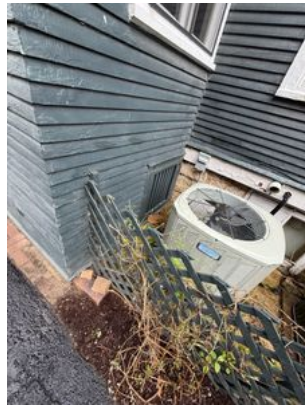
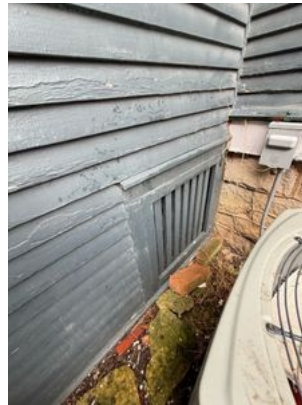
Movement noted in the enclosed porches flooring. The crawlspace under the porch was not fully accessible, the hatch was painted shut and not accessible. The flooring structure may require repairs. Recommend further evaluation by a licensed contractor.

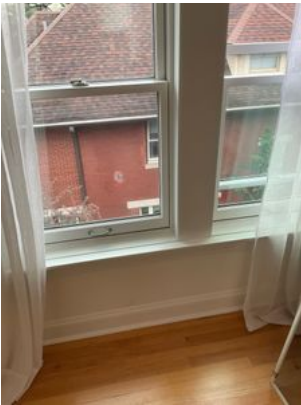
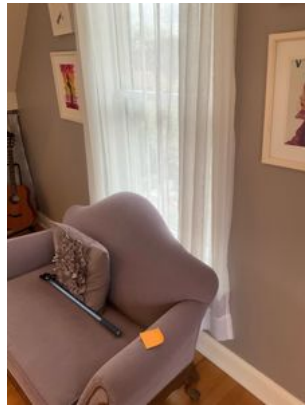
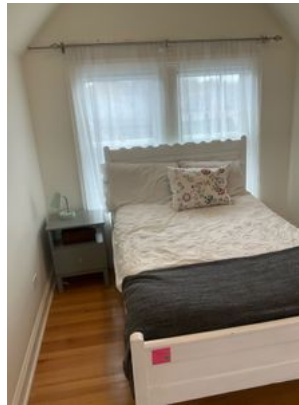
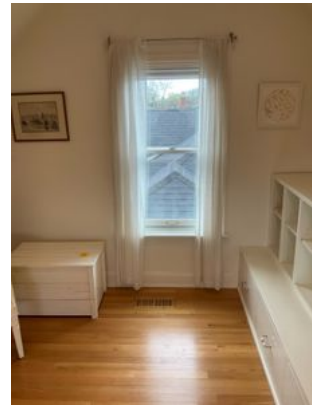
The base of the windows are close to the floor. The minimum recommended window height from the floor is 24". Low windows should have a locking system so the windows do not fully open and tempered glass should be installed. Open windows can be a safety hazard for children.

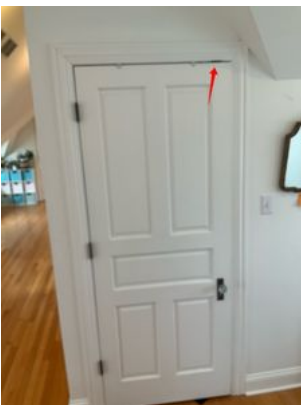
Comment 67

The door does not latch and lock. The door or the spring loaded lock requires adjustment.

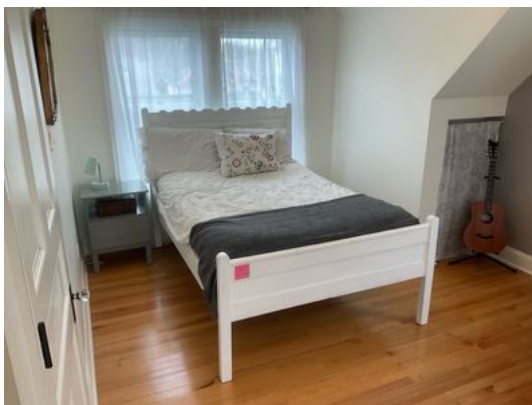
Comment 69
Deficiency

Furnace is located in a closet for a room that is correctly used as a bedroom. It is not recommended that a furnace pull its combustion air from a bedroom or be placed in a bedroom due to a fire hazard and the potential for toxic fumes to emit from the furnace.

Recommend that a sealed, fire rated door be installed on the furnaces closet. The installed furnace is high efficiency and pulls combustion air from the homes exterior, no further modifications should be necessary.

Recommend further evaluation and repair by a licensed contractor.

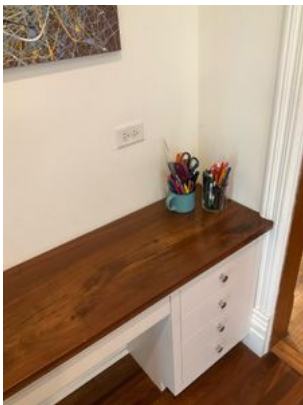
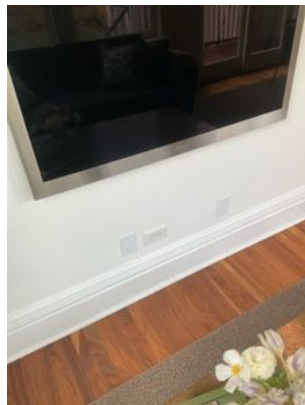
The interior outlets are loose in the wall. Recommend securing the outlets.

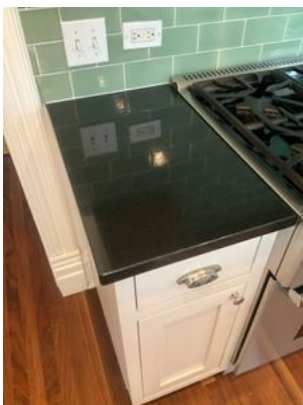
Comment 71

Corner of countertop is loose. Recommend attaching to the cabinet base.

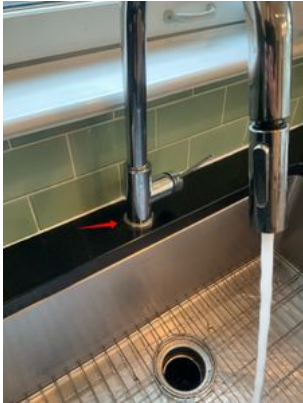
Comment 72

The faucet is loose at the base.

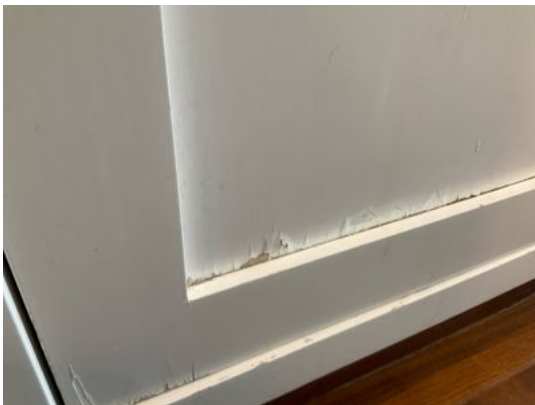
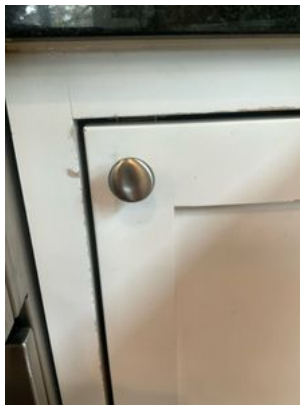
Comment 73

Small areas of loose and peeling paint noted across the kitchen cabinets.

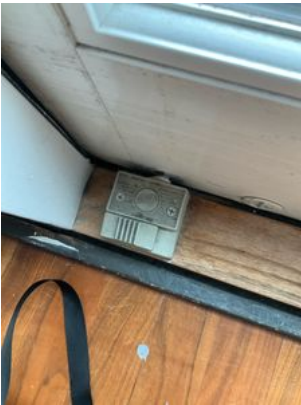
Comment 74

The secondary lock on the sliding entry door sticks when locked and is difficult to open. Recommend lubricating and exercising the lock.

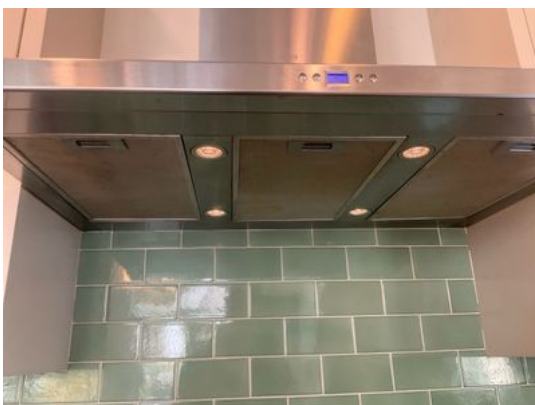
The range hood lights flicker when on the lowest setting.

Recommend cleaning the screens on the range hood so it will draft more effectively.

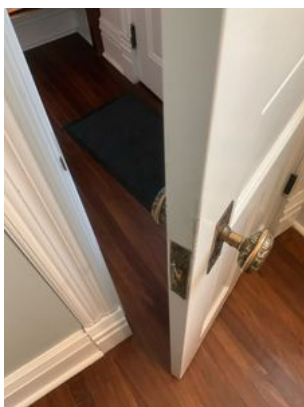
The entry door does not latch properly and stay locked. Recommend adjusting the door lock plate as needed.

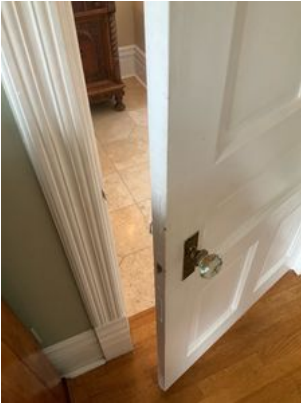
The entry door does not latch properly and stay locked. Recommend adjusting the door lock plate as needed.

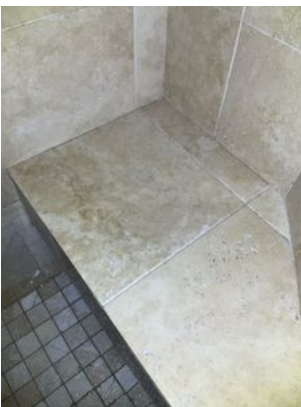
Comment 79

Recommend caulking the corners around the bench in the shower stall.

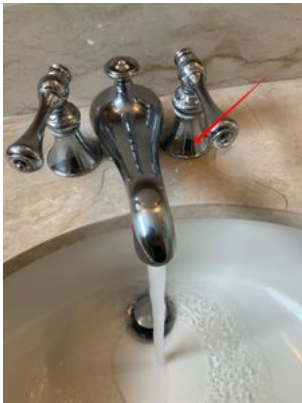
The cold water valve leaks when in the on position. Recommend repair or replacement of the faucet valve by a qualified plumber.

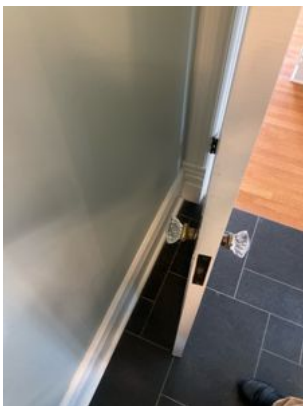
Missing door stopper, recommend installing door stoppers to prevent wall damage from the door knob.

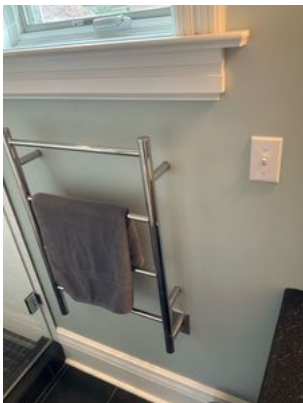
Comment 82

Heated towel rack is activated by using the adjacent wall switch.

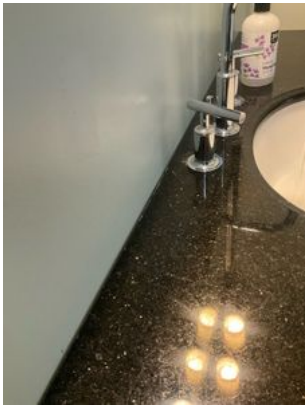
Comment 83
Deficiency
Recommend caulking all seams and edges around the vanity top.

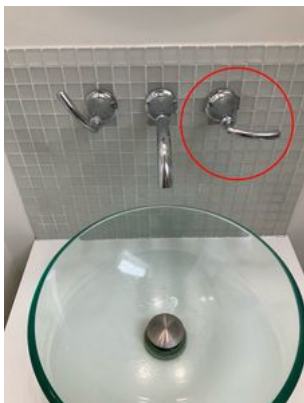
The cold water valve at the sink does not have a stop installed. The valve continues to spin and does not stop when turning off. The valve must be positioned as pictured to turn off the flow of water. Recommend repair or replacement of the valve by a licensed plumber.

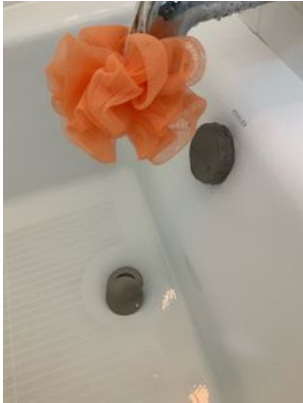
Comment 85

The drain stopper is not functional using the control button on the front of the bathtub.

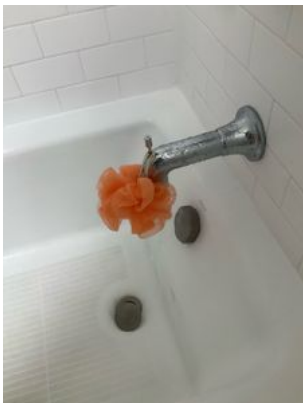
Comment 86

Shower diverter is leaking and allowing water to exit from the tub spout. This will not allow for full water pressure at the shower. Recommend repair by a licensed plumber.

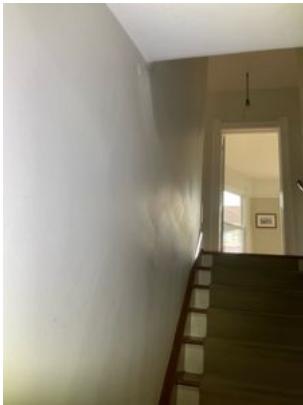
Comment 87

Bulging in separation of the plaster noted in the second floor staircase. This is common with plaster as a home settles and ages. Repairs to the plaster are considered cosmetic and can be made by a qualified contractor.

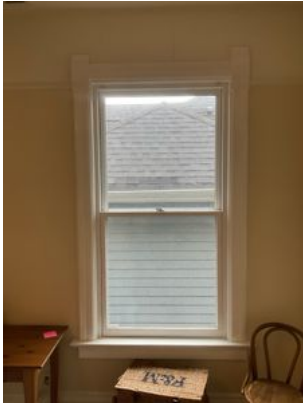
Window is stuck and could not be opened during the inspection.

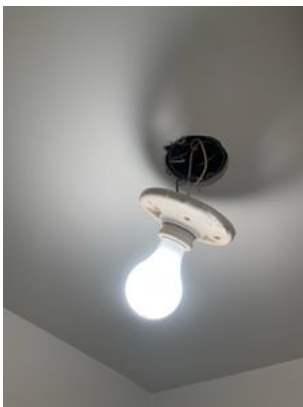
Comment 89

Loose light fixture in the closet. Recommend replacing the fixture with a covered fixture.

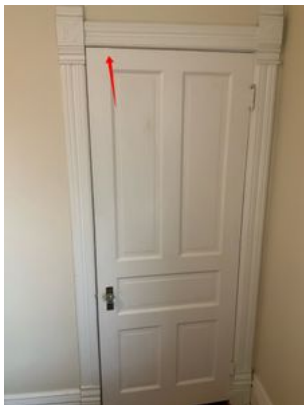
Comment 90

Bedroom closet door binds at the top of the door frame. Recommend adjusting the door as needed so it will close and latch.

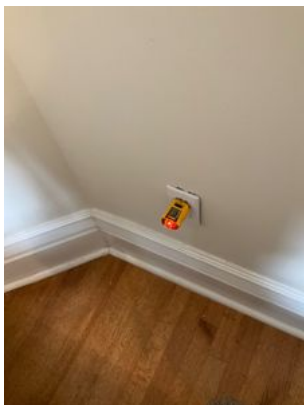
Comment 91

The interior outlet is loose in the wall. Recommend securing the outlet.

Open ground in outlet. Recommend further evaluation by a licensed electrician.

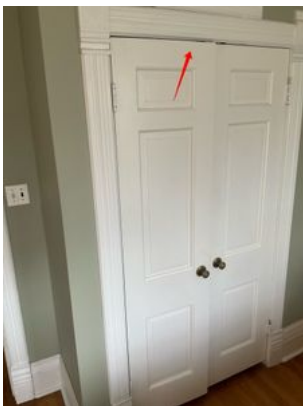
The closet door does not latch and lock. Recommend adjusting the locking mechanism as needed.

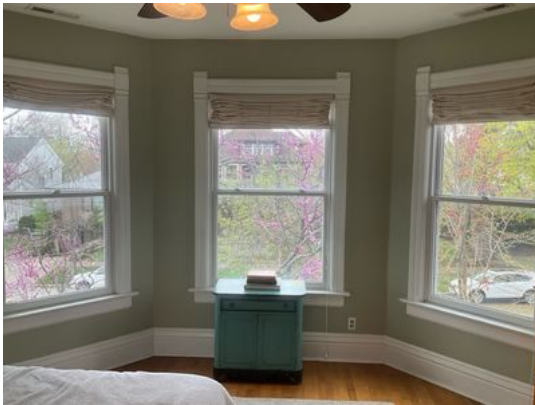
Comment 93

The lower window sashes (3) do not stay open and fall closed. The windows must be propped open. Recommend repair by a licensed contractor.

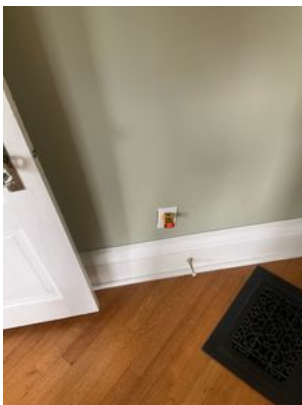
Comment 94

The interior outlet is loose in the wall. Recommend securing the outlet.

Open ground in outlet. Recommend further evaluation by a licensed electrician.

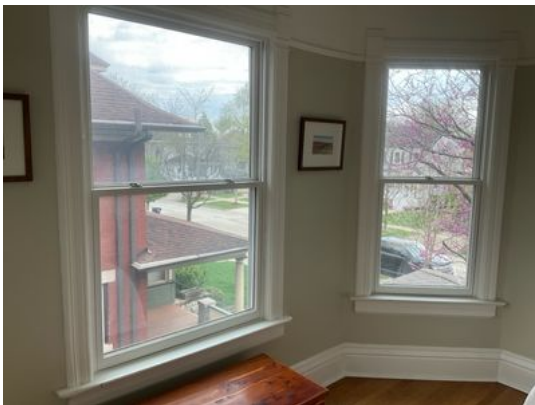
The lower window sashes (2) do not stay open and fall closed. The windows must be propped open. Recommend repair by a licensed contractor.

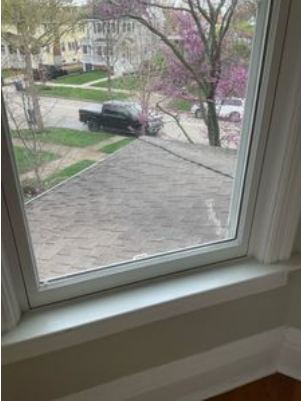
Comment 96

Torn window screen, recommend repairing.

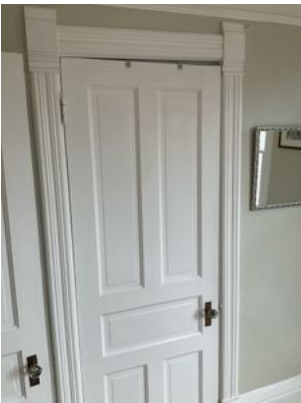
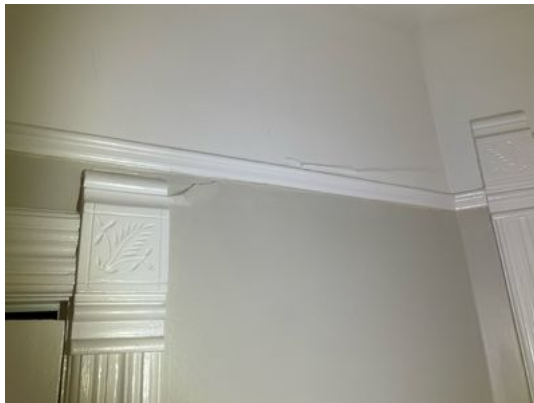
Comment 97

The door frame is out of square, this is visible by looking at the top of the door frame and the door. Larger cracks above and to the right of the closet door frame. This indicates structural settlement. Based on the age of the home, this is considered normal settlement. However, the area should be monitored, additional cracking or expansion of the existing cracks could indicate a larger structural issue. If noted it is recommended that a licensed contractor further evaluate.

Recommend that a licensed contractor repair the closet door.

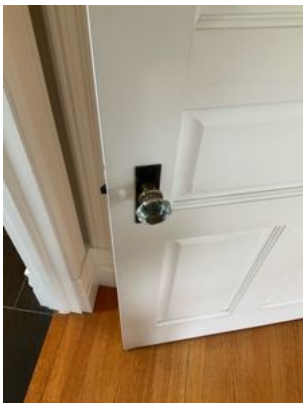
The bedroom entry doors door knob sticks and does not always operate the locking mechanism.

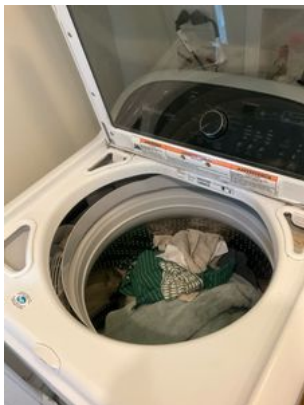
The washing machine was filled with the occupants clothing. The washing machine was not run and tested during the inspection.

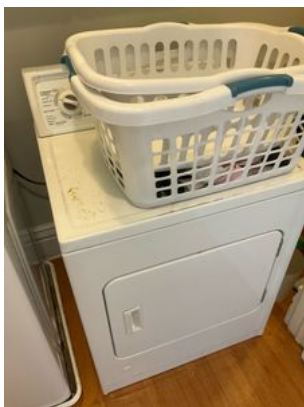
Comment 101

Dryer does not shut off when the door is opened. The dryer is operational but is older and replacement in the near future may be necessary.

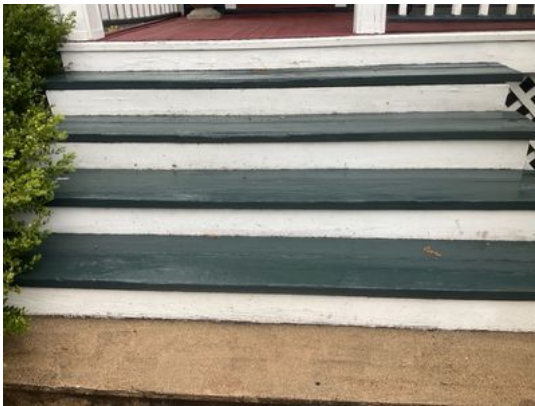
Older peeling paint noted on the entryway steps. Recommend scraping and painting the staircase.

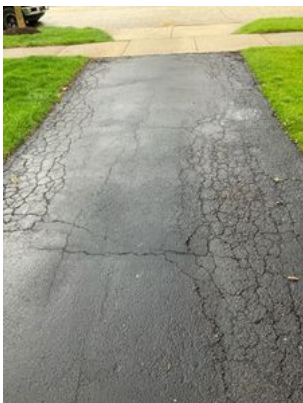
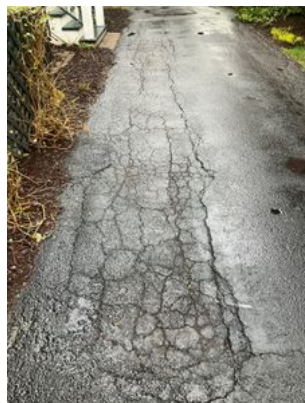
Cracking noted in the asphalt driveway. Recommend keeping the driveway sealed to prevent further deterioration of the driveway. The driveway will require patching and repairs in the next few years.

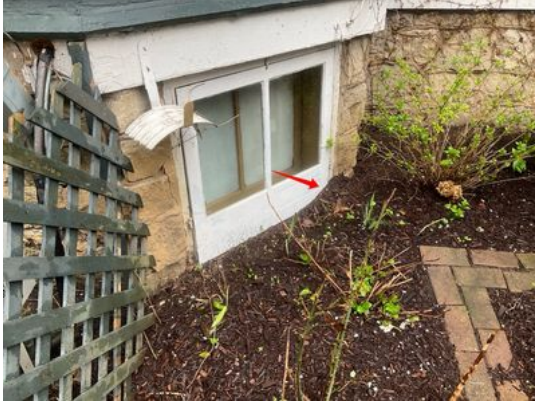
Soil/mulch in contact with the exterior wood storm windows. Recommend moving the soil back from the exterior of the house so it is not in contact with the wood trim or storm windows.

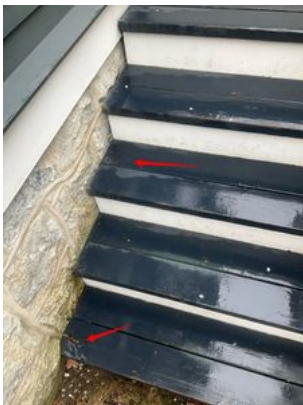
Deteriorating stair treads located at the rear staircase. Recommend replacement of the deteriorating stair treads.

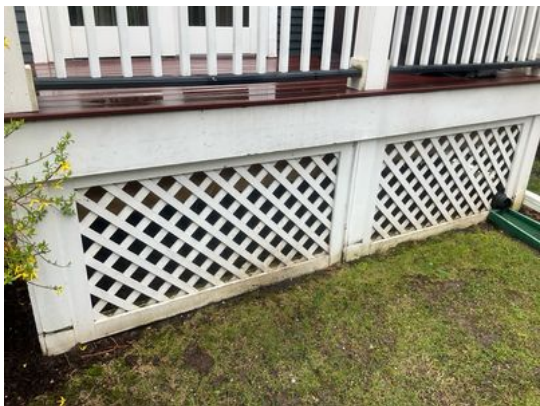
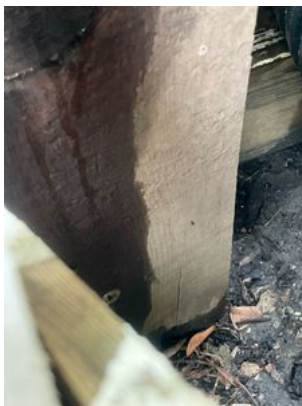
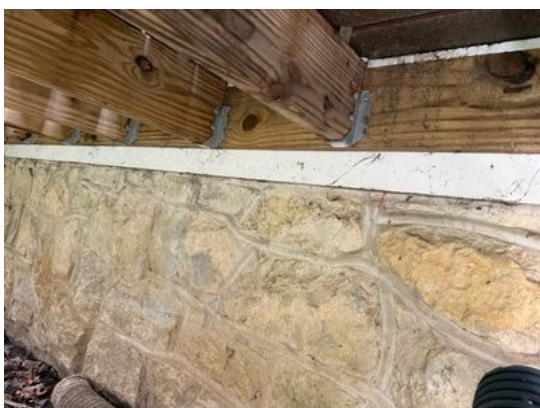
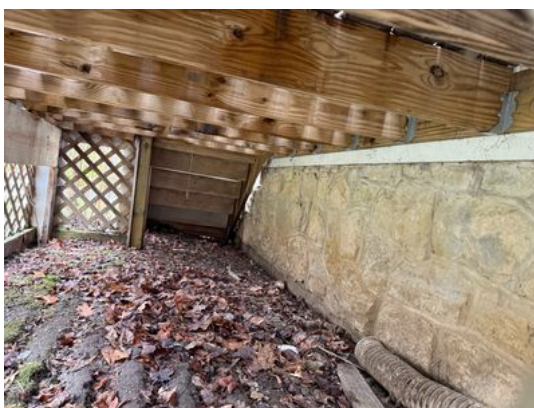
The supporting post on the rear deck are set slightly below grade. This can allow for the wood posts to slowly deteriorate, causing settlement of the deck.

The ledger board is not bolted to the homes exterior but appears to be nailed. The supporting board should be bolted it the homes exterior. Recommend monitor for movement or settlement of the deck. Future repairs should be made by a licensed contractor.

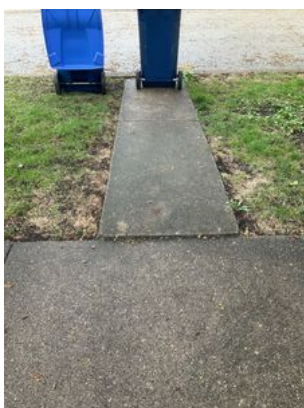
The walkway is uneven leading to the street and is a potential tripping hazard.

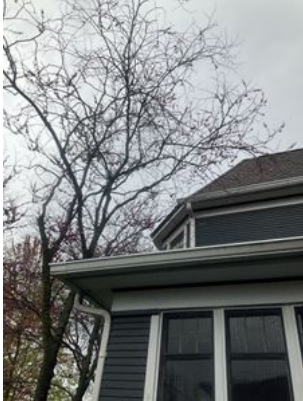
Tree hanging over the front of the house may require periodic maintenance to keep the branches from coming in contact with the roof or exterior of the home.

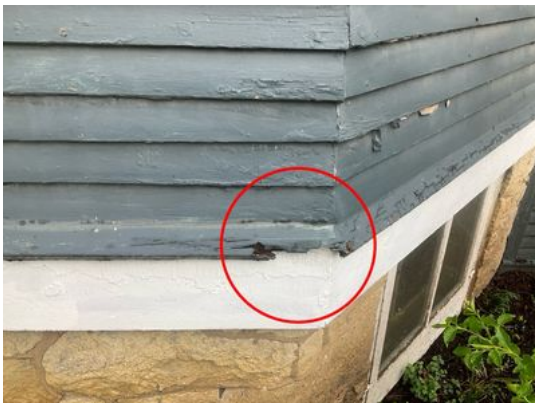
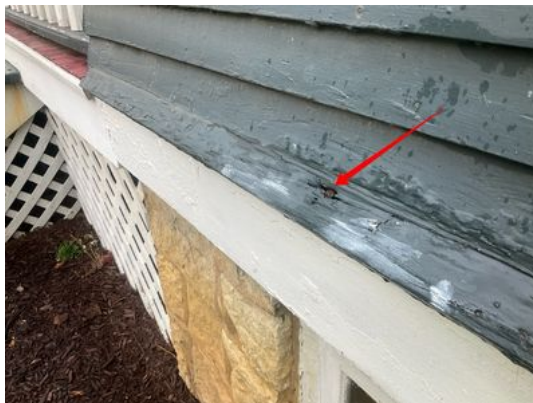
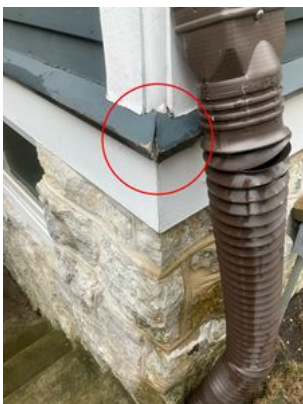
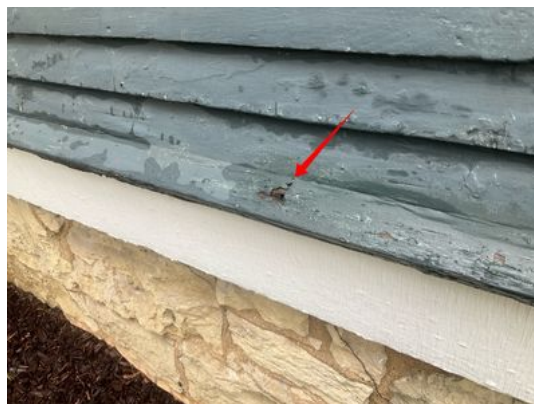
The kick out trim at the base of the homes wood exterior is deteriorating in several areas around the home. The deteriorating wood should be repaired or replaced. The corners of the newer section of the home have separated and should be sealed and repaired. Recommend repair by a licensed contractor or qualified painter.
