Home Inspection Report

123 Brick Rd
Sample, IL 12345

Inspected By: Erich Rohloff IL License
450.011661 Expires 11/30/2026

Brick by Brick Inspections Inc.
(708) 261-4467
brickbybrickinspections.com

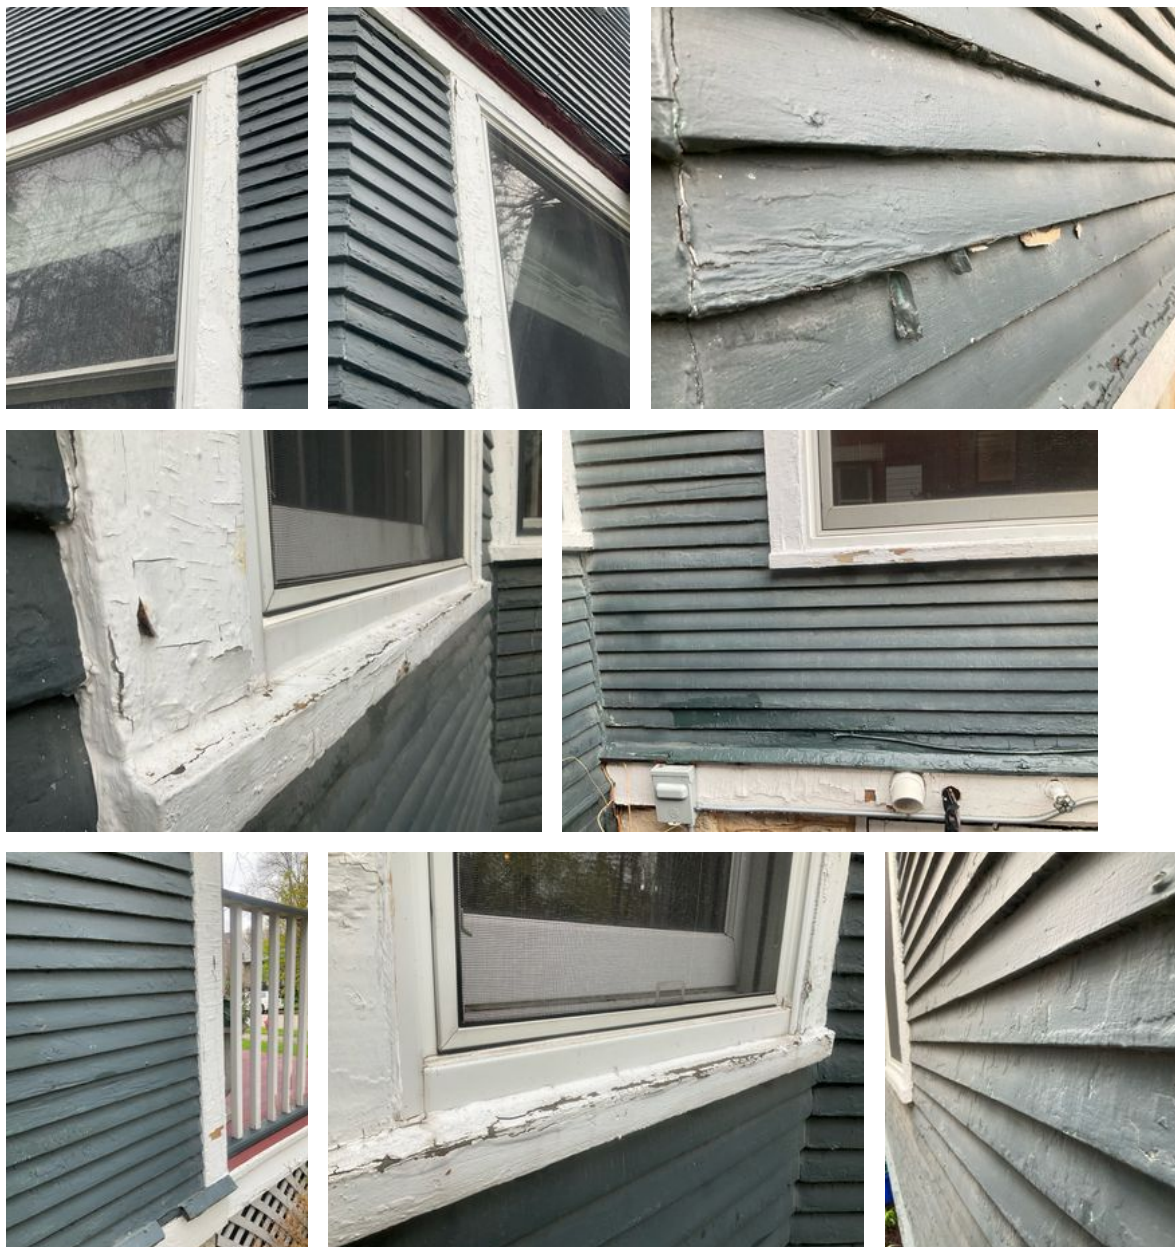
Peeling paint noted along the home exterior wood siding, trim, and railings. Multiple layers of paint over the original sections of the house. It is recommended that a professional painter further evaluate and make recommendations for painting the home exterior.

Continued moisture exposure to the exterior wood siding and trim can begin to cause deterioration of the wood. It is recommended that the exterior be repaired and painted in the near future.

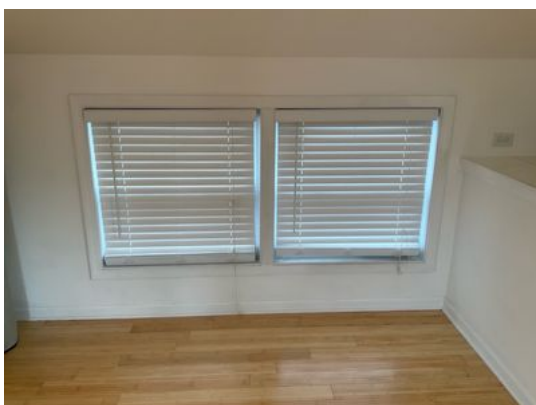
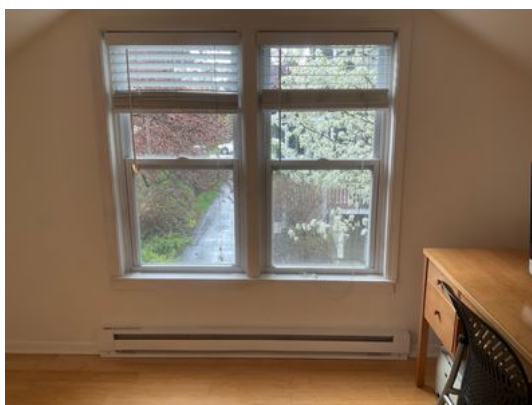
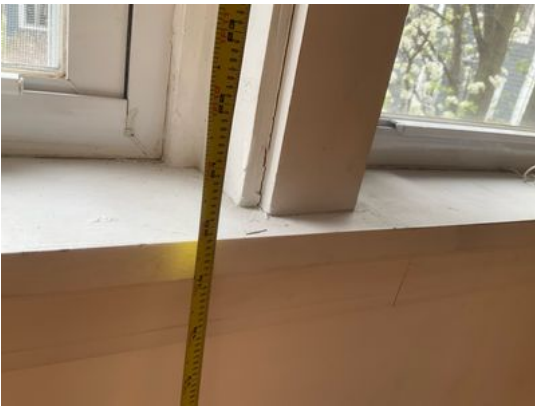
Garage

The side lock on the west facing window is broken.

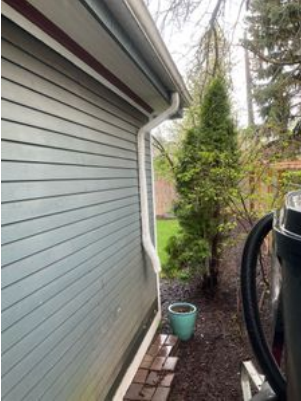
Roofing

The downspouts are draining along the exterior but not moving water far enough from the home. All downspouts should discharge water 4-6 feet away from the structure, preferably where the water can run off and drain. Recommend extending downspouts and underground drainage away from the foundation.

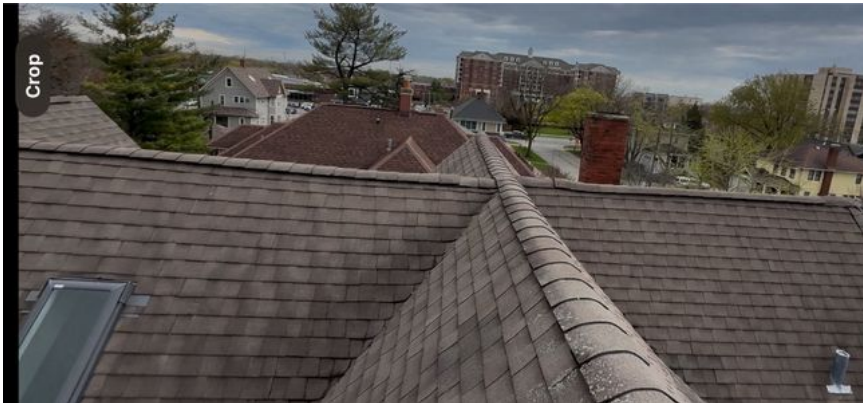
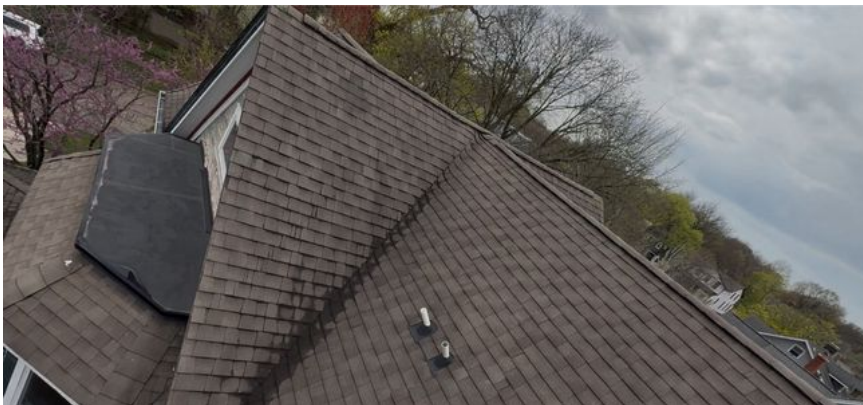
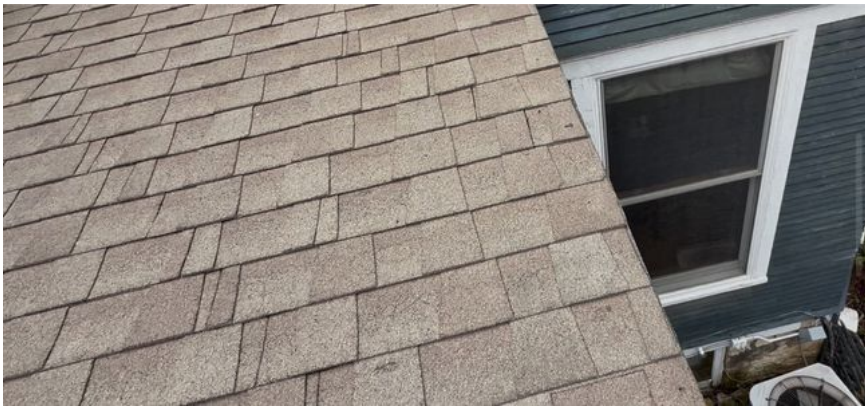
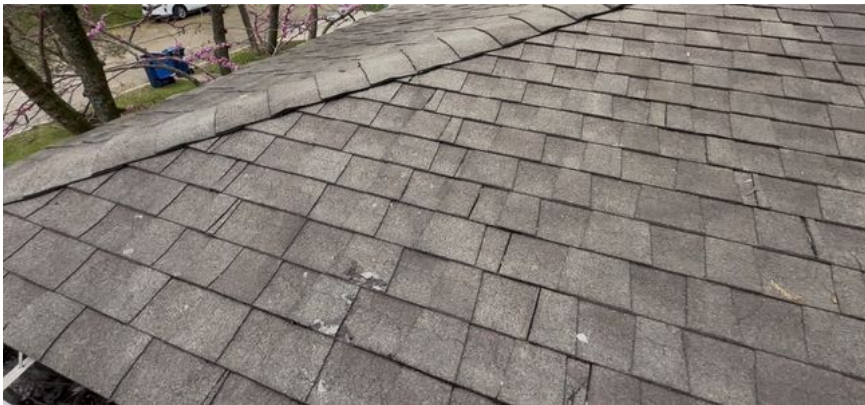
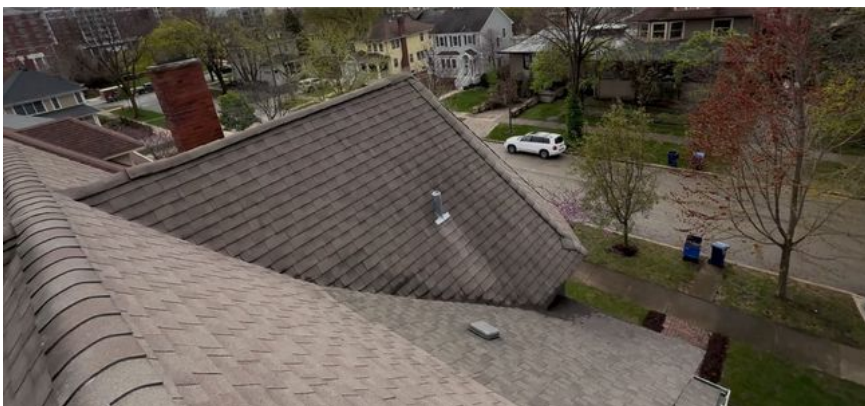
Roofing

The wood exterior siding is in contact with the roofing shingles, this has caused the wood trim and siding to deteriorate around the corners of the home. A minimum of a 1" gap should be present between the siding and the roofing shingles.

A metal flashing should be installed behind the siding and under the roofing shingles where the roof meets the exterior walls, this was not visible in some corners of the home but appears to be installed.

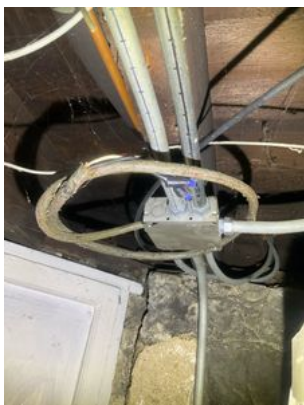
Non metallic shielded electrical wiring that has been capped up along the basement ceiling over the utility sink. Recommend that the wiring be removed by a licensed electrician.

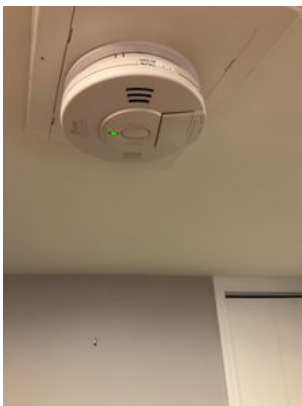
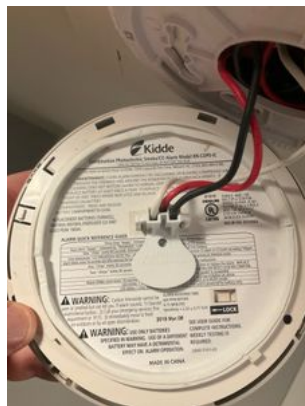
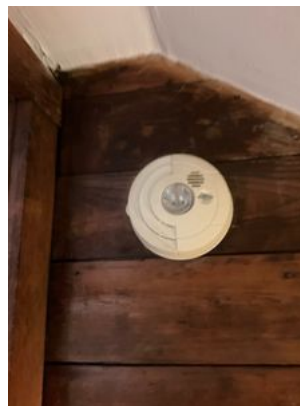
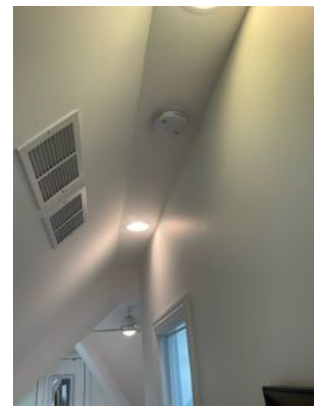
Smoke and carbon monoxide detectors installed in the home dated 2019. Some older smoke detectors were present that were over 10 years old.

Smoke and carbon monoxide detectors installed in the home on the 2nd and 3rd floors. Recommend adding a combination smoke and carbon monoxide detector near the 2nd floor rear bedroom and in the basement near the furnace and water heater. Adding individual smoke detectors to each bedroom is also recommended.

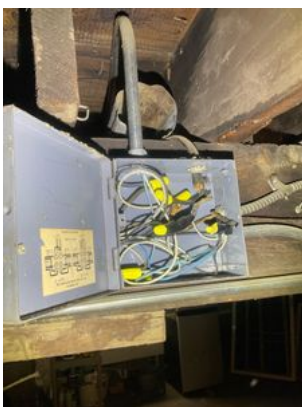
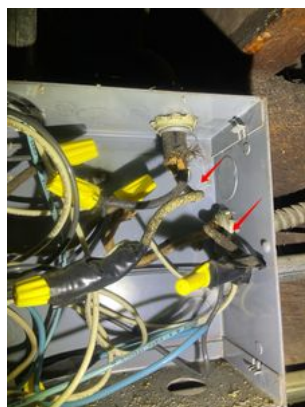
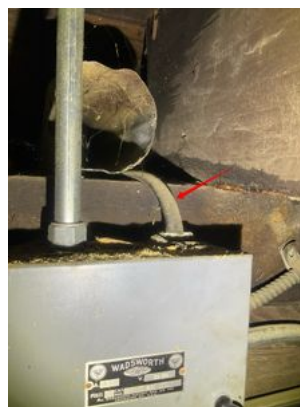
Older fuse box has been abandoned, several electrical connections have been made inside the fuse box. Recommend that the fuse box be sealed closed.

Older, cloth insulated wiring was present. This wiring insulation can wear down or can become brittle and break. Non metallic shielded wiring extending from the fuse panel. Recommend that the wiring be replaced by a licensed electrician.

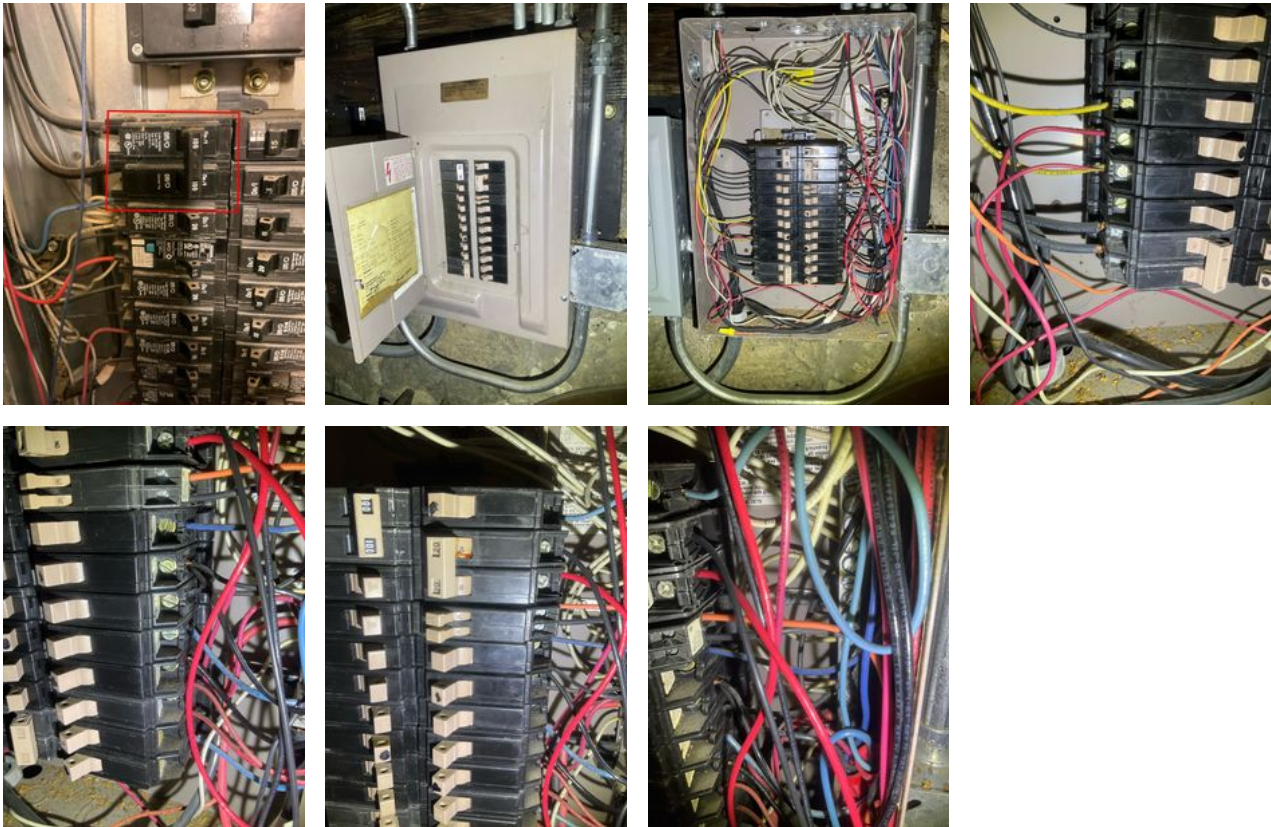
A double breaker has been installed in the panel, the panel schematic was not available to determine if these breakers are allowed in the panel.

Recommend repair of the double taps and evaluation of the double breaker by a licensed electrician. The service panel may require an upgrade.

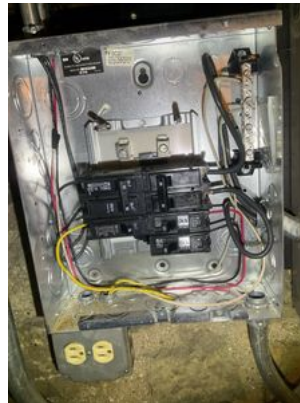
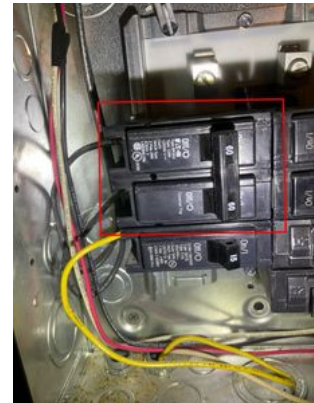
10 AWG wiring connected to a 60 amp breaker in the 2nd sub panel. The circuit wiring is undersized for the 60 amp breaker and poses a safety hazard. Recommend repair by a licensed electrician.

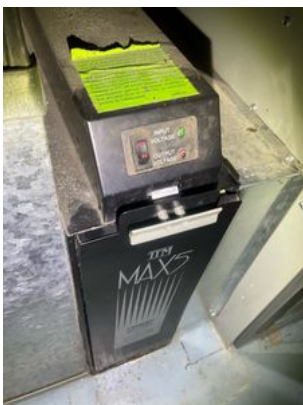
The older electric filter was no longer in use. The cover where the disposable filter is installed does not fully close and latch.

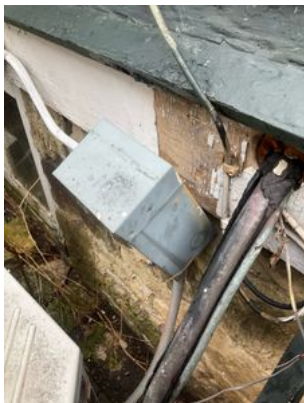
The electrical disconnect box for the air-conditioning condenser is not secured to the home exterior. Recommended a qualified contractor secure the electrical disconnect box to the exterior of the home.

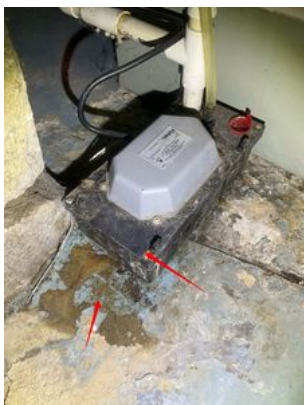
The condensation pump on the furnace appears to be leaking. Recommend repair or replacement of the condensation pump by a qualified HVAC contractor.

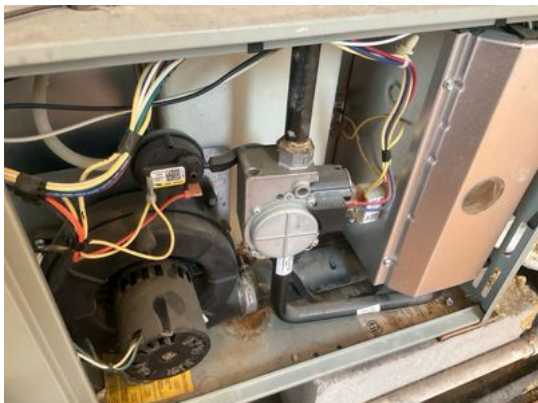
The furnace is dirty on the interior. Recommend having the furnace cleaned and serviced by a professional HVAC technician.

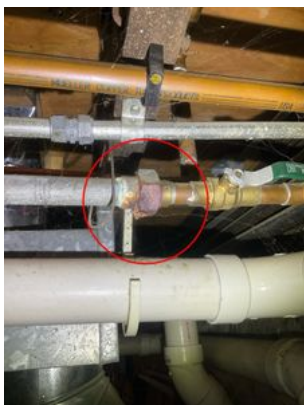
Corrosion at a water supply union connection indicates a water leak. This is located above the basements water heater. Recommend repair by a licensed plumber.

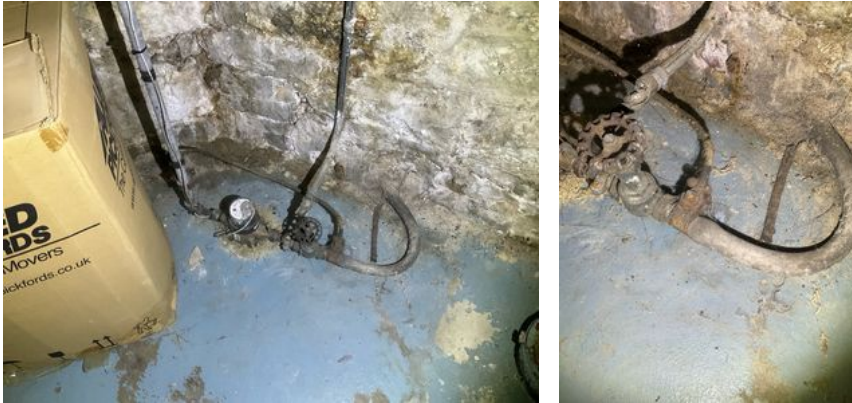
The main water shut off valve was not operational when tested. Recommend replacement of the valve by a licensed plumber.

The water supply line entering the home from outside appears to be made of lead. These pipes are common in the area and sometimes cause elevated levels of lead contamination in water levels. If levels test high the pipe can be coated, replaced or a filtration system put in place to remove contaminants. Recommend testing the water quality for lead content.

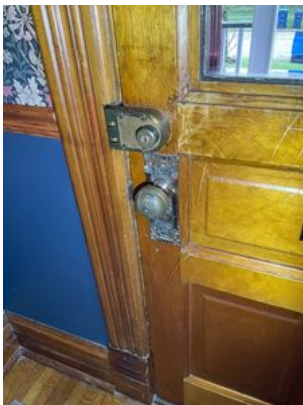
Keyed lock on the front entry door. This can create a safety hazard in the event of a fire or other emergency if the door cannot be opened. Recommend replacing with a standard deadbolt lock.

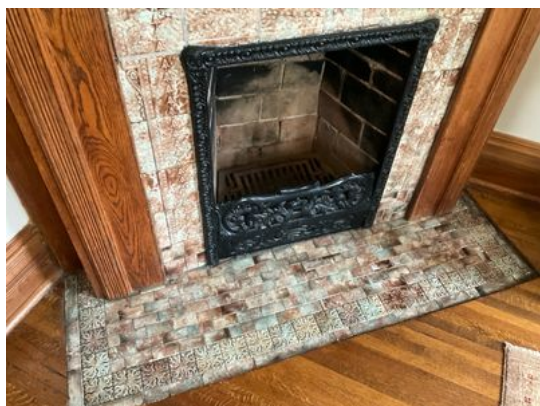
Tiles along the hearth along the floor appear to be loose. Recommend mo, the tiles may need to be re secured.

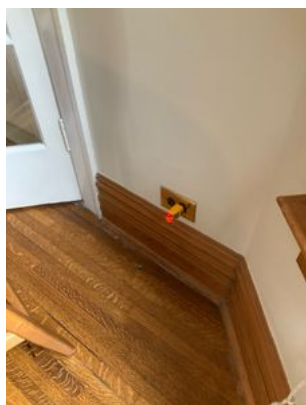
The interior outlet has reversed polarity (hot and neutral reversed). Recommend repair by a licensed electrician.

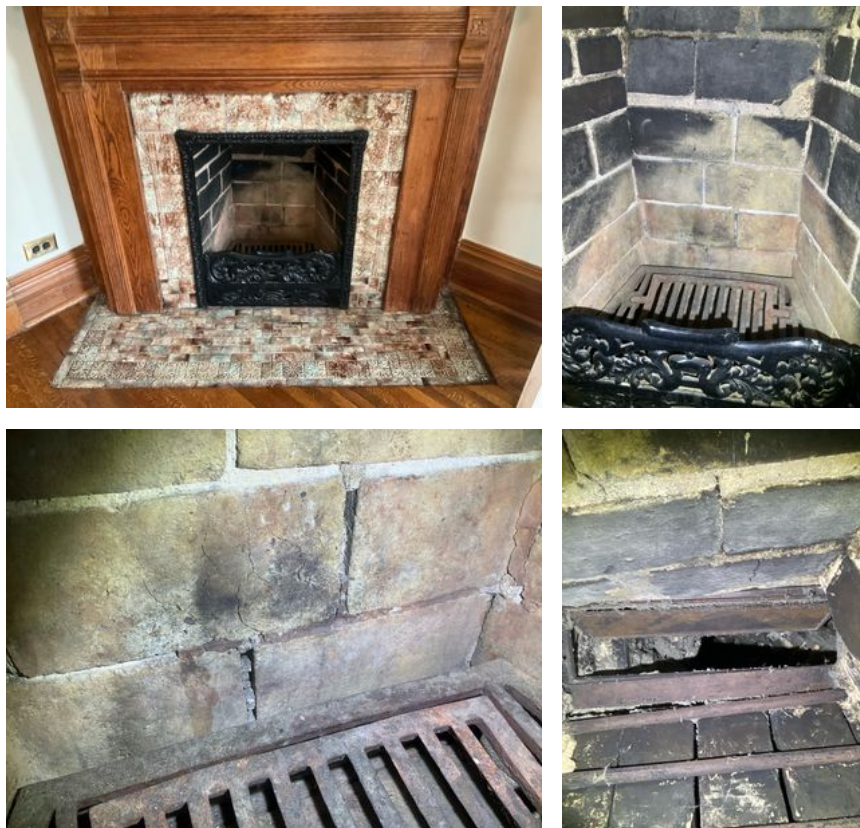
Masonry wood burning fireplace. The flue was functional. There is missing mortar between the bricks in the firebox that should be repaired. Recommend having the fireplace inspected by a professional chimney contractor prior to use.

The full condition of the chimney flue is not available, the entire chimney was not visible during the inspection. Further evaluation of the chimney by a professional chimney contractor or chimney sweep can determine the condition of the chimney flue.

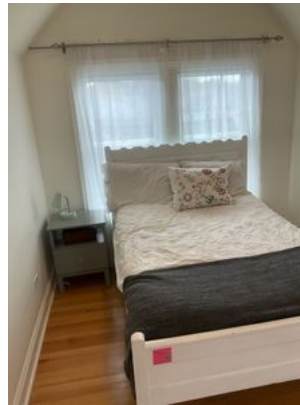
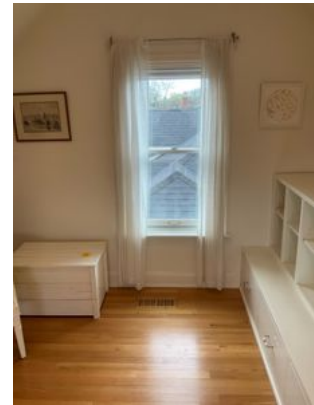
The base of the windows are close to the floor. The minimum recommended window height from the floor is 24". Low windows should have a locking system so the windows do not fully open and tempered glass should be installed. Open windows can be a safety hazard for children.

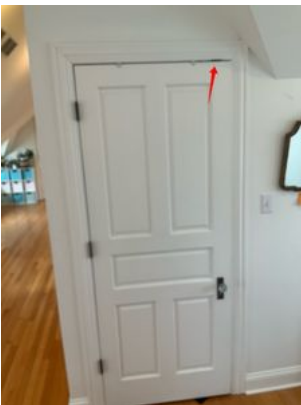
The door does not latch and lock. The door or the spring loaded lock requires adjustment.

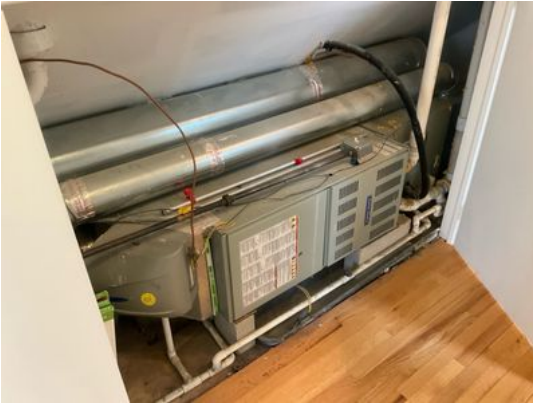
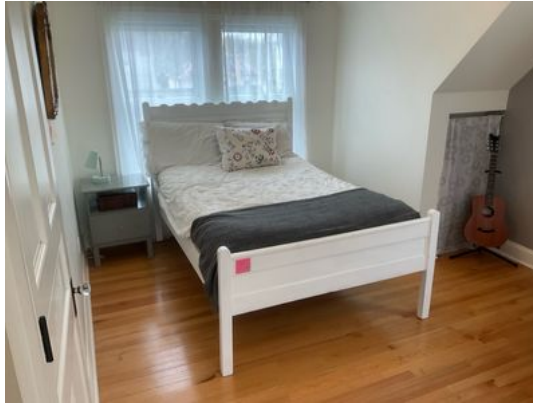
Furnace is located in a closet for a room that is correctly used as a bedroom. It is not recommended that a furnace pull its combustion air from a bedroom or be placed in a bedroom due to a fire hazard and the potential for toxic fumes to emit from the furnace.

Recommend that a sealed, fire rated door be installed on the furnaces closet. The installed furnace is high efficiency and pulls combustion air from the homes exterior, no further modifications should be necessary.

Recommend further evaluation and repair by a licensed contractor.

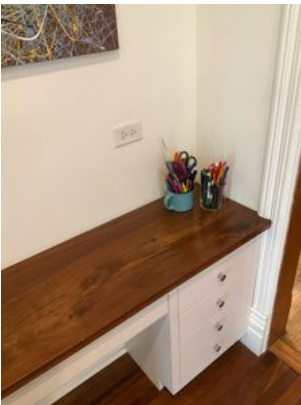
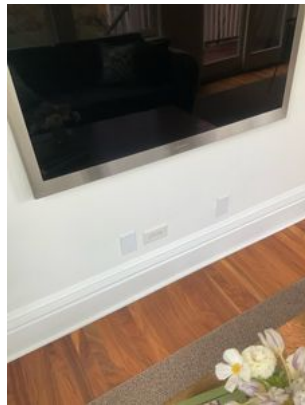
The interior outlets are loose in the wall. Recommend securing the outlets.

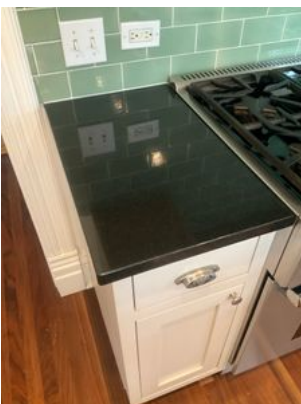
Corner of countertop is loose. Recommend attaching to the cabinet base.

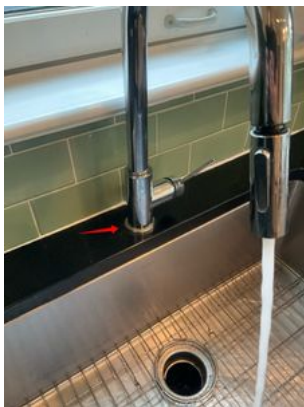
The faucet is loose at the base.

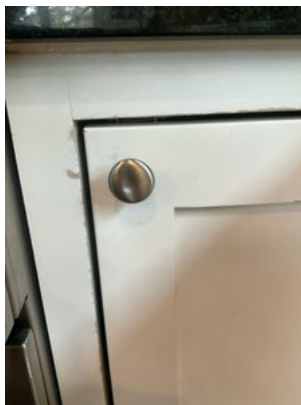
Small areas of loose and peeling paint noted across the kitchen cabinets.

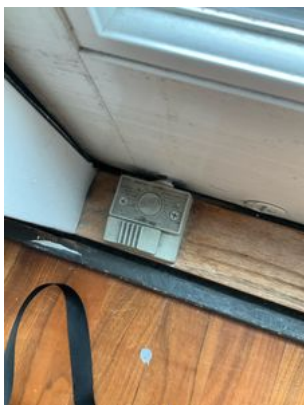
The secondary lock on the sliding entry door sticks when locked and is difficult to open. Recommend lubricating and exercising the lock.

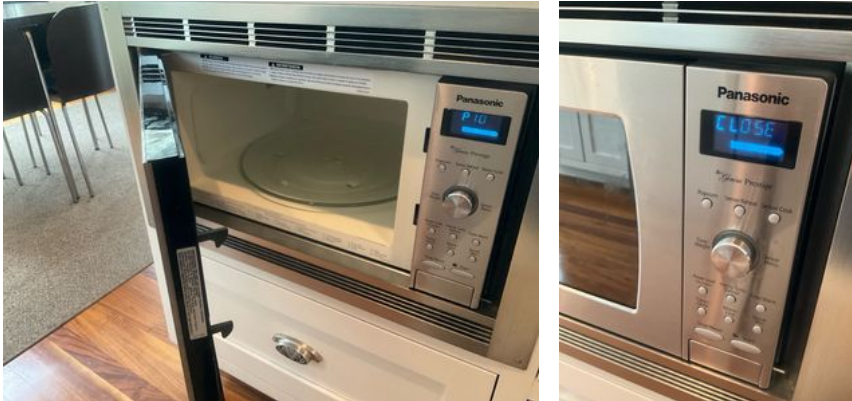
The microwave door sticks when opening. The microwave won't run as it is showing an error that the door is not closed. Recommend repair or replacement of the microwave.

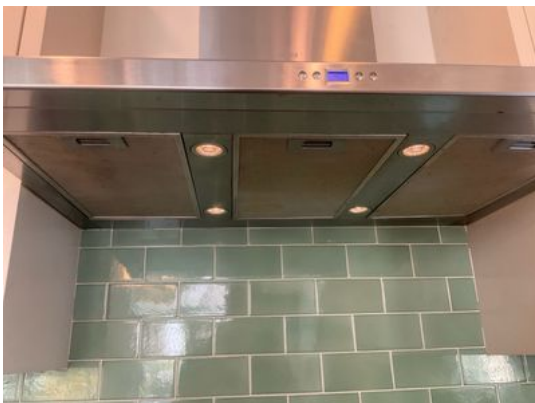
The range hood lights flicker when on the lowest setting.

Recommend cleaning the screens on the range hood so it will draft more effectively.

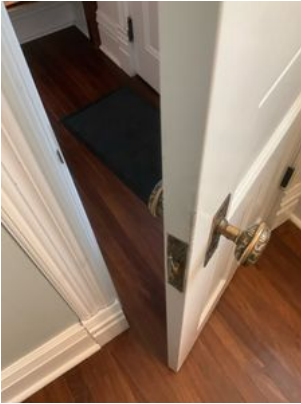
The entry door does not latch properly and stay locked. Recommend adjusting the door lock plate as needed.

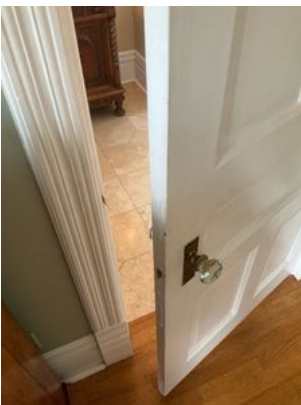
The entry door does not latch properly and stay locked. Recommend adjusting the door lock plate as needed.

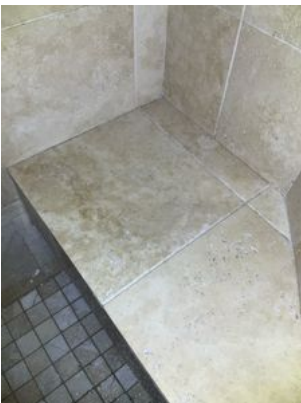
Recommend caulking the corners around the bench in the shower stall.

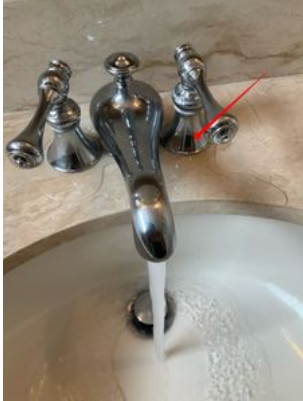
The cold water valve leaks when in the on position. Recommend repair or replacement of the faucet valve by a qualified plumber.

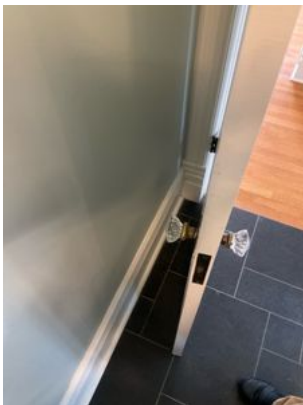
Bathrooms: Bathroom #3

Missing door stopper, recommend installing door stoppers to prevent wall damage from the door knob.

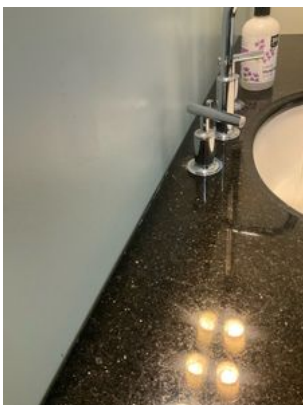
Bathrooms: Bathroom #3

Recommend caulking all seams and edges around the vanity top.

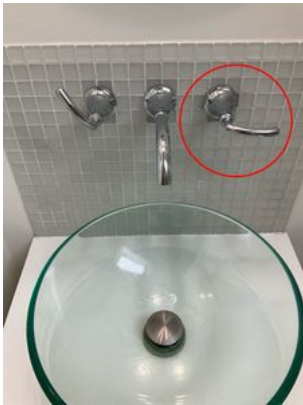
Bathrooms: Bathroom #4

The cold water valve at the sink does not have a stop installed. The valve continues to spin and does not stop when turning off. The valve must be positioned as pictured to turn off the flow of water. Recommend repair or replacement of the valve by a licensed plumber.

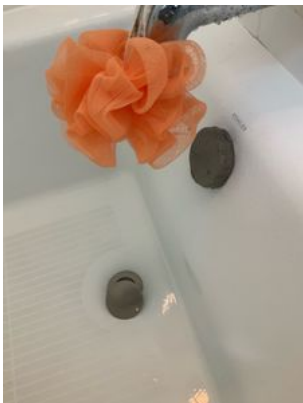
Bathrooms: Bathroom #4

The drain stopper is not functional using the control button on the front of the bathtub.

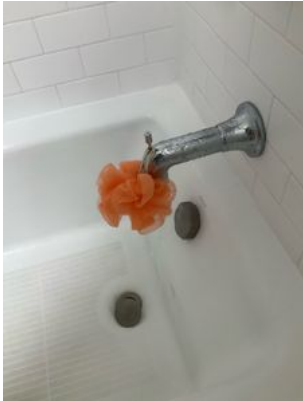
Bathrooms: Bathroom #4

Shower diverter is leaking and allowing water to exit from the tub spout. This will not allow for full water pressure at the shower. Recommend repair by a licensed plumber.

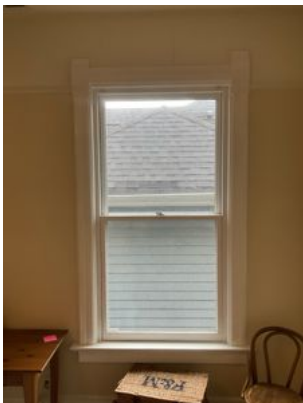
Bedrooms: Bedroom #1

Window is stuck and could not be opened during the inspection.

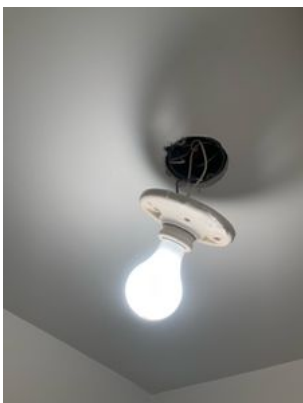
Bedrooms: Bedroom #1

Loose light fixture in the closet. Recommend replacing the fixture with a covered fixture.

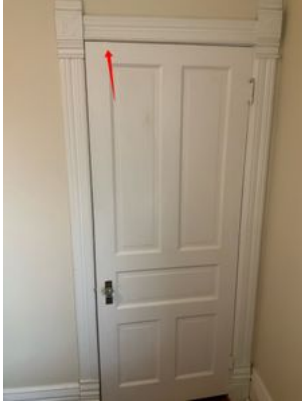
Bedrooms: Bedroom #1

Bedroom closet door binds at the top of the door frame. Recommend adjusting the door as needed so it will close and latch.

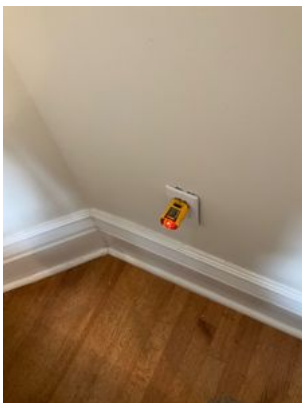
Bedrooms: Bedroom #1

The interior outlet is loose in the wall. Recommend securing the outlet.

Open ground in outlet. Recommend further evaluation by a licensed electrician.

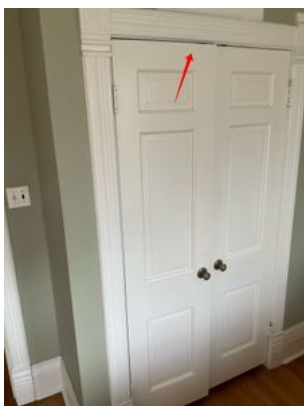
Bedrooms: Bedroom #2 (Front En-suite)

The closet door does not latch and lock. Recommend adjusting the locking mechanism as needed.

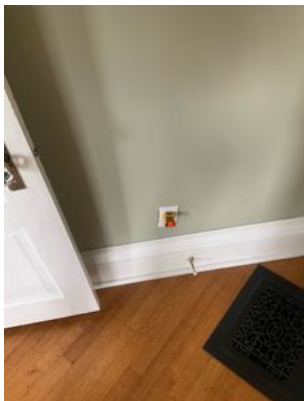
The interior outlet is loose in the wall. Recommend securing the outlet.

Open ground in outlet. Recommend further evaluation by a licensed electrician.

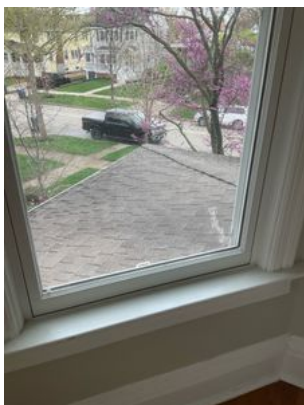
Bedrooms: Bedroom #3

Torn window screen, recommend repairing.

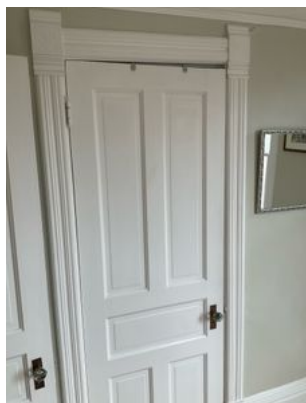
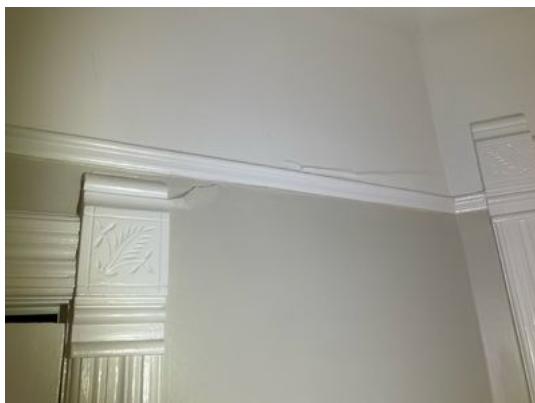
Bedrooms: Bedroom #3

The door frame is out of square, this is visible by looking at the top of the door frame and the door. Larger cracks above and to the right of the closet door frame. This indicates structural settlement. Based on the age of the home, this is considered normal settlement. However, the area should be monitored, additional cracking or expansion of the existing cracks could indicate a larger structural issue. If noted it is recommended that a licensed contractor further evaluate.

Recommend that a licensed contractor repair the closet door.

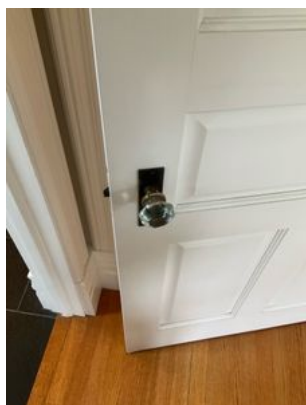
Bedrooms: Bedroom #4 (Rear Bedroom)

The bedroom entry doors door knob sticks and does not always operate the locking mechanism.

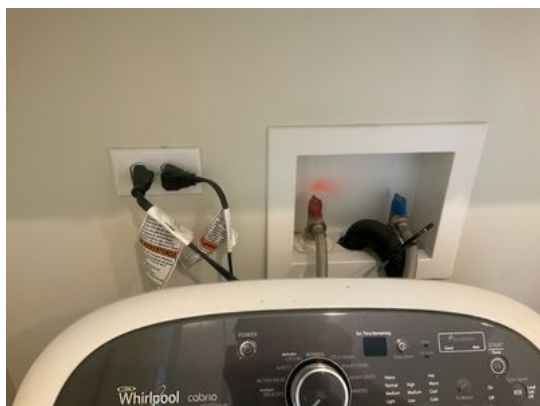
Laundry

Non GFCI protected outlets in laundry room. Recommend adding GFCI outlets within 6' of any water source.

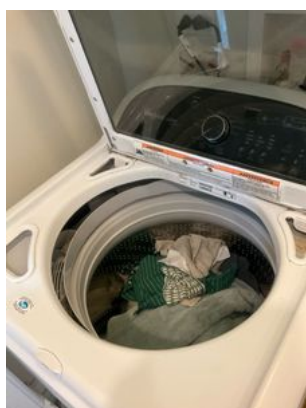
Laundry

The washing machine was filled with the occupants clothing. The washing machine was not run and tested during the inspection.

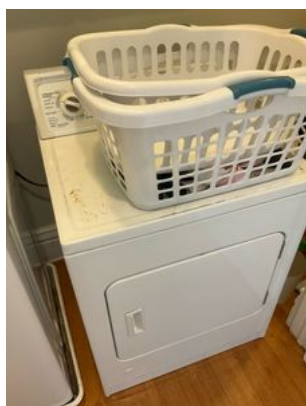
Laundry

Dryer does not shut off when the door is opened. The dryer is operational but is older and replacement in the near future may be necessary.
