***EXPERIENCE WITH GRADE 91
MATERIAL IN BOILER & HRSG
APPLICATIONS***

Dr. Gang Zhou

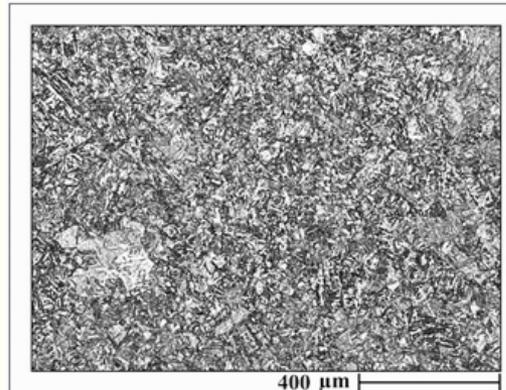
Case Study 1: Cracking in Type IV and Creep Damage in Base Metal

- P91 main steam manifold saddle joint.
- ASME SA-335, P91, 4" NPS x Sch.120.
- 27,000 hrs in service.
- Creep Damage in BM with uncharacteristic microstructure – ultra-fine mixed with ultra-coarse grains

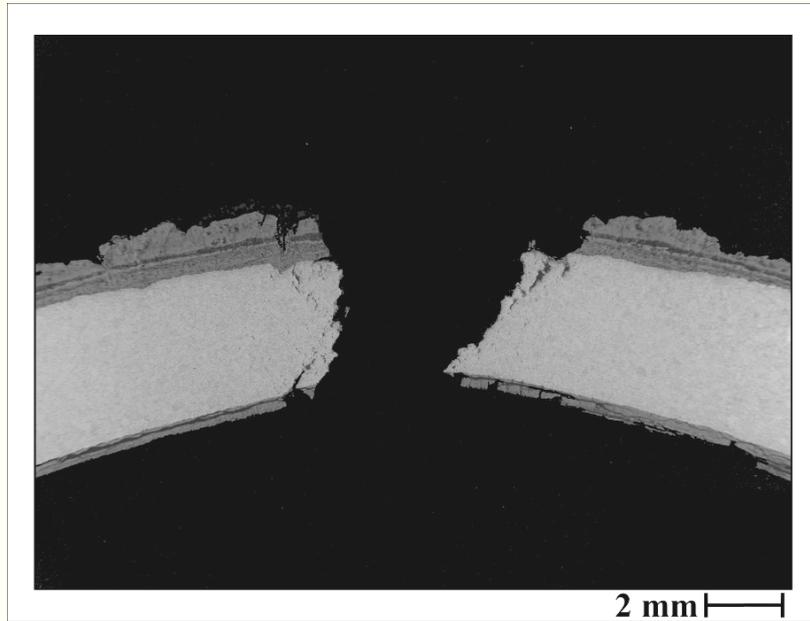
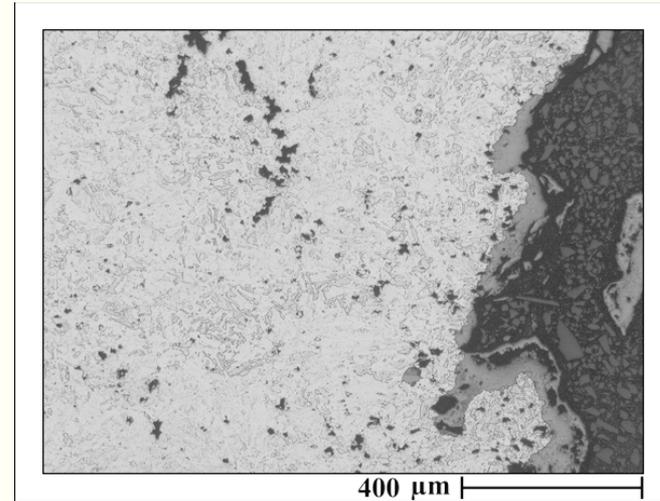
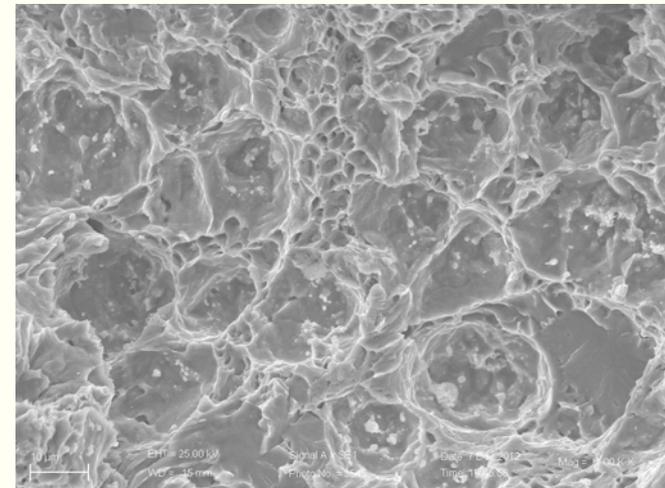
Case Study 5: T91 Reheater Tube

- Multiple Failures on the intrados of the front bend after ~17,000 hrs in service.
- ASME SA-213, T91, 2.75" OD x 0.150" MWT.

Conclusion: Torch-Heating Intrados of Bend in Manufacture

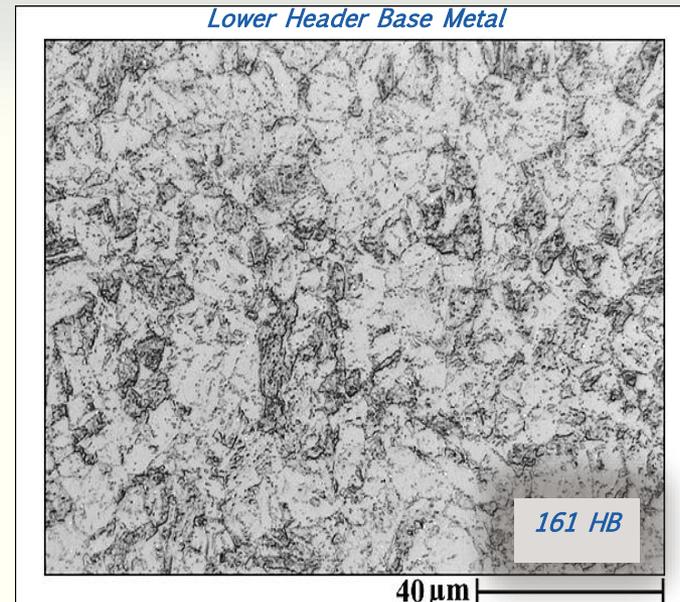
Lower Header Base Metal

- Was the low hardness in upper & lower headers of harp assemblies the result of overheating?
- Did accumulated-temper effect in manufacture & installation play any role?
- The MTR data of the original pipe appears to be normal. Could it be possible that this was the original piping condition? If so, how did the original piping have this condition?

- The condition of the CGHAZ and weld metal appears to be normal with no sign of any overheating and consistent with a normal Gr. 91 weld.
- The fine-grained ferrite structure with moderately spheroidized precipitates are likely consistent with improper-normalizing practice and a slow-cooling rate.
- It is recommended:
 - Investigate the details of the heat-treatment in the pipe mill.
 - Remove the sample(s) for destructive examination.
 - Determine the creep properties of the low-hardness pipe.
 - Design-review to determine whether Gr. 22 fits the design criteria for lower header.
 - Discuss the recommendations above with customer.

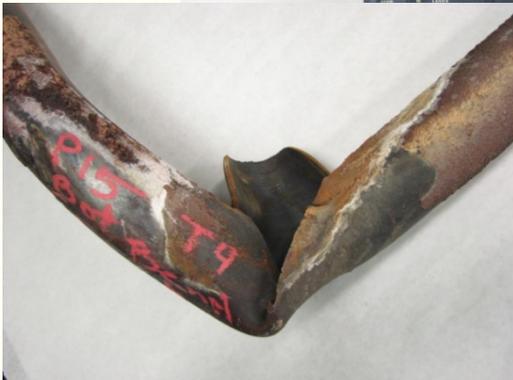
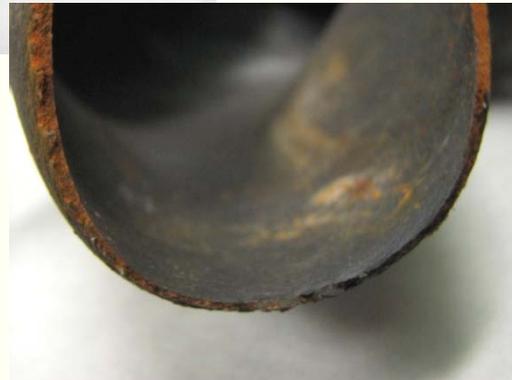
Case Study 7: T91 Superheater Tube Failure

- A front bend in finishing superheater assemblies failed after over 20,000 hrs service.
- ASME SA-213, T91, 2.25” OD x 0.240” MWT.
- Failure caused severe damage to the entire loop.

Conclusions: The bends had been improperly heated during manufacture.

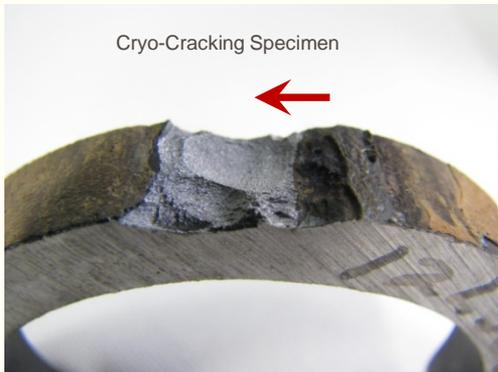
Case Study 10: Cree-Fatigue Crack

~400 μ m
Crack Tip

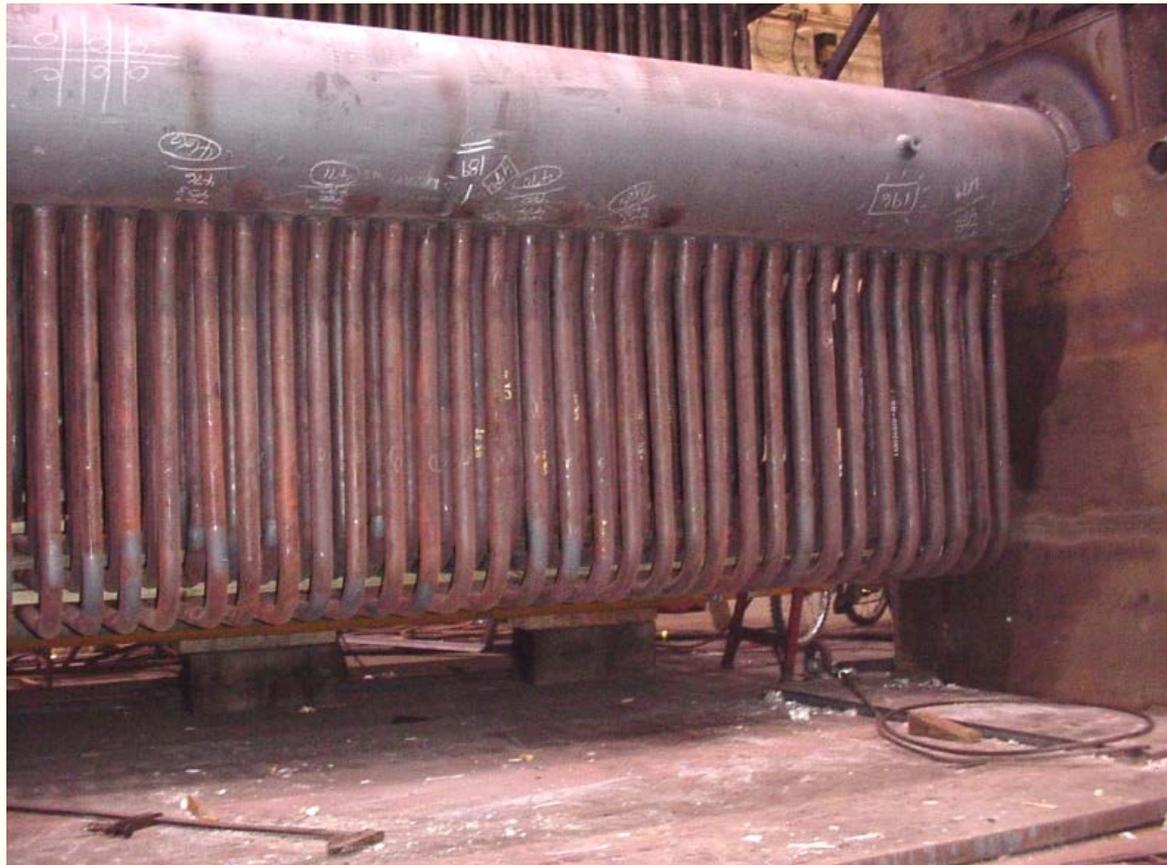
Case Study 11: Low Hardness in Grade 91 Header

Effect of Over-Tempering Accumulative

Hardness Measurements after PWHT revealed ~150 HV.

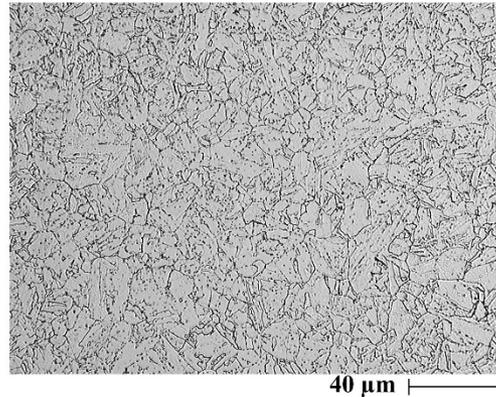
Case Study 11: Uneven Hardness in Grade 91 Header

Effect of PWHT Temperature > A_{C1}

HARDNESS VALUES-HV* (Equotip)					
Sample	Location	0°	90°	180°	270°
Header Body	North**	214	216	218	224
	South**	213	213	210	208
Girth Weld	North	258	267	280	274
	South	227	241	229	230
Hemi-Head	North	135	137	160	141
	South	168	176	175	172
