1 **Historic Weaverville Colored School Assessment Report**

7 The Preservation Society of Asheville and Buncombe County assessed the major visible
8 components of the Weaverville Colored School and documented their existing conditions on
9 April 17, 2023. Based on the information compiled through the assessment, prioritized treatment
10 recommendations were developed to help with the long-term care of the building.
11

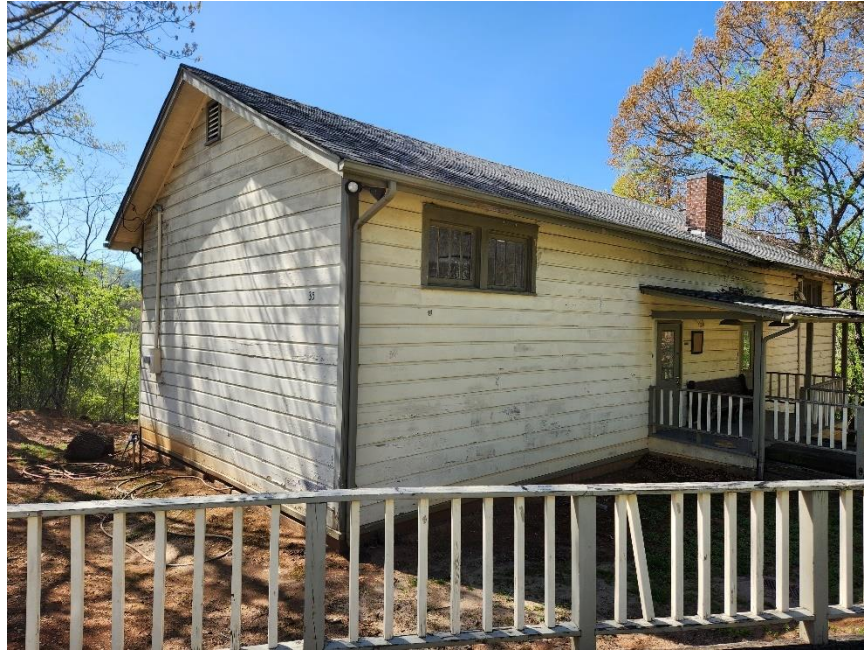
8
9 Figure 2. View of the historic Weaverville Colored School looking south at the northwest elevation (front)
10 and the northeast elevation. (PSABC 2023)
11

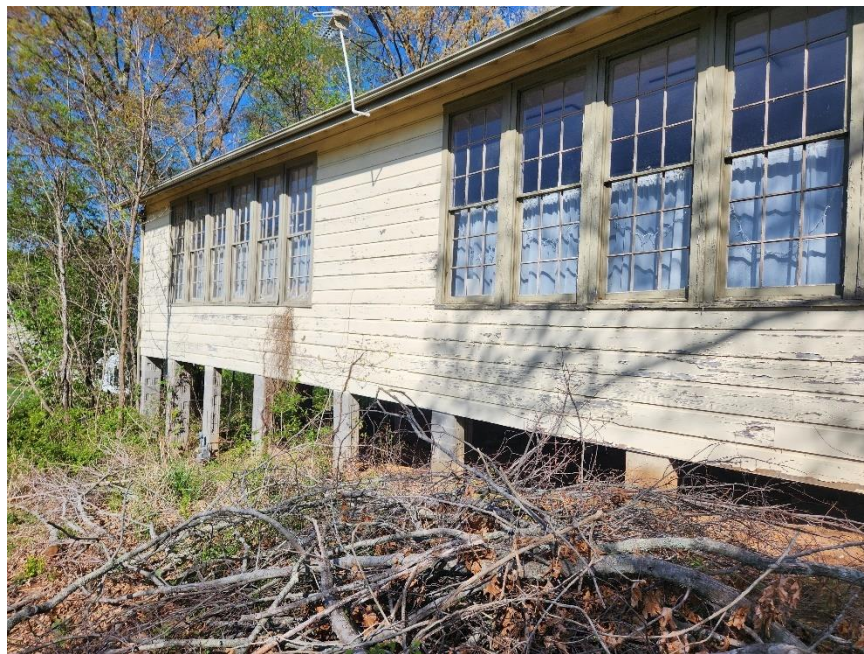
12
13 Figure 3. View of the southeast elevation (back) of the historic Weaverville Colored School.
14 (PSABC 2023)

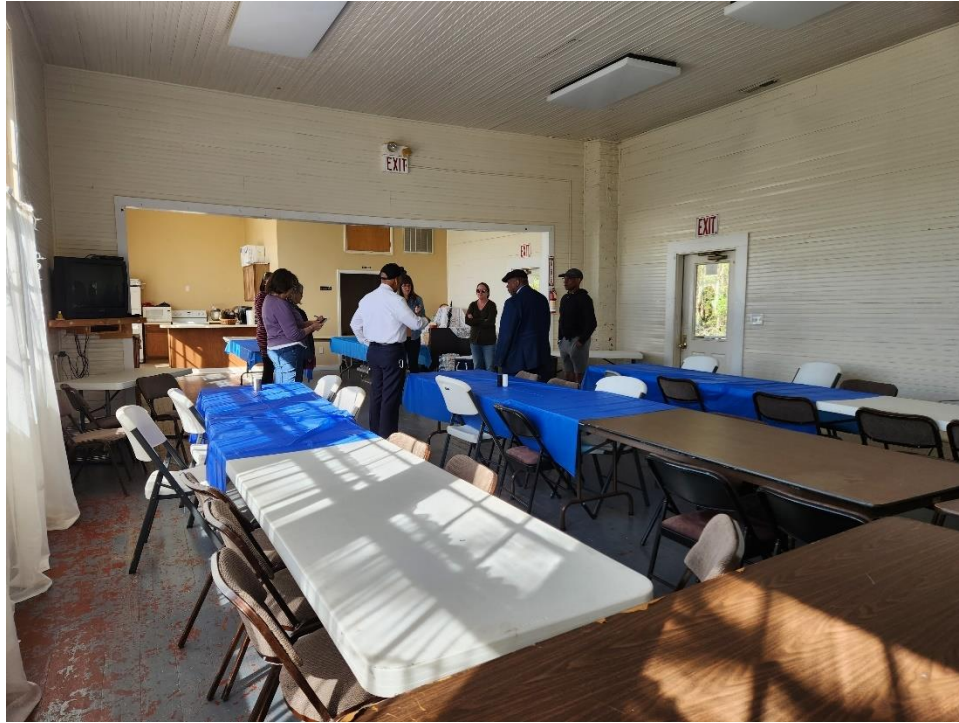
8
9 Figure 14. Interior view of the historic Weaverville Colored School. (PSABC 2023)

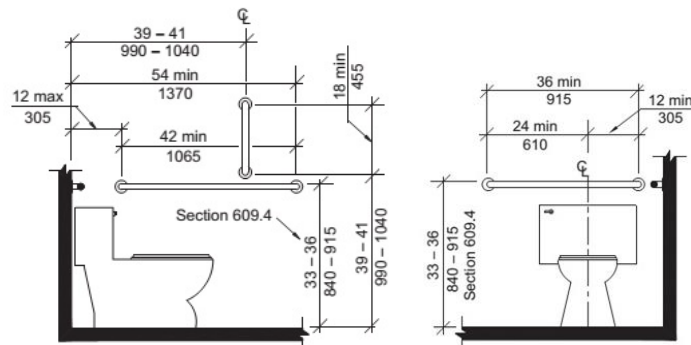
37 Figure 21. ANSI A117.1 grab bar requirements. (ANSI A117.1)

- 34 floor with the center line of the bar located between 39-inches and 41-inches
- 35 from the rear wall. Reference the diagram below for grab bar requirements.

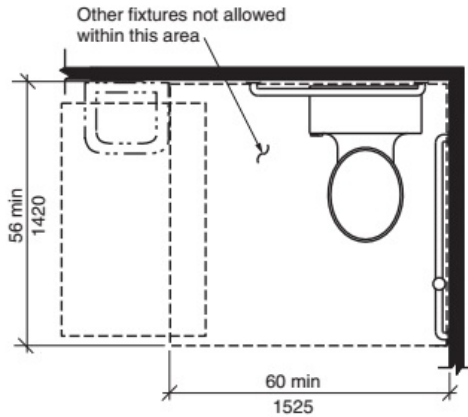
5
 6 Figure 22. Required toilet clearance. (ANSI A117.1)
 7

- 1 ○ Remove shelves and storage items from within the restroom to create the
 2 required accessible clearance next to the toilet. Reference the diagram below for
 3 required clearances.
 4

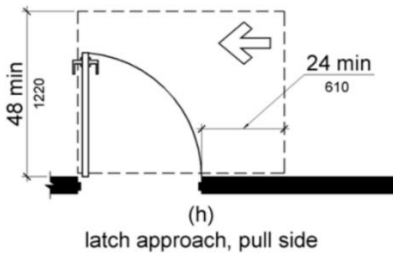
12
 13 Figure 23. Required door maneuvering clearance at the restroom doors from the corridor. (ANSI A117.1)
 14

- 8 ○ Remove shelves and storage items from outside the restrooms in the corridor to
 9 create required accessibility maneuvering clearances at each of the restroom
 10 doors.
 11
