VILLAGE AT HAILE CONDOS

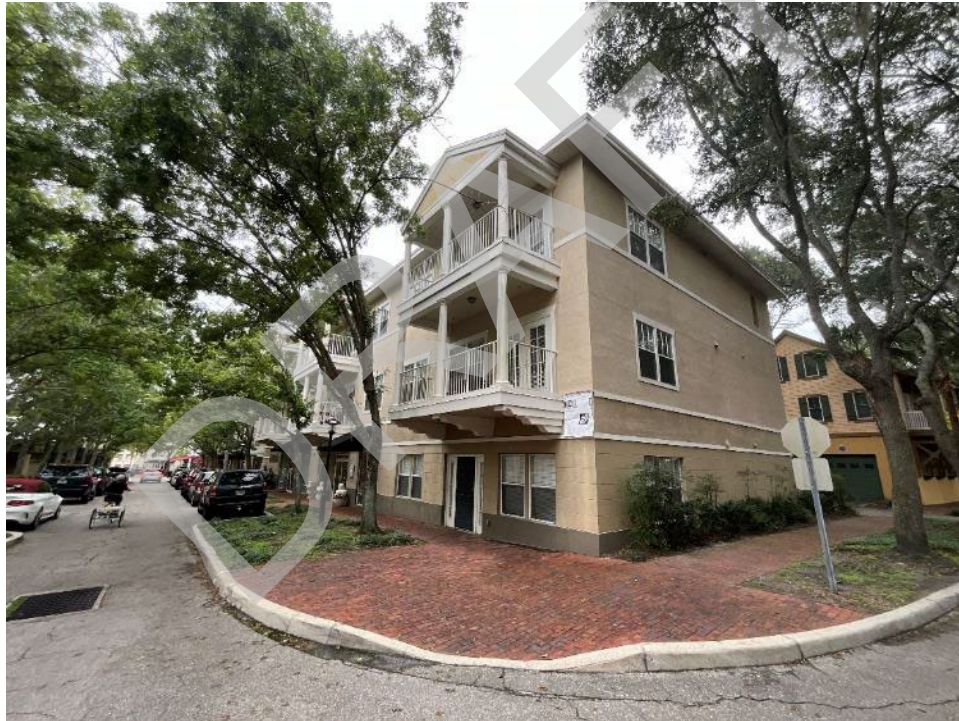
2. View of the typical front elevation of the subject complex.

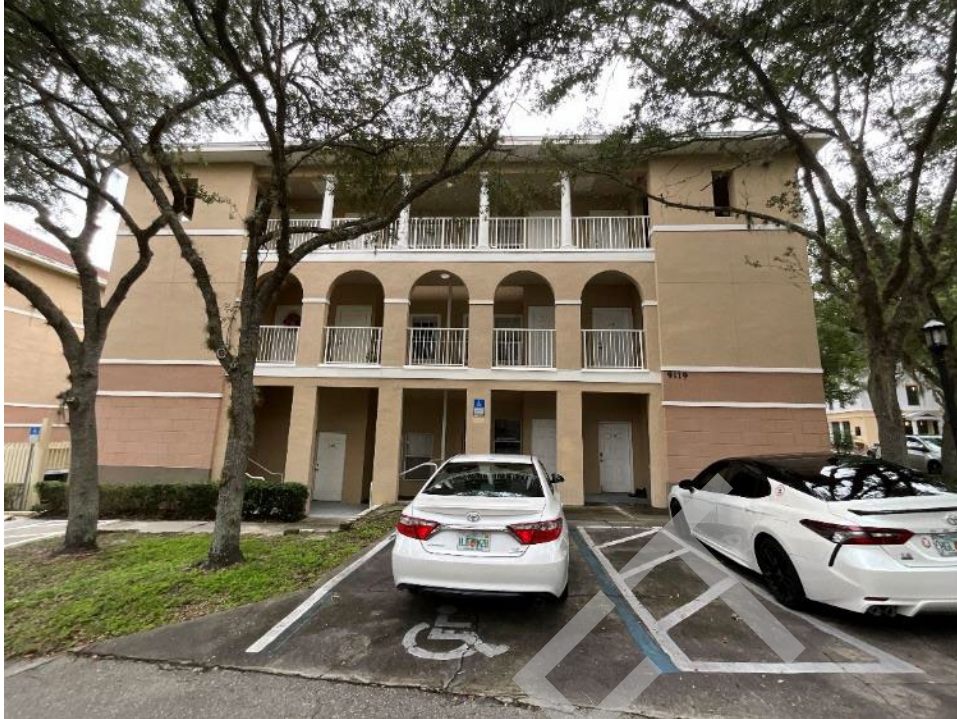
3. View of the typical rear elevation of the subject complex.

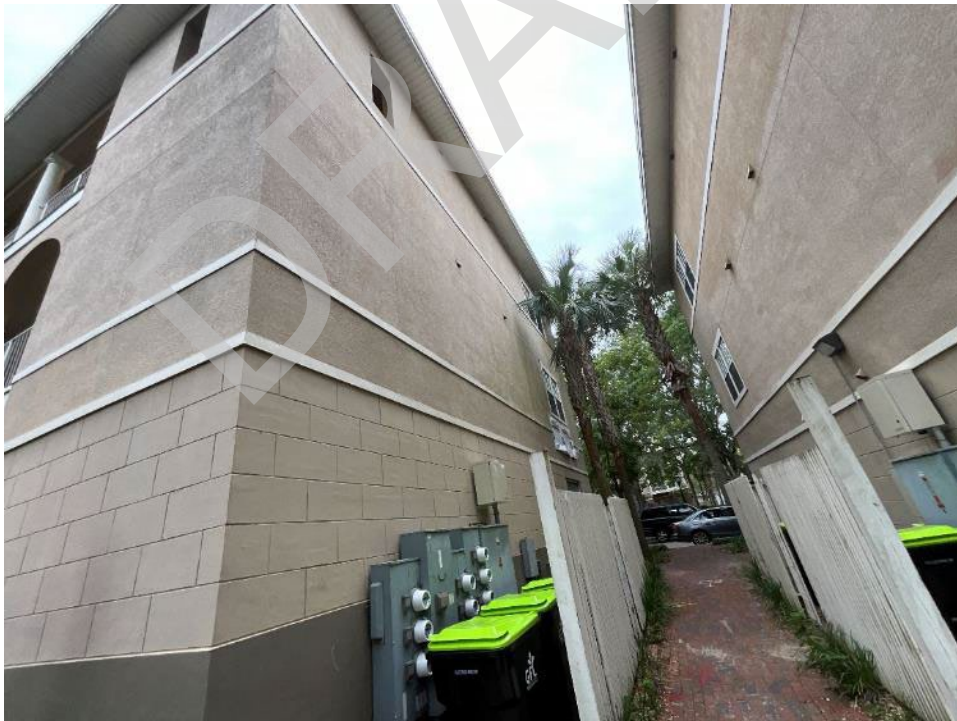
4. View of the typical side elevation of the subject complex.

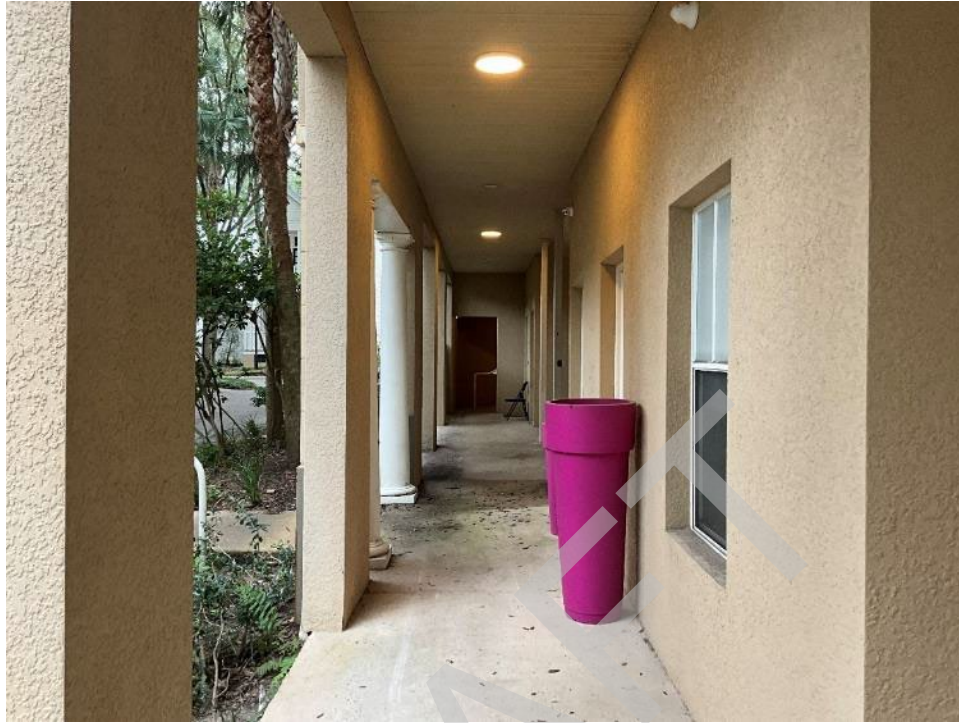
5. View of typical breezeways throughout the buildings.

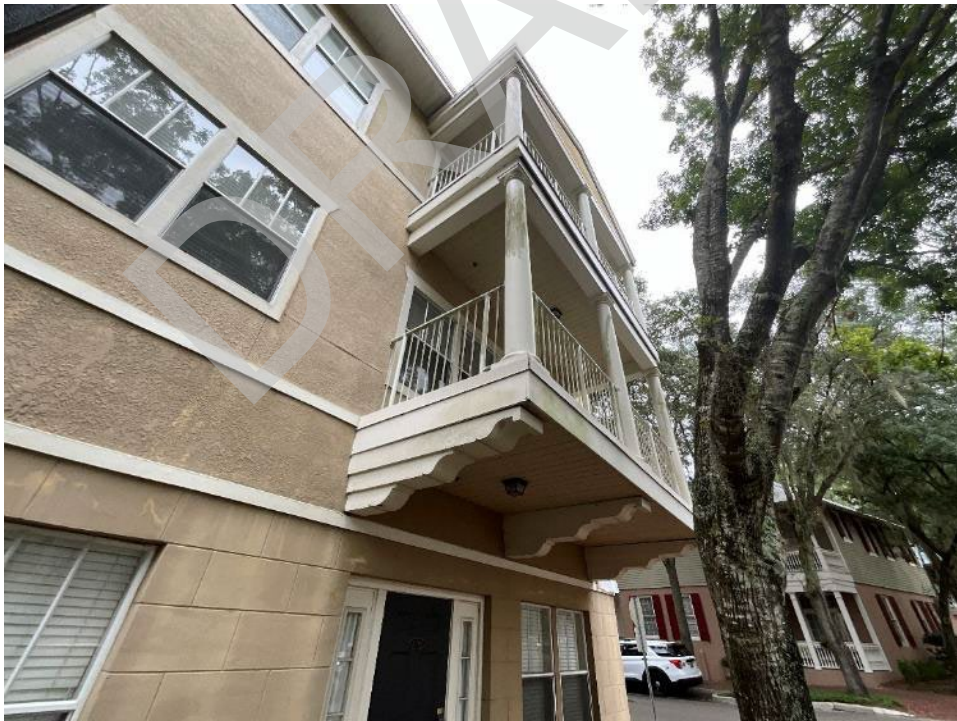
8. View of staining observed along the walls, columns, and beams of the balconies of all buildings.

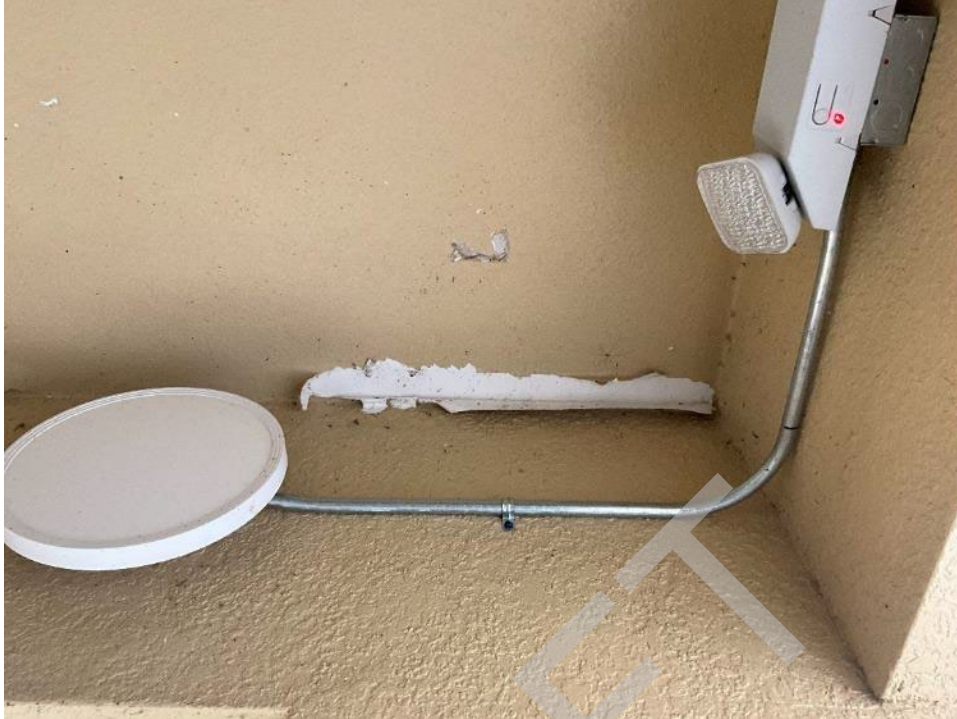
13. View of paint delamination along the ceiling of the stairwells.

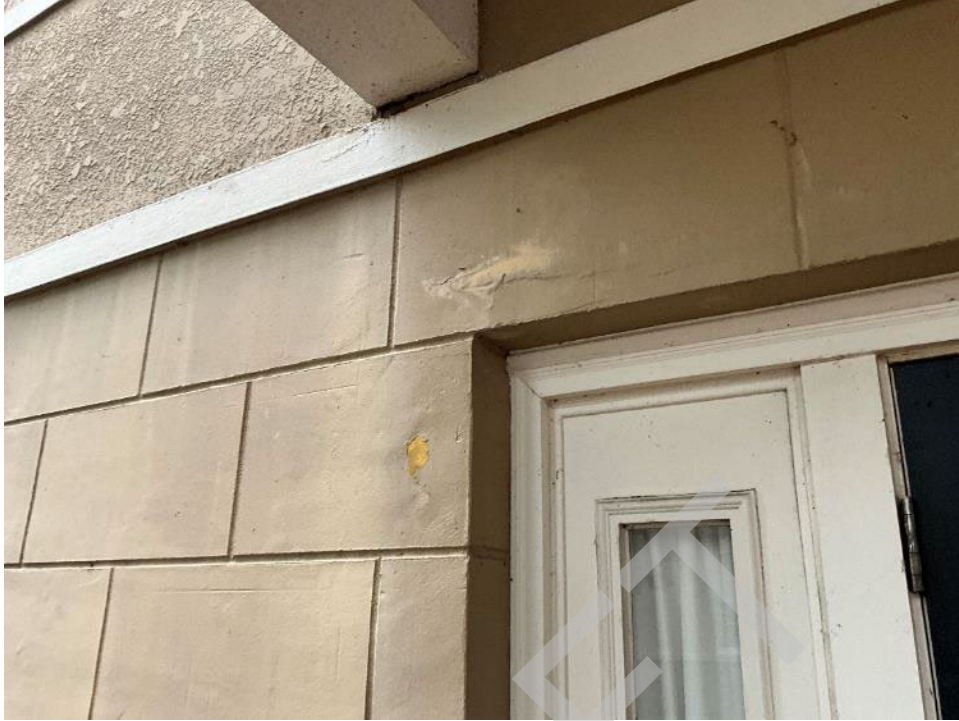
15. View of paint delamination along the walls of Building A.

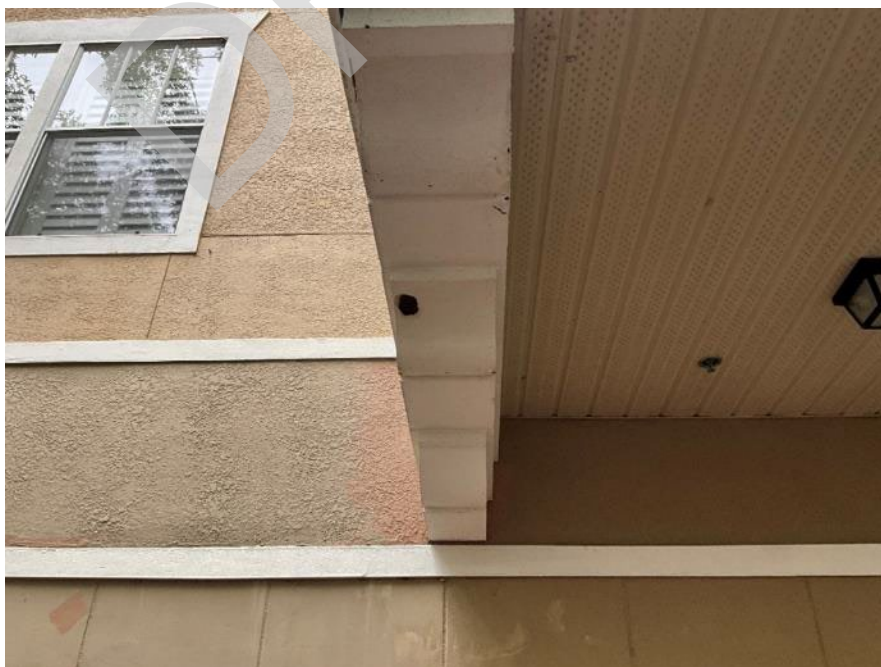
28. View of spalling in decorative beam below balcony above unit B101.

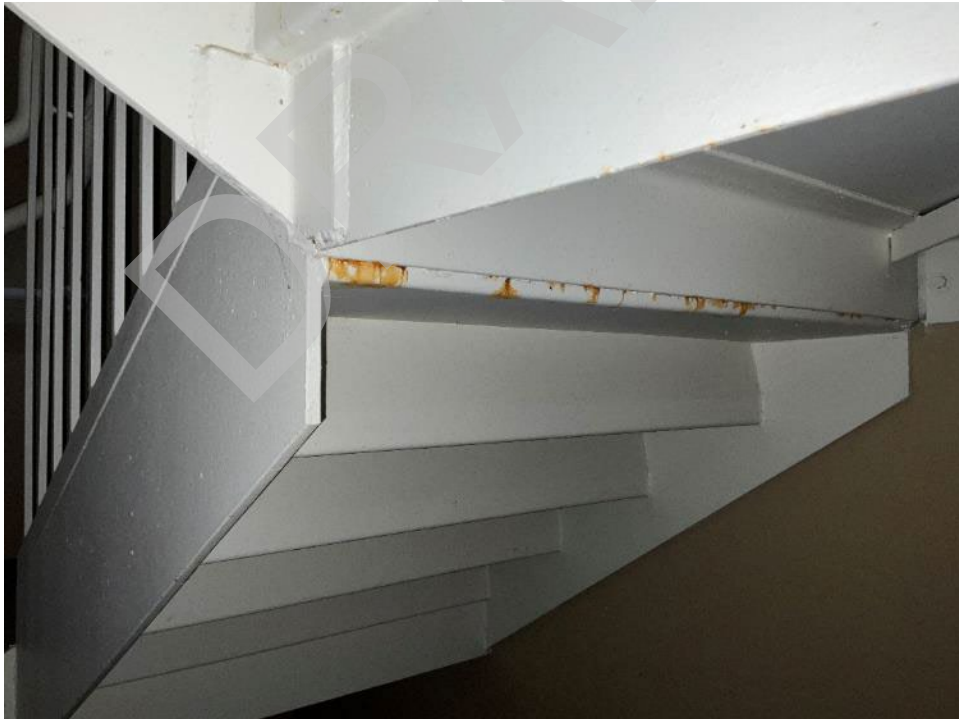
32. View of corrosion under stairs in stairwell.

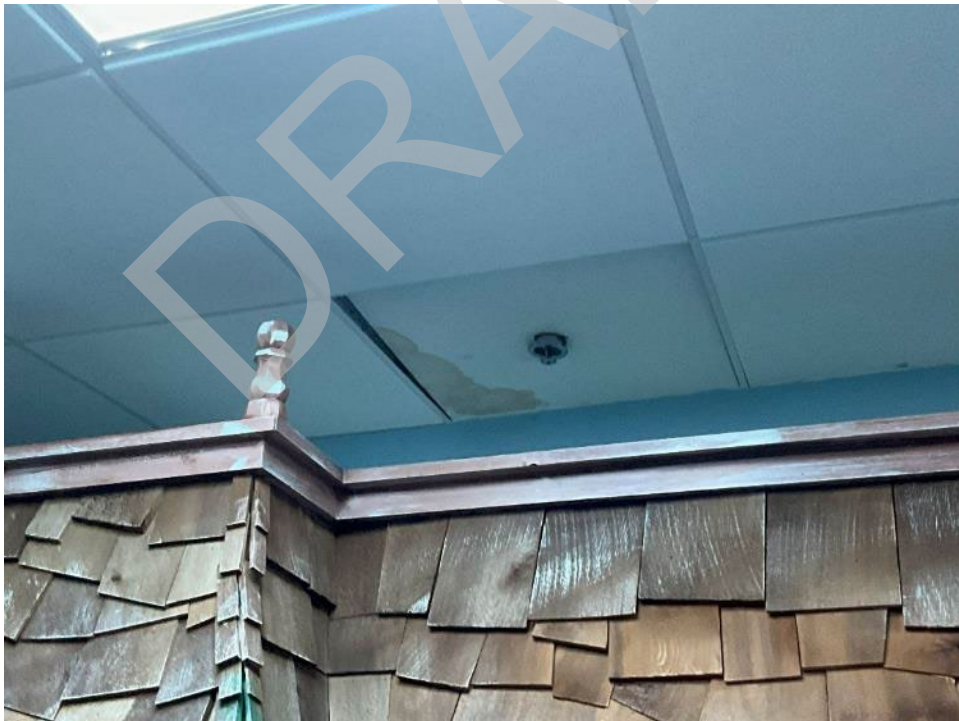
40. View of water intrusion along a ceiling panel in suite B-103.

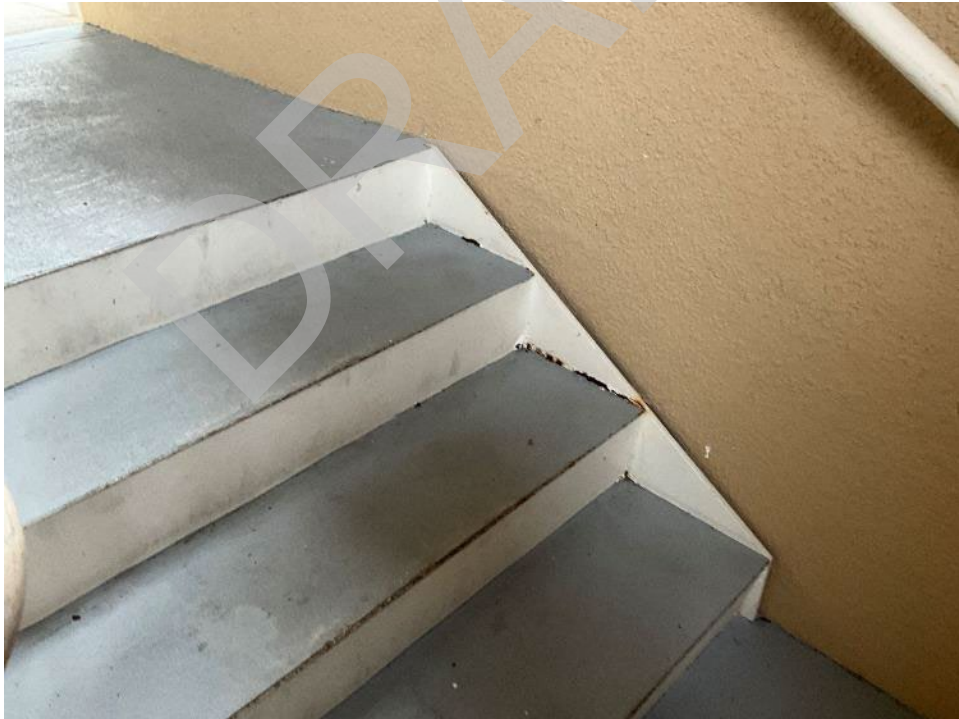
48. View of corrosion along the stairs.

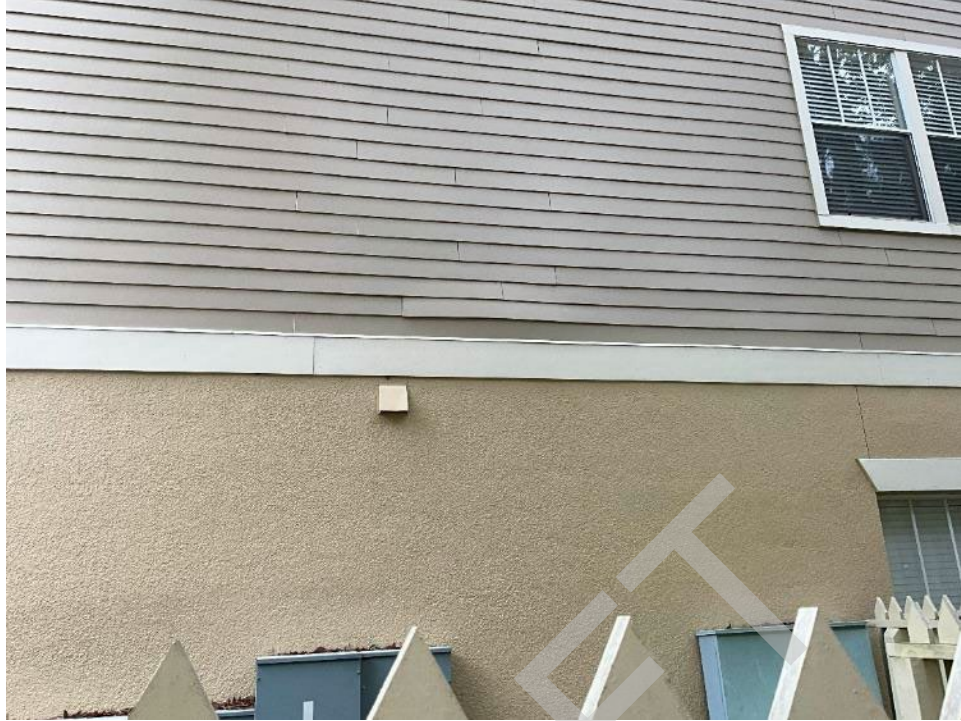
81. View of bulging along the siding of the building.

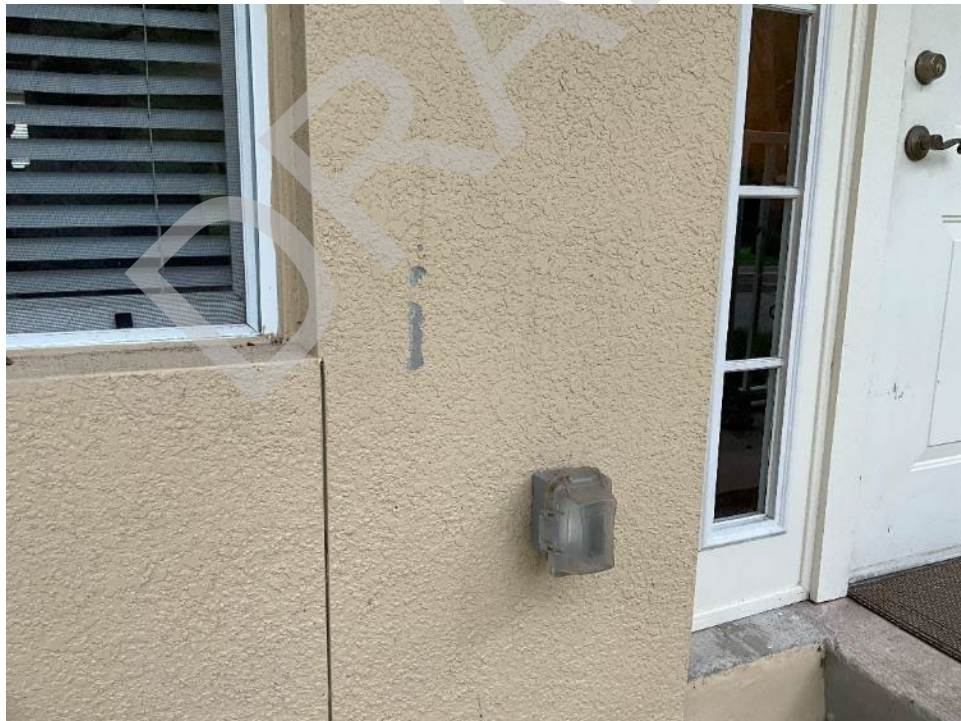
82. View of delamination on the exterior of the building.

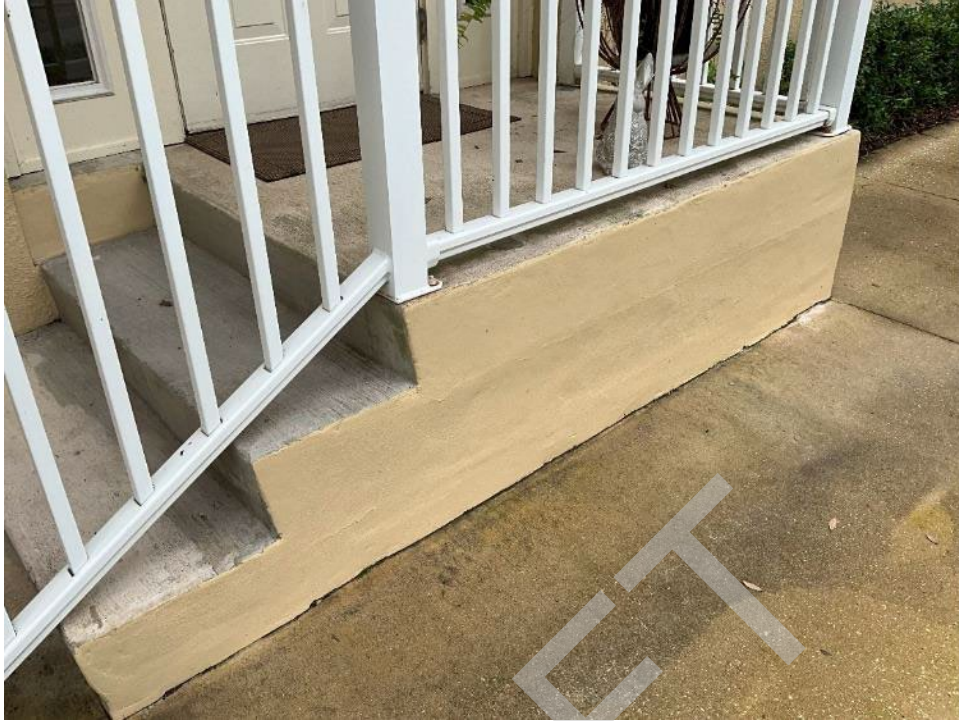
83. View of bulging along the stairs leading to unit G102.

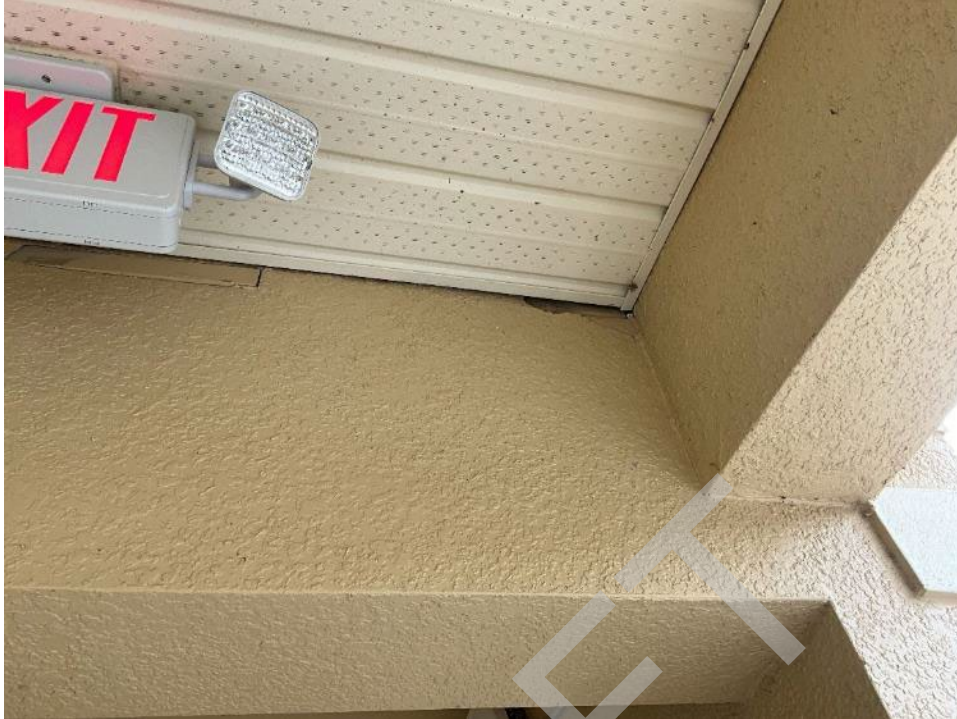
85. View of finish cracking in the beam near the stairwell.

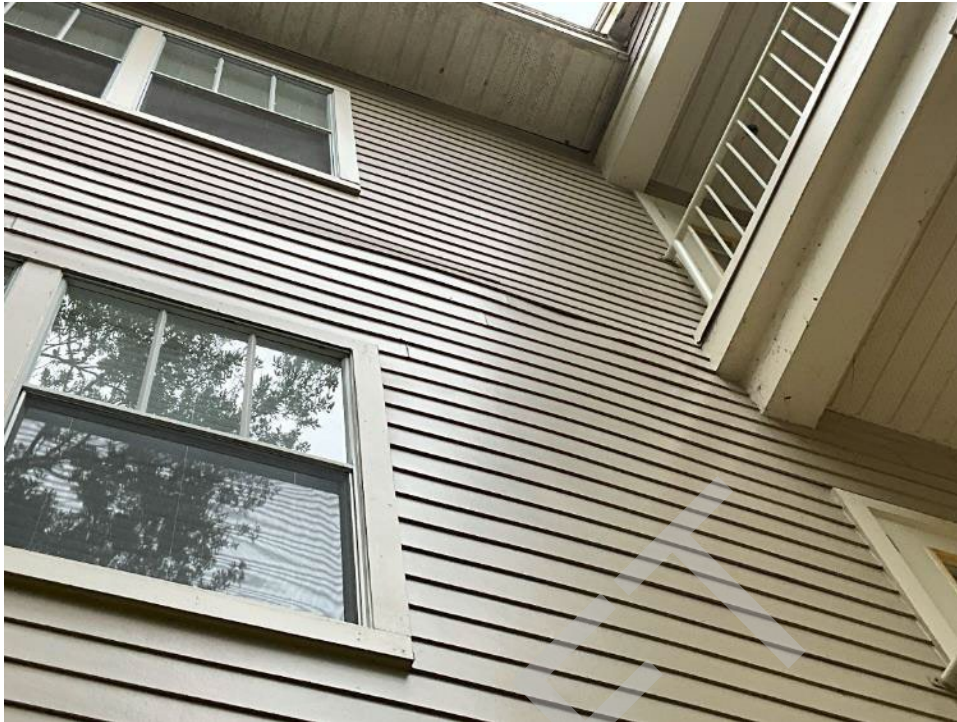
95. View of bulging in siding along the rear elevation.

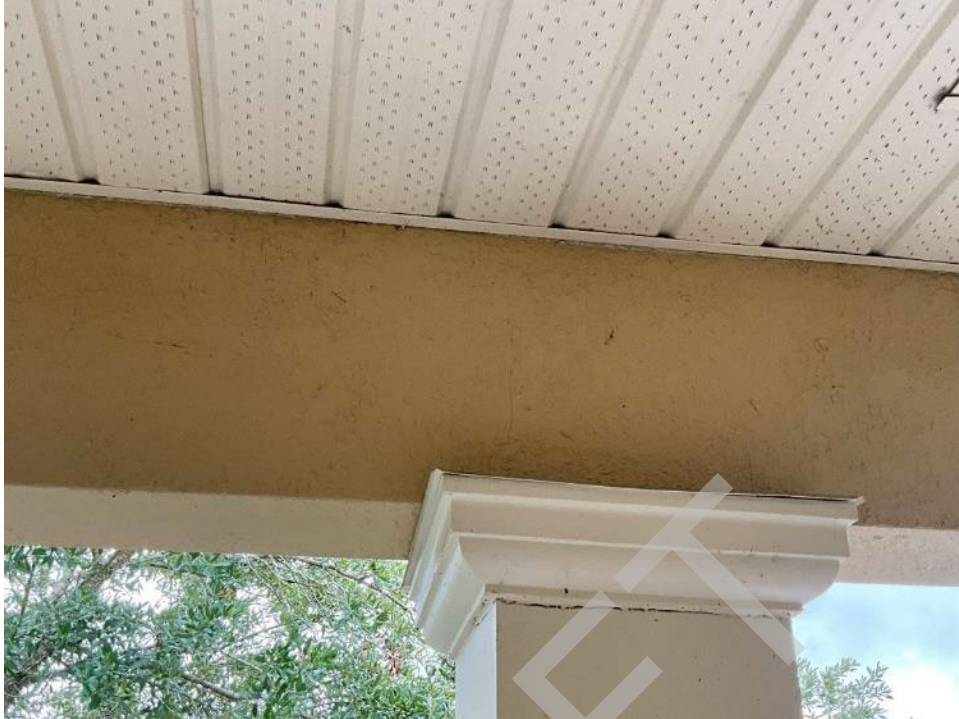
99. View of cracks in the interface of the column top and the column.

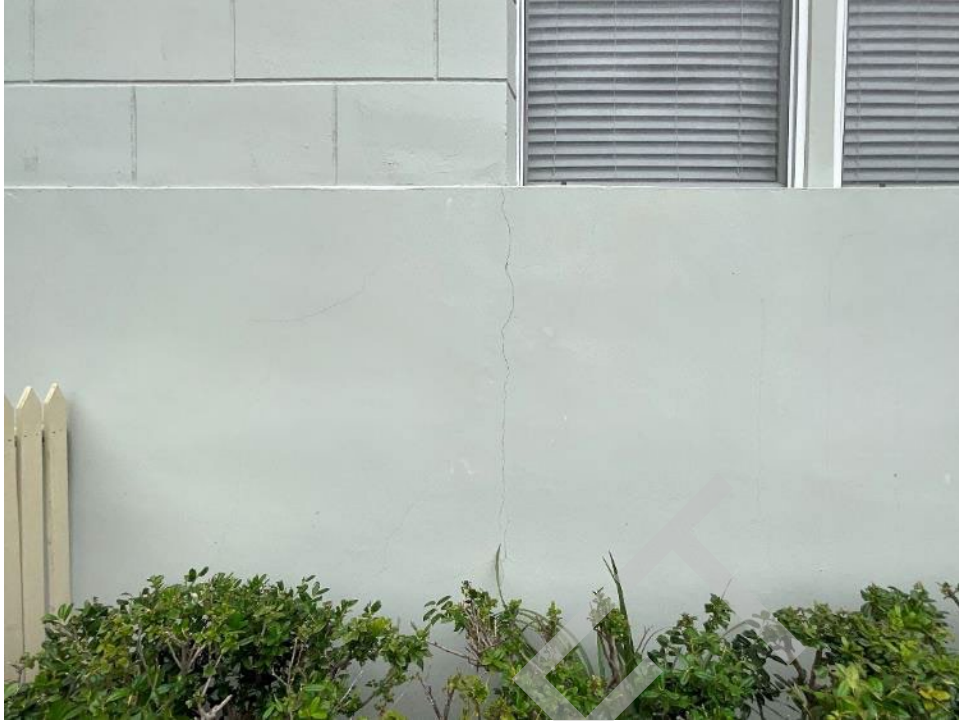
111. View of vertical cracking observed around the base of the wall.

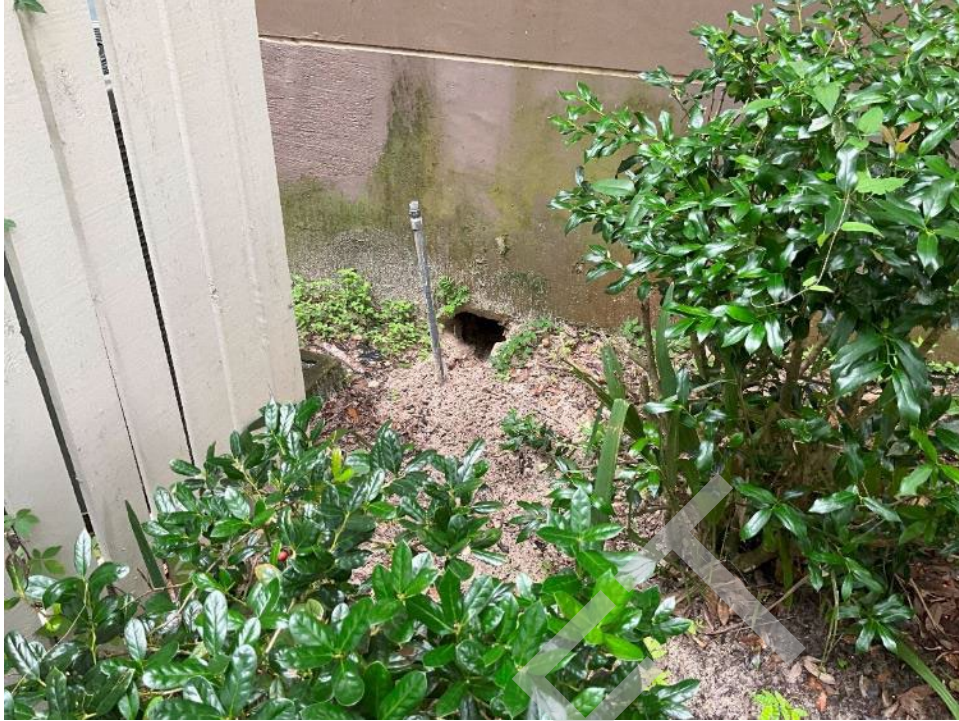
125. View of hole dug out under the building.

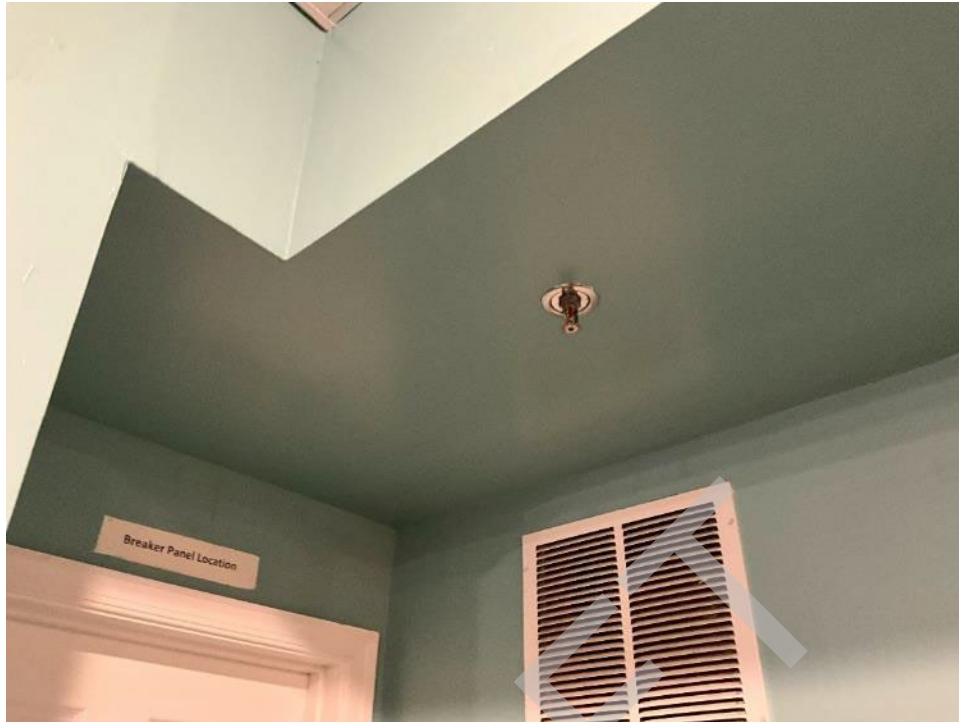
129. View of typical sprinklers through out the buildings.
