VILLAGE AT HAILE CONDOMINIUM – DESTRUCTIVE TESTING SUMMARY

January 30, 2026

SUBJECT: Destructive Testing Summary and Recommendations

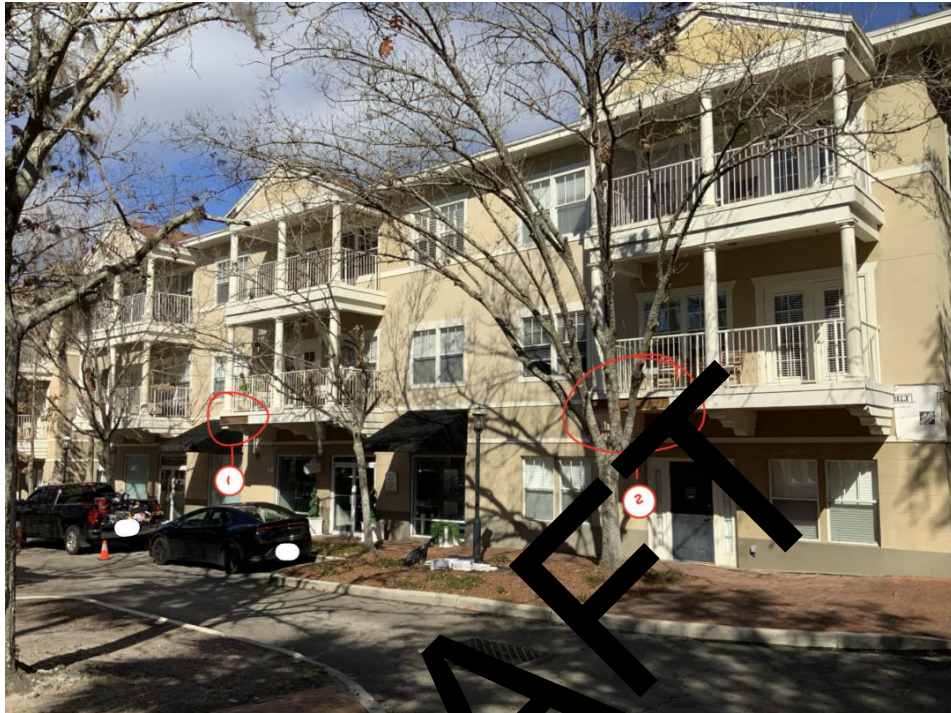
Elevation 1: View of the south elevation of Building A.

DT # on Elevation	Photo	Building	Elevation	Floor	Location	Destructive Testing	Condition	Recommendation	Temporary Shoring Needed
2		A	South	2	East Balcony	Remove fascia board	Stained floor joists	Replace fascia board	No
1		A	South	2	Center Balcony	Remove fascia board	Stained floor joists	Replace fascia board	No
3		A	North	2	Outside of the east portion of the breezeway beam	Cut/remove stucco	No connection between beam and CMU wall (assumed)	Add connection with engineered solution	Yes
2		A	North	3	Inside of the east portion of the east breezeway beam	Remove plastic	Tight connection between beam and CMU wall	Replace connection with engineered solution	No
1		A	North	3	Inside of the west portion of the west breezeway beam	Remove plastic	Separation between beam and CMU wall	Replace connection with engineered solution	Yes
1		B	South	1	East of the center balcony	Cut/remove stucco and EIFS	No structural concerns	Replace stucco and EIFS	No

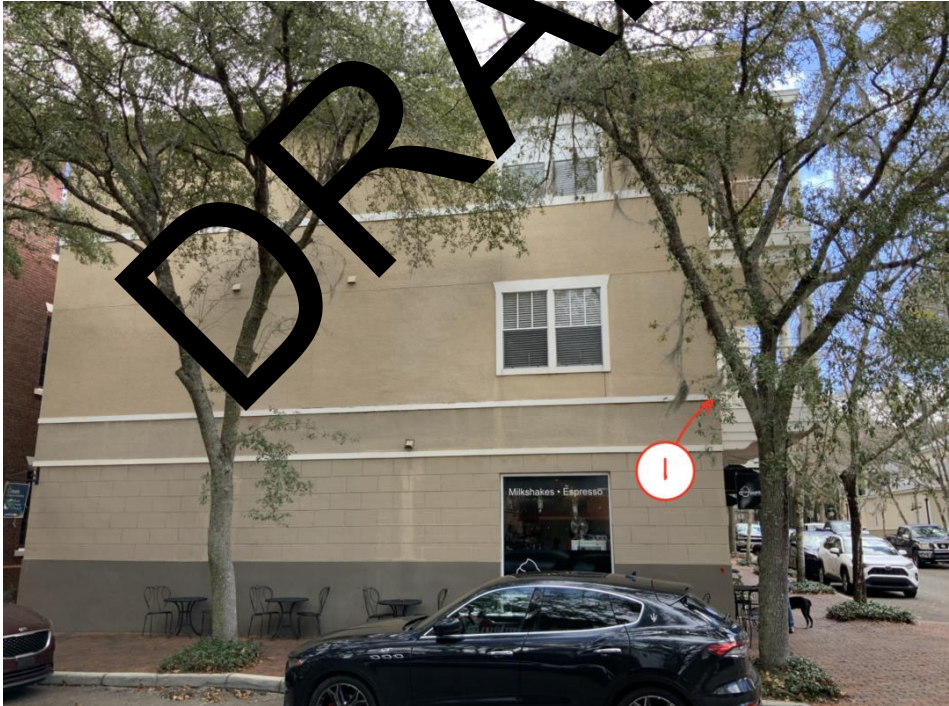
Elevation 4: View of the west elevation of Building B.

1		B	West	1	South portion of the wall	Cut/remove stucco and EIFS	No structural concerns	Replace stucco and EIFS	No
1		B	North	1	Outside of the west portion of the east beam	Cut/remove stucco	No structural concerns	Replace stucco	No
2		B	North	1	Outside of center span	Cut/remove stucco	No structural concerns	Replace stucco	No
3		B	North	1	Inside of west portion of the wall	Cut/remove stucco	No structural concerns	Replace stucco	No
1		C	South	2	Inside of breezeway column	Cut/remove stucco	No stained or deteriorated sheathing	Cut sheathing to expose connection	No
2		C	South	2	Inside of the west portion of the breezeway beam	Cut/remove stucco and sheathing	No connection between beam and CMU wall	Add connection with engineered solution	Yes
3		C	South	2	Portion of the west breezeway wall	Cut/remove stucco	No structural concerns	Replace stucco	No
1		D	South	1	Outside of the west portion of the west beam	Cut/remove stucco	No structural concerns	Replace stucco	No

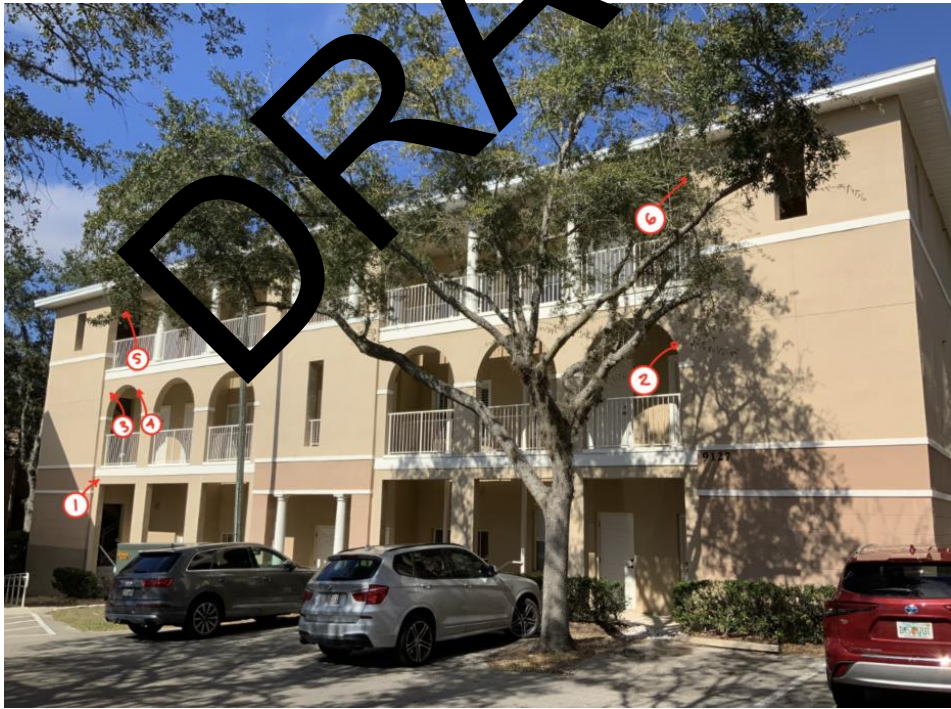
Elevation 8: View of the south elevation of Building D.

2		D	South	2	Inside of the east portion of the breezeway beam	Cut/remove stucco	No connection between beam and CMU wall	Add connection with engineered solution	Yes
3		D	South	2	Inside of the west portion of the breezeway beam	Cut/remove stucco	No connection between beam and CMU wall	Add connection with engineered solution	Yes
4		D	South	2	Portion of the west breezeway wall	No DT	Cracked stucco	Remove and replace stucco	No
5		D	South	3	Inside of the west portion of the west breezeway beam	Cut/remove stucco	Separation between beam and CMU wall	Add connection with engineered solution	Yes
6		D	South	3	Inside of the east portion of the east breezeway beam	Remove stucco	Separation between beam and CMU wall	Add connection with engineered solution	Yes
1		E	South	1	Outside of the west portion of the west beam	Cut/remove stucco	No structural concerns	Replace stucco	No
2		E	South	1	Outside of the east portion of the west beam	No DT	Cracked stucco	Remove and replace stucco	No

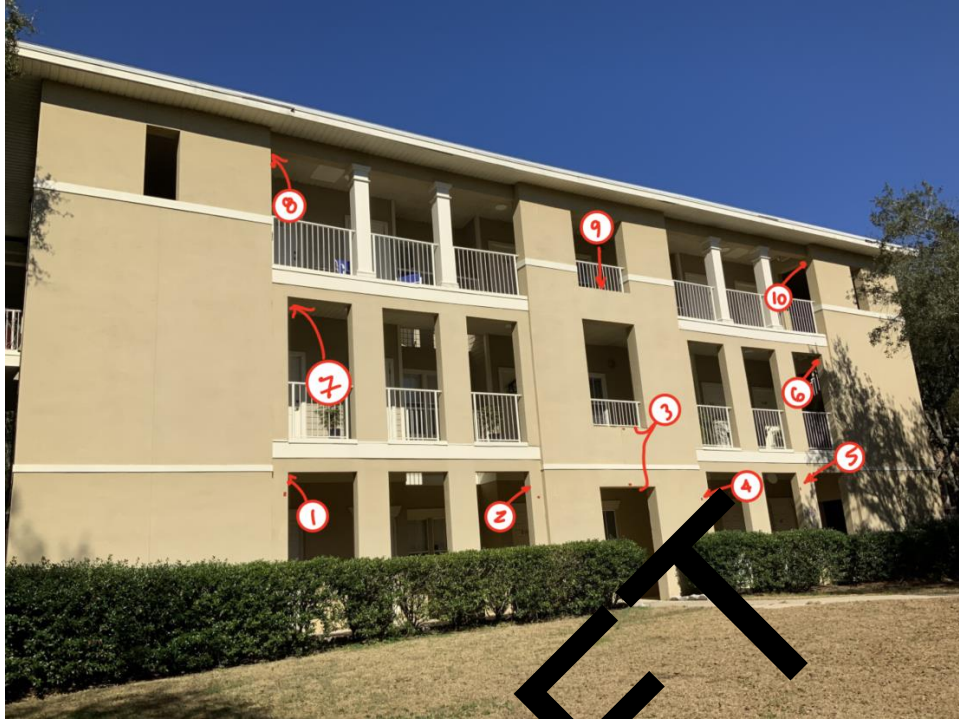
Elevation 9: View of the south elevation of Building E.

3		E	South	1	Outside of center span	No DT	Cracked stucco	Remove and replace stucco	No
4		E	South	1	Outside of the west portion of the east beam	No DT	Cracked stucco	Remove and replace stucco	No
5		E	South	1	Outside of the east column of the east beam	No DT	Cracked stucco	Remove and replace stucco	No
6		E	South	2	Inside of the east portion of east beam	Cut/remove stucco and sheathing	No connection between beam and CMU wall	Add connection with engineered solution	Yes
7		E	South	2	Inside of west portion of west beam	Cut/remove stucco and sheathing	No connection between beam and CMU wall	Add connection with engineered solution	Yes
8		E	South	3	Inside of west portion of west beam	Cut/remove stucco and sheathing	Underdesigned connection	Replace connection with engineered solution	Yes
9		E	South	3	Inside of center span	Cut/remove stucco and sheathing	Wood frame column	Replace sheathing and stucco	No
10		E	South	3	Inside of east portion of east beam	Cut/remove stucco and sheathing	Underdesigned connection	Replace connection with engineered solution	Yes

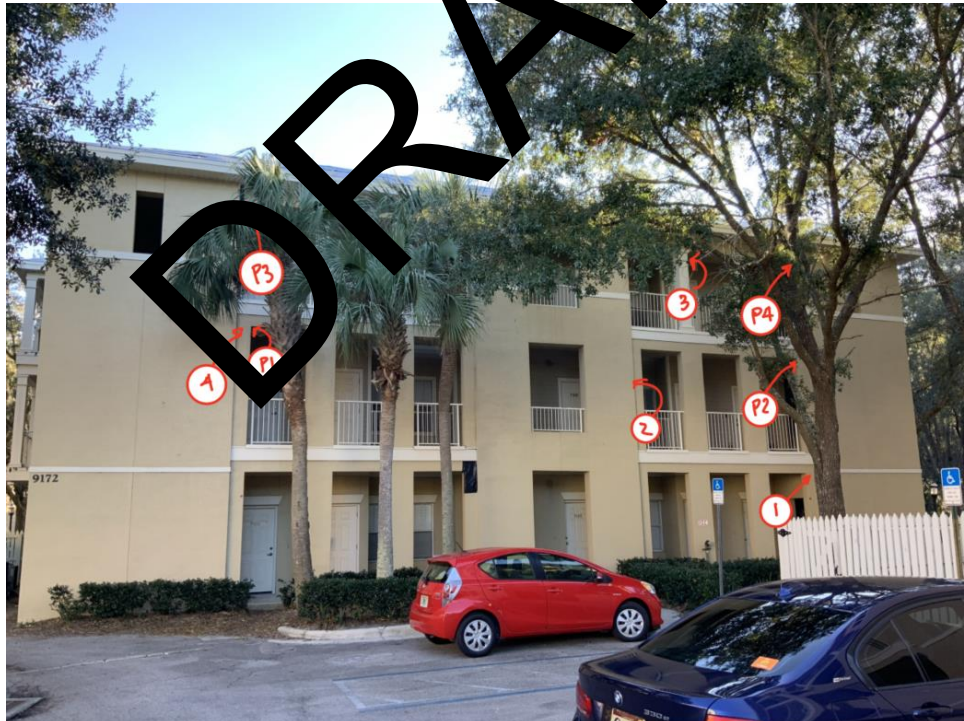
Elevation 10: View of the north elevation of Building F.

DT # on Elevation	Photo	Building	Elevation	Floor	Location	Destructive Testing	Condition	Recommendation	Temporary Shoring Needed
1		F	North	1	Outside of the west portion of the west beam	No DT	Cracked stucco	Remove and replace stucco	No
2		F	North	2	Inside of east portion of the west beam	No DT	Cracked stucco No connection between beam and column (assumed)	Add connection with engineered solution	Yes
3		F	North	3	Inside of west beam above column	Cut/remove stucco	Hollow column No structural concerns	Replace stucco	No
4		F	North	2	Outside of the east portion of the east beam	Cut/remove stucco and sheathing	No connection between beam and CMU wall	Add connection with engineered solution	Yes
P1		F	North	2	Inside of the east portion of the east beam	Remove plastic and cut sheathing	No connection between beam and CMU wall	Add connection with engineered solution	Yes
P2		F	North	2	Inside of the west portion of the west beam	Remove plastic	No connection between beam and CMU wall (assumed)	Add connection with engineered solution	Yes

P3		F	North	3	Inside of the east portion of the east beam	Remove plastic	Tight connection between beam and CMU wall	Replace connection with engineered solution	No
P4		F	North	3	Inside of the west portion of the west beam	Remove plastic and cut stucco	Tight connection between beam and CMU wall	Replace connection with engineered solution	No
1		G	East	3	Above north stairwell	No DT	Delaminated ceiling finish	Remove and replace ceiling finish	No
2		G	East	3	Inside of the north portion of the north beam	Cut/remove stucco	Separation between beam and CMU wall	Replace connection with engineered solution	Yes
S1		G	East	1	Soffit above north breezeway	Remove soffit	Stained and deteriorated wood decking	Remove and replace wood decking	No
P1		G	East	2	Inside of the south portion of the south beam	Remove plastic	No connection between beam and CMU wall (assumed)	Add connection with engineered solution	Yes
P2		G	East	2	Inside of the north portion of the north beam	Remove plastic	No connection between beam and CMU wall (assumed)	Add connection with engineered solution	Yes

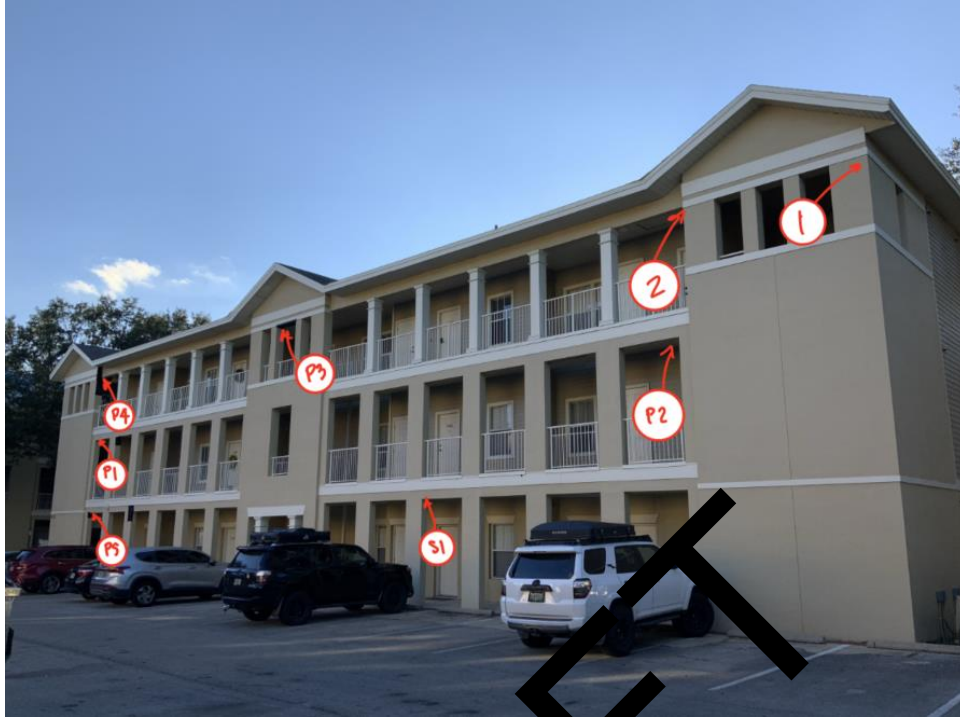
Elevation 11: View of the east elevation of Building G.

P3		G	East	3	Center span	Remove plastic	Stained and deteriorated wood framing	Remove and replace wood framing	No
P4		G	East	3	Inside of the south portion of the south beam	Remove plastic Cut/remove stucco	Separation between beam and CMU wall	Replace connection with engineered solution	Yes
P5		G	East	1	Below the south portion of the south beam	Remove plastic	No structural concerns	Replace stucco	No
1		H	East	1	Outside of the south portion of the south beam	No DT	Cracked stucco	Remove and replace stucco	No
S1		H	East	1	Soffit above north breezeway	No DT	Cracked concrete flooring on breezeway above	Remove soffit for further inspection	No
S2		H	East	2	Soffit above north breezeway	No DT	Cracked concrete flooring on breezeway above	Remove soffit for further inspection	No
1		I	West	1	Wall outside of doorway	No DT	Cracked wall finish	Remove and replace wall finish	No

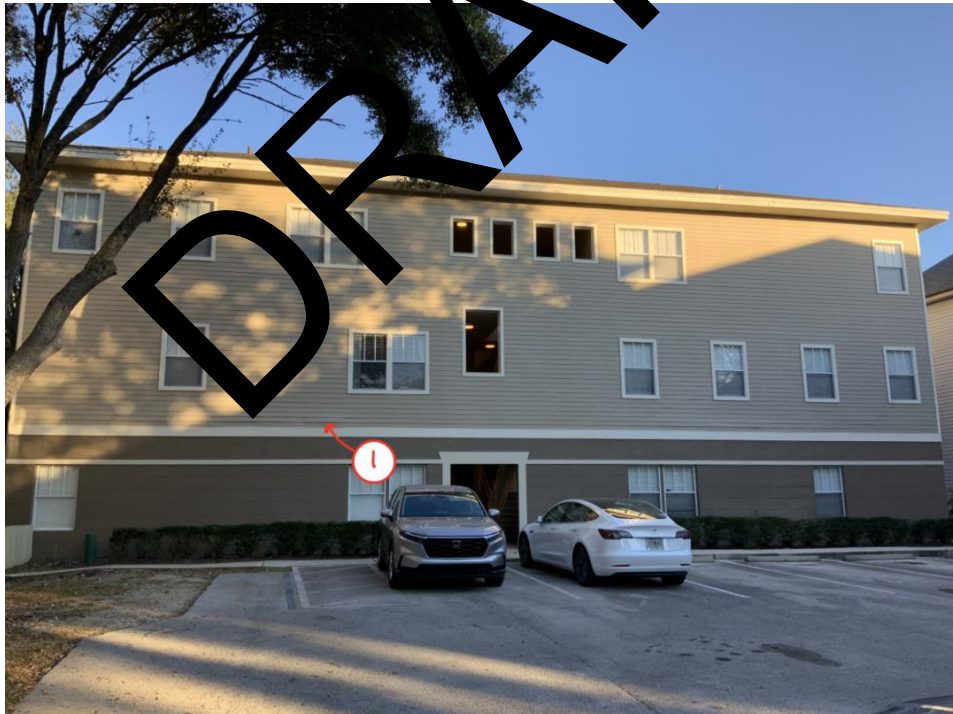
Elevation 16: View of the west elevation of Building K.

-		J	-	-	Not checked locations	-	-	-	No
1		K	West	1	Siding along north portion of wall	No DT	Bulging wall siding	Remove siding for further inspection	No
1		L	North	1	Exterior finish along west portion of the wall	No DT	Cracked wall finish	Remove and replace wall finish	No

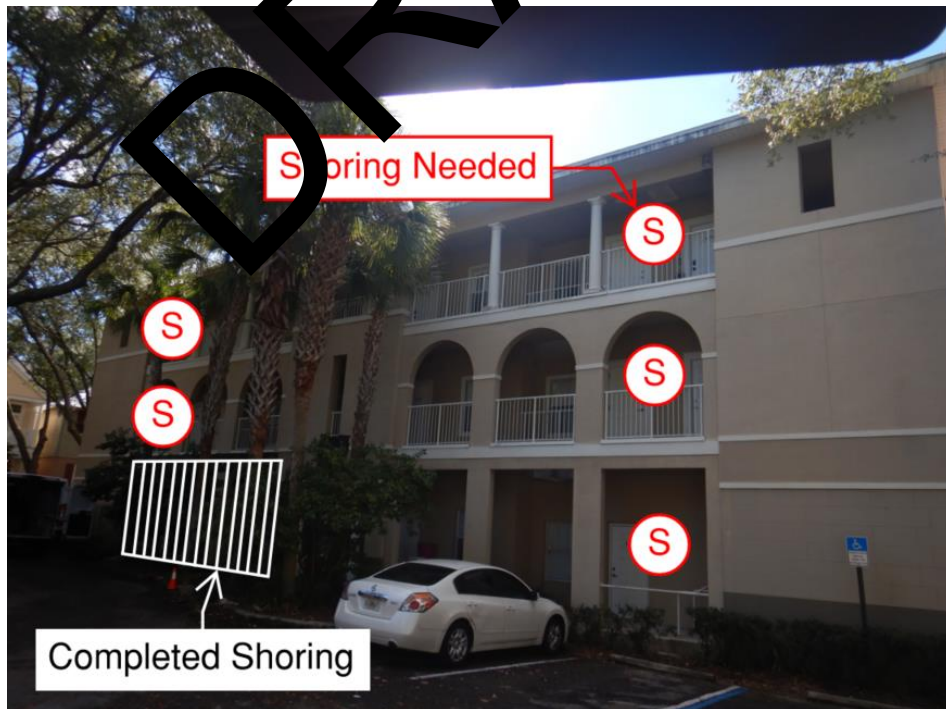
Shoring 2: View of shoring locations along the north elevation of building A.

NV5 recommends installing temporary shoring at all locations where the existing beam-to-wall connections present a structural concern (**Attachment C – Shoring Locations**). Additional shoring will also be required at locations below these elevated concern areas to ensure proper load transfer to the ground level and to prevent unintended overloading of intermediate building components. We further recommend that a properly engineered, permanent connection be designed and installed at these locations to prevent any additional structural movement. In addition, NV5 recommends expanding the destructive testing scope to confirm whether similar conditions exist throughout all buildings. These measures will help mitigate further damage and support timely and effective resolution of the issue.

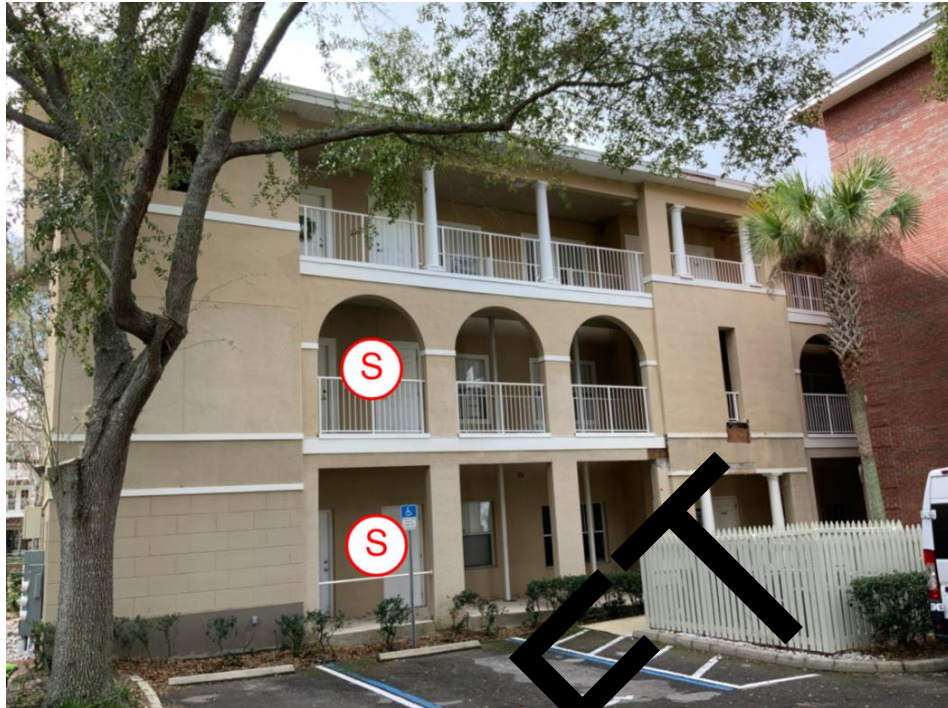
Shoring 3: View of shoring locations along the north elevation of building B.

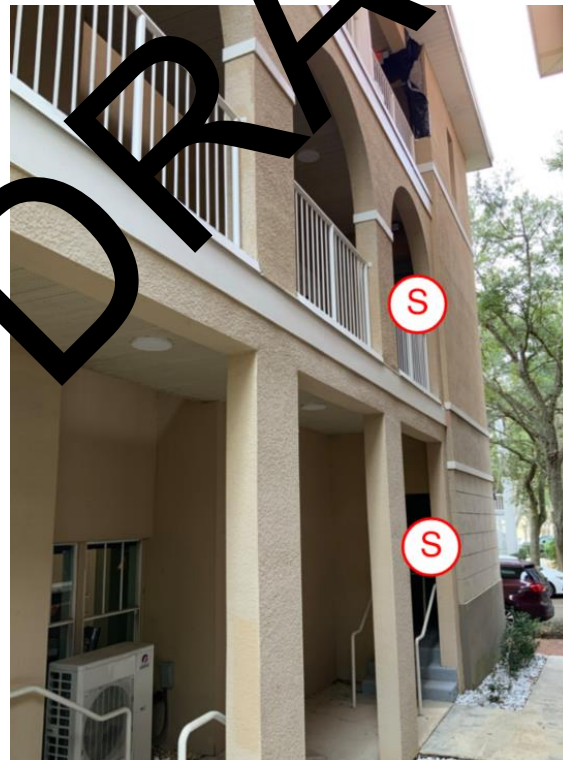
Shoring 4: View of shoring locations along the north elevation of building B.

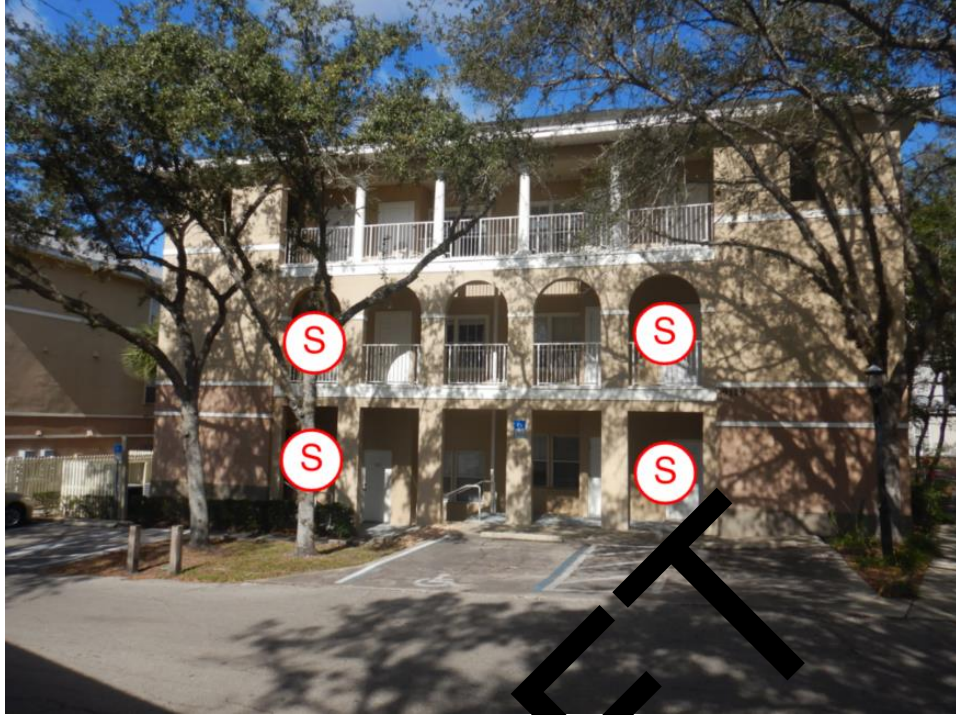
Shoring 5: View of shoring locations along the north elevation of building C.

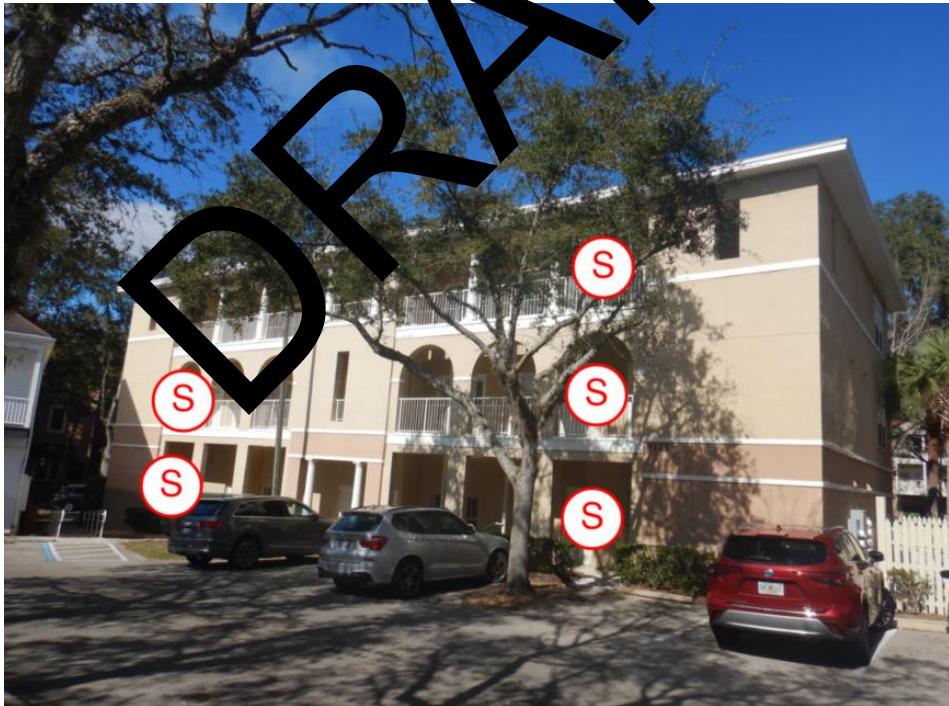
Shoring 6: View of shoring locations along the south elevation of building D.

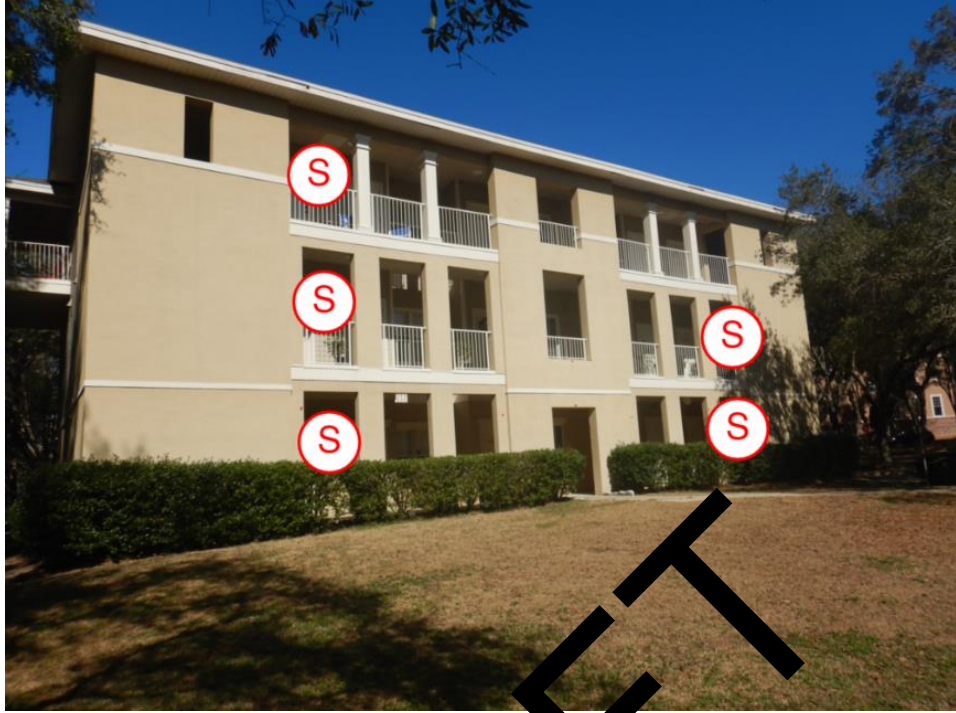
Shoring 7: View of shoring locations along the south elevation of building E.

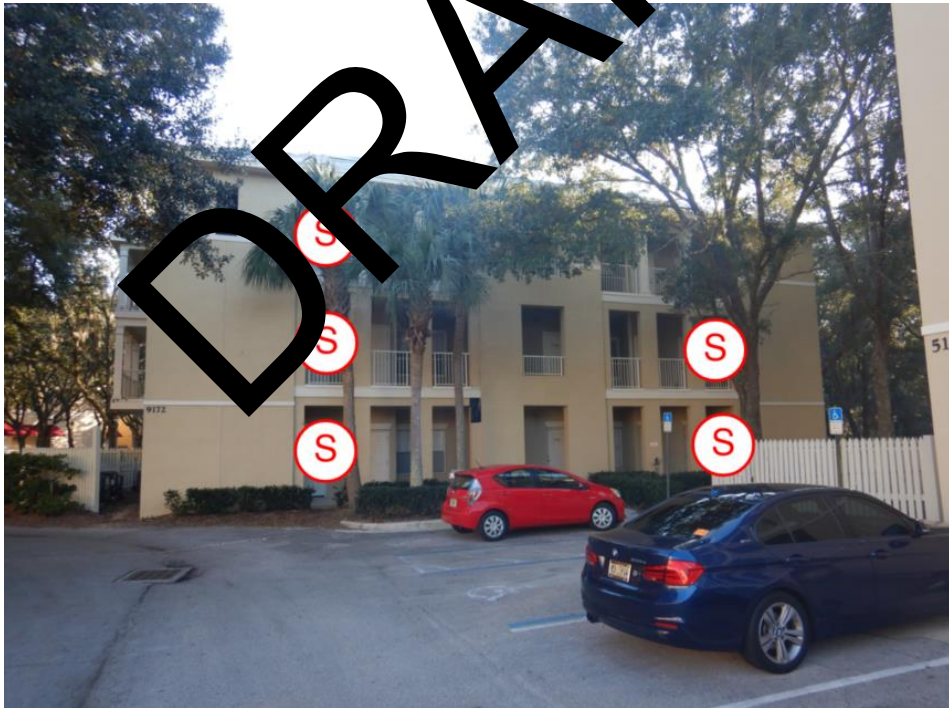
Shoring 8: View of shoring locations along the north elevation of building F.

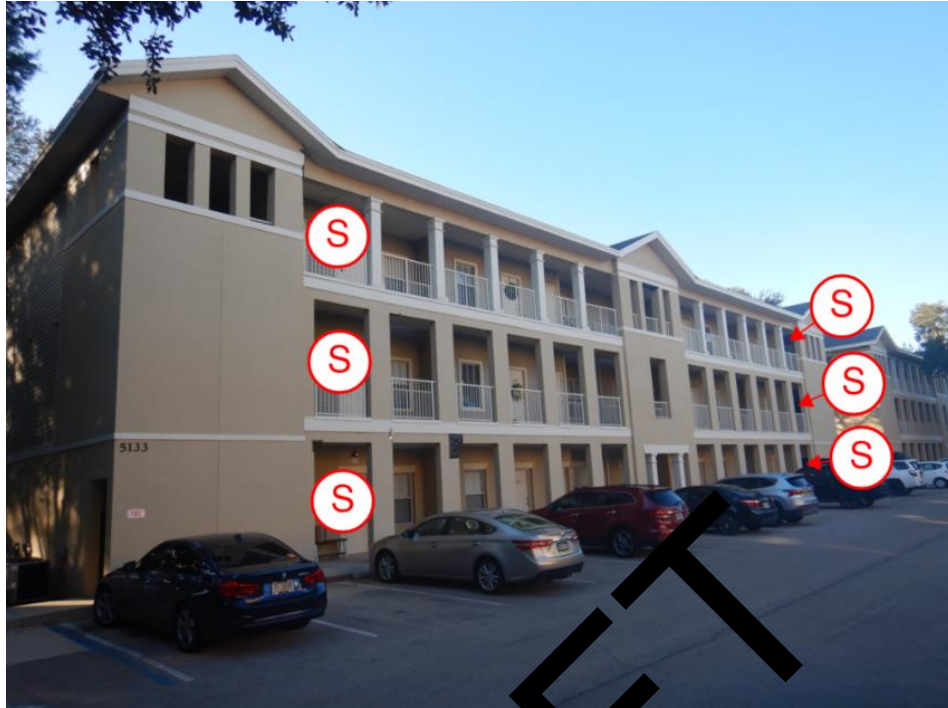
Shoring 9: View of shoring locations along the west elevation of building G.
