Your Inspection Report

123 Home Pro Blvd
Harrisburg, PA 17104

INSPECTION DATE:
Friday, September 1, 2023

Home Pro Inspectors LLC
153 Crooked Hill Road
Hummelstown, PA 17036

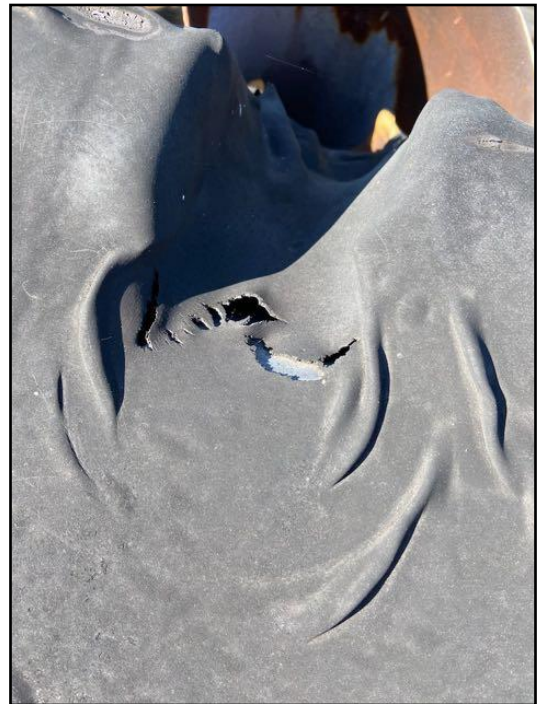
There are quite a few open seams and holes in the rubber roof. It does appear to be at the end of its life. I would recommend replacing the rubber roof and resealing around all of the metal flashing and roofing.

Holes

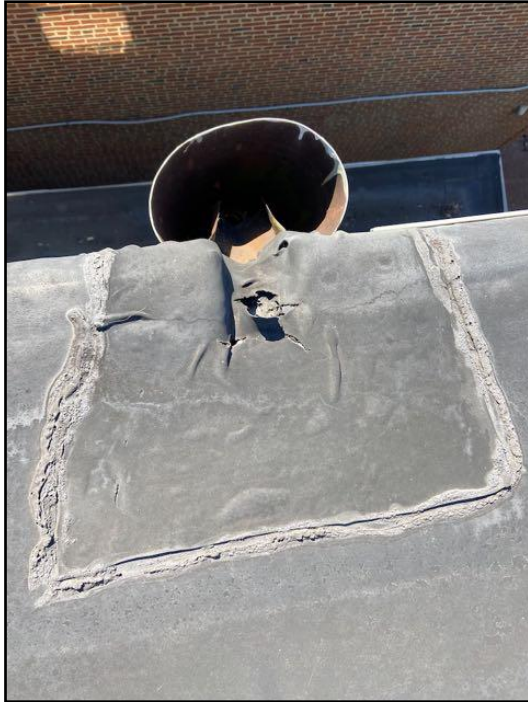
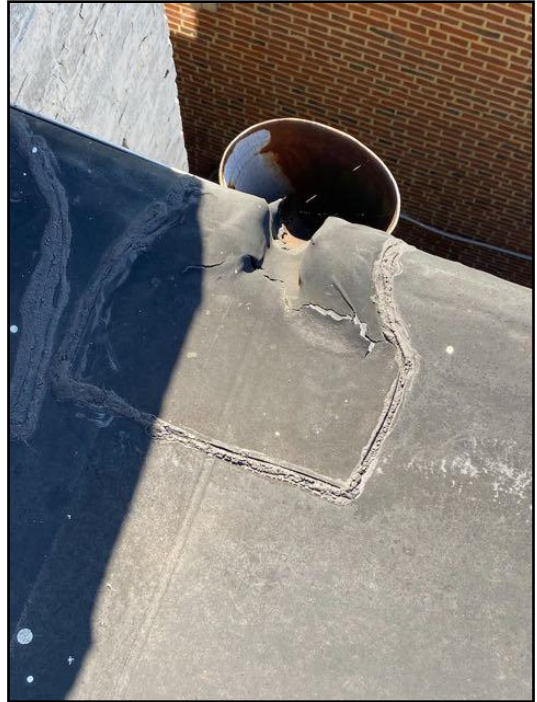
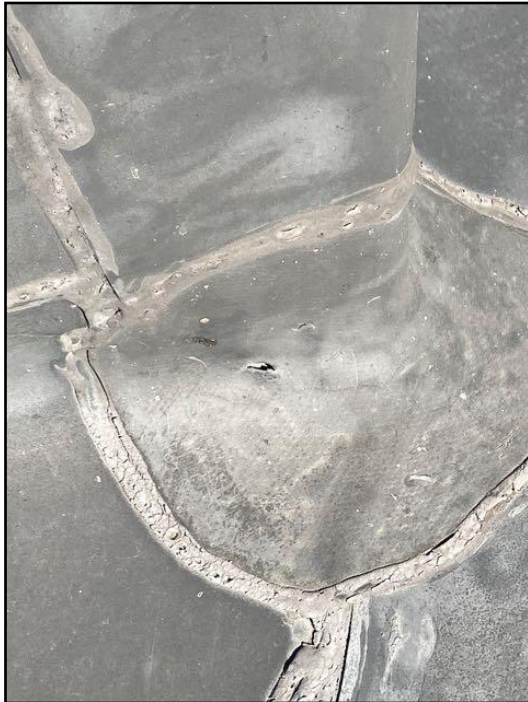
Holes

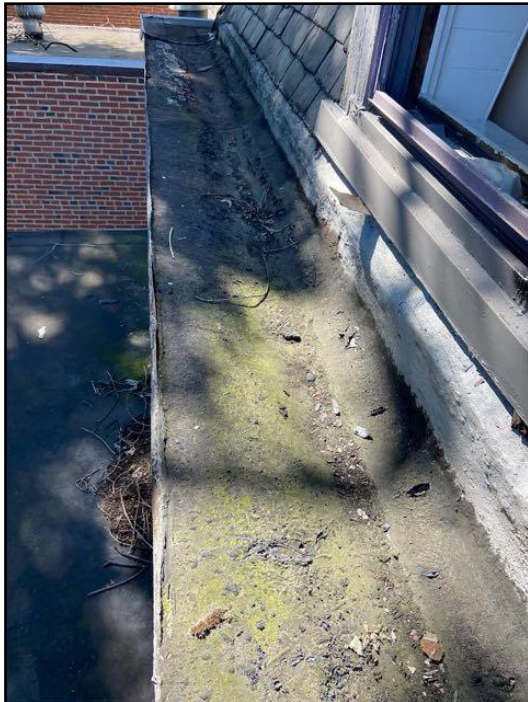
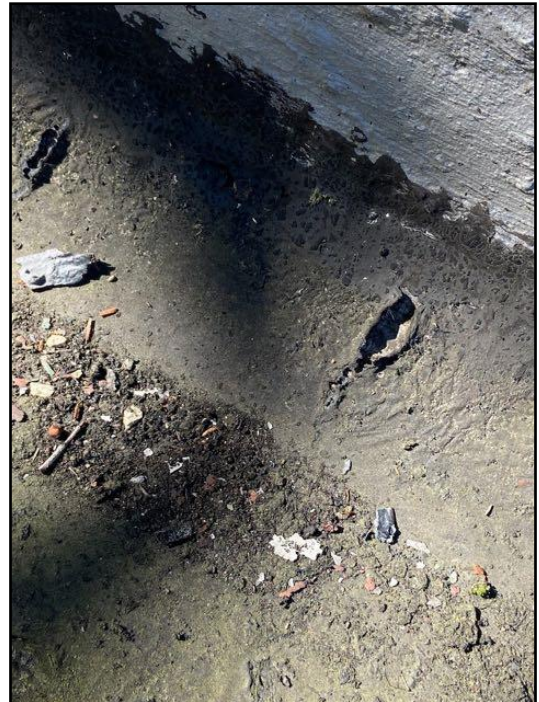
Lost seal

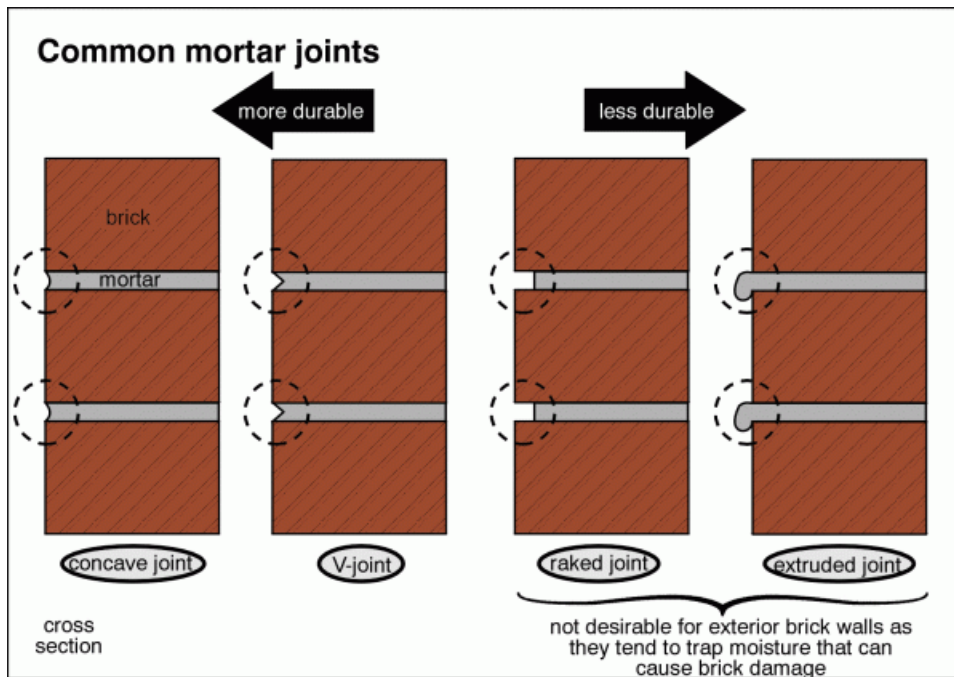
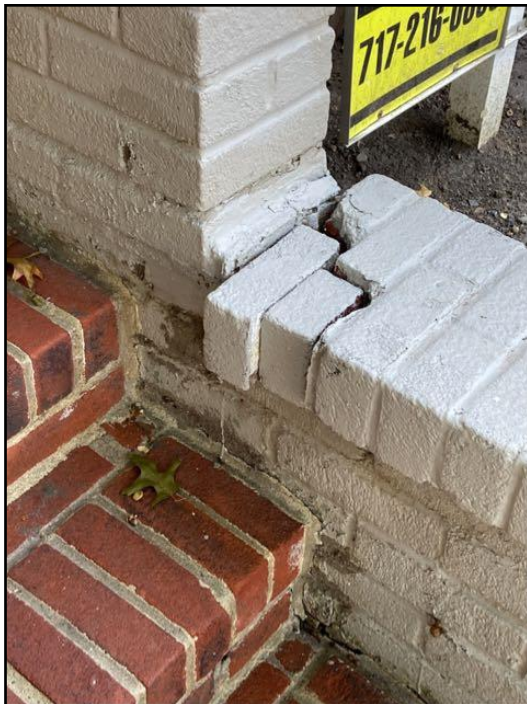
Condition: • There are a few locations outside where the mortar is loose or missing. Mortar only has a lifespan of 50 years. This can allow water to seep in and freeze causing additional damage to the facade. I would recommend having a mason come out to chisel out the old worn out mortar and replace it.

Mortar loss

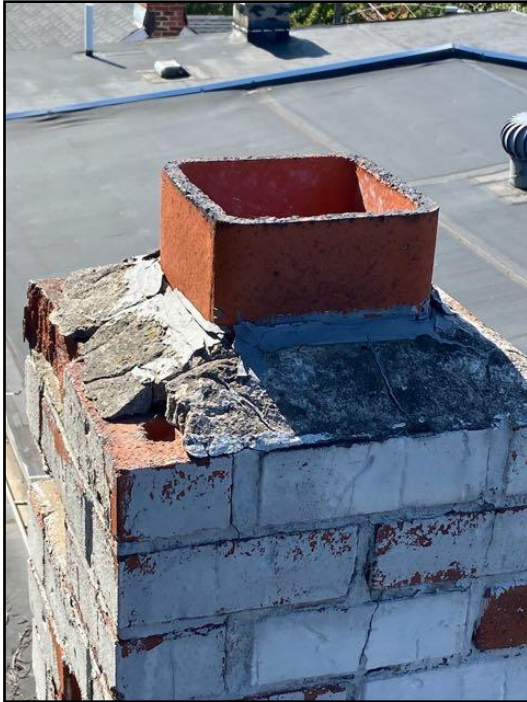
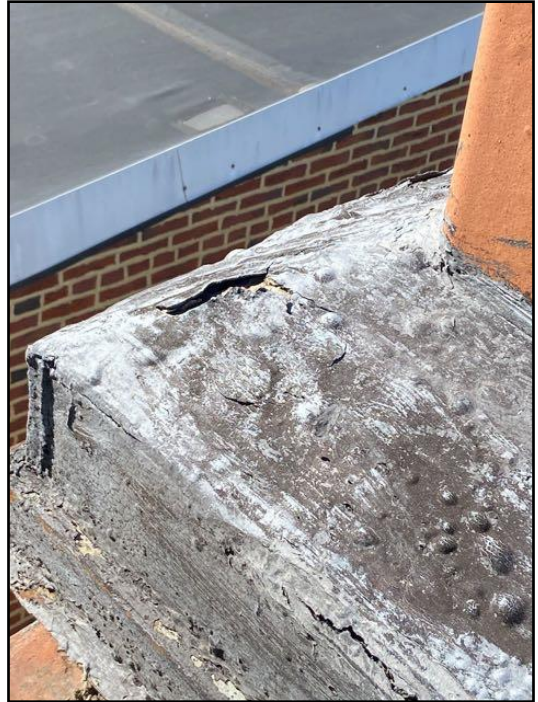
Condition: • The crown on the top of the chimney is cracked/missing. This will allow water to seep in between the terra cotta sleeve and the block.

Bad crown

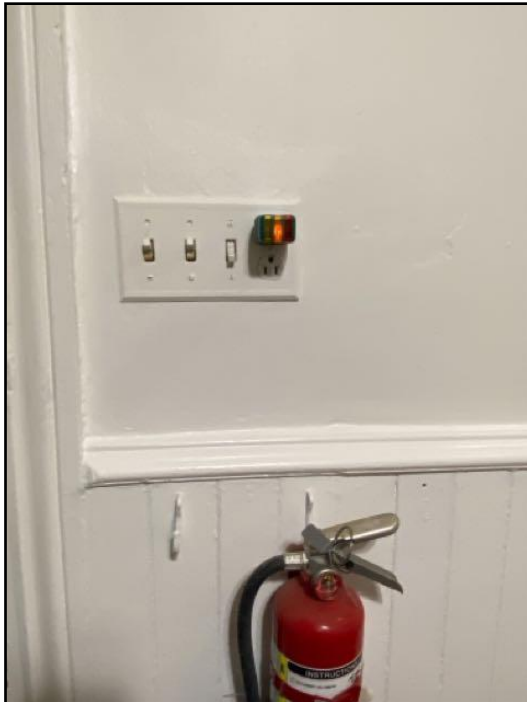
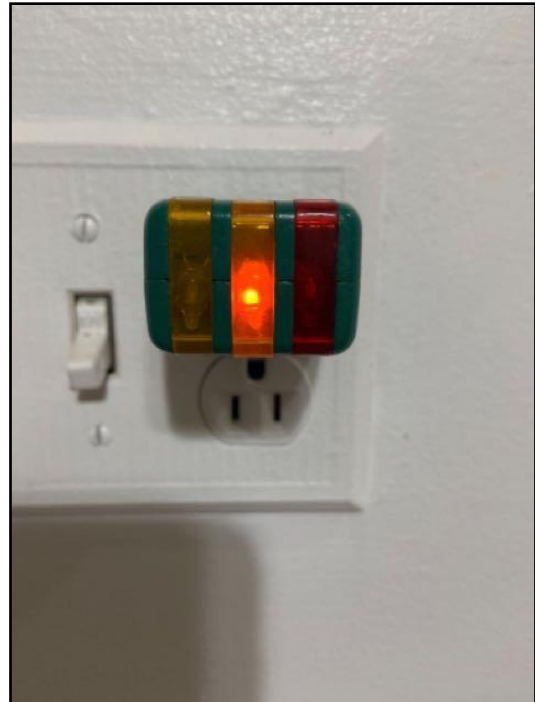
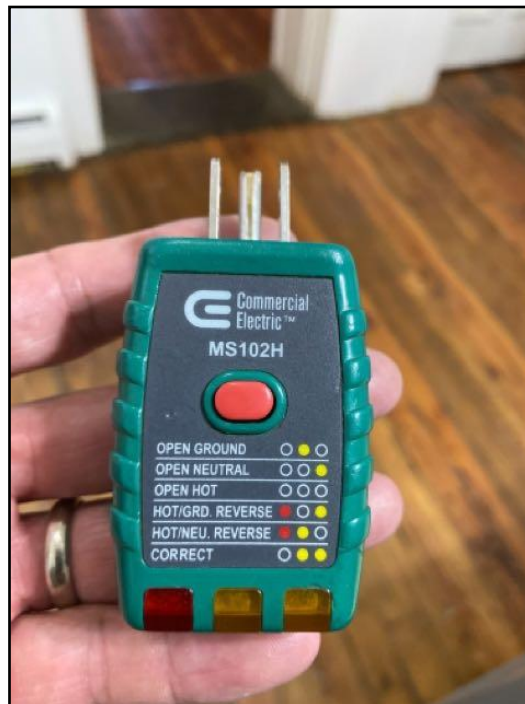
Condition: • There are ungrounded outlets in the home. I would recommend hooking the ground wire back up or replacing the outlets with two prong receptacles.

Ungrounded

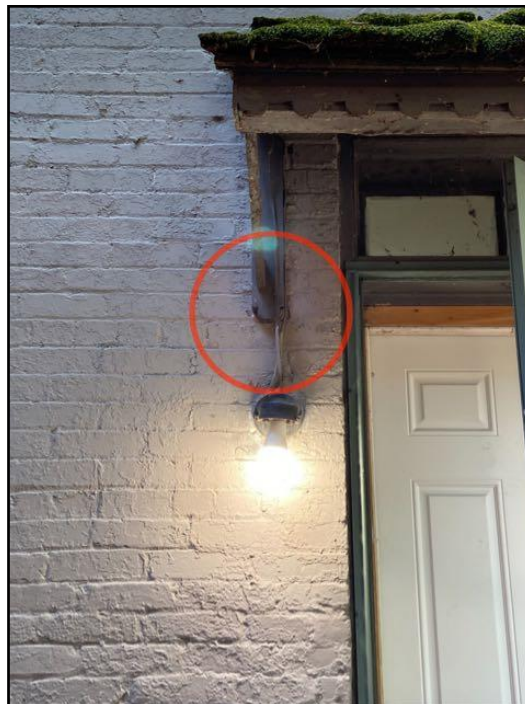
Currently, they are using lamp wire to wire up the back patio light. I would highly recommend changing this out with a UV rated permanent outdoor wire.

Wrong type

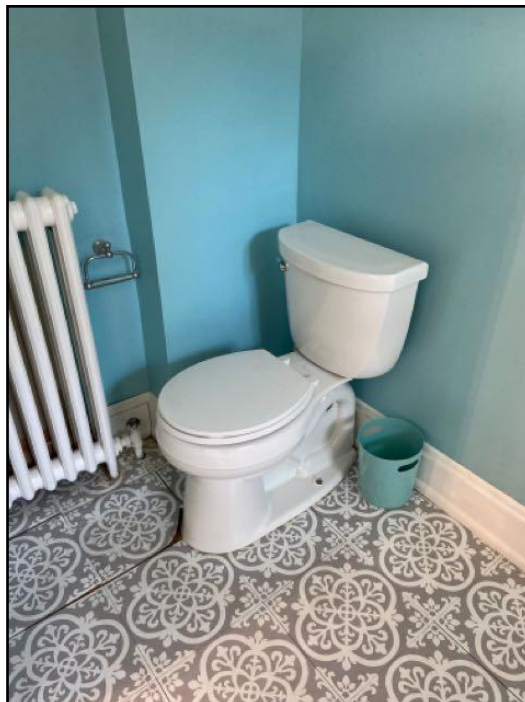
Condition: • You have a toilet that is loose and shifting back and forth.. This can allow minor leaking to begin around the wax flange causing damage to the subfloor.

Loose toilet

No leaks were found below the toilet with a thermal camera. I would recommend tightening the toilet down.

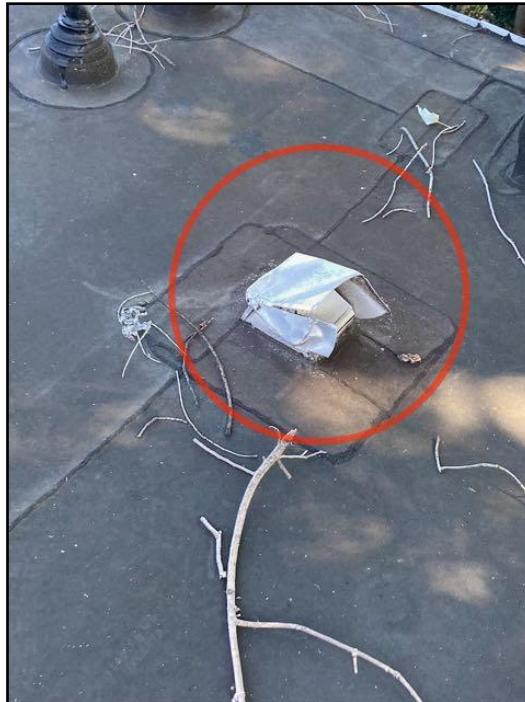
The exhaust fan on the second floor roof is damaged. This could allow water to seep down into the living space below. I would recommend replacing the vent cover on the roof.

Damaged

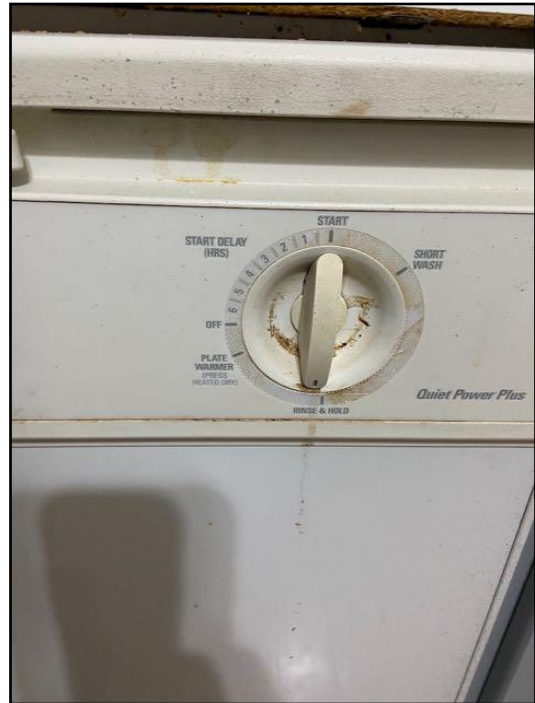
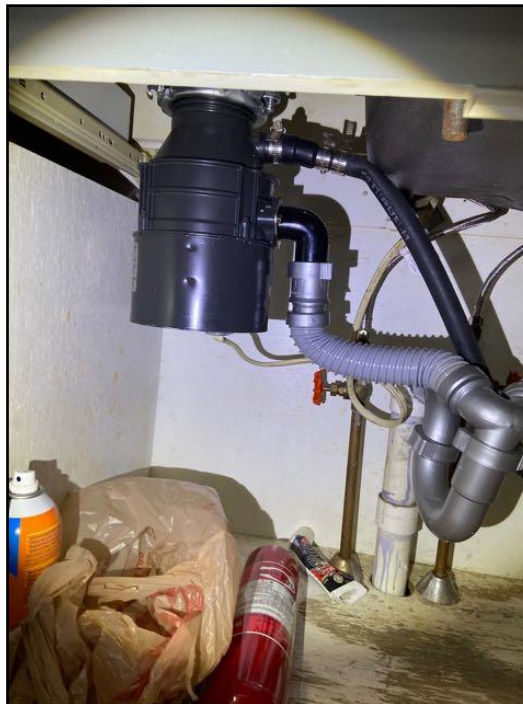
Condition: • When the dishwasher is draining, it is filling up the sink on the left-hand side. Most likely the garbage disposal is clogged.

Sink backing up

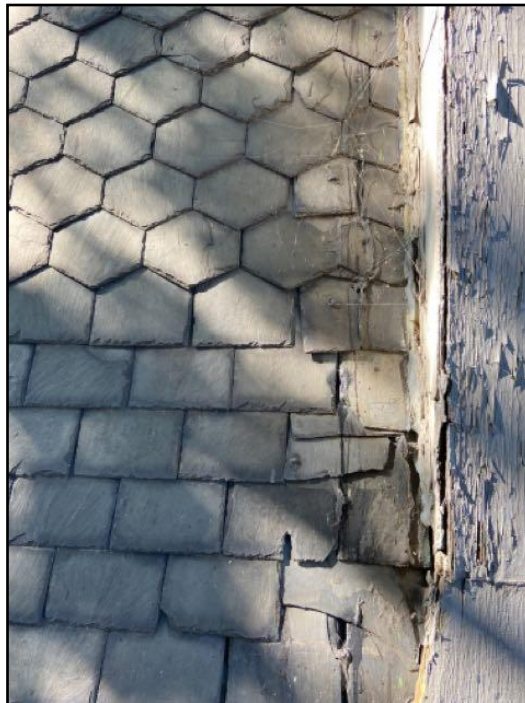
Slate needs maintained

Slate roofing does become brittle and cracks over time. You should keep an eye on the roof especially after hail storms and heavy winds for damage. If you notice damage you will want to take care of it immediately by contacting a slate roofer.

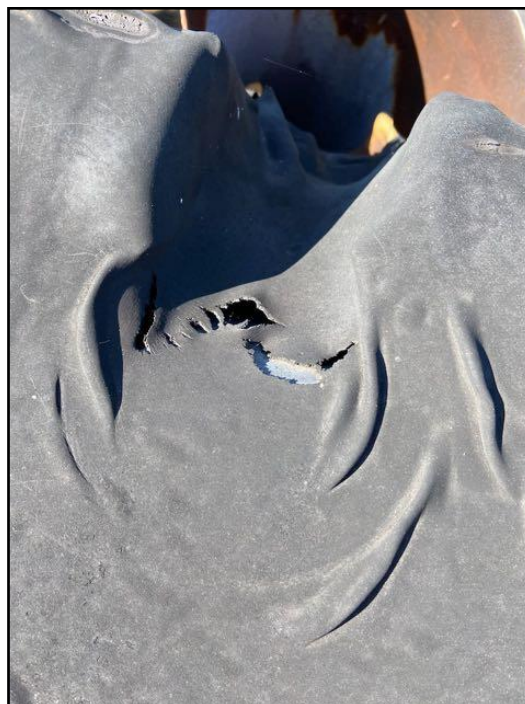
There are quite a few open seams and holes in the rubber roof. It does appear to be at the end of its life. I would recommend replacing the rubber roof and resealing around all of the metal flashing and roofing.

Holes

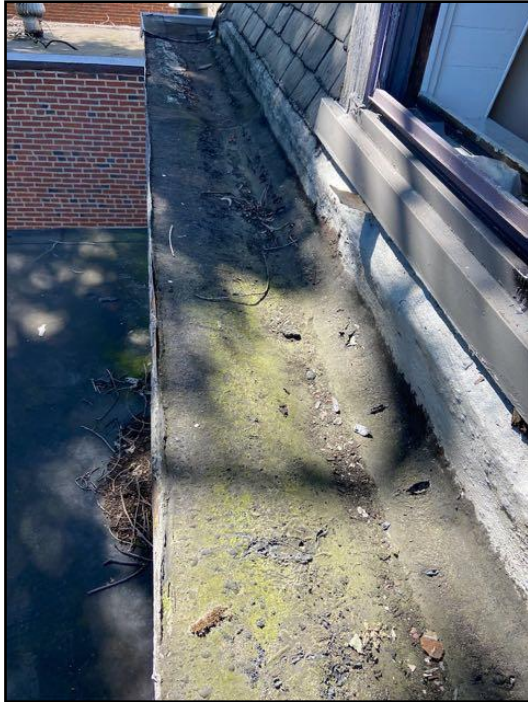
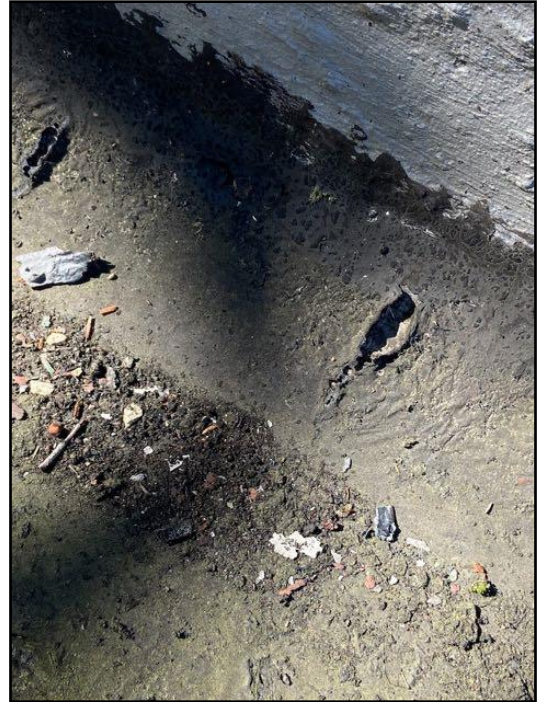
Lost seal

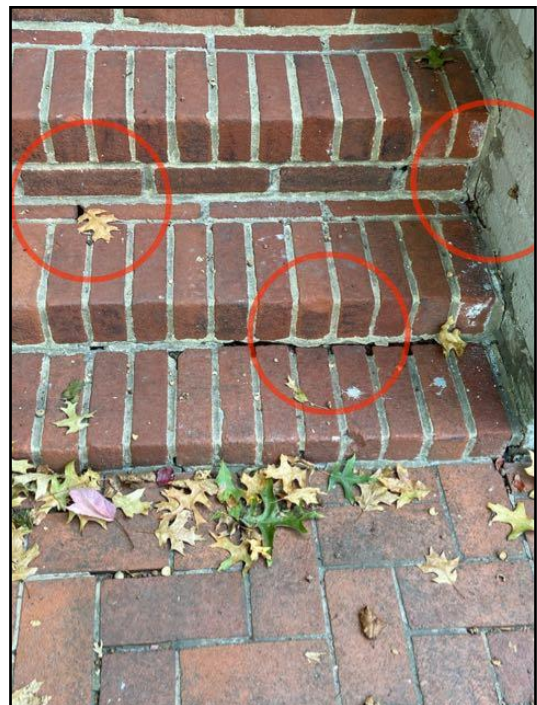
Condition: • There are a few locations outside where the mortar is loose or missing. Mortar only has a lifespan of 50 years. This can allow water to seep in and freeze causing additional damage to the facade. I would recommend having a mason come out to chisel out the old worn out mortar and replace it.

Mortar loss

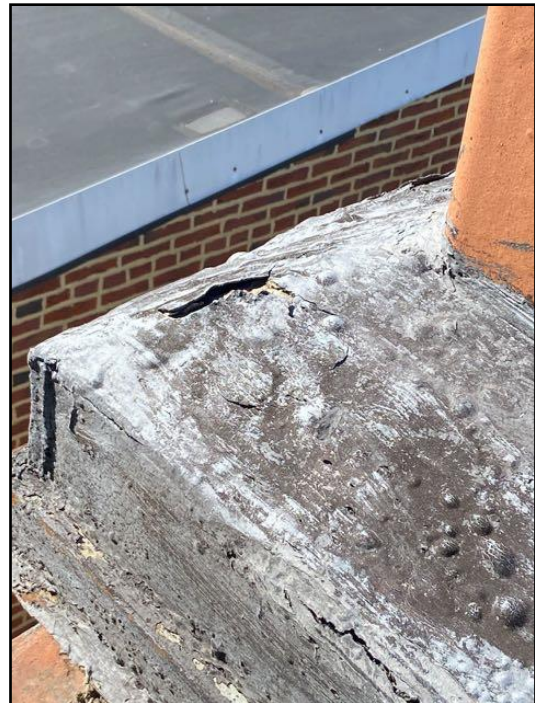
Condition: • The crown on the top of the chimney is cracked/missing. This will allow water to seep in between the terra cotta sleeve and the block.

Task: Major Defect

Bad crown

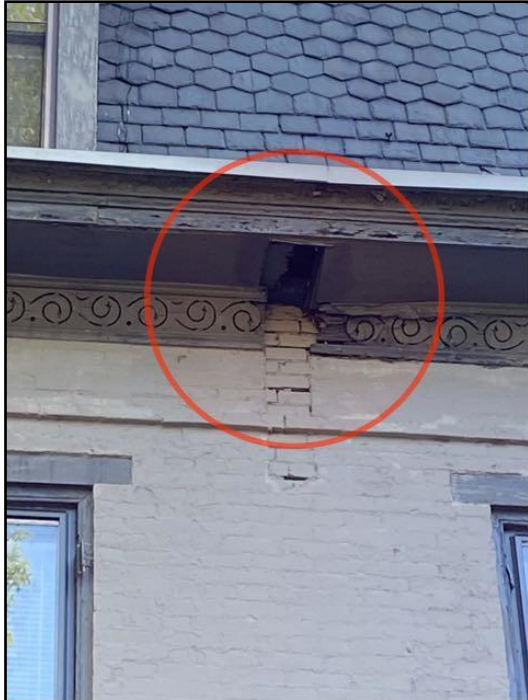
There is rotted wood on the outside of the home in numerous locations. There is some rotted trim up in the front of the home near the roof top. There is missing and rotted trim at the fascia and soffit. The front porch is a bit rotted. Some of the boards are coming up. The columns are a little rotted and need attention. There are some issues with the windowsills on the outside that are also rotted as well as the little overhang in the back. I would recommend going around the outside and replace all of your rotted wood.

Rot

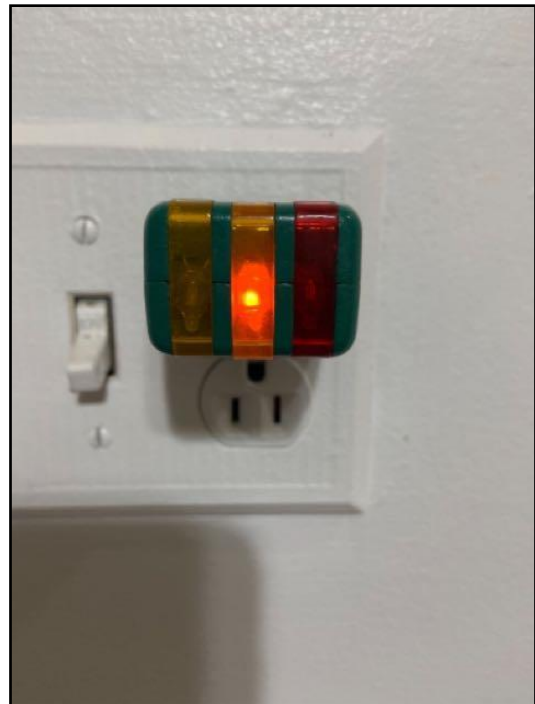
Condition: • There are ungrounded outlets in the home. I would recommend hooking the ground wire back up or replacing the outlets with two prong receptacles.

Task: Safety Defect

Ungrounded

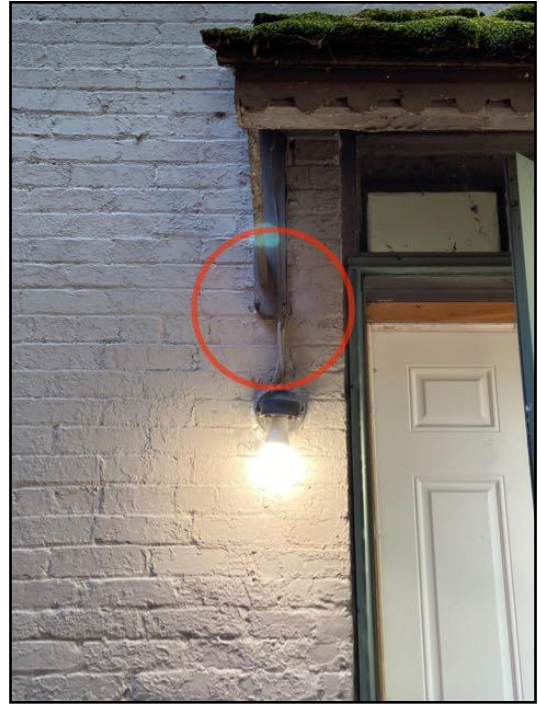
Currently, they are using lamp wire to wire up the back patio light. I would highly recommend changing this out with a UV rated permanent outdoor wire.

Implication(s): Electric shock | Fire hazard

Task: Safety Defect

Wrong type

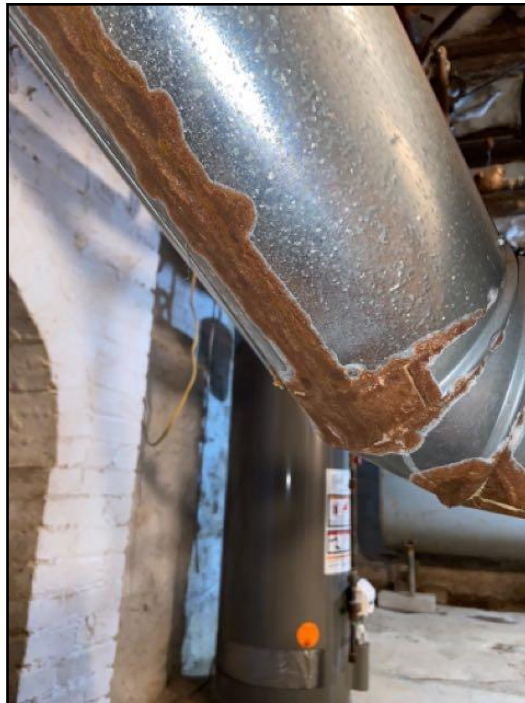
Rust

There is a bit of rust on the bottom side of the boiler exhaust pipe. You may want to keep an eye on this area for any holes rusting all the way through. If that happens, you will need to replace the vent pipe from the boiler to the chimney.

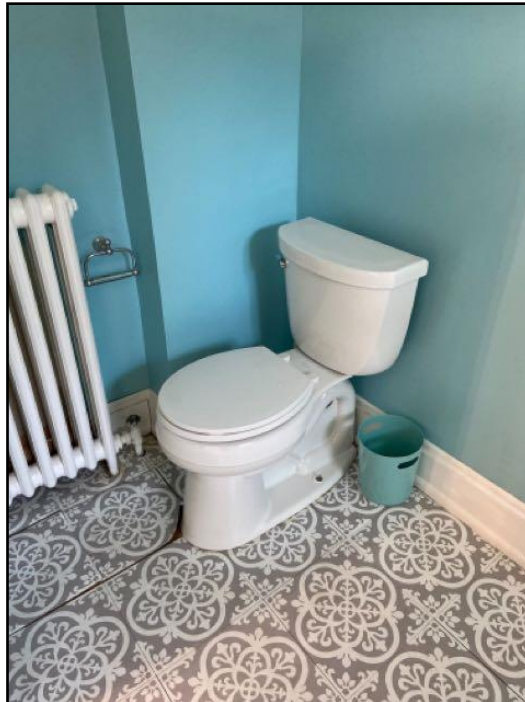
Condition: • You have a toilet that is loose and shifting back and forth.. This can allow minor leaking to begin around the wax flange causing damage to the subfloor.

Loose toilet

No leaks were found below the toilet with a thermal camera. I would recommend tightening the toilet down.

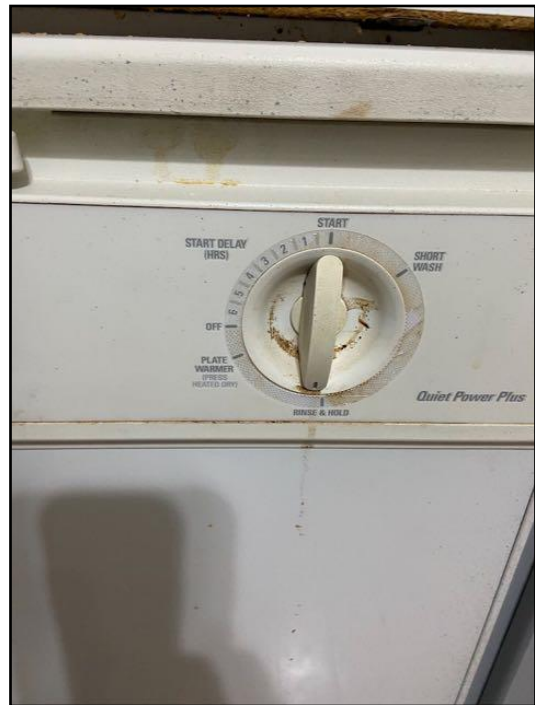
Condition: • When the dishwasher is draining, it is filling up the sink on the left-hand side. Most likely the garbage disposal is clogged.

Sink backing up

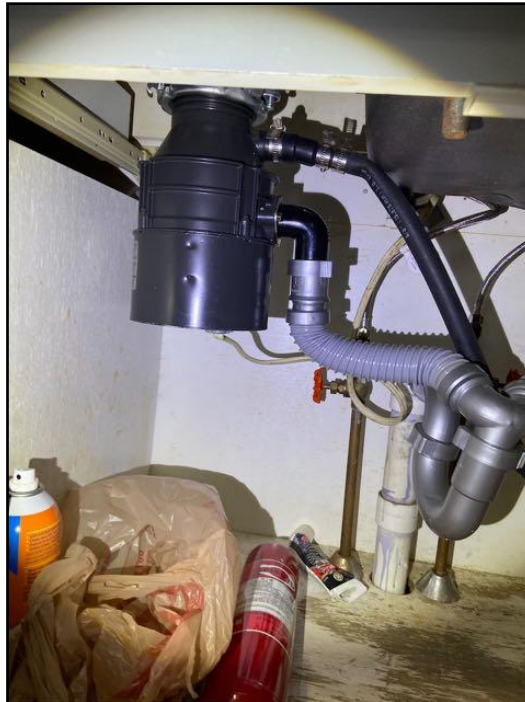
Sink backing up
