# Your Inspection Report

PREPARED FOR:
JANE SMITH

INSPECTION DATE: Monday, July 18, 2022

Report No. 2938, v.0 For inspection at: 123 Sample Road Hummelstown, PA 17036 on: Monday, July 18, 2022

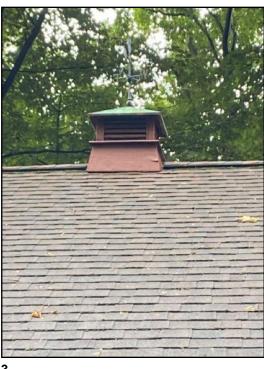
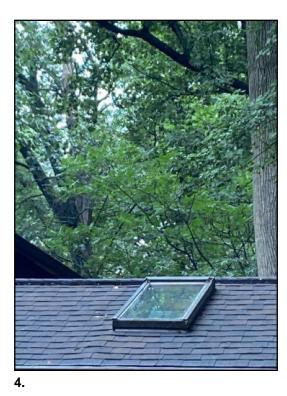
3.

- ROOFING OVERVIEW: Based on the current overall condition of the roof, I would consider it:
- Satisfactory: In above average condition.
- Photos

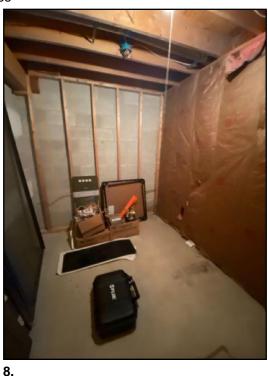
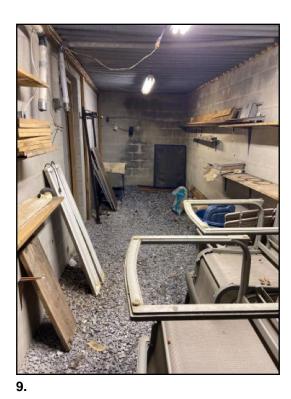
- STRUCTURAL OVERVIEW: Based on the current overall condition of the structure, I would consider it:
- Satisfactory: In above average condition.
- Photos

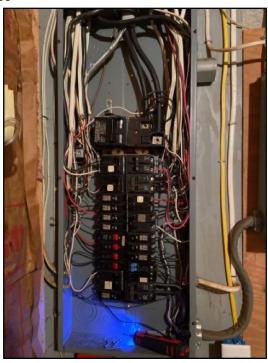
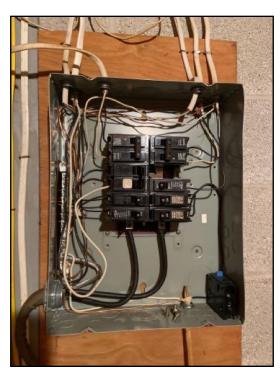
12.

- ELECTRICAL OVERVIEW: Based on the current overall condition of the electrical system, I would consider it:
- Satisfactory: In above average condition.
- Photos

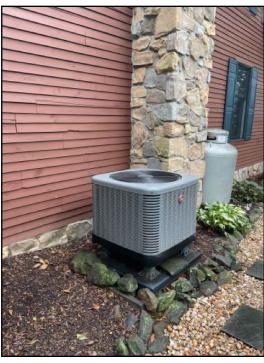
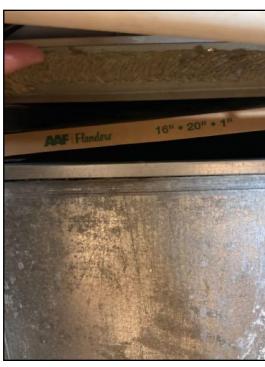
20.

- COOLING OVERVIEW: Based on the current overall condition of the cooling system, I would consider it:
- Satisfactory: In above average condition.
- Photos

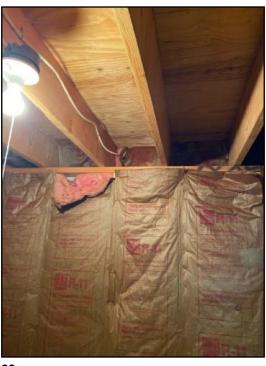
23.

INSULATION OVERVIEW: Based on the current overall condition of the insulation, I would consider it:
