May 23, 2025

Subject: **Geotechnical Evaluation of Paver Roads**
Enclave at Lake Havasu (34.508809⁰, -114.251130⁰)
Lake Havasu City, Arizona 86406
CSET 81-142

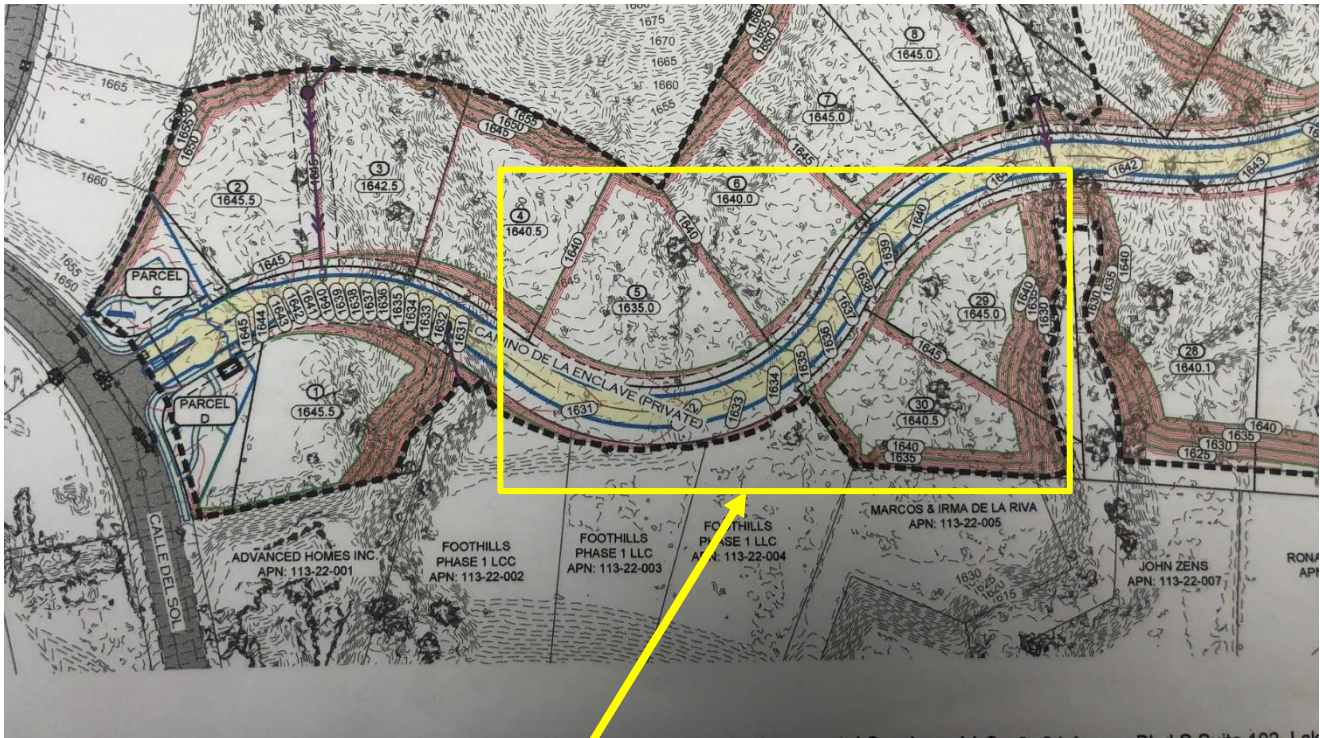
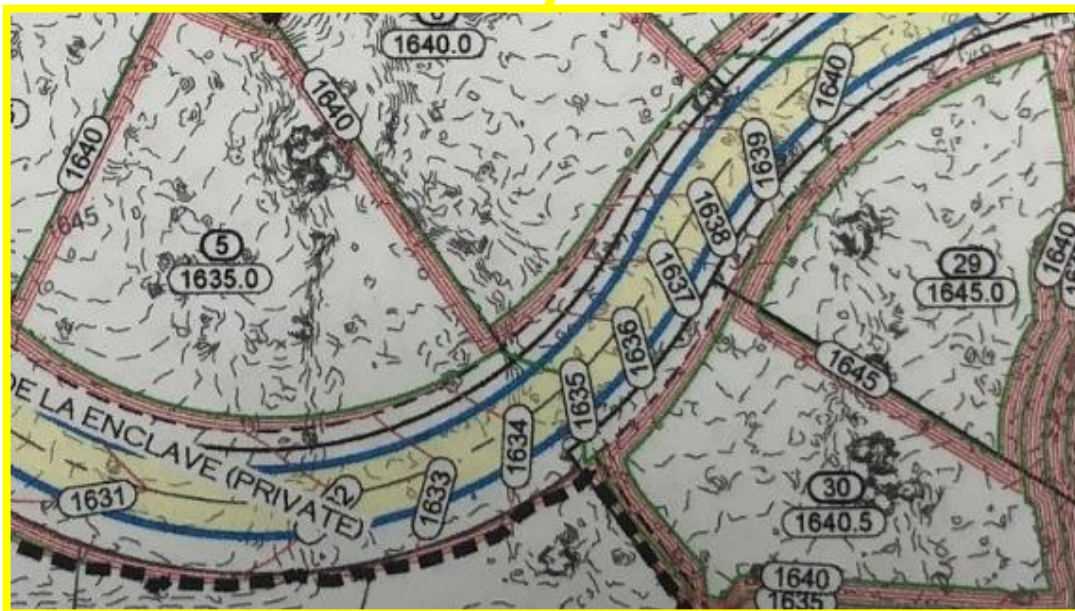
Copper State Engineering, Inc (CSE) was acquired by another company about a year ago and became Copper State – Team, Inc (CSET). The authors of this report previously evaluated the slope between the Enclave subdivision and the Ladera South subdivision situated north and northwest of Enclave. As part of that work, CSE took photos of the grading and drainage plan for Enclave at Havasu Foothills, prepared by Advanced Engineering and Environmental Services, LLC. The grading and drainage plan shows that the Camino de la Enclave Road was designed with an inverted crown (the center of the road is lower than the edges).

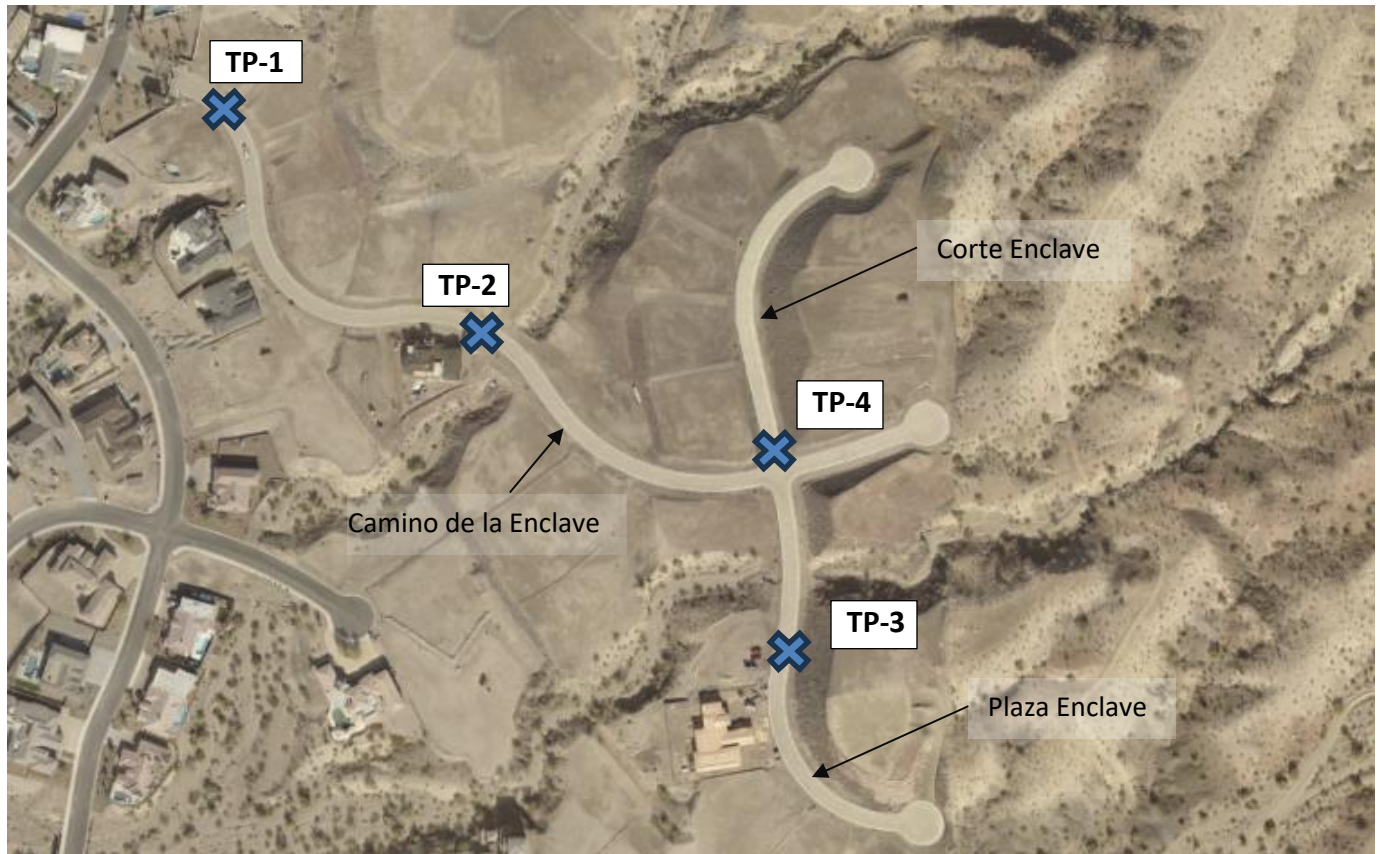
CSET representatives visited the site on April 7, 2025 and conducted field density tests, documented the condition of the roads and collected soil samples. The pavers were removed at four locations for field density testing. The locations shown below were selected by the contractor.

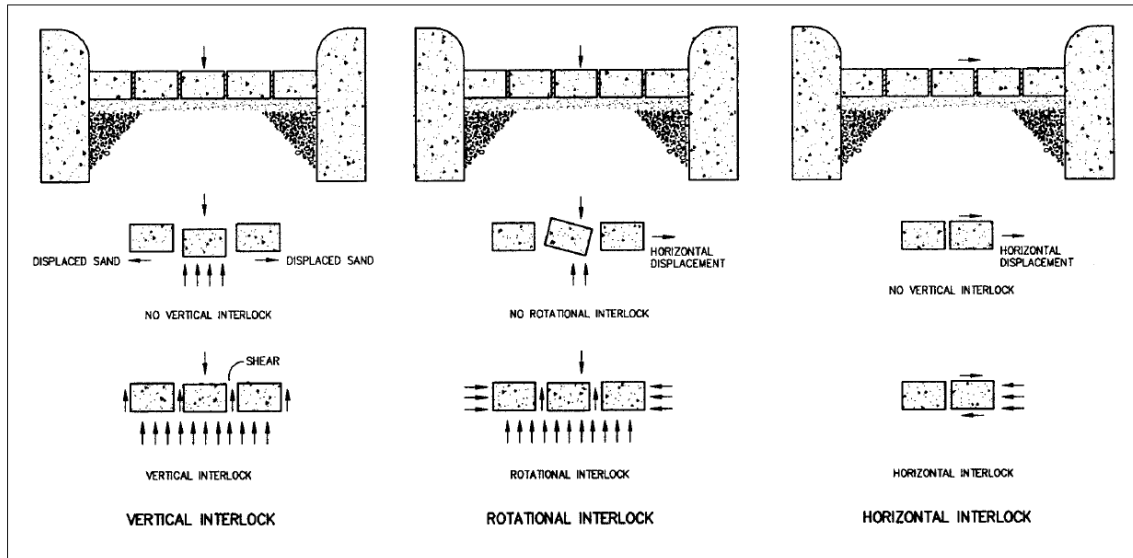
Figure 2. Types of interlock: vertical, rotational, horizontal

- *Interlock is the inability of a paver to move independently from its neighbors. It is critical to the structural performance of interlocking concrete pavement. When considering design and construction, three types of interlock must be achieved: vertical, rotational, and horizontal interlock.*

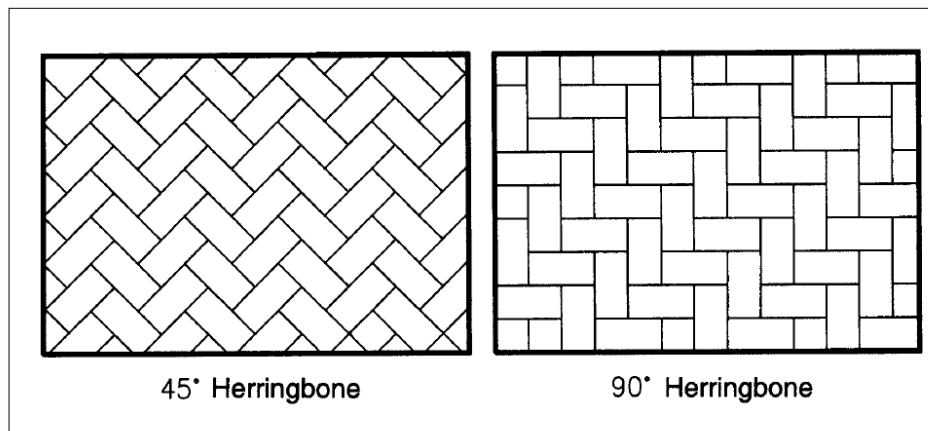
- *Herringbone patterns are recommended in areas subject to vehicular traffic.*
