# Your survey report

EXAMPLE\_GLOUCESTER

11/11/2024

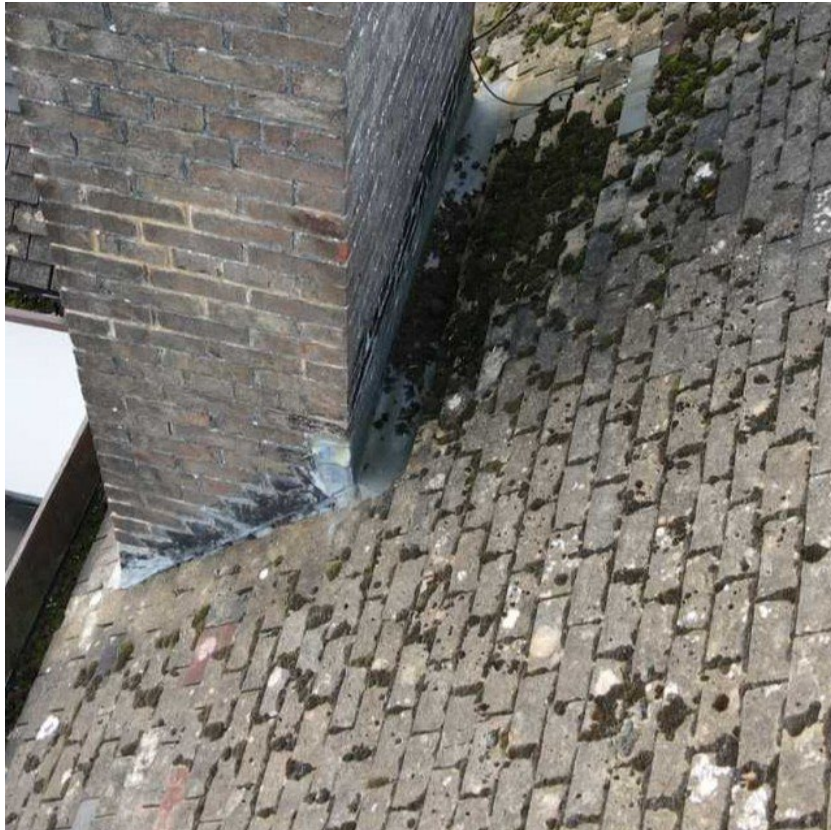
Additionally substantial moss growth to the rear of the stack at roof level can often draw moisture into the property via capillary action - it is advisable to clear the moss growth.

***Moss growth.***

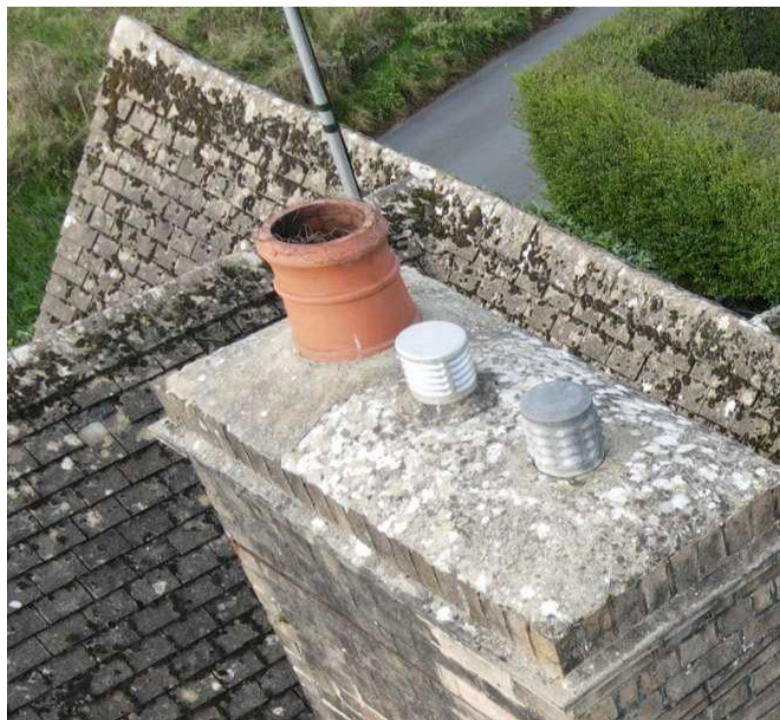
On the balance of probability, gravity is drawing moisture down to the living room fireplace chimney breast reveals also, we could not inspect or test for damp because of furniture obscuring the wall. It is likely that the open chimney pot is allowing water to run inside the flue and to migrate back into the property, a simple cowl will prevent rainwater ingress.

***Flue servicing living room and capped flues.***

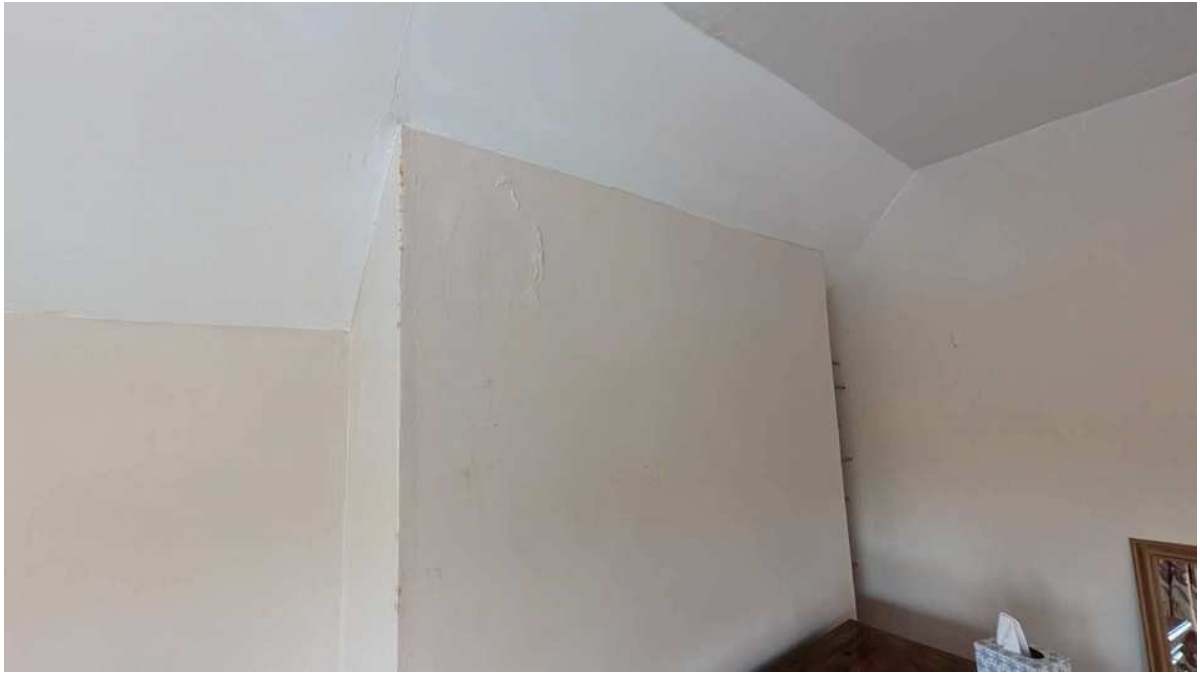
However, it is clear that rainwater is penetrating through the stack and is permeating in bedroom number 2, plaster finishes and chimney breast reveals were recorded as having raised/ damp moisture readings using an electronic damp meter.

***Damp to the chimney breast bedroom 2.***

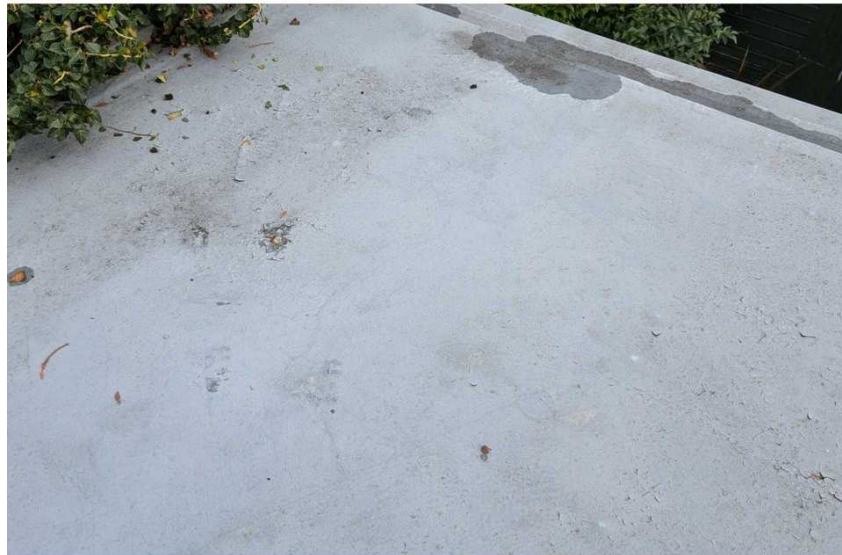
The kitchen extension includes a flat roof with a glass reinforced (GRP) roof covering. Construction of the roof covering appears to be of good quality; falls to the roof were adequate and drain to perimeter guttering. We saw no evidence of blisters cracks or water ingress. However, the painted surface over the glass reinforced plastic has become embrittled as a result of ultraviolet degradation and we advise that it is repainted. The paint covering enables solar / ultraviolet radiation to reflect and to protect the waterproof glass fibre covering from embrittlement. Polyurethane coatings are highly recommended due to their flexibility and resistance to weathering, making them ideal for restoring and protecting GRP surfaces.

***Embrittlement to painted surface.***

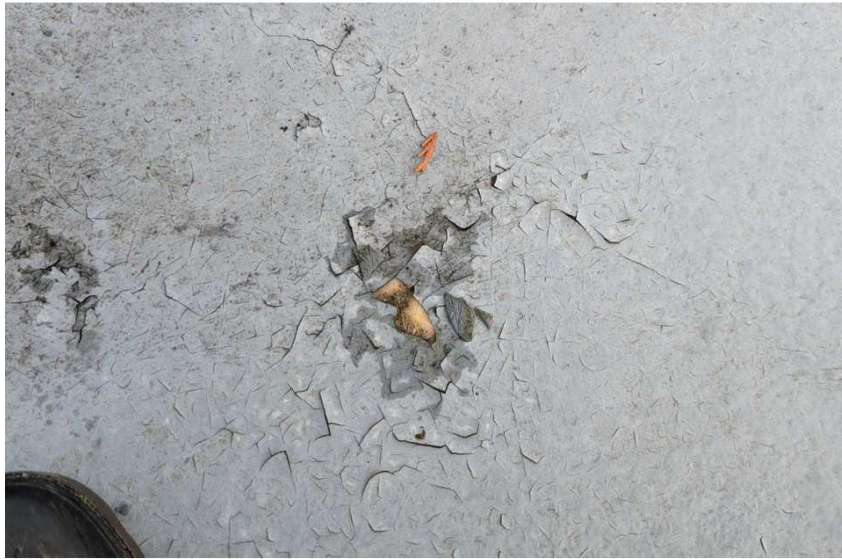
***GRP exposed below paint.***

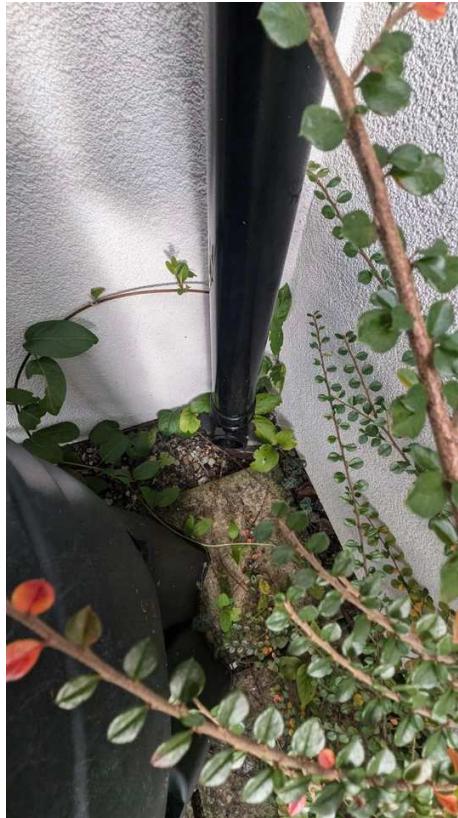
The PVCu guttering is in good condition, showing no signs of damage and remaining free of debris, which is essential for effective water management. However, there are issues with the hallway downpipe, which discharges directly to the ground, contributing to dampness inside the property. Additionally, the downpipe connected to the rainwater harvesting system is overflowing and may be leaking, leading to moisture problems in the conservatory and other areas.

***Downpipe adjacent to Hall.***

To address these issues, it is recommended that the downpipe be fitted with a shoe extension that extends at least 1 meter from the property. This will help direct water away from the foundation. Furthermore, creating a gravel French drain or an appropriate drainage discharge route to the ground will effectively manage rainwater runoff, preventing it from pooling near the building and mitigating dampness issues. Implementing these changes will enhance the drainage system's efficiency and protect the property from moisture-related damage.

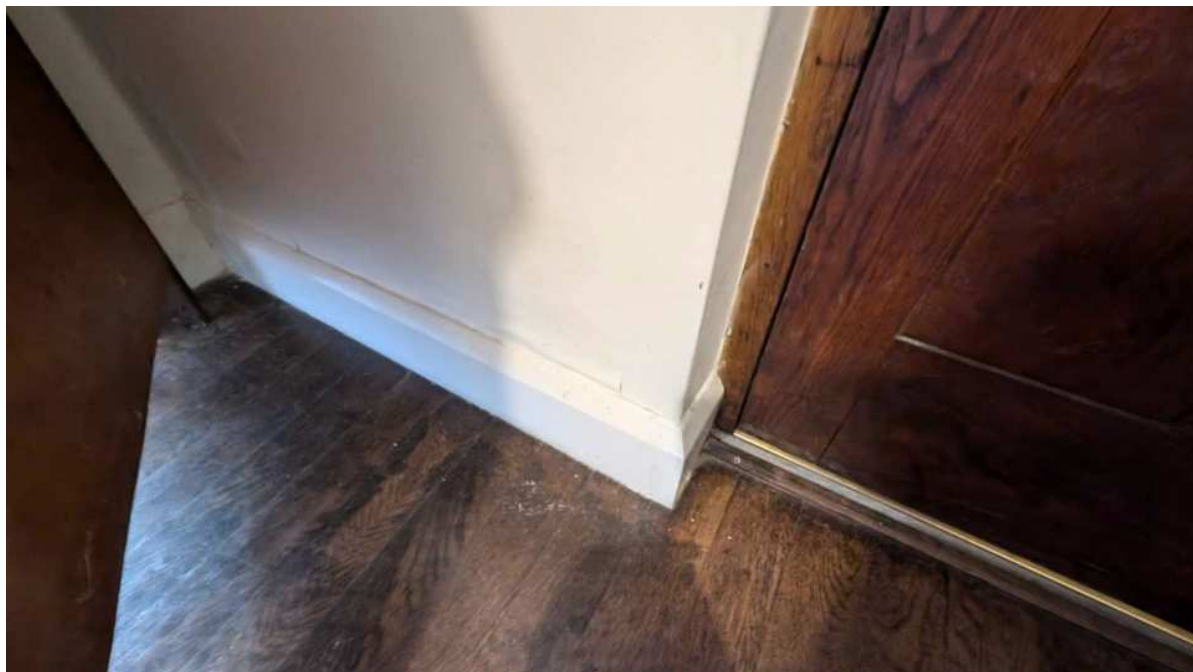
***Hallway damp by front door.***

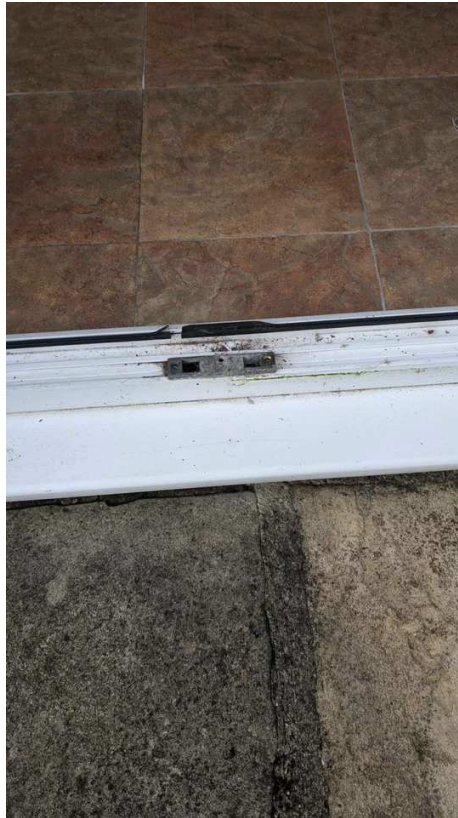
Conservatory doors: The Conservatory doors incorporate two double opening door units made of PVCu. One of the door leaves has a key operated bolt which anchors into the floor with the other door leaf , a series of multipoint locks engage the adjacent door leaf. The door was stiff to open and caught slightly on the bottom lock keep. As an advisory measure we recommend the door is eased and adjusted

***Conservatory doors catch to base.***

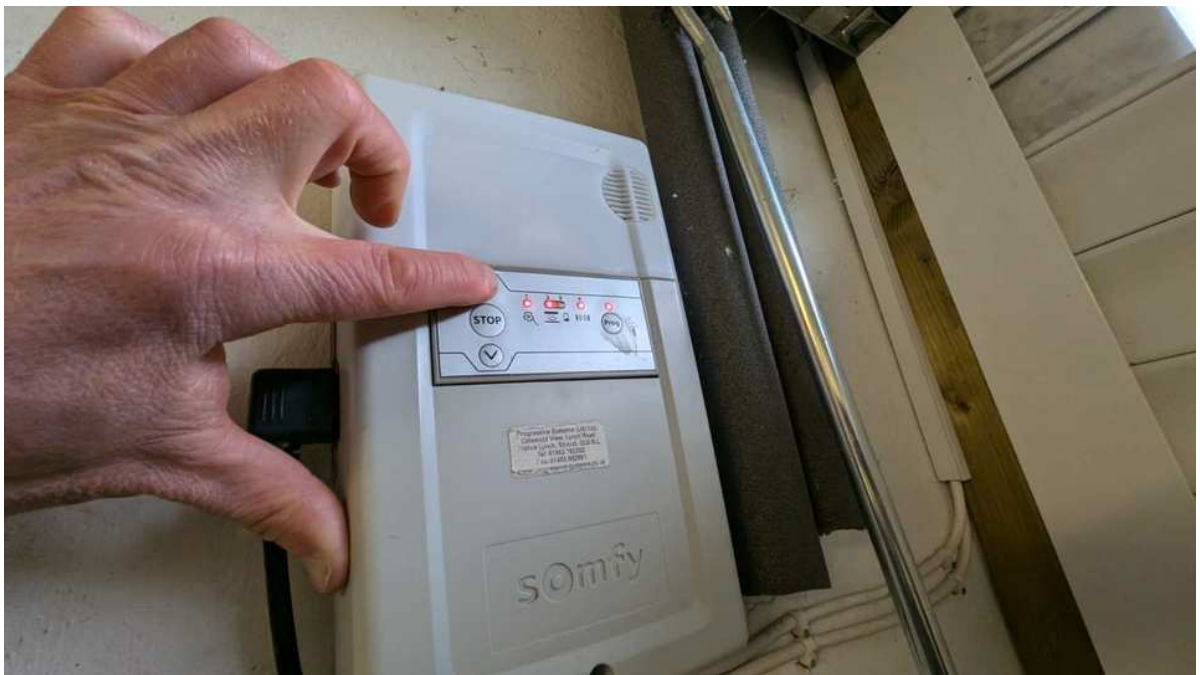
Garage roller shutter door: The garage benefits from an automated roller shutter door we attempted to operate the door however its operation was not fully understood. The control panel registered. red when touched. The vendor or vendor's representatives should provide operation manuals and guarantees for the installation of the unit.

***Inoperable at time of inspection.***

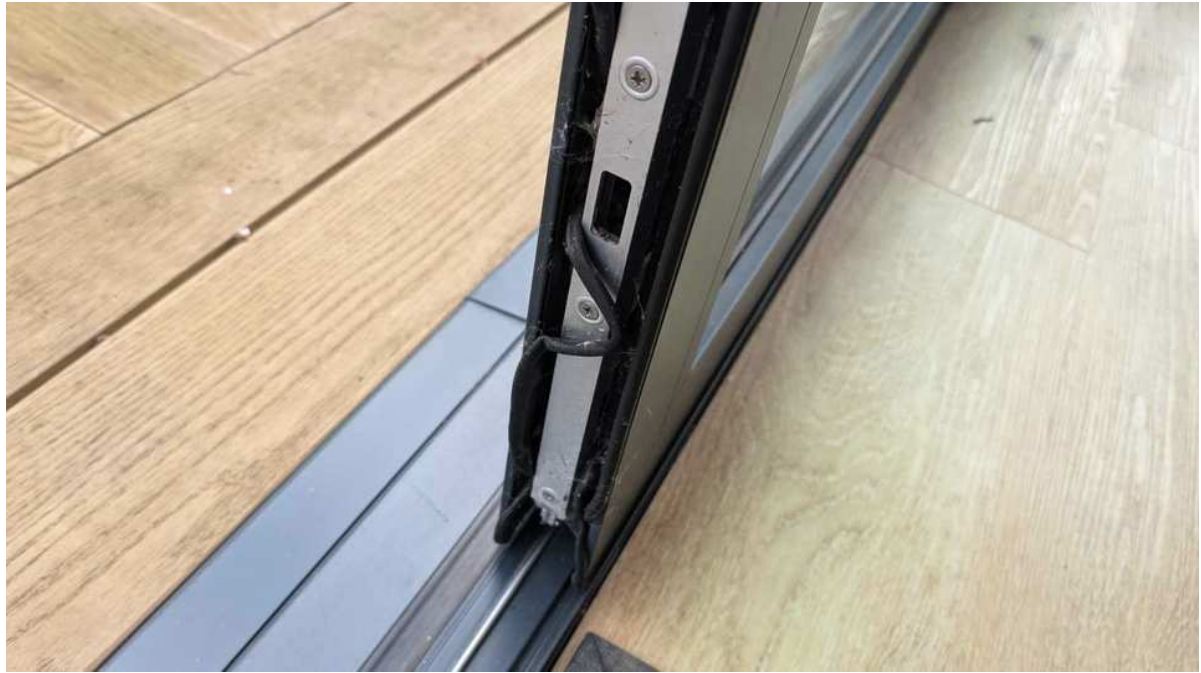
***Gasket to sliding patio door.***

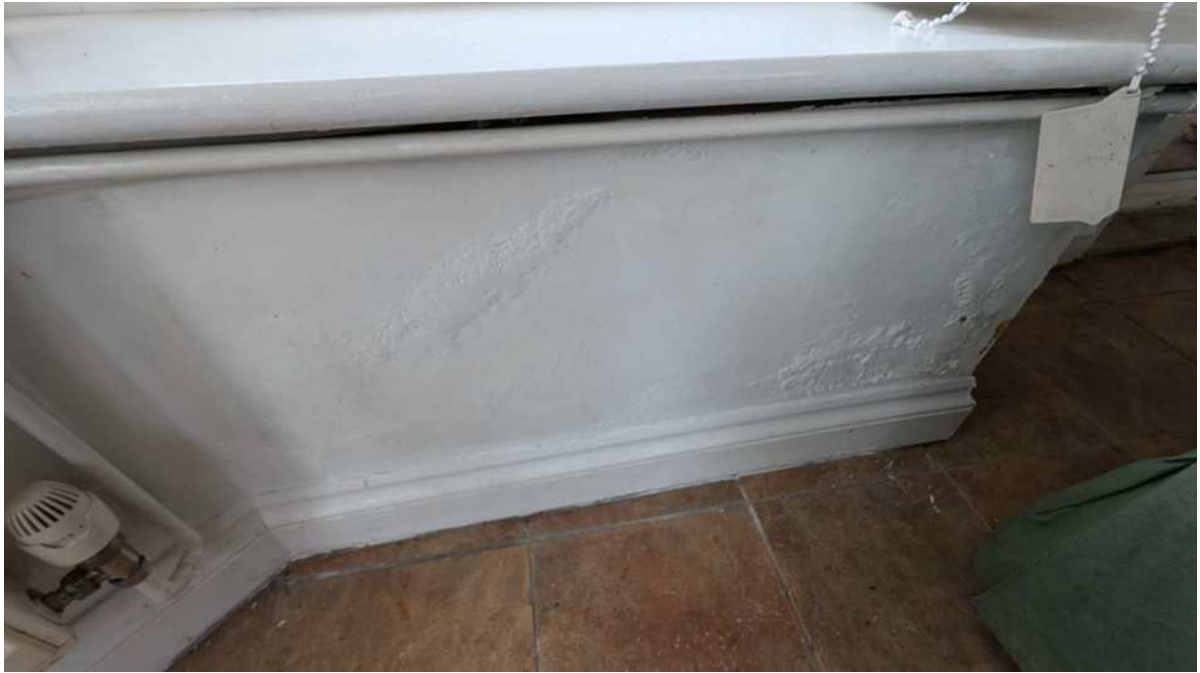
However, there are significant concerns regarding dampness to the internal plaster finishes of the low-level brickwork facing wall. While the damp has not migrated elsewhere into the house, the damp is likely caused by several factors:

- the proximity of a pond, which may allow for capillary action drawing moisture into the conservatory;
- a leaky rainwater harvesting water butt that enables water penetration;
- and most likely failed lime mortar jointing to the external face of the low level perimeter brick wall.

***Damp internal perimeter walls.***

To address these issues, it is crucial to either remove or make watertight the rainwater harvesting water butt. Additionally, it is important to break out and completely repoint all low-level brickwork in the conservatory using medium-strength cement mortar. Allow the walls to dry out, ideally utilising an industrial dehumidifier to expedite the process. If dampness persists, consider emptying the pond and ensuring that there are no cuts or leaks in its lining, preventing further moisture from permeating back into the conservatory - or worst case, infill the pond.

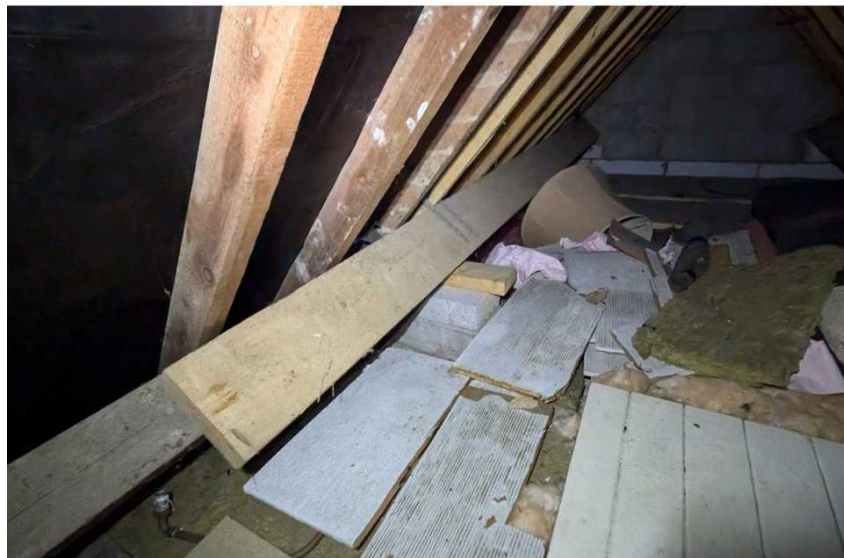
Finally we note that the extension roof was constructed with a purlin that appears to have been bolted onto the existing purlin. It was difficult to see how the purlin is fixed and whilst does not necessarily appear to be a well crafted installation, it appears to be performing.

***Purlin to extension rafters.***

If any building control certification exists for the extension, it should be requested.

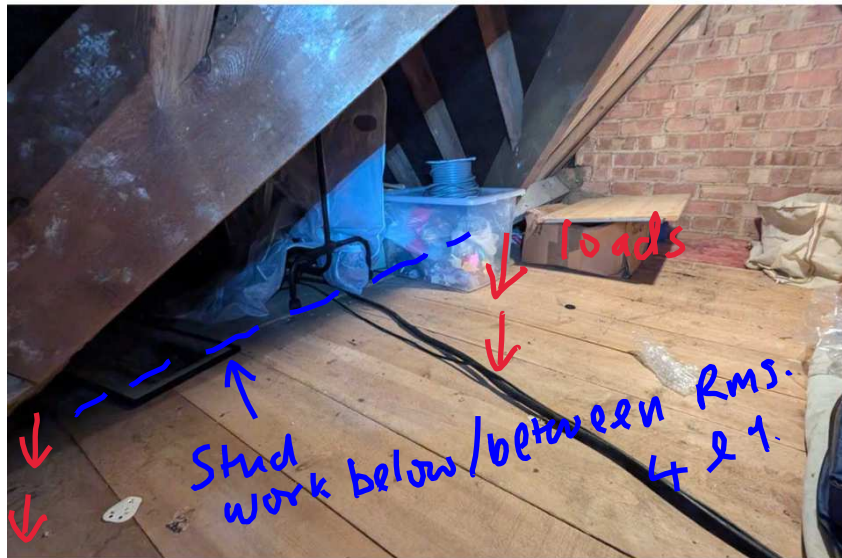
Cracking is predominantly observed between the solid brick walls and the stud walls, where differential movement has led to a rate of expansion between the differing building materials, resulting in cosmetic cracking. Importantly, these cracks are not structural in nature. They arise from the way the ridge rafters are seated onto the solid brick walls, combined with the use of stud walling during the construction phase, likely implemented to economise on costs.

***Note position of the ridge rafters***

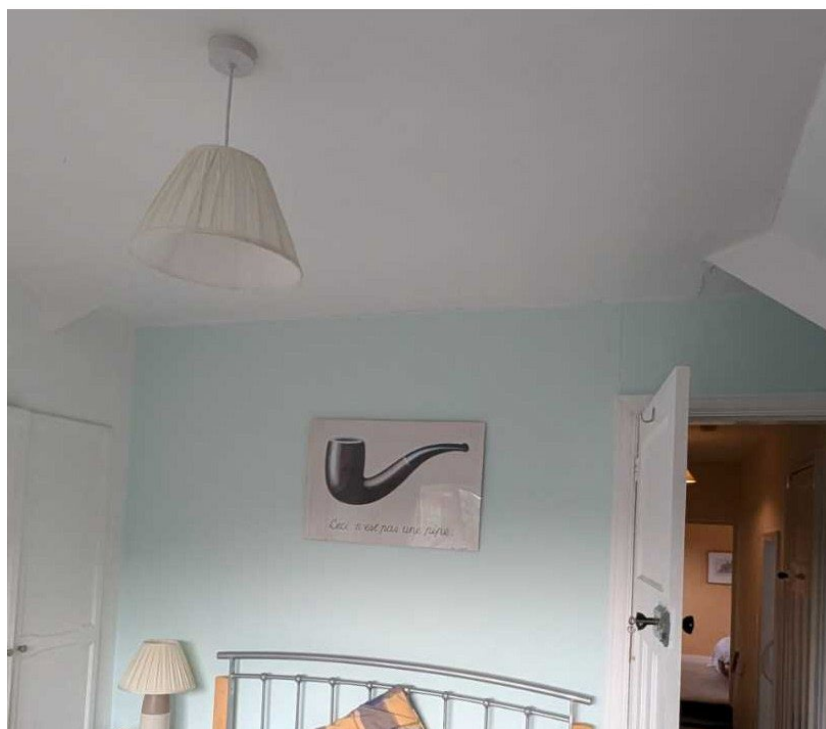
As part of your instructions, we assessed whether the wall between bedroom 4. and bedroom 1. is structural. We found that the wall is largely stud work formation. The rafters rest on the structural brickwork either side which supports the roof structure, with stud walling below that does not require support. While the brickwork supporting the ridge rafters must remain intact, it is feasible to completely open the wall between the two rooms.

***Ridge rafter positions to bed 1.***

1. **Break Open Stud Work:** Carefully remove the stud work between the brickwork, ensuring to empty any boarding and Rockwool insulation from the loft space.
2. **Retain or Trim Joists:** Assess the existing joists; retain them where necessary, or trim them back as needed to accommodate the new layout.
3. **Create New Stud Wall:** Construct a new stud wall to define the space, including a door opening and frame if required. Alternatively, consider creating an open space that seamlessly integrates into the new room.
4. **Modify Existing Door:** If applicable, remove the existing door to bedroom four and close the opening using stud work and plaster finishes to maintain a cohesive look.

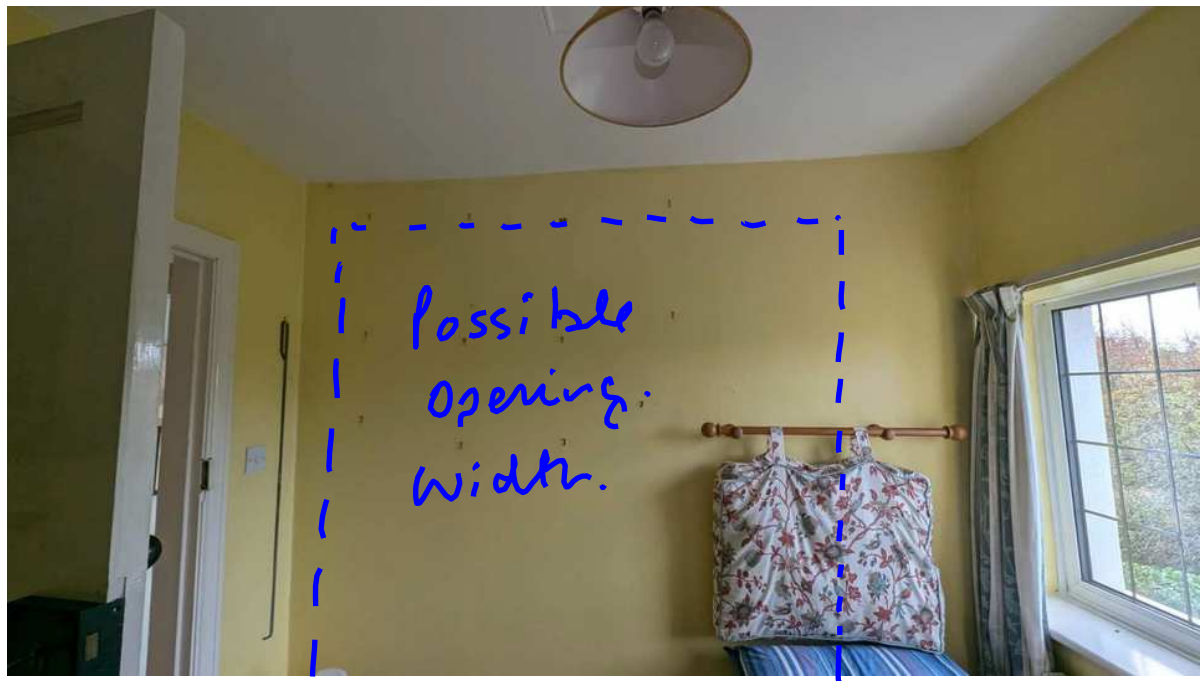
***Bed 4. opening width.***

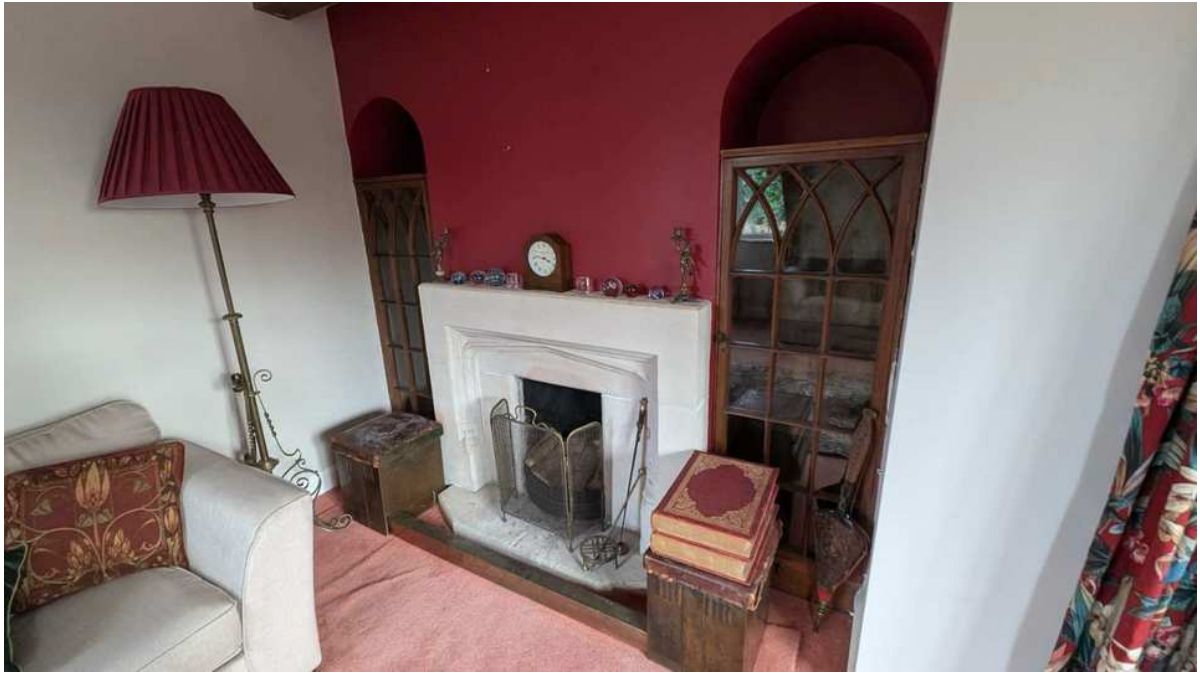
The brick-built chimney stack has an open pot at the top, which unfortunately maybe allowing water to penetrate down the flue to ground level, affecting bedroom number 2, with moisture visible to the chimney breast. The sitting room chimney breast is likely damp as well, but it's obscured by storage units, preventing a thorough inspection.

***Damp smell to room - damp behind storage units.***

Plaster finishes to bedroom number 2 and the sitting room appear to be in reasonable condition despite damp staining and bubbled decorations. Use of a dehumidifier to dry the room out once the chimney pot has been capped it should be sufficient. Nonetheless redecoration will be required.

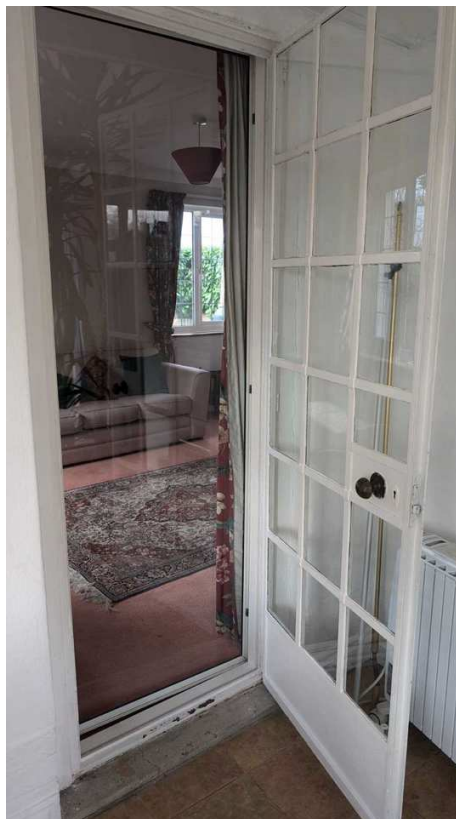
The original crittall metal multilight door once provided access to the garden before the conservatory was built. However, it no longer fits properly within the aperture, catching on the carpet and allowing drafts to enter. To mitigate this, a large hinged secondary glazed panel has been added, but this solution is cumbersome and difficult to lock.

***Draughty crittal door.***

While the crittall door is a unique piece of the home's history, its practicality is questionable. Given its current state, it might be best to consider replacing it with a purpose-built plastic or aluminium-framed door. A new door that opens toward the window, rather than into the sitting room, would enhance functionality and improve the overall comfort of the space.

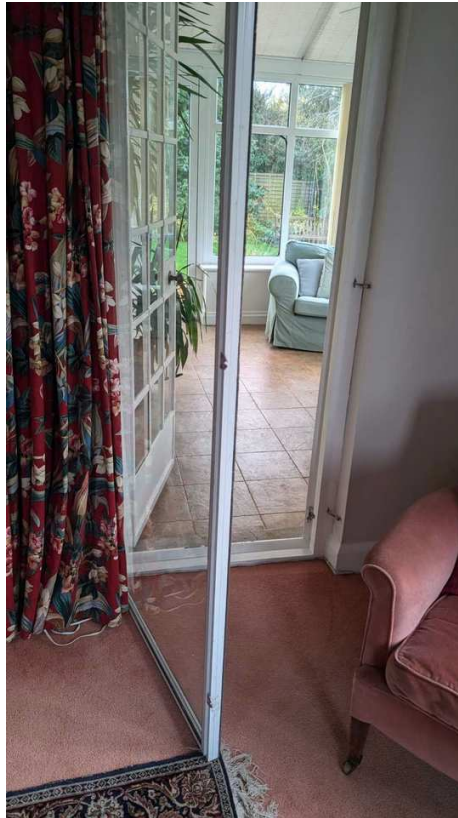
***Secondary glazing is cumbersome.***

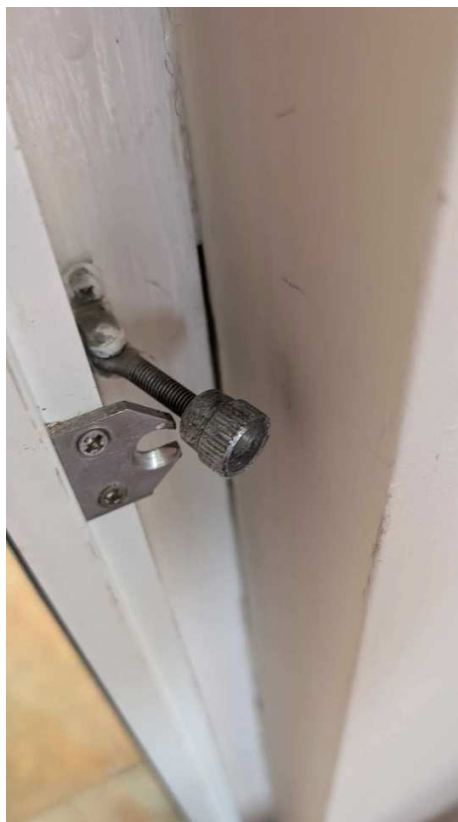
***The lock is awkward to operate.***

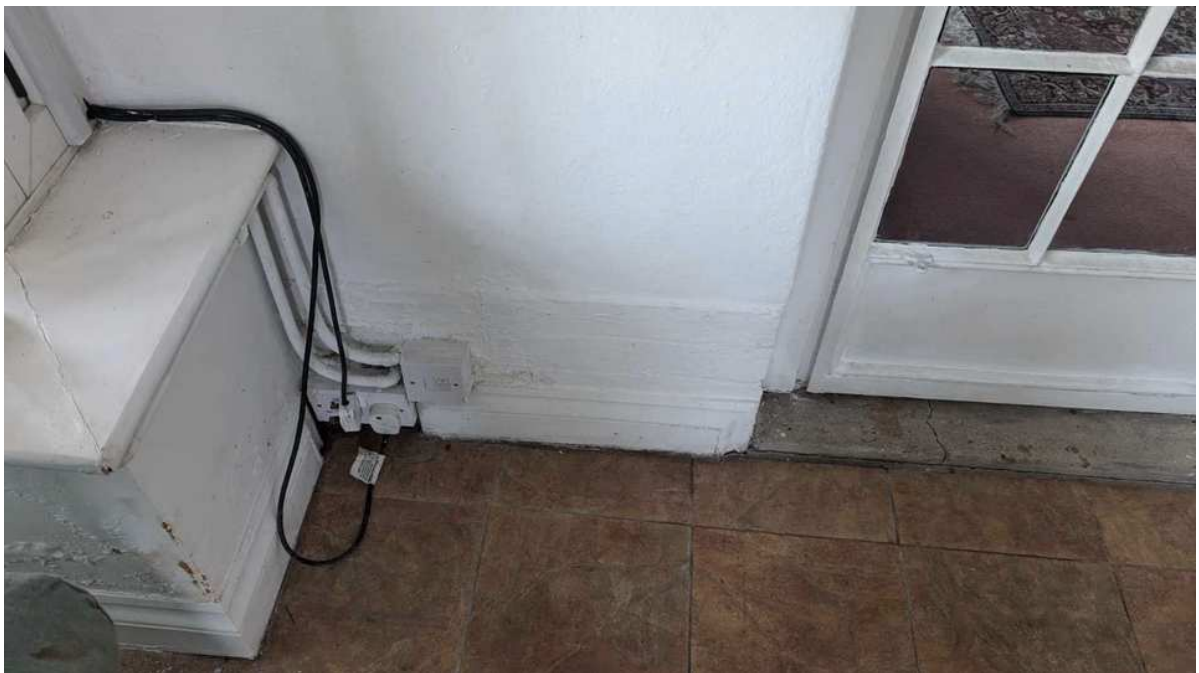
However, we did notice a low-level socket fixed to the damp wall of the conservatory, which may present an electrical safety hazard.

***The power socket to damp wall.***

We recommend requesting electrical test certificates from the vendor. If it's not available, consider obtaining your own fixed wire certificate ASAP, and be prepared to address any C1, C2, or C3 defects that may be identified during the electrical testing. This proactive approach will help ensure the safety and reliability of the electrical system in your new home.

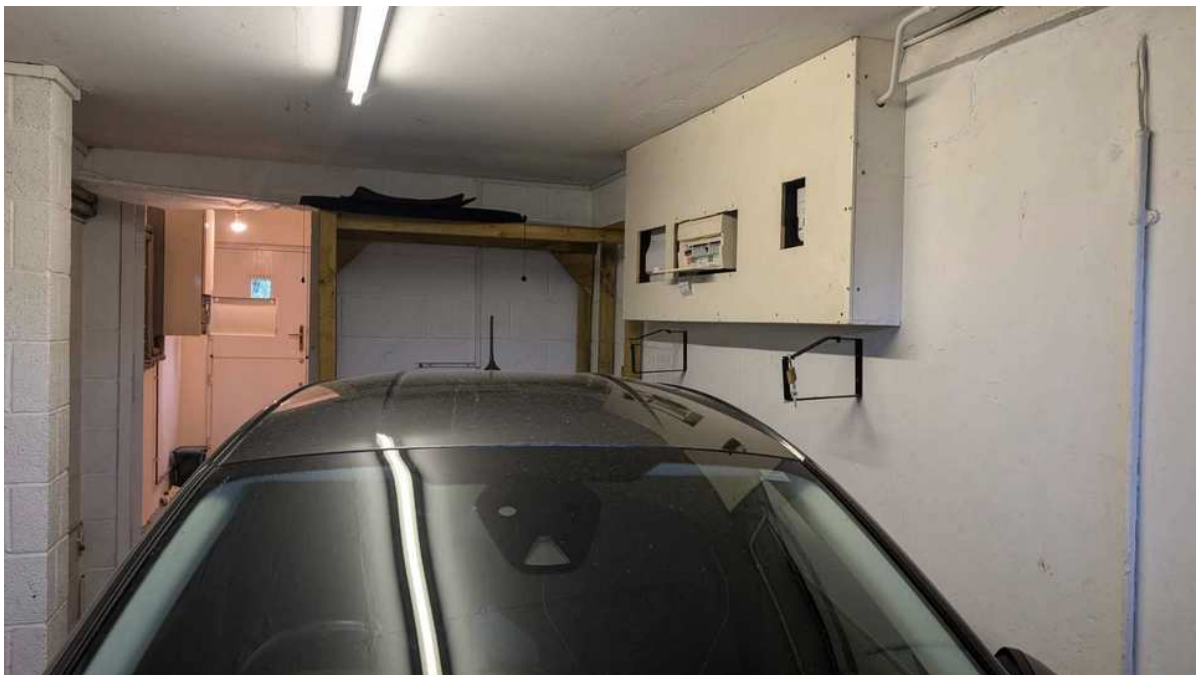
***Access obscured by vehicle.***

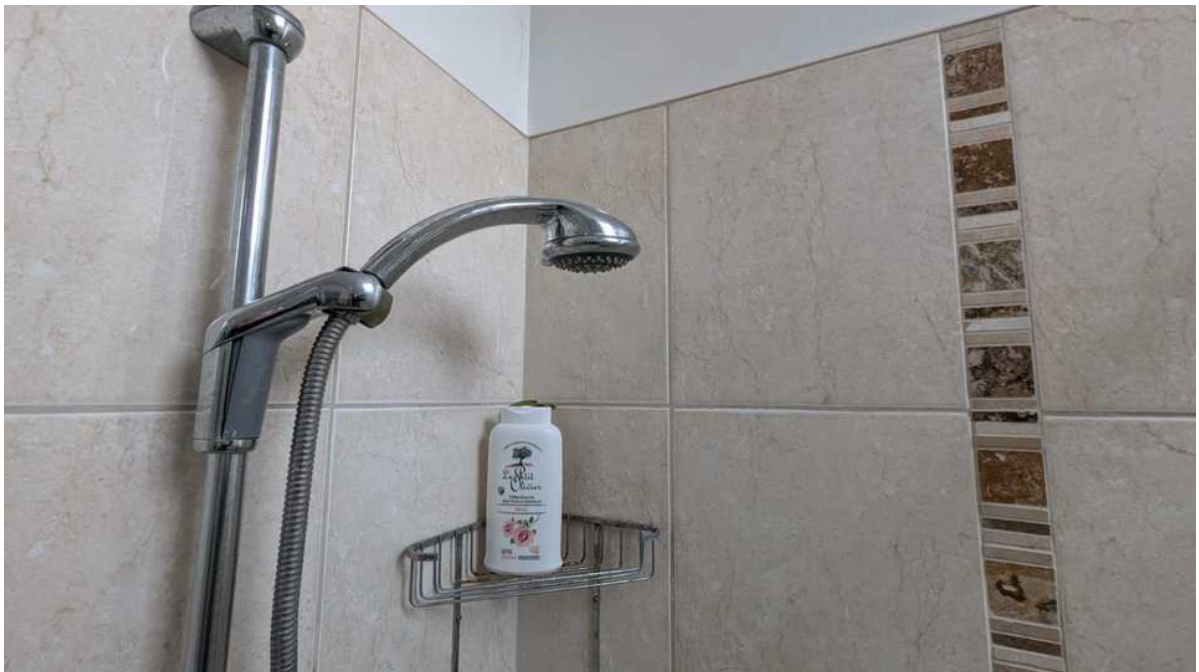
However, the shower produced loud hydraulic 'thumps', suggesting possible hydraulic hammer, possibly due to water being drawn from the immersion tank, which may have been drained. A plumber could provide further advice on this issue. The stop tap is located below the kitchen sink.

***Hydraulic hammer noise.***

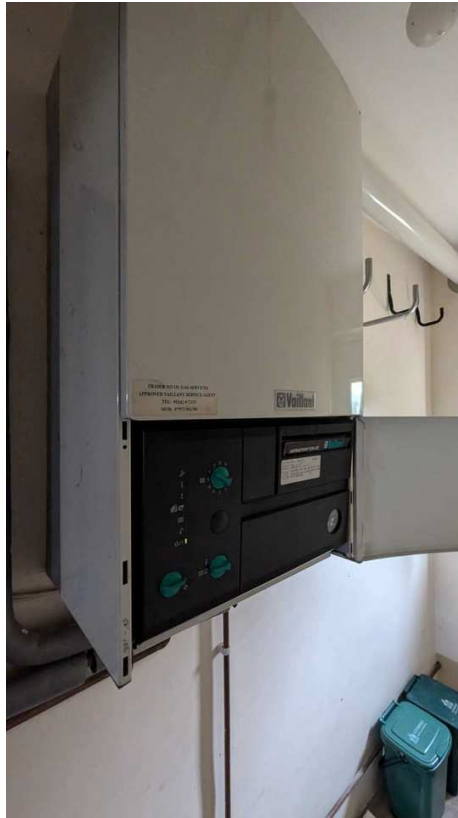
However, the boiler is at least 30 years old and has undergone numerous repairs over the last 20 years, indicating it may be nearing the end of its serviceable life. It also requires a separate immersion heater for hot water. Upgrading to a new combination boiler would be beneficial, providing adequate output for both the underfloor heating and radiators, as well as hot water.

***The boiler appears to be an old installation.***

Currently, the system includes thermostatic valves on all radiators and independent controls for upstairs and downstairs which is a positive. If you choose to keep the existing system, it's advisable to obtain a Gas Safe certificate from the vendor and hire a qualified plumber to ensure the service pipework and immersion heater are functioning effectively.

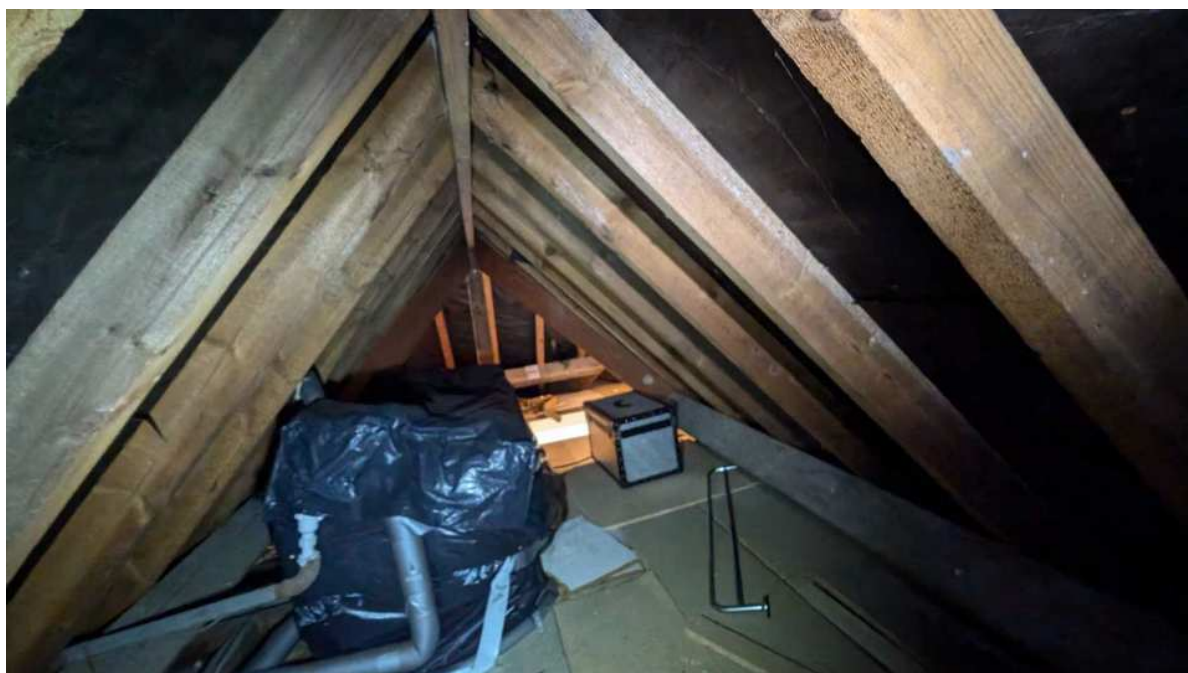
At the time of inspection, the immersion heater was turned off, and no hot water output was observed when the taps were run. This likely contributed to the hydraulic hammer heard from the shower, possibly due to the immersion being drained. We recommend hiring a competent plumber to assess and potentially overhaul the water heating system in the short term, with attention paid to the potential presence of legionella disease often associated with still water (loft water tank).

***Water tank to the loft.***

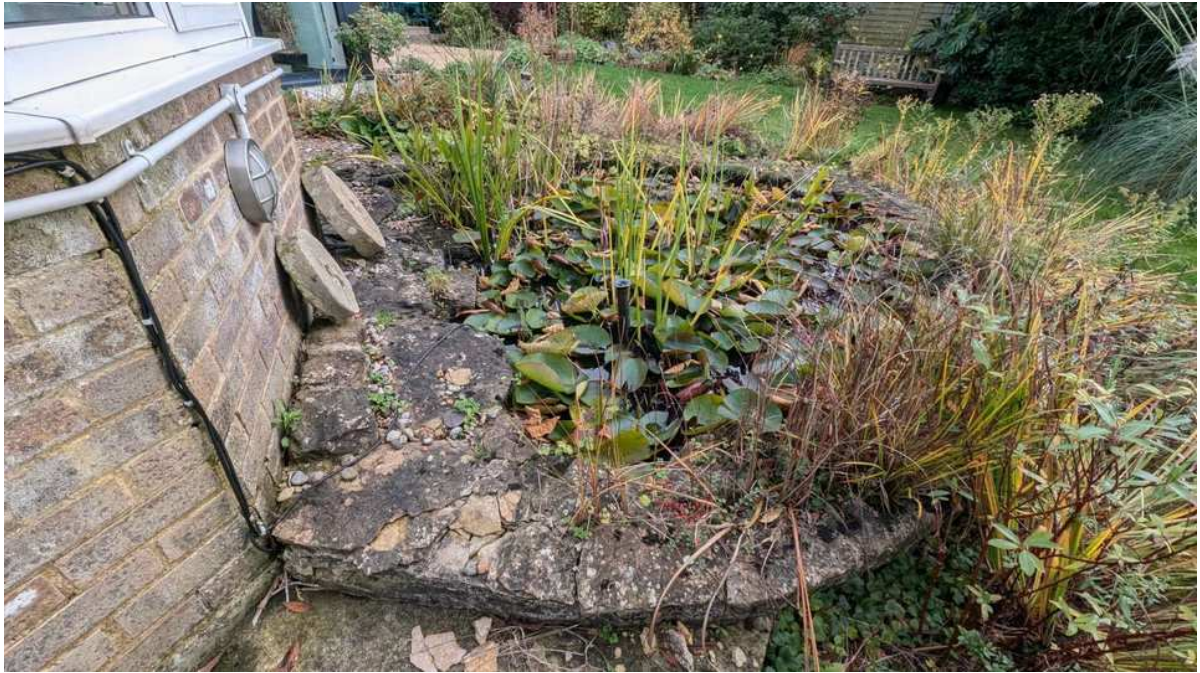
As discussed, there is a pond located close to the conservatory. While the pond was full, indicating no leaks, there is a risk of minor seepage into the conservatory's brickwork through capillary action. It's recommended to repoint the wall and check or remove the rainwater harvesting tanks for leaks, as the pond's proximity could be detrimental.

***Proximity of pond.***

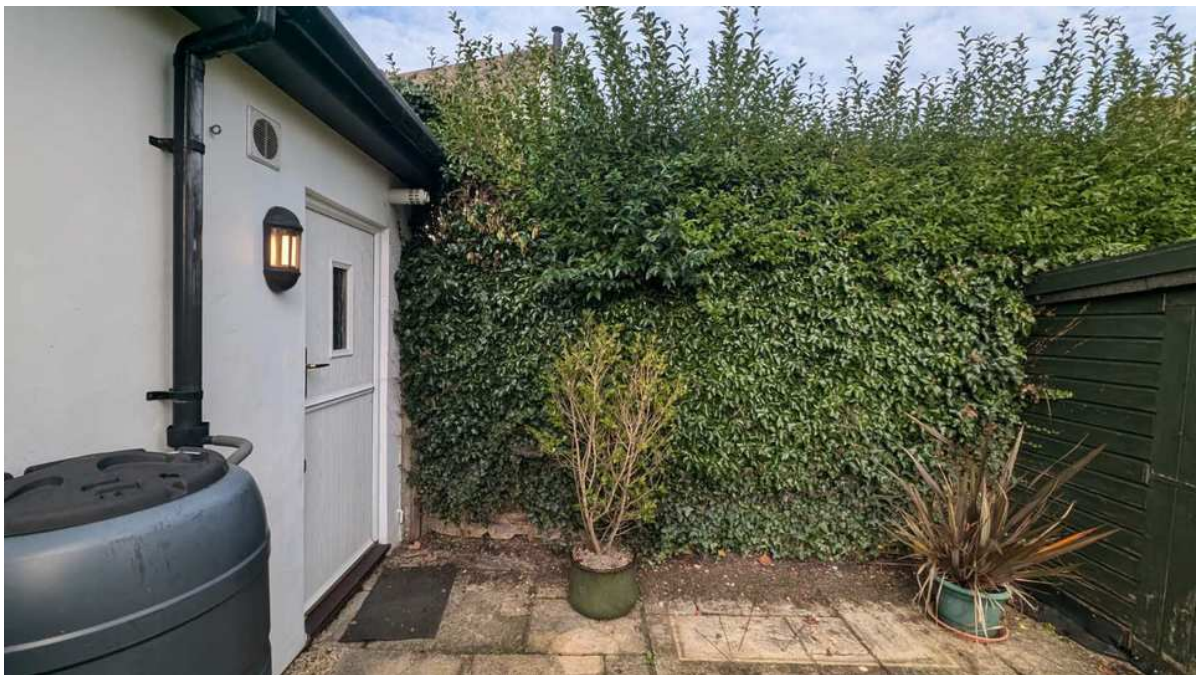
***Privet requires regular maintenance.***

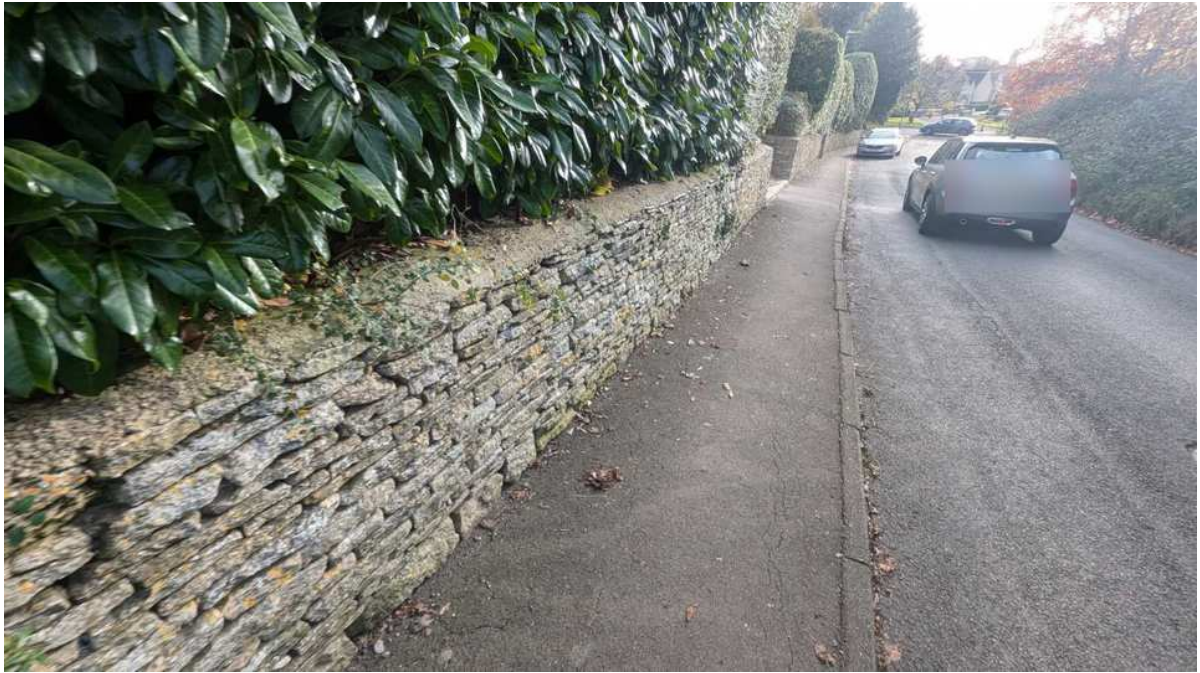
***Dry stone wall to the front.***

- Confirm any cancel repair obligation for local parishes and churches.
- Ensure your solicitor confirms any repair obligation for boundaries, fences and the stone wall.
- Establish if the area is classified as a smokeless zone before using the fireplace.
