FULL HOUSE INSPECTIONS

RESIDENTIAL HOME INSPECTION

1234 Main Street
Waco TX 76708

10/10/2023 9:00AM

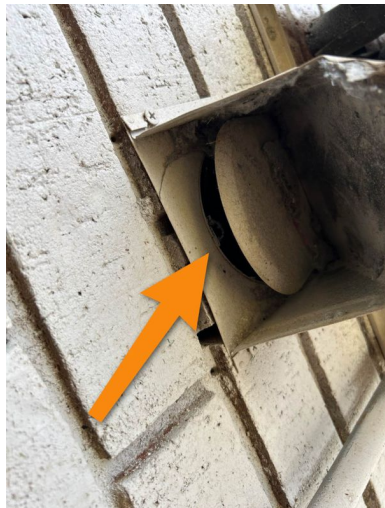
Front Exterior

Cleaning or adjustments needed at the dryer vent exterior termination for the damper to close when not in use.

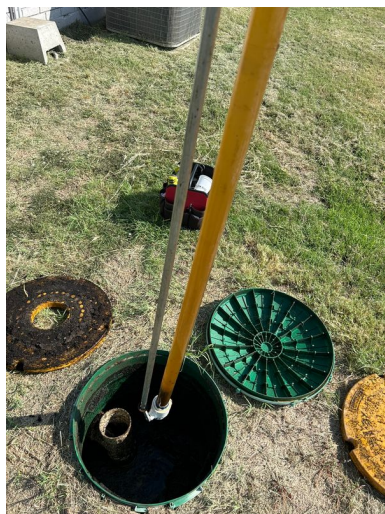
Measured the water, scum, and sludge levels of the primary tank:

Water level depth: 54 Inches

Scum level thickness In Primary Chamber: 2 Inches
