# RESERVE STUDY

**The Colony at Edina Condomonium Association**  
**6330 Barrie Road**  
**Edina, MN**

**Date of Inspection: November 28, 2020**

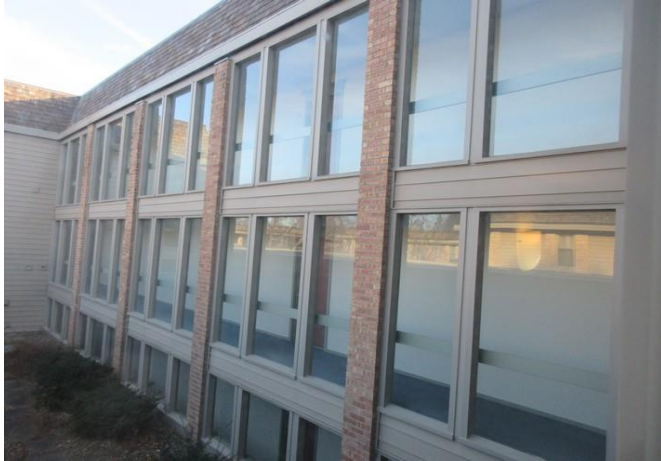
**LINE ITEM: 1**

ESTIMATED UNIT QUANTITY		ESTIMATED REPLACEMENT COSTS	
Present:	4,500 Square Feet	Current Unit Cost:	\$80.00
Replacement Per Phase:	1,125 Square Feet	Current Cost Per Phase:	\$90,000
Replaced in Next 30-Years:	4,500 Square Feet	Total Cost Next 30-Years:	\$435,944
ESTIMATED AGE AND REPLACEMENT YEARS		CONDITION AND USEFUL LIFE	
Estimated Current Age in Years:	to 52	Overall Current Condition:	Fair
Remaining Years Until Replacement:	5	Useful Life in Edina, MN	30 to 40 Years
Estimated First Year of Replacement:	2026	Full or Partial Replacement:	Full
PRIORITY RATING		PRIORITY SCORE	
Priority Rating	Medium Priority	Priority Score	97

Common windows at Gallery building

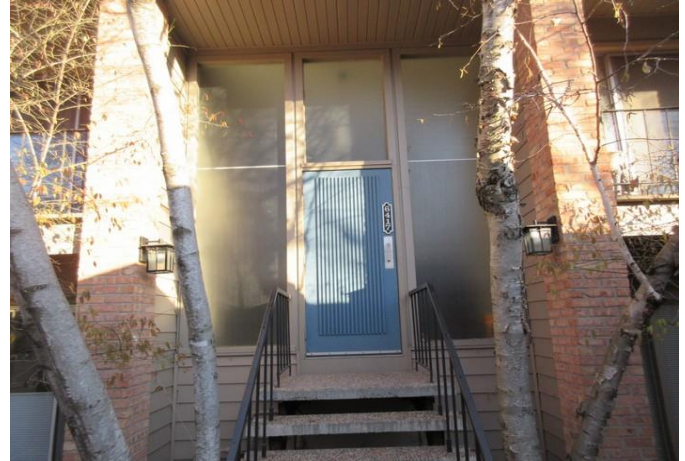
Cluster entry door and surrounding glazing

This component includes replacement of the storefront style windows at front entries and the doors at the Galleries and Cluster buildings. It also includes common windows at the Galleries buildings and Clubhouse. These windows and doors appear to be older components. We have included phased replacement starting in 2026.

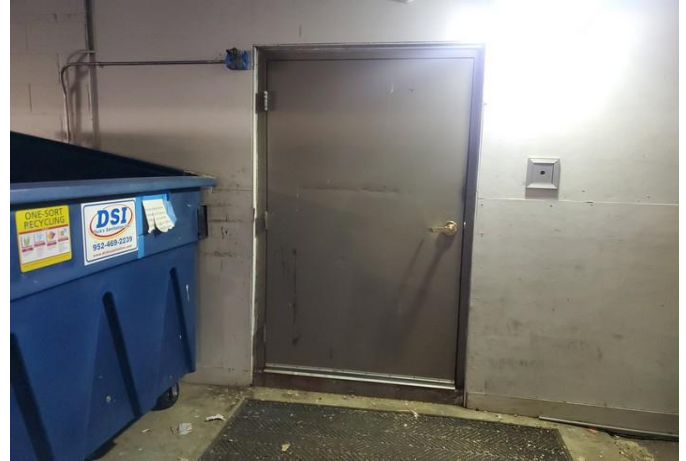
Utility door near dumpsters in garage

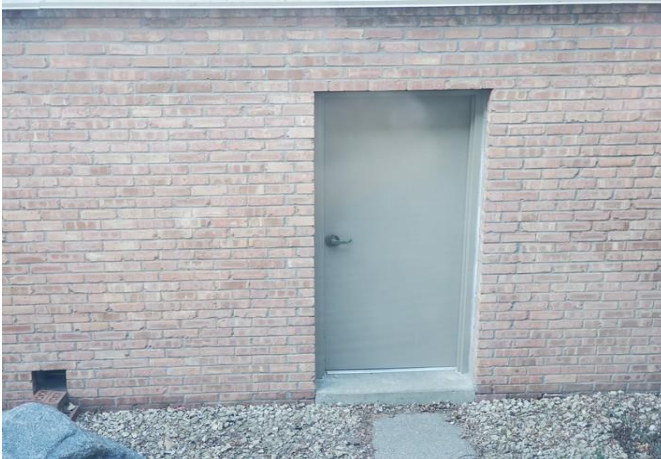
Exterior view of door to Galleries courtyard

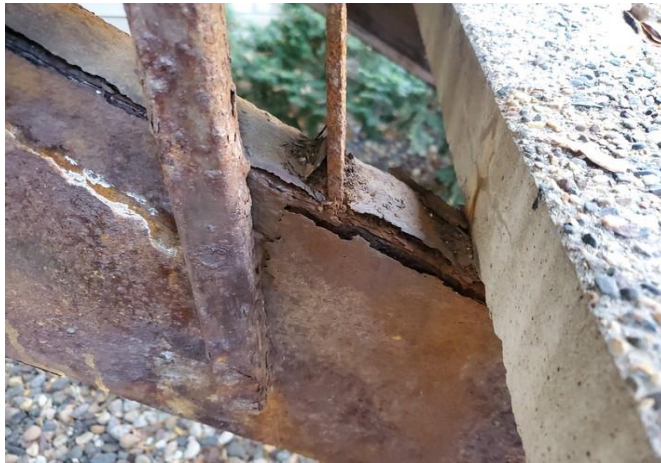
Rusted and flaking steel support

The 17 cluster buildings each have two entries with concrete steps. These steps are constructed on steel support beams and include steel railings. Many of these entries are deteriorating and in poor condition. We have included phased replacement of these steps starting in 2022. Replacement cost includes steel supports, steel railings, and new concrete steps.

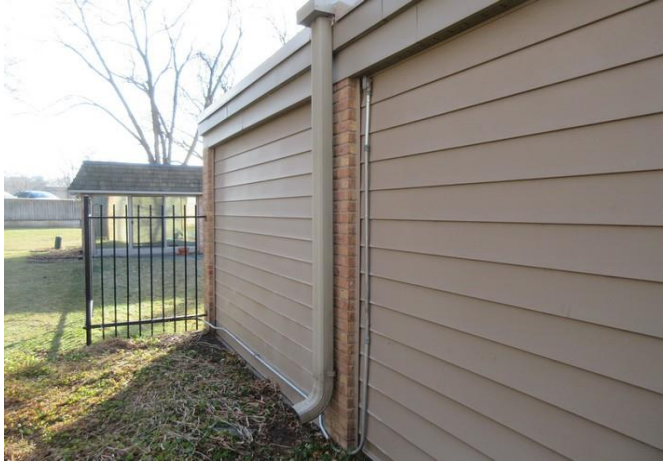
Scupper and downspout at garage

Exterior roof drainage for the flat roofs at all units are piped through scuppers and into downspouts. These items are varied in age. We suggest that the Association reserve funds for the replacement of the downspouts and scuppers every 20 years starting in 2031.

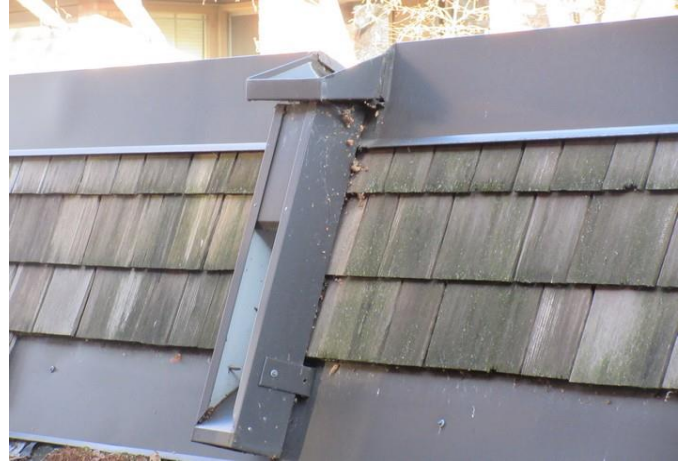
View of scupper

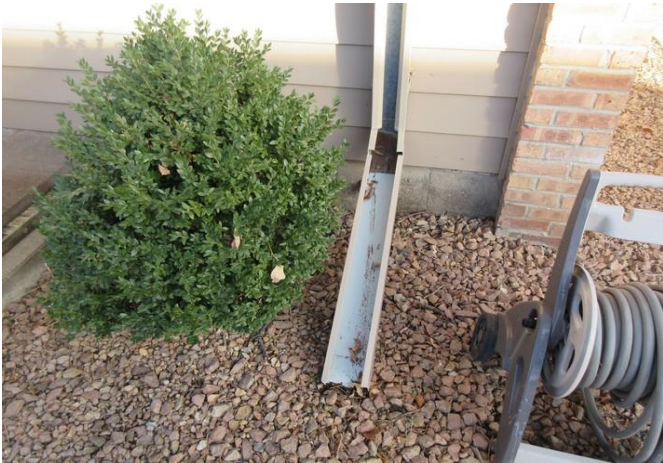
Downspout at grade

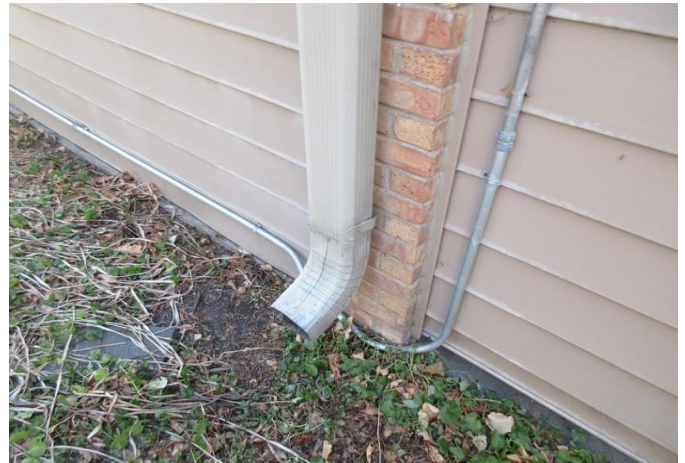
Downspout at rear of garage (note different style)

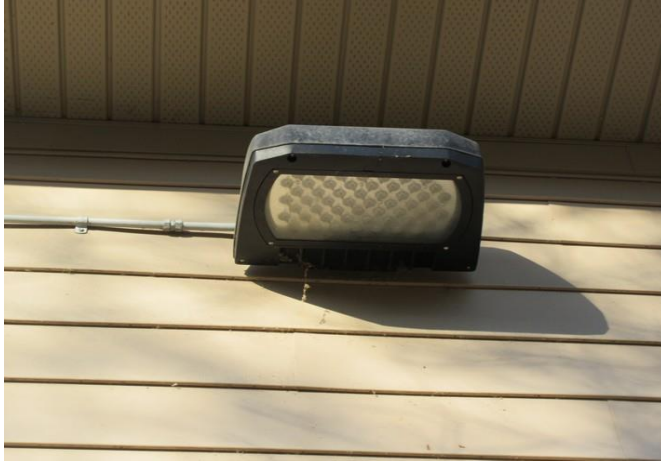
Area light at side of building

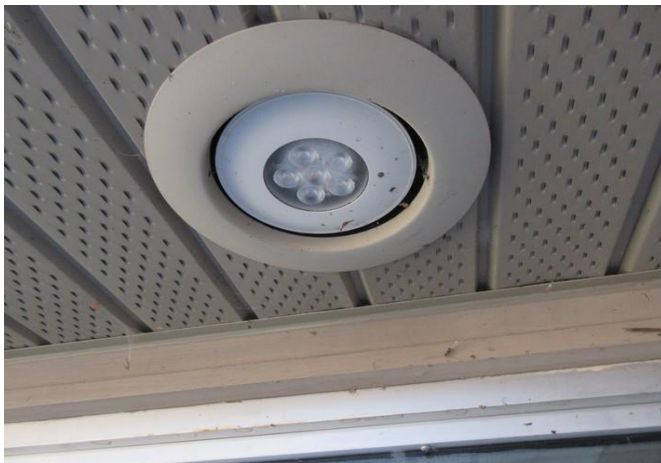
Can light at entry

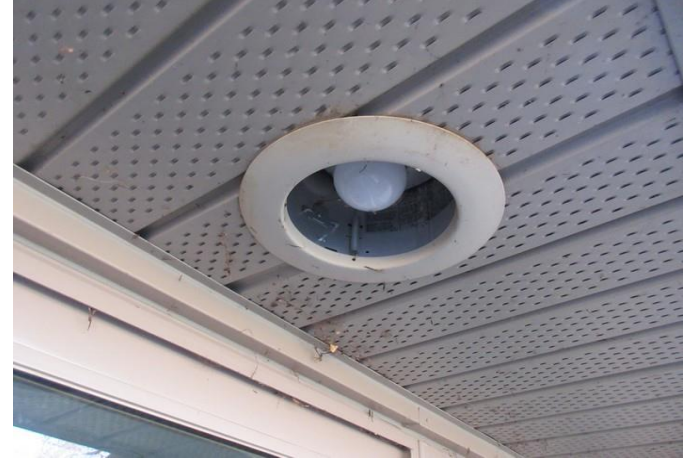
Exterior can fixture

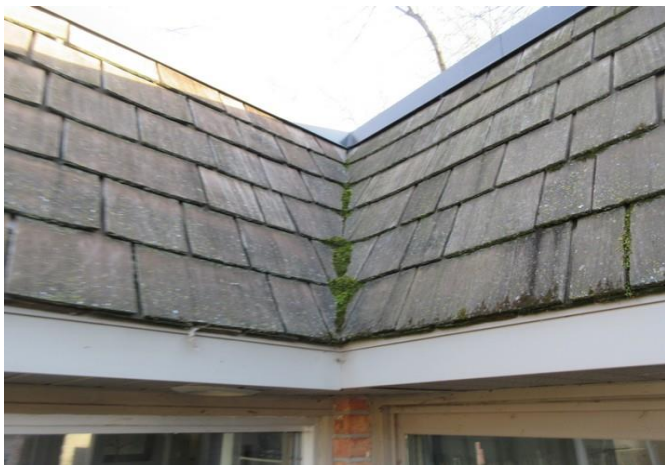
Moss growing in shake roof corner

Cedar shake mansard style roofs are located at each building. These roofs appear to be deteriorating. At the direction of Management we have excluded full replacement of the roofs. We recommend that the Association fund repairs to the roofs and ongoing treatment of the cedar shakes to extend the life of this roof feature. Instances of repair have been included in 2022 and every 10 years thereafter.

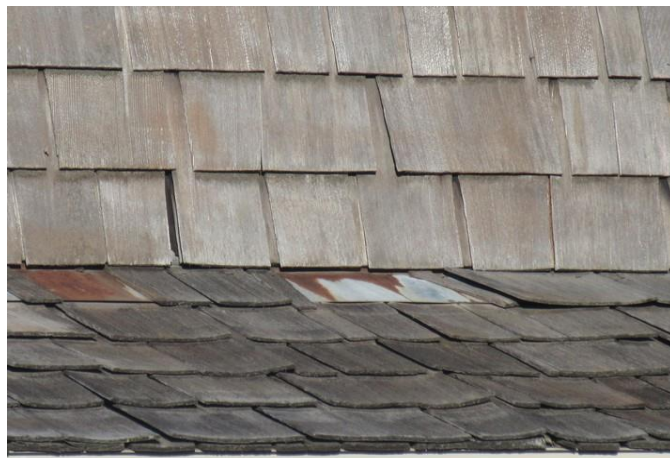
Missing shakes visible

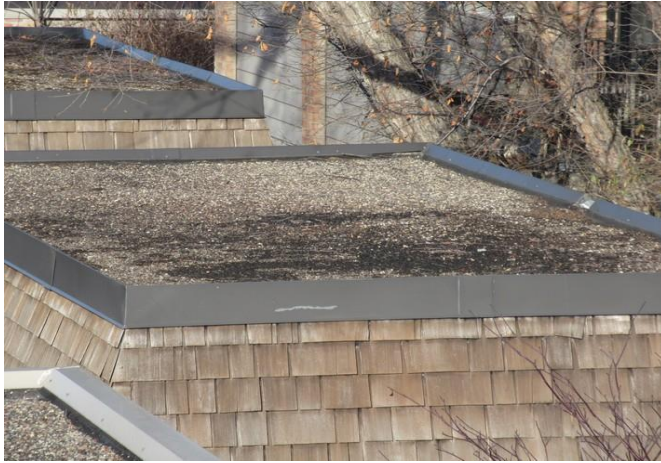
View of older ballasted roof

Engineering Narrative
Existing ballasted roofs are being replaced in phases at the community. Phases of replacement started in 2016 and the final phase of roof replacement is scheduled for 2021. Cost for this work is from the cost summary provided by Management. Future roof replacements have been included in phases to match the previous replacement schedule starting in 2036.

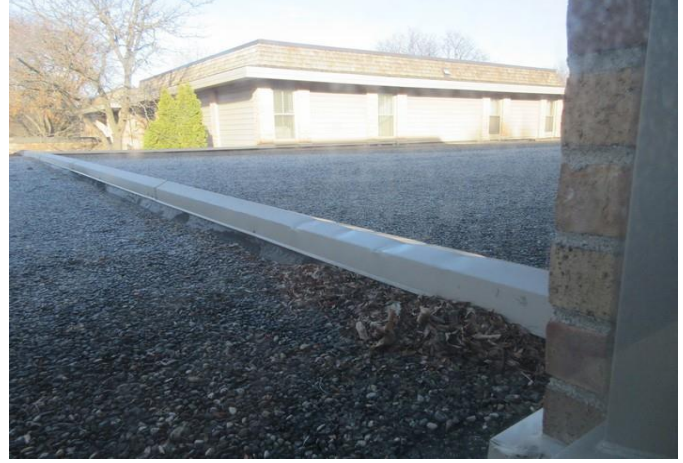
Coping and ballasted roof over garage

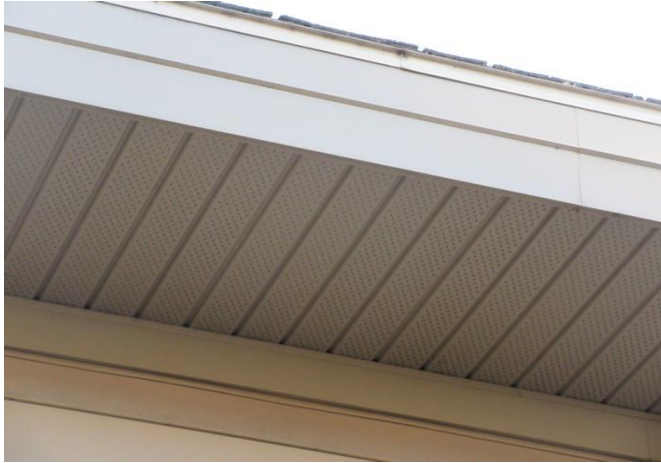
Soffit at Galleries overhang

Aluminum soffits and fascia at roof edges were replaced within the last 7 years per Management. At the end of this study the soffits and fascia will have reached approximately 80% of their typical useful life. We have included long-term funding of 80% of the replacement cost for the soffits and fascia in 2051.

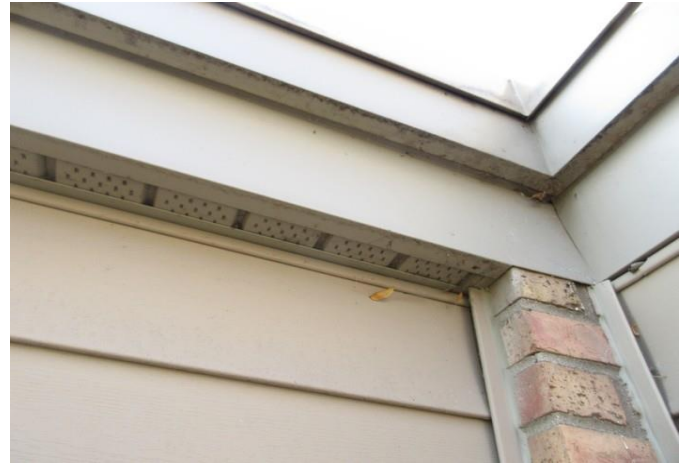
Soffits along rear of garage

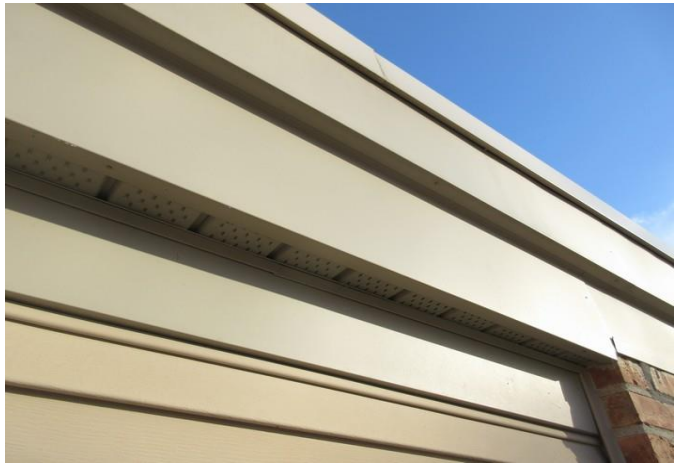
Typical fascia condition

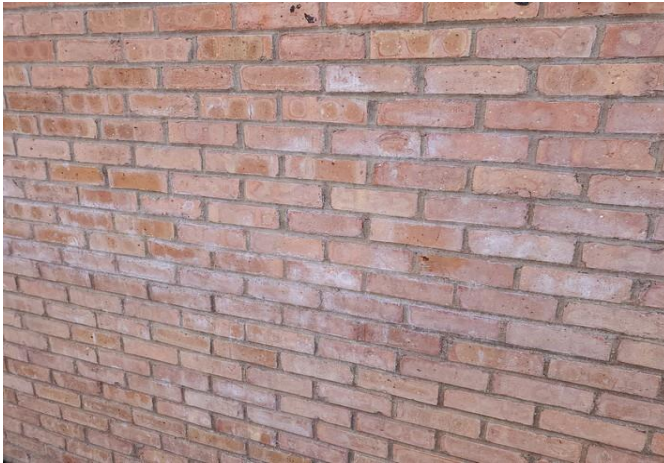
Efflorescence on brick

The Association has been completing repairs to the masonry facades every year. Based on discussion with the Property Manager we have included phased repairs every 5 years, allowing for the entire property to be addressed every 15 years. Unit cost includes full inspection of the masonry façades, as well as partial repointing and capital repairs as necessary, every 8 to 15 years. The current condition of the masonry is good to fair. We recommend funding for initial repairs in 2021 based on the previous scheduled work. Sealant replacement is a responsibility of the individual unit owner.

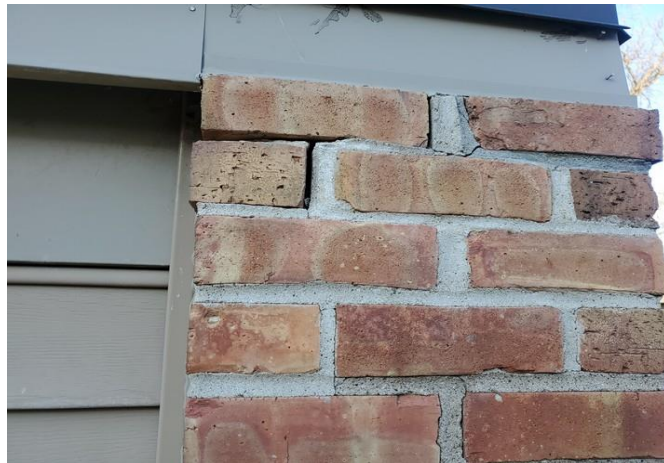
Repairs completed at edge of masonry

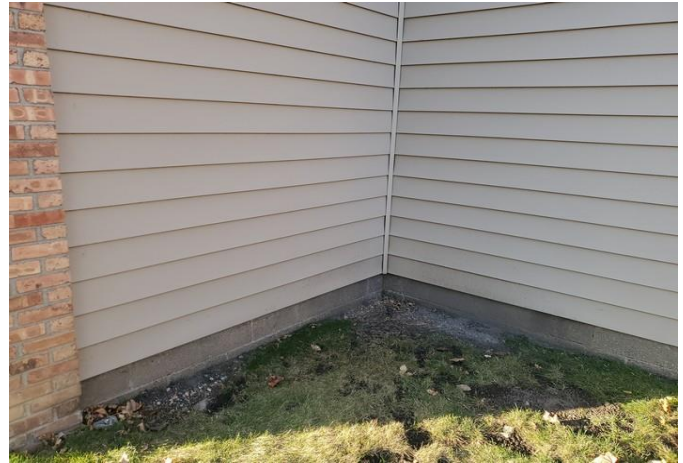
Vinyl siding at building corner

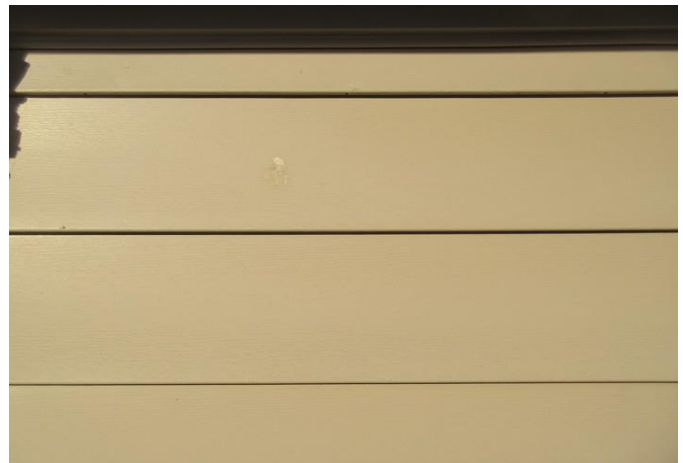
Vinyl panel siding in good condition

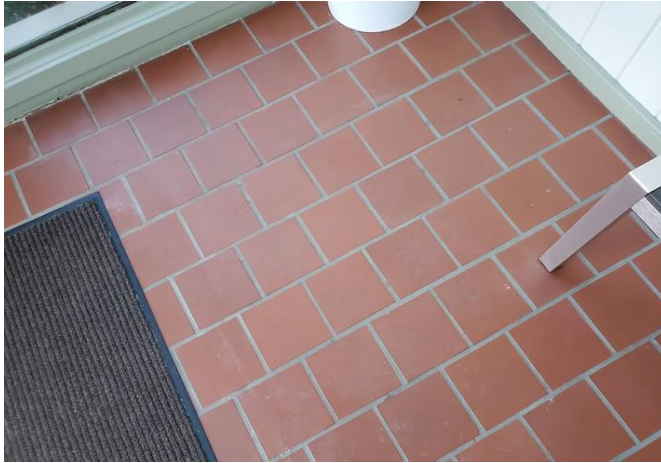
Typical tile at front entry

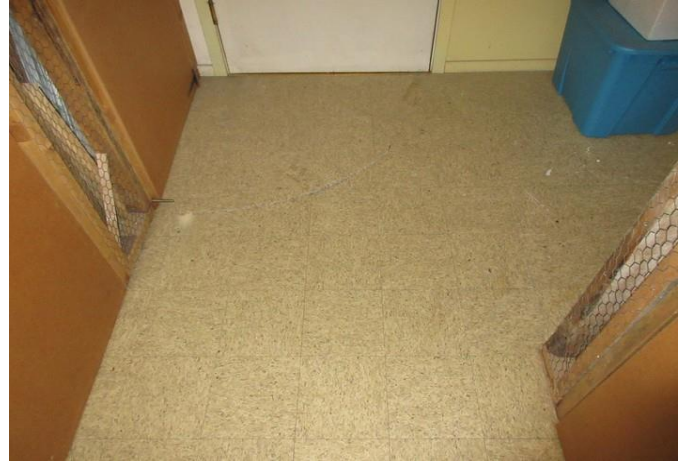
Storage area flooring

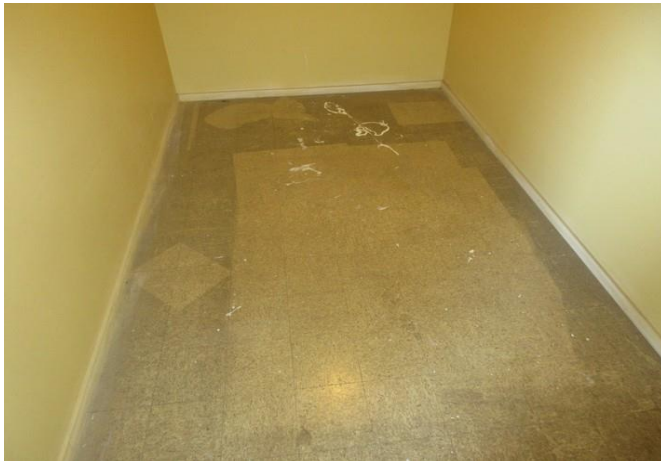
Discolored vinyl floor in storage

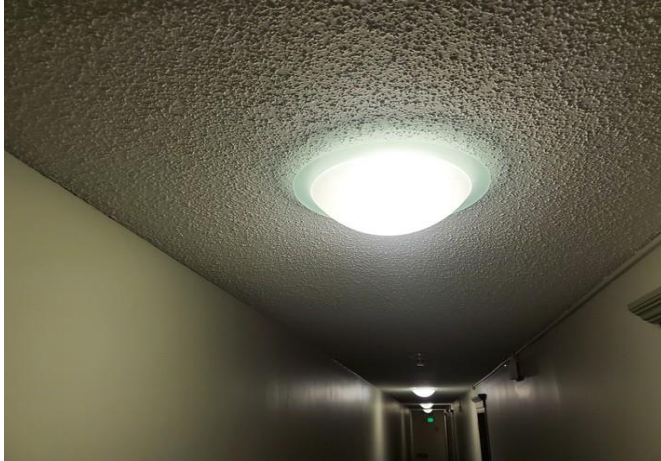
Typical hallway fixture

Ceiling fixture

Wall sconce in Galleries building

Interior can fixture

Interior light fixtures vary in style and age. Included in this component are fixtures in the Galleries buildings and Cluster buildings. We recommend that the Board fund replacement of all of the common fixtures in a single instance in 2035. Replacement at one time will allow for consistent style and appearance across the entire community common areas.

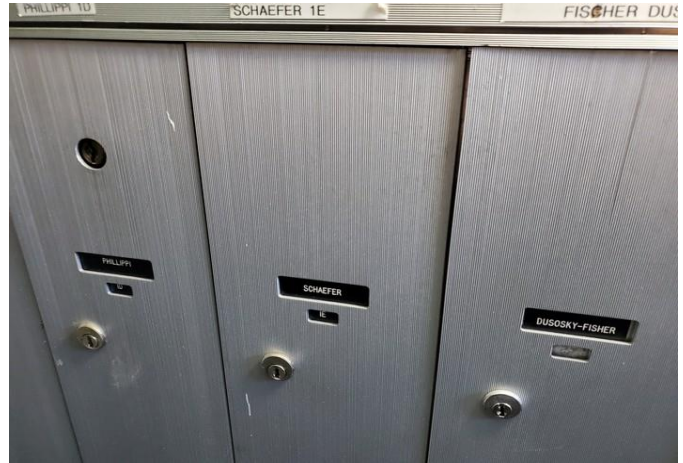
Typical mailboxes

Mailboxes in galleries stairwell

Mailbox surfaces

Mailboxes are in fair to good condition

Interior mailboxes have a typical useful life of up to 35 years. We recommend that the Board reserve funds for the eventual replacement of the mailboxes. For budgetary reasons we have included this replacement by 2041. Mailboxes includes are located at the Galleries and XXX buildings.

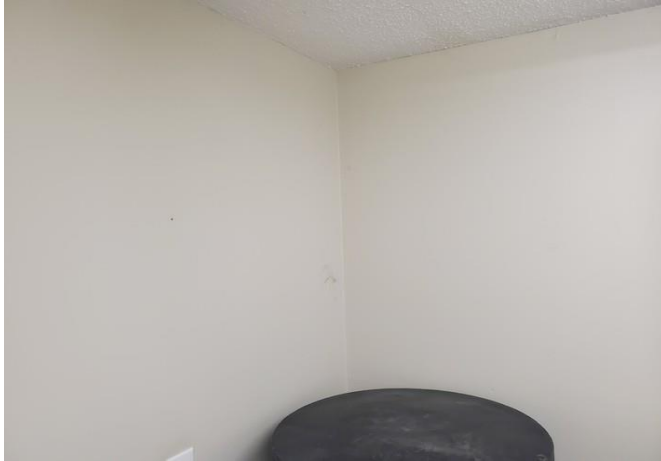
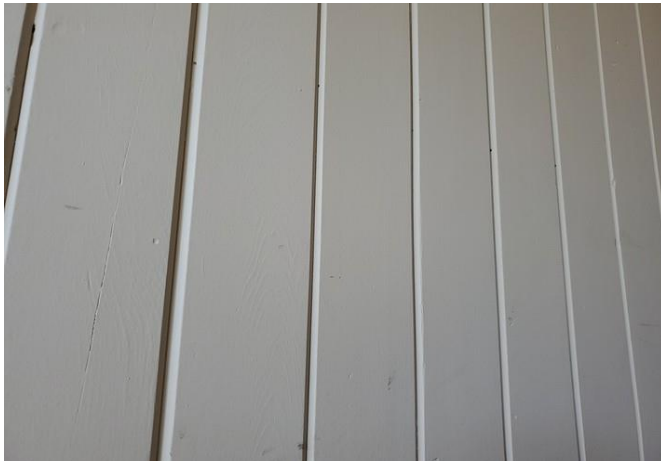
Painted walls and ceiling in common laundry

Hallway paint

Painted wood in stairwell

Wallpaper (anticipated to be removed) in Clusters

Common area paint finishes include hallway walls and ceilings, and stairwell surfaces in the Galleries and Cluster buildings. Painting appears to be over 5 years of age, although actual age is not known. We recommend that the Board fund scheduled painting of common areas every 12 years starting in 2023. This schedule coincides with carpeting replacement.

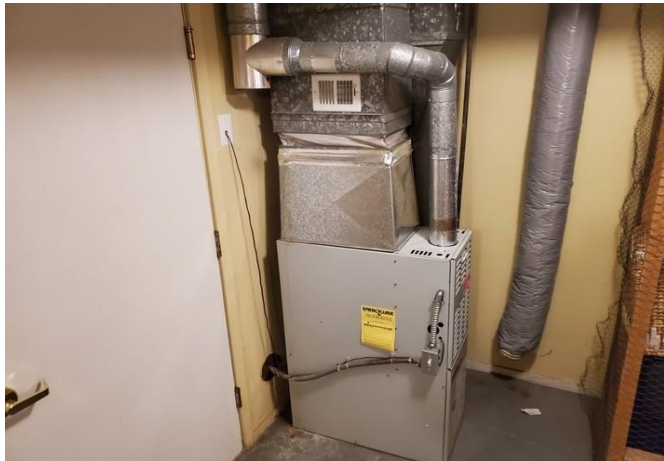
Typical furnace

Furnaces are in common storage

Furnace in common storage room

Newer furnace

Common furnaces are located at the Galleries buildings. These units provide heat for the common hallways at all three floors. These units vary in age. We recommend that the Board reserve funds for the phased replacement of the furnaces, with 33% replaced each instance starting in 2027.

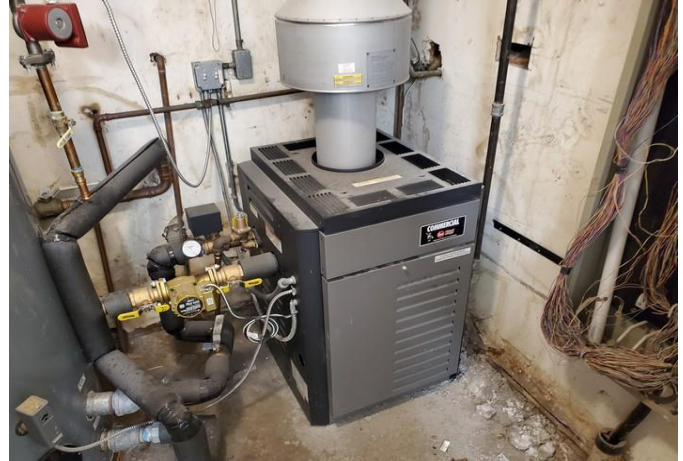
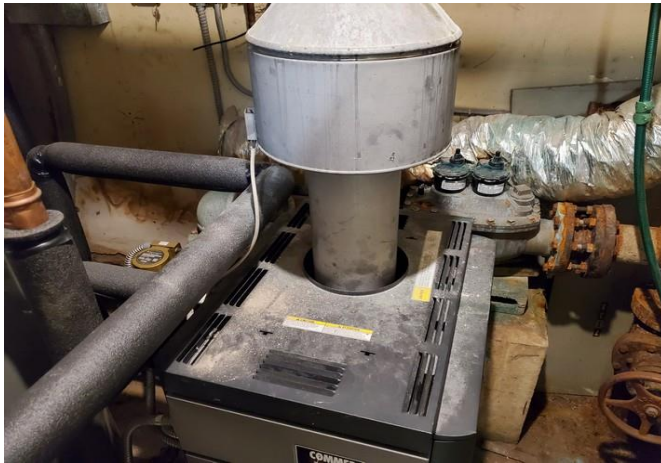
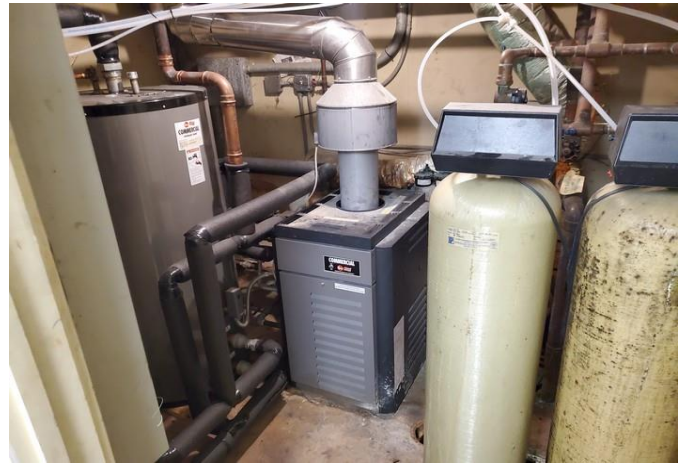
Typical boiler

Boiler located in behind laundry room

Boiler vent hood

View of boiler in mechanical room

There are 2 hot water boilers located in the Galleries buildings. These units have a manufacture date of 2015. Storage tanks located at the boilers are anticipated to be long-lived. We recommend that the Association reserve funds for replacement of these units in 2035.

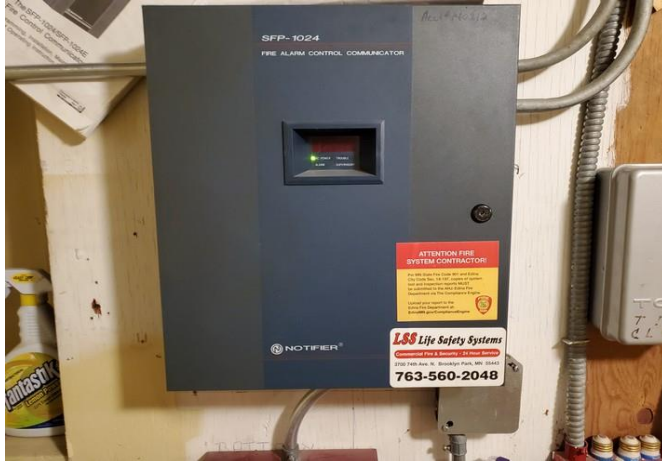
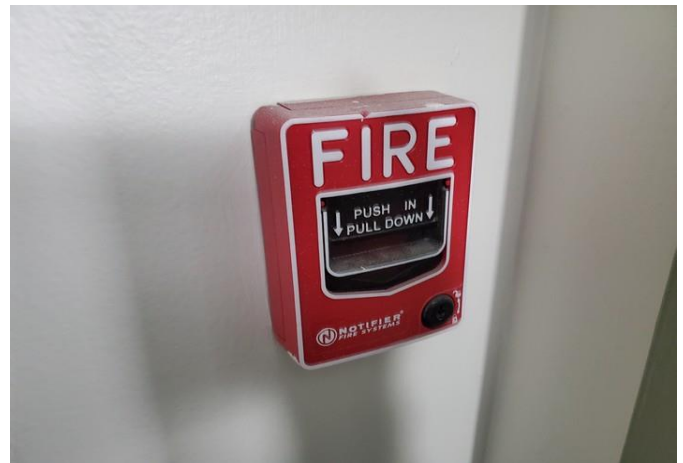
Typical fire panel in storage room

Smoke detector

Annunciator in hallway

Pull station in common hallway

Fire detection devices include smoke detectors, heat detectors, annunciators, panels, and horn/strobes at the Galleries and Clusters common hallways and rooms. Devices in individual residences are the responsibility of the individual homeowner. We recommend replacement in 2031 to update the system to future code requirements.

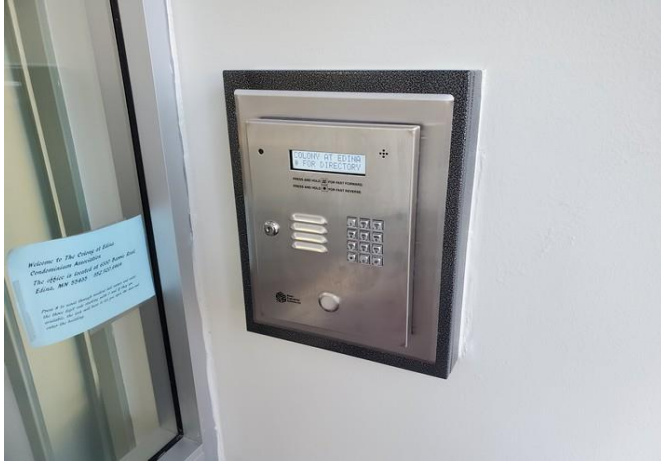
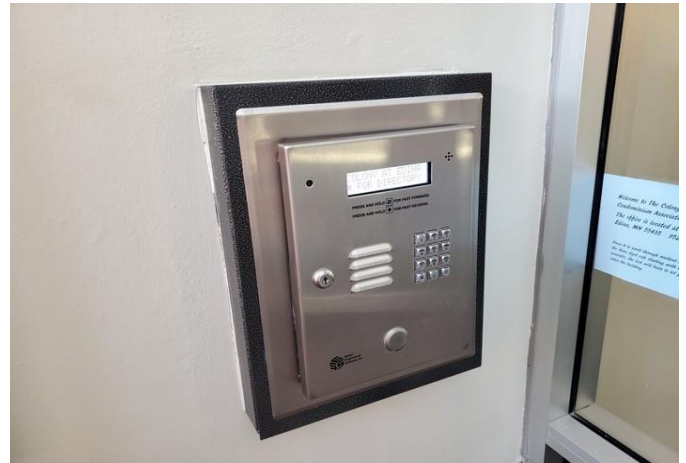
Typical intercom panel

Intercom at galleries entry

View of intercom panel surface

Typical panel

Intercom entry panels at the Galleries exterior entries are in fair to poor condition. The units are older per Management. We have included replacement of the intercoms in 2022, with subsequent replacement in 2047.

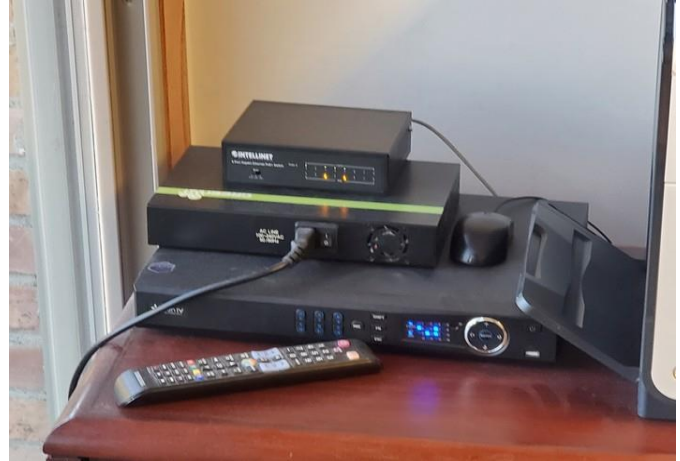
Monitor in clubhouse

DVR and monitoring system

Exterior camera

Typical camera at garage

Engineering Narrative
Unit cost is an average cost among the following surveillance system items: (15) security cameras, (1) surveillance monitor, and (1) digital video recorder. Future replacements are recommended at 15-year intervals. The system appears to be in good current condition. Age is not known. We recommend replacement in 2028.

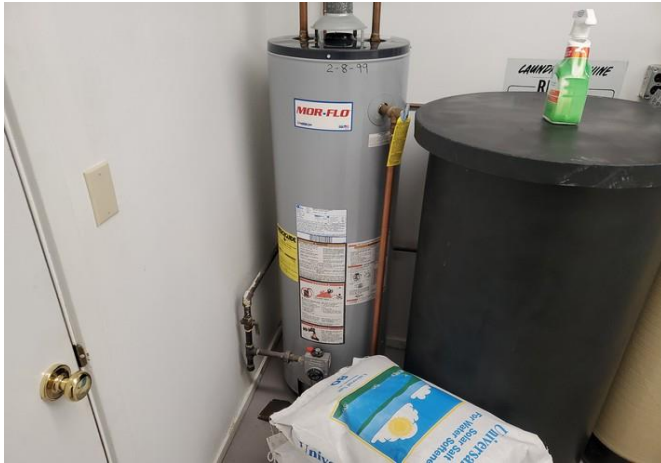
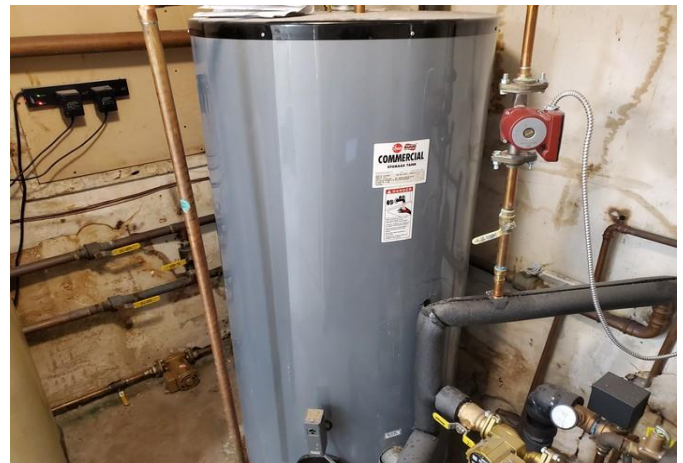
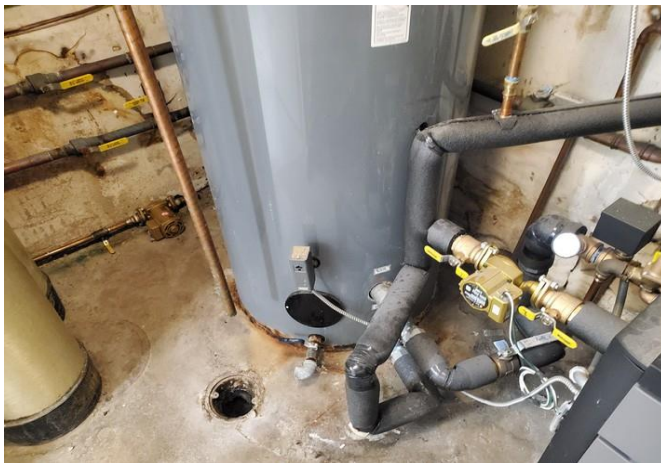
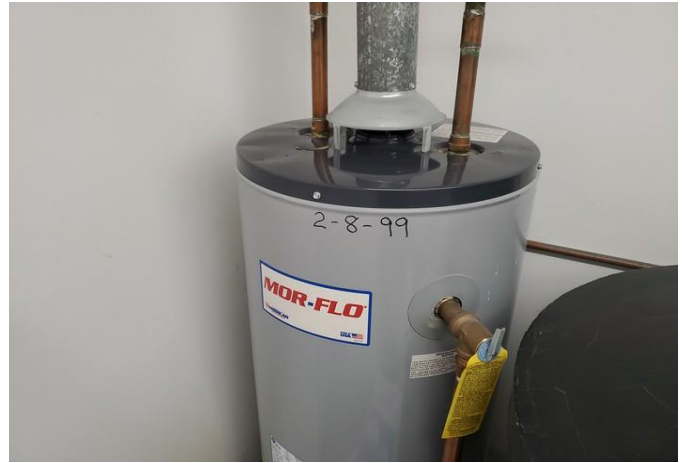
Laundry room water heater

Water heater in Galleries building

View of water heater

Laundry room heater with date installed shown

Water heaters are located in Cluster building laundry rooms and the two Townhomes laundry rooms. These units provide hot water to the laundry only. We recommend that the Association fund phased replacement of the water heaters by 2026, due to the varied ages of the heaters.

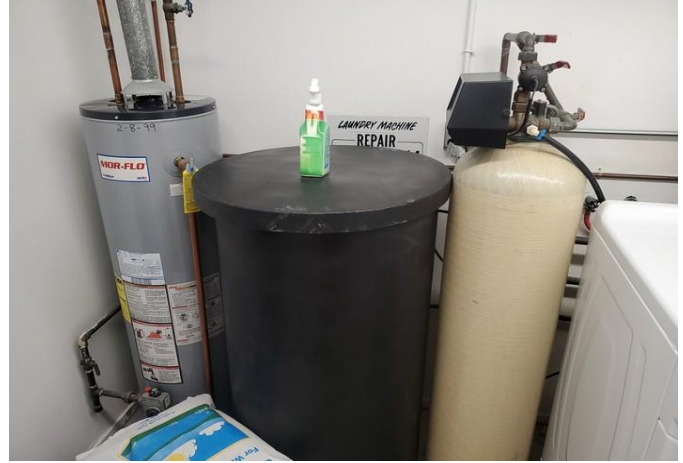
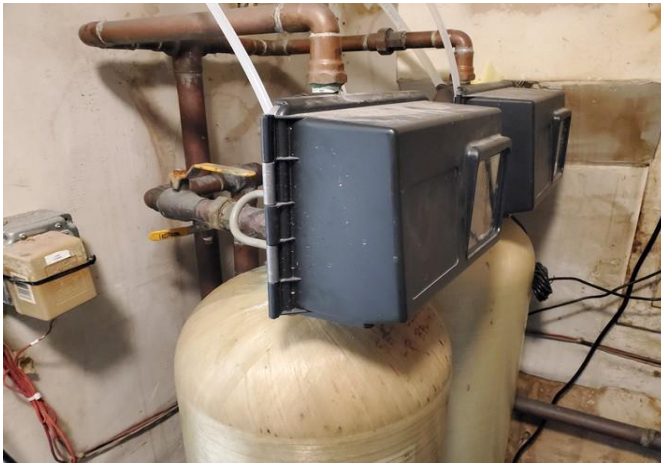
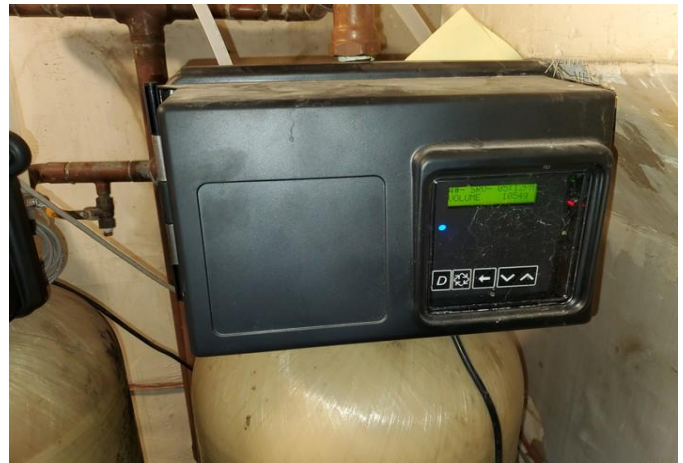
Galleries softeners

Water softener in laundry

Hardware on softener

Water softener panel

Engineering Narrative
Water softening systems are located at the Galleries and Clusters buildings. Systems vary in age. The Association has been replacing rental units with purchased units. We recommend continuing this pattern, with the replacements being scheduled in phases starting in 2026.

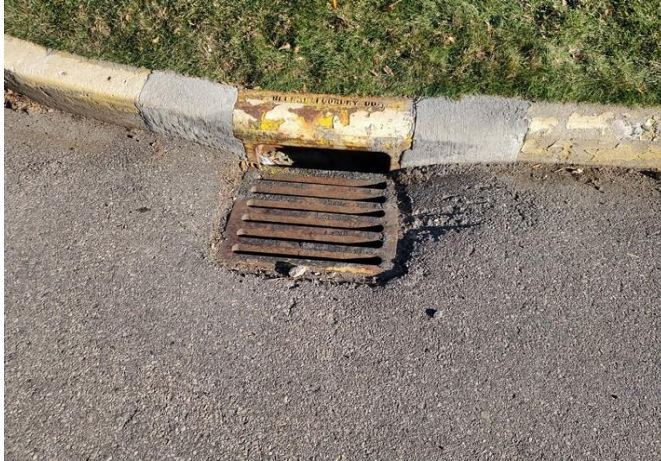
Catch basin that has been repaired at curb

Engineering Narrative
<p>Storm water catch basins collect water from the streets and direct it into an underground pipe system. Over time, the concrete adjusting collars, mortar and pipe connections may deteriorate, shift or sustain damage from vehicle loading. As the integrity of the basins is compromised, water and sediment may erode from the surrounding soil and create voids that lead to potholes. We recommend the Association budget for catch basin repairs by 2025 and again by 2045, in coordination with repaving, due to the interrelated nature of these elements.</p>

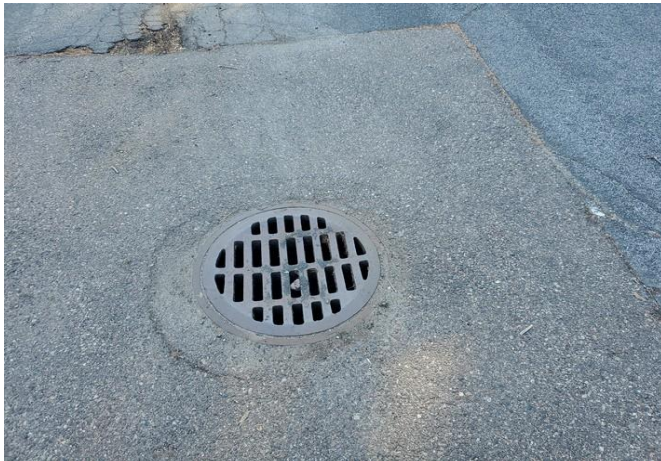
Catch basin in patched pavement

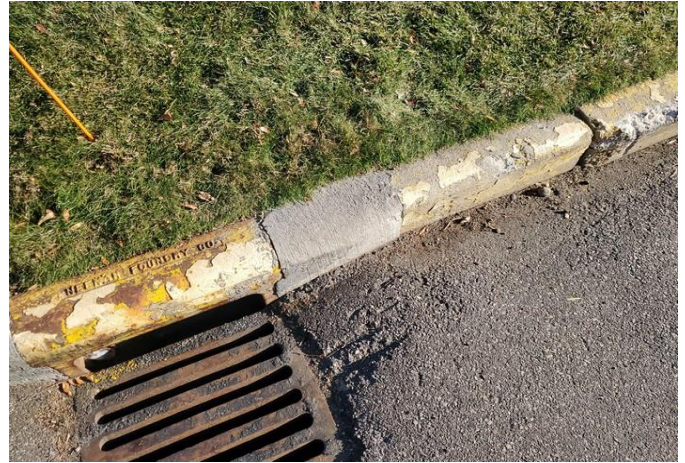
Repair at catch basin

Concrete curbs typically has a useful life of up to 65 years with ongoing replacements. We have included replacement of 60% of the curbs starting in 2025 and coinciding with other paving projects.

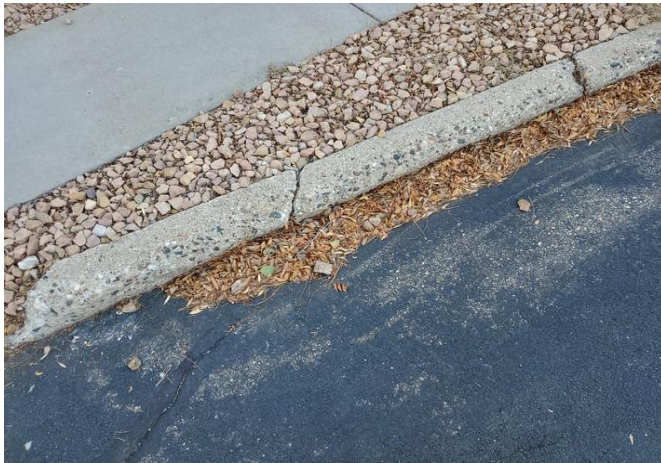
Cracks in curb

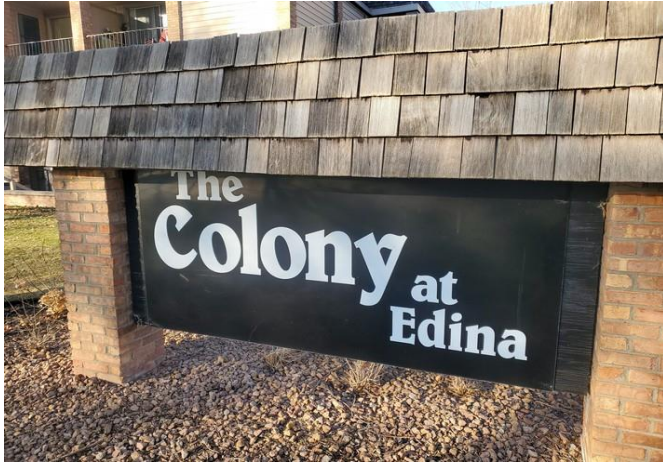
View of typical sign

Plastic placard

Cedar shake accent

Masonry pillar

There are 2 monument signs in the community. Signs are built with a wood frame, include mansard cedar shakes, and have plastic placards with the community name. We recommend that the Board reserve funds for the eventual replacement of the monument signs by 2036.

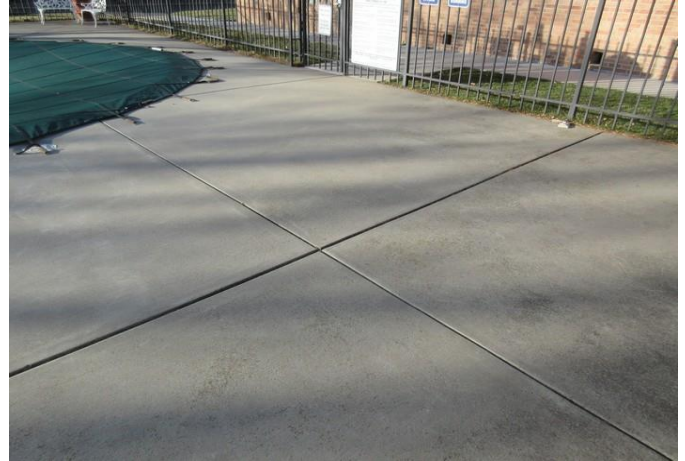
View of deck section in good condition

The concrete pool deck is recommended for replacement in 2030. This is the same time as the pool is scheduled for replacement. Future replacement of individual panels should be completed as-needed out of the operating budget (after replacement in 2030).

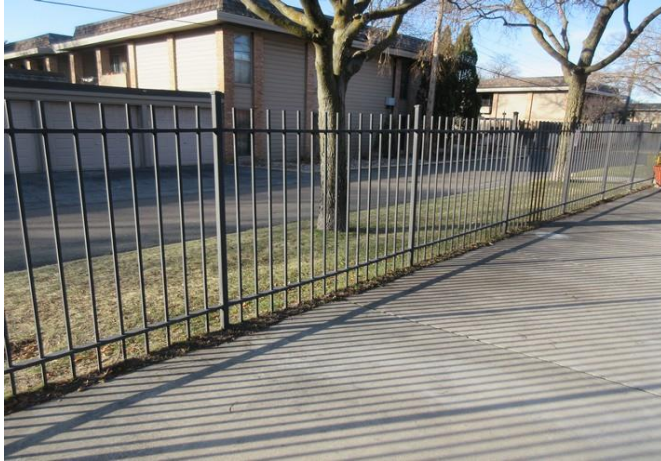
View of steel fence

A metal picket fence is located at the pool. It is anticipated that this fence will be replaced when the pool is replaced in 2030. Future repairs to the fence are anticipated to be operating expense.

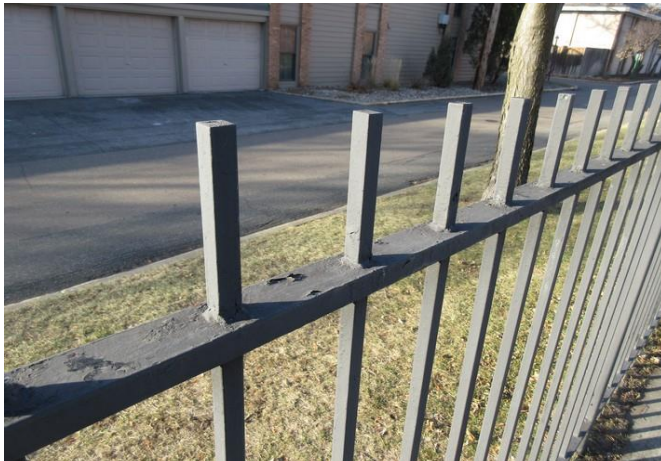
Typical condition of fence surfaces

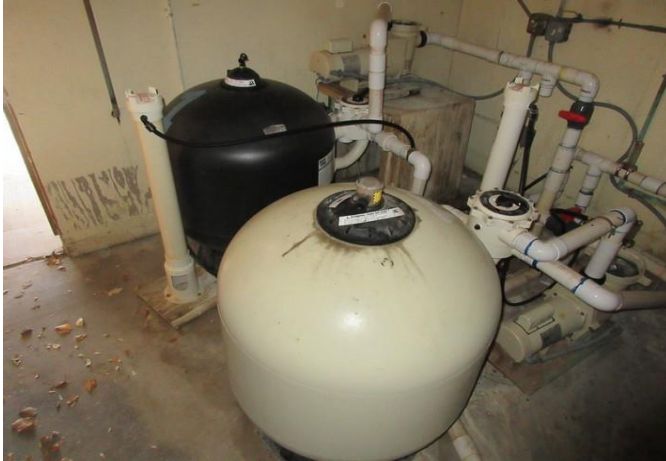
View of filters

Engineering Narrative
<p>Pool mechanical systems include the pump, two filters, heater, and chlorinating system. We recommend that the mechanical systems be replaced as part of the pool replacement in 2030. Future replacement is recommended 15 years after replacement in 2045.</p>

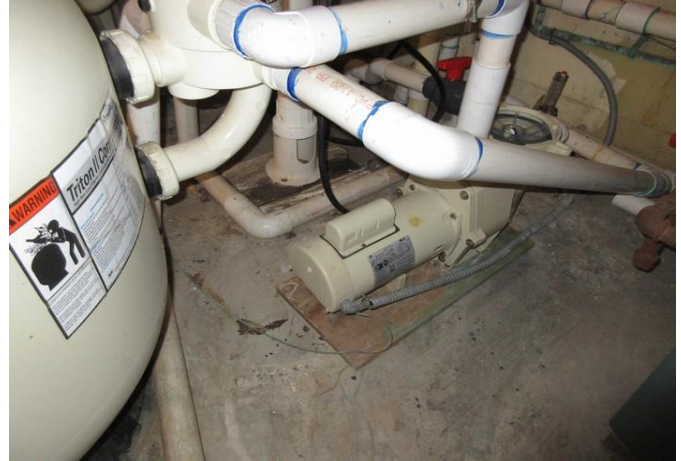
Pool pump in mechanical room

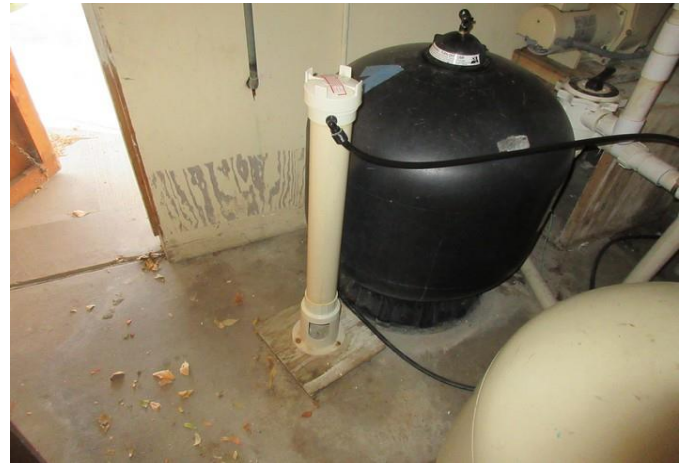
Chlorinating system and filter

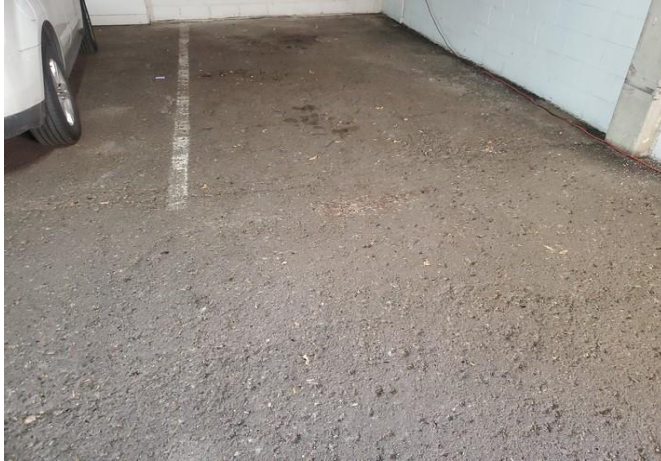
Pavement surface at parking stall

The garage surfaces are asphalt pavement. It appears that this pavement has not had a lot of maintenance in the past. We recommend crack repairs and patching the asphalt garage floors approximately every 5 years. The first instance of this repair is included in 2022. The exception to this is 2026 when we recommend replacement of the asphalt pavement.

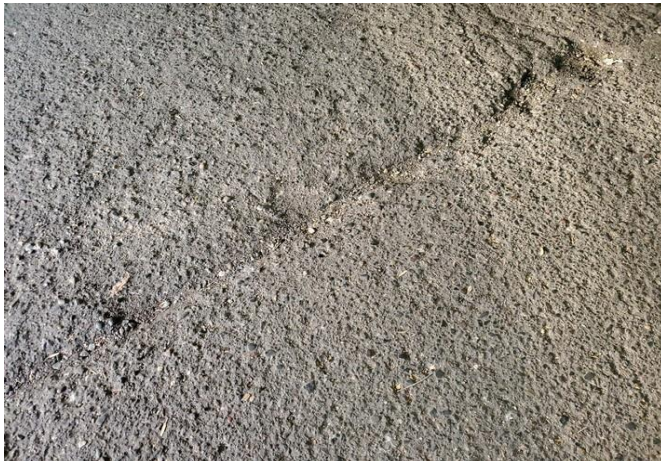
View of surface condition

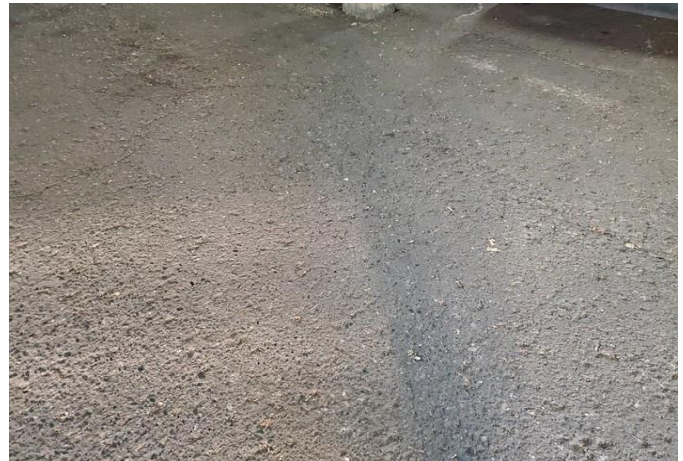
Asphalt surface in garage

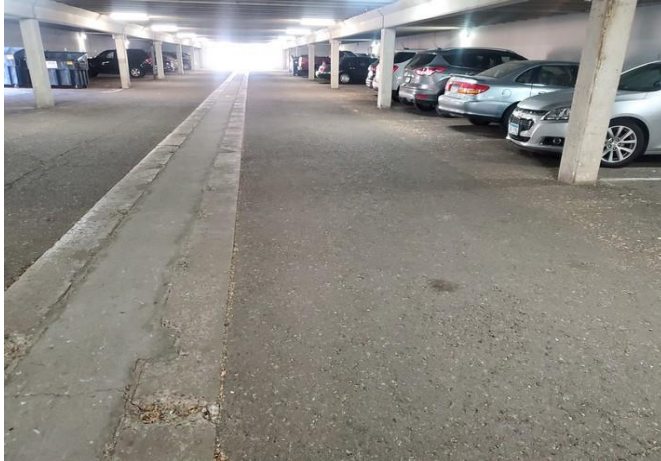
Paved garage floor

Engineering Narrative
<p>The asphalt garage surface are in fair to poor condition. It is not known when the garages floors were last replaced. We recommend that the floors be replaced every 20 years starting in 2026. We anticipate that this replacement will include removal of the pavement, regrading and repair of the base material, and installation of new asphalt.</p>

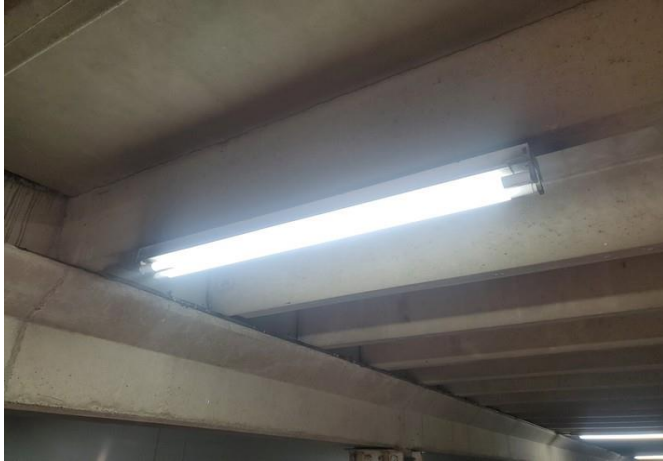
Fluorescent light fixture

Light fixtures at the garages include various halogen and fluorescent fixtures. These fixture appear to vary in age. We recommend that the lights be replaced at the same time as the asphalt replacement in 2026.

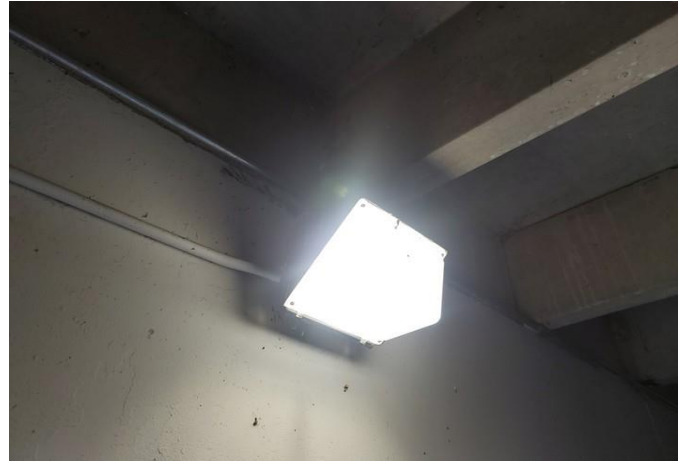
Typical wall fixture

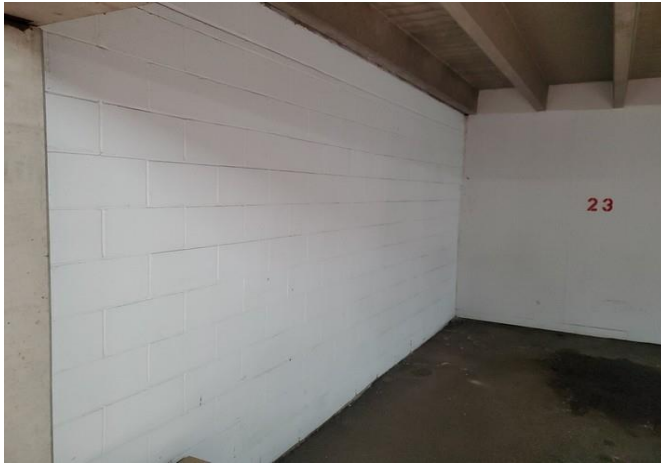
Painted concrete block
