# RESERVE STUDY

**The Colony at Edina Condomonium Association**  
**6330 Barrie Road**  
**Edina, MN**

**Date of Inspection: November 28, 2020**

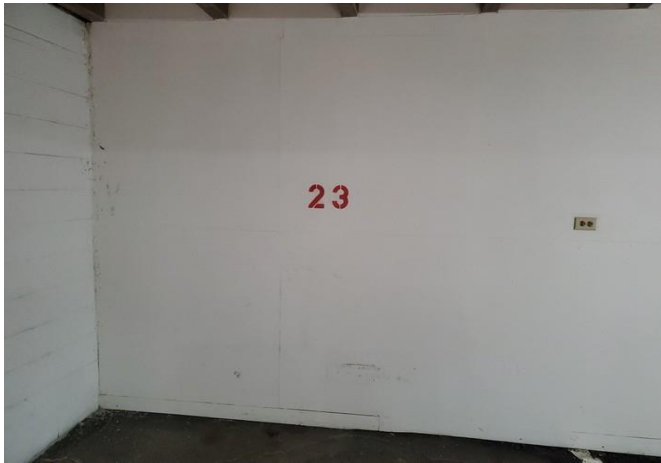
Typical wall surface
