# Private Home Inspection Report

## Wright-Pro Home Inspection LLC

**22560 Country Ave.  
Anytown, MI 48000**

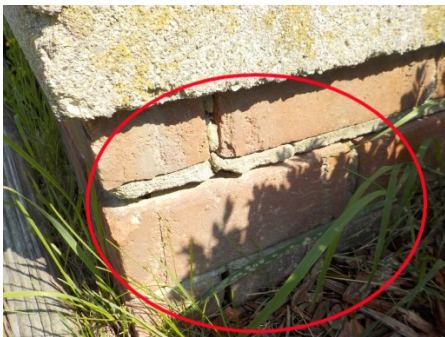
- Porch needs tuckpoint repairs where brick mortar is loose or missing, and cap has cracked in a couple of places.

Loose or missing mortar.

Have repaired then monitor. If cracks reappear this will suggest ongoing movement. Making sure all downspout run-off is directed away from the porch structure -- this should help to stop further movement.

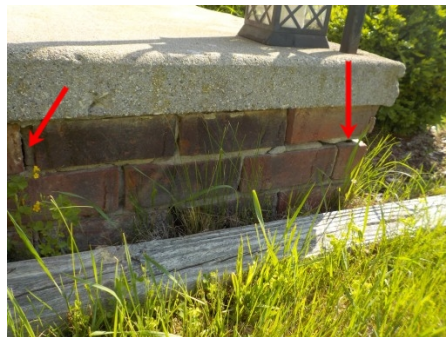
Areas of missing or gapped mortar

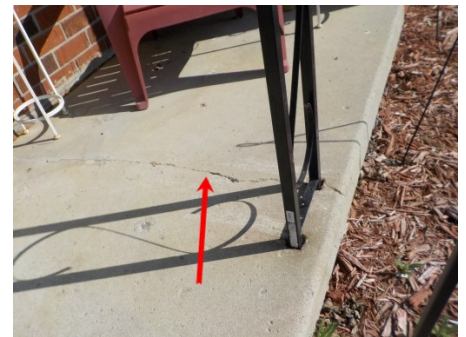
Cap has cracked

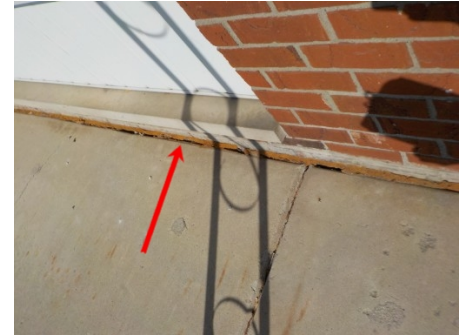
Evidence of movement/separation from structure

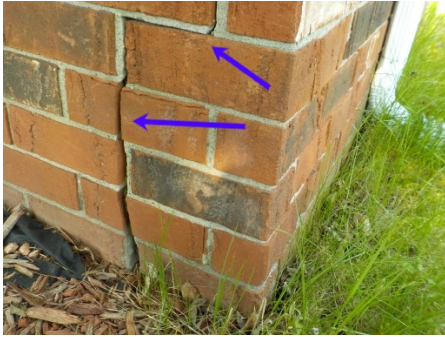
- 1. Movement of brick noted in several areas. Cracks in brick and mortar and areas of missing mortar should be repaired. Recommend further evaluation by a brick mason or qualified handyman when repaired.
- 2. Lowest run of bricks has areas of no mortar as they allow the brick to drain moisture and circulate air as needed. These should not be sealed. However, these "weep holes" should have a mesh screen installed to avoid pest and rodent intrusion and nesting. See example picture.

Garage corner has shifted

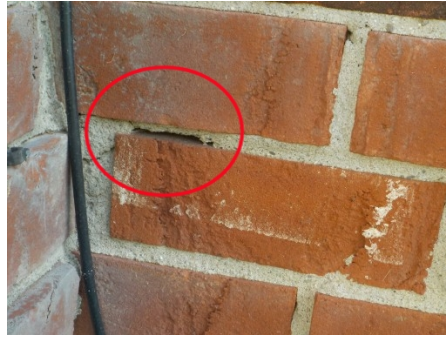
Fill any missing mortar to keep bricks supported

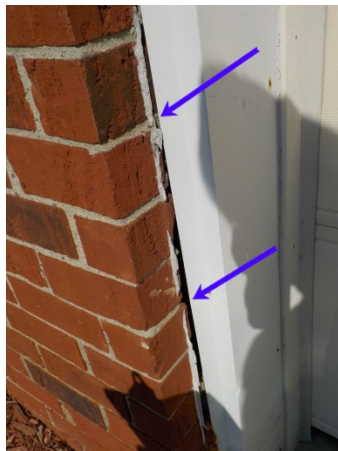
Wall at garage trim has pulled away

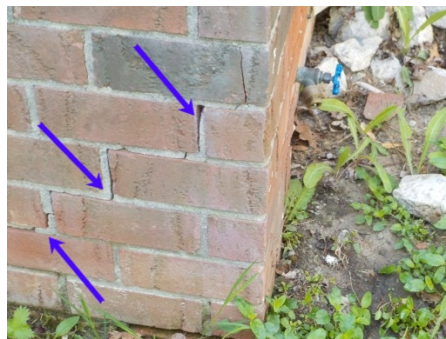
Step crack at North corner

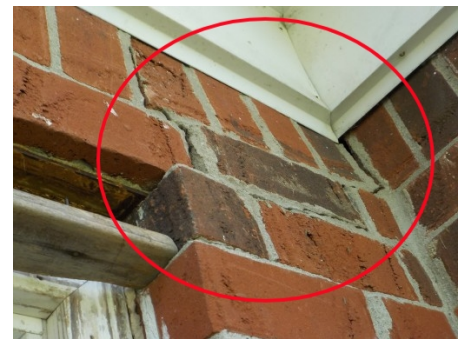
Movement of brick at garage service door.

As discussed, we noted the wall at the service door showed movement at some point as mentioned in Exterior section. Recommend further evaluation when repairs are made.

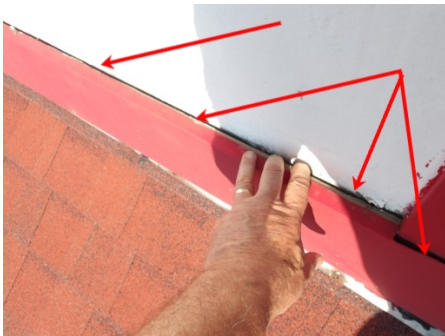
The decorative aluminum trim on the front of the upper wall requires proper fastening and sealing to prevent potential water intrusion. Further evaluation and corrective work by a qualified roofer or siding contractor is recommended.

Loose trim needs sealing

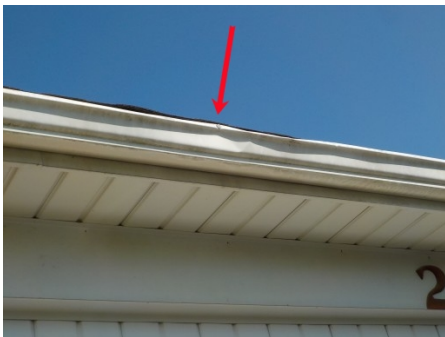
1. Minor damage to gutter above garage area. Upper gutter nails are coming out, need to be pounded back in to be sure gutter doesn't pull away from the fascia.
2. Stains are areas of potential leak. It's hard to predict how the gutters system functions in dry weather. Certain cues and symptoms can suggest issues. It is important to monitor your gutter system during rain and snow melt to be sure it functions to move water away from your home and to see where repairs may be needed.
3. Gutters should run past the corners, some areas are short. This allows corner run-off to fall at the foundation.
4. Downspout extensions need some repair. As discussed, we recommend using rigid aluminum downspout material as extensions as the plastic tend to crack and split after just a few seasons and splash blocks tend to overflow leaving water at the foundation walls.

Damaged gutter above garage.

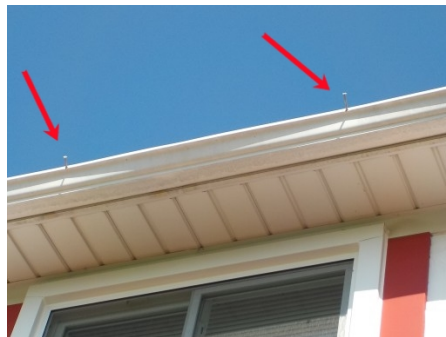
Nails need to be pounded in on upper gutter.

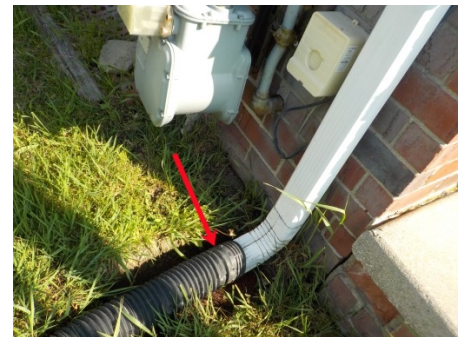
Appears water is falling out of the plastic extensions here.

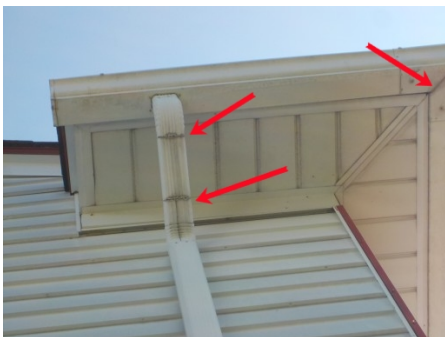
Stains can suggest potential areas of leaks, monitor during rain.

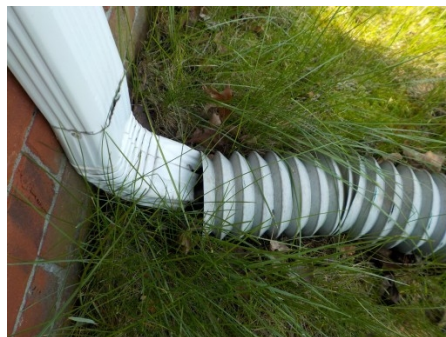
Needs a better extension, water falling at the foundation.

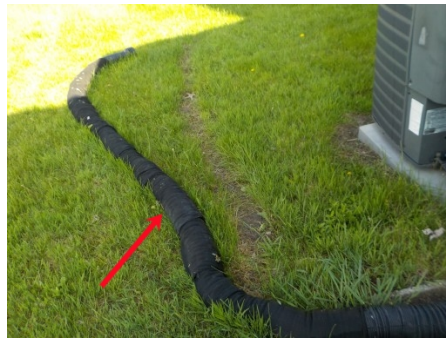
Extension is too long, too many turns.

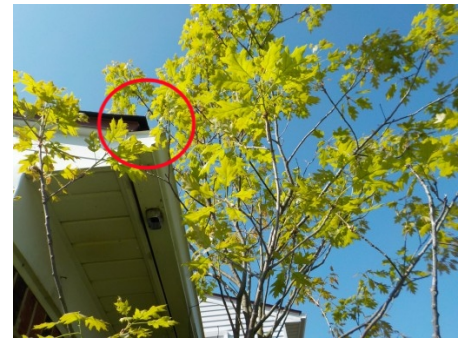
Gutter runs short of the roof length.

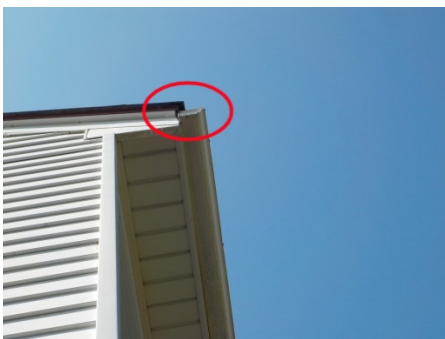
Gutter should run past corner.

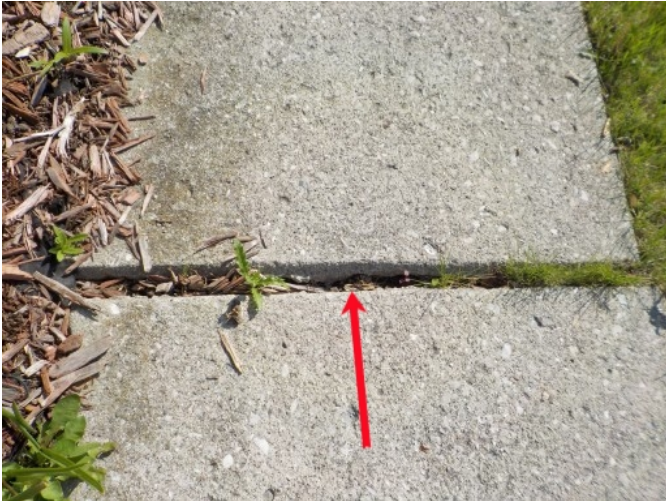
1. The issue is the size of the expansion gaps on the walk to the porch. These can be considered

a potential safety hazard as a small child's foot, a bike tire, or a shoe heel can get caught in these larger gaps. Easiest form of repair is to fill them with sand or gravel until sidewalk is repaired or replaced.

Wide expansion gaps present on walk to porch.

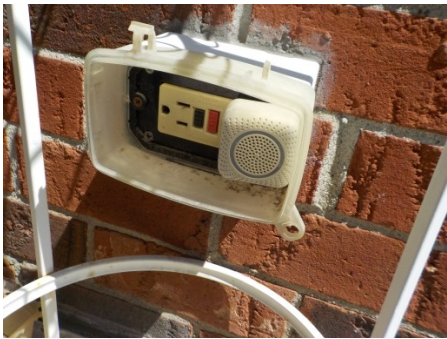
- 1. Front GFCI outlet tripped and reset when tested, however, it requires a weather cover. See example picture.
- 2. Rear GFCI outlet showed no power and did not test or reset when tested. Requires replacement, old model. GFCI outlets should be replaced every 15-20 years, they are mechanical and can quick working to protect the user at any time.

Requires a protective weather cover (porch)

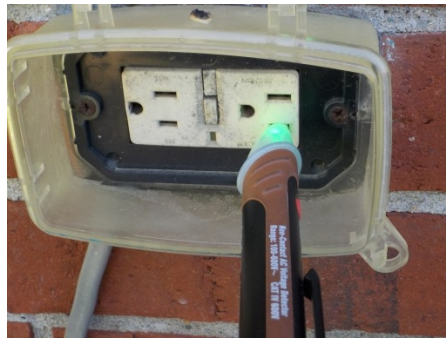
Requires replacement, showing no power.

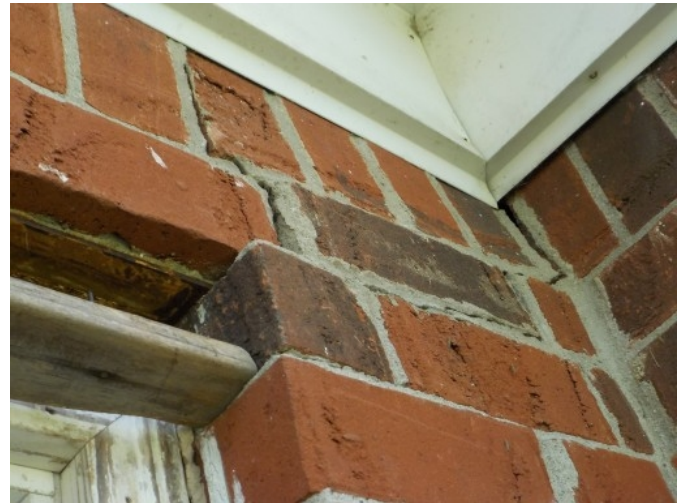
Exterior, brick shows movement.

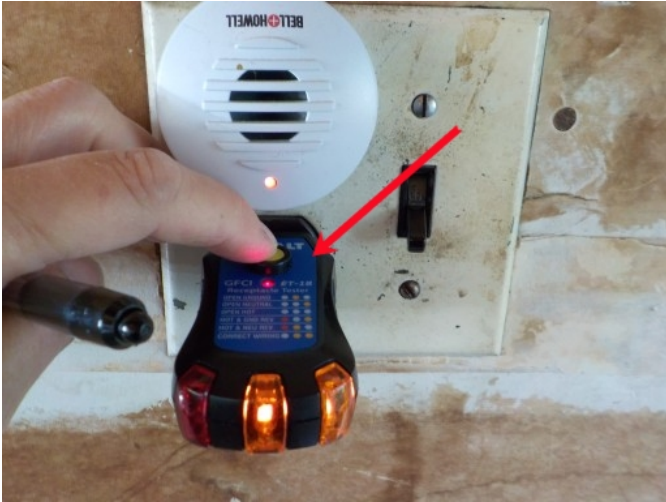
All garage wall outlets are required to be GFCI protected. A representative number of pictures reflect all outlets tested (all accessible outlets were tested). Recommend a licensed electrician correct for safety before use.

There is no GFCI protection on all wall outlets.

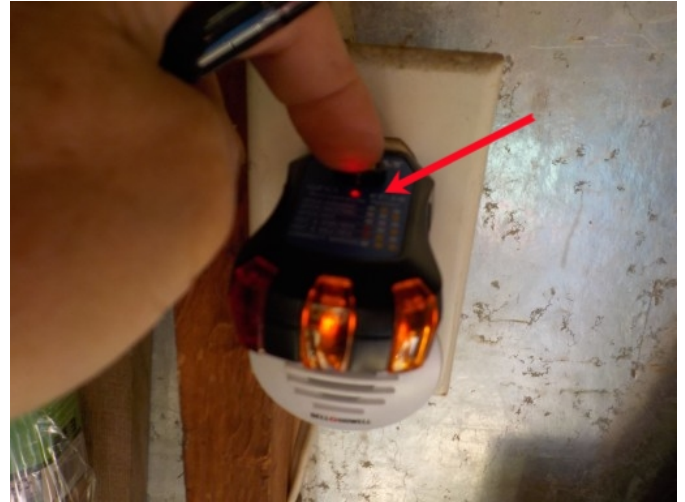
No GFCI protection

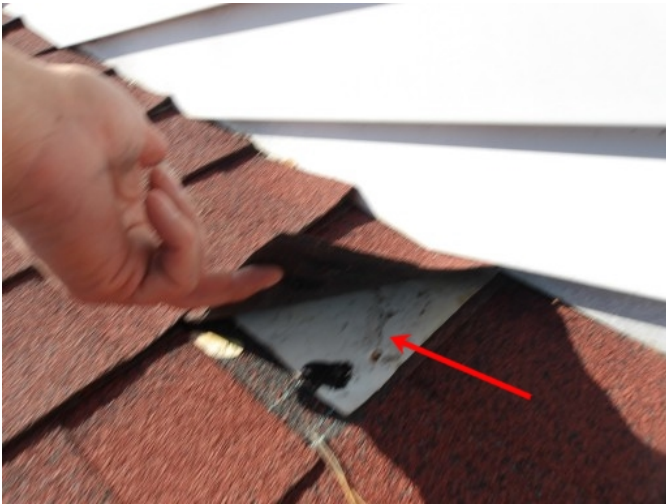
Step flashings are present at roof to wall transitions.

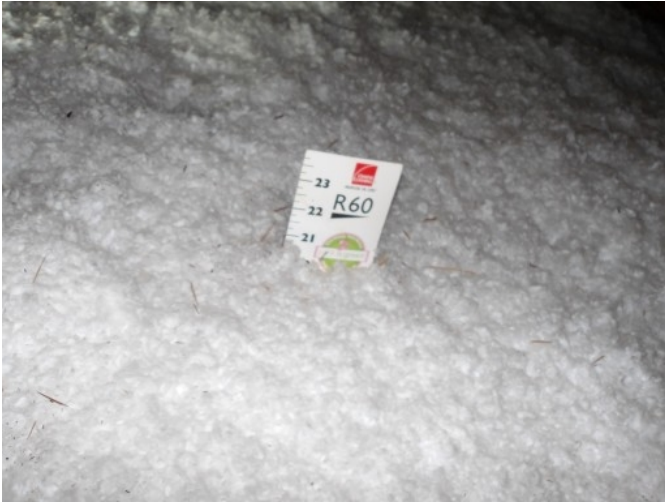
21 inches of blown in fiberglass insulation

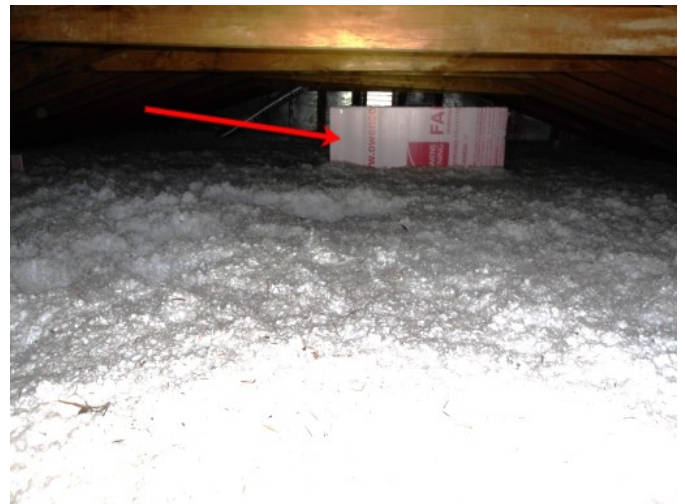
2.) A belt-driven whole-house attic fan is present. These systems often include a large ceiling opening that can allow warm interior air to leak into the attic during the winter if not properly sealed. This leakage of heated indoor air into the cold attic space may also lead to condensation, which can contribute to moisture damage and mold formation.

Attic fan barrier

It is recommended to have a qualified insulation or ventilation contractor further evaluate the attic space. Corrections may include installing proper baffles at the soffits to maintain airflow, sealing any bypasses, and insulating or covering the attic fan opening during winter months. Addressing these issues will help maintain the integrity of the insulation system and prevent potential moisture-related problems. Mold / mildew growth as a result of moisture issues can be a health concern for some people.

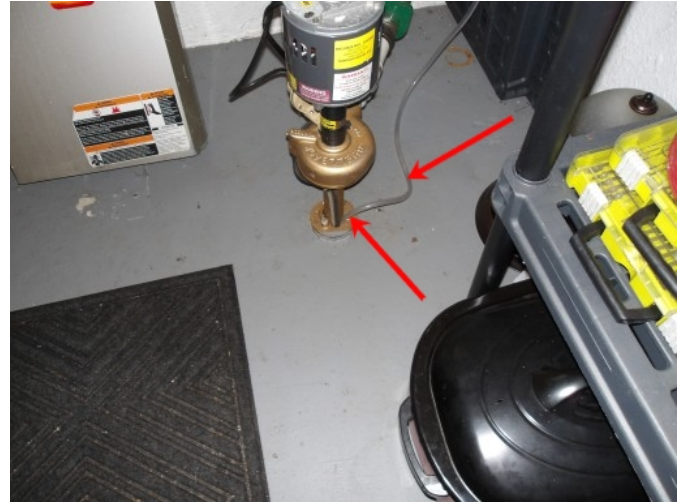
An electric condensate pump with a plastic drain tube is present, with the drain line terminating at the sump pump. While the general configuration is functional, the condensate drain tube should be better routed and properly secured to prevent potential leaks, disconnections, or damage. Recommend adjustment by a qualified technician to ensure proper drainage and long-term reliability.

Condensate drain tube terminates into the sump crock.

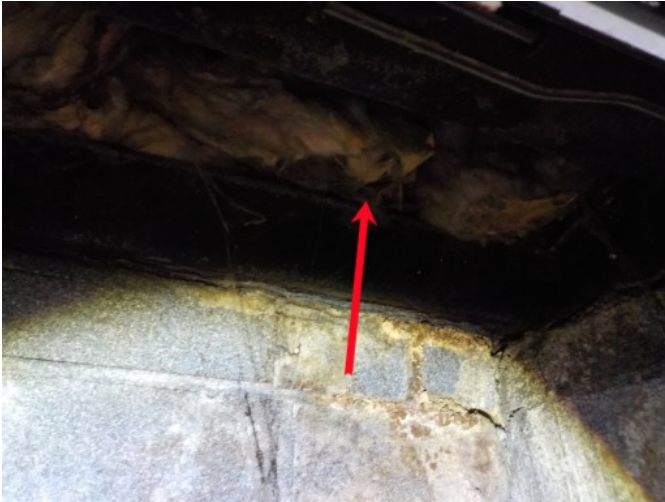
Unable to see, smoke chamber area was stuffed with insulation.

Smoke chamber is stuffed with insulation

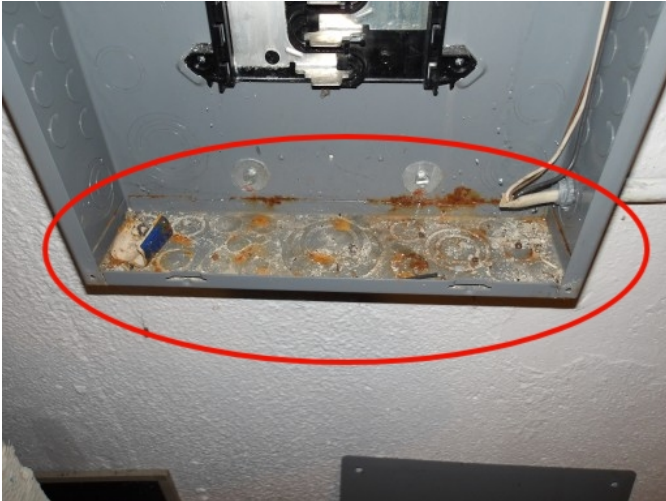
Rust at the bottom of the panel housing.

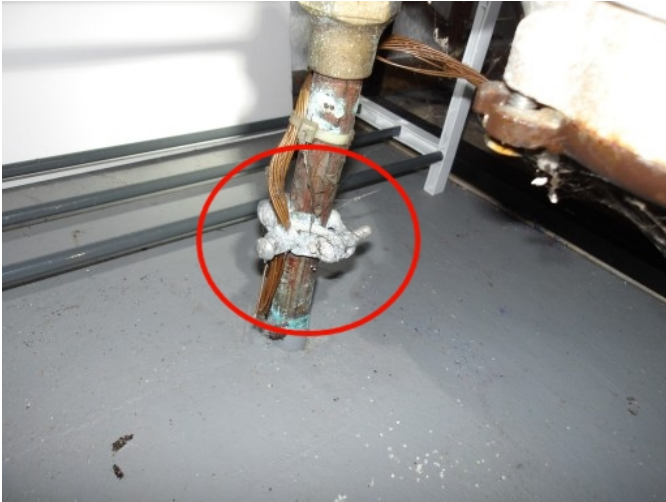
The plumbing ground wire and clamps are present and appear to be properly secured. However, the lower grounding clamp is exhibiting advanced corrosion. This corrosion may compromise the integrity of the grounding connection over time. It is recommended that a licensed electrician replace the corroded clamp and clean the copper water pipe at the connection points to ensure a reliable and effective ground.

Corroded ground clamp at incoming copper water line.

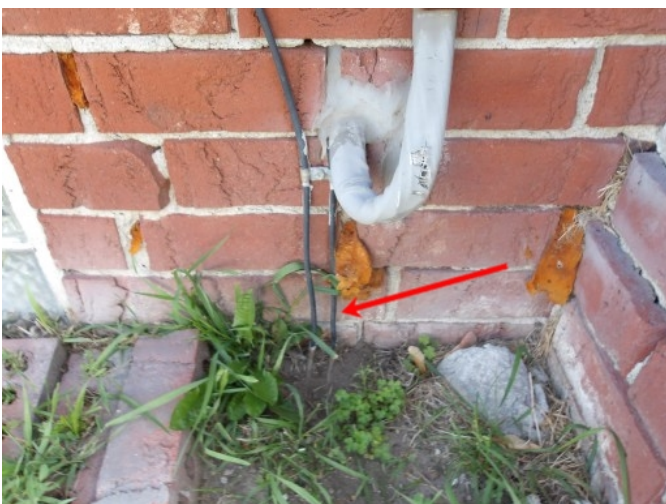
Ground rods appear to be present and properly installed in accordance with standard requirements. No deficiencies were observed at the time of inspection.

Earth rod ground wire

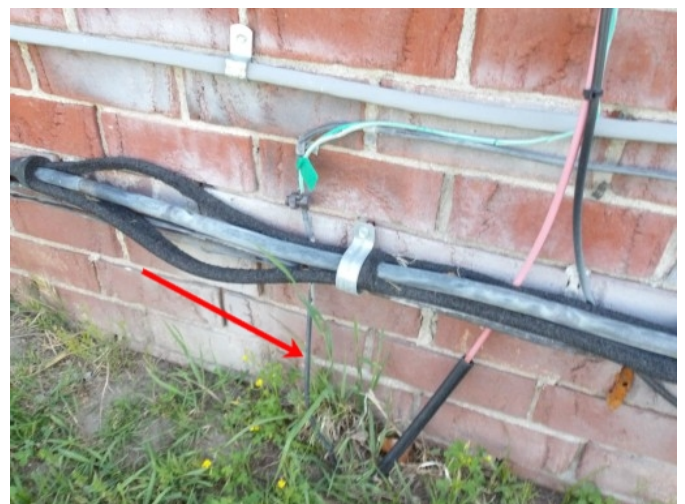
Second earth rod ground

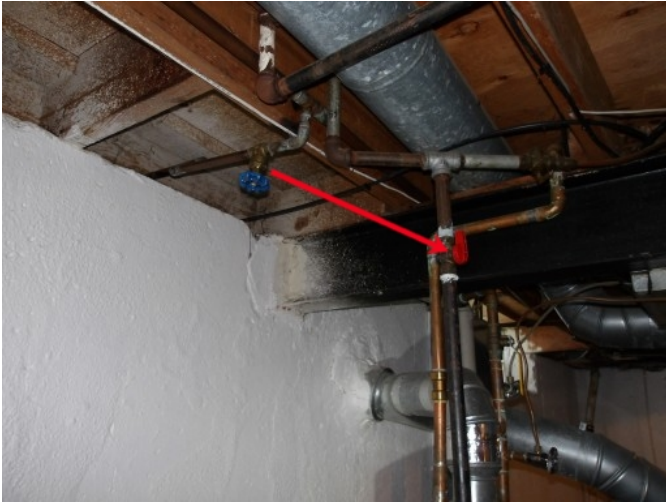
Water heater gas supply shutoff valve

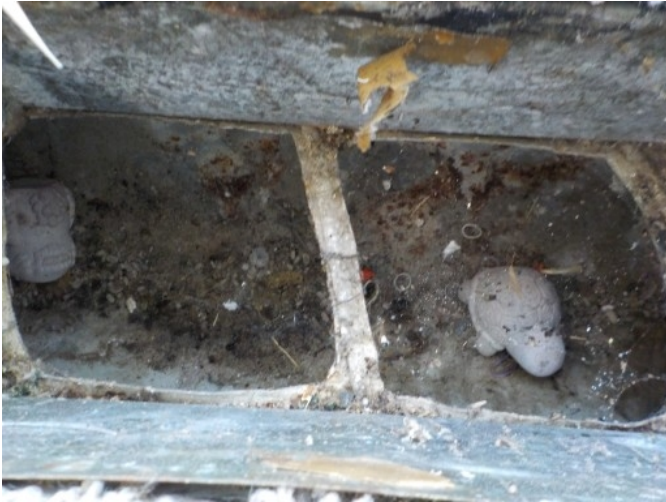
Not all of the vents were accessible due to furniture, however, those checked showed that some had airflow adjusters that were frozen or difficult to turn (fins wouldn't open/close easily). Those that could be pulled up easily, some showed dirt and debris in the ducts. Consider you may want to have the ducts cleaned at some point.

Family room register needs cleaning.

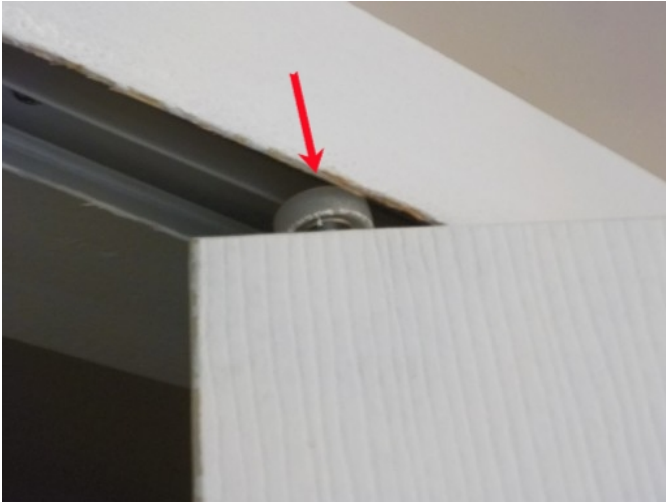
1. The closet doors in the hallway and red & gray bedroom both need track wheel adjustments for the wheel to stay in the track. Currently they both ride along the molding that is in place and this has caused damage to the molding in the bedroom. These track wheels can easily be adjusted up and down to remain in the track as they were designed to do.
2. Master bedroom doors function but have a gap present, not properly fitted to the opening.

Hallway closet - wheel needs adjustment to stay in track.

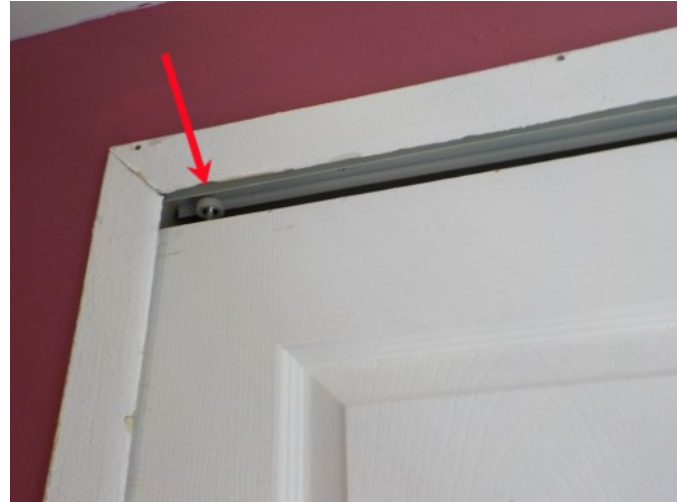
Track wheel needs to be adjusted, rides along molding.

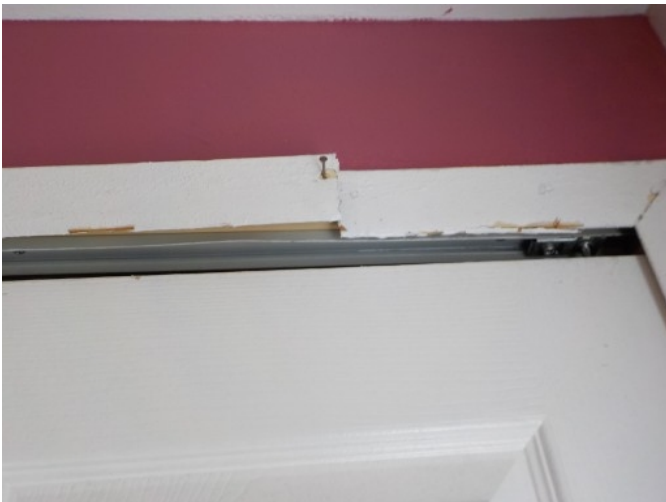
Damage to bedroom door molding.

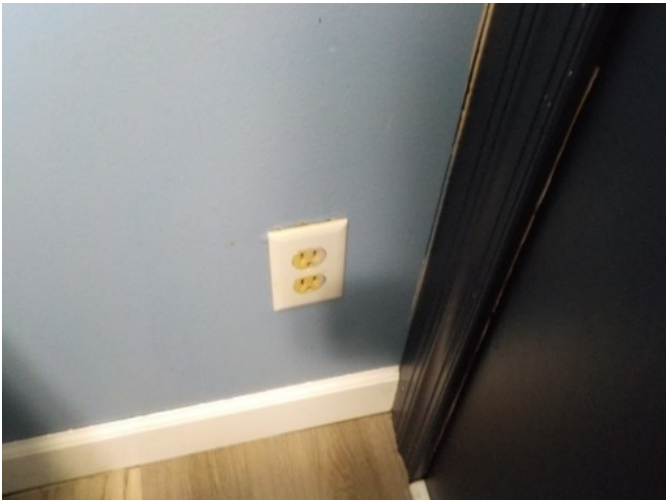
2. Loose outlets - Southeast wall, lower outlet; Microwave outlet in cabinet. Outlets should be secured before use. Using loose outlets can cause wires in the receptacle to come loose causing potential shock hazard.

Loose outlet - should be GFCI protected as well.

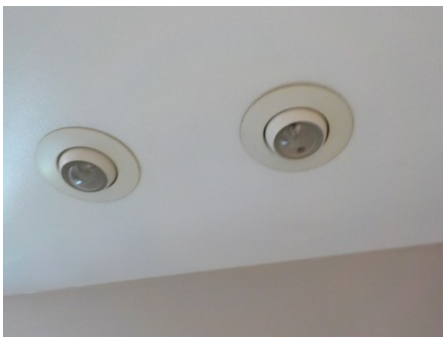
1. Upper hall/master bathroom lights showed no power present when tested. It's possible there is a light switch that wasn't found at time of inspection, however, recommend asking seller. Lights may no longer be operational.

No power to lights above the sink.

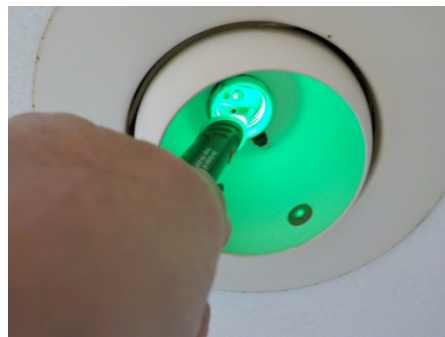
Tester shows no power (green) to light with switch on.

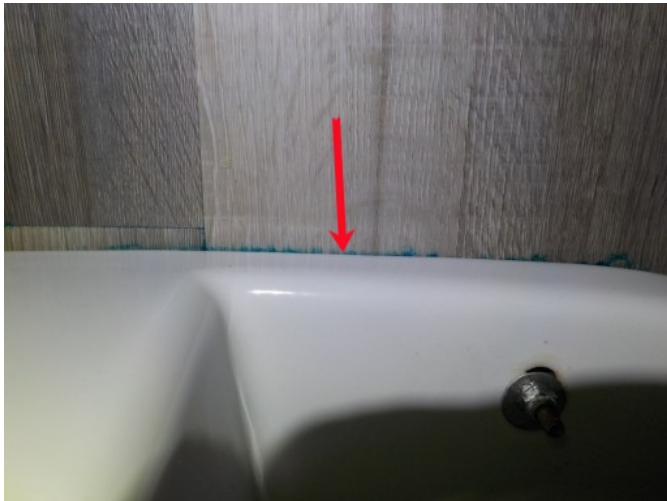
1. The 1/2 bath toilet is showing possible signs of leaking. Note the toilet bowl cleansing color which appears to have seeped out of the toilet base. As mentioned above, it's hard to determine with a single visit to the property. The toilet may leak slowly over time.
2. The upper hall bath toilet continued to run after flushing, had to shake handle for it to stop running. This may be sporadic, however, consider the flush/fill valve may need to be replaced in the near future.

Blue color likely a sign of toilet leak at the base.

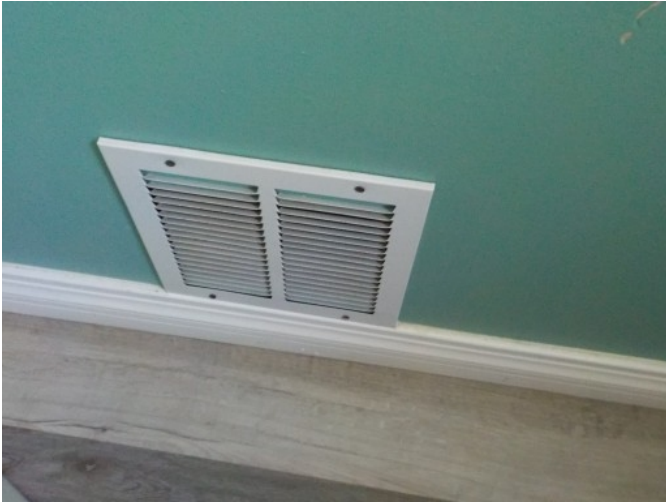
Present in both rooms - noted that the lower bathroom has a cold air return vent cover with no airflow adjuster present.

Heat vent has a cold air return cover, no airflow adjustment
