## Wright-Pro Home Inspection, LLC

# Home Inspection Report

Inspection Date: March 12, 2020

**1234 Anytown St.  
Downriver, MI 48190**

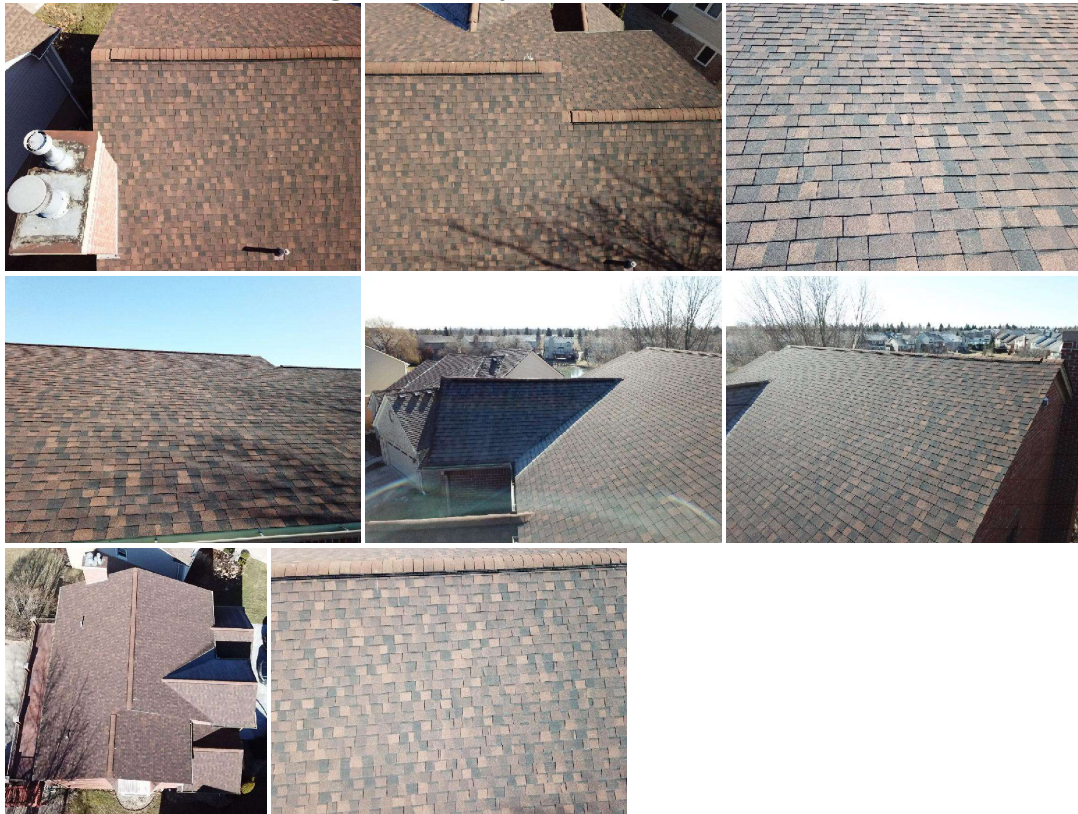
Good Material: Architectural Fiberglass Shingle - Roof shingles appear in very good condition. Current owner confirmed roof is age is about 9 years old.

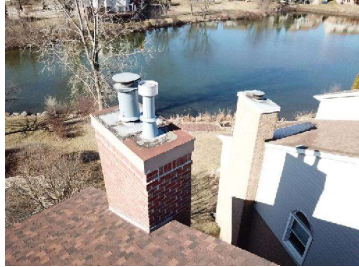
Chimney: Framed - Services gas fireplaces on main floor and basement

Chimney Crown: Metal - Chimney metal flue flashing caulk (tar) is weathered/cracked. Flashings should have old weathered caulk remover and new sealer installed to avoid any possible moisture intrusion. Wood crown side fascia is rotted. Recommend a chimney repair contractor or a qualified handyman to further evaluate.

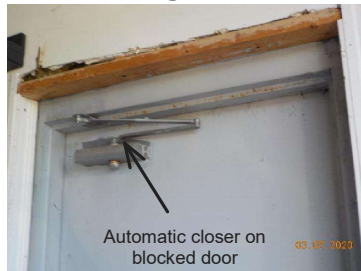
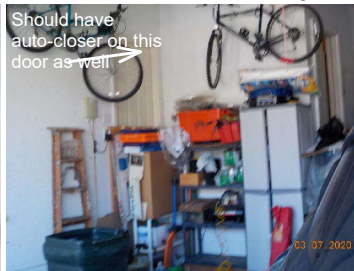
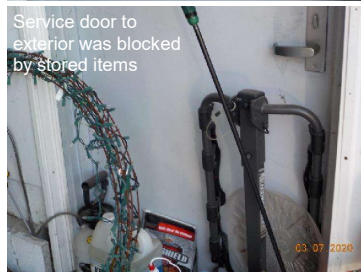
Good, Limited Inspection Service Door(s): Steel - Two doors to interior, one to exterior. Door with automatic closer is blocked off from use. Door to laundry room should have an auto-closer to keep fumes from entering home. Door to exterior was blocked by stored items, not tested for function.

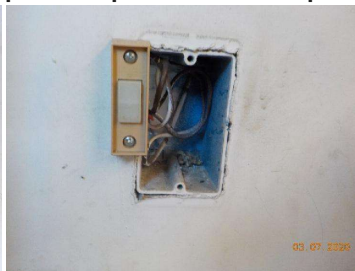
Minor Issue Electrical: 120 VAC GFCI Protected; Equipped for generator back-up - If a generator is run, be sure it is located outside of the home/garage. Do not run a generator in a closed garage as carbon monoxide will build up. The open box with exposed wires needs a cover.

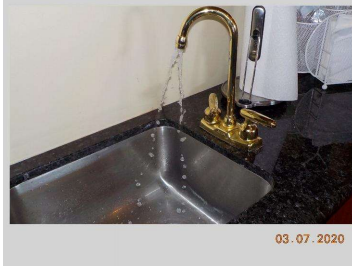
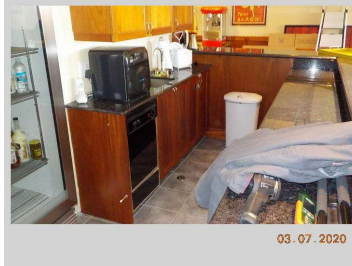
Minor Issue	Sink Drain: PVC - Minor leak. Connections need to be tightened.
Minor Issue	Faucet: Two handle. Faucet screen is clogged with debris causing poor water flow.
Good	Bar Counter Top: Granite
Minor Issue	Bar Cabinets: Wood - End cabinet door is loose.

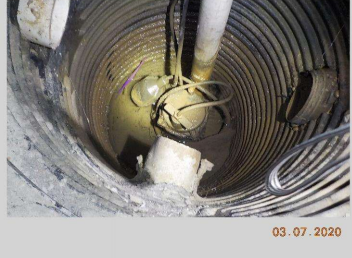
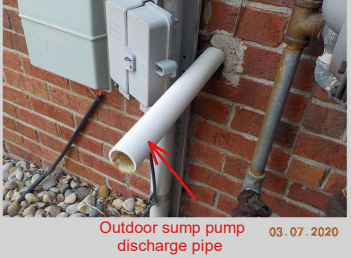
| | <p>Outdoor sump pump discharge pipe</p> |

- Good      Sump Pump:    Submerged pump with float switch - Sump pump worked as designed when tested, however, in addition to a back-up generator, should consider A battery powered back-up or a water powered back up system for the sump pump that will allow the pump to operate in the event of a lengthy power failure if a generator is not available

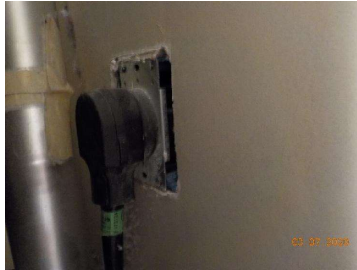
Laundry Room/Area	
Not Present	Closet:
Good	Doors: Solid wood, Steel
Good	Floors: Luxury Vinyl Tile
Good	Walls: Painted Drywall
Good	Ceiling: Painted Drywall
Not Present	Ventilation: Doors, no window or fan
Not Present	Windows:
Safety Issue	Electrical: GFCI & Non-GFCI Outlets Present - <b>Dryer outlet needs a cover plate for safety.</b>

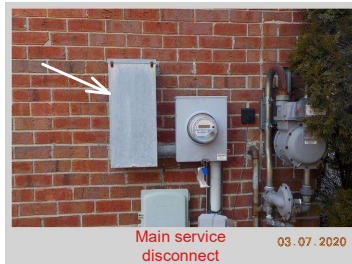
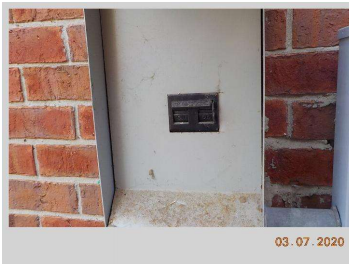
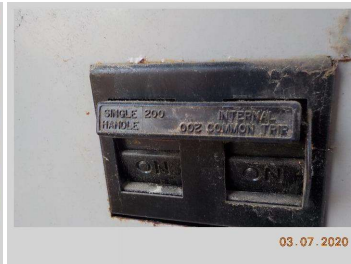
Good, Safety Issue Is Panel Bonded?: No As discussed, bonding strap is present in main sub-panel but is not secured to ground bus bar, however is touching bare copper ground wires and should be removed. Recommend a licensed electrical to further evaluate

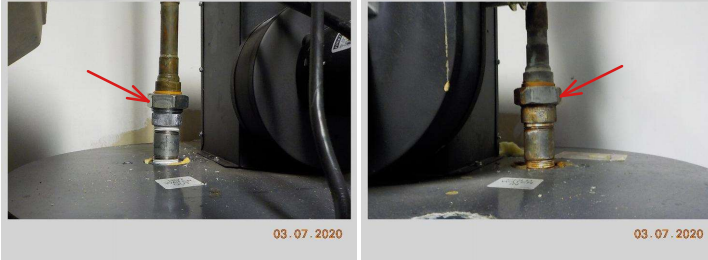
Water Temperature: 160 Degrees - **Water above 120 is considered a scalding hazard.**  
Flue Pipe: Electric inducer / fan blower, PVC

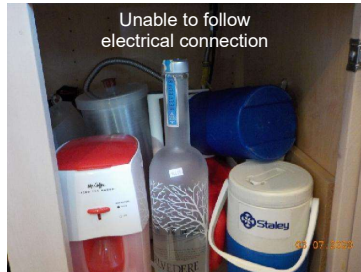
Good, Limited Inspection Cooktop: Broan - All burners lit and functioned good. Due to amount of personal items stored in cook top cabinet, unable to see electrical connection. Gas valve is located in cabinet & was visible.
