285 Home Inspection Services LLC

Home Inspection Report

117 Elk Creek Drive

Inspected on Tue, Apr 2 2019 at 10:09 AM

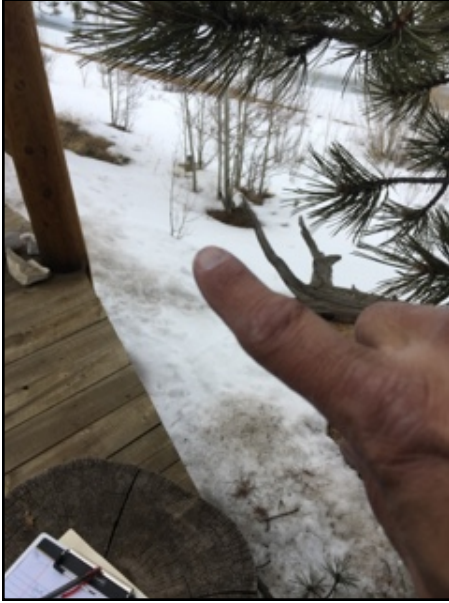
Wood

Condition: Repair or Replace

The deck at this house on the northside leading to the front door is older and is showing its age there are areas where the wood is loose and could be a tripping hazard. Where indicated in the photographs there is no handrail which could be a hazard and should be corrected.

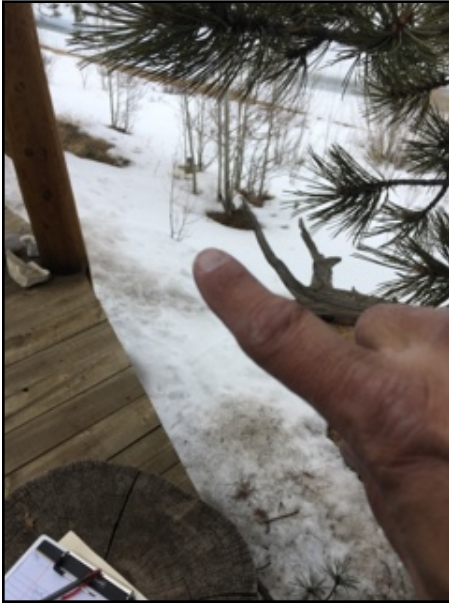
Railings:

Wood

Condition: Marginal

On the north east side of the home where the deck meets the driveway there are no handrails. This could be hey hazardous condition considering that the deck is raised more than 18 inches off the ground it is highly recommended that some sort of handrail be added to this section.

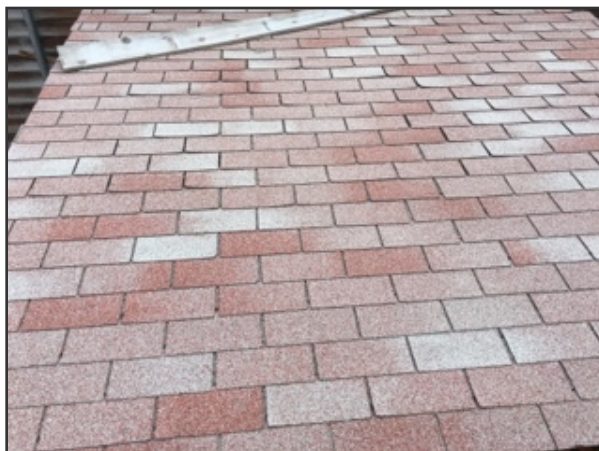
Roof Design: Gable
Roof Covering: 3 Tab Shingle, Metal
Condition: Marginal

The roof on this home is a combination of metal and three tab shingle which is located on the southern lean to section. The shingles are showing wear and should eventually be replaced. The metal roof shows some age as well but appears to be in good condition overall.

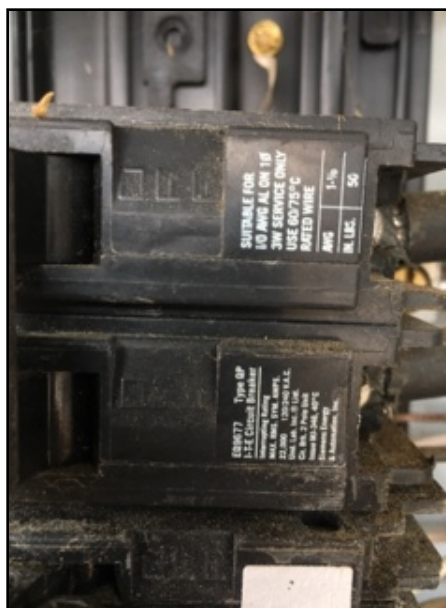
Condition: Further Evaluation Required

The service panel is located on the southwest part of the home, upon opening the service panel it is noted that there is no dead front protection to this panel. This is a possible shock hazard and should be addressed by a licensed electrician as soon as possible.

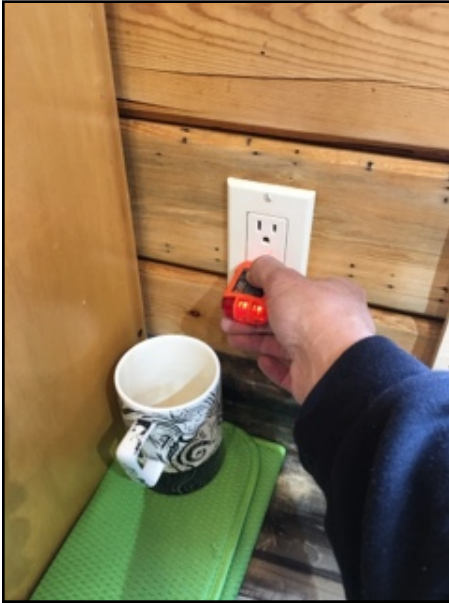
Condition: Repair or Replace

In the kitchen area to the left of the sink one outlet does not have a GFCI breaker connected to it. It is highly recommended that a licensed electrician review this and re-connect to an available breaker. All other outlets near the water source are GFCI and are acceptable.

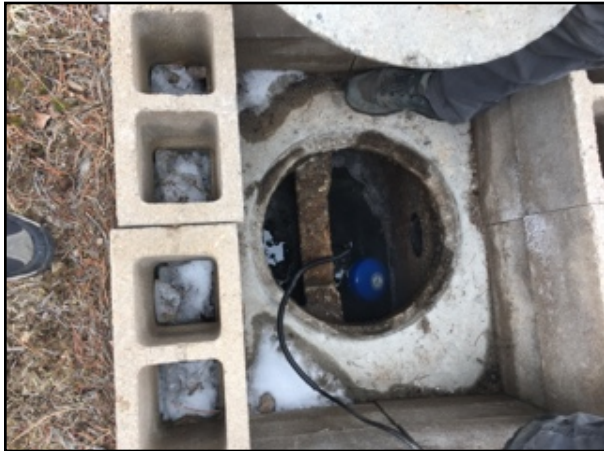
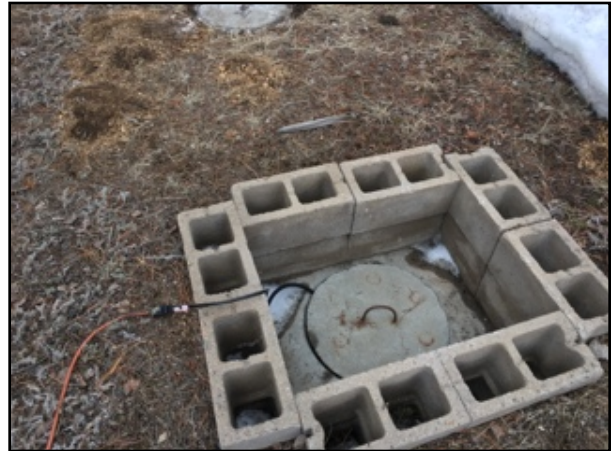
Comment 10:

Please note prior to the inspectors arrival the septic system had been worked on as it was frozen. There was an immersion heater put in place to help solve the septic tank.

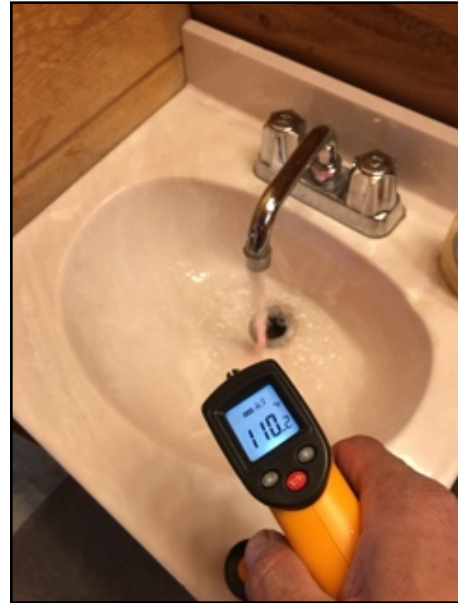
Figure 11-2

The homes full bathroom is located in the main hallway the toilet is a bit loose and should be tightened. The shower fixture is leaking slightly but all in all the bathroom is fully functional.

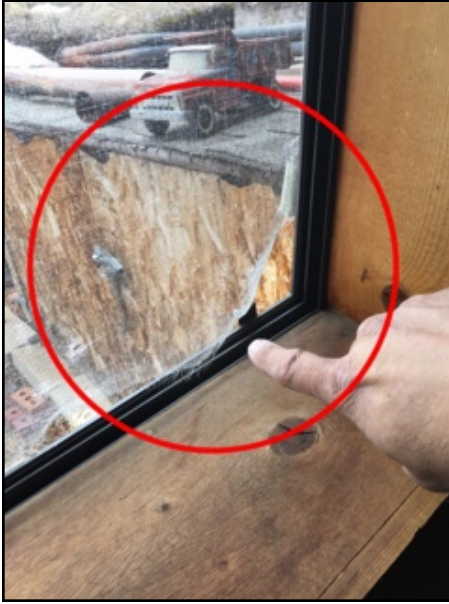
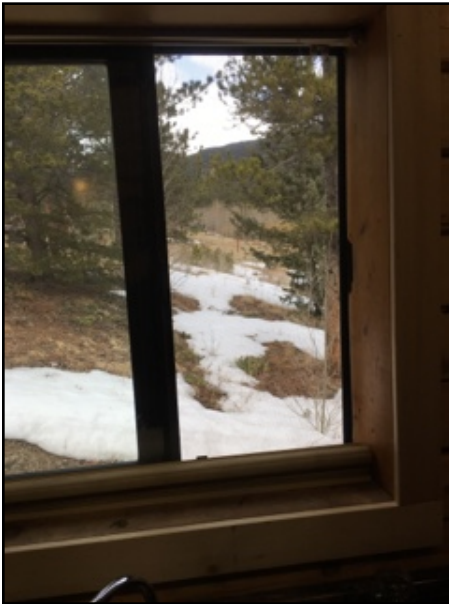
Comment 14:

Windows are a double pane aluminum design there are a few torn screens that should be replaced.

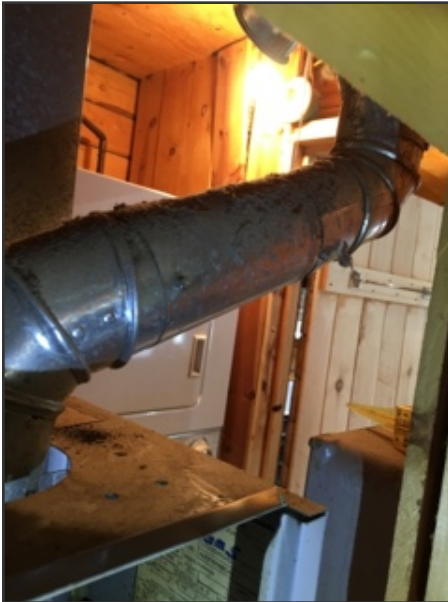
Comment 15:

With all wood-burning stoves it is highly recommended that a professional chimney sweep clean the flue and certify the woodstove prior to first use.
