Home Inspection Report

1288 Royal Ridge Drive

Inspected on Fri, Jul 24 2020 at 2:14 PM

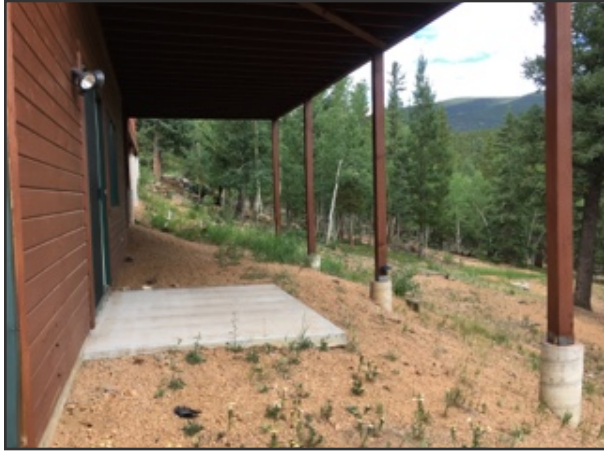
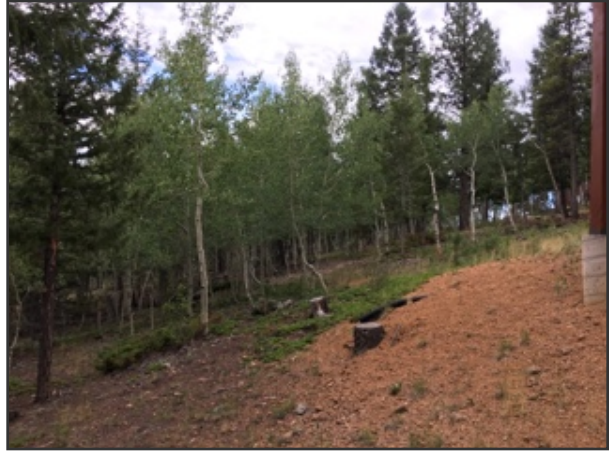
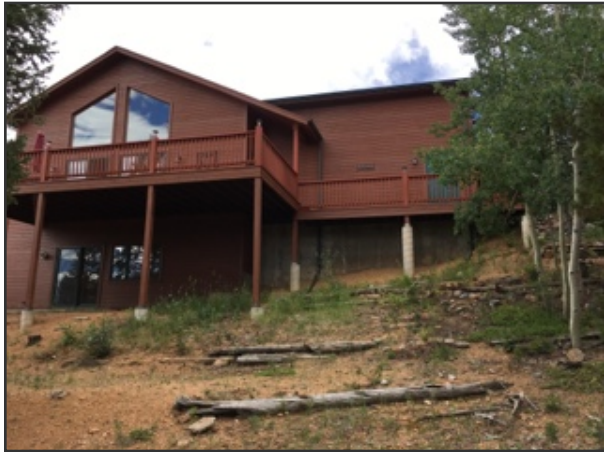
This home is built into a hillside with two levels above grade and a walk out basement. The site drainage is well planned and doesn't provide a particularly bad water pathway.

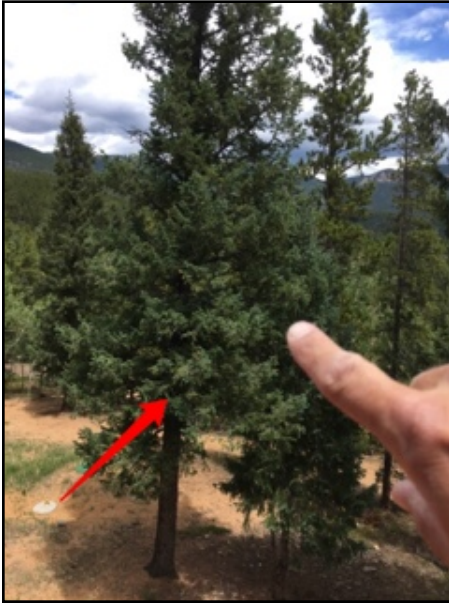
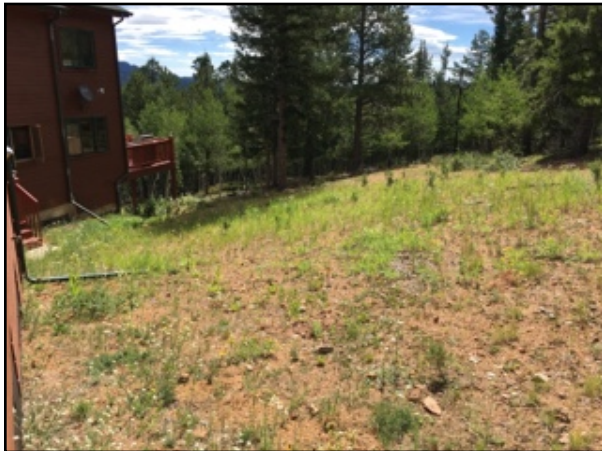
Generally the vegetation around this home is in very good condition there are a few pine trees that could be limbed up to a height of approximately 15' from the ground, however there are no glaring issues for fire mitigation concerns.

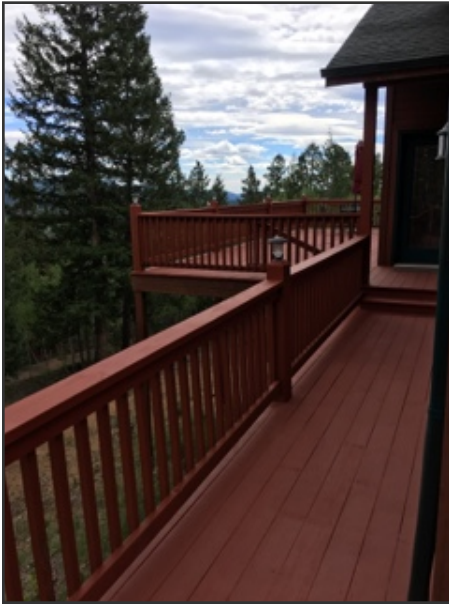
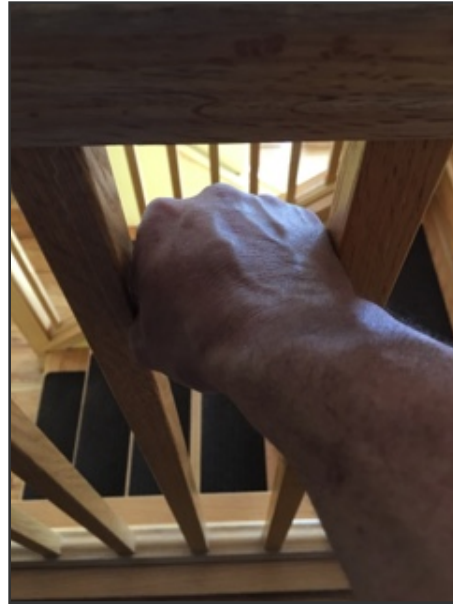
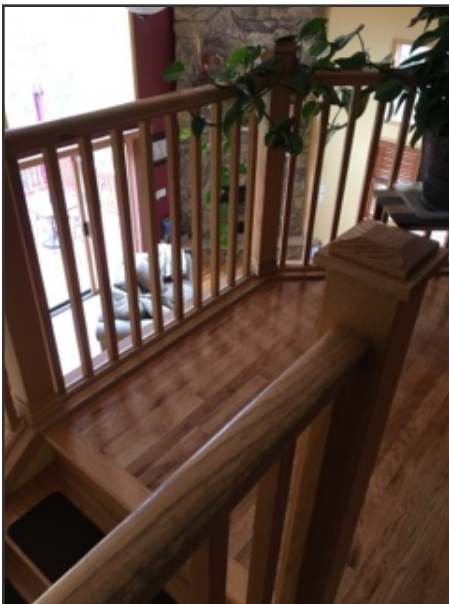
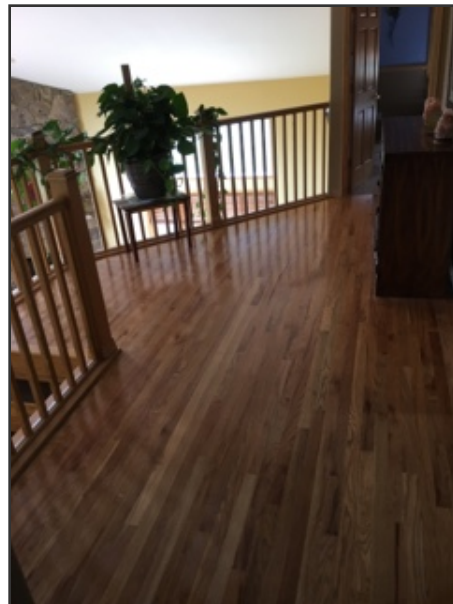
The railings on this home are in good condition, secure, and well spaced no problems found.

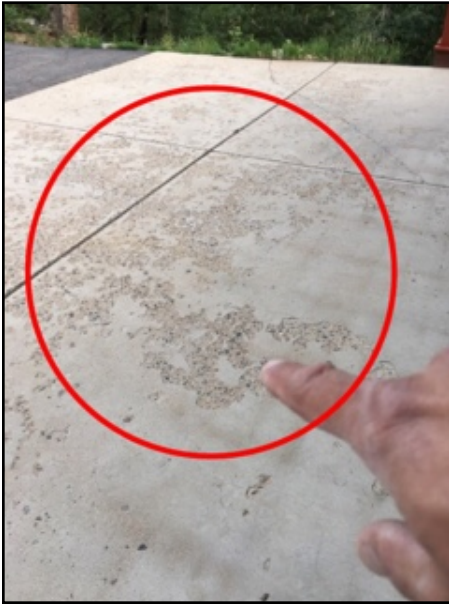
Figure 4-1

The garage floor in all five stalls of the garage we're in very good condition there was some spalling and stress cracks as indicated in the photos. This typically occurs when vehicles have ice on them and it deteriorates the concrete skirt at the entrance to the garage.

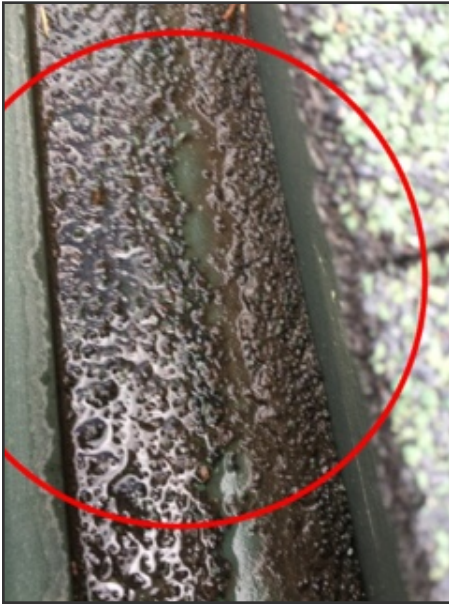
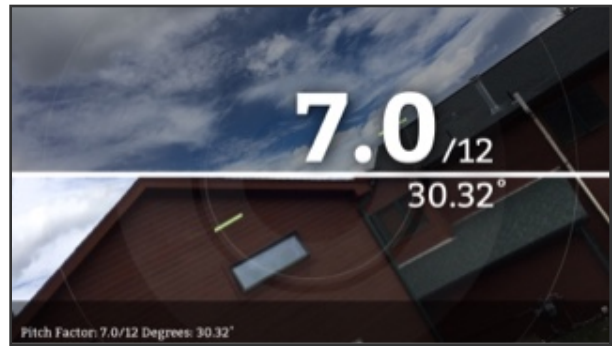
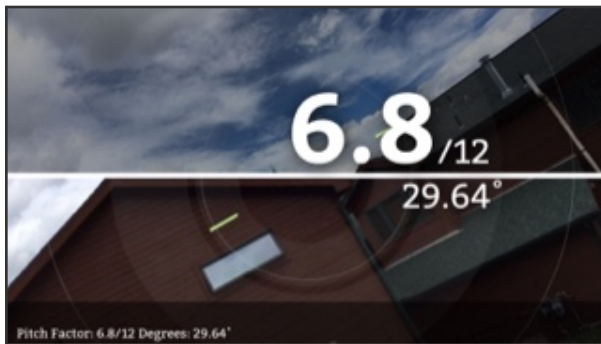
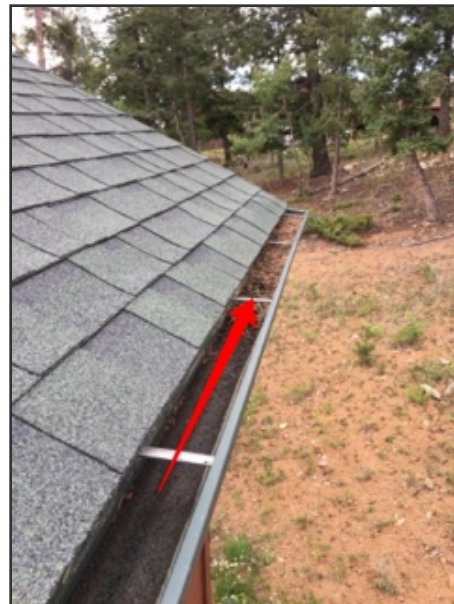
Condition: Marginal

The roof on this home is beginning to show its age and is estimated to be approximately 10 to 12 years old. Although the roof does have life left in it it is recommended that the roof be further evaluated by a qualified roofing contractor.

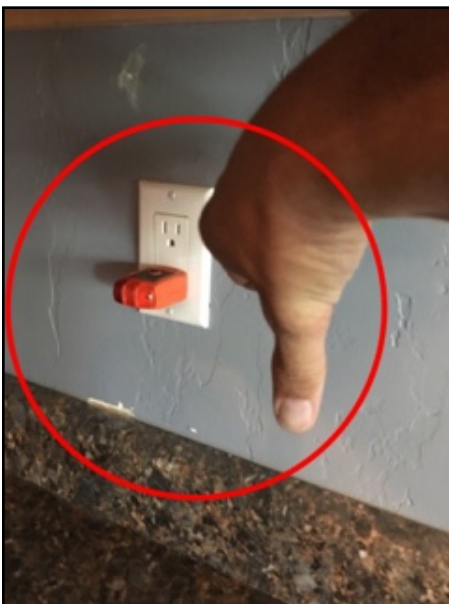
GFCI/AFCI Breakers:

Yes
Condition: Repair or Replace

All GFCI outlets in the home the kitchen and the bathrooms all function normally. The only exception was in the guest suite at the wet bar there was no connection to GFCI and could not find a reset breaker. These two outlets in the guest suite should be re-wired properly to a GFCI outlet breaker.

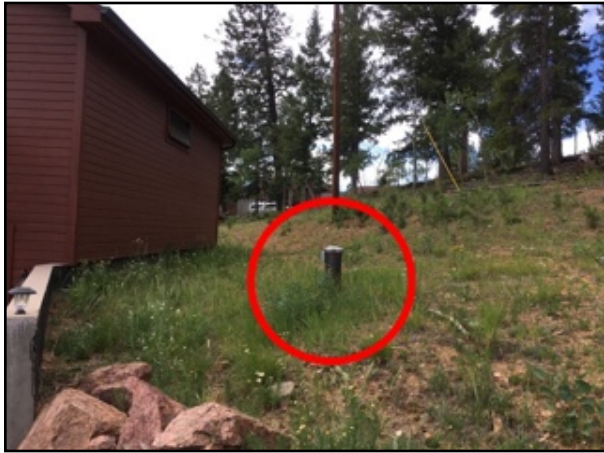
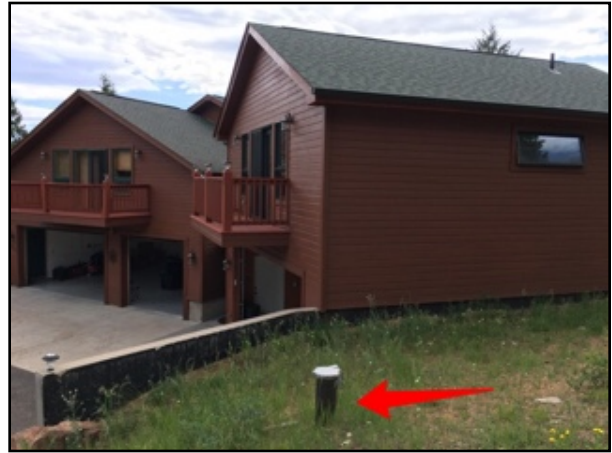
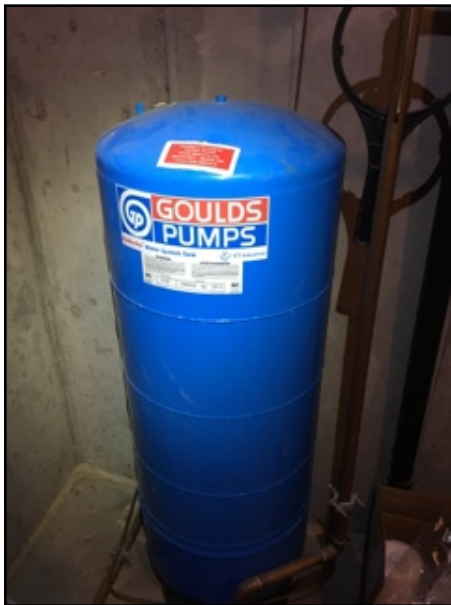
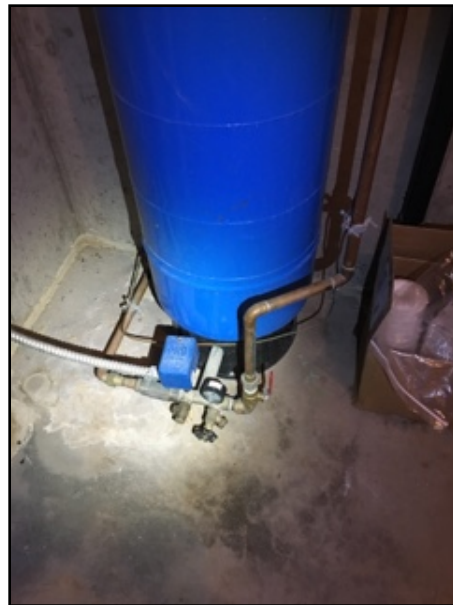
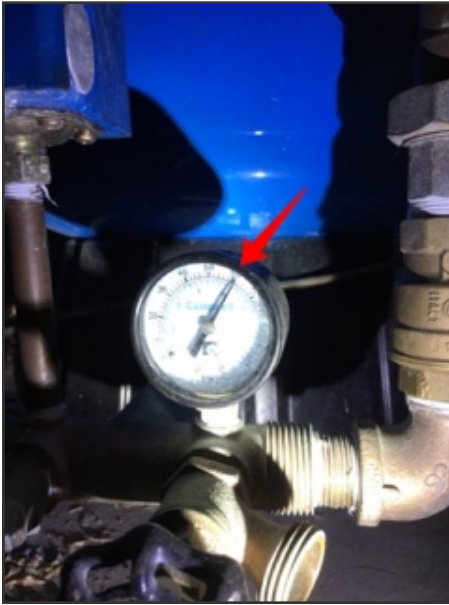
This home is supplied by an underground well. The well flow and potability were not tested during our inspection. There was no problem with temperature or supply during the inspection.

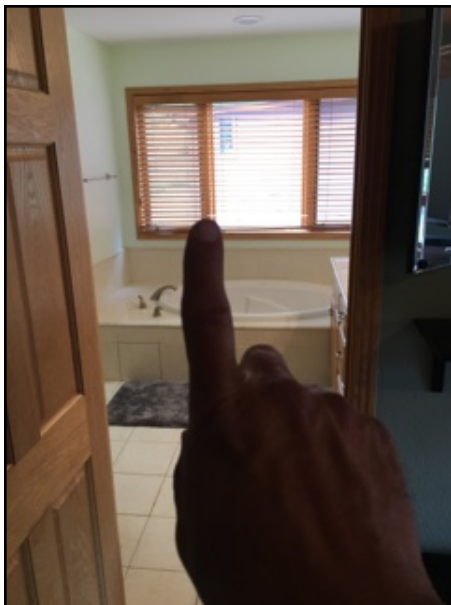
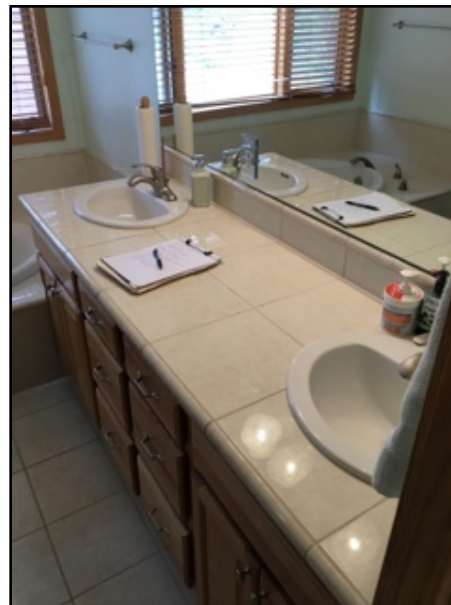
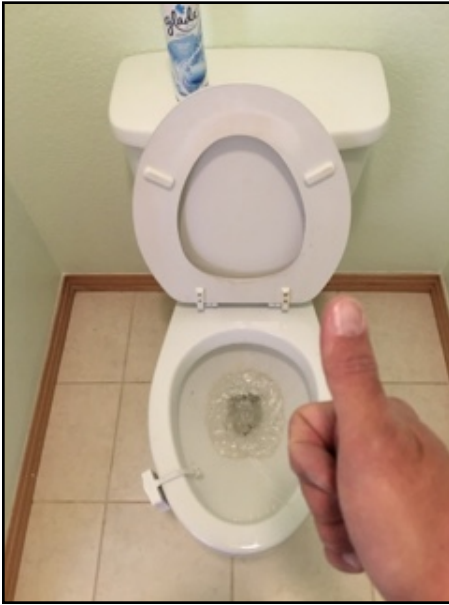
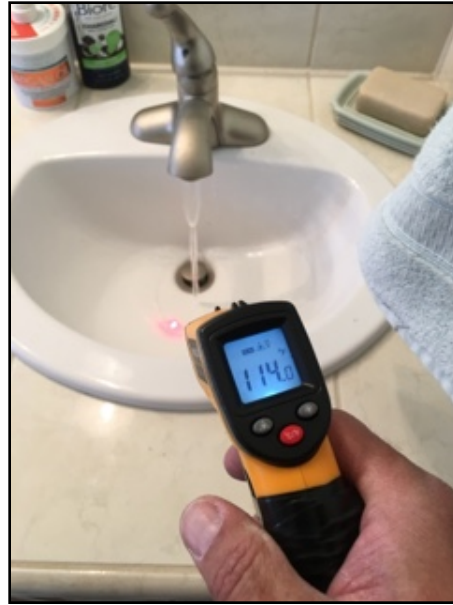
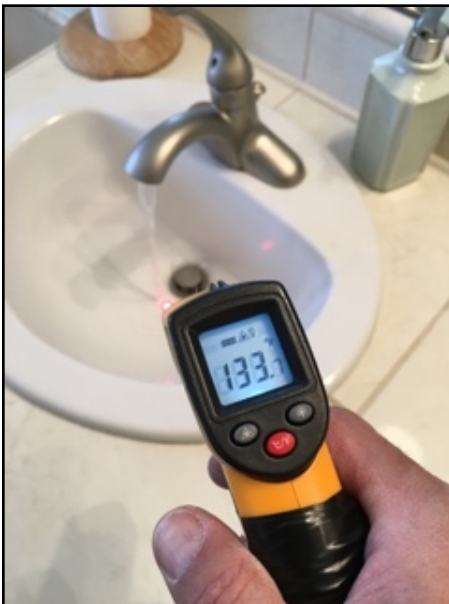
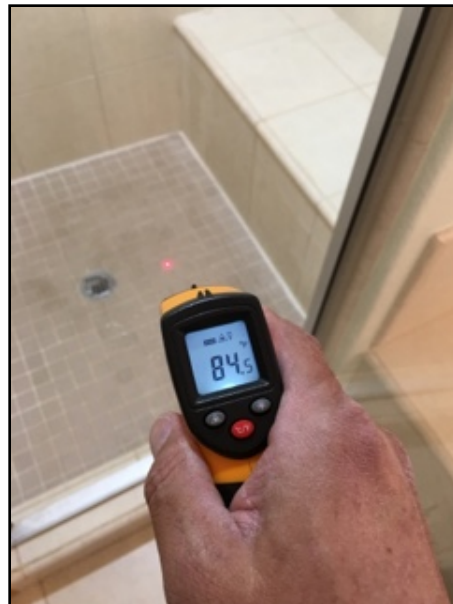
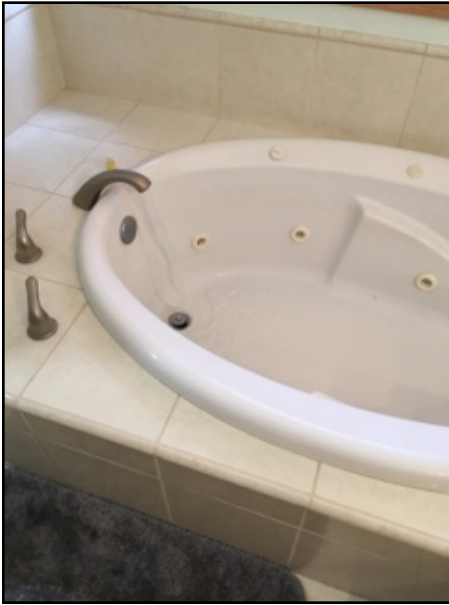
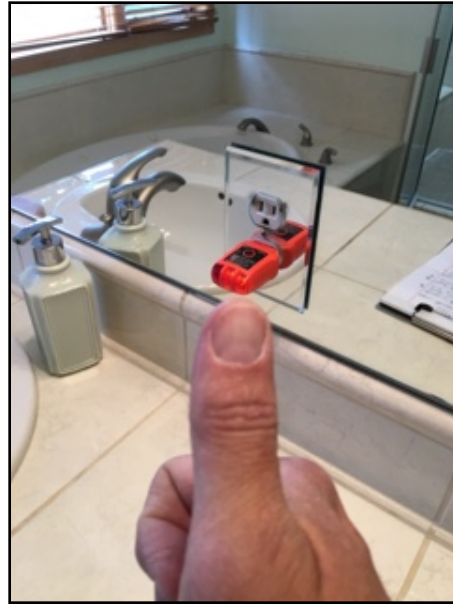
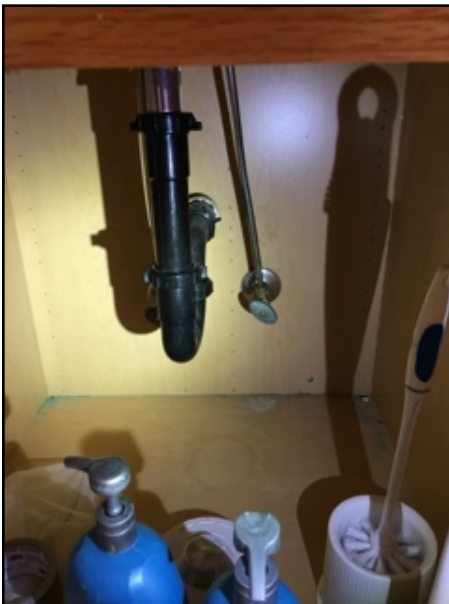
Bathroom number one is the master bathroom located on the upper level by the master bedroom. It contains a dual vanity sink a separate jetted tub stall shower GFCI outlet exhaust fan and the toilet.

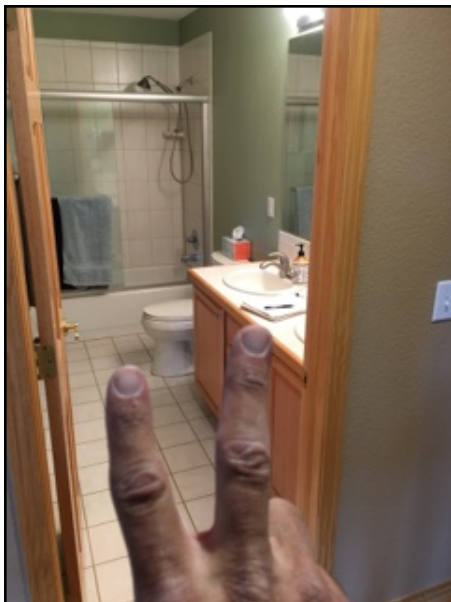
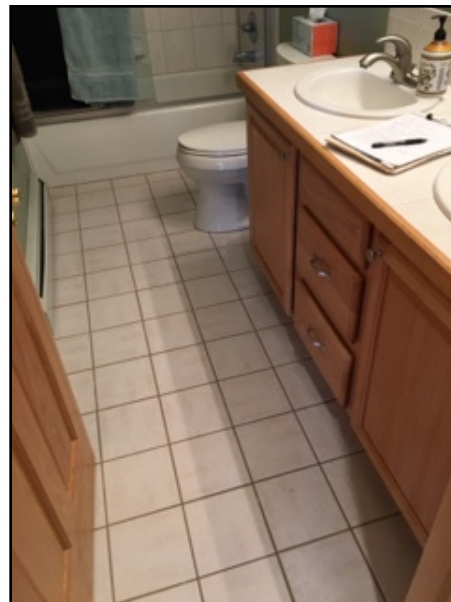
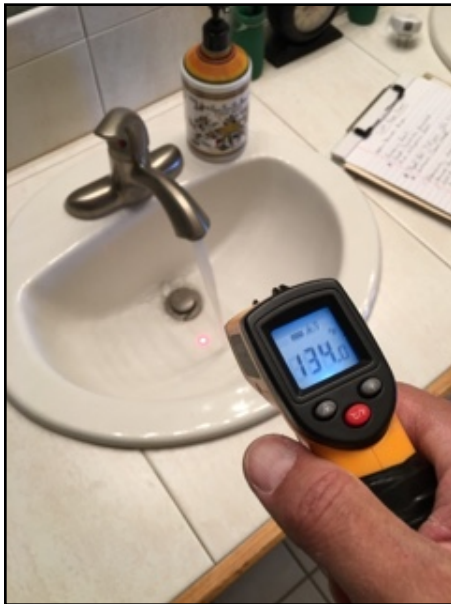
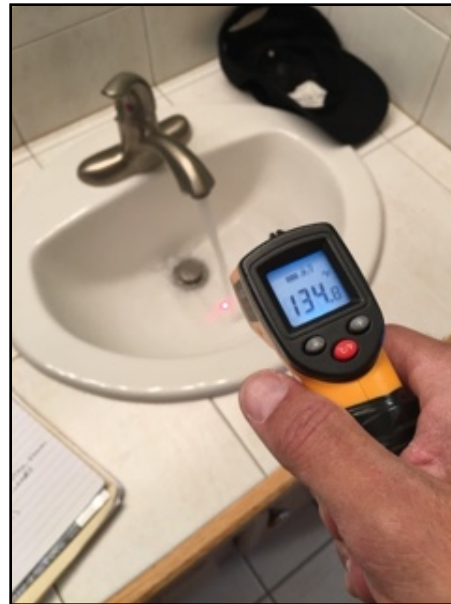
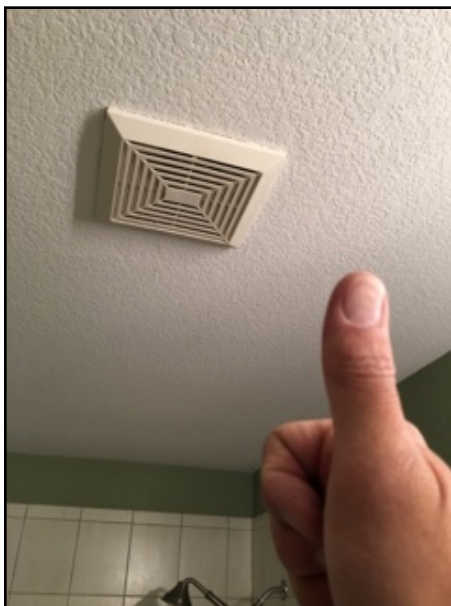
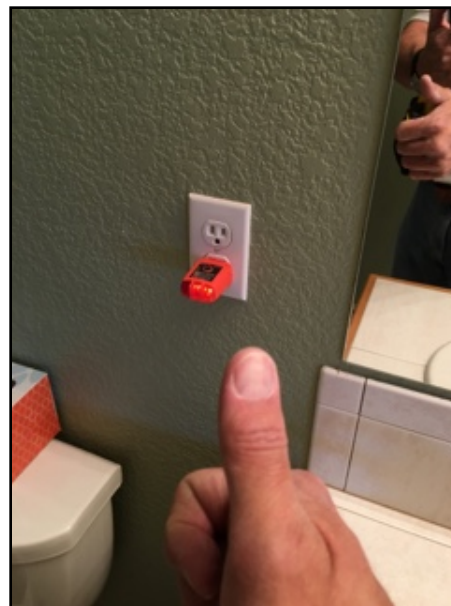
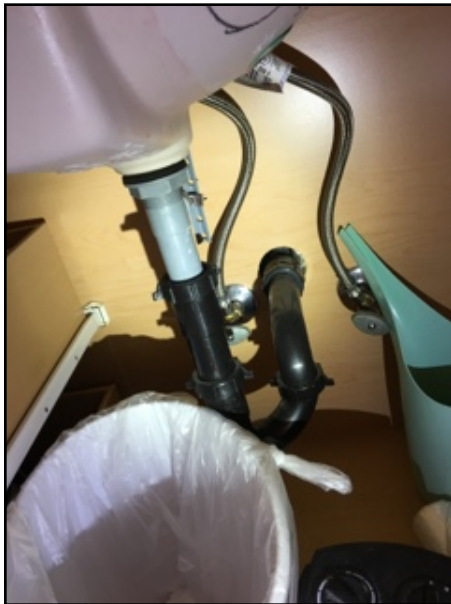
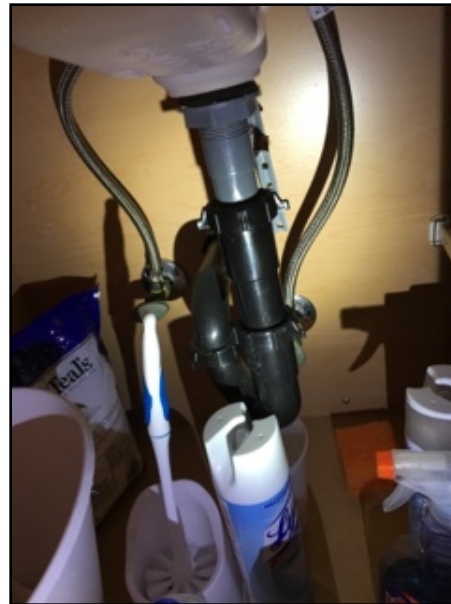
Bathroom number two located in the upstairs hallway location. It contains a dual vanity sink toilet exhaust fan GFCI outlet a combination tub and shower.

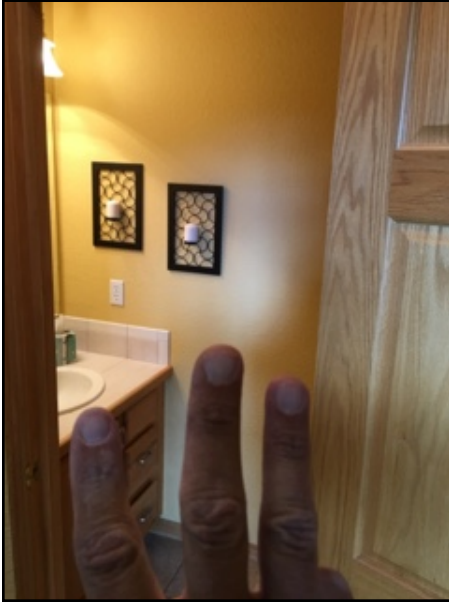
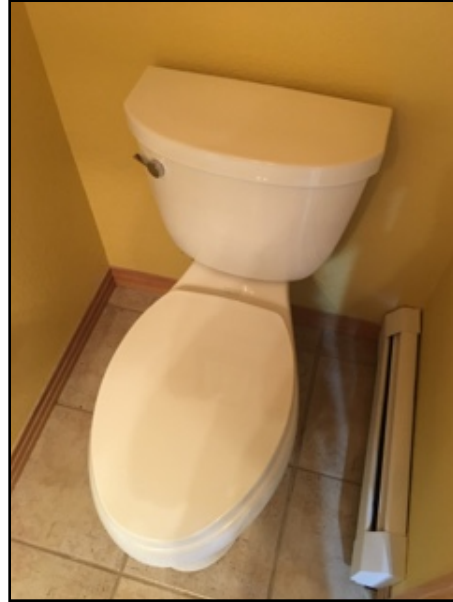
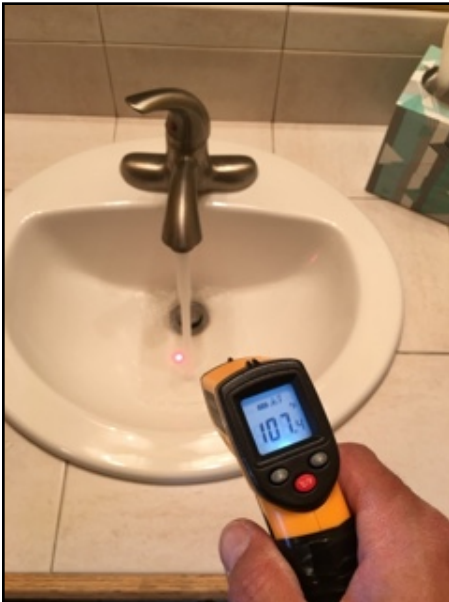
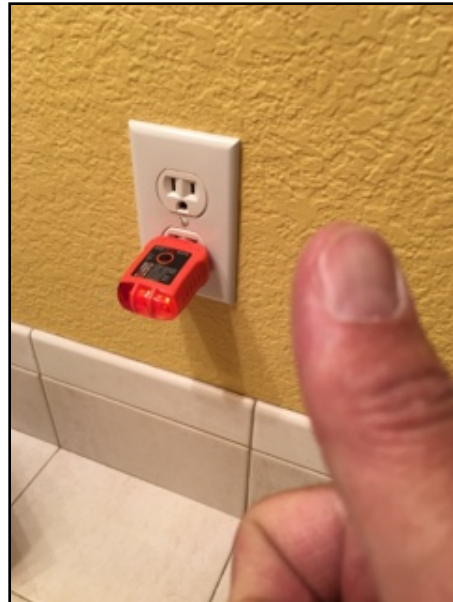
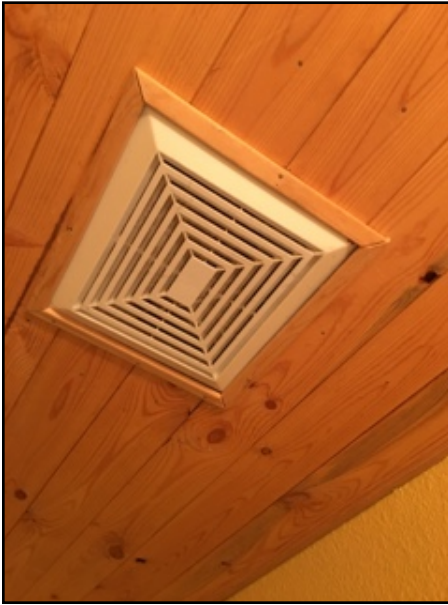
Bathroom number three is located on the main level near the garage it is a half bath. It contains a single vanity sink toilet GFCI outlet and an exhaust fan.

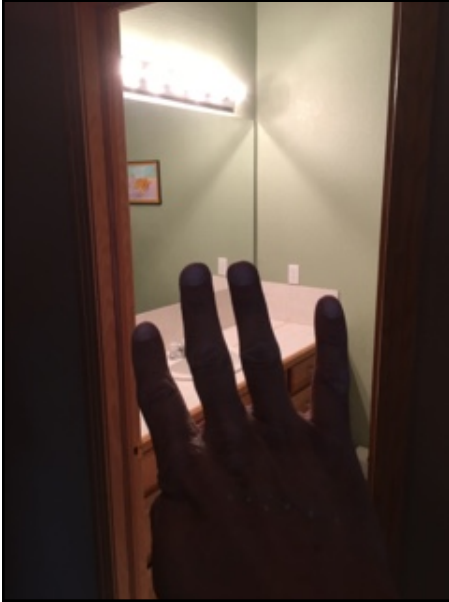
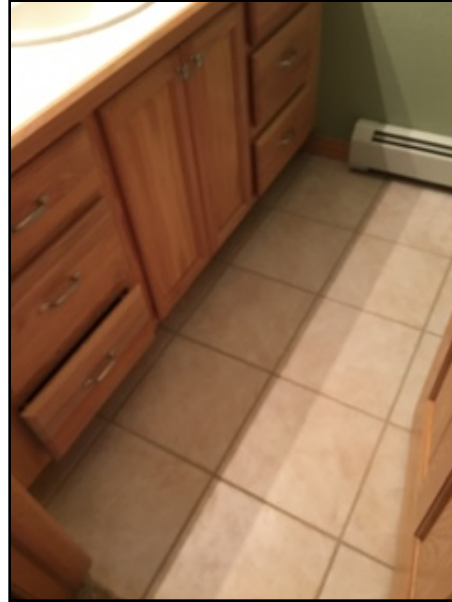
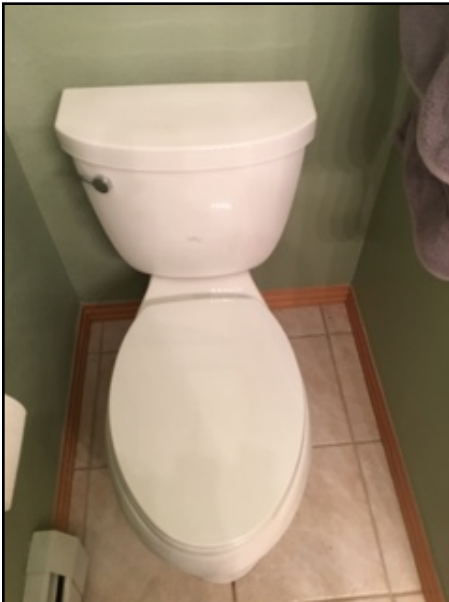
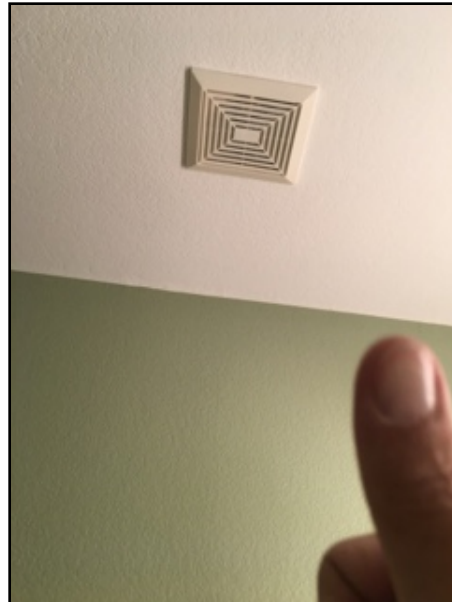
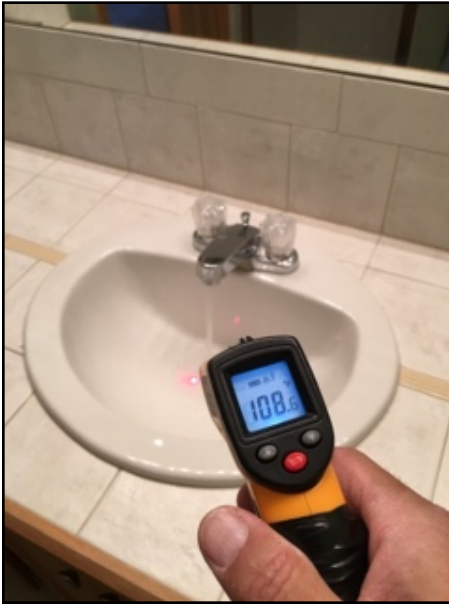
Bathroom number four is located on the lower level it contains a single vanity sink toilet GFCI outlet exhaust fan and a separate stall shower.

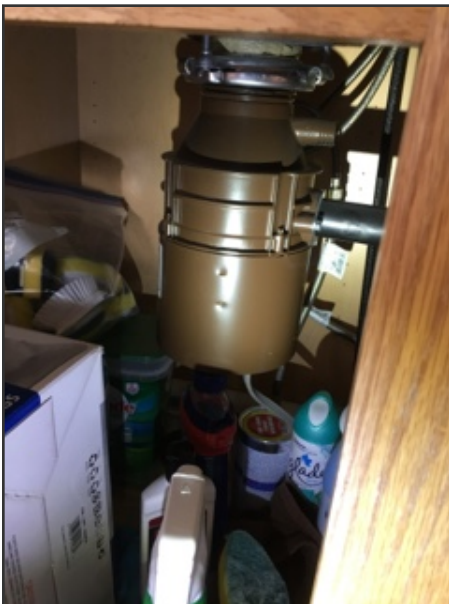
Condition: Repair or Replace

On activating the disposal electrical switch the disposal did not operate during this inspection it is recommended to have this removed and replaced as soon as possible.

6) On activating the disposal electrical switch the disposal did not operate during this inspection it is recommended to have this removed and replaced as soon as possible.

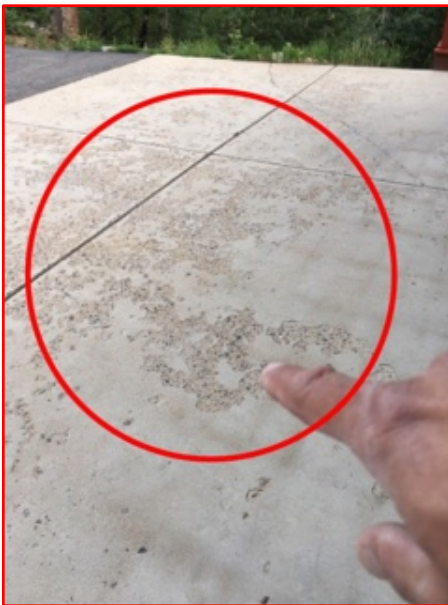
Figure 4-1

2) The garage floor in all five stalls of the garage we're in very good condition there was some spalling and stress cracks as indicated in the photos. This typically occurs when vehicles have ice on them and it deteriorates the concrete skirt at the entrance to the garage.
