285 Home Inspection Services LLC

Home Inspection Report

196 Beaver Trail

Inspected on Fri, Feb 22 2019 at 9:16 AM

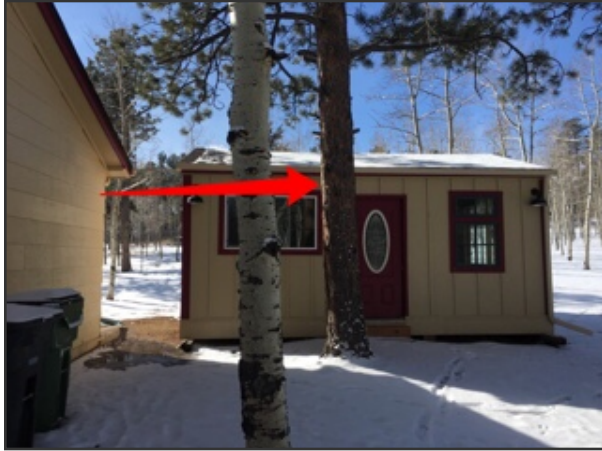
Comment 1:

Generally there is no vegetation against the home or the detached workshop. However the one Pinetree located very near the home as pictured could be a fire hazard. It is recommended that this tree be removed as soon as practicable. All other trees are aspens and are except a bowl as they are not nearly as flammable as Pines.

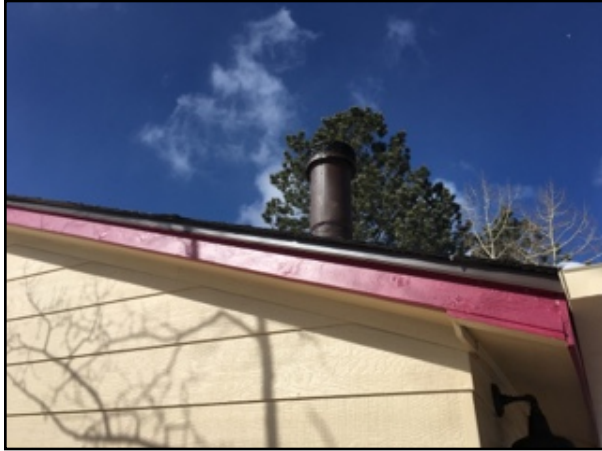
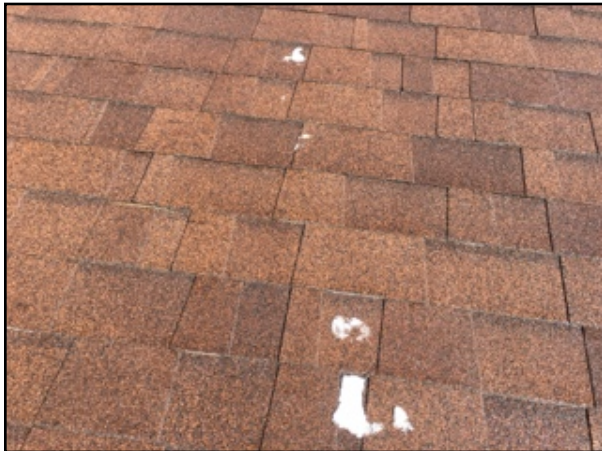
Comment 5:

The roof at this property appears to be new and in very good condition.

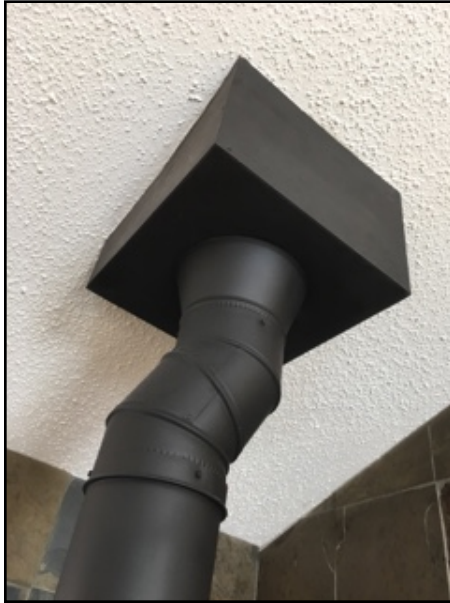
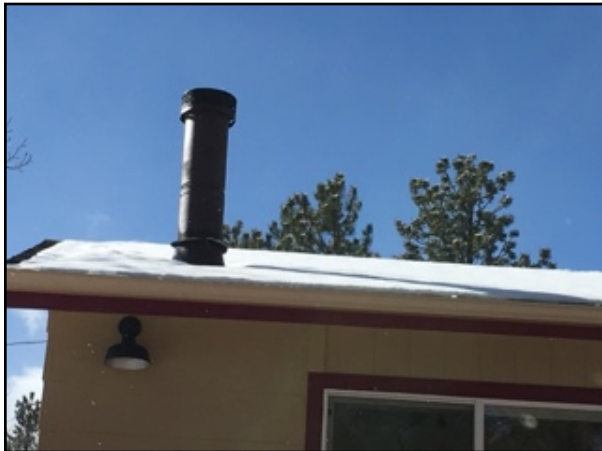
Comment 6:

This property has a wood-burning stove chimney and flue, all appear to be in very good condition. It is always highly recommended that he certified chimney sweep clean and certify the wood-burning stove prior to first use.

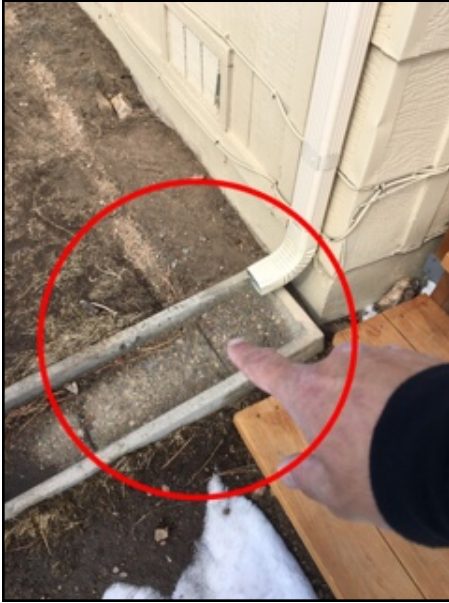
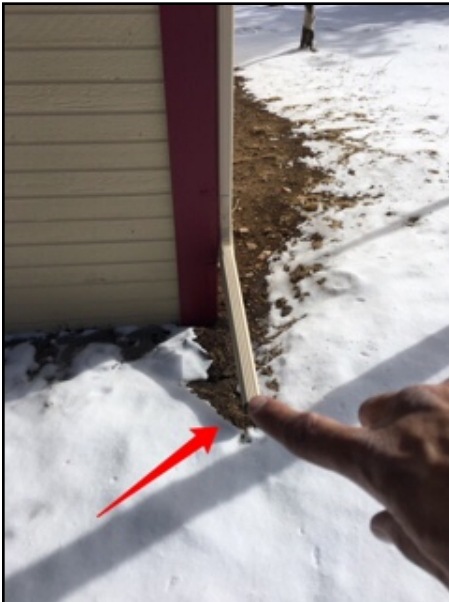
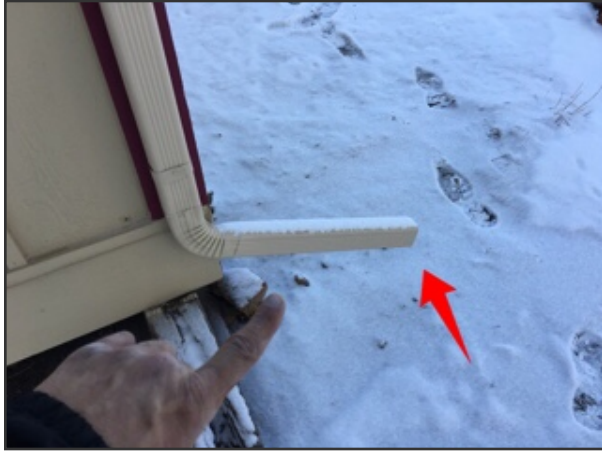
Condition: Marginal

Comment 7:

The gutters and downspouts appear to be in very good condition however extensions should be added so that water flows from foundation a minimum of 5-7 feet. Problems were found on the extensions of both structures.

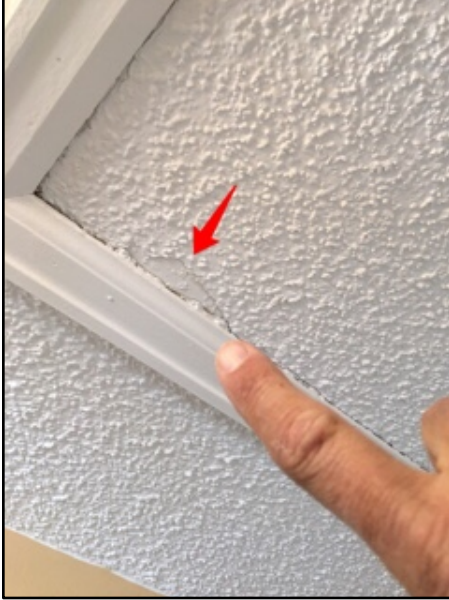
Hallway

The attic entry is located in the main hallway please note prior damage as indicated in the photograph. There were no issues found in the attic during visual inspection no water stains insulation is very good at approximately 10 to 11 inches depth.

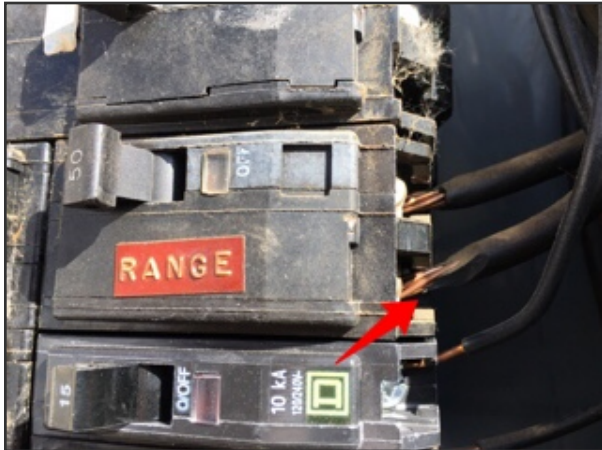
Conductors in the service panel should be insulated up to the point of insertion on the bus bar. In this panel there is quite a lot of exposed copper which could be a hazard. Further evaluation by licensed electrician is highly recommended.

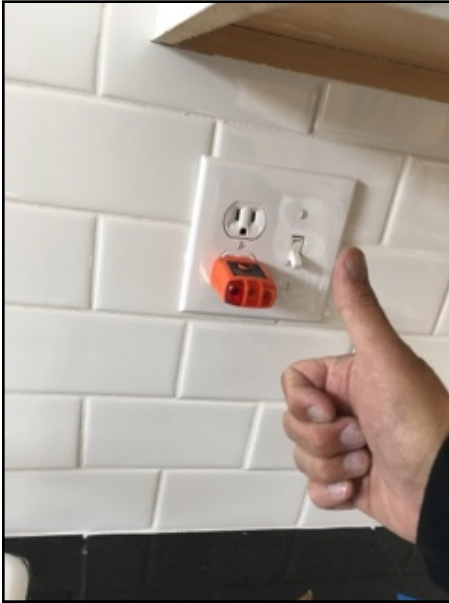
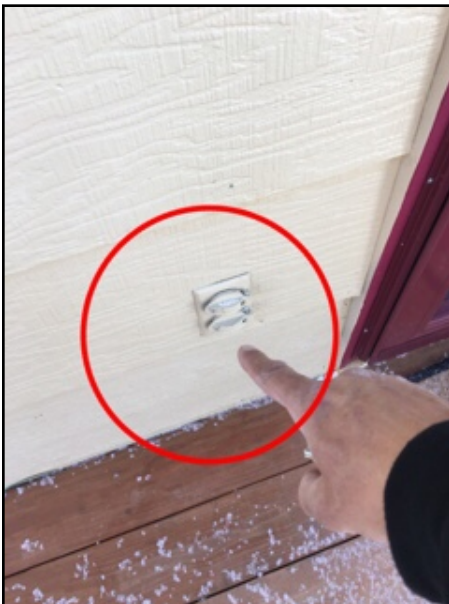
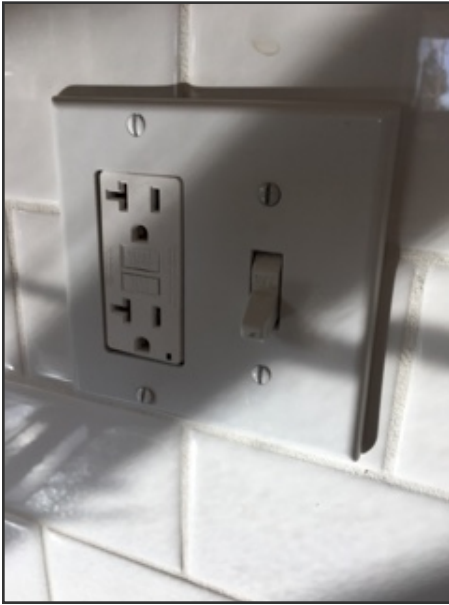
GFCI outlets are required within 5 feet of water source and outdoor locations. During inspection all GFCI outlets functioned properly except for the outlet located on the front deck that should be converted to GFCI by licensed electrician.

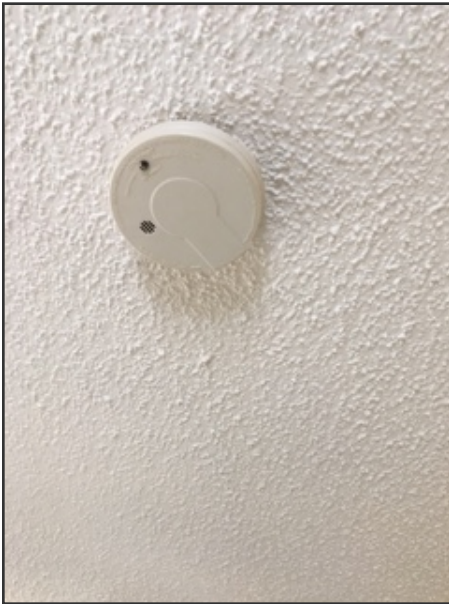
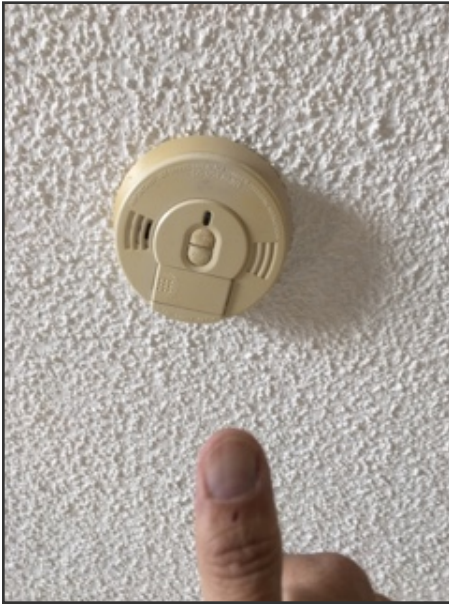
This property has an appropriate amount of smoke detectors and a carbon monoxide detector all devices tested properly during this inspection.

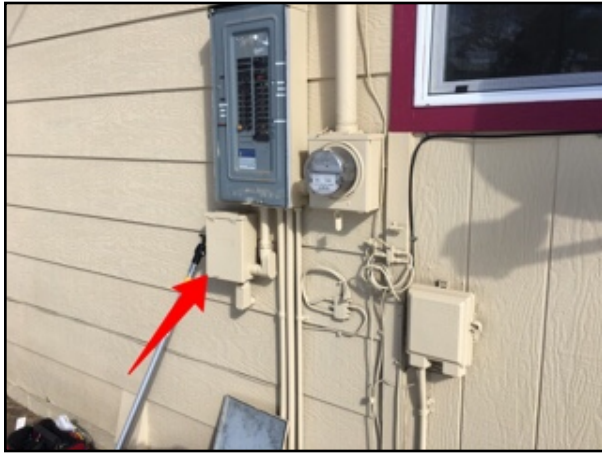
Figure 13-1

Comment 13:
Well pump sub panel.

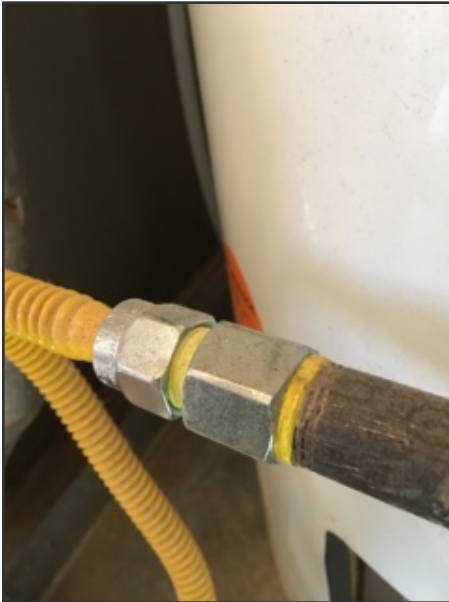
Natural gas supply line is located between water heater and gas forced air furnace a natural gas leak detector was used to test for any gas leakage. No gas leakage was detected during this inspection.

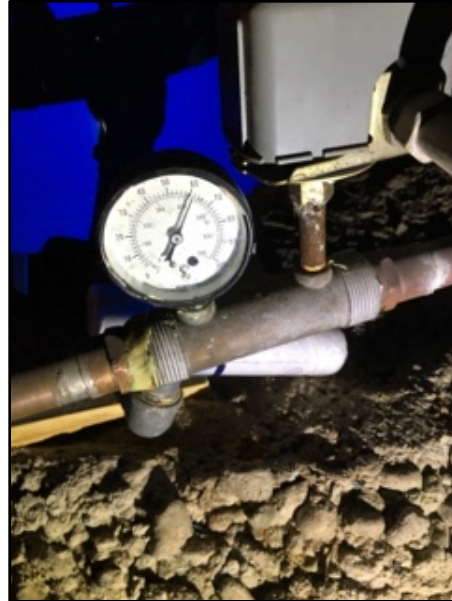
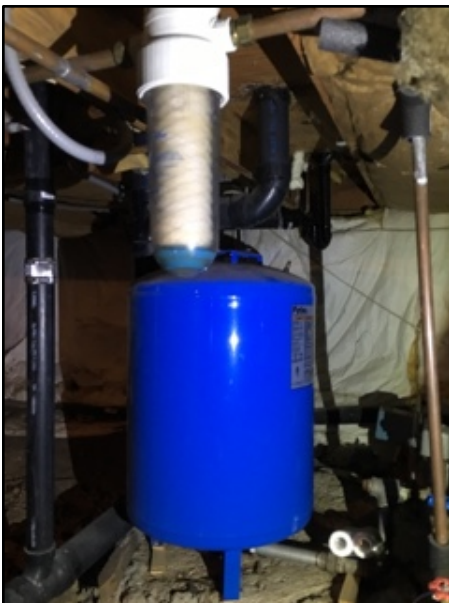
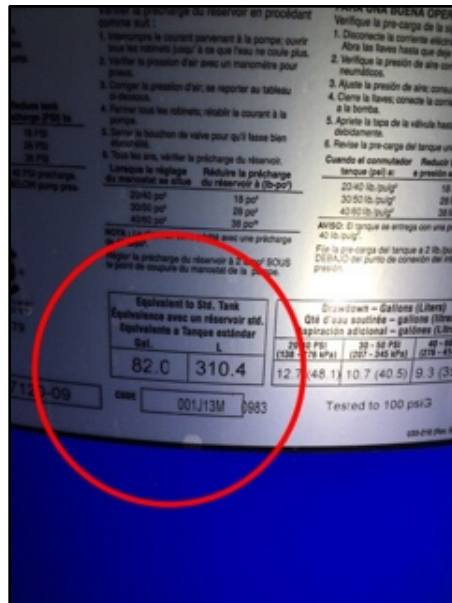
Water for this home is provided by an underground well system. There is a blue pressure tank located in the crawlspace pictured. Water pressure appeared to be at 62 psi during this inspection no problems found with water distribution. A stabilized well flow test and water potability test was performed separately results will be sent when available.

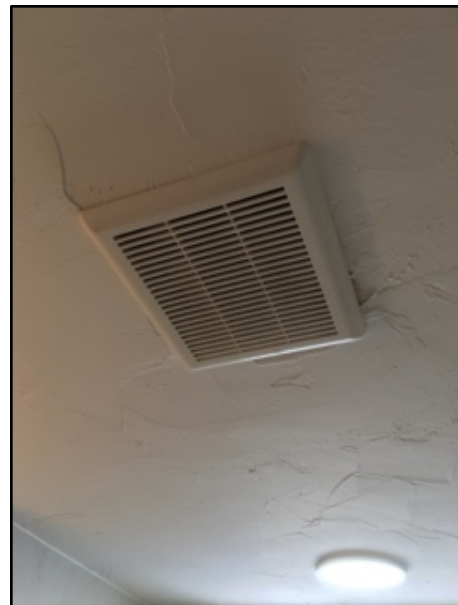
Figure 18-2

Main bathroom is in very good condition water flow and pressure and temperature are sufficient no leaks found toilet is secure and exhaust fan works properly. GFCI outlet near the sink water source is installed and functional.

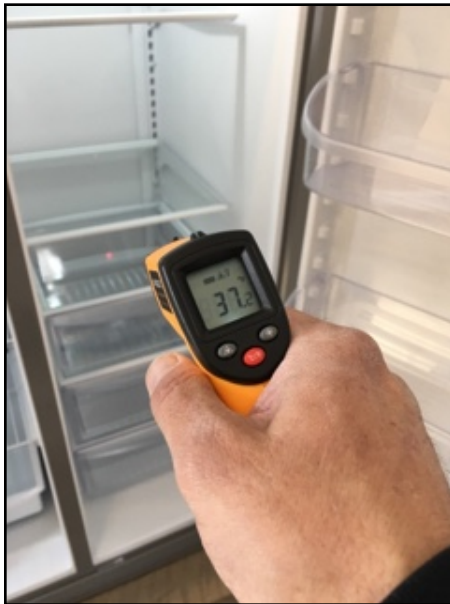
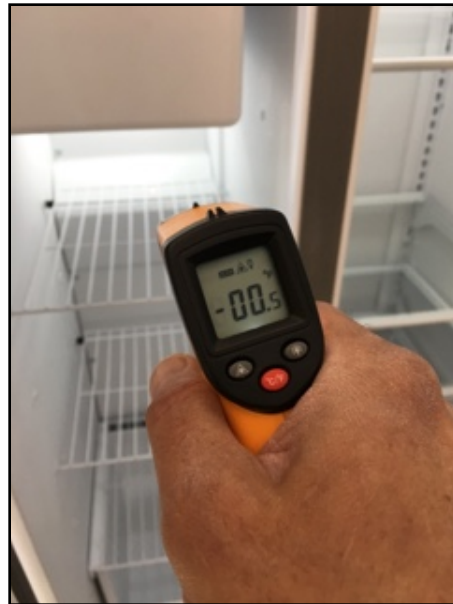
Refrigerator:

Frigidaire
Condition: Satisfactory

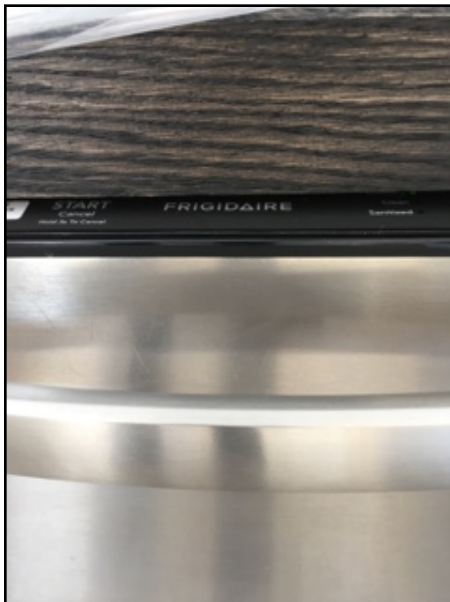
Dishwasher:

Frigidaire
Condition: Satisfactory

Dishwasher was run a full cycle no leaks found and operated normally during this inspection.

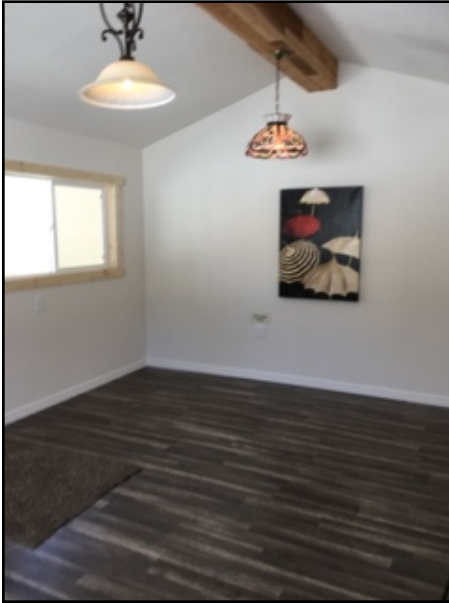
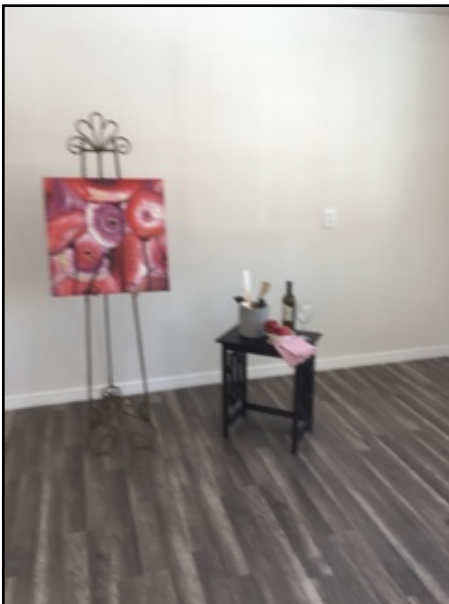
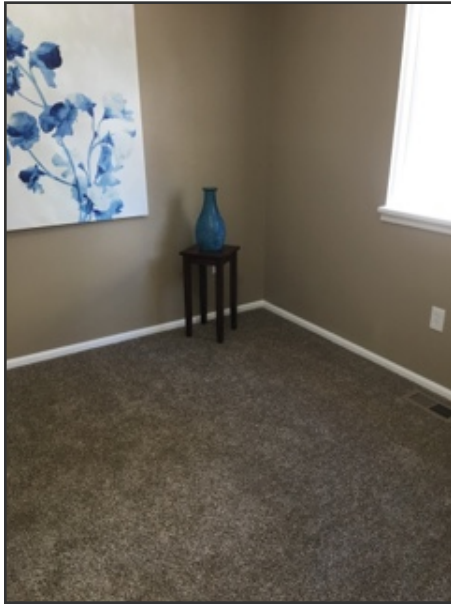
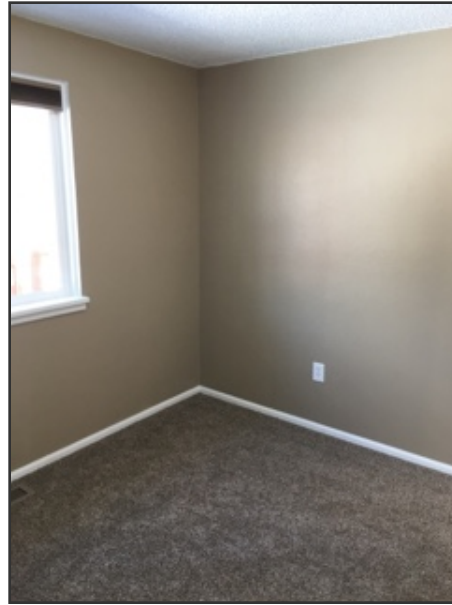
Floors:

Carpet, Wood Laminate
Condition: Satisfactory

Flooring throughout this house is primarily a wood laminate design with the exception of the closets and bedrooms which have new carpeting installed.

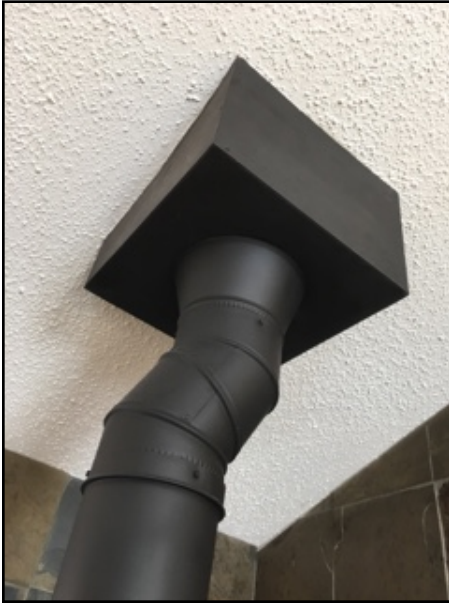
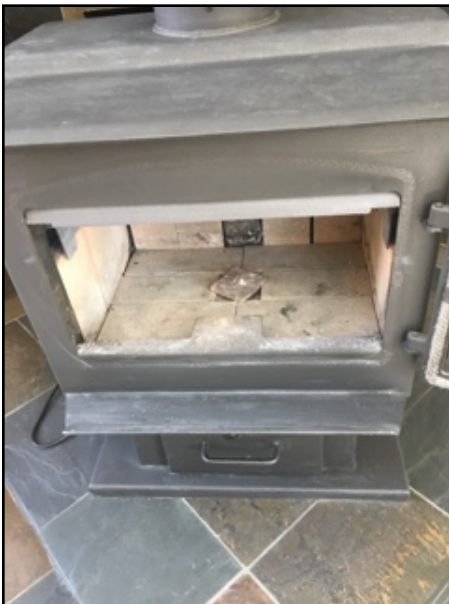
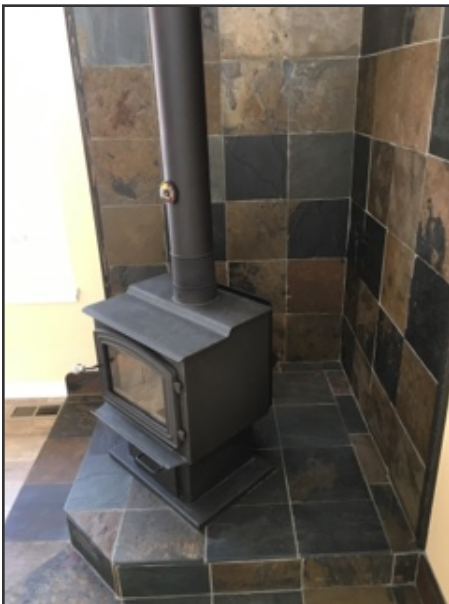
Fireplace:

Wood Burning
Condition: Satisfactory

This home has a new wood-burning stove installed in the living room area. With all wood-burning stove's it is highly recommended that a certified chimney sweep clean and certify wood-burning stove prior to first use.
