Home Inspection Report

168

Glen Isle Road

Inspected on Fri, Sep 28 2018 at 5:08 PM

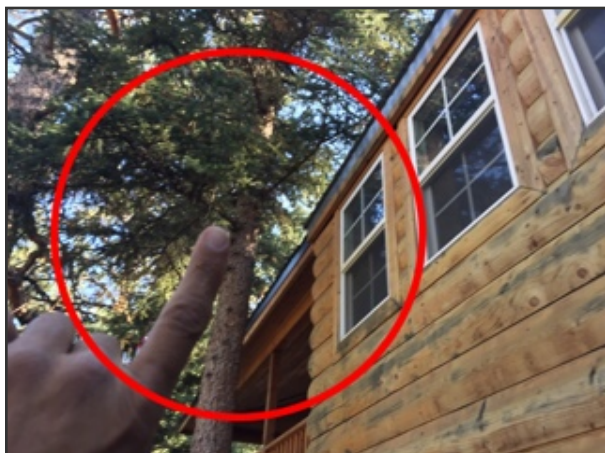
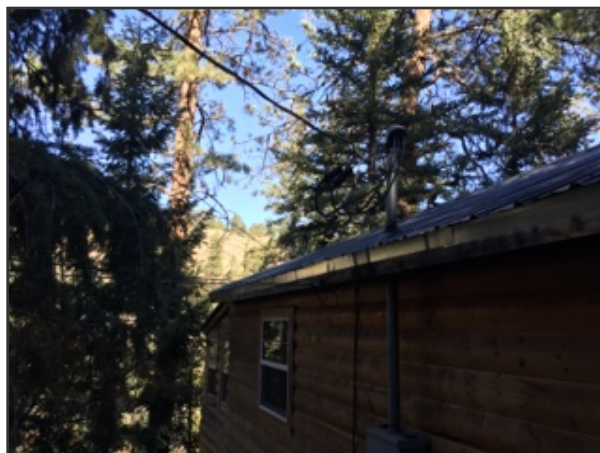
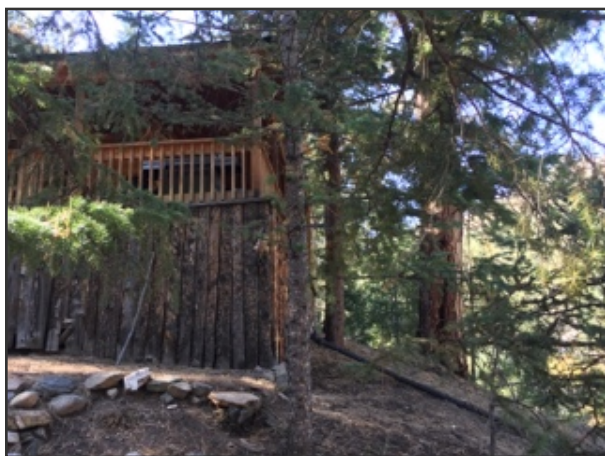
Growing Against Structure
Condition: Marginal

Generally the vegetation around the perimeter of this house is acceptable, with the exceptions of the north west and north portions of the home these trees should be trimmed back, limbed up to a minimum of 8-10 feet, or removed so as not to contact the exterior of the home or the roof.

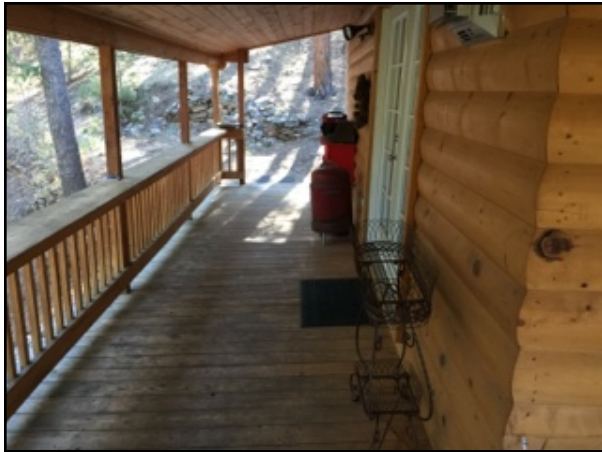
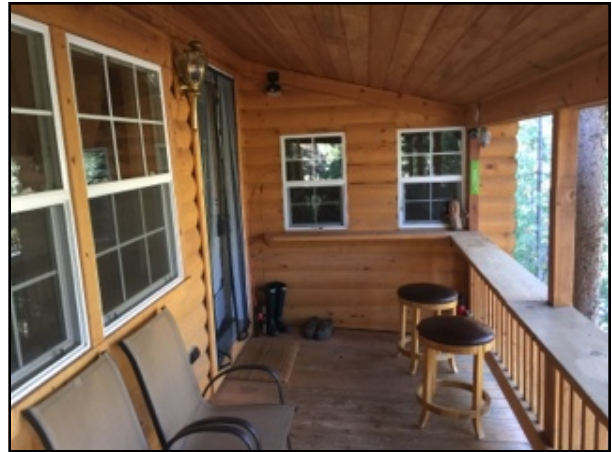
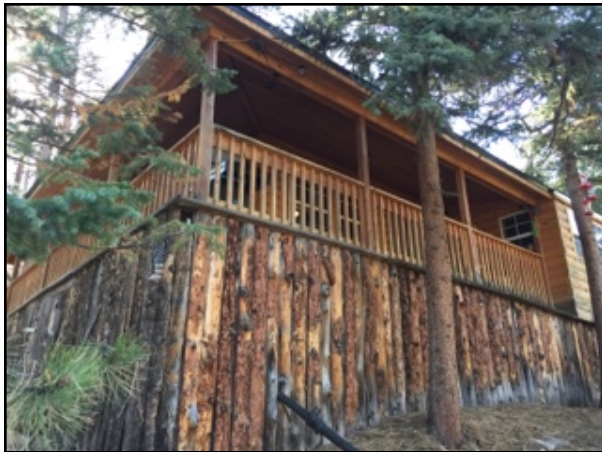
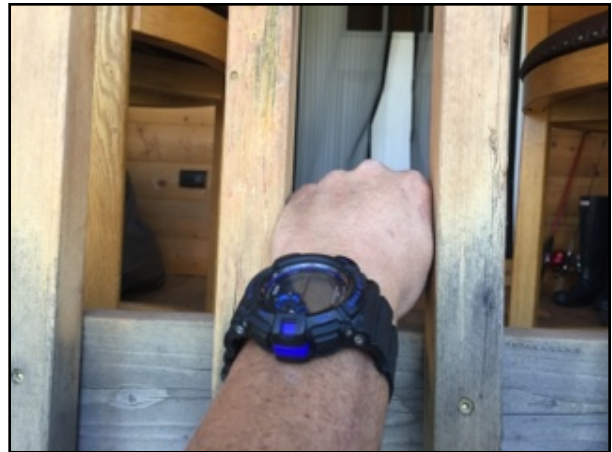
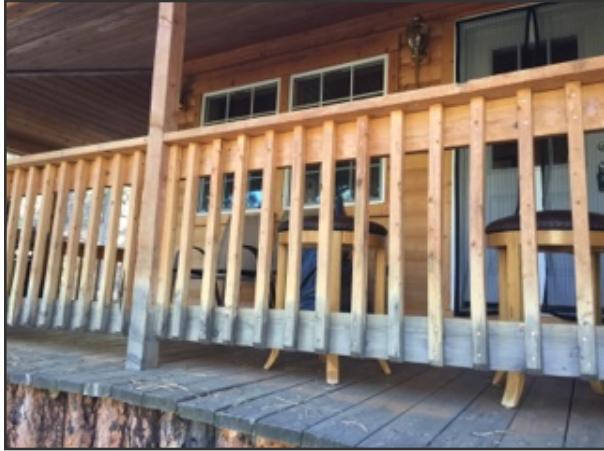
The deck on this home is in very good condition and the railing and stiles are properly spaced no problems found.

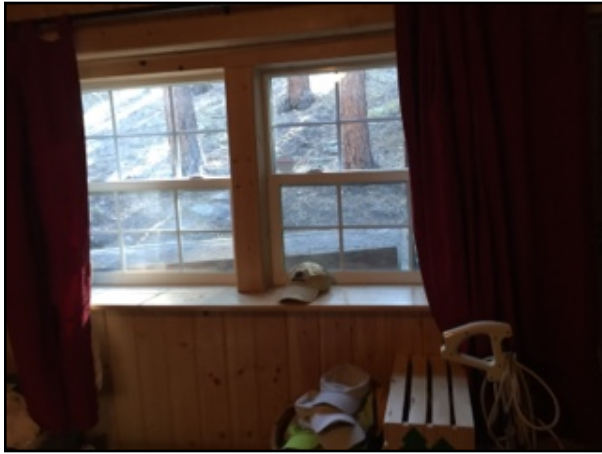
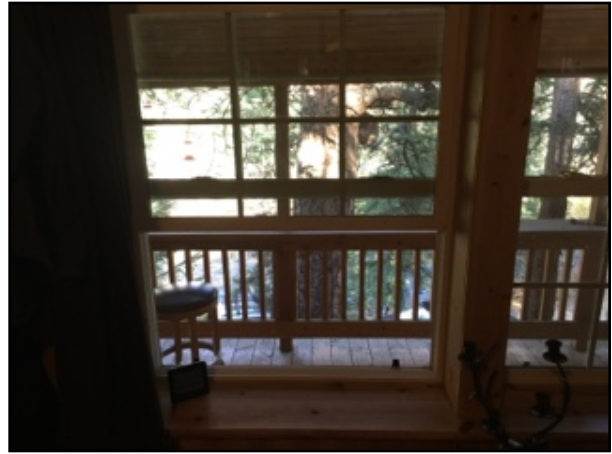
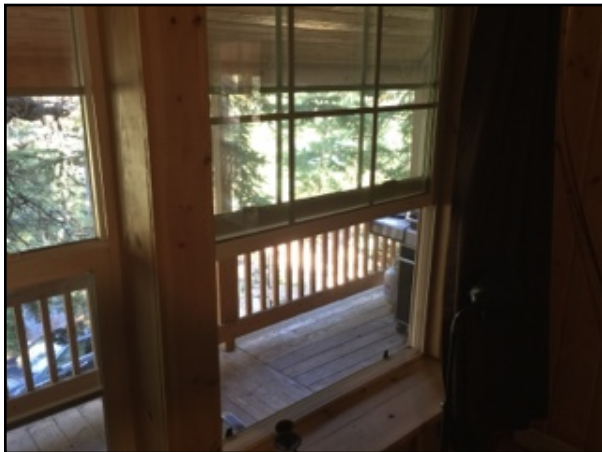
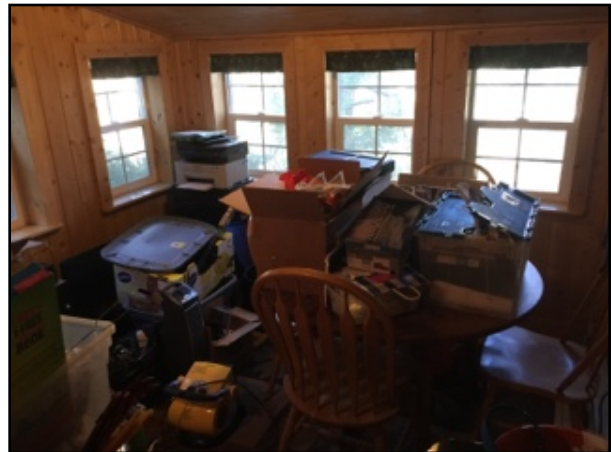
All windows in this home appeared to be in very good condition all were operational I did not find any broken seals.

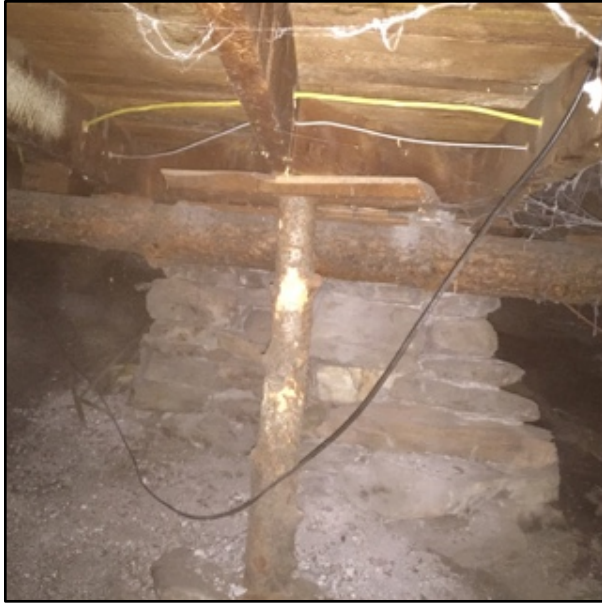
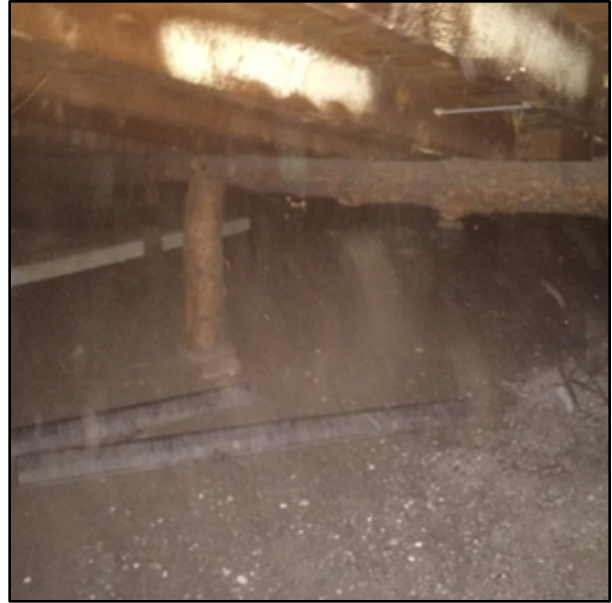
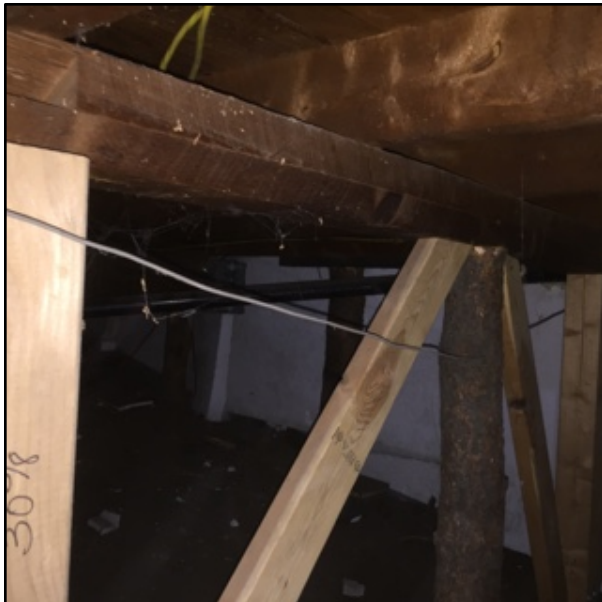
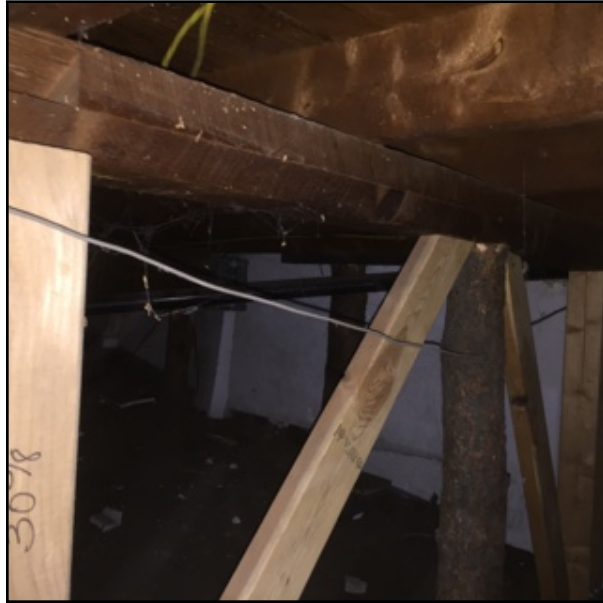
Poured Concrete, Wood
Condition: Satisfactory

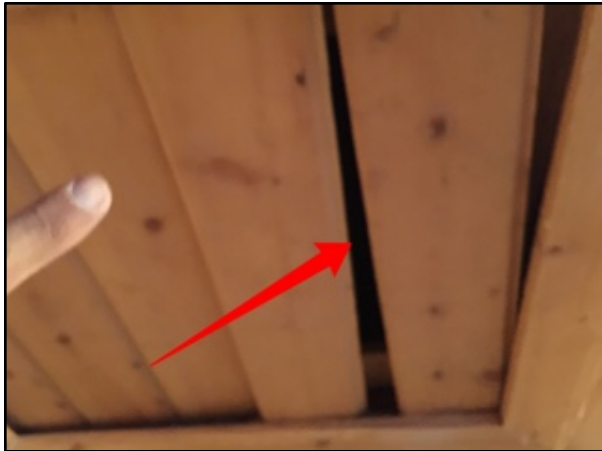
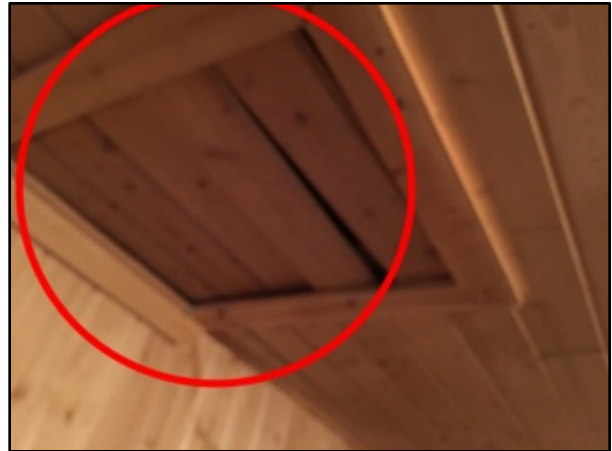
Attic access is through the bedroom and over the dresser area during this inspection the panel was removed and once the attic was fully inspected I attempted to replace the panel which fell apart it is recommended that this be screwed together rather than simply tongue and groove fitment as it currently is, in order to maintain structural integrity of the panel.

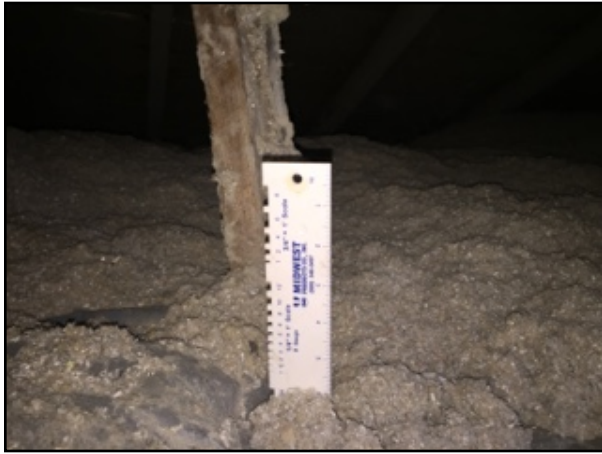
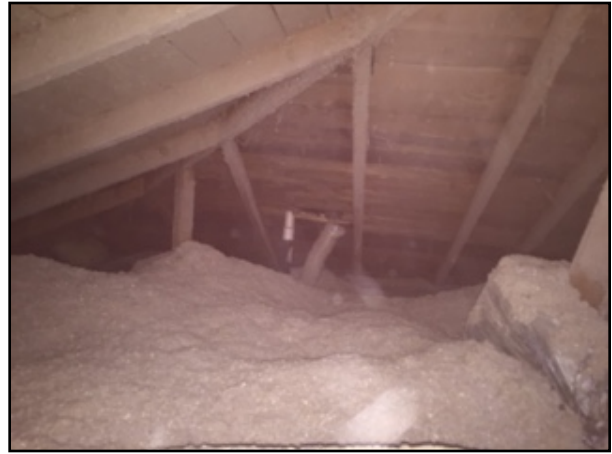
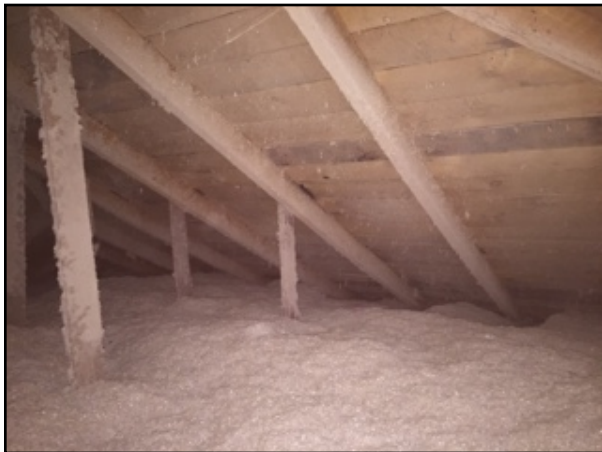
Upon inspection of the attic it is noted that there was a minimum of 8 inches of insulation in the attic area which is appropriate no problems found.

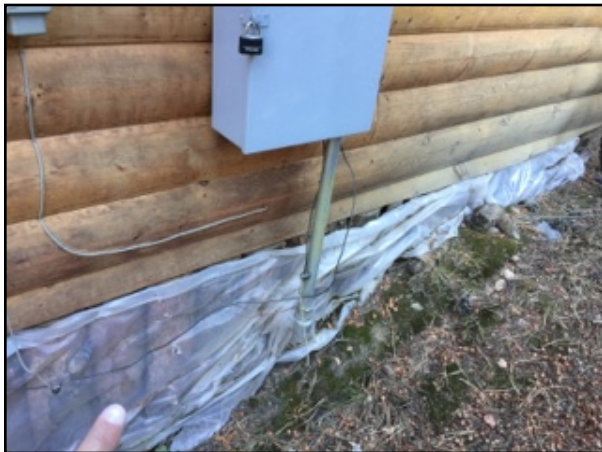
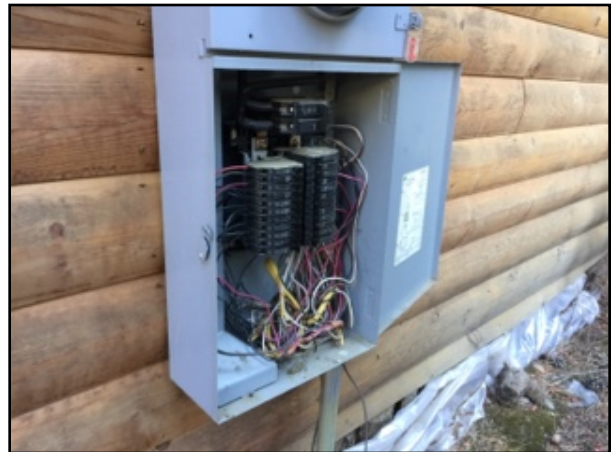
Upon attempting to open the service panel it was noted that it was padlocked. We contacted the owner who provided us with a pair of bolt cutters and instructed us to remove the padlock which we did in order to for fill this portion of the inspection.

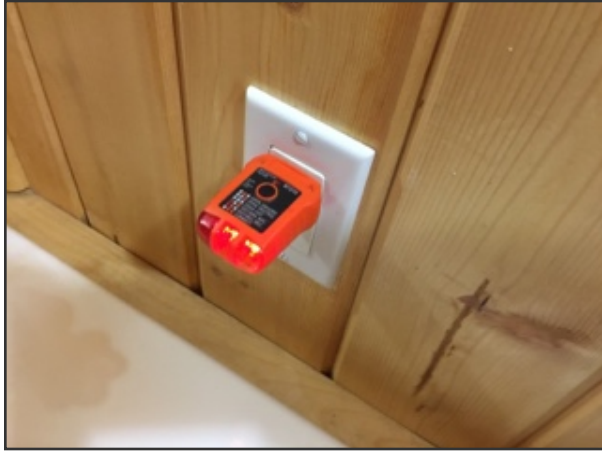
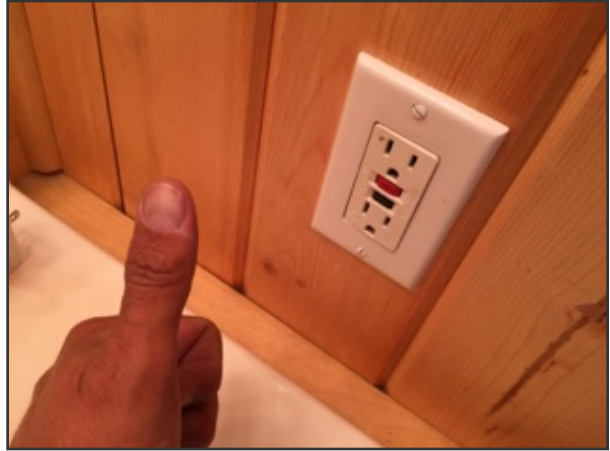
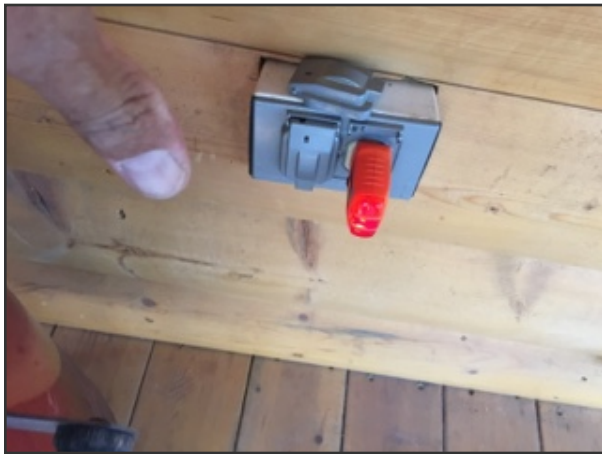
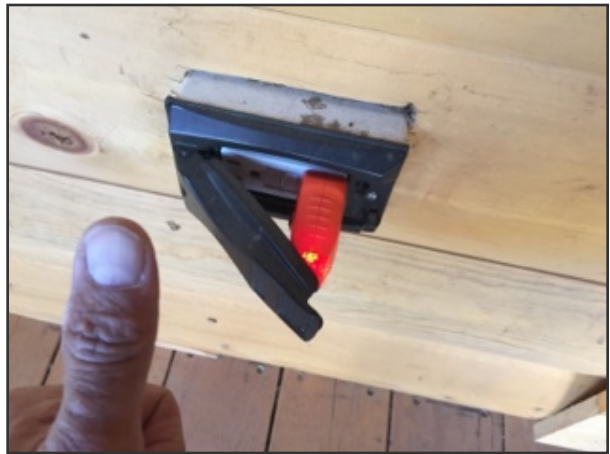
Comment 14:

This home has a series of retrofitted GFCI outlets near any water sources including kitchen bathroom and laundry area.

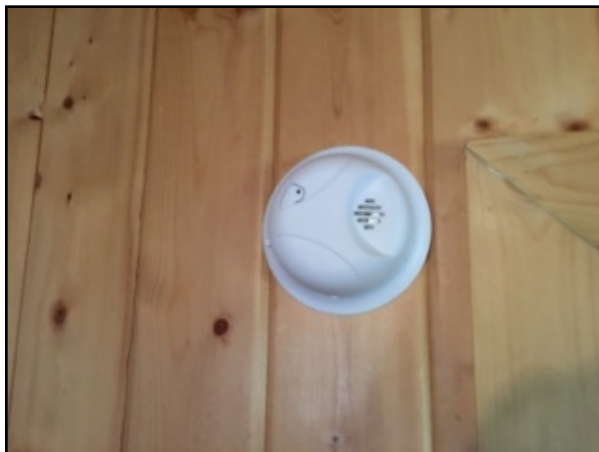
Comment 15:

There are two smoke detectors located outside the kitchen area and outside the bedroom area both were functional during this inspection.

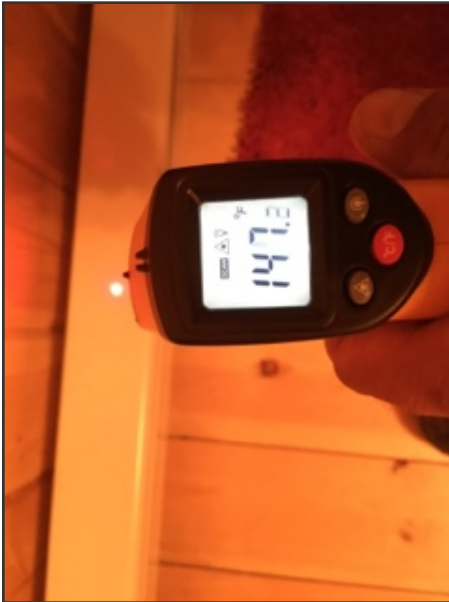
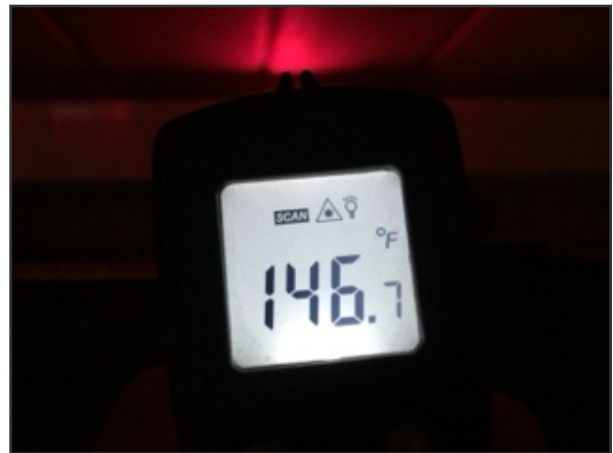
Comment 16:

This home has a series of electric baseboard heaters along with control units in the respective areas during this inspection all baseboard heaters operated properly no problems found.

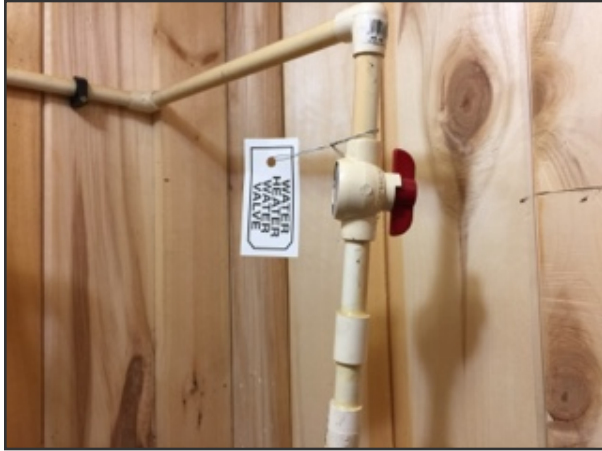
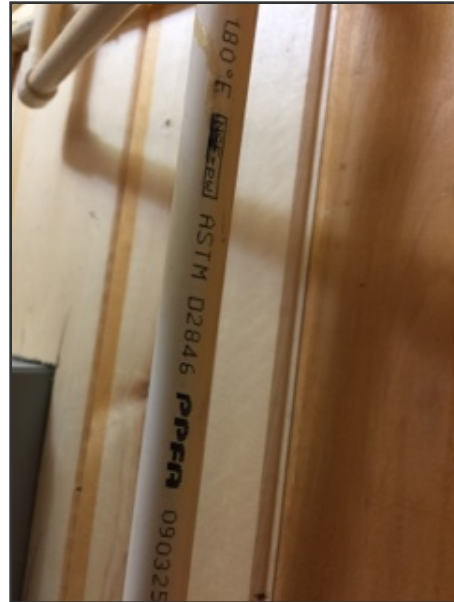
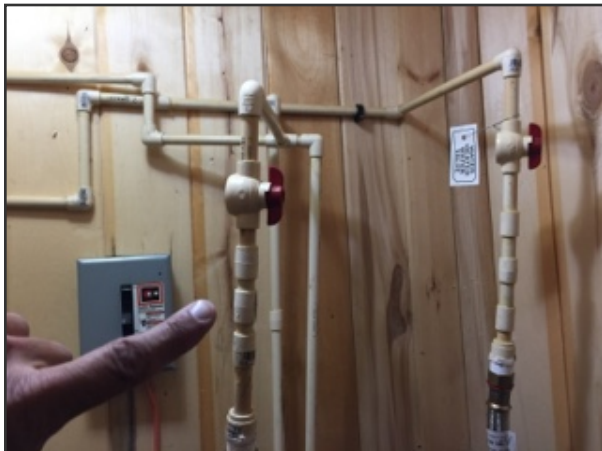
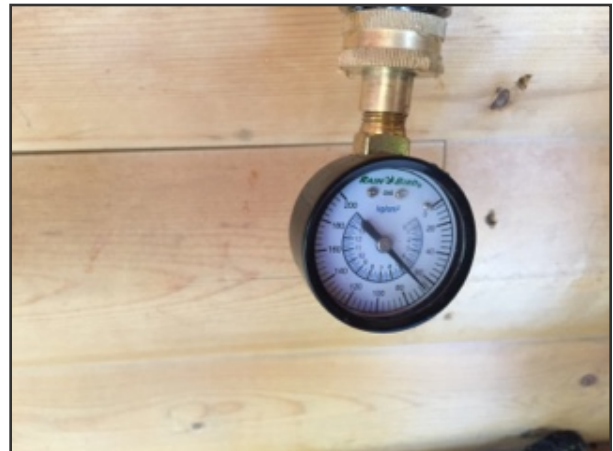
Comment 17:

Overall system pressure for the home is approximately 70 psi and is acceptable.

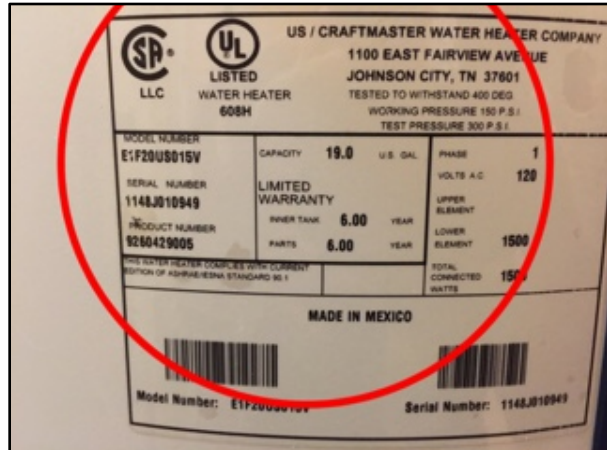
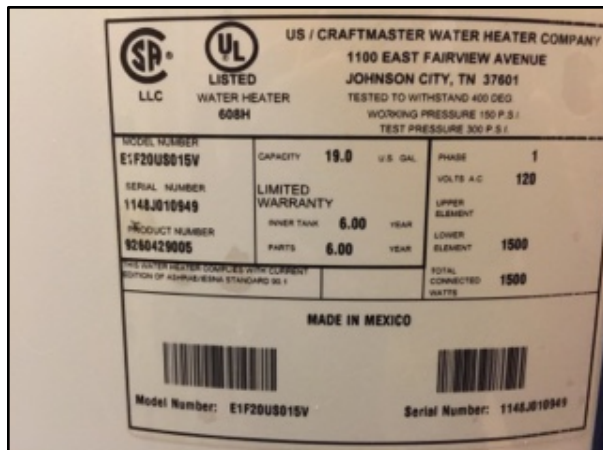
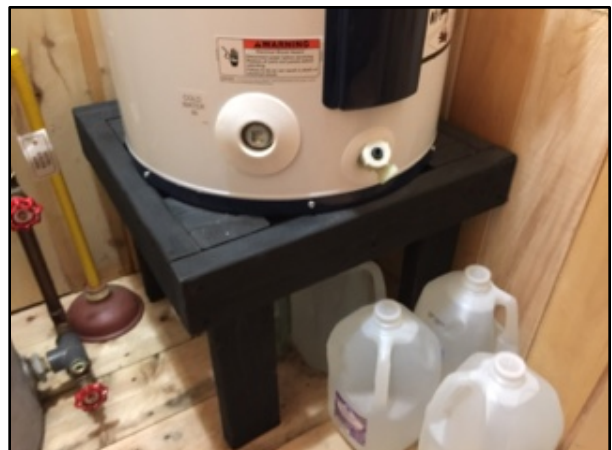
Capacity:	19 gallon
Approximate Age:	Unable To Determine Age
Temp & Pressure Relief Valve:	Present no blow off leg
	Condition: Satisfactory
Fuel Disconnect:	In Same Room
Seismic Straps Installed:	Not Present

It appears for the size of this home having two bathrooms, clothing washer, and a full kitchen that a 19 gallon water heater is insufficient. Highly recommend increasing capacity of water heater so that the new purchaser does not run out of hot water. Additionally CPVC materials connecting to the water heater should be replaced.

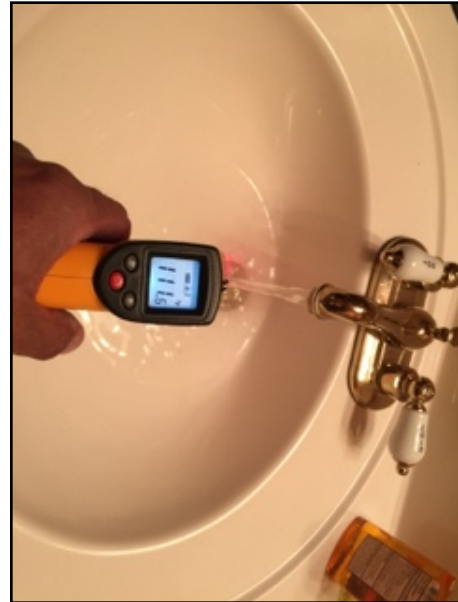
Figure 20-2

Main bathroom location has a full bathtub with shower, the valve and faucet is very loose and should be replaced or repaired. Light fixture has either a burned out bulb or other issue to be further evaluated. Under sink flex pipe appears to be leaking slightly as there were small water droplets on the bottom of the cabinet.

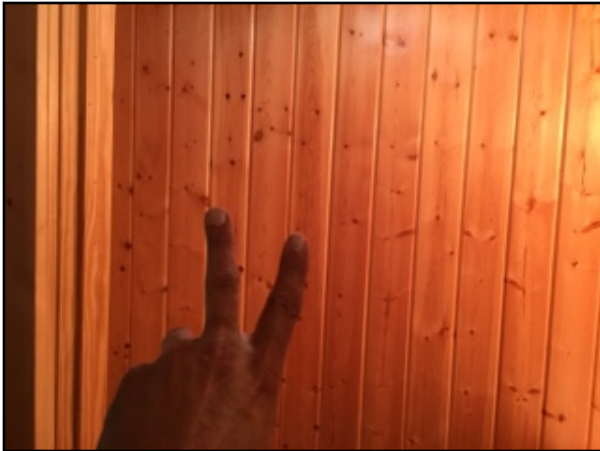
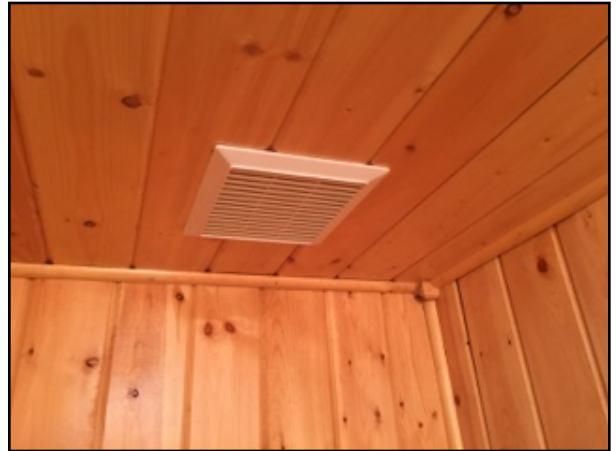
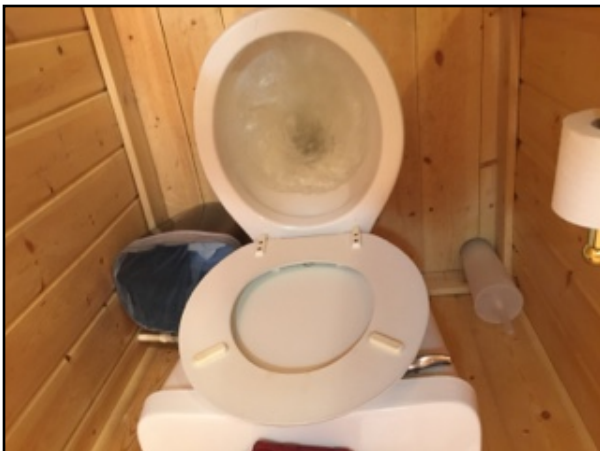
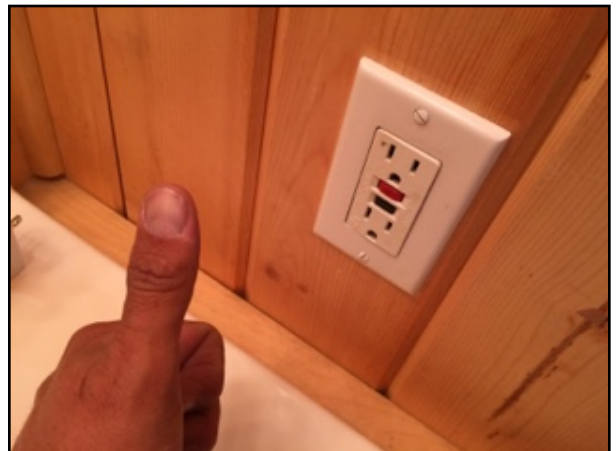
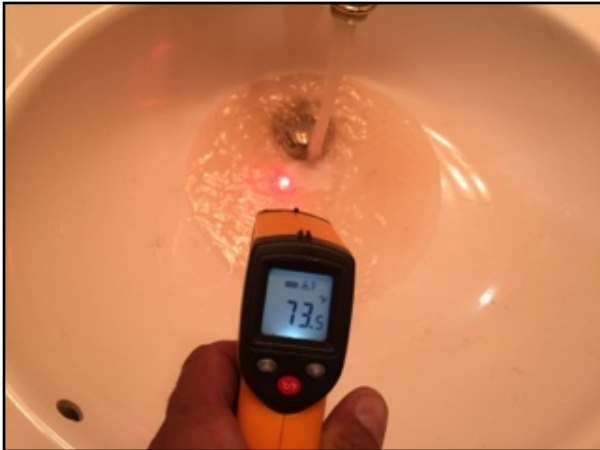
Bathroom two located near the kitchen hallway is a half bath configuration. Everything was functional sink operational, no leaks , toilet flushed and was solidly affixed to the ground ventilator operated properly and GFCI operated normally.

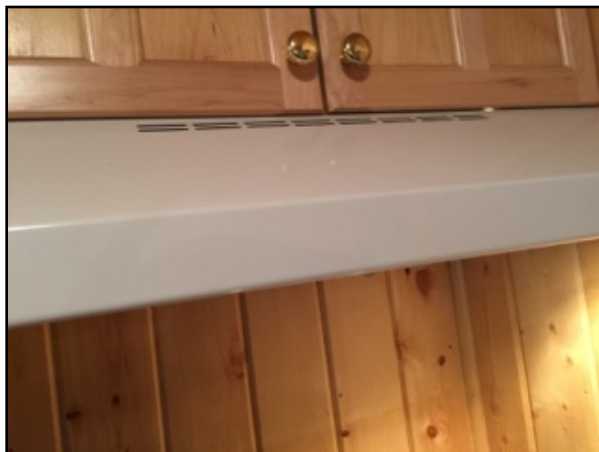
One of the two bulbs on the range hood is burned out recommend replacing or repairing. The fan did operate normally.

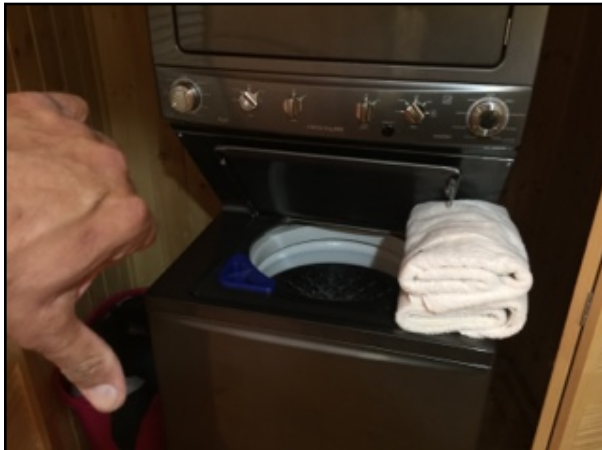
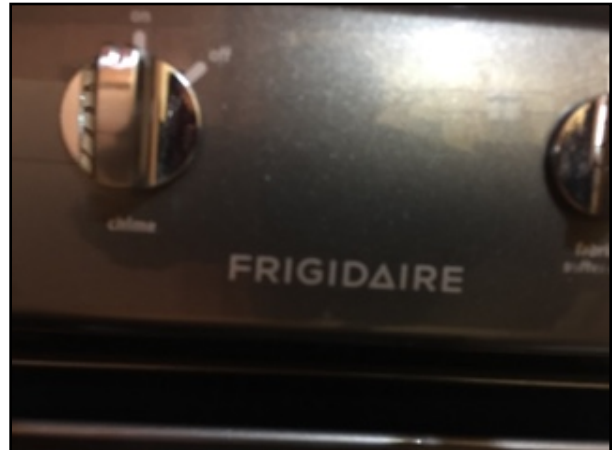
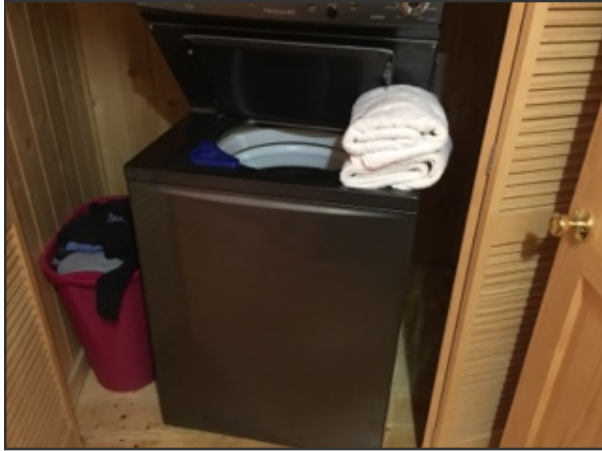
Both the clothes in washer and clothes in dryer were not inspected based on a clogged drain line according to the seller.

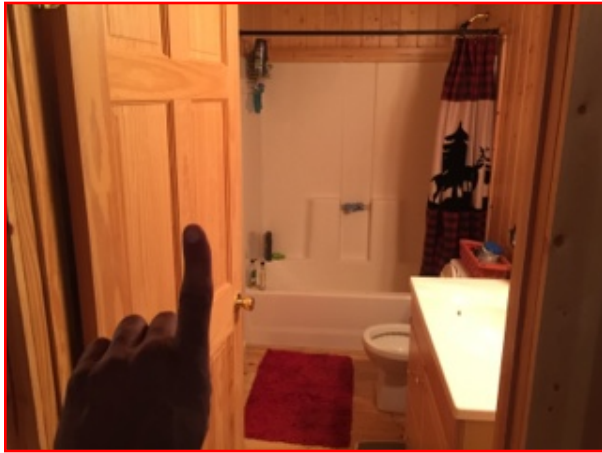
Figure 20-1

9) Main bathroom location has a full bathtub with shower, the valve and faucet is very loose and should be replaced or repaired. Light fixture has either a burned out bulb or other issue to be further evaluated. Under sink flex pipe appears to be leaking slightly as there were small water droplets on the bottom of the cabinet.
