# 285 Home Inspection Services LLC

## Home Inspection Report

**9948 Fallen Rock Road**

Inspected on Fri, Aug 31 2018 at 12:48 PM

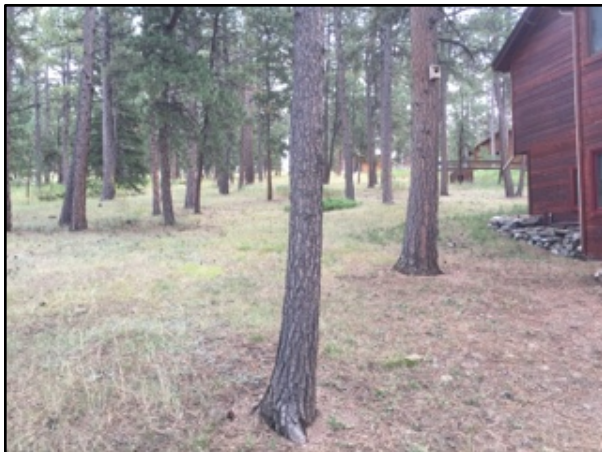
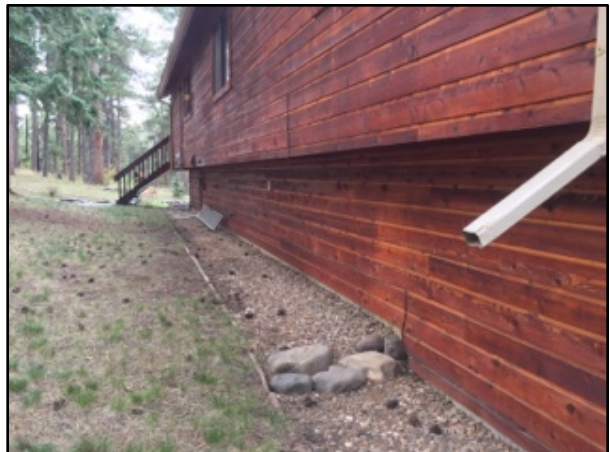
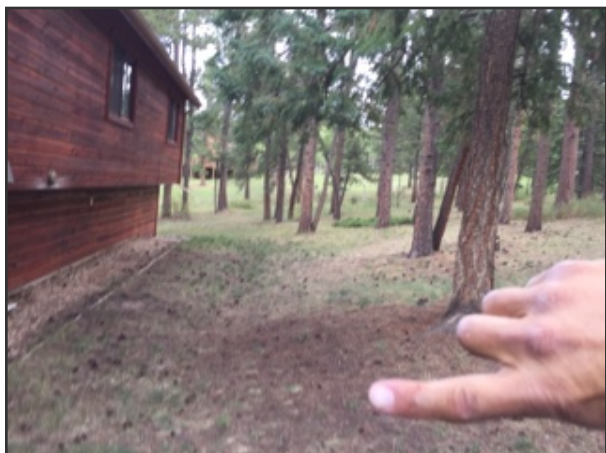
Site is well maintained, there is a slope on east side of home that may allow drainage towards home. Generally home grading looks good.

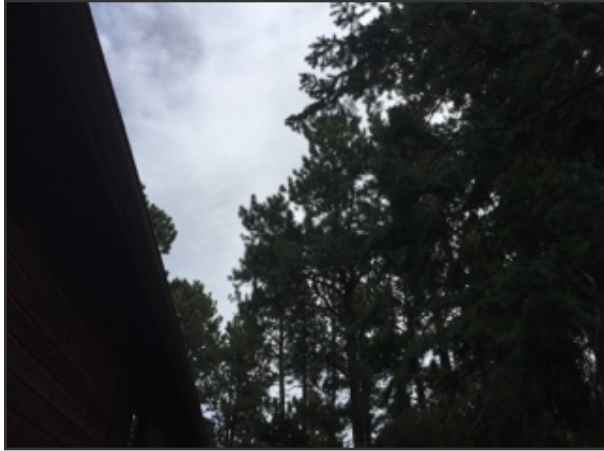
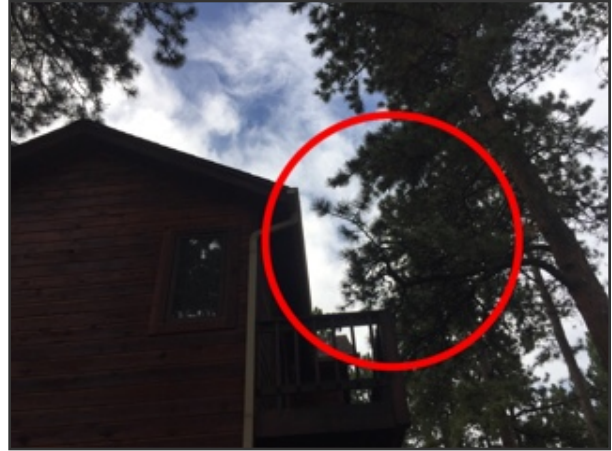
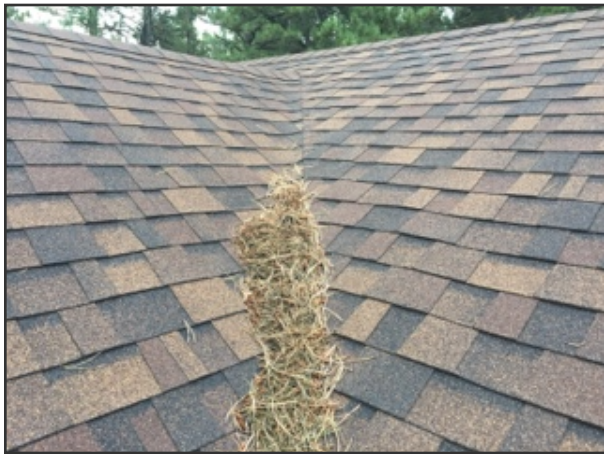
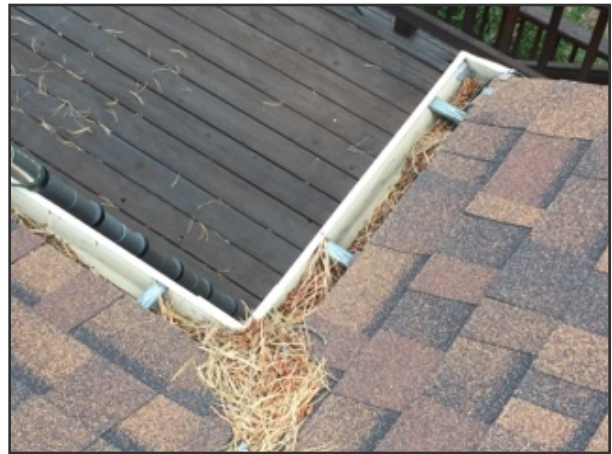
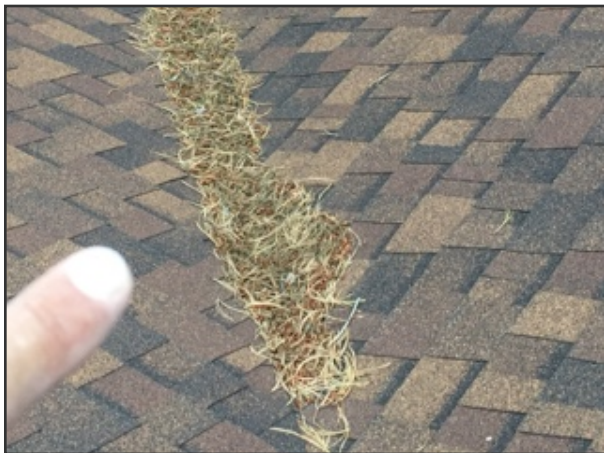
Trees and vegetation are generally in good condition at this home there are a few instances of trees touching the roof or very near the roof line these branches should be trimmed back to allow for less Pineneedle drop into the gutters and on the roof.

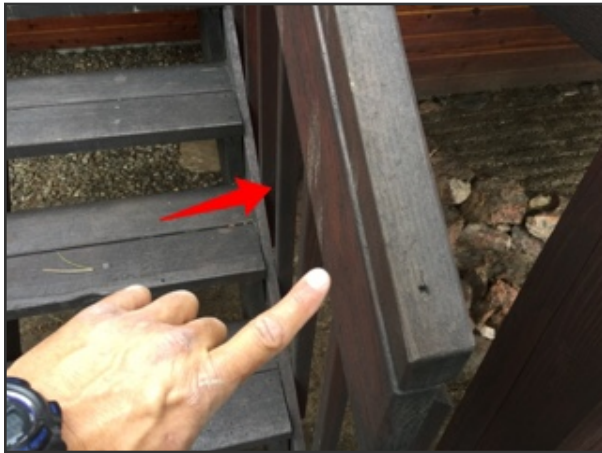
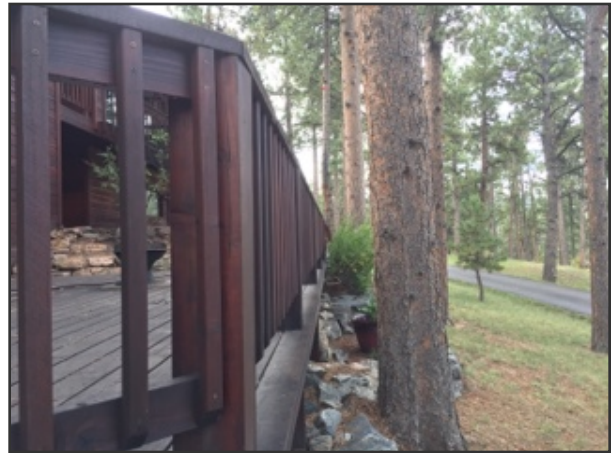
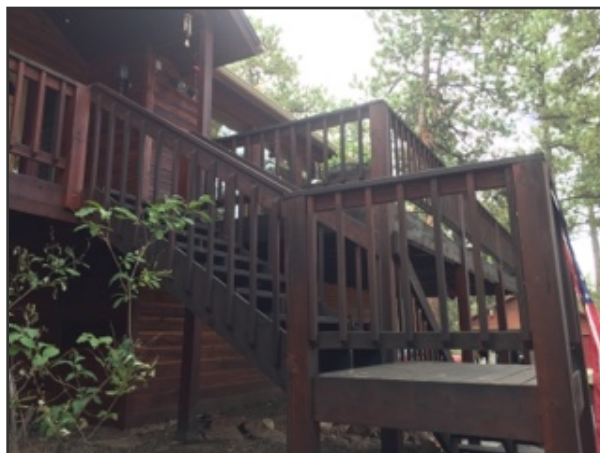
One handrail leading from the landing to the upper level deck is slightly loose on the right-hand side recommend retightening if possible.

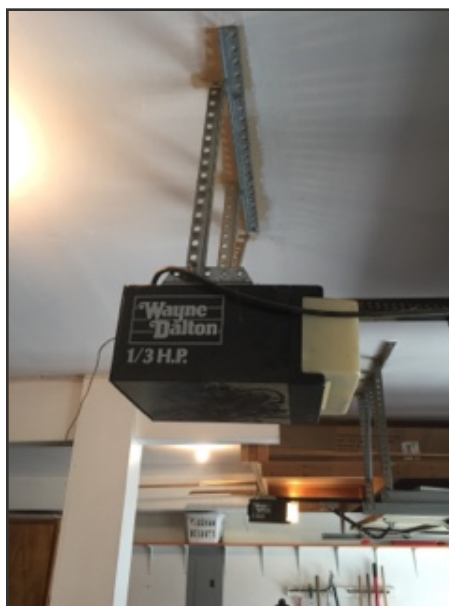
Please note attached two car garage has two separate opener's neither one has infra red beam on them, it is a mechanical safety only.

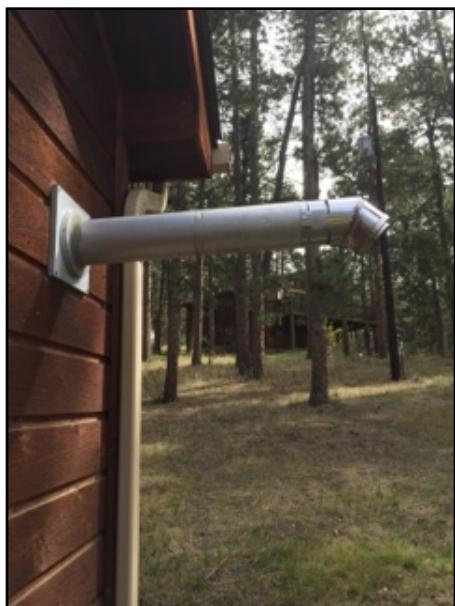
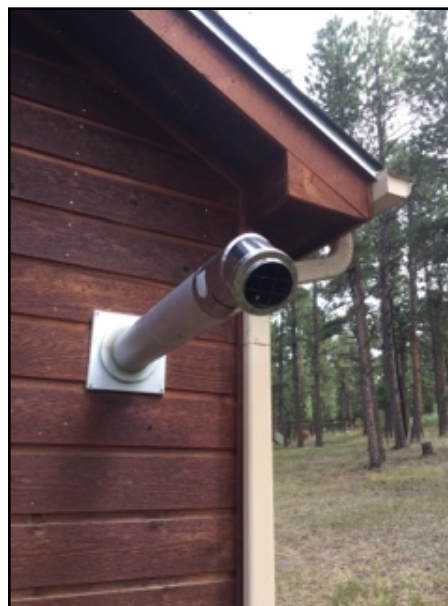
Figure 8-1

Comment 8:  
Pellet stove exterior pipes.

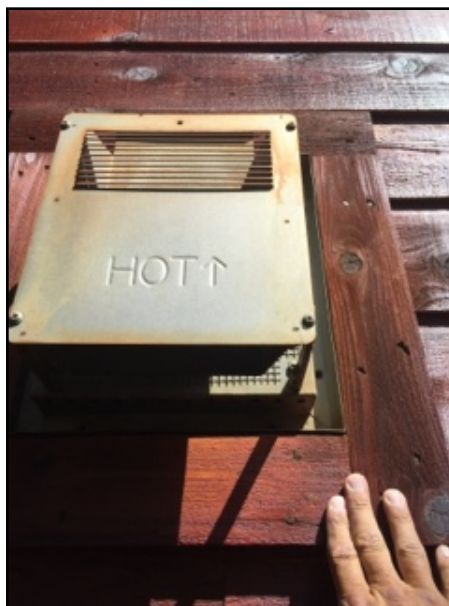
There is no chimney per se as the fireplace is a gas fireplace pictured is the vent for that gas fireplace.

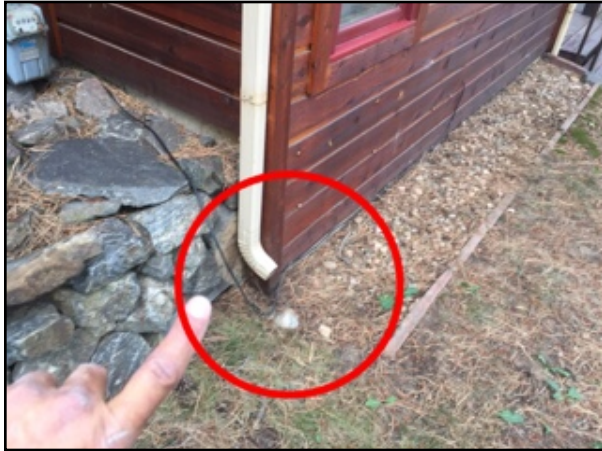
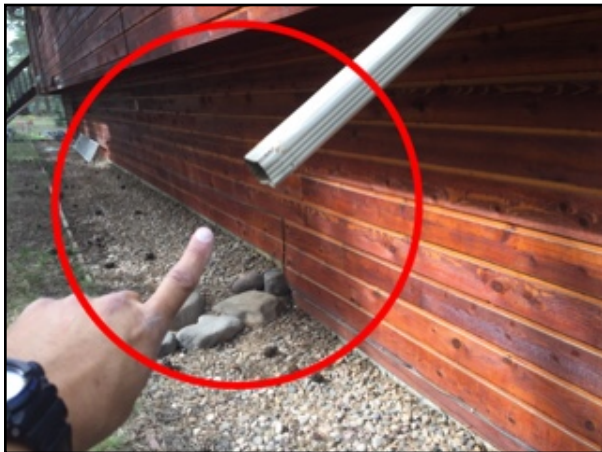
Flashings:	Metal
	Condition: Satisfactory
Soffit and Fascia:	Wood
	Condition: Satisfactory
Gutters & Downspouts:	Metal
	Condition: Marginal

It is recommended that all downspouts coming from roof to the ground should be extended away from foundation to ensure no moisture enters the foundation.

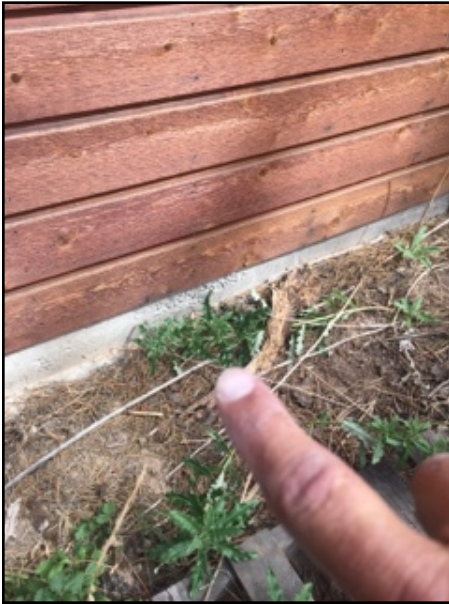
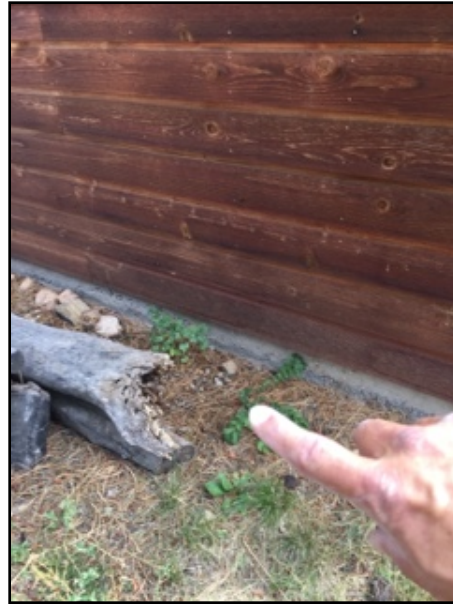
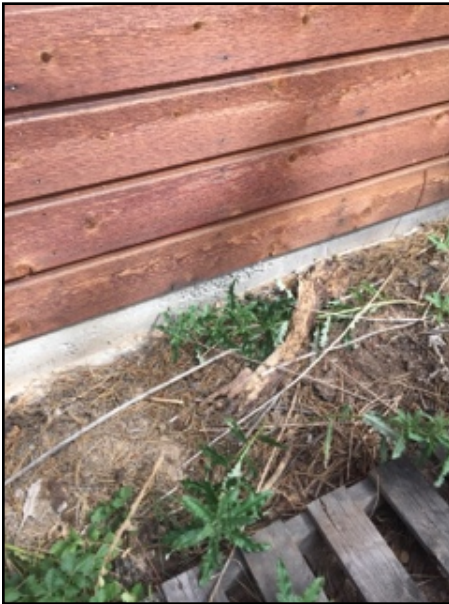
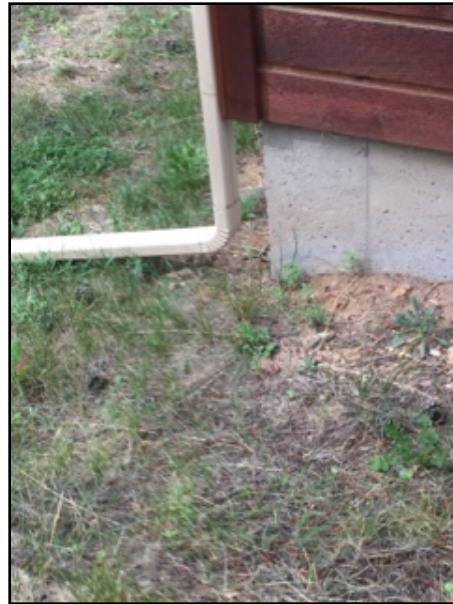
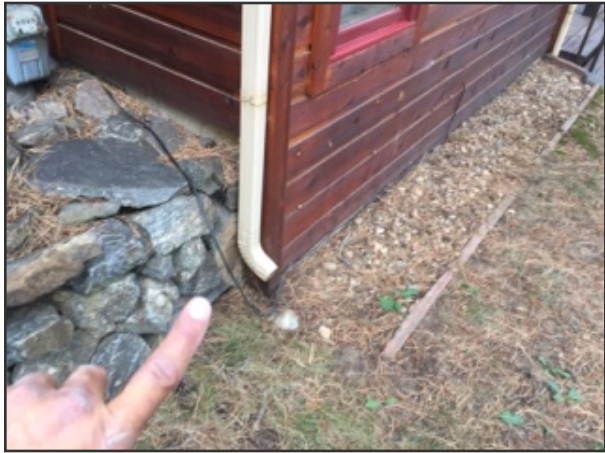
Comment 12:  
Above photographs illustrate a basement structure the fingers pointing at these areas are not indicating a deficiency.

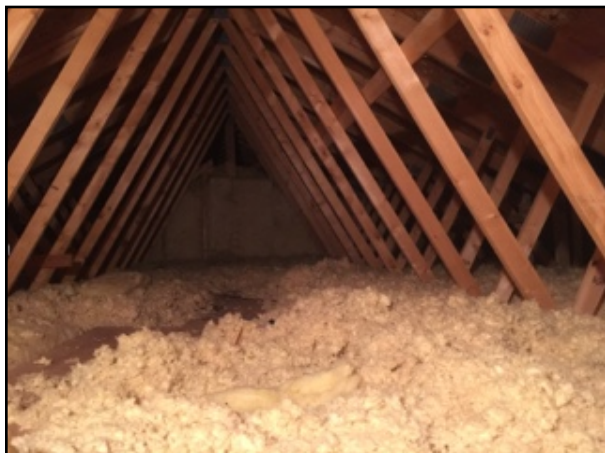
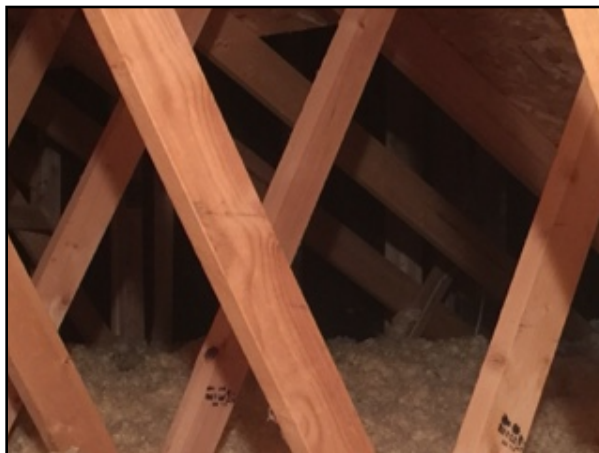
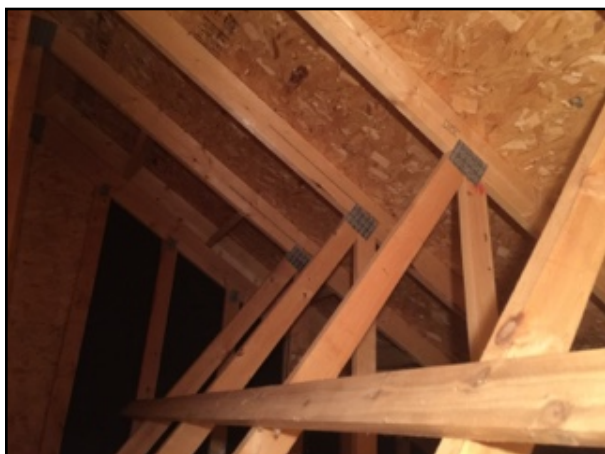
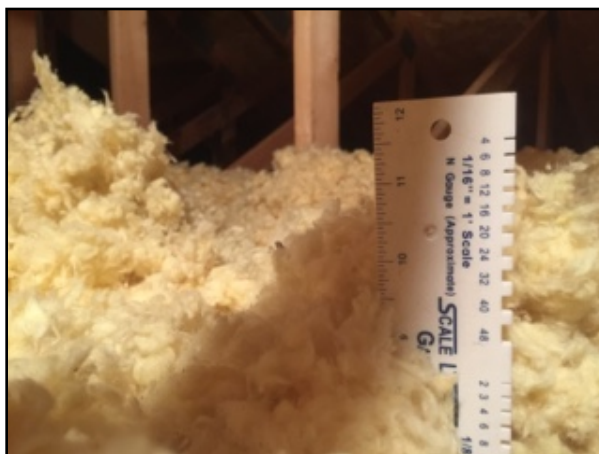
Attic entry is an upper main hallway location attic insulation is in good shape minimum of 8 inches up to 10 inches.

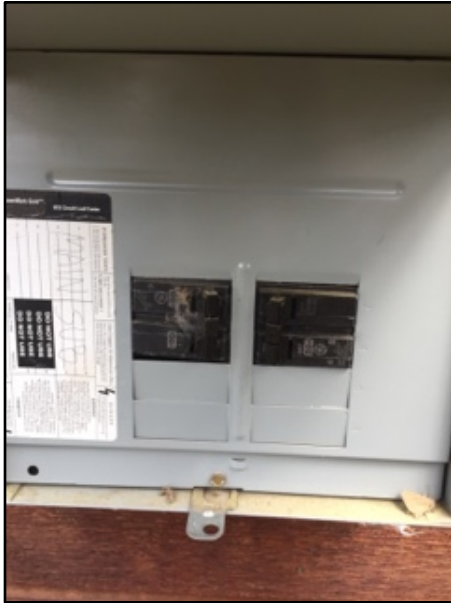
Figure 15-1

Photos indicate garage sub-panel with 100 amp main switch. The location of the panel is on the exterior of the detached garage.

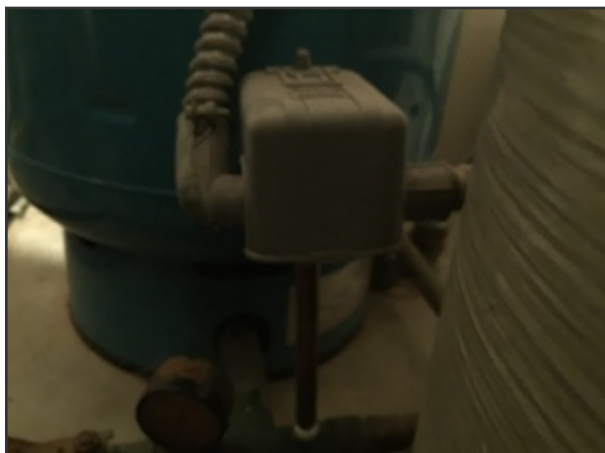
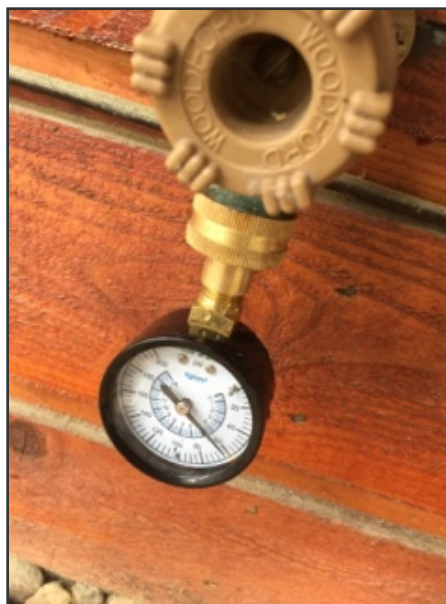
Well water is being evaluated by a Colorado certified laboratory water pressure is measured at 62 PSI which is in the acceptable range.

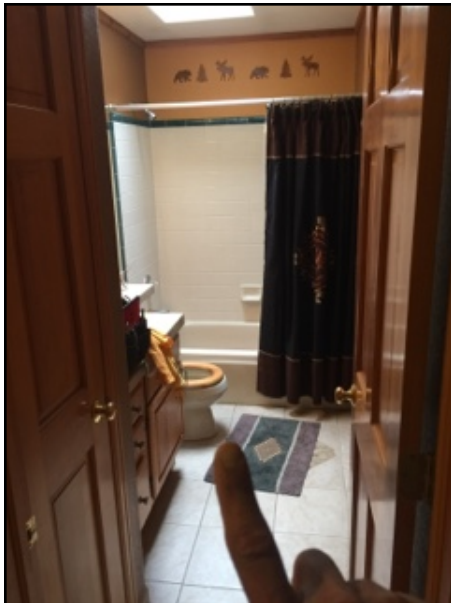
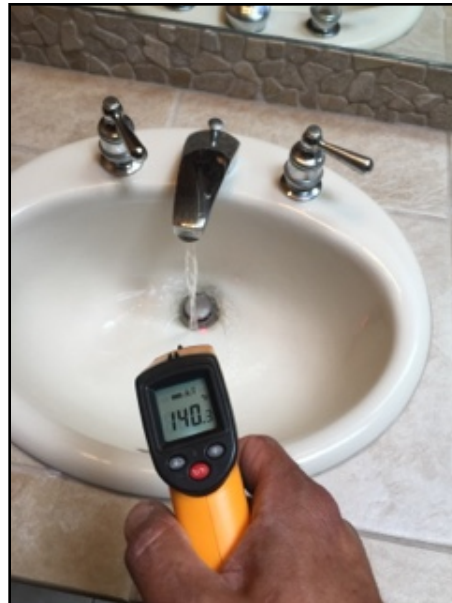
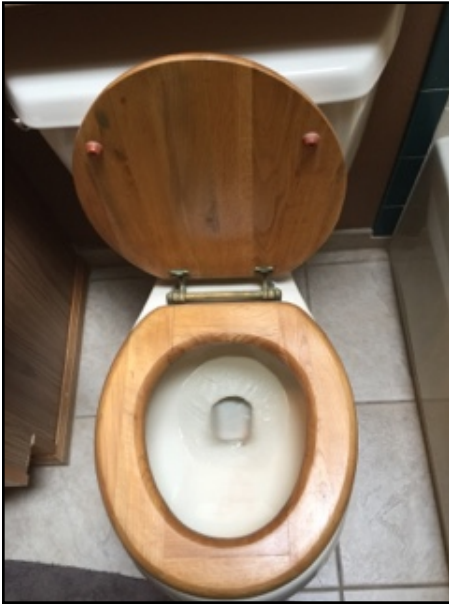
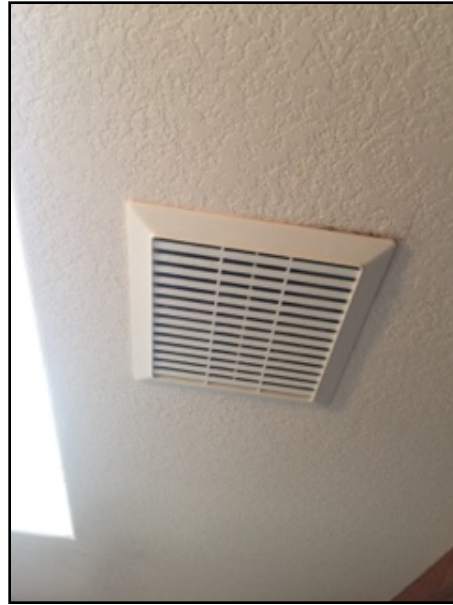
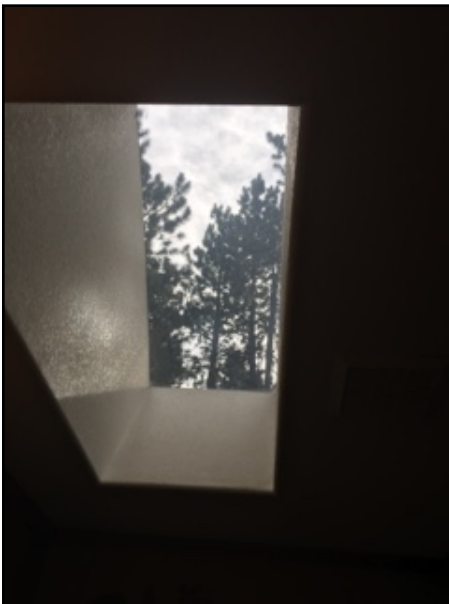
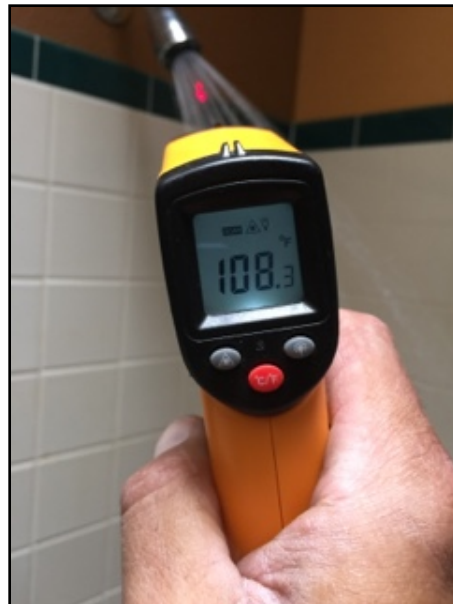
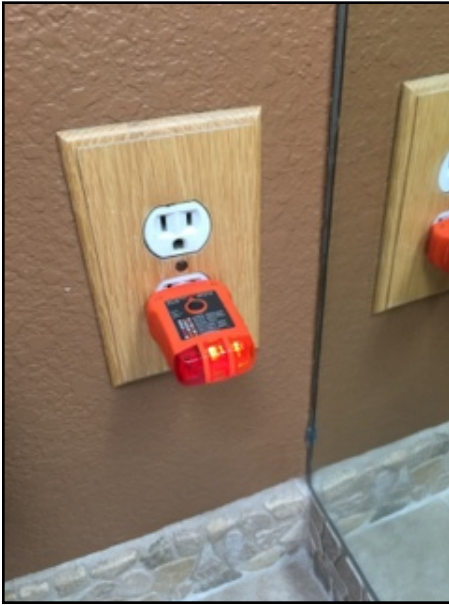
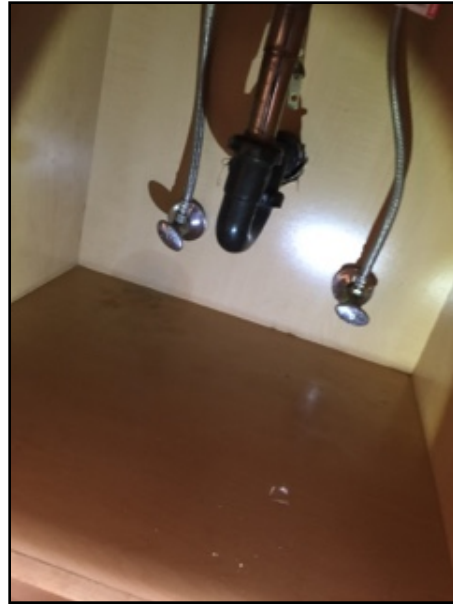
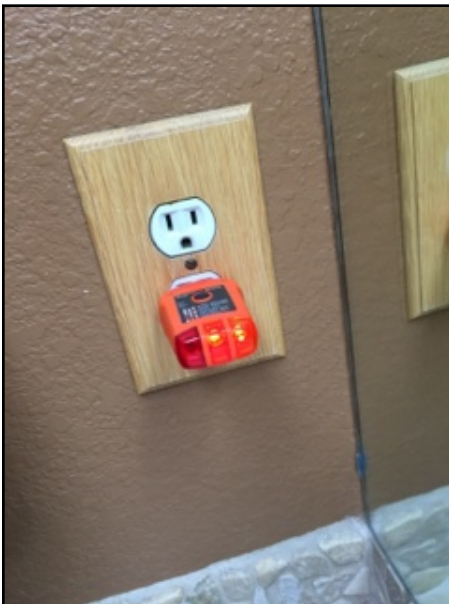
Bathroom number one operated properly toilet flushed hot water at taps shower and bath are in good condition ceiling fan was operational and GFCI was present in bathroom.

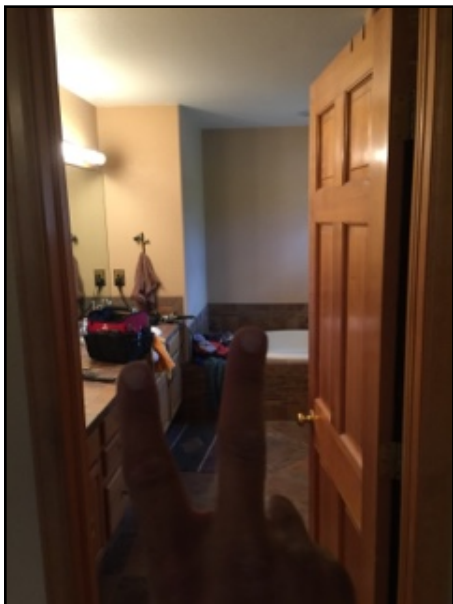
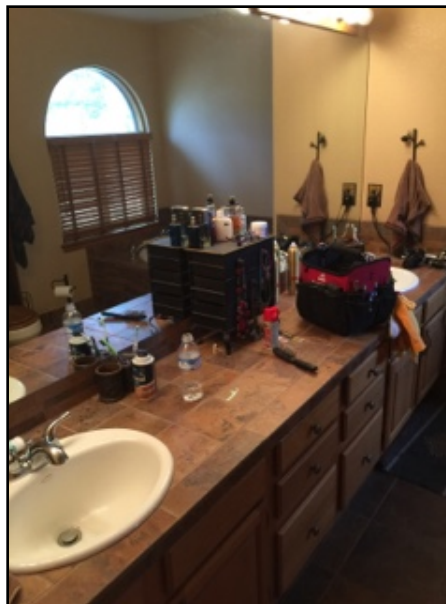
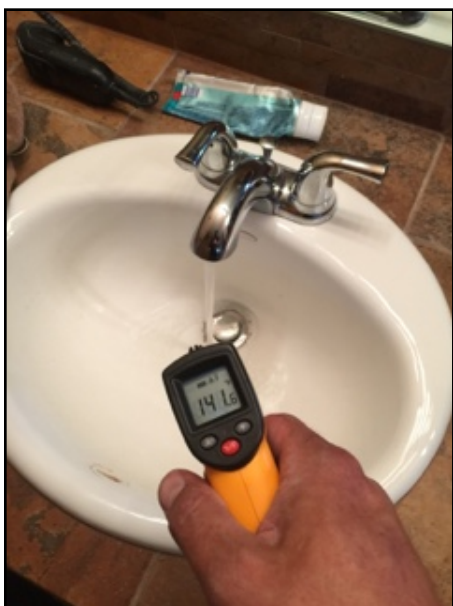
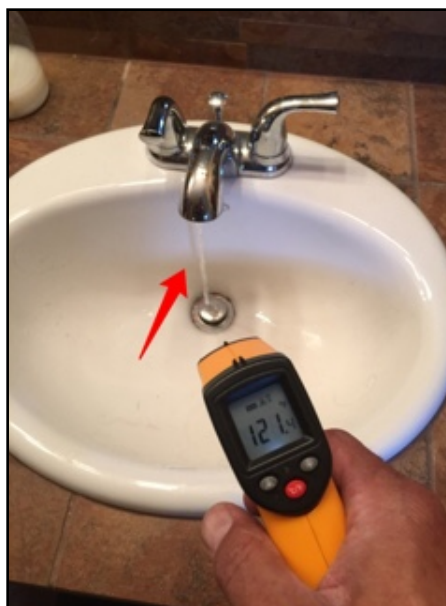
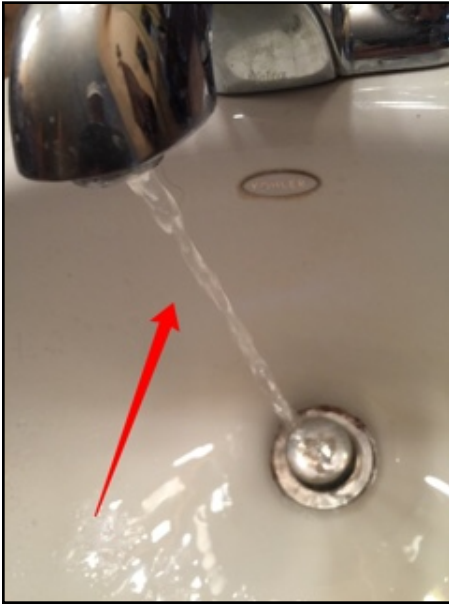
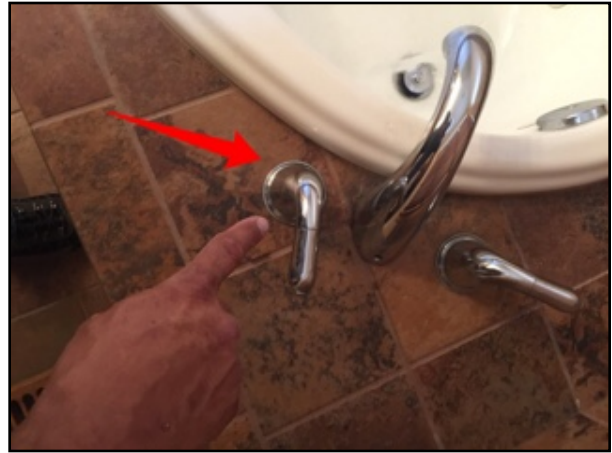
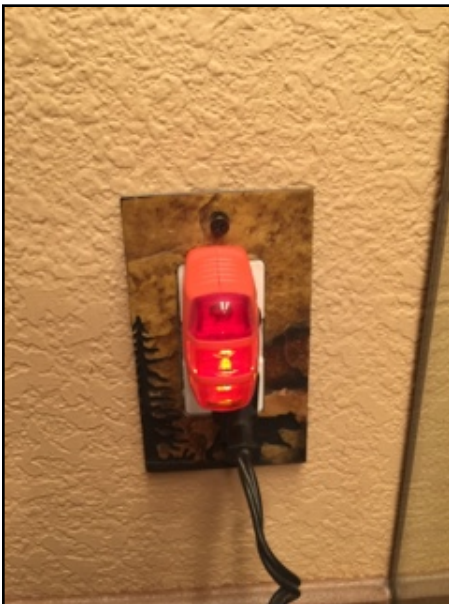
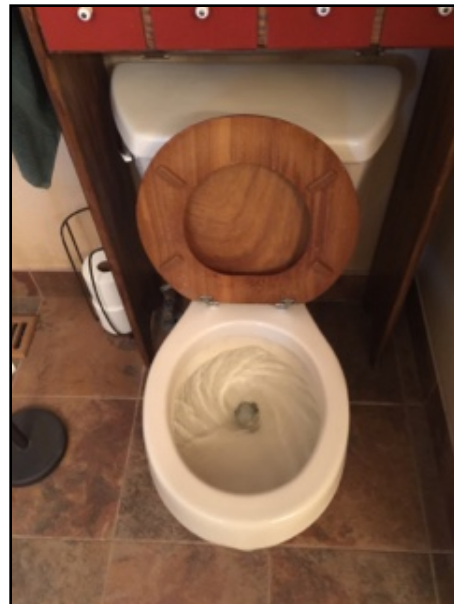
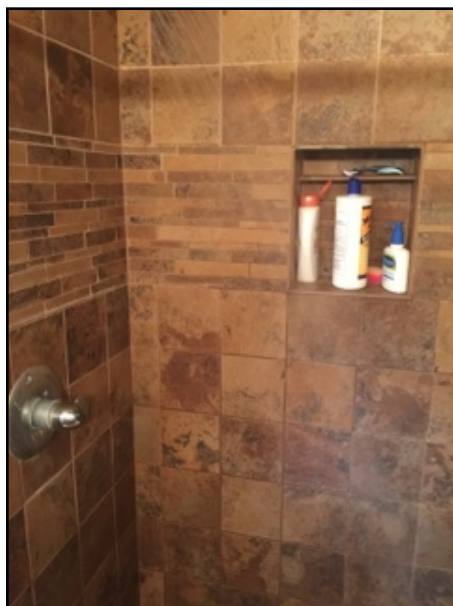
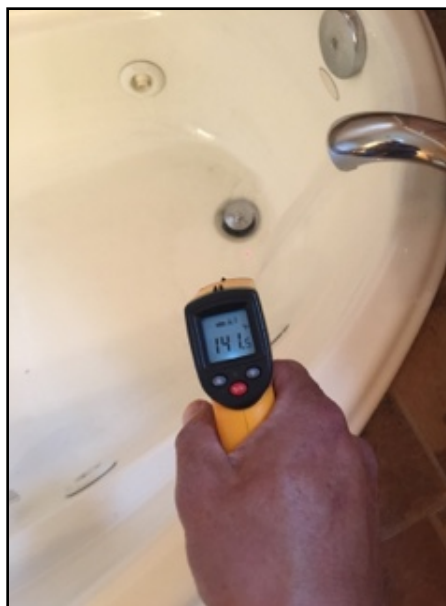
On the recirculating tub in this bathroom the right hand or heart valve appears to be stripped out is still functional but recommend it be further evaluated by a licensed plumber.

Right hand sink water pressure is very low recommend a licensed plumber to further evaluate.

Master bathroom has a jack and Jill sink separate jetted tub separate shower stall issues with pressure on right hand sink and hot water valve for jetted tub ceiling fan operational and GFCI in place.

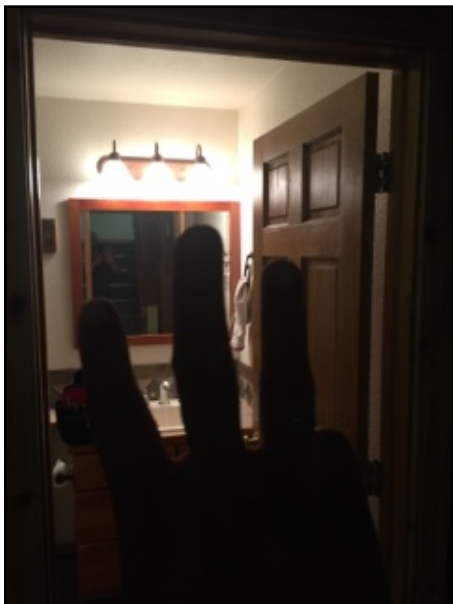
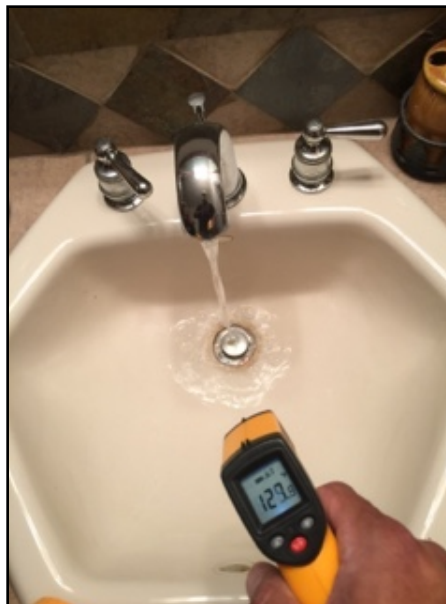
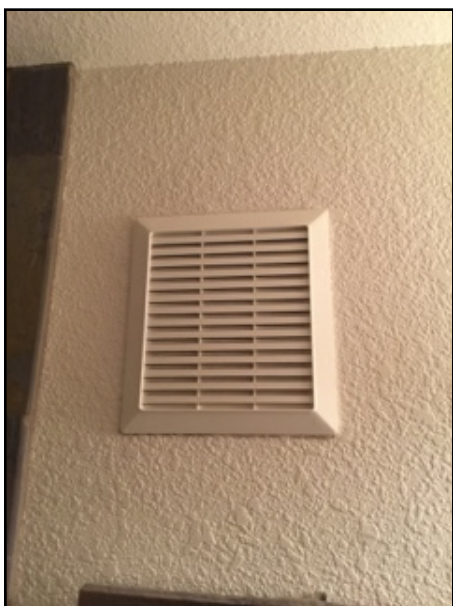
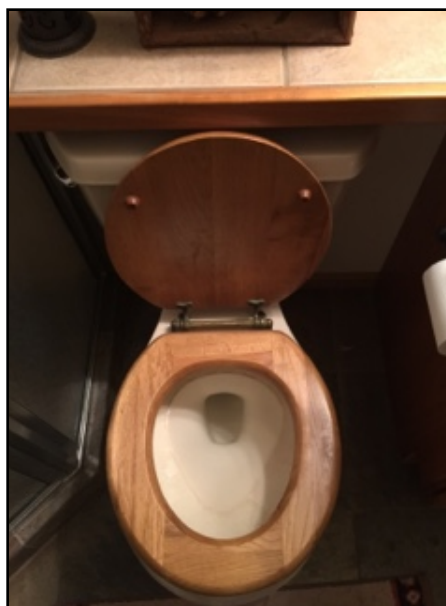
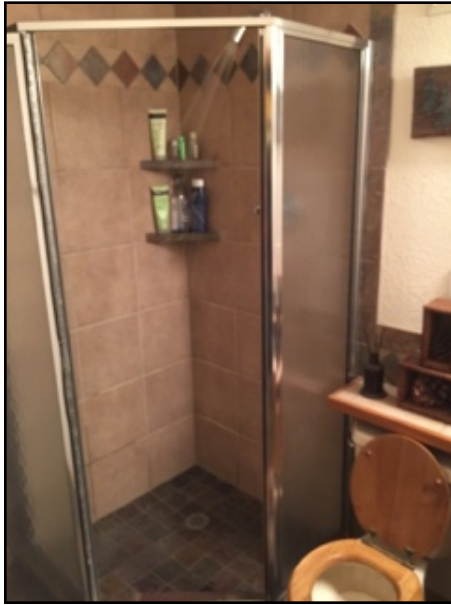
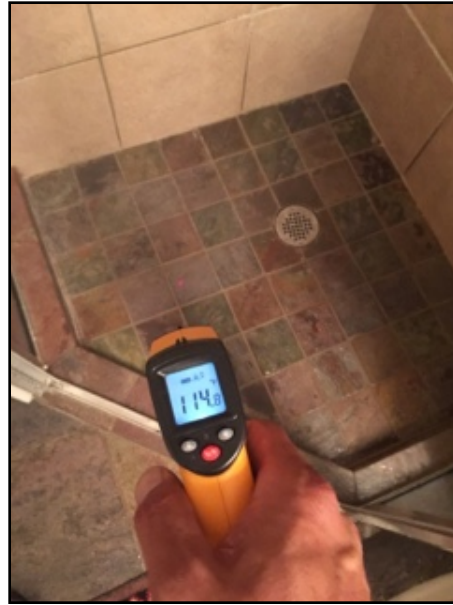
Bathroom number three is located on the lower level all items appear to work properly water pressure was good toilet flushed ventilator fan is operational GFCI is in place stall shower in place without bath tub.

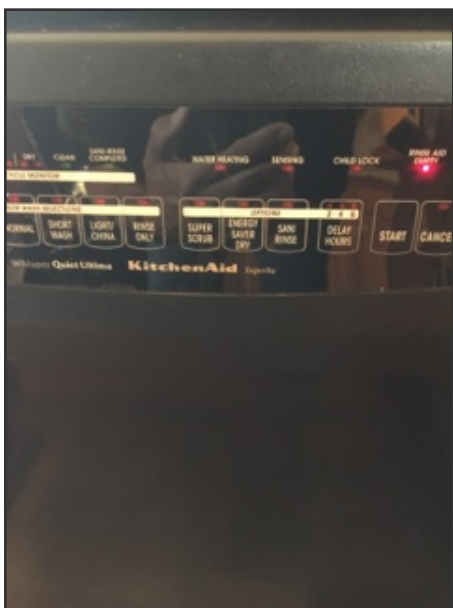
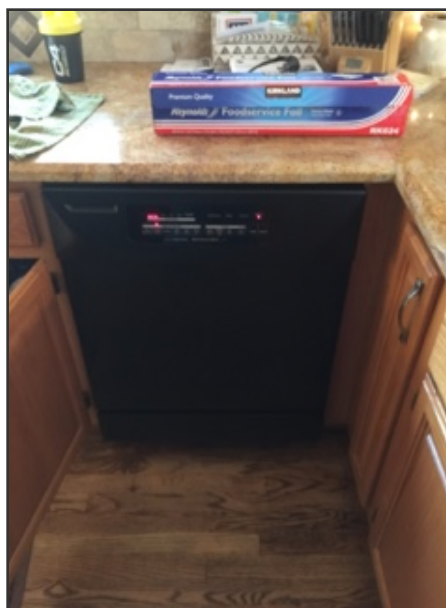
Comment 24:  
Ran full cycle of dishwasher no leaks and the unit operating properly.

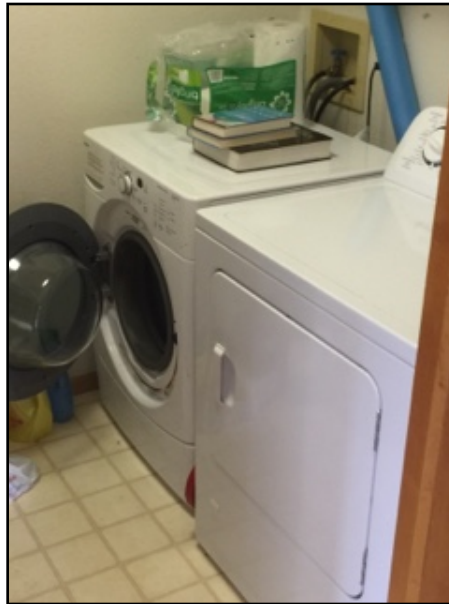
Ran a short cycle of washer no leaks and operational.

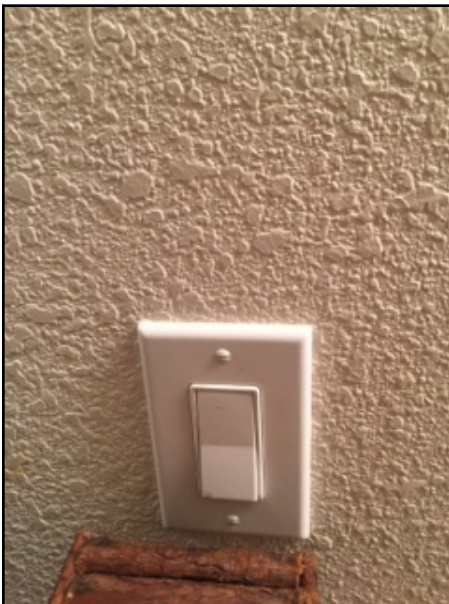
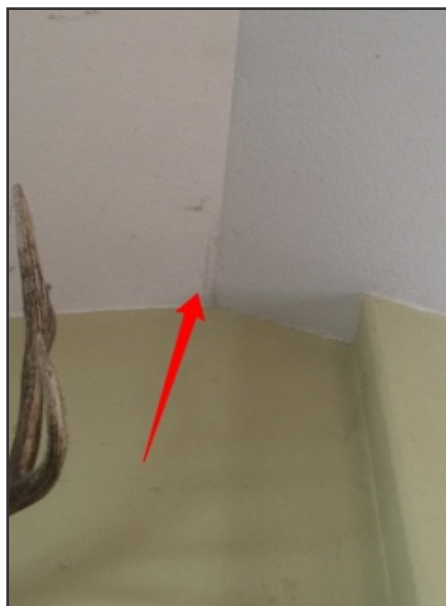
Textured Over Drywall  
Condition: Marginal

Overall walls and ceilings are in good condition there are some signs of cracked drywall around the skylight and in the living room where indicated by red arrow.

11) Overall walls and ceilings are in good condition there are some signs of cracked drywall around the skylight and in the living room where indicated by red arrow.

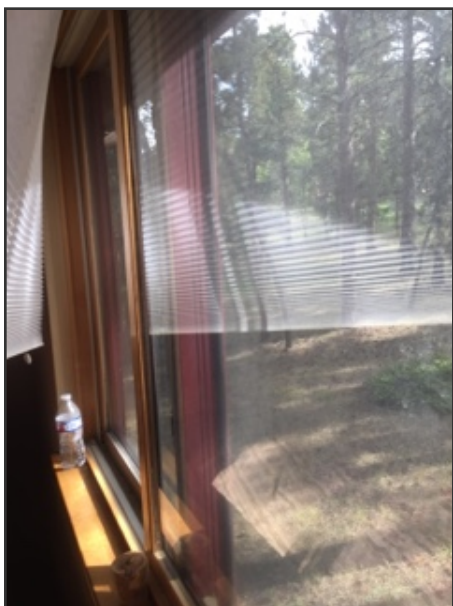
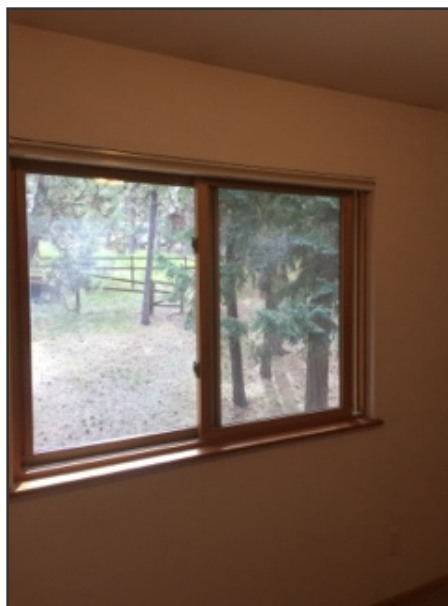
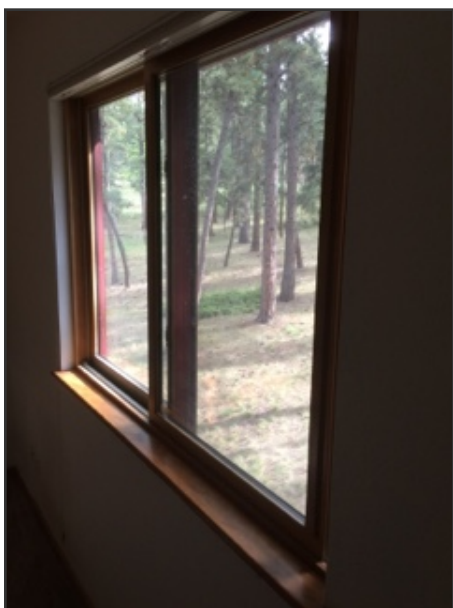
This home has a combination of slider and casement wood windows all were operational during this inspection.

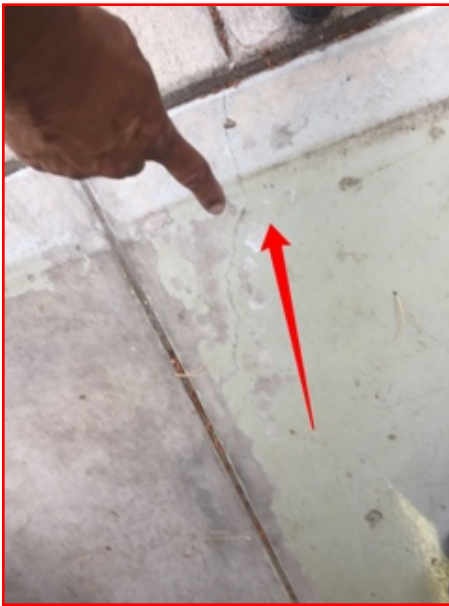
Figure 7-1

4) In the detached garage floor there is a minor crack near the roll up door location.
