285 Home Inspection Services LLC

Home Inspection Report

1671

Little Bear Creek Rd

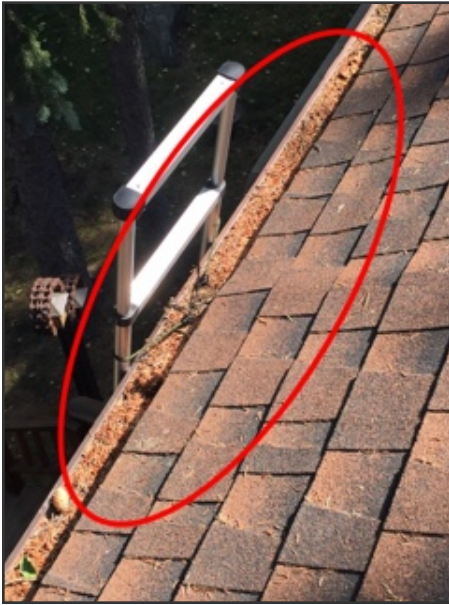
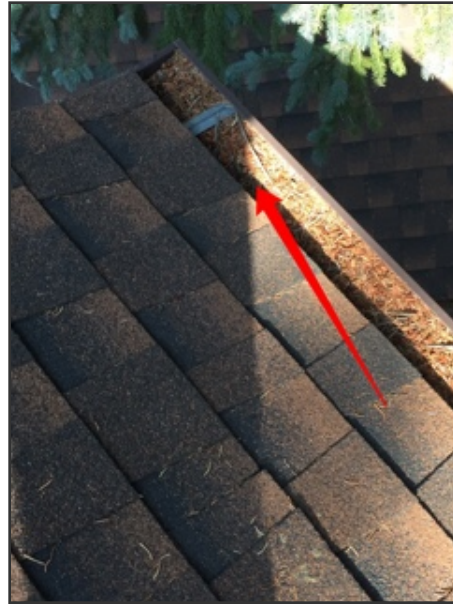
Evergreen trees are in contact with power line and the roof on the northeast and northwest location. They should be trimmed back and mitigated to ensure no electrical grounding issues as well as limiting pine needles in gutters.

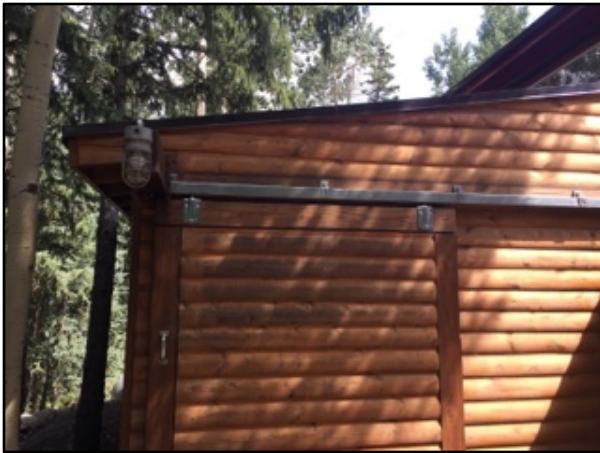
Figure 3-1

Log construction .

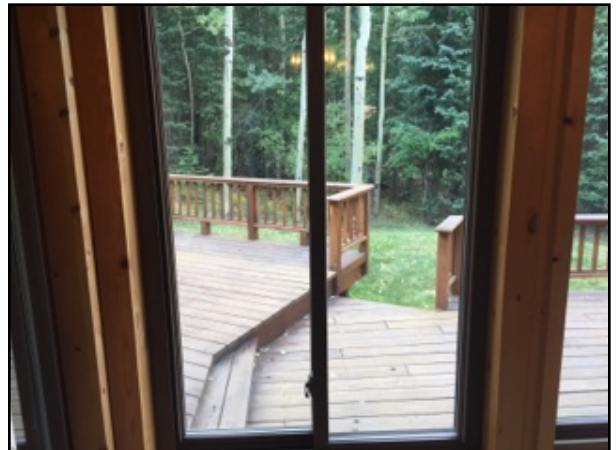
Figure 4-2

Windows are a combination of vinyl and original wood casement windows. Most of the wood windows are sealed shut and weren't operational during this inspection. All appear in good condition.

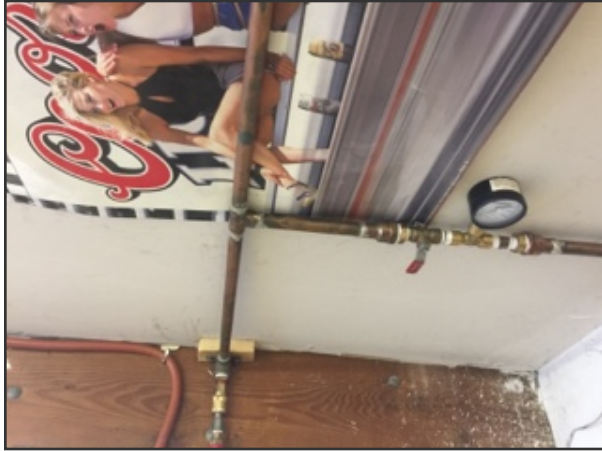
Garage is a detached 3 car with connection for LP gas heater, electrical sub panel for living structure above garage. All 3 garage door opener operating normally and safety features are operational as well.

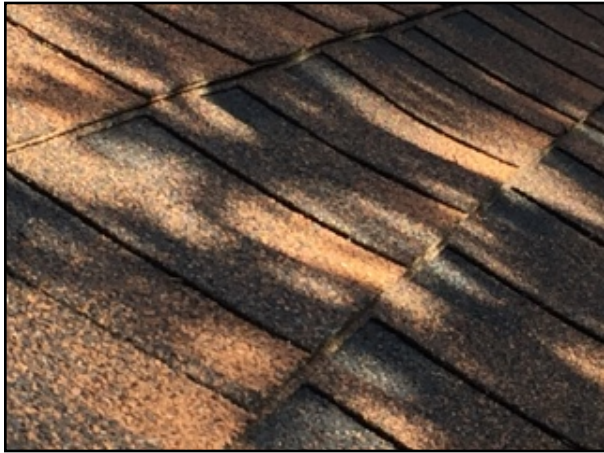
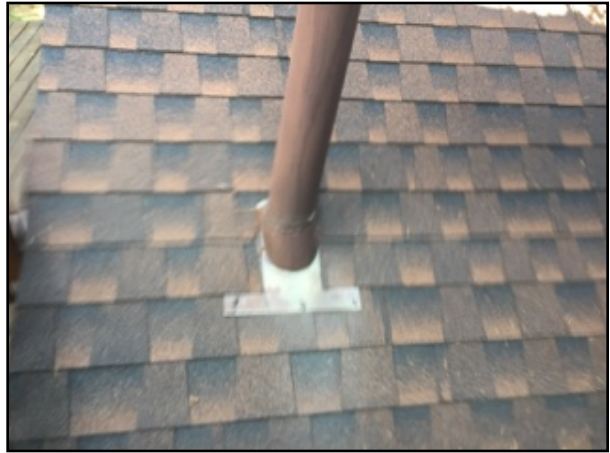
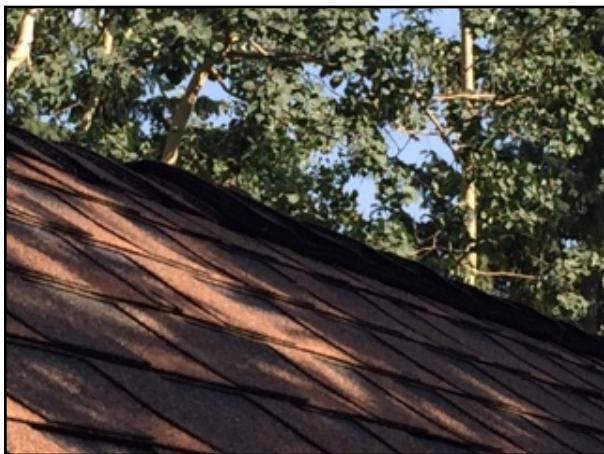
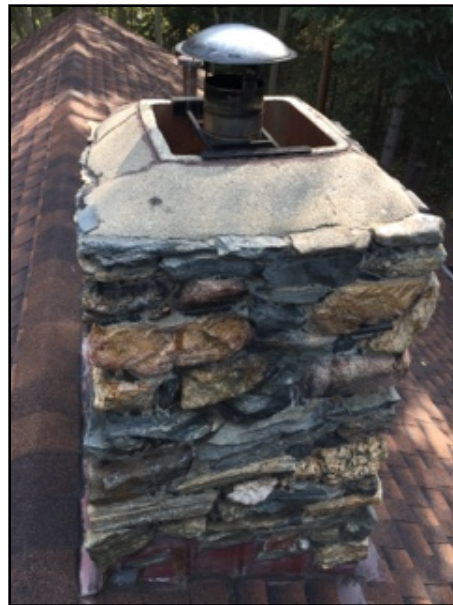
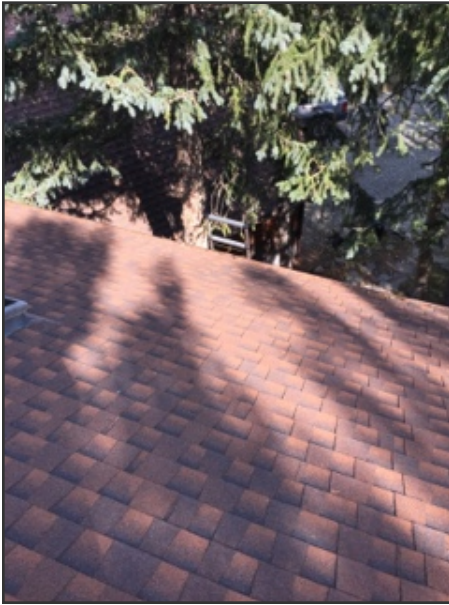
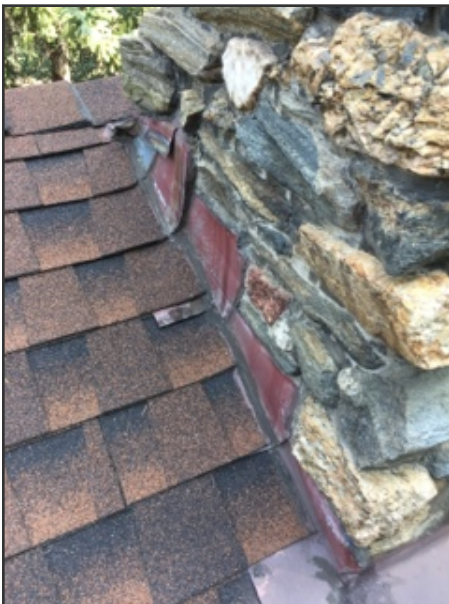
There is a great deal of debris from pine needles in gutter. They should be cleaned and the trees near the area should be trimmed back. The roof is generally in good condition.

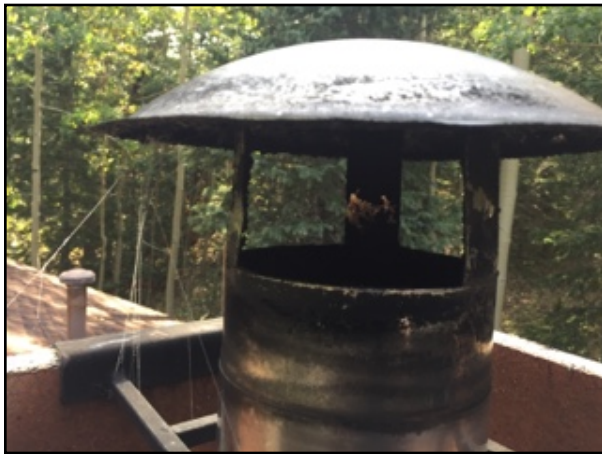
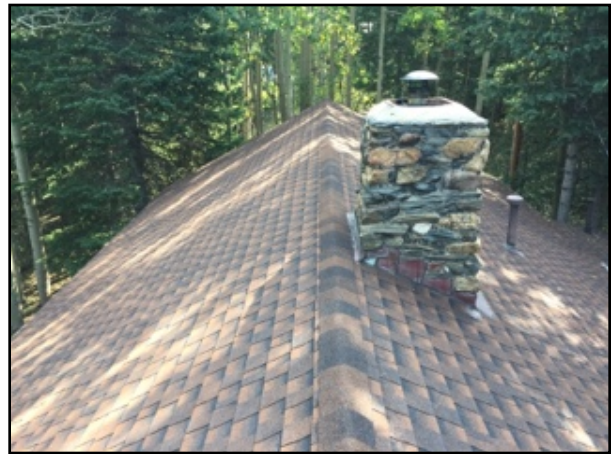
Vent stacks, skylights and chimney appear to be sealed well and are in good condition.

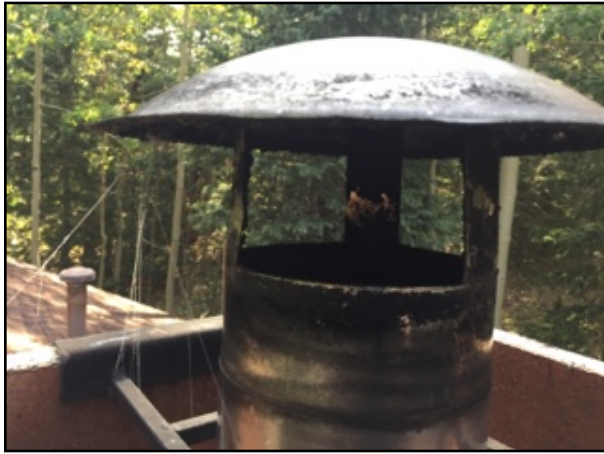
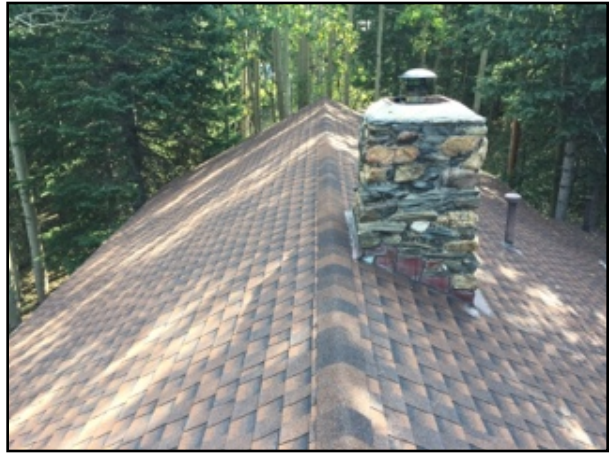
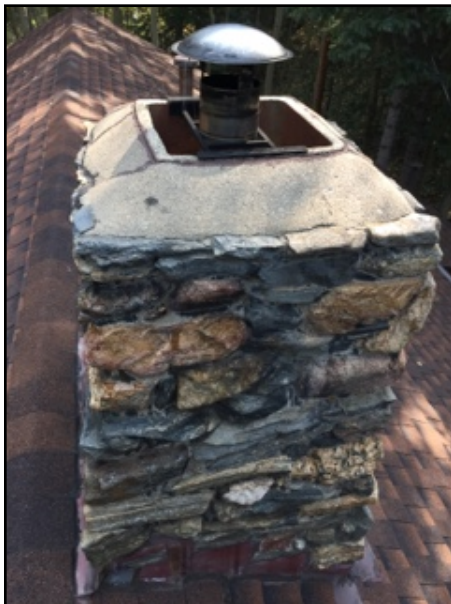
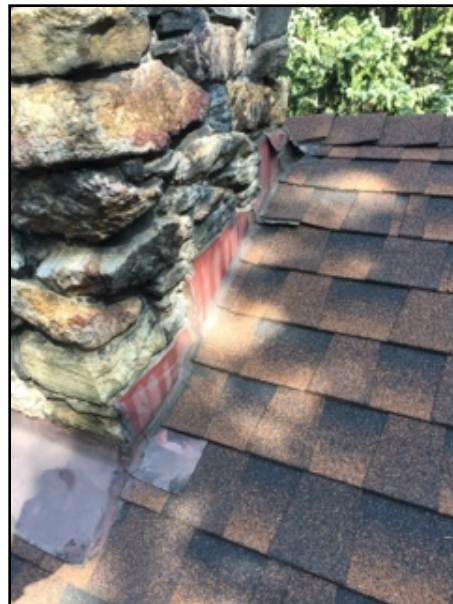
Chimney cricket, cap and flashing are in good condition.

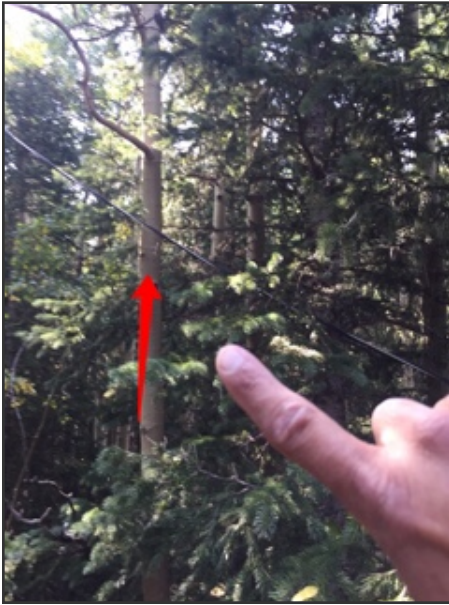
Comment 13:

Overhead power line in contact with trees near corner of home, should be trimmed or tree removed to ensure service reliability and safety.

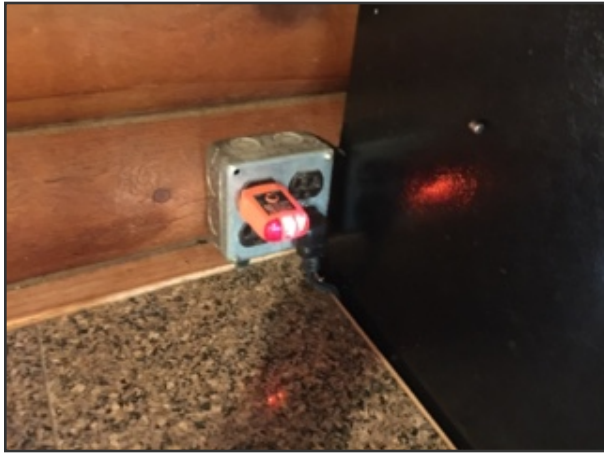
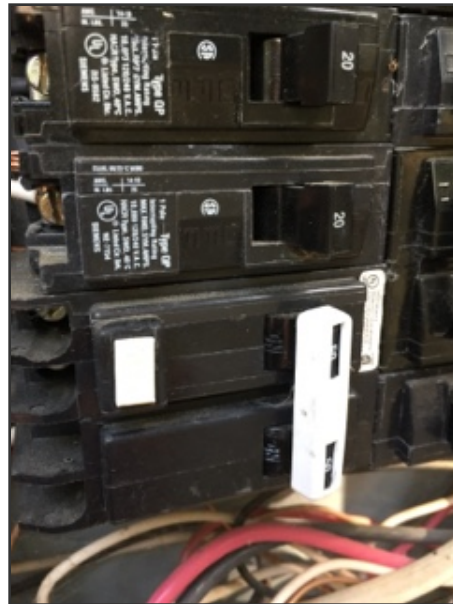
Comment 14:

Kitchen counter near sink and bathroom location both require GFCI circuits should be further evaluated by licensed electrician and corrected.

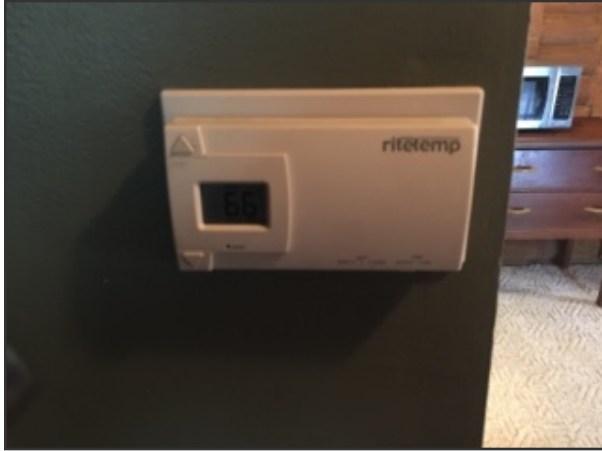
Comment 16:

Main unit has LP gas fed forced air furnace and front sunroom expansion is fitted with electric baseboard heater units. Both systems operating normally during inspection period.

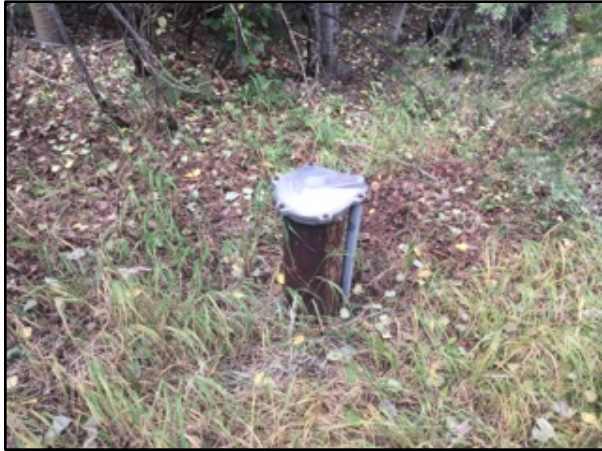
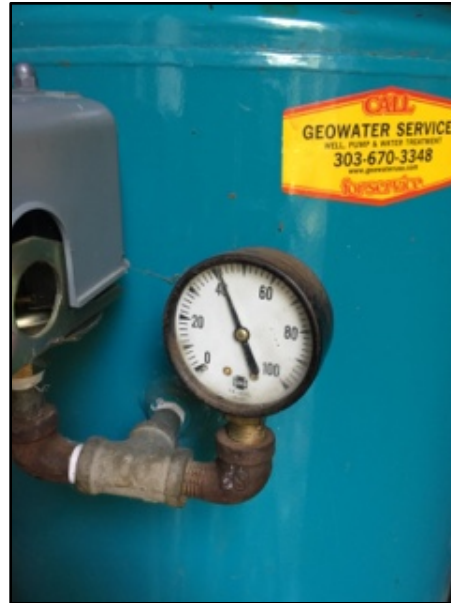
Comment 19:

Water tests on well recovery and water quality have been performed and have adequately passed previously to today's inspection.

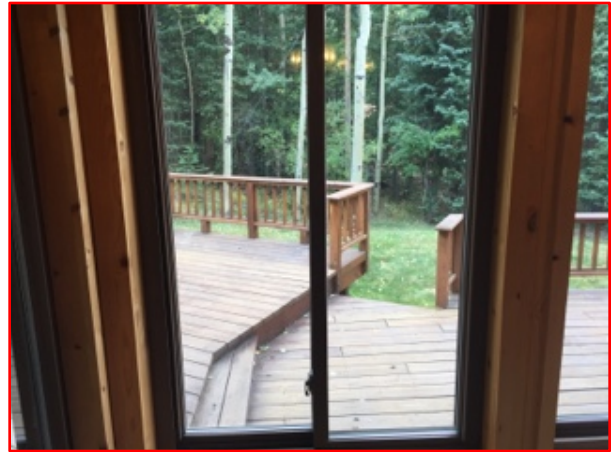
Figure 4-2

2) Windows are a combination of vinyl and original wood casement windows. Most of the wood windows are sealed shut and weren't operational during this inspection. All appear in good condition.
