285 Home Inspection Services LLC

Home Inspection Report

2287

Roland Drive

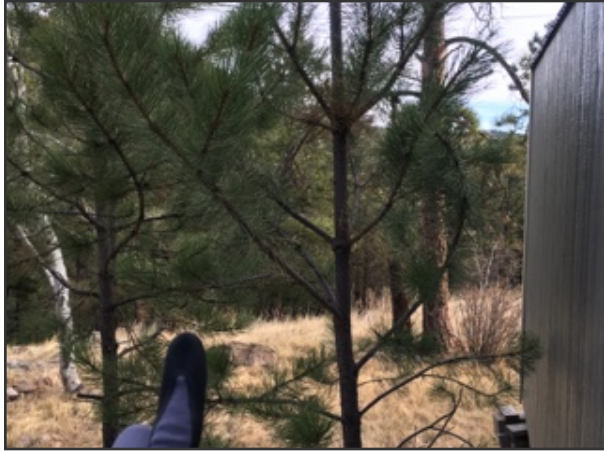
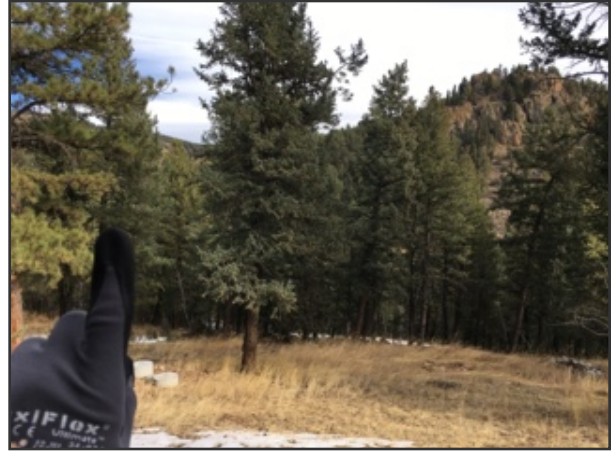
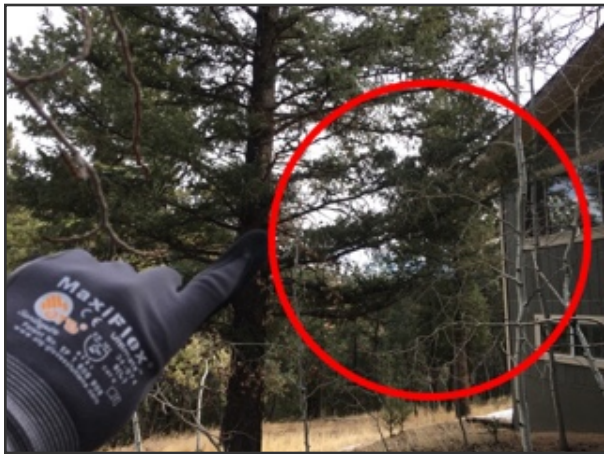
Growing Against Structure
Condition: Marginal

It is highly recommended that all Evergreen, conifer, and spruce trees be limbed up properly or completely removed when near the structure. These trees act as accelerants in a fire situation and should be removed or mitigated professionally.

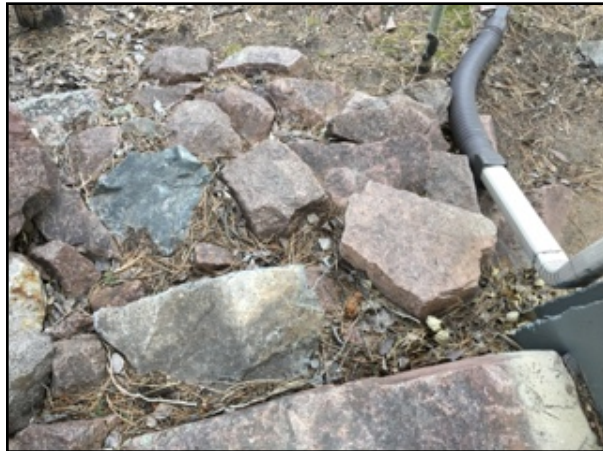
Walkways:

Stepping Stones

Condition: Marginal

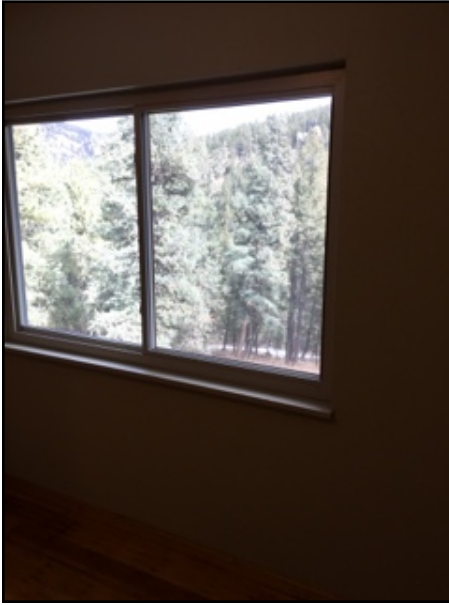
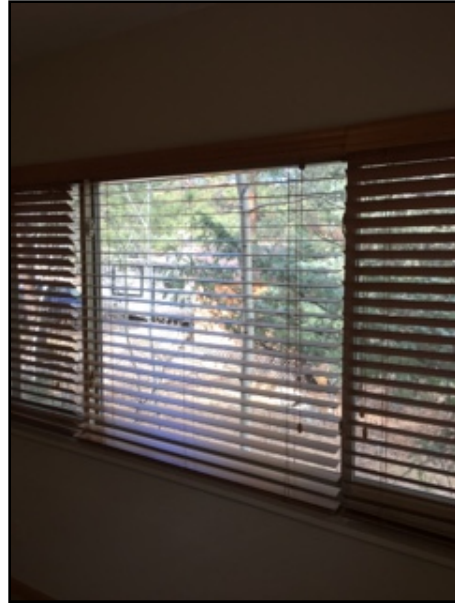
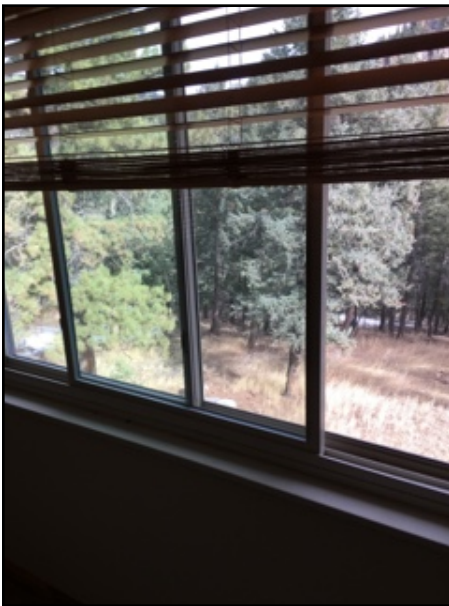
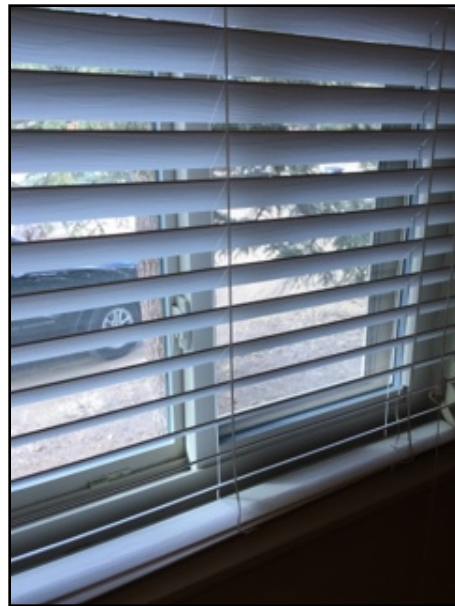
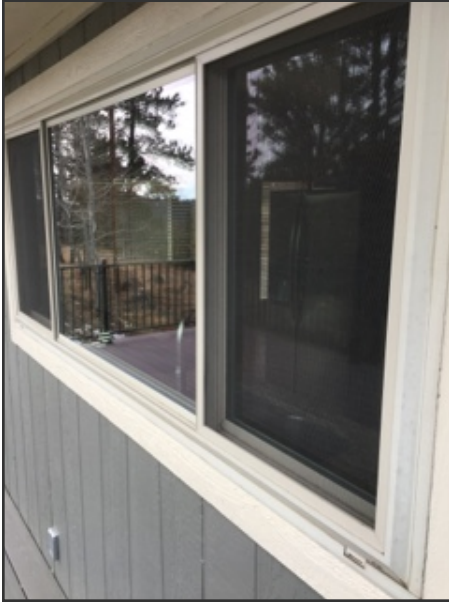
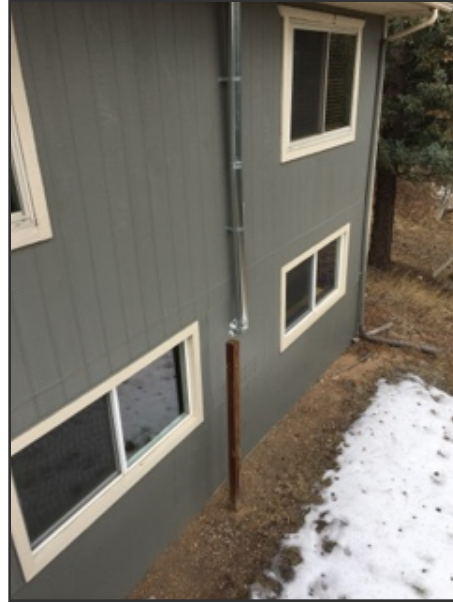
Windows:

The homes windows appear to be in good physical condition no broken seals.

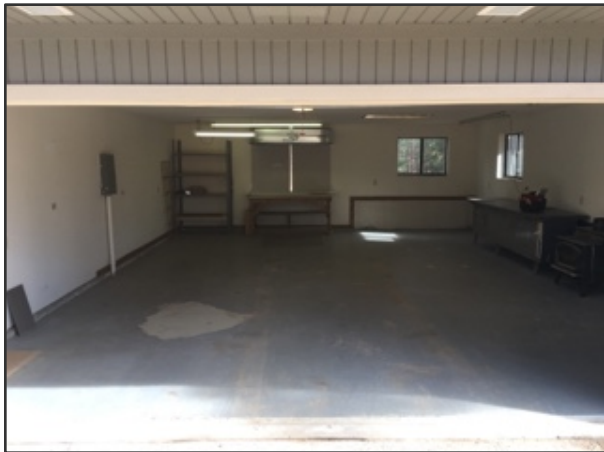
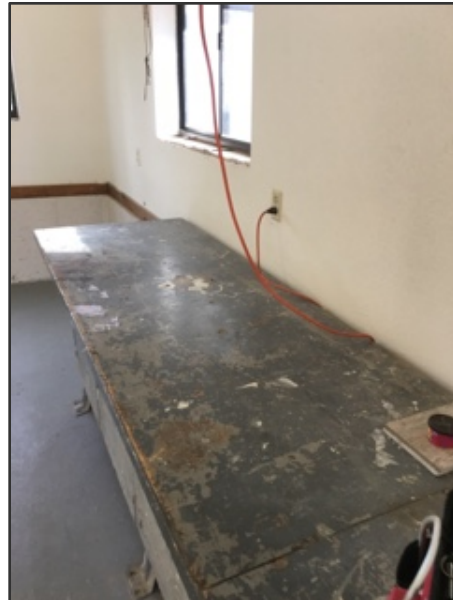
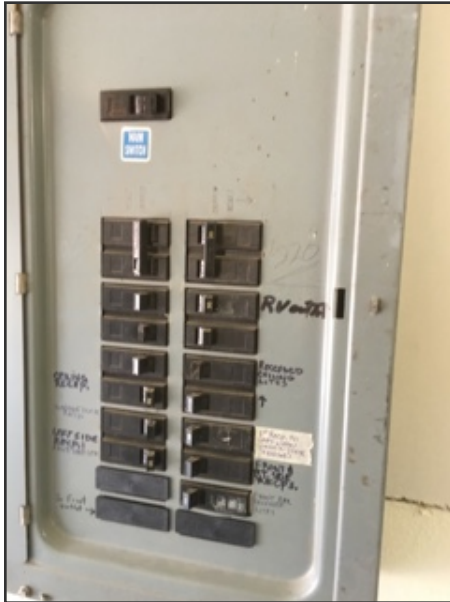
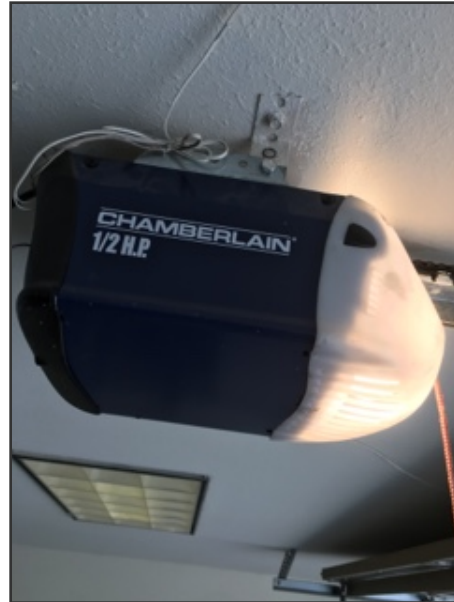
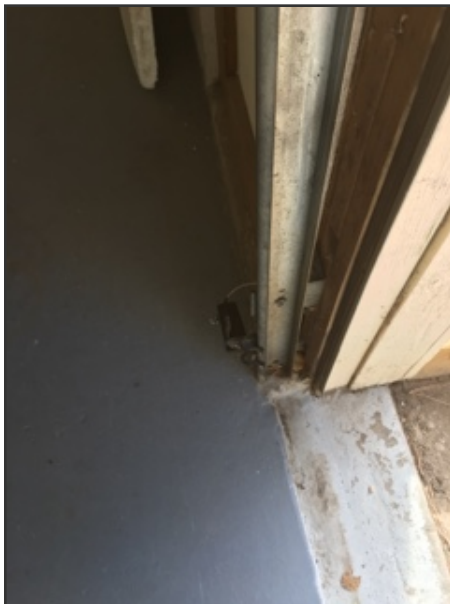
This home has a detached two car garage with a rollup door electric garage door opener with safety I sensors. No issues were found in the garage during this inspection.

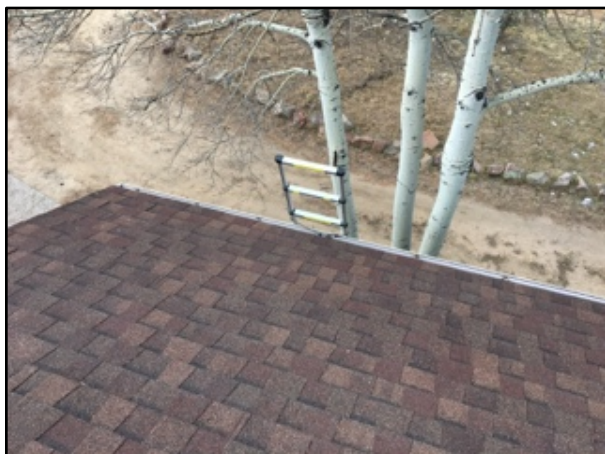
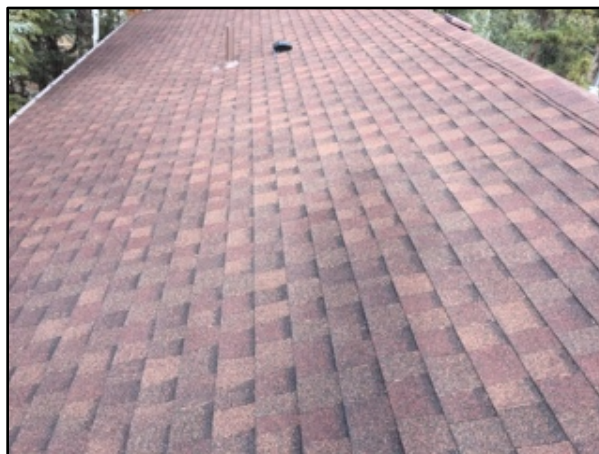
The roof appears to be in very good and new condition no problems found on the roof. As indicated in the photographs any spruce trees nearby should be trimmed back so as not to touch the roof area.

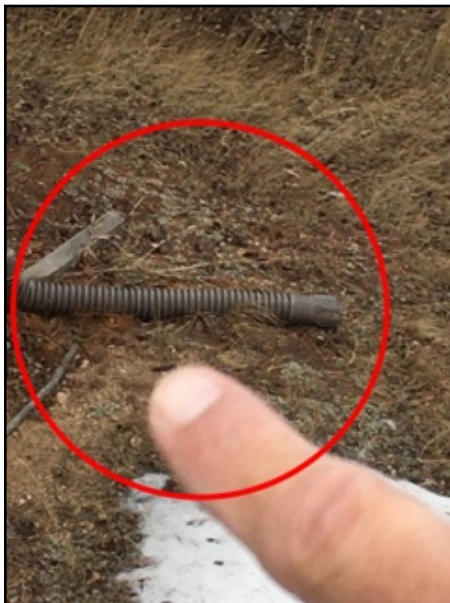
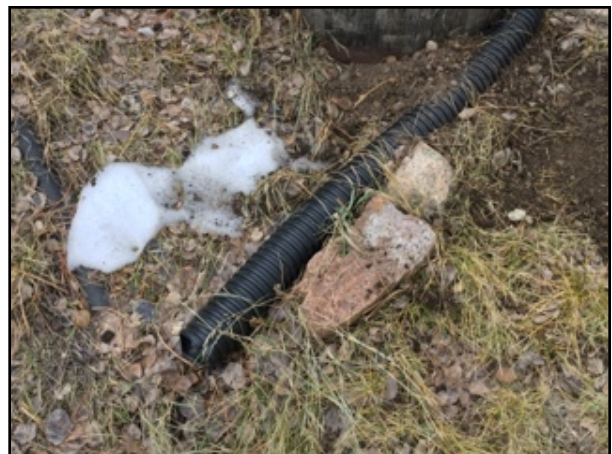
Where indicated with the red highlights the downspout should be extended away from the home approximately 5 to 7 feet minimum. The gutter on the rear of the home towards the north east corner is loose and should be tightened.

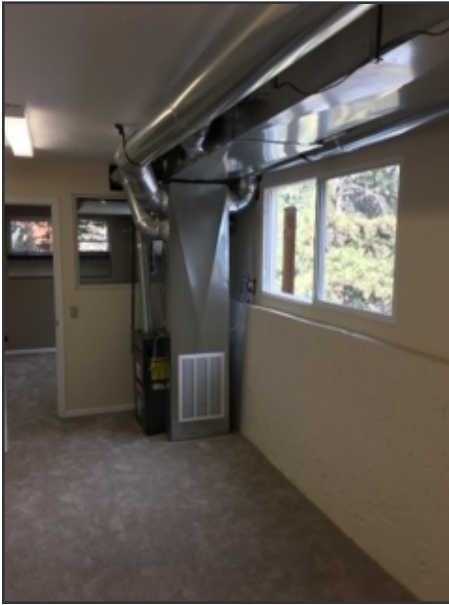
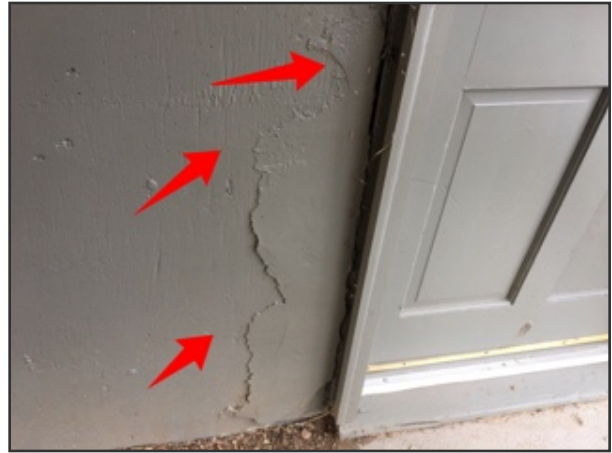
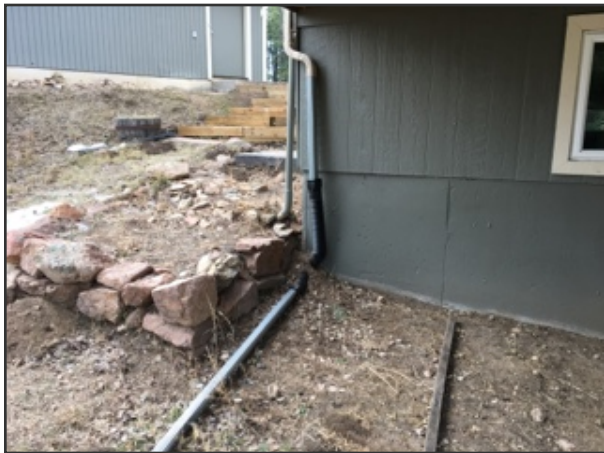
Upon inspection of this home is foundation generally speaking the home is in good condition. There are some areas where there is evidence of prior work on the foundation near the laundry room where the water heater is located. Where indicated in the photographs there is an aberration that has been worked on previously indicating that there may have been some digging in this foundation. It is highly recommended that he structural engineer review the foundation flaws as pictured. Additionally there is no floor drain located in this area.

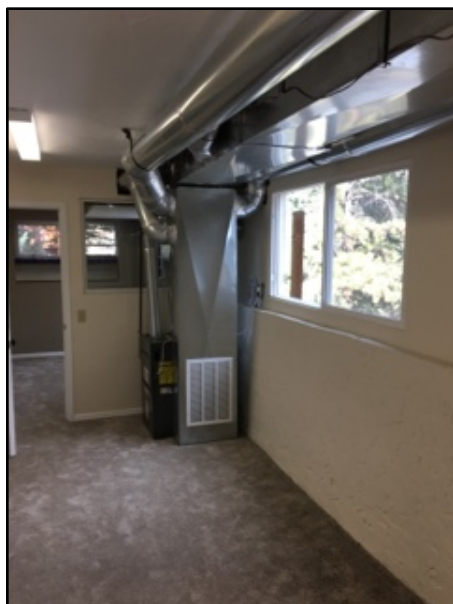
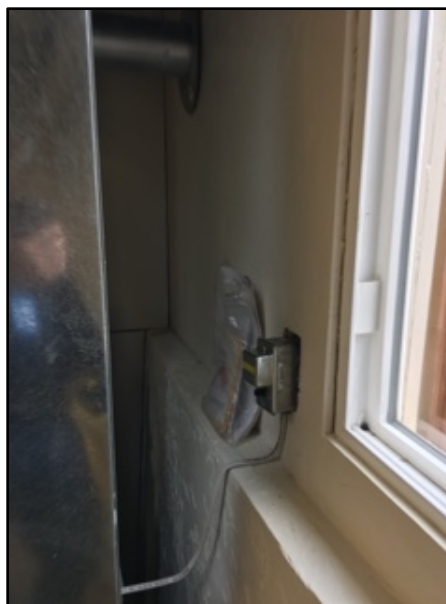
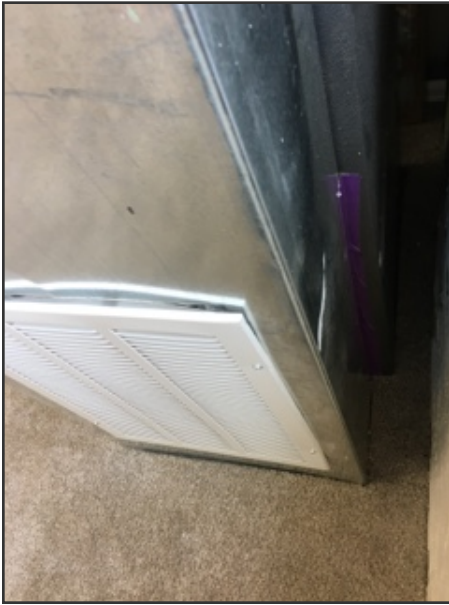
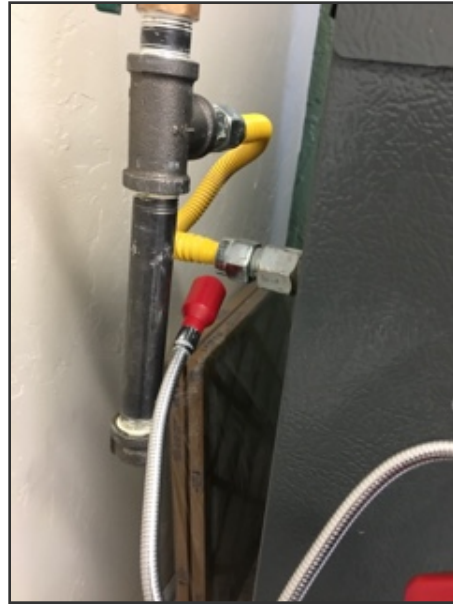
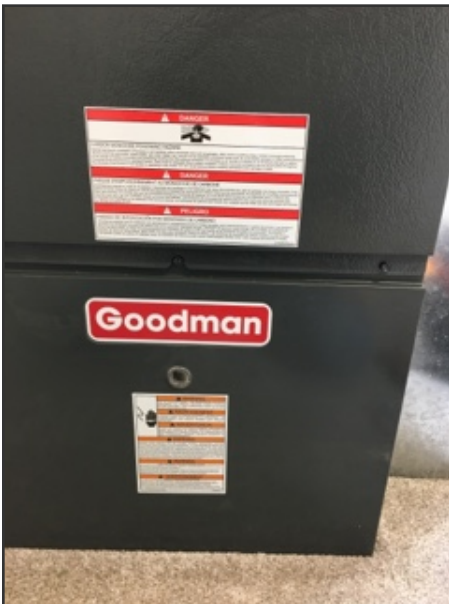
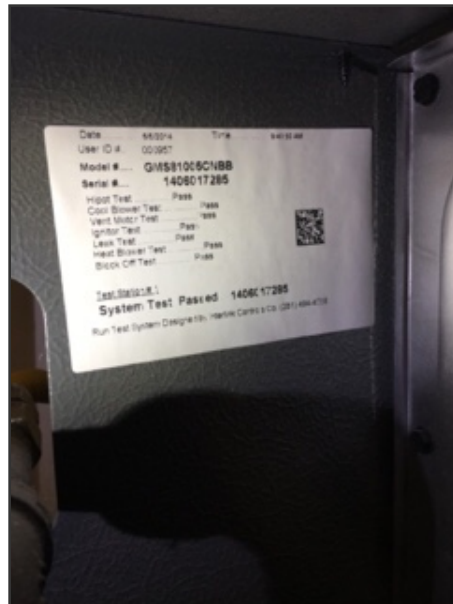
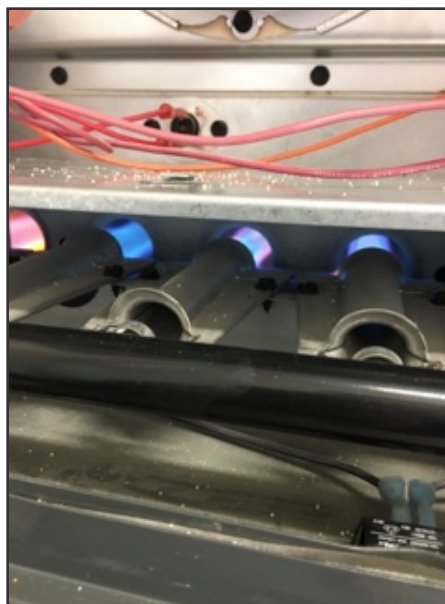
The natural gas forced air furnace operated very well throughout this inspection. It is noted that this is a high altitude unit from Goodman created in 2008 and installed in 2014 no problems found. It is always recommended that a furnace should be cleaned and certified prior to use.

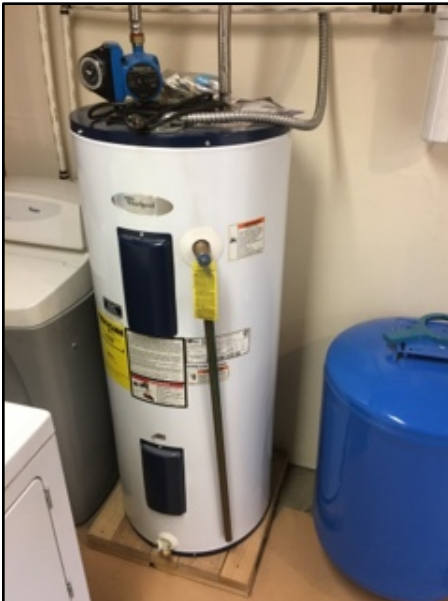
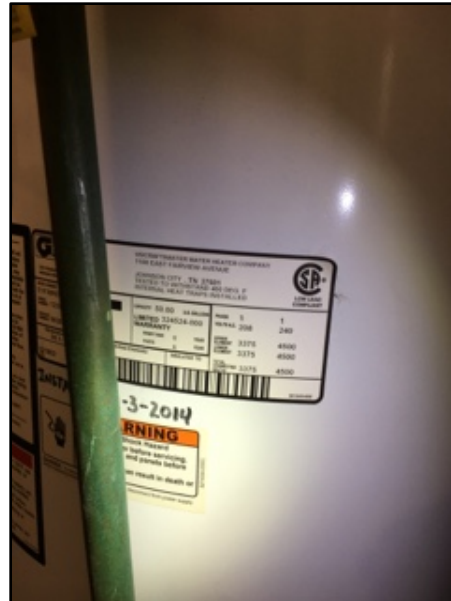
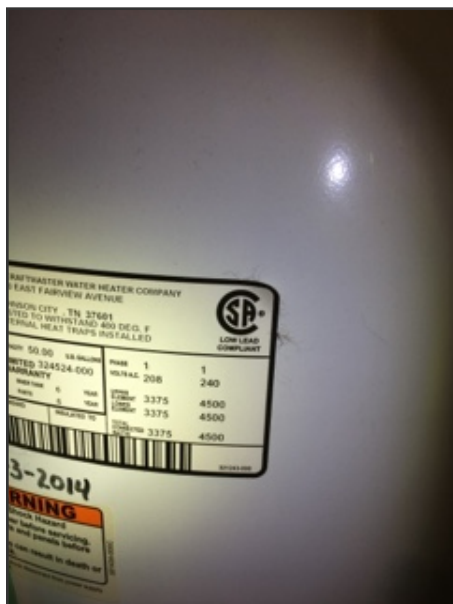
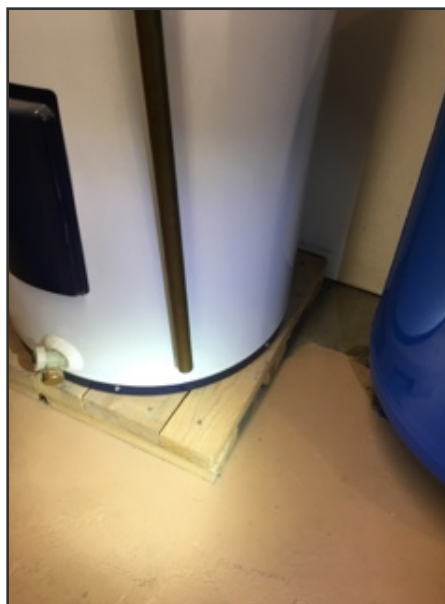
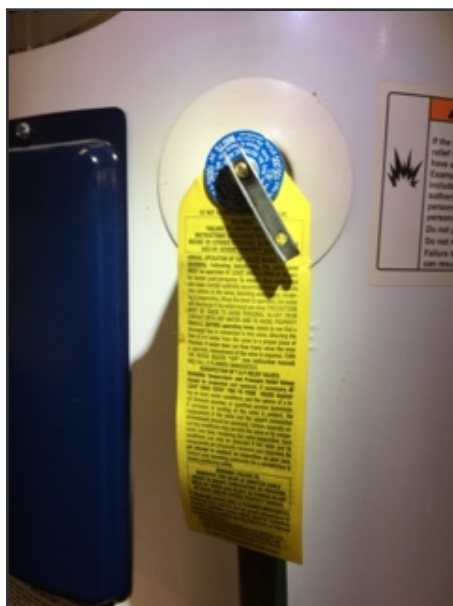
Electric
50 gal
2014 installation of a 2008 unit
Present With Blow Off Leg
Condition: Satisfactory
In Same Room

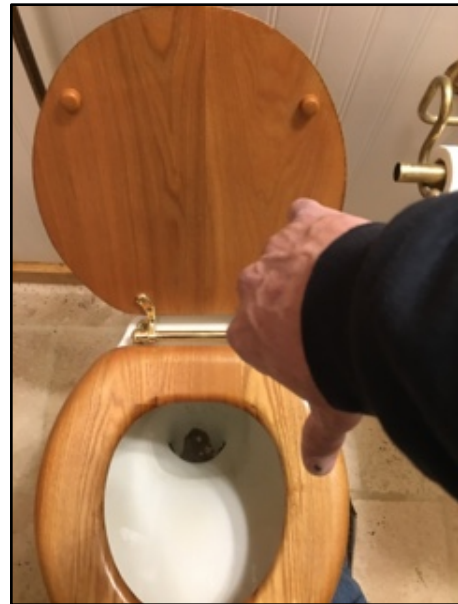
Figure 9-2

Bathroom number one is located near the master bedroom. All were found to be serviceable except for the toilet which is loose all items function properly during this inspection.

4) Bathroom number one is located near the master bedroom. All were found to be serviceable except for the toilet which is loose all items function properly during this inspection.

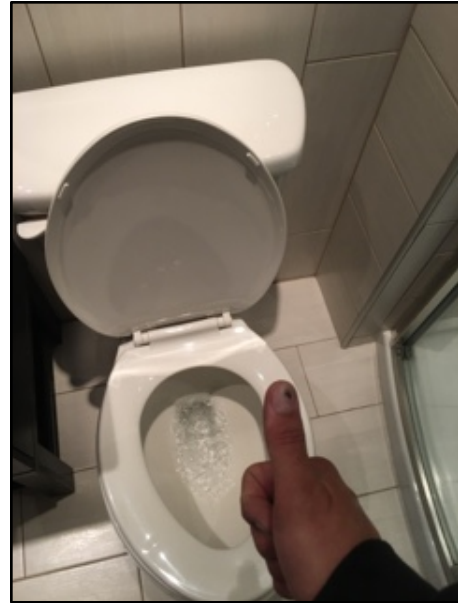
Figure 11-2

Bathroom number two had no issues found everything work properly in this location.
