# 285 Home Inspection Services LLC

## Home Inspection Report

**27295 Spruce Lane**

Inspected on Fri, May 3 2019 at 4:24 PM

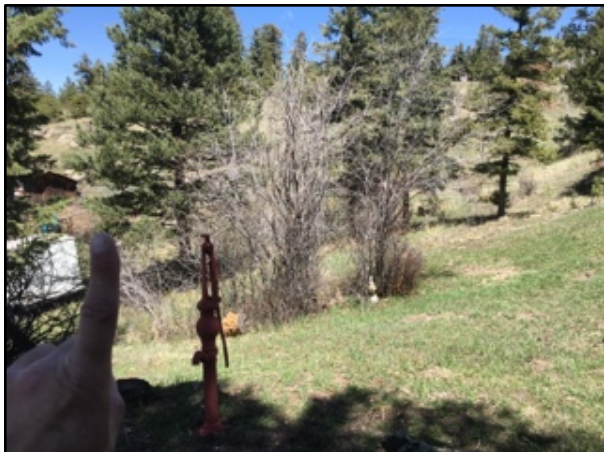
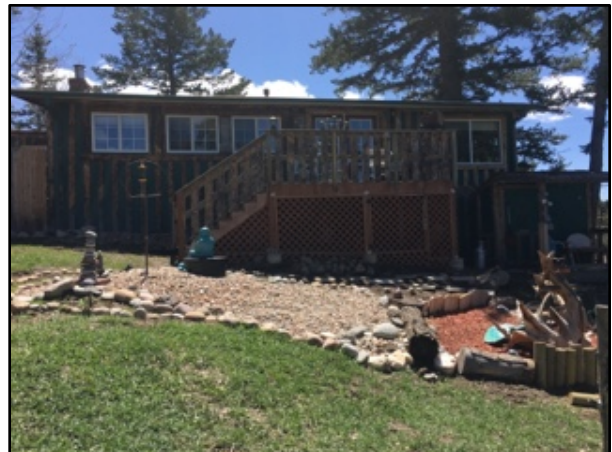
Site Grading: Sloped Toward Structure  
Condition: Satisfactory

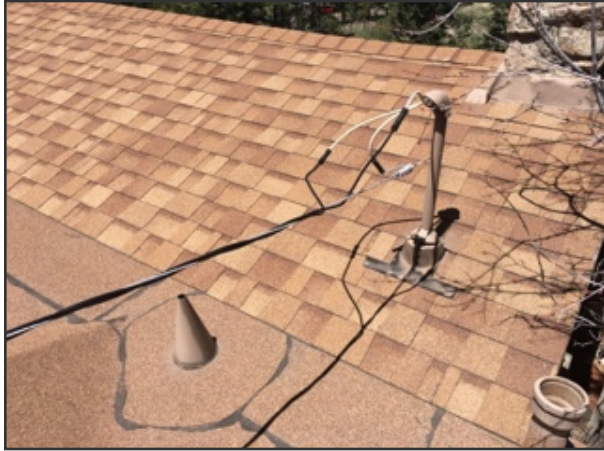
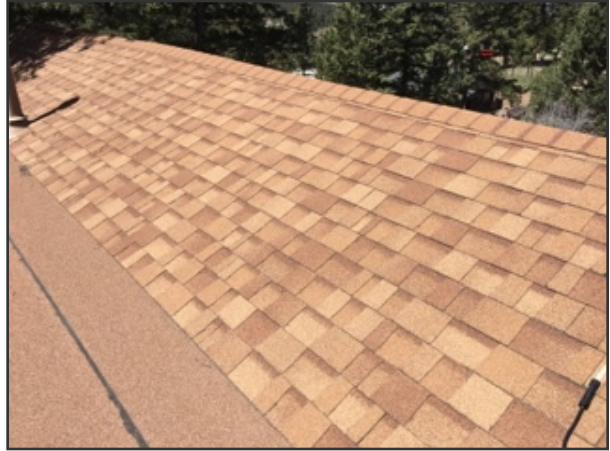
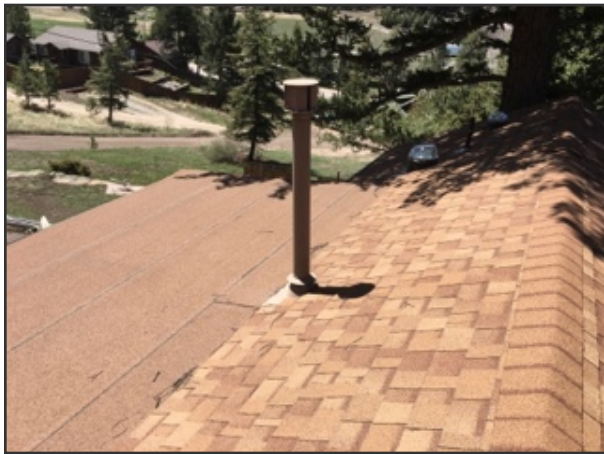
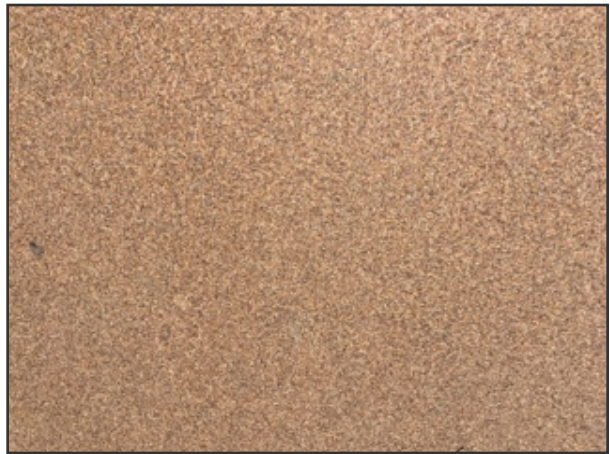
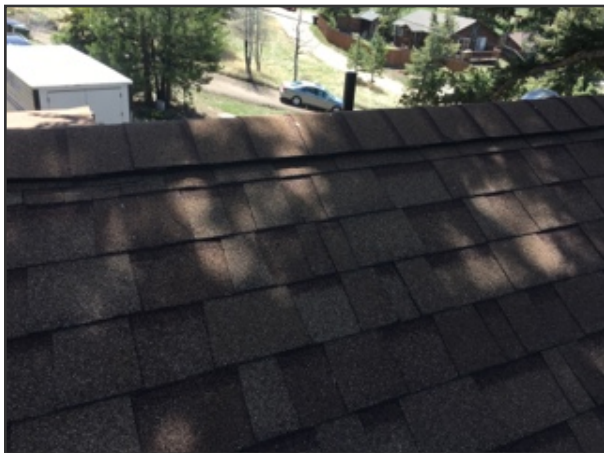
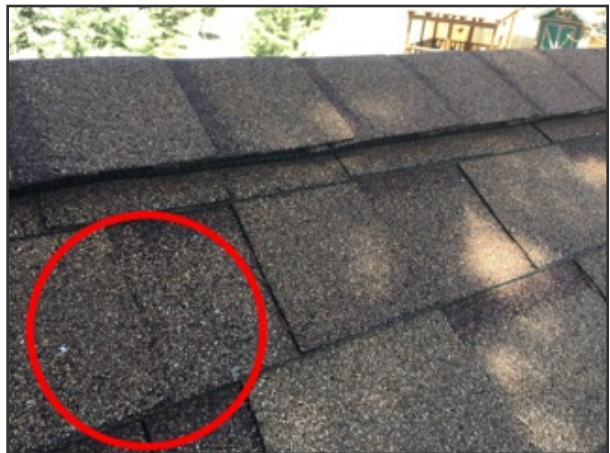
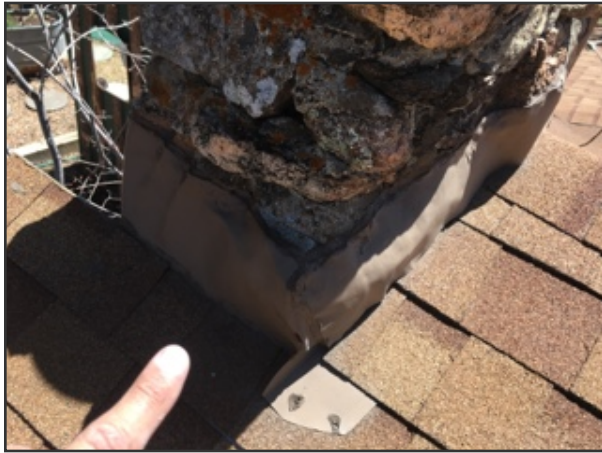
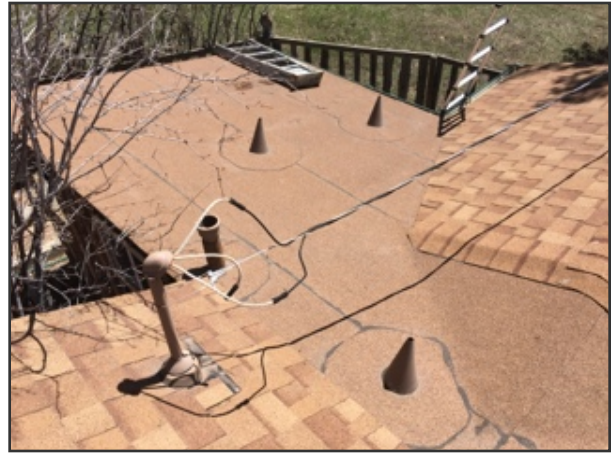
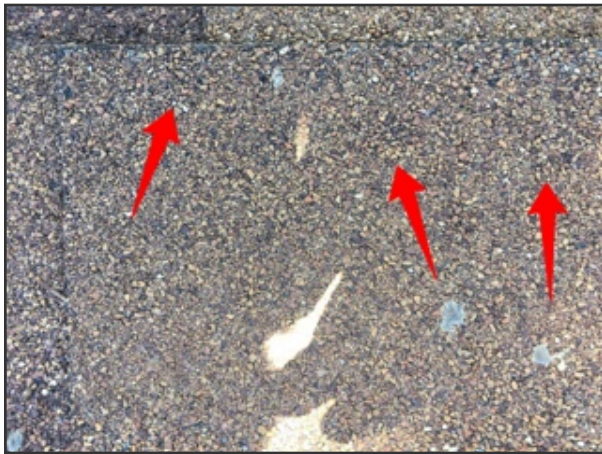
**Comment 3:**

The roof at this property is a combination of three tab asphalt shingle and modified bitumen flat roofing. The roof appears to be reaching the end of its effective life and should be further evaluated by a competent roofing company.

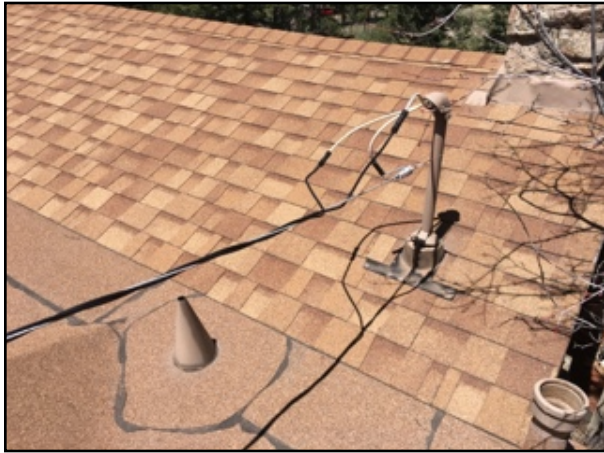
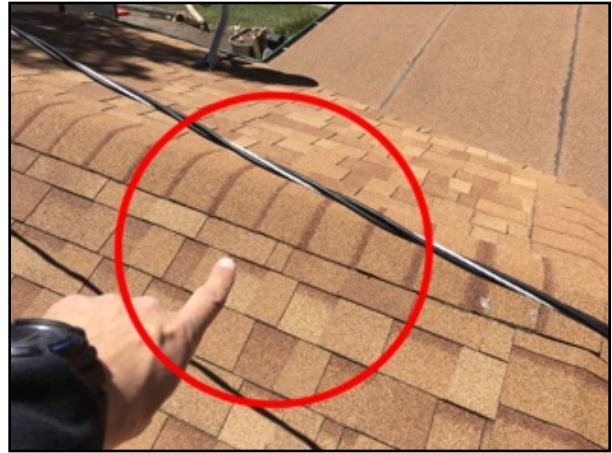
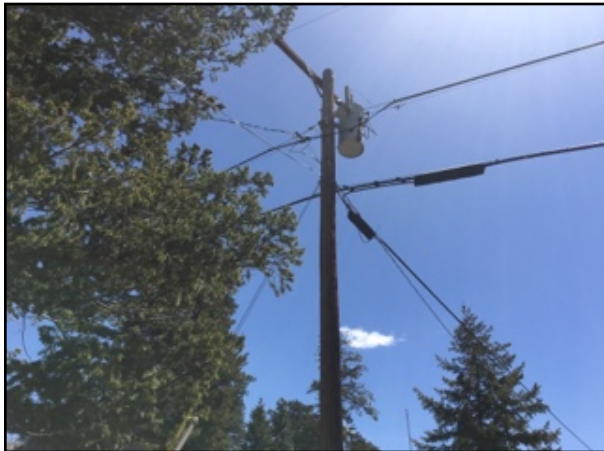
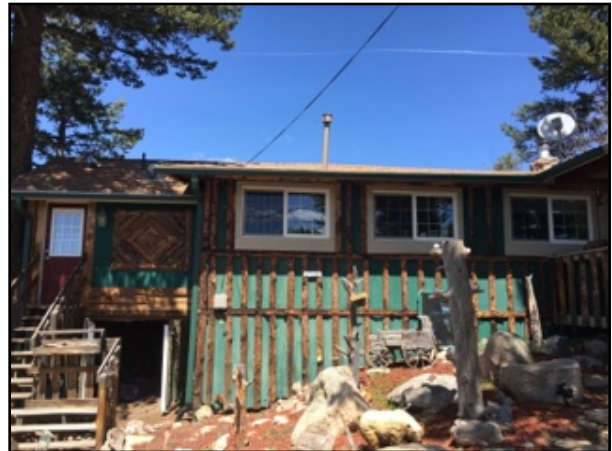
Although not an immediate problem the height between the power connection to the mast and the top of the roof is less than 3 feet which could be a problem when there is a high snow amount.

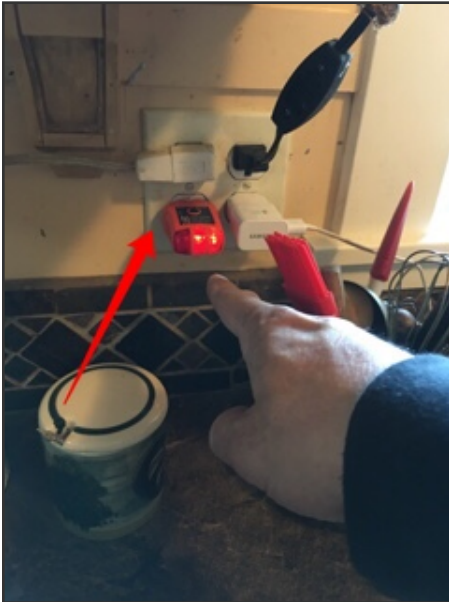
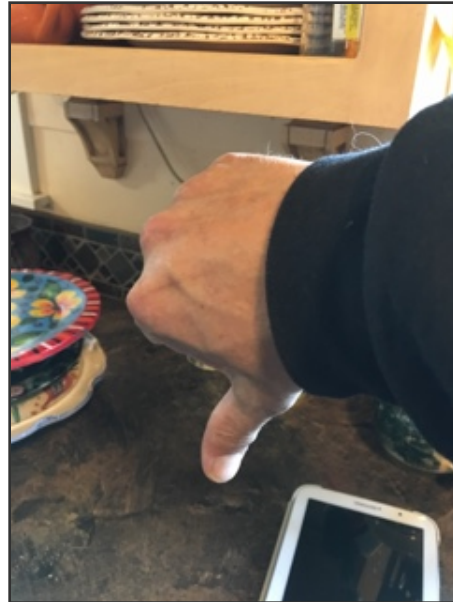
The three locations in the house where GFCI should be in place are the bathroom near any water sources and in the kitchen. As indicated in the photograph both bathrooms have GFCI outlets that work properly. The kitchen to the left of the main sink location does not have GFCI connection and should be further evaluated by a licensed electrician.

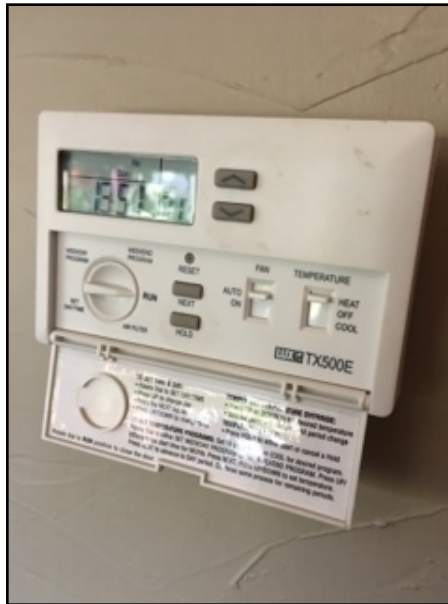
Programmable  
Condition: Marginal

In addition to the heater not functioning properly during the inspection it is noted that there is a ventilation pipe running directly through the closet on the main floor this should be addressed by a licensed HVAC professional to determine if this pipe should be enclosed or insulated.

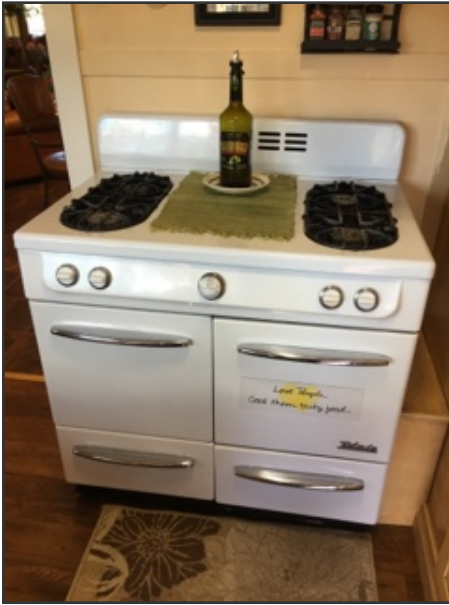
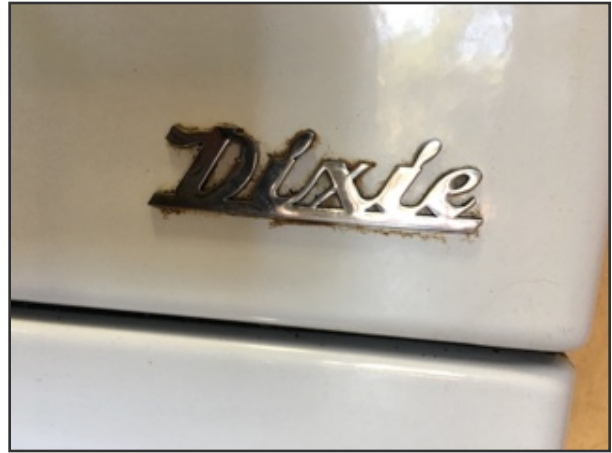
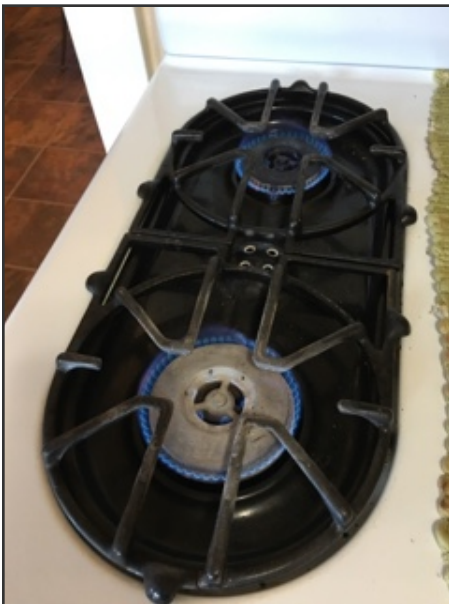
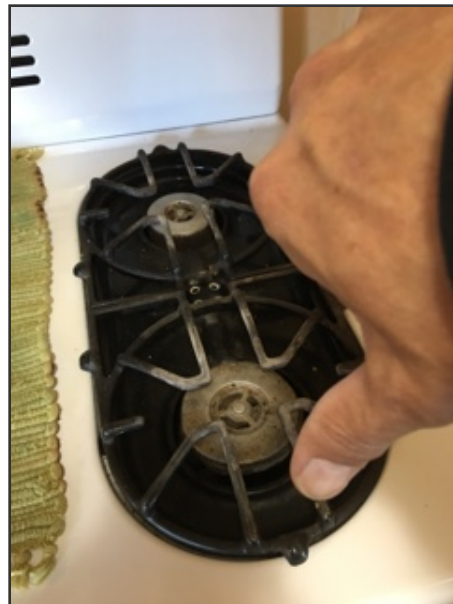
Cooktop:

Dixie  
Condition: Marginal

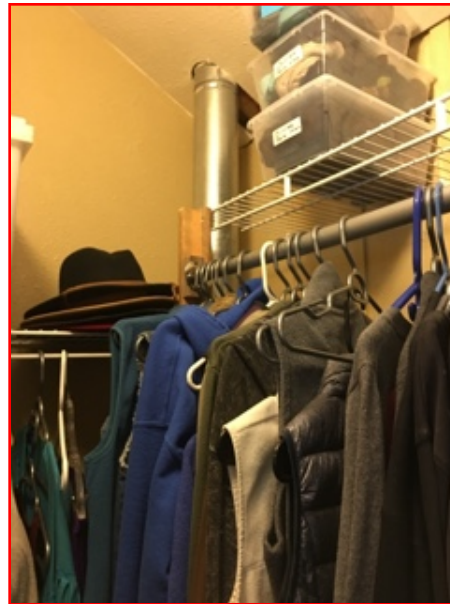
Figure 9-2

8) In addition to the heater not functioning properly during the inspection it is noted that there is a ventilation pipe running directly through the closet on the main floor this should be addressed by a licensed HVAC professional to determine if this pipe should be enclosed or insulated.
