285 Home Inspection Services LLC

Home Inspection Report

409 Ward Street

Inspected on Sun, Mar 10 2019 at 1:16 PM

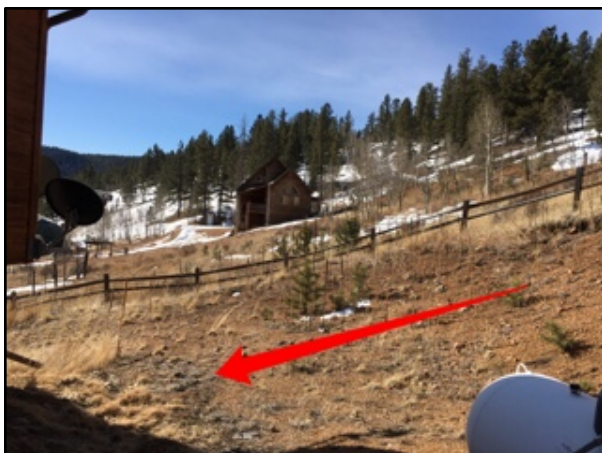
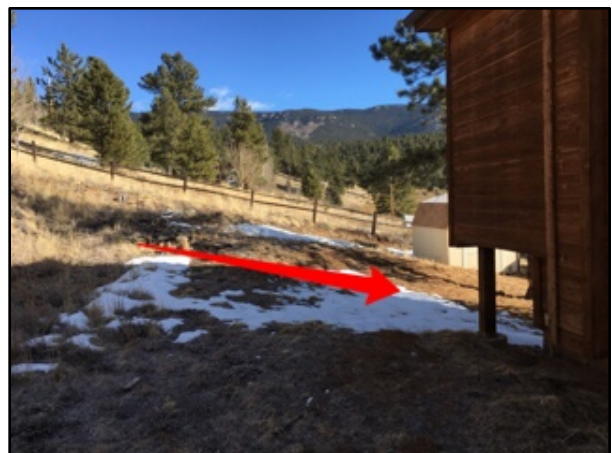
Site Grading: Sloped Toward Structure
Condition: Marginal

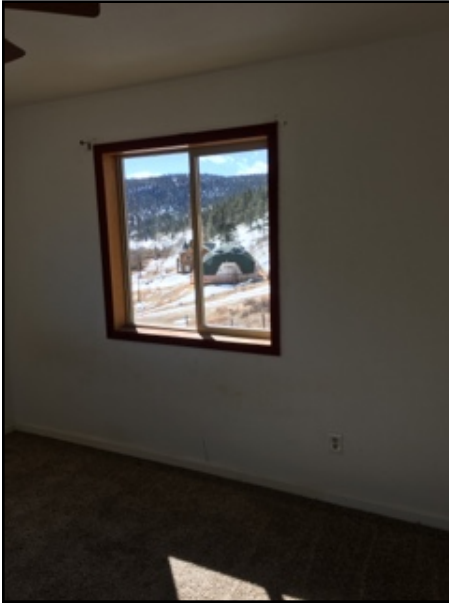
Windows in this home appeared to be in good condition and operate properly they are vinyl double pane windows. Where indicated in the photograph there is a torn screen which should be replaced.

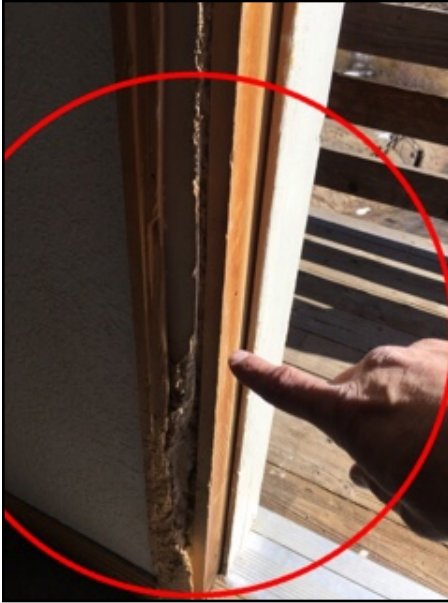
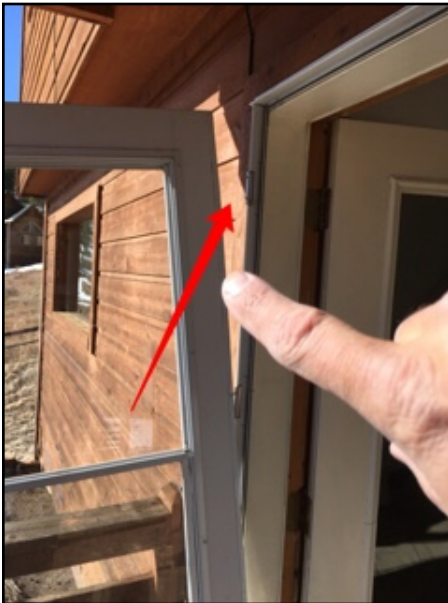
The main entry to the home is up at stairwell onto the upper level entry. Where indicated in this photograph the screen door is off its hinges and should be replaced otherwise the doors appear to seal properly and close correctly.

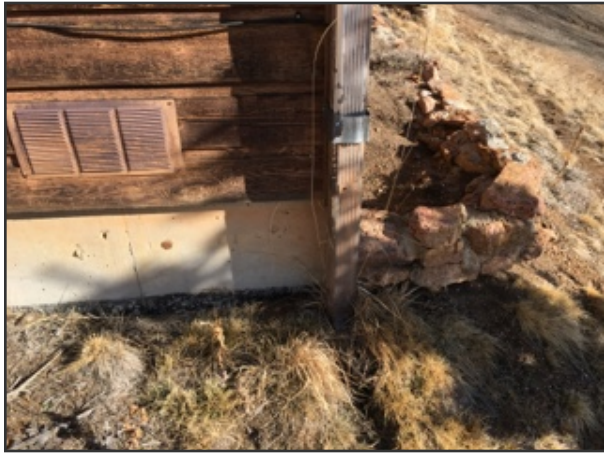
Signs of Water Penetration:

Moisture
Condition: Further Evaluation Required

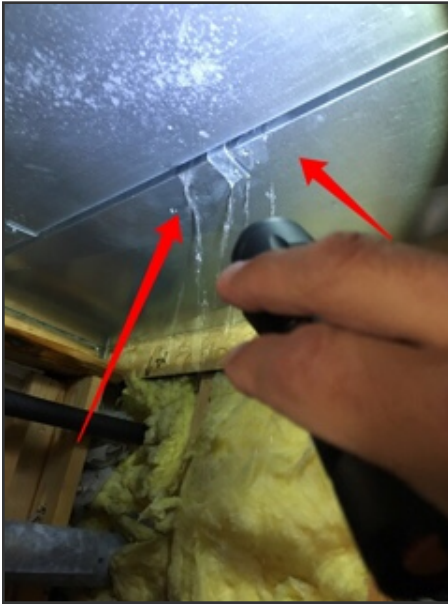
This home has an active water leak when I initially putting on the electrical for the pump to the well at the pressure tank there was a build up and subsequent major water leak in this home's lower level area. Water was pouring from the sink area upstairs in the kitchen and coming all the way through it is highly recommended that a professional plumber review and correct all plumbing issues in this home.

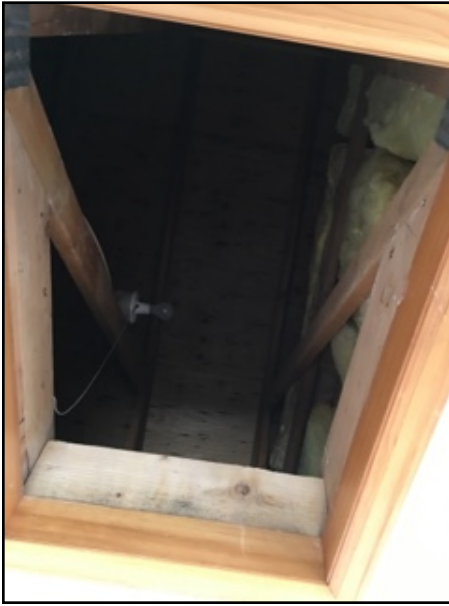
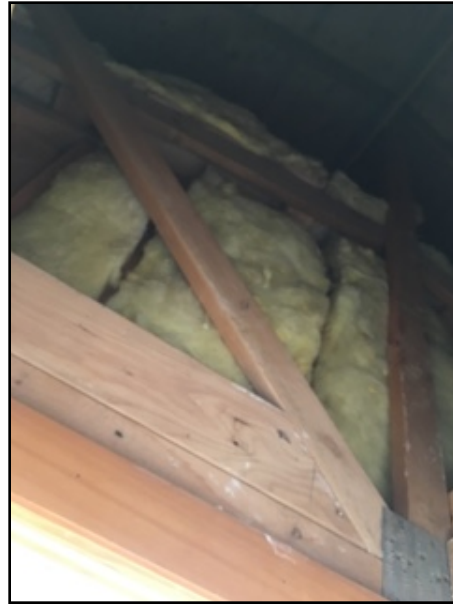
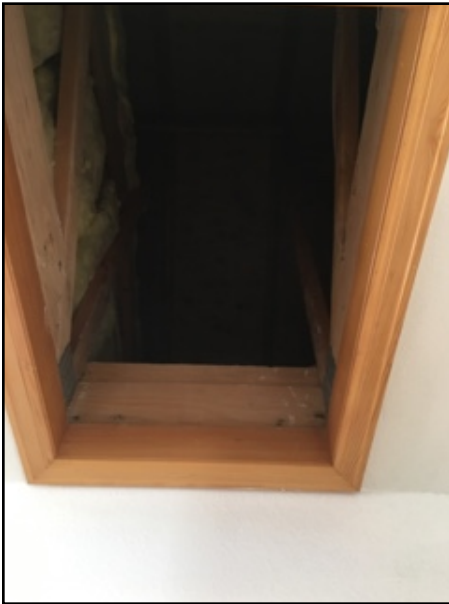
Hallway

The attic entry to this home is located on the upper level main hallway between the two bedrooms. During this inspection there was no cover on the attic access it is highly recommended that a cover be fabricated and put in place as the insulation and all of the heat what little there is would go to the attic area immediately.

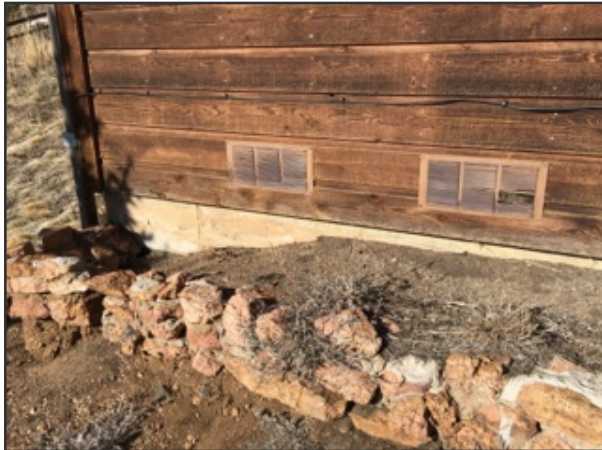
Moisture Condition:

Wet

Condition: Further Evaluation Required

In this home the crawlspace access was not investigated as all appliances such as water heating unit, well water pump, and water heater are all located on the main level. as this home has an active water leak it is highly recommended that all plumbing work be completed prior to crawlspace investigation.

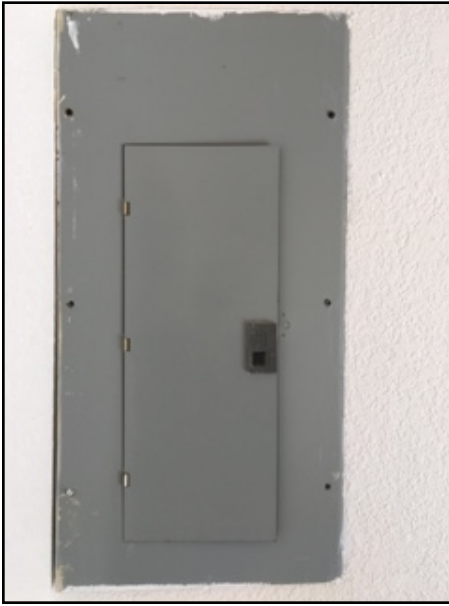
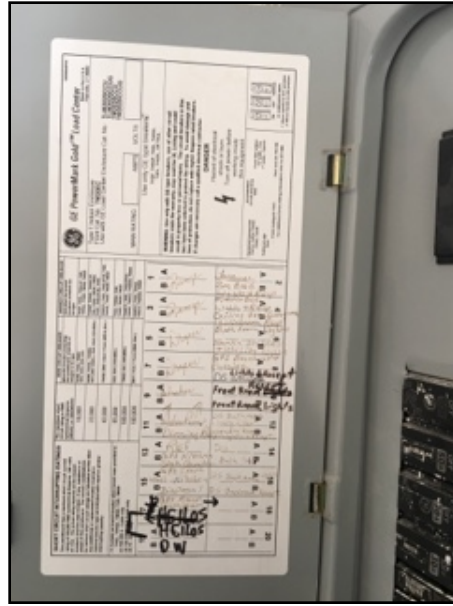
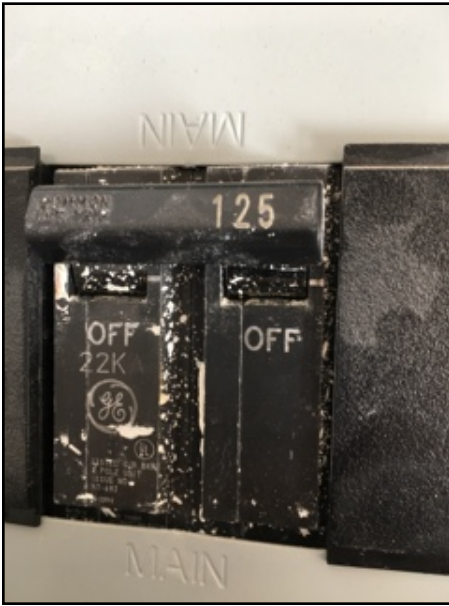
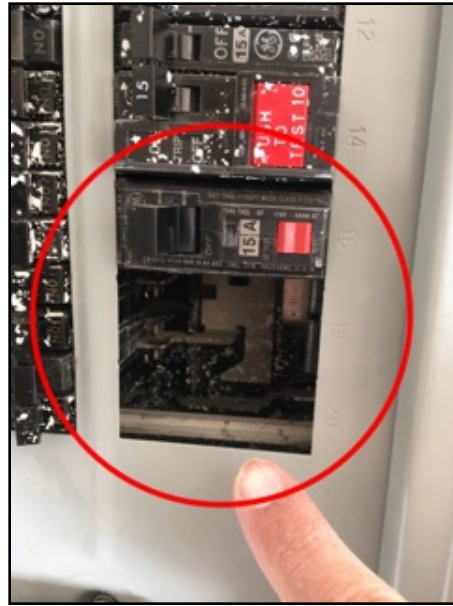
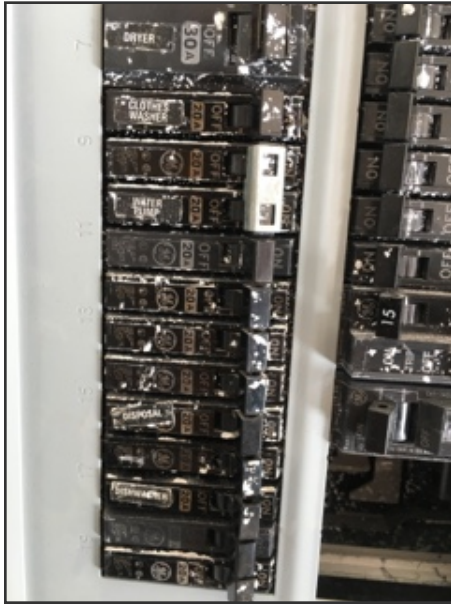
Electrical service for this home utilizes a 125 amp main circuit. As pictured there are missing cover plates on the service panel we should be replaced as to correct any possibility of a shock.

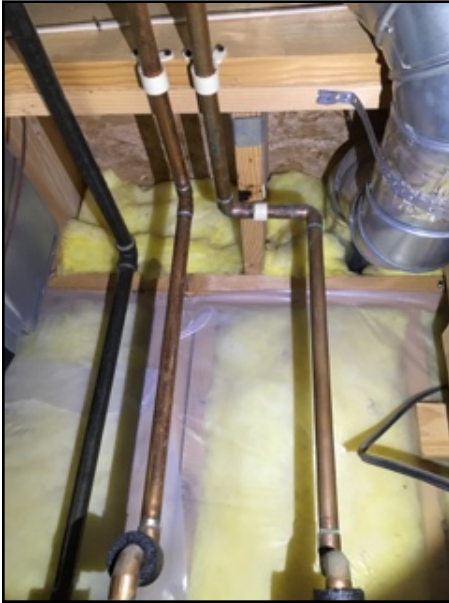
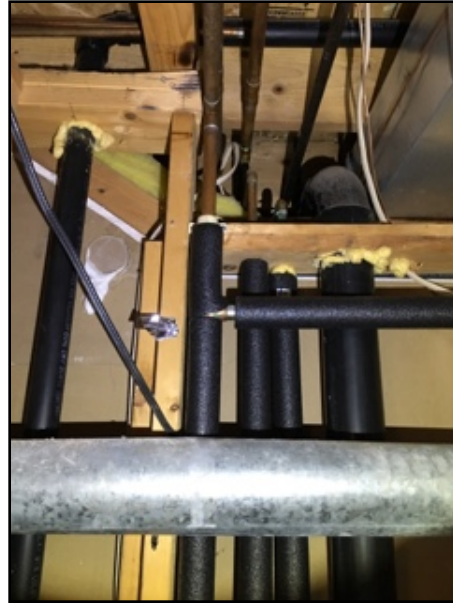
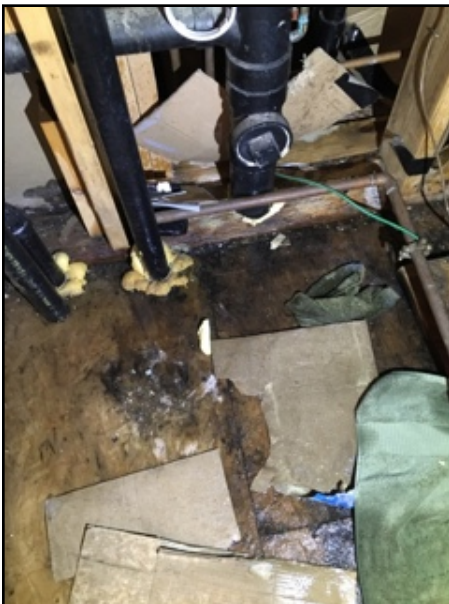
Pertaining to the water service the well may be working properly, however the supply line coming into the home is leaking very badly right above the water heater room. When the electrical connection is restored to the pump it severely overflows from the kitchen all the way down into the utility room. It is highly recommended that a professional plumber review and correct all supply line problems in this home as it will cause moisture issues.

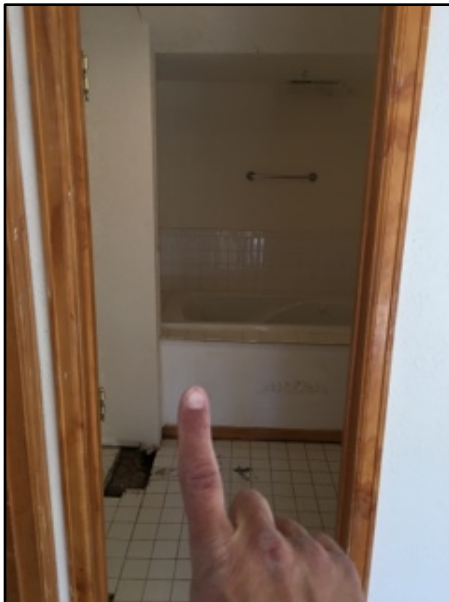
Figure 13-1

As stated before there is no water pressure in this home nor any gas so it was not possible to test the water pressure or temperature in the bathroom.

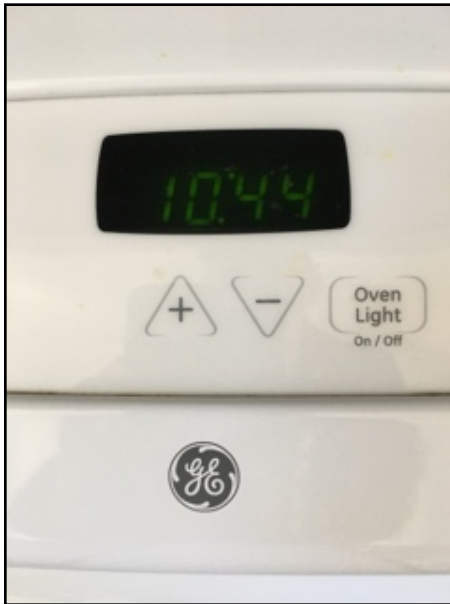
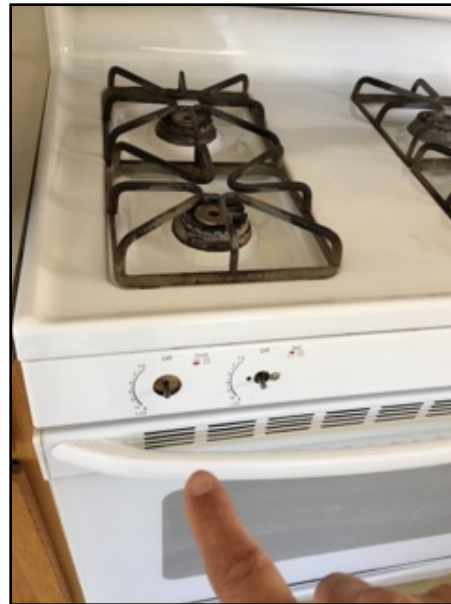
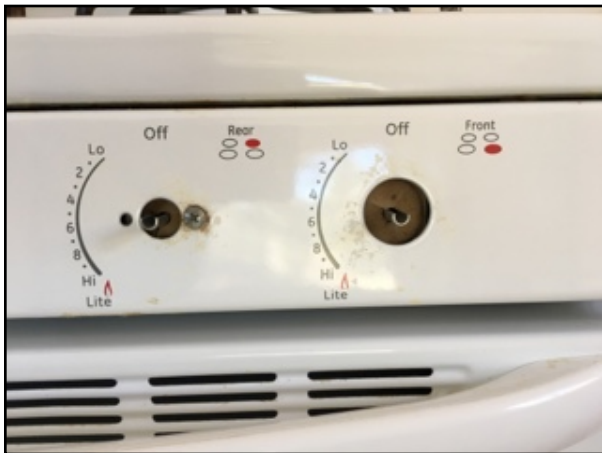
Condition: Further Evaluation Required

Comment 19:
No gas supply unable to test.

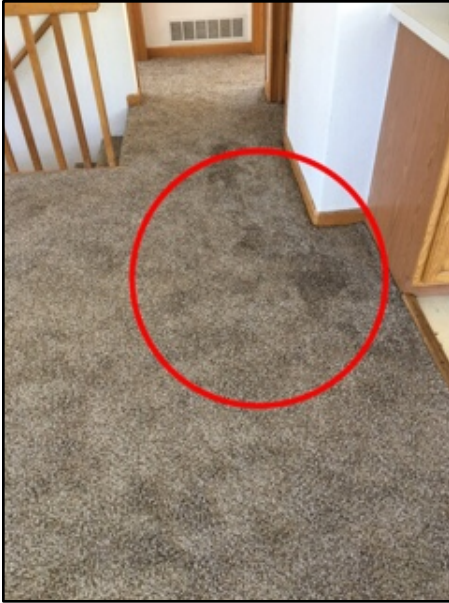
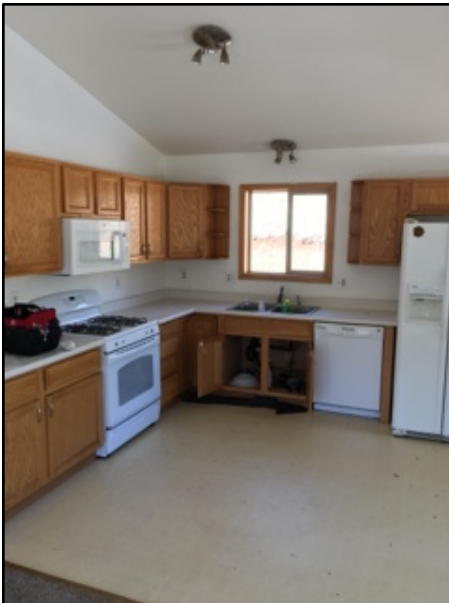
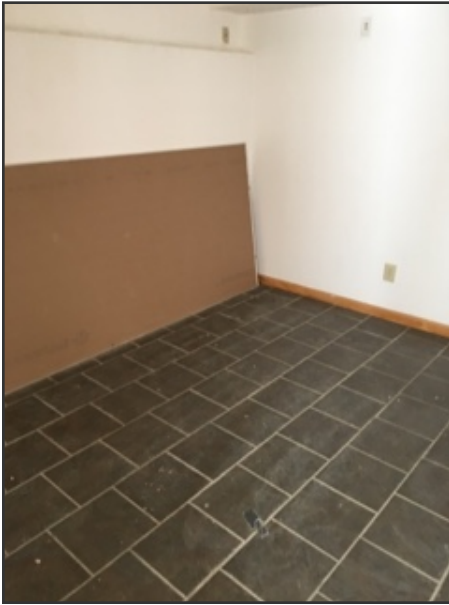
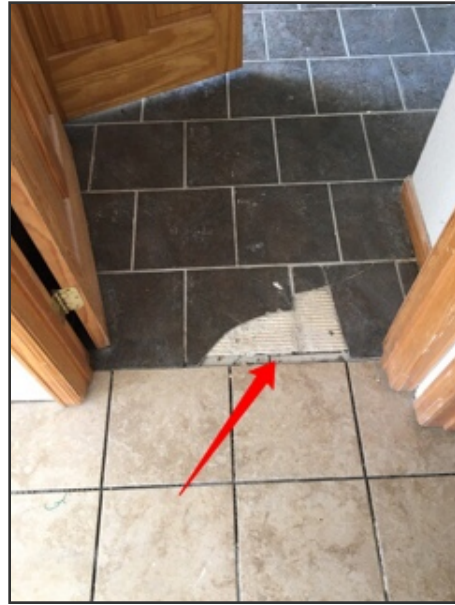
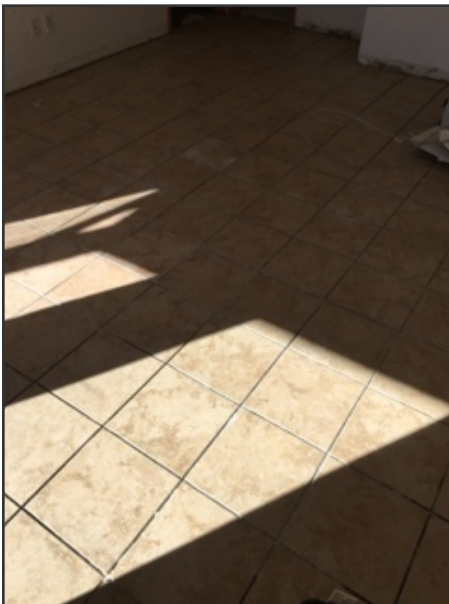
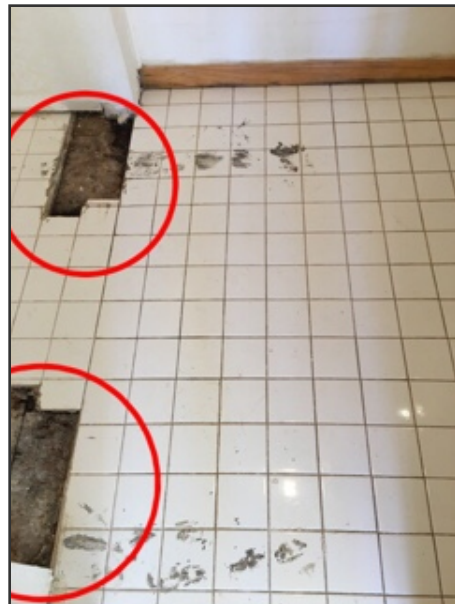
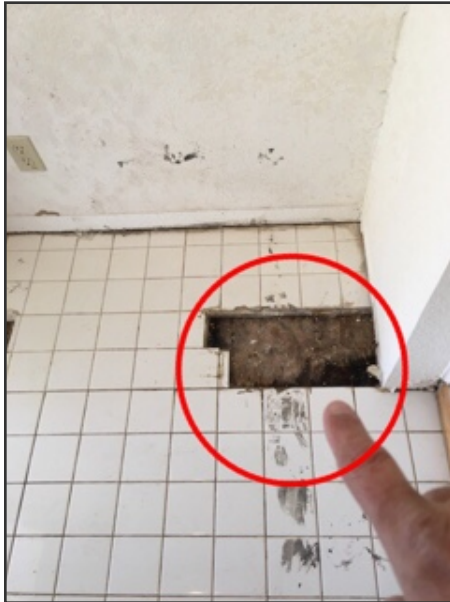
Condition: Repair or Replace

This home has a mixture of newer carpeting on the upper level and a mixture of stone and tile and linoleum on the lower level. Some of the tiles are cracked and broken as pictured and require removal and replacement.

18) This home has a mixture of newer carpeting on the upper level and a mixture of stone and tile and linoleum on the lower level. Some of the tiles are cracked and broken as pictured and require removal and replacement.
