285 Home Inspection Services LLC

Home Inspection Report

471 Bell Road

Inspected on Sat, Apr 27 2019 at 8:38 PM

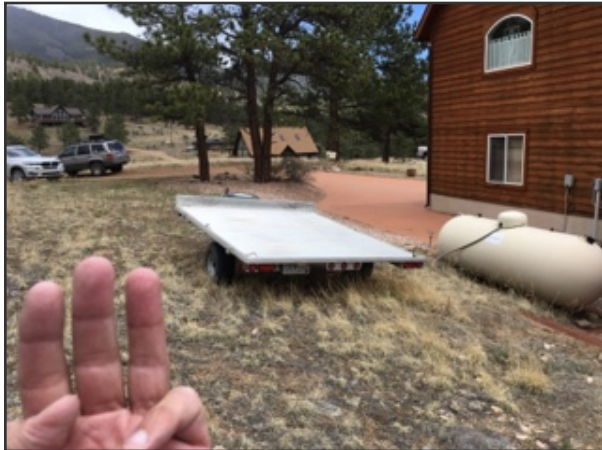
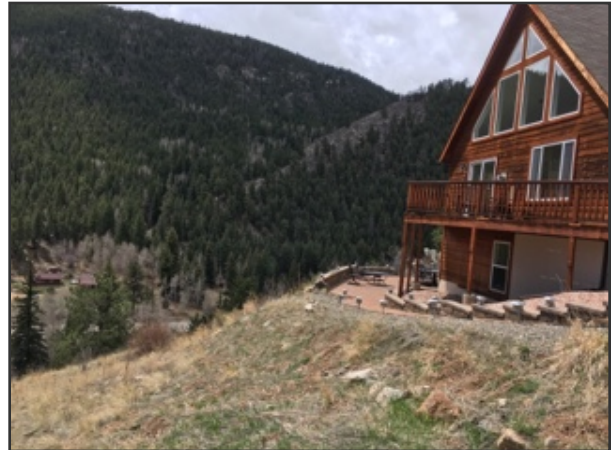
Generally Maintained
Condition: Marginal

Generally this home landscaping is very good there is one tree as indicated in the photograph that should be trimmed back.

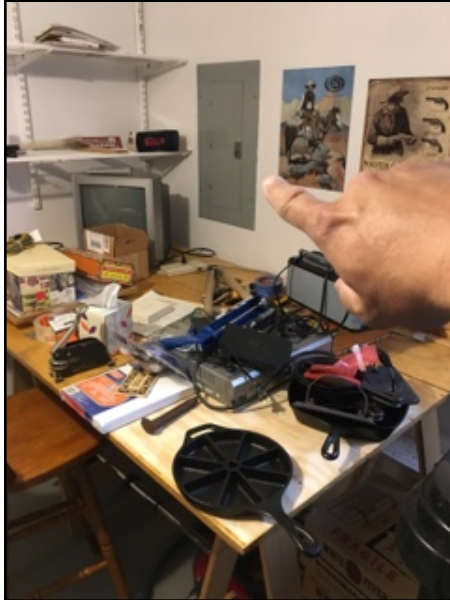
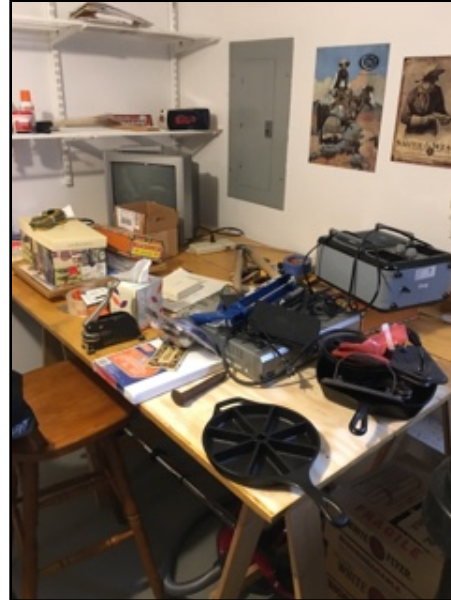
Comment 4:

Service panel access was blocked by a desk as illustrated in the photograph the dead front panel cover was not removed.

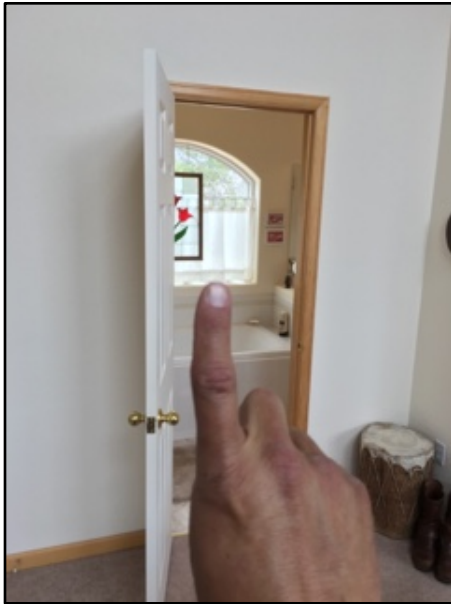
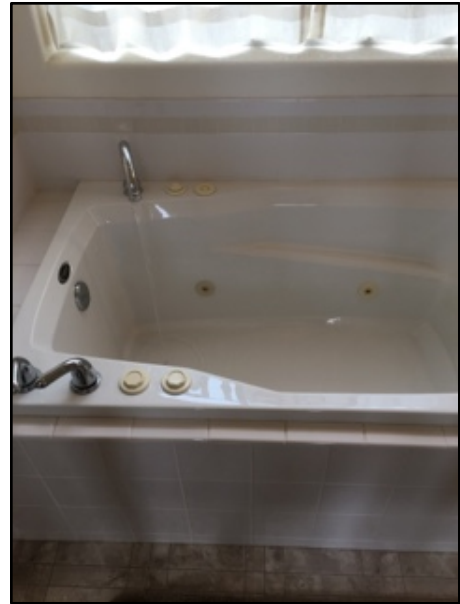
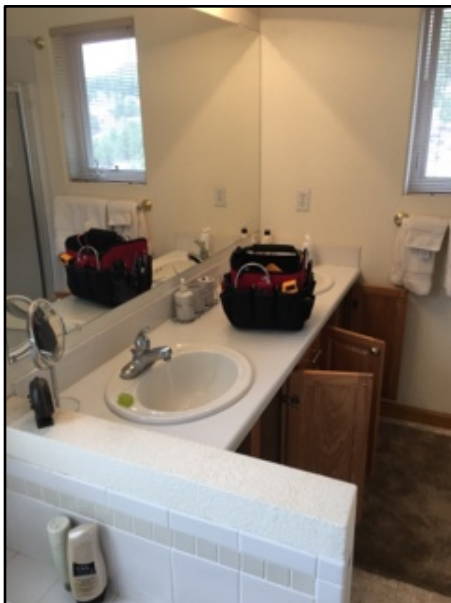
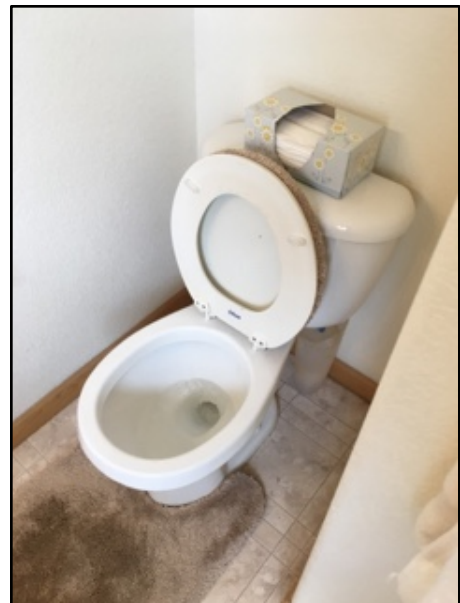
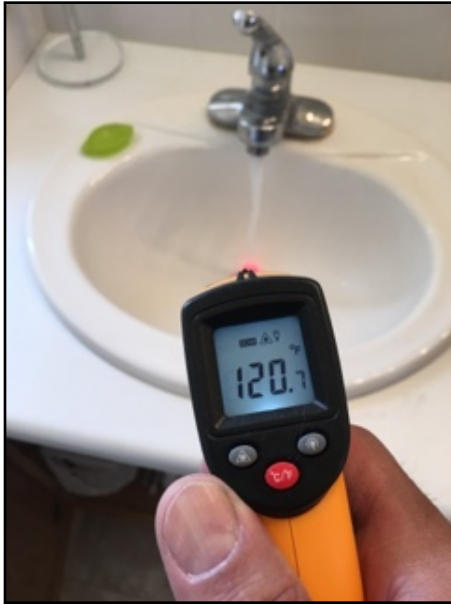
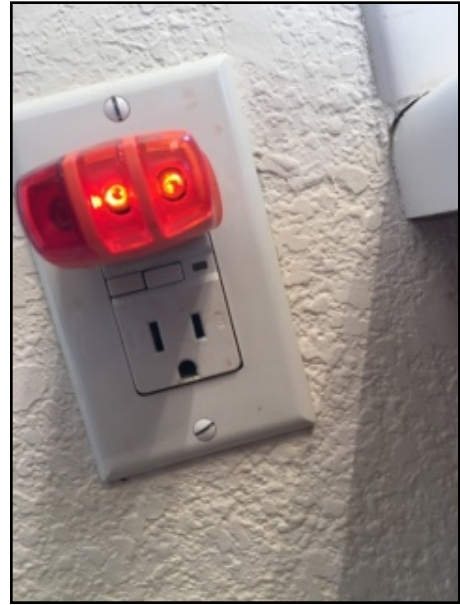
Comment 8:
Master Bathroom Upper Level.

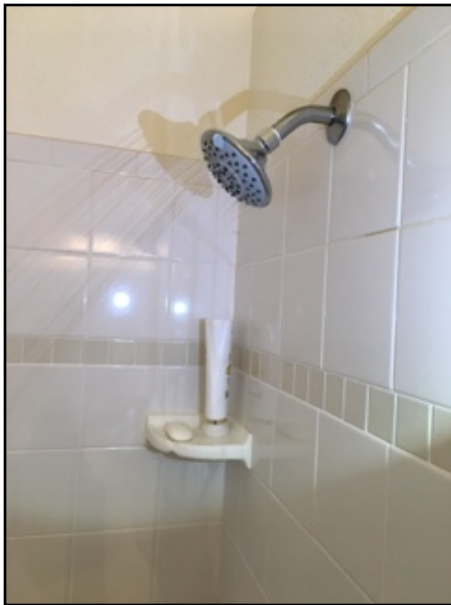
Figure 9-1

Comment 9:
Stall shower.

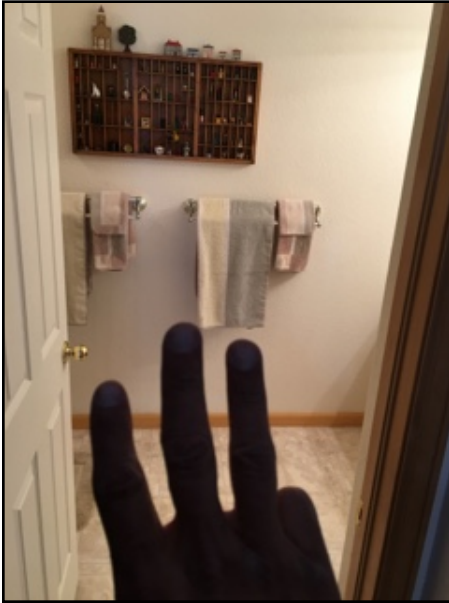
Figure 12-1

Comment 12:
Lower Level full bath.

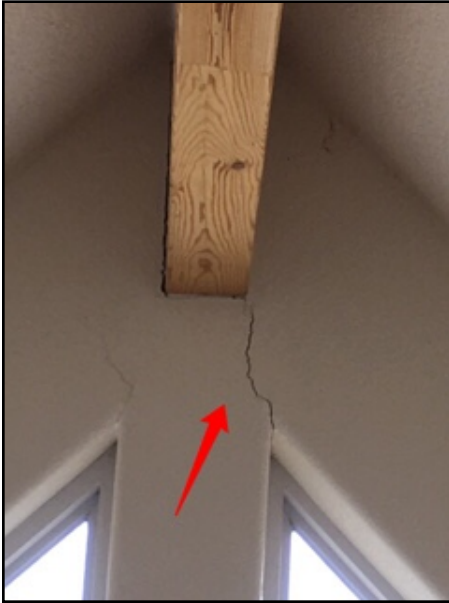
Comment 14:

Textured Over Drywall
Condition: Marginal

In the master bedroom as well as the main living room support beam areas as pictured there are surface cracks that appear to be from winds and roof loading. As the roof itself should be replaced in the near future it is highly recommended that the drywall be patched and repainted.
