Home Inspection Report

51 Suffolk Way

Jefferson, CO 80456

Inspected on Sun, Jul 26 2020 at 1:49 PM

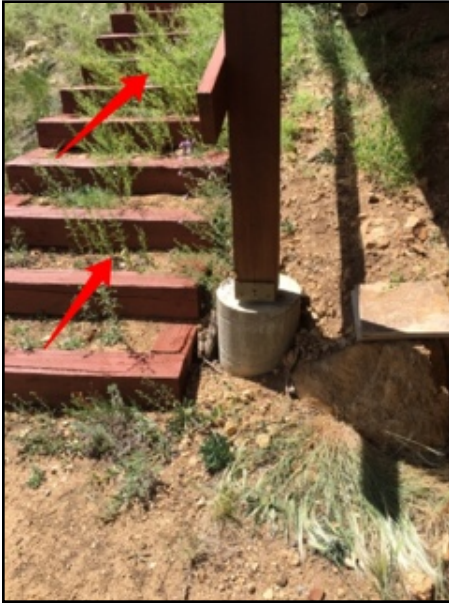
During the inspection there were really no problems found with walkways around the home there is a series of steps on the east side of the home that should be cleared out from any brush so as to not have a tripping hazard.

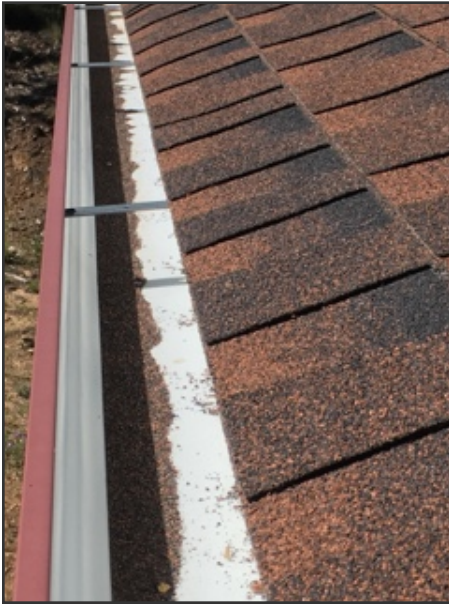
The roof on this home is in good condition it is estimated to be between five and seven years old there is some granular structure that has lost in the gutters as seen in the photographs. The roof is serviceable and in reasonably good condition.

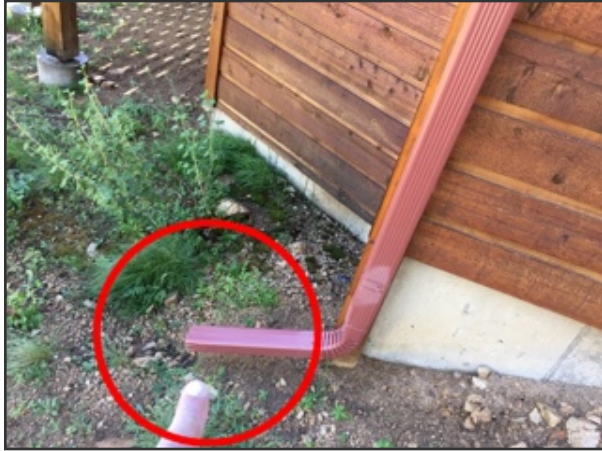
Generally speaking the gutters and the downspouts of this home are in good condition. There are a couple of instances where the downspout should be extended away from the foundation a minimum of 5 to 7 feet there are two locations where they need to be extended.

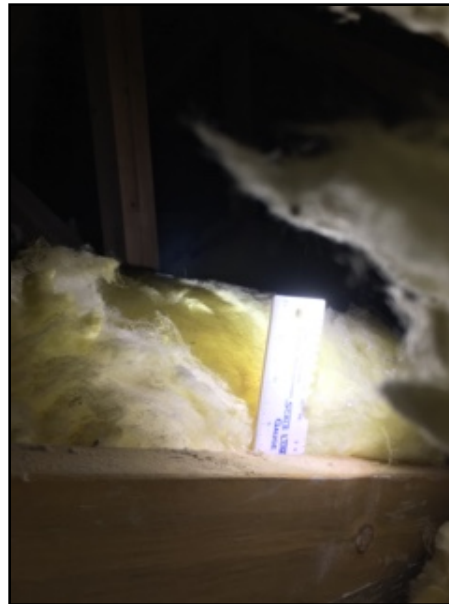
The insulation present in the attic is approximately 10 inches deep which is adequate for this location.

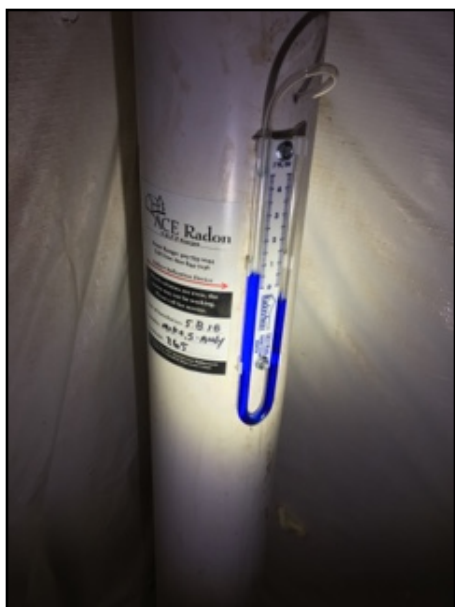
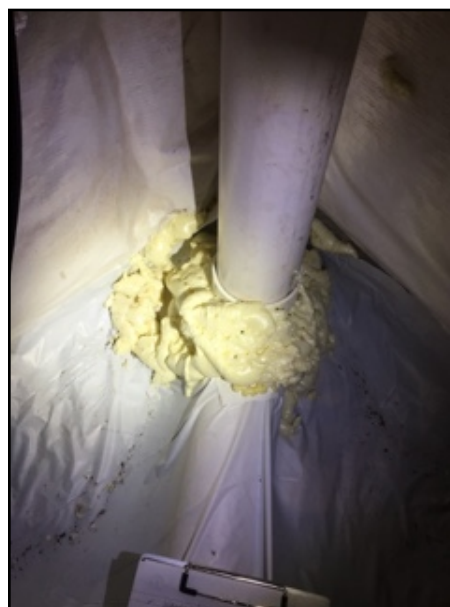
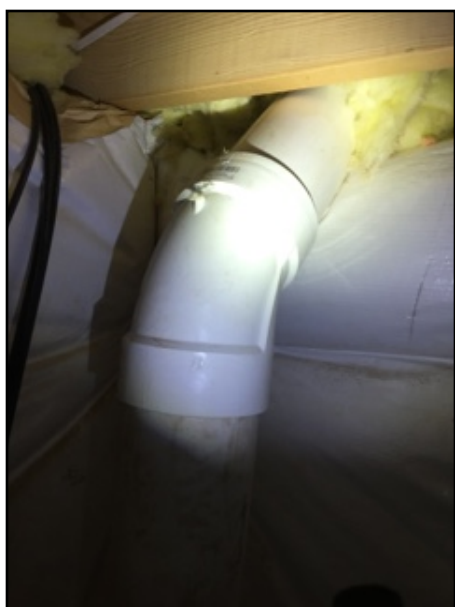
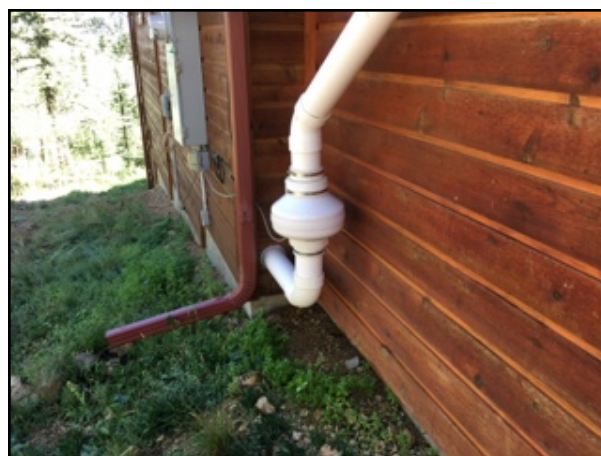
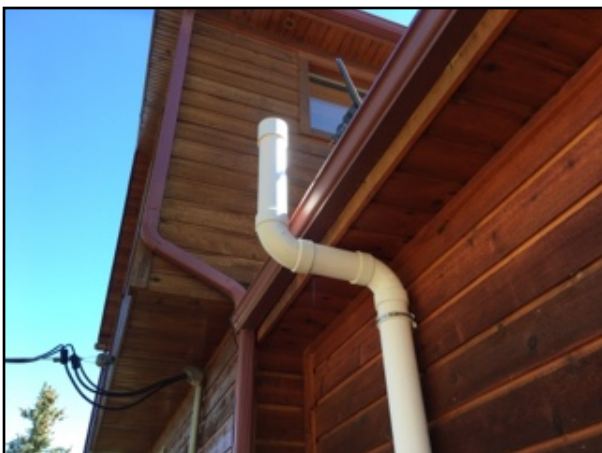
There is a Radon mitigation system installed and is operating normally.

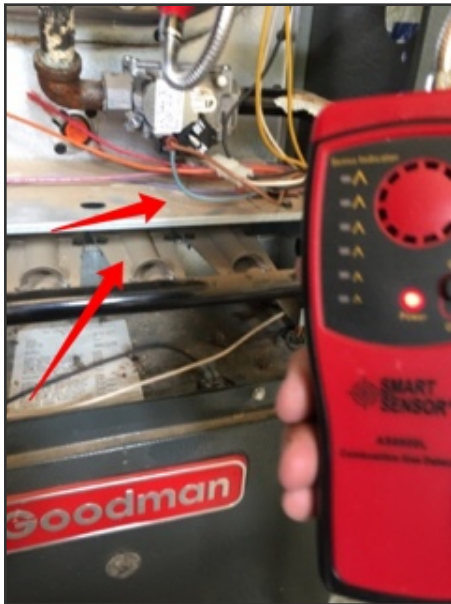
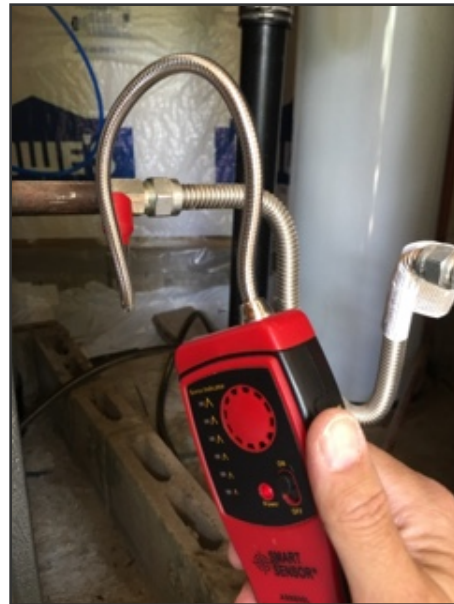
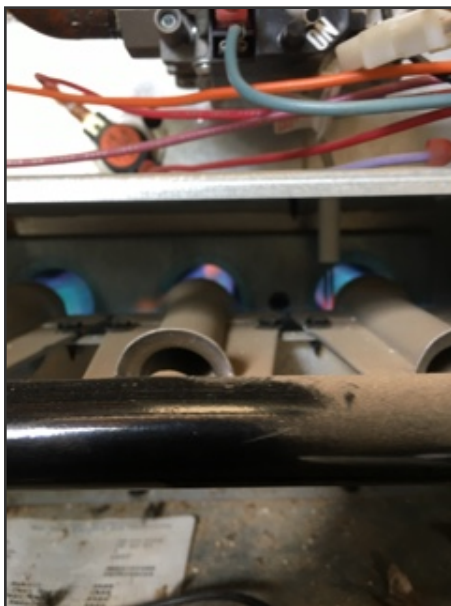
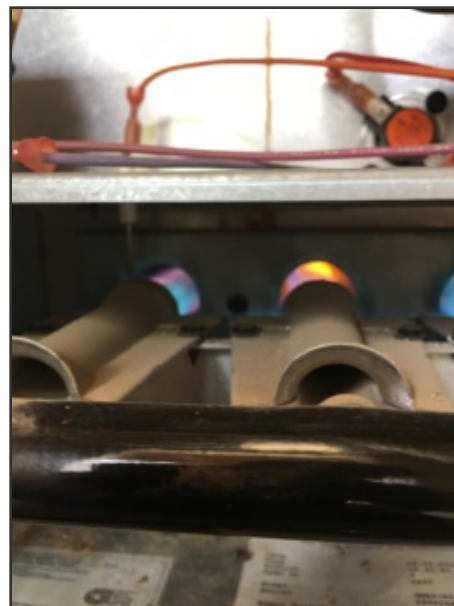
The gas forced air furnace operated normally however there was a great deal of noise when operating probably due to being extremely dirty. It is highly recommended that this furnace be cleaned and certified prior to use. A combustible gas meter was used and no gas leaks were found.

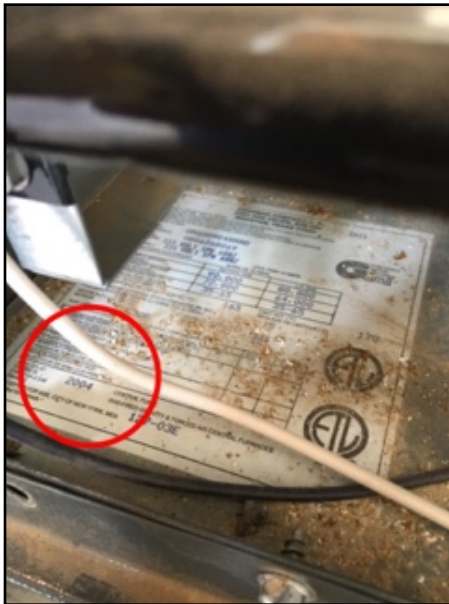
Figure 9-1

Comment 9:
2004 per label.

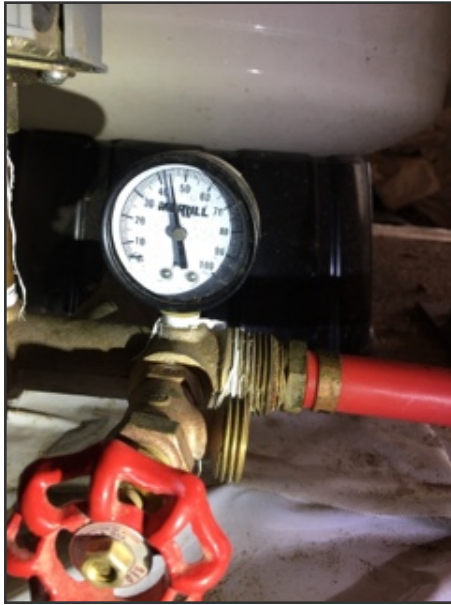
Upon arrival to perform the inspection the well pump had been shut off with notes in the home. I did switch the breaker back on for the well pump and continue to do the inspection.

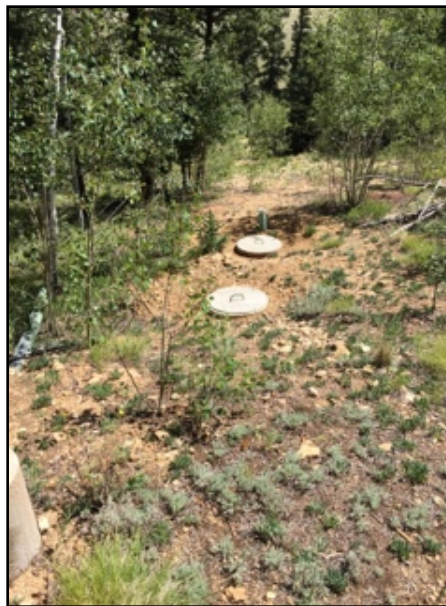
The septic system is a separate system that is serviced by a pumping provider. Please contact the septic pumping company for latest information about the septic system tank and Leach Field.

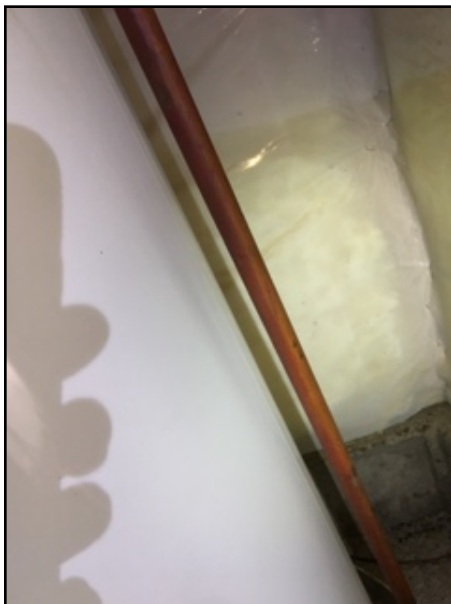
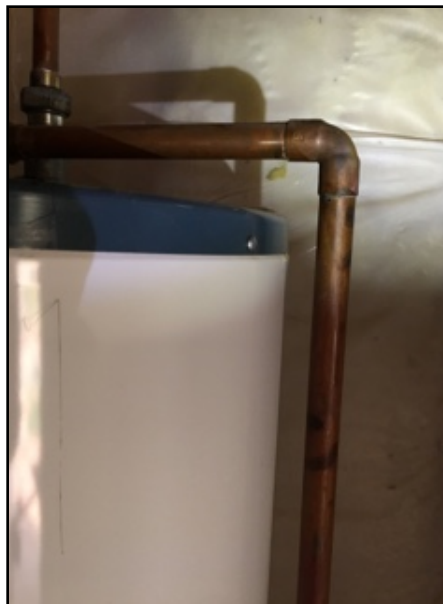
Temp & Pressure Relief Valve:

Present With Blow Off Leg
Condition: Satisfactory

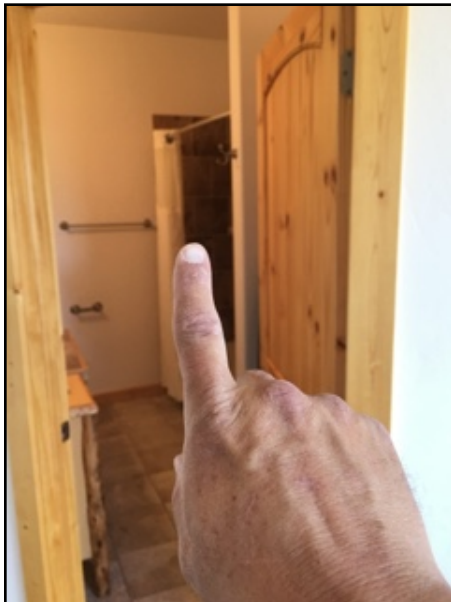
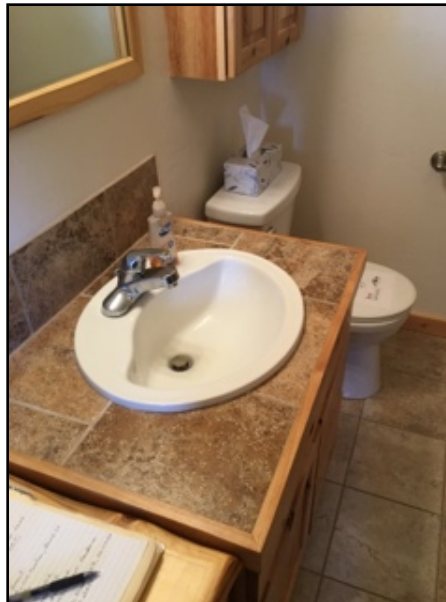
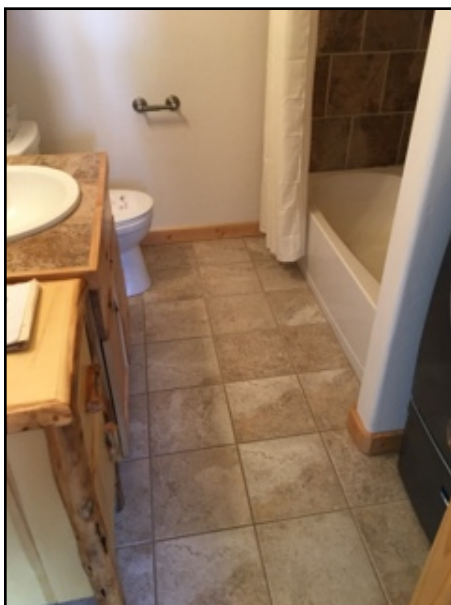
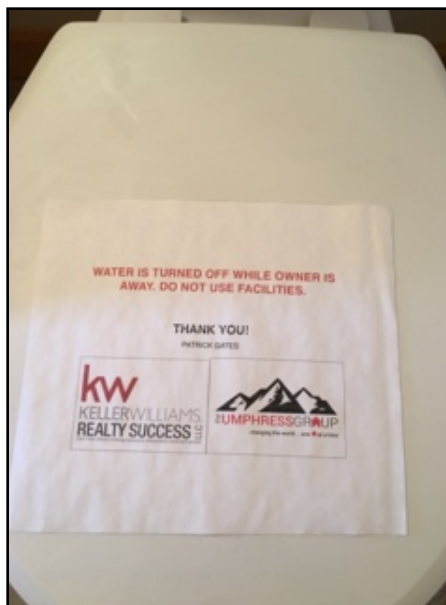
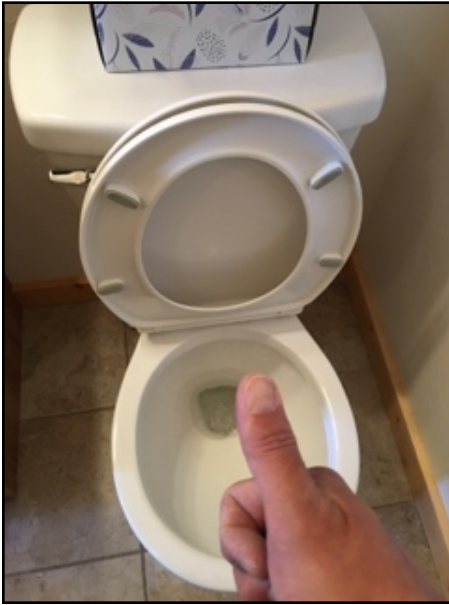
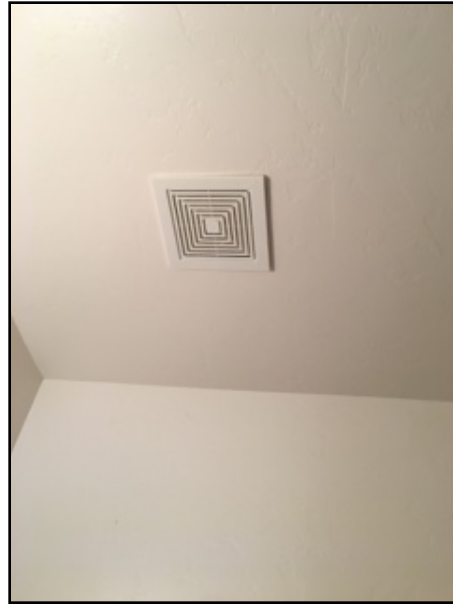
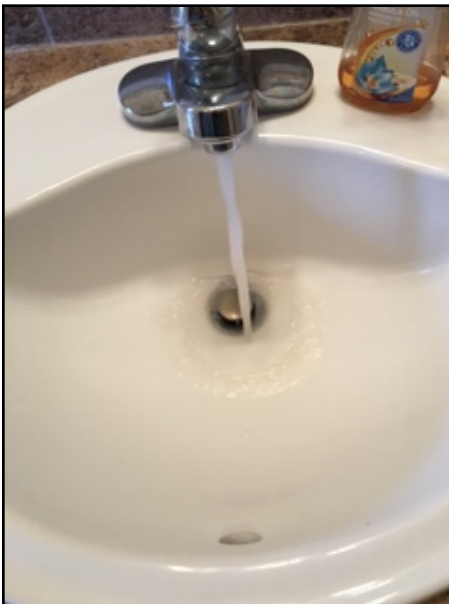
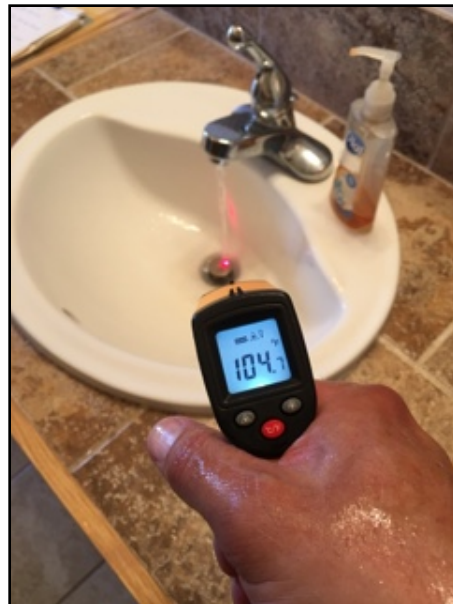
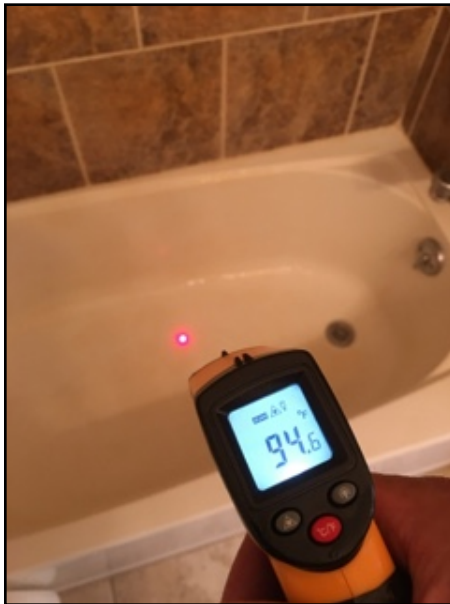
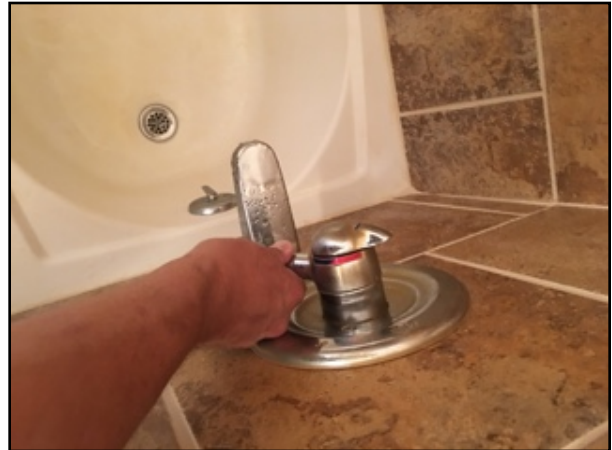
Bathroom number one is located upstairs it contains a toilet, a single vanity sink, a bathtub/shower combination, exhaust fan, and GFCI outlet.

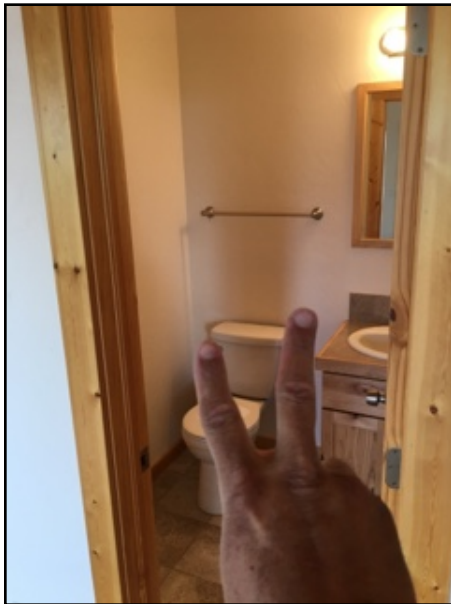
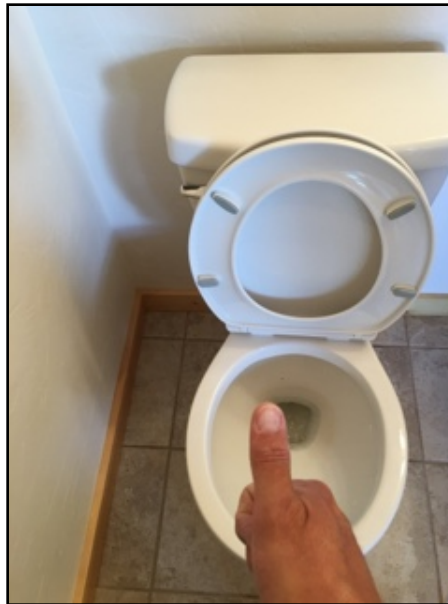
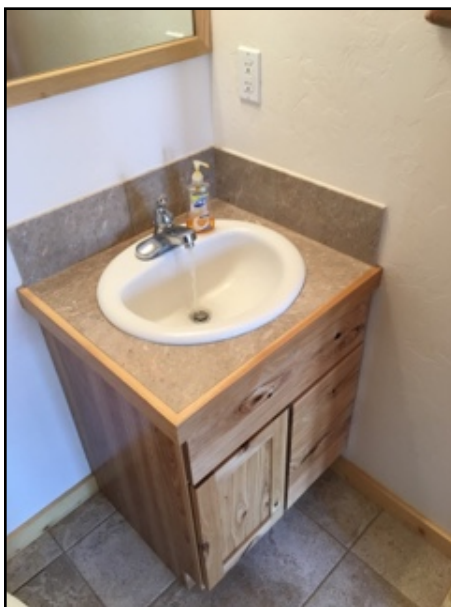
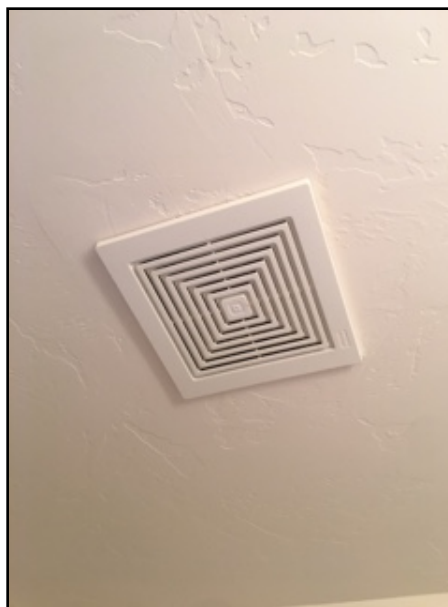
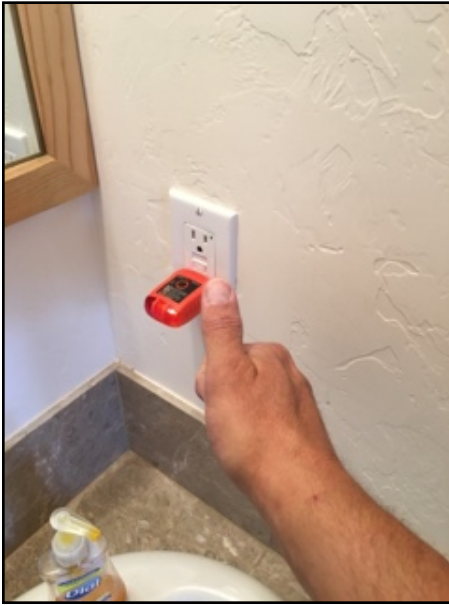
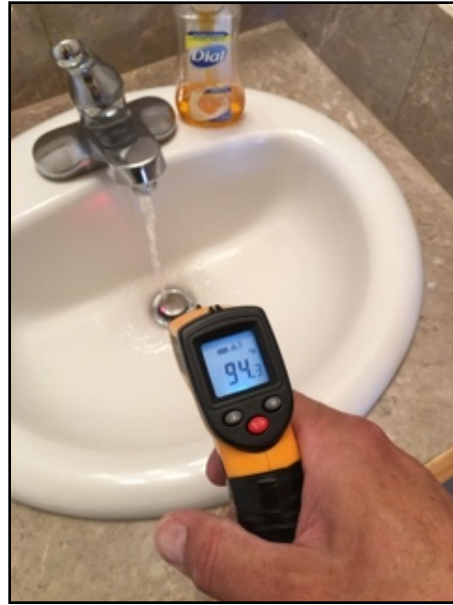
Bathroom number two is located on the lower level it is a half bath and contains a toilet, a single vanity sink, GFCI outlet, and an exhaust fan.

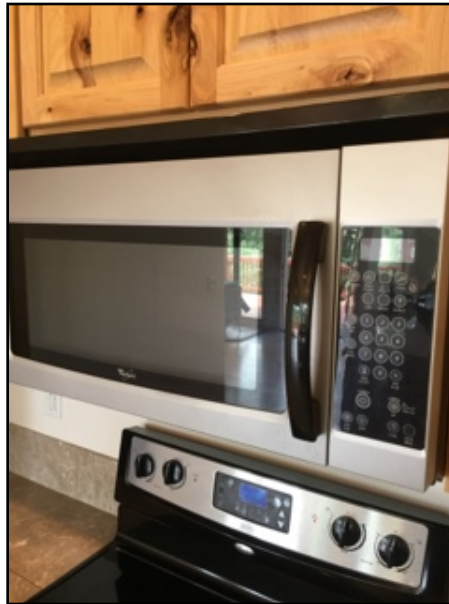
The microwave oven also contains a fan and a surface light all operating normally during this inspection.

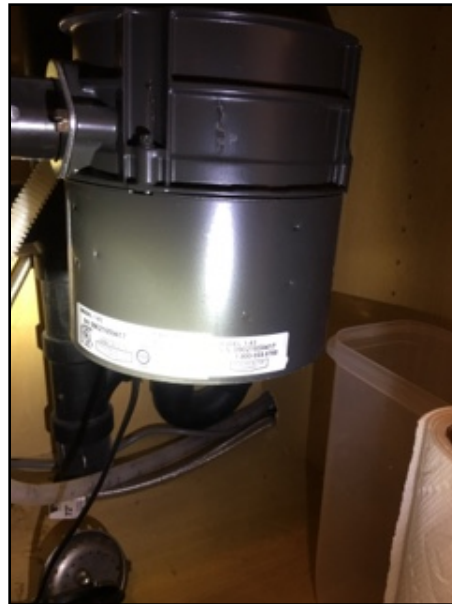
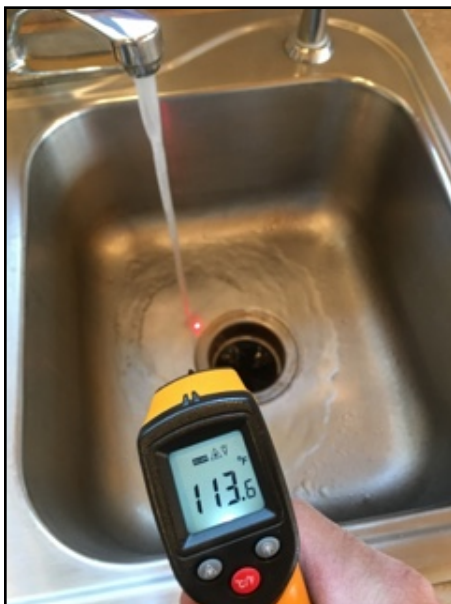
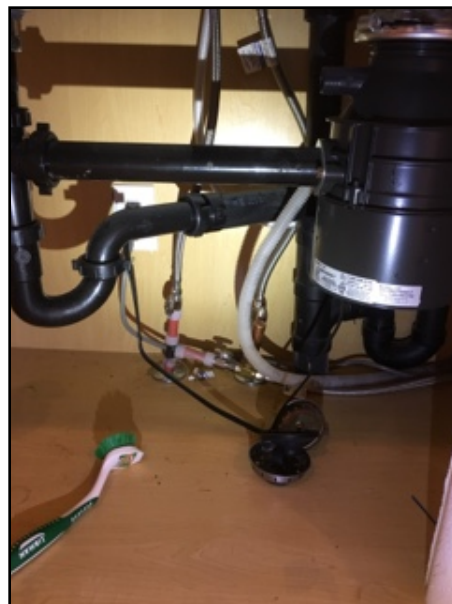
Badger/Insinkerator
Condition: Satisfactory

The disposal worked normally during this inspection no leaks found.

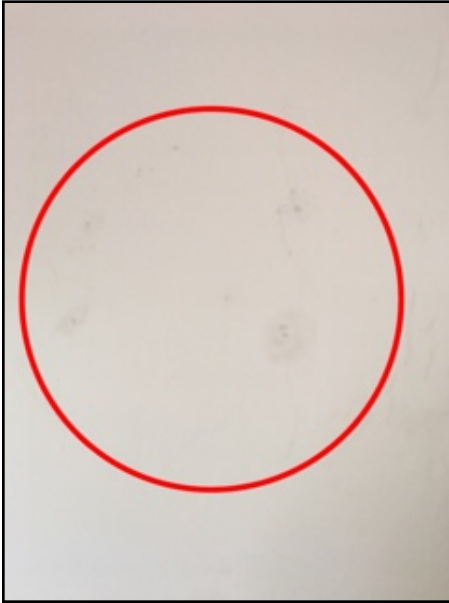
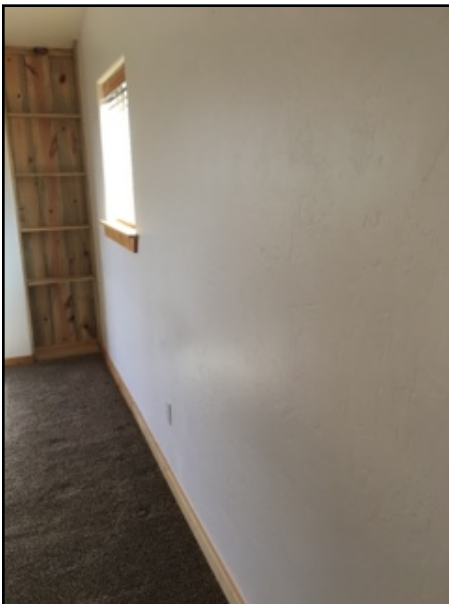
Plaster
Condition: Satisfactory

The walls in this home are a combination of textured drywall and knocked down plaster which is very well done and looks great. There is one location upstairs in one of the bedrooms that some patching should occur otherwise very good condition.

7) The walls in this home are a combination of textured drywall and knocked down plaster which is very well done and looks great. There is one location upstairs in one of the bedrooms that some patching should occur otherwise very good condition.

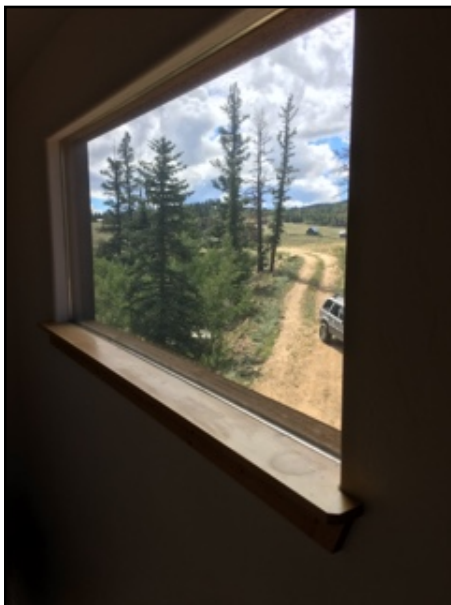
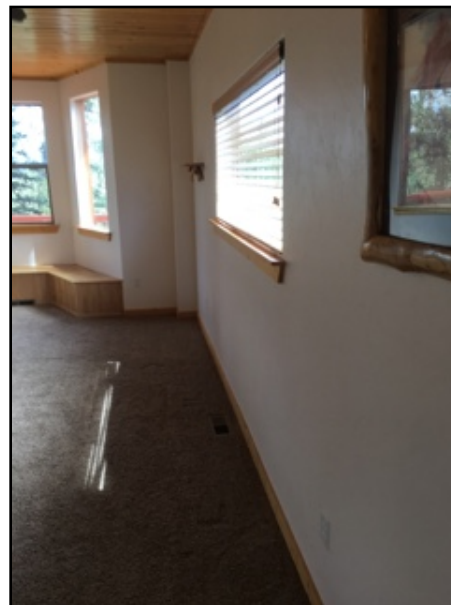
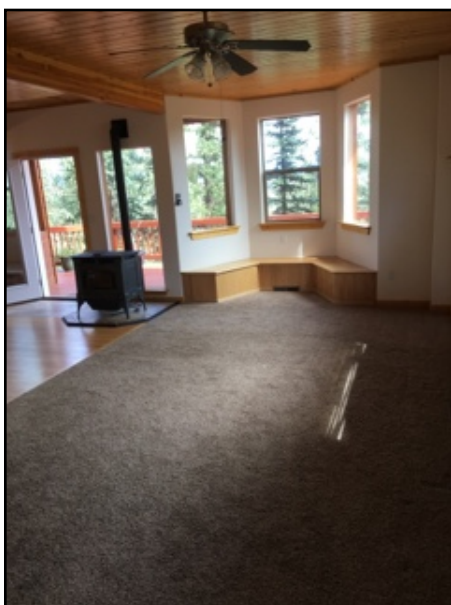
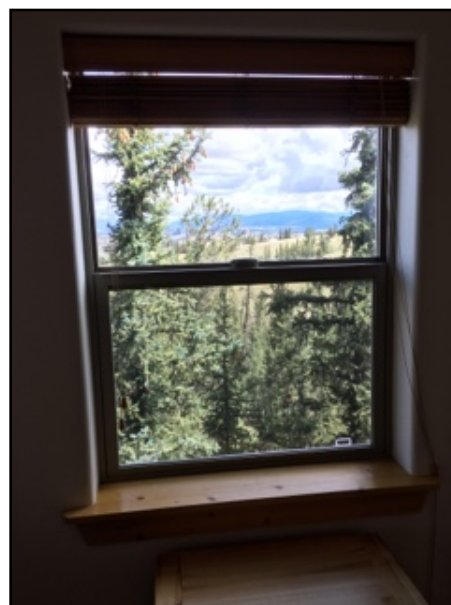
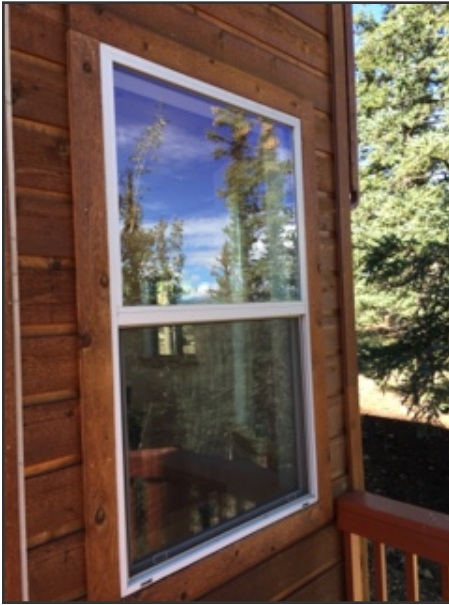
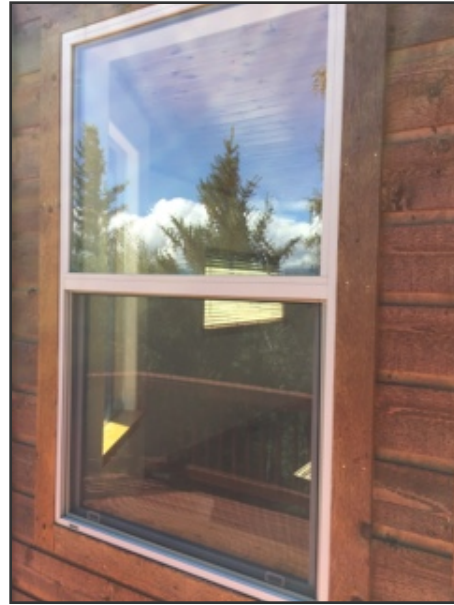
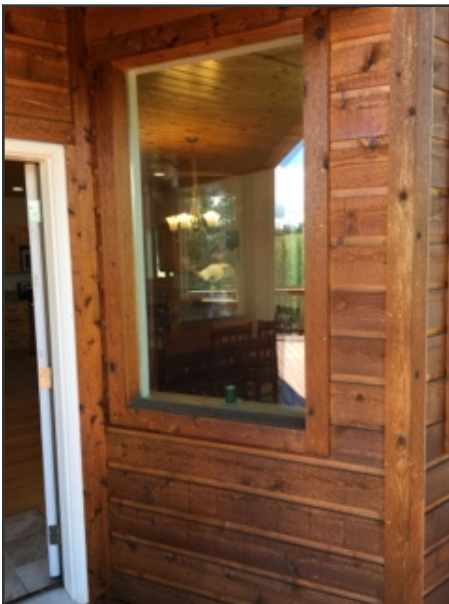
Condition: Satisfactory

The windows in this home or in good condition no broken seals or cracks found during this inspection.

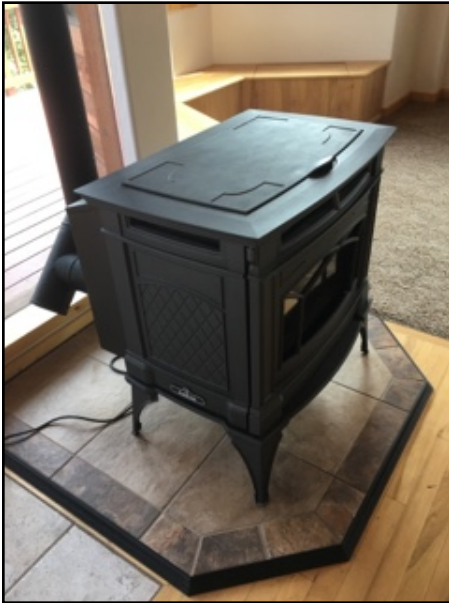
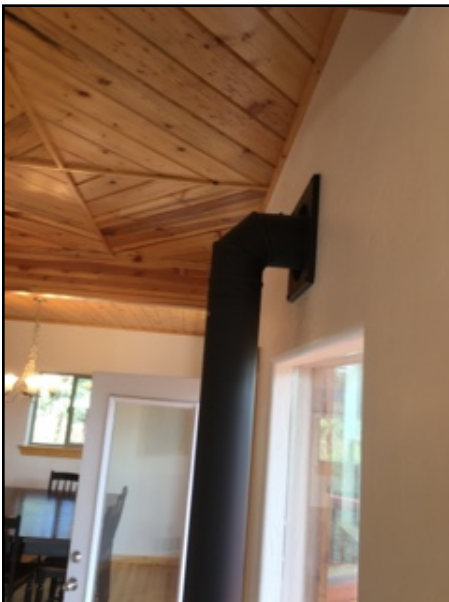
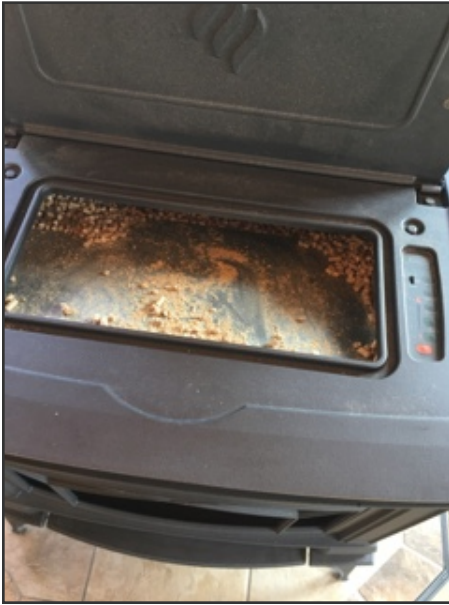
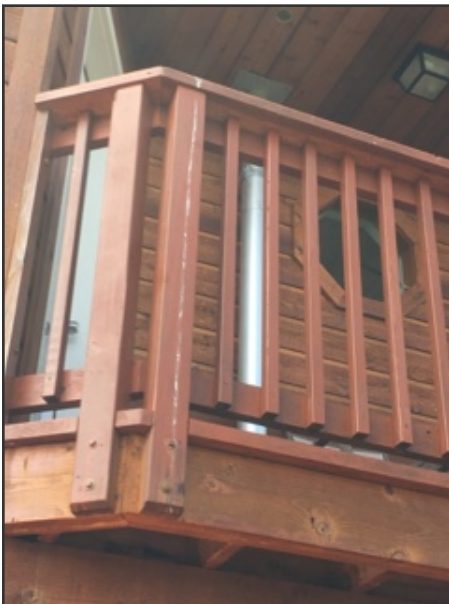
Wood pellets stove

Condition: Further Evaluation Required

As with all wood-burning appliances, wood-burning stoves, and pellet stoves, it is highly recommended that a certified chimney sweep clean and certify the appliance prior to first use.

8) As with all wood-burning appliances, wood-burning stoves, and pellet stoves, it is highly recommended that a certified chimney sweep clean and certify the appliance prior to first use.
