RE: Dam and Spillway Condition Assessment
Final Report

DAM & SPILLWAY ASSESSMENT REPORT

DAM: Frog Pond Lake Dam

FROG POND LAKE DAM, COLMESNEIL, TX 75938

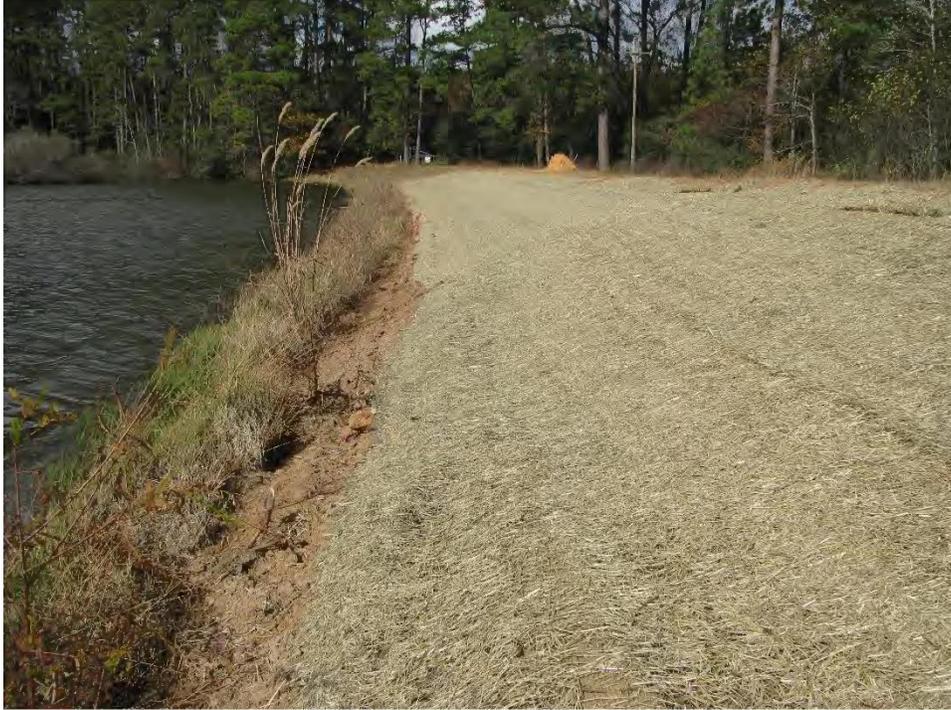
Photograph No. 8 – A view of Frog Lake bank protected by vegetative cover. Budget for rock riprap to protect slope against wind action erosion looking South West.

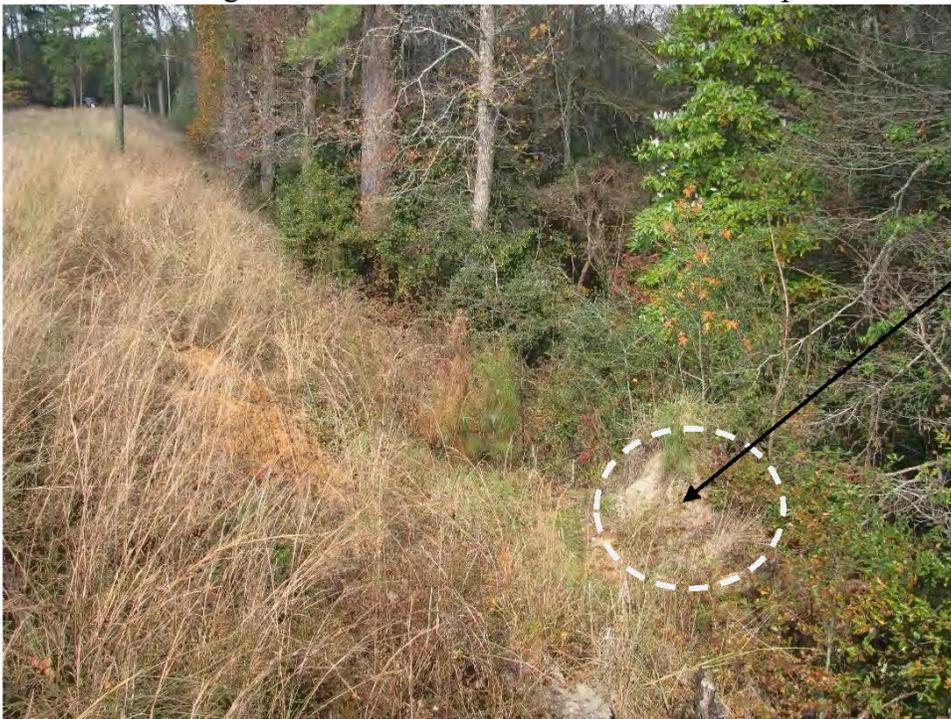
Signs of erosion

Photograph No. 26 – Standing about 200 ft away North from the spillway looking North. A view of a dam's downstream slope.

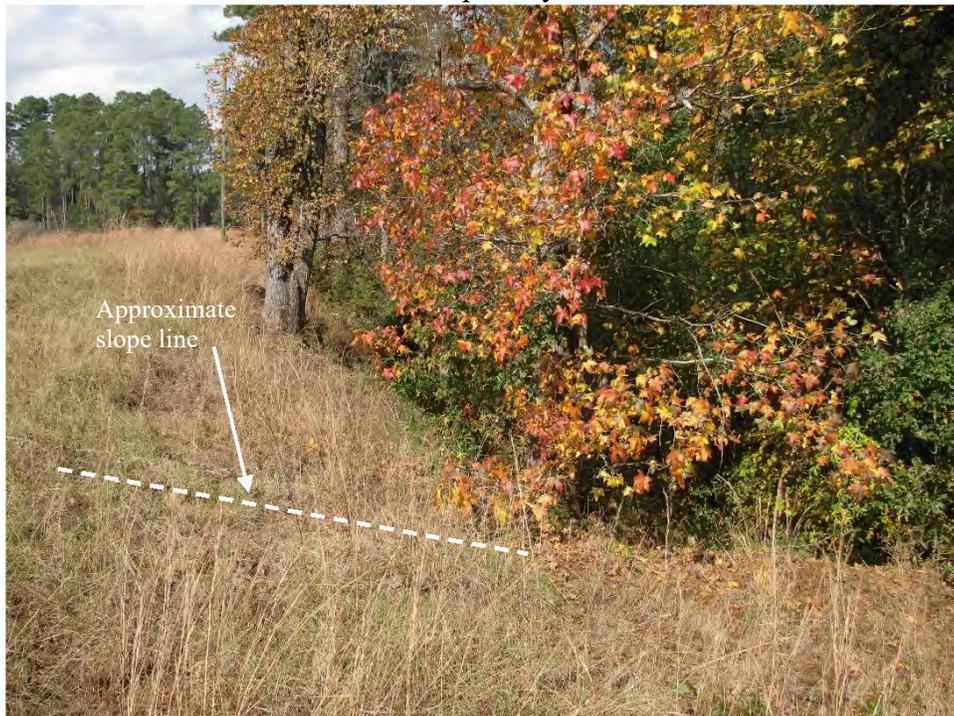
Photograph No. 28 – Standing on the right side of the dam looking North.
A view of the 5H:1V downstream slope at the point of connection of the old spillway.

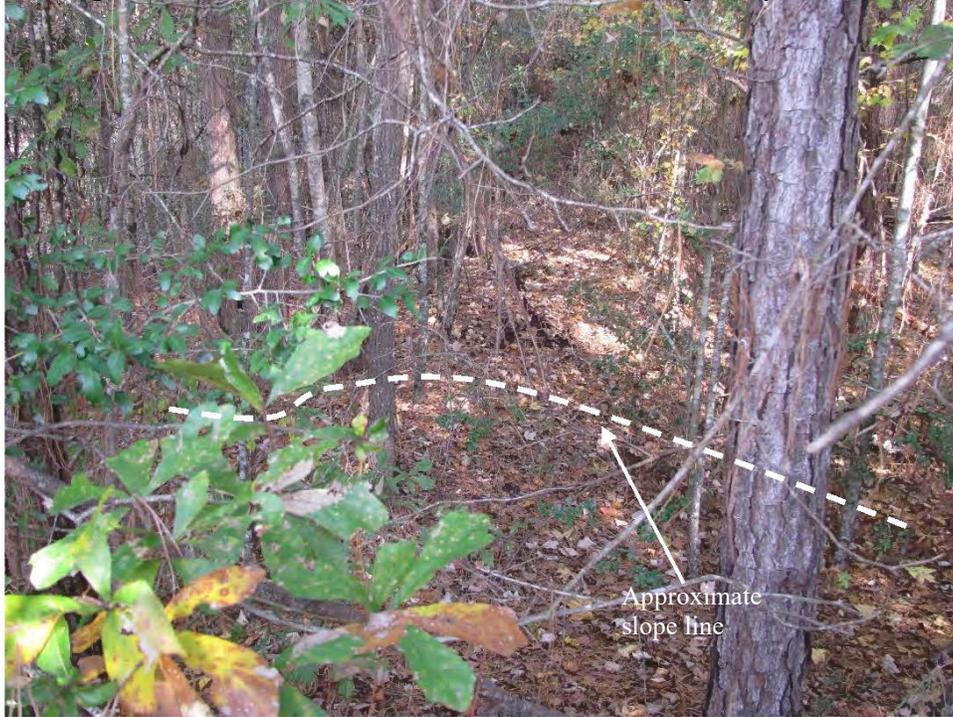
Photograph No. 29 – Standing about 60 ft away North from the spillway looking East. A view of an embankment for the old spillway channel wall.

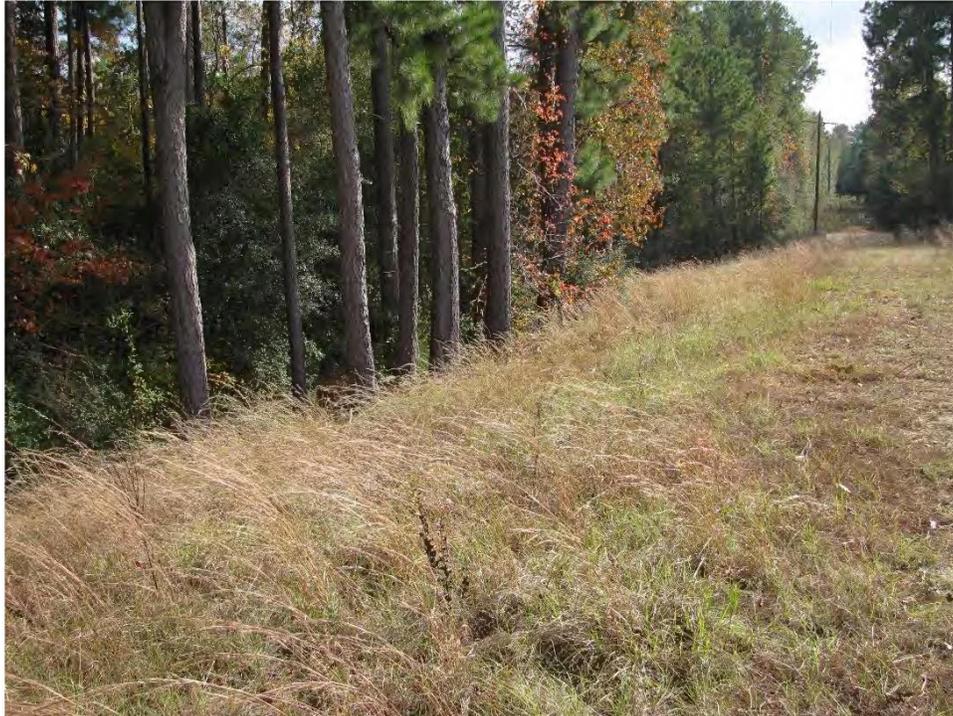
Photograph No. 30 – Standing on the right end of dam looking South East. A view of the well-maintained vegetative cover along the crest.

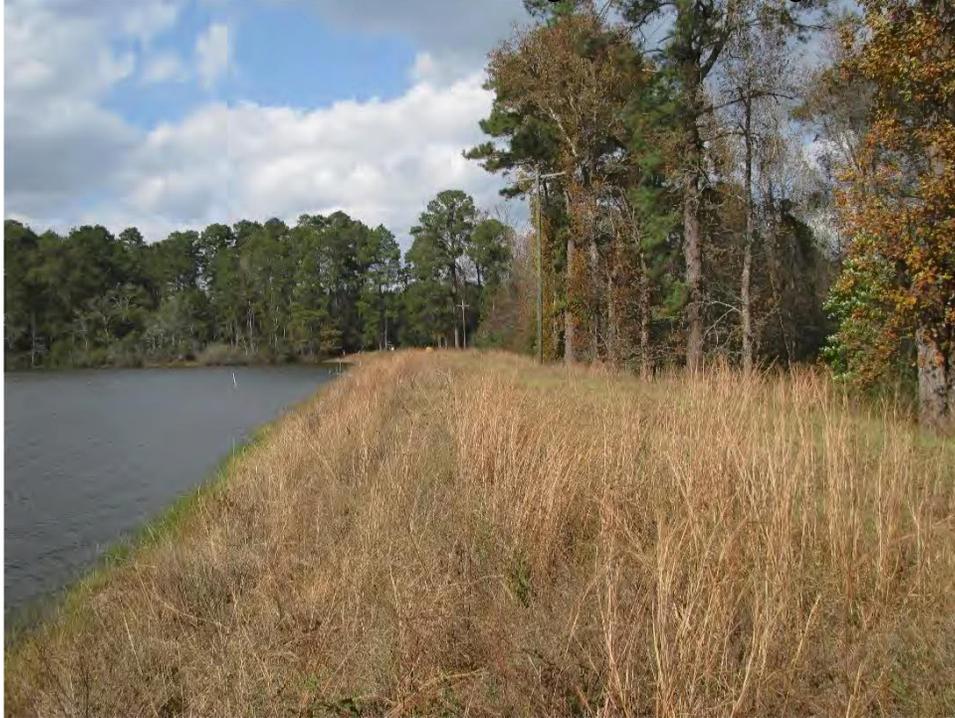
Photograph No. 31 – Standing on the right end of dam looking North West. A view of the well-maintained vegetative cover along the crest.

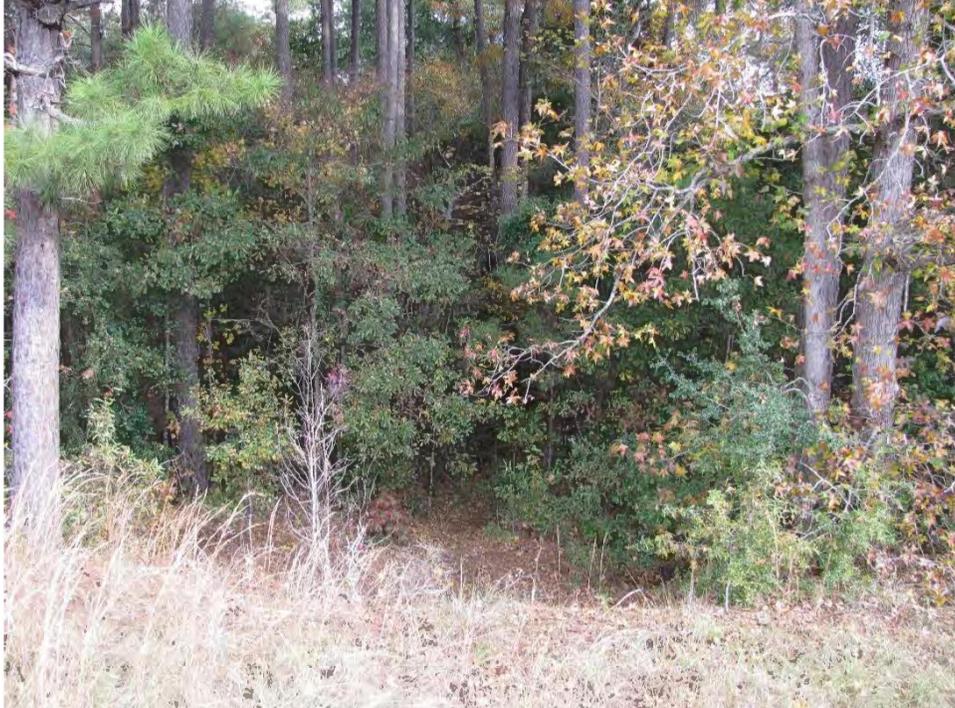
Photograph No. 33 – Standing about 30 ft to the North from the spillway. A view of the dry area between old spillway embankment (on the left) and new spillway downstream mouth.

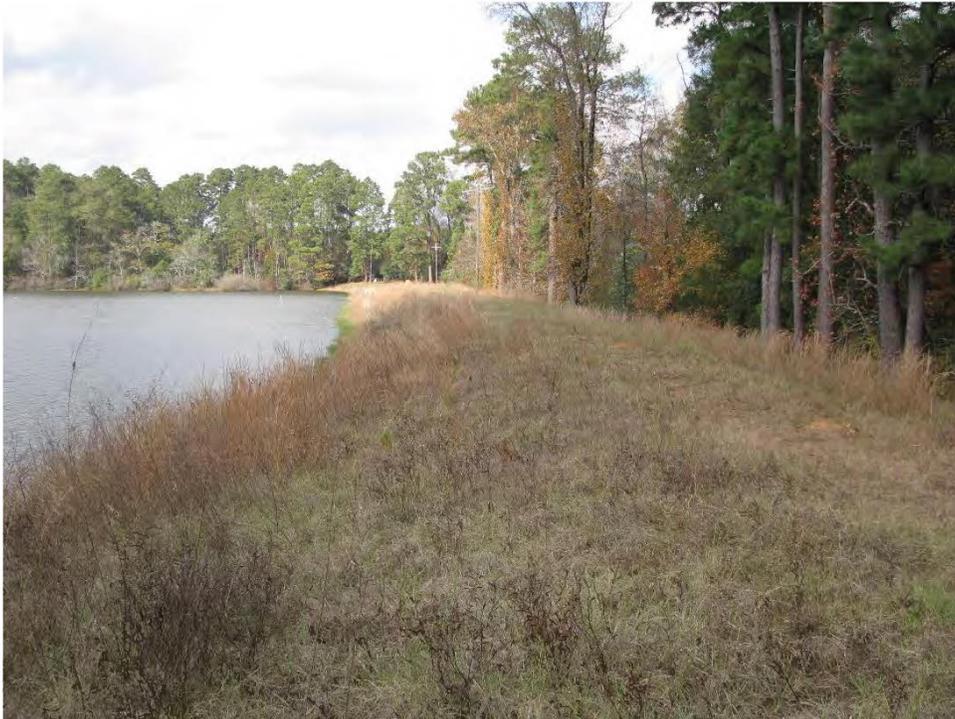
Photograph No. 34 – Standing on the left edge of the spillway looking North West. A view of the dam toe widening closer to the spillway.

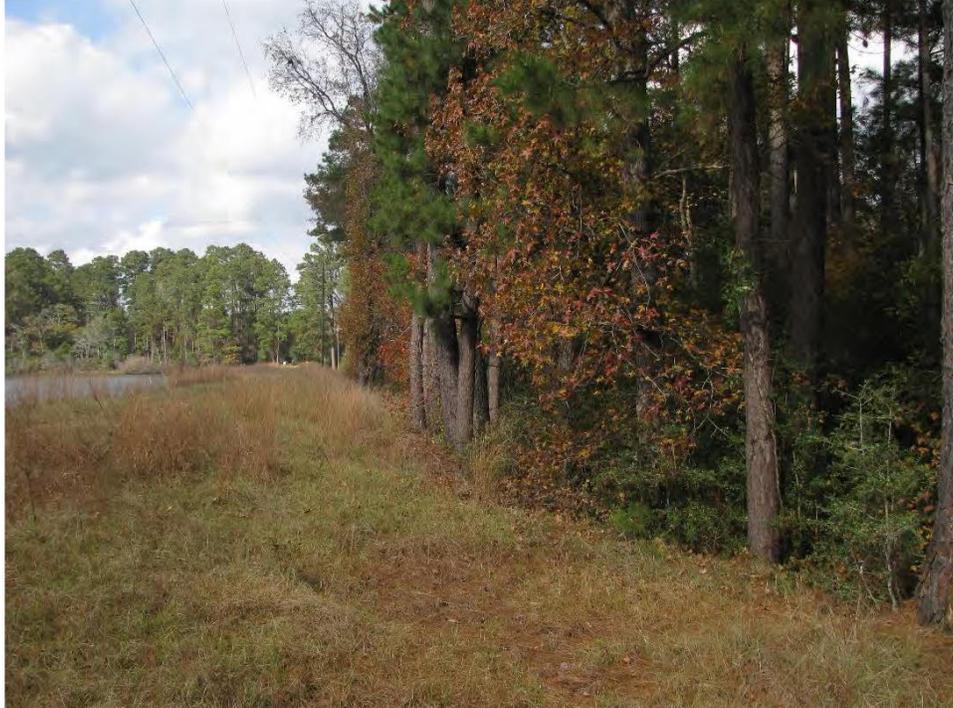
Photograph No. 35 – Standing on the left edge of the spillway looking North West. A view of the well-maintained vegetative cover along downstream slope of the dam.

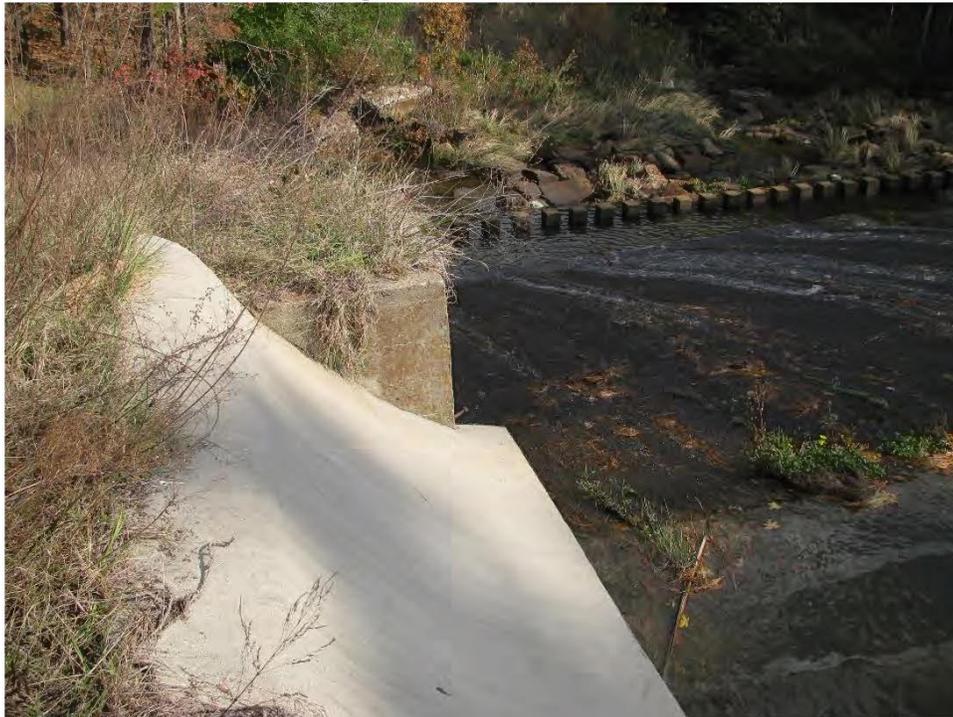
Photograph No. 36 – General view of the left side of the service spillway looking downstream to the East.

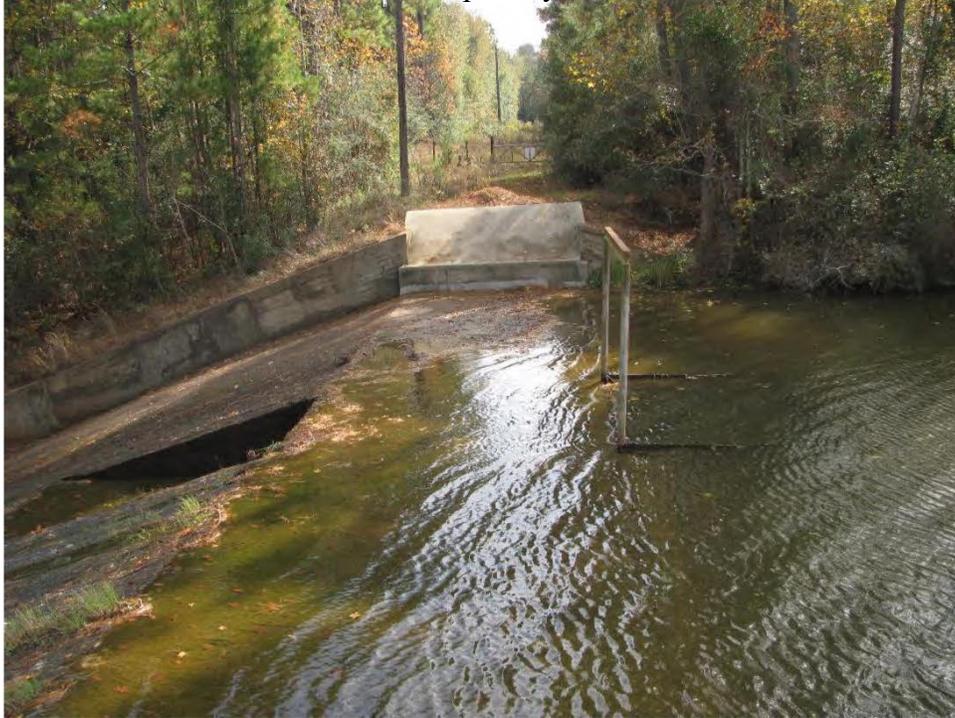
Photograph No. 37 – Standing on the left of the spillway inlet looking South East. A view of the spillway and box culvert inlets.

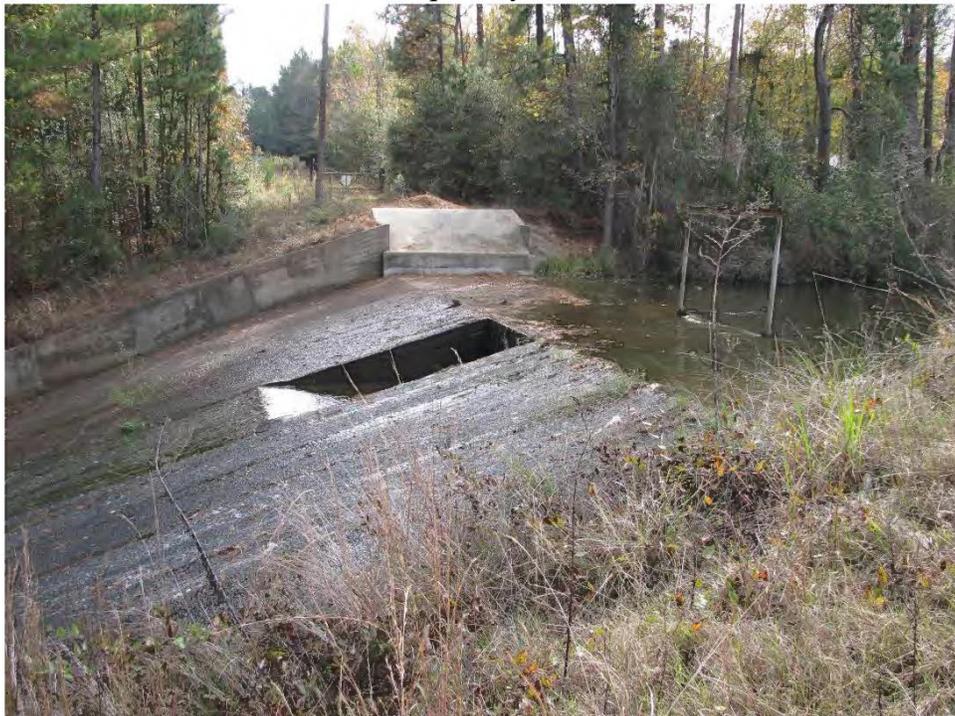
Photograph No. 38 – Standing on the left of the spillway inlet looking South. A view of the spillway and box culvert outlet.

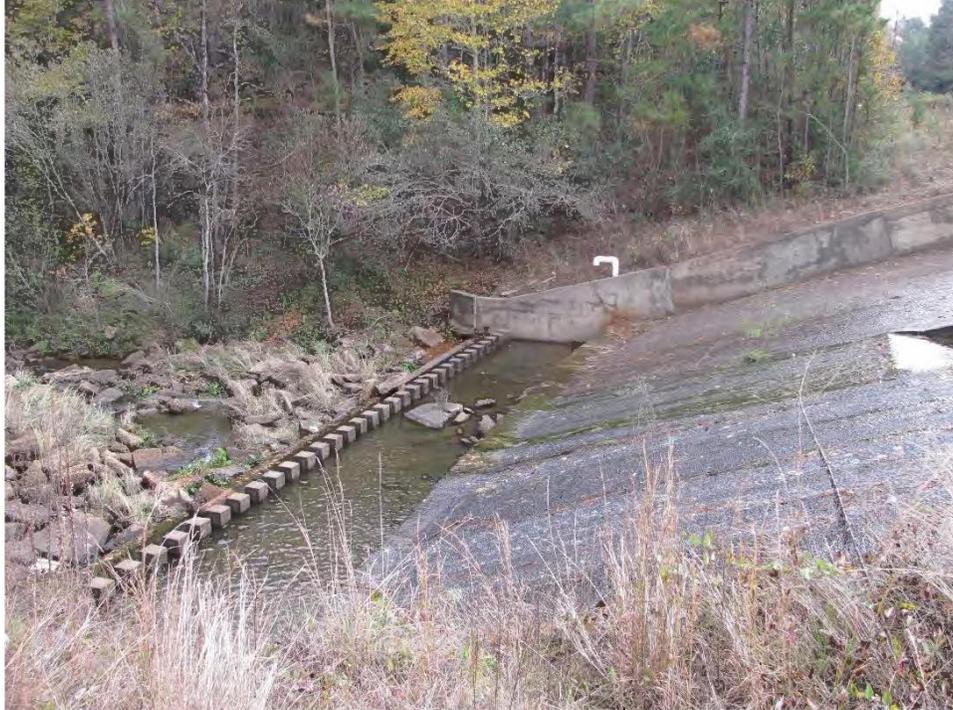
Photograph No. 39 – Standing before the left side wall of the spillway looking South East. A view of the concrete discharge slab and riprap lined earthen channel.

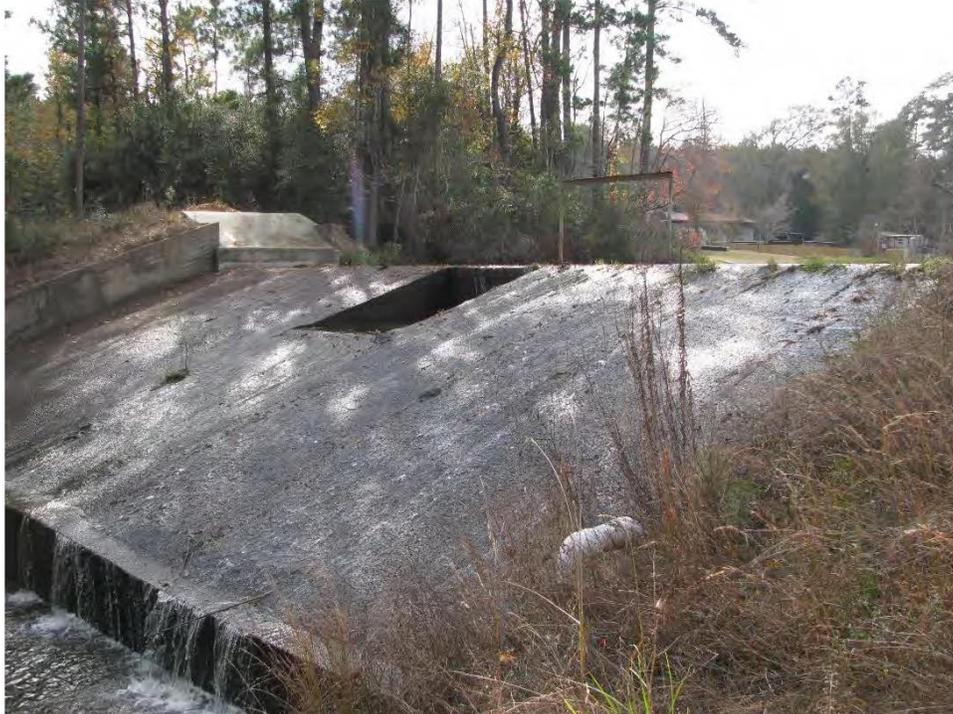
Photograph No. 40 – A view of the left 4-inch diameter pipe installed as a part of the spillway drain system.
