# Inspection Report

**500 North Doolin Drive  
Roswell, Georgia 30076**

**Inspection Date** ~~October 2, 2020~~  
**Client** Sabra  
**Inspector** Julius Gresham  
goodvibeshomeinspections@gmail.com  
Hit-It Certified InterNachi Certified

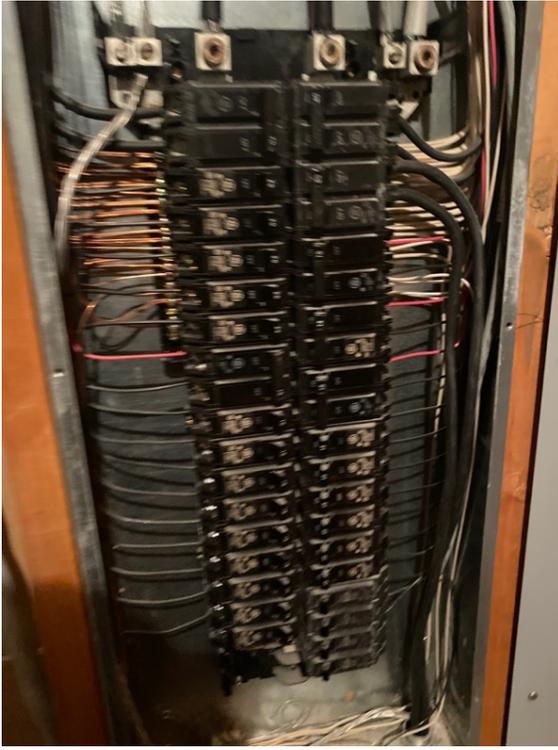
**Location** Basement

**Electrical panel was inspected. Everything visually was intact and labeled. Main cutoff can be found outside near electrical meter**

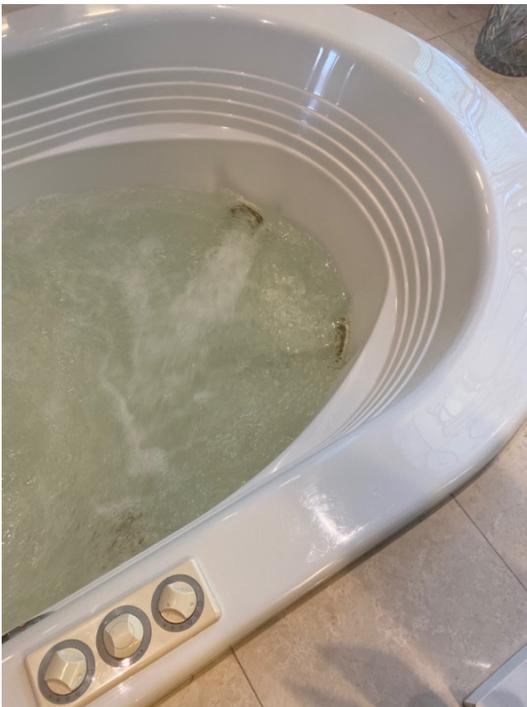
**Location** Master Bathroom

### Tub jets were tested and worked during time of inspection.

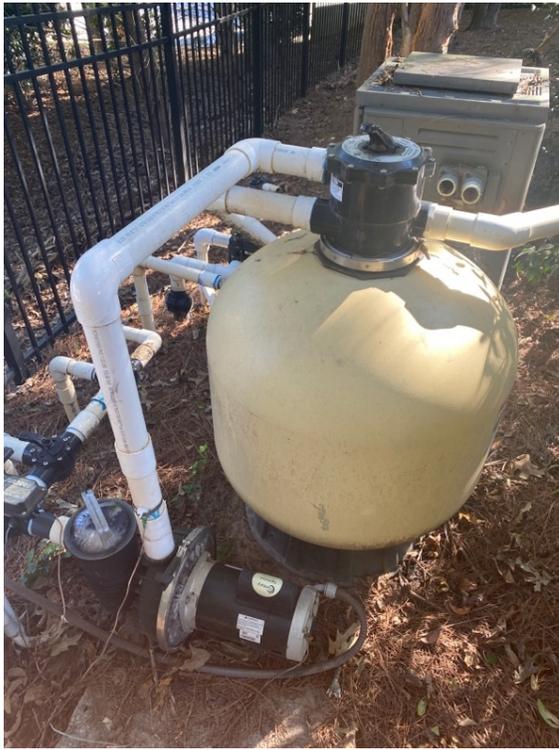
**Location** Pool Area

**The in ground pool was working and in usesble condition during time of inspection. No leaks or drainage issues present.**
