We Inspect NJ

Inspector: Brian Duggan: NJ State License #21GI00228700

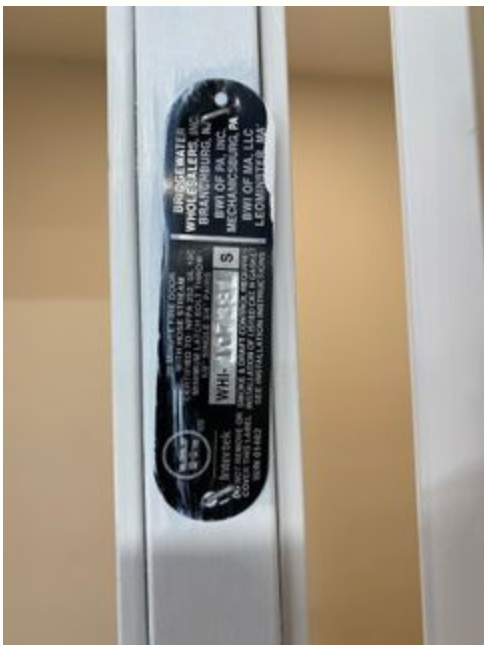
✧ **(G-2) Note:** Correct fire rated door between garage and house.

20 minute fire rated door tag

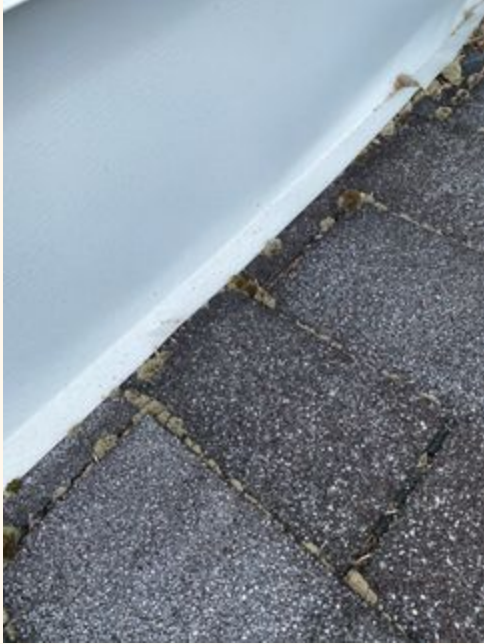
🔧 (RCG-3) Repair: Metal flashing has deteriorated and lifted in areas near the roof surface. Recommend further evaluation and repair by a qualified roofer.

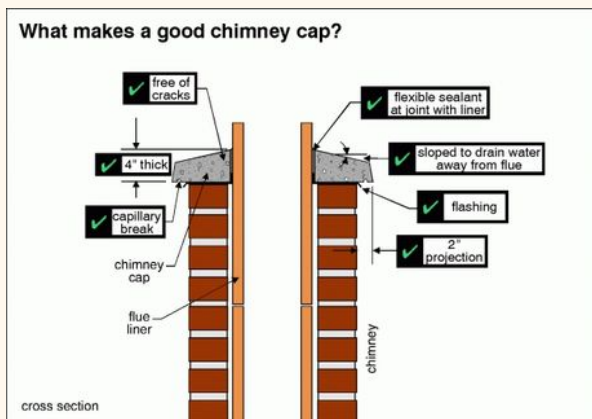
Around the chimney mortar, sealant was used. This is not a proper way to seal the chimney and it is recommended for a qualified mason to further evaluate and make repairs.

This illustration demonstrates the proper installation of a chimney crown

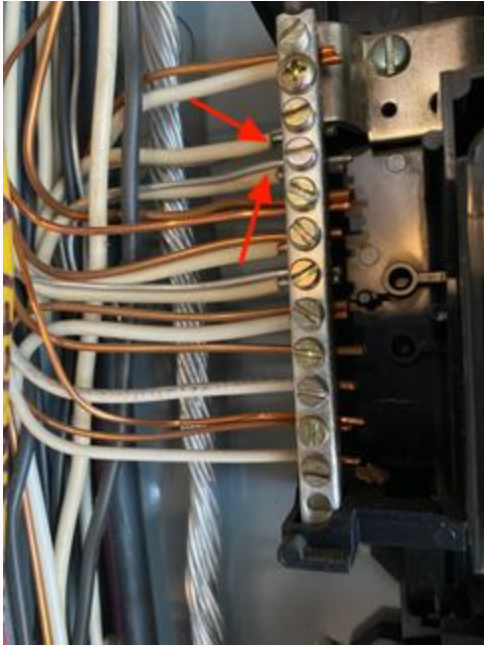
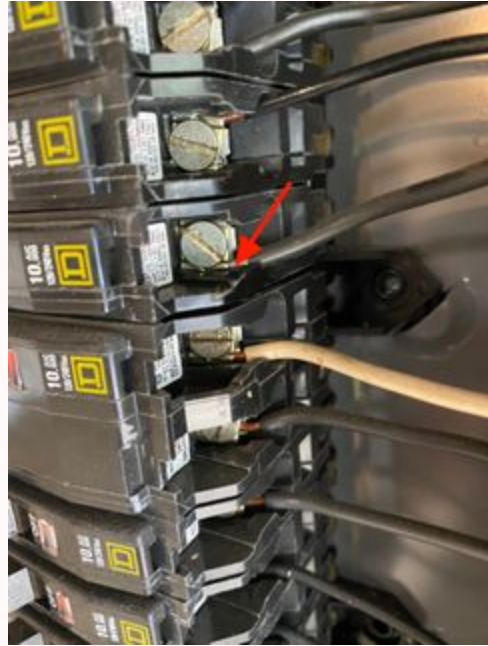
- The aluminum alloys used prior to 1972 (AA-1350) are generally more problematic and this wiring should be replaced.
- Post 1972 single strand aluminum should employ an improved alloy (AA-8000) that can be safely kept in service when properly installed at termination points. For more information on solid strand aluminum wiring see:
- <https://dylanchalk.com/single-strand-aluminum-wiring-safe/>
- <http://structuretech1.com/aluminum-wiring/>
- <https://www.cpsc.gov/s3fs-public/516.pdf>
- <https://inspectapedia.com/electric/Old-Fabric-Insulated-Electrical-Wire-ID.php>
- <https://www.alwirerepair.com/photo-gallery/burned-purples>

Examples of specific observations noted during inspection today include:

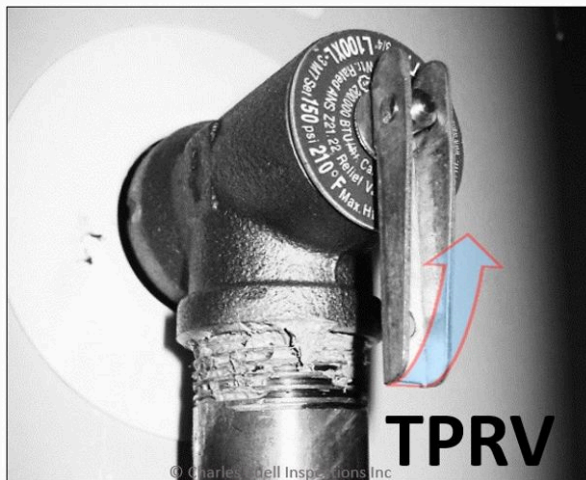
Most codes defer to manufacturer instructions and I favor those recommendations. The yellow tag on the valve states clearly the termination should be 6" above the floor which is more consistent with the UPC code requirements.

The arrow shows how a TPRV can be tested

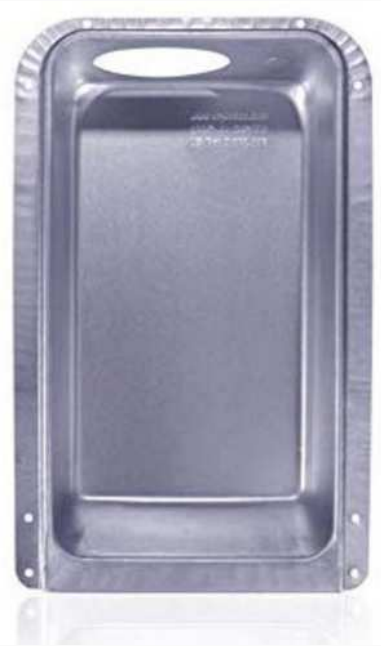
This shows an example of a dryer vent box

🔧 **(LF-3) Recommended Maintenance:** The dryer exhaust ductwork is dirty and needs to be cleaned for improved safety. This is important regular maintenance to eliminate a potential fire hazard.

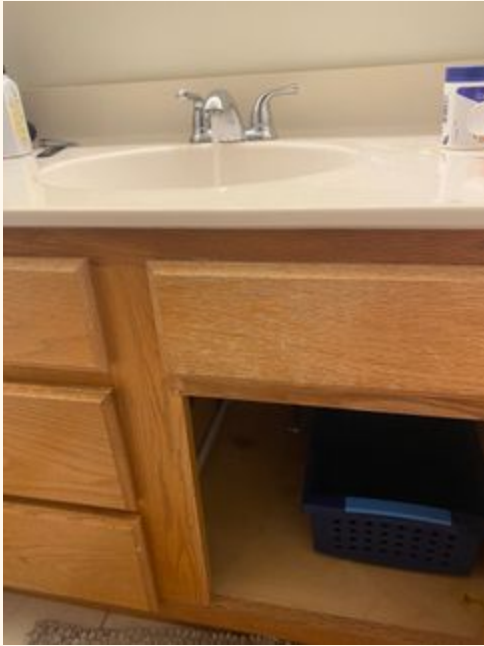
🔧 (FB5-1) Repair: The waste plumbing below the new master bathroom sink is leaking and requires immediate repair. Hire a licensed plumber to further evaluate and repair.

Sink performing

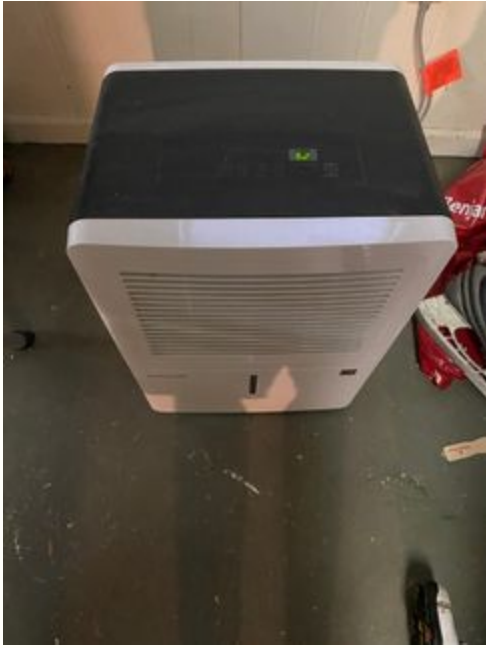
✦ **(SB-1) Note:** Dehumidifier operating in the basement at the time of the inspection. Although evidence of moisture was not present, it is worth noting the operation of the dehumidifier.
