Gingrich Home Inspections

Confidential Inspection Report

LOCATED AT:
1011 Ironwood Court
Leavenworth, KS 66048

INSPECTED ON:
Tuesday, August 3, 2021

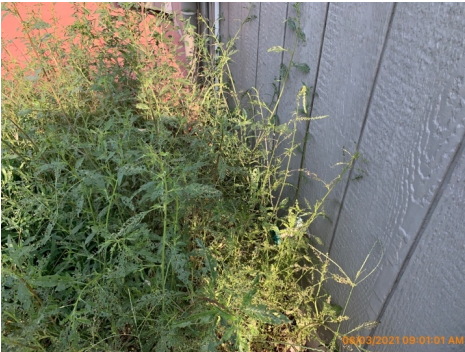
LANDSCAPING

Upgrade: Vegetation growing on or within 6 inches of exterior walls should be kept trimmed away from siding, window trims, and the eaves.
