# PROPERTY INSPECTION REPORT

**Concerning:** 1977 build - 2619 sf, Houston, TX 77071  
(Address or Other Identification of Inspected Property)

**By:** David Gibbs, Lic #7406 TREC Professional Inspector 02/09/2021  
(Name and License Number of Inspector) (Date)

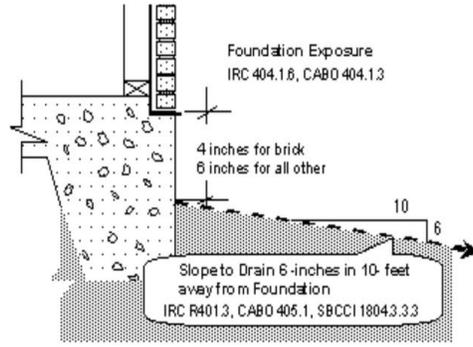
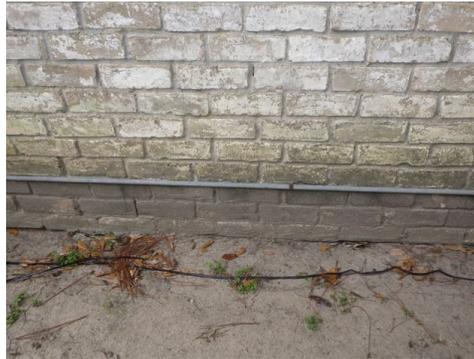
The drainage swale was not continuously sloped to street as required according to today's standards, may cause water ponding at sides and rear of house. We recommend repair as necessary to promote proper drainage away from foundation and extend service life of fence.

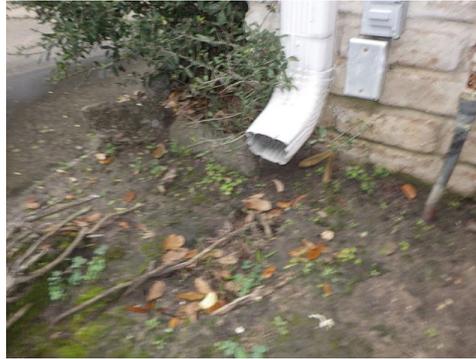
The gutters were damaged in one or more areas, had accumulated debris preventing proper drainage. We recommend all debris be cleared.

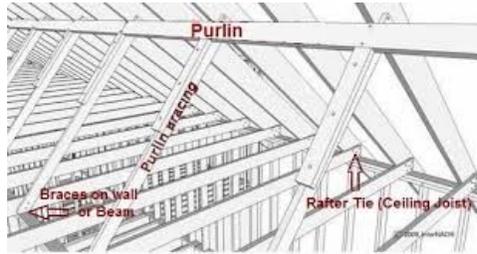
A purlin / strut (roof support) was loose at front near attic access. We recommend repair as necessary.

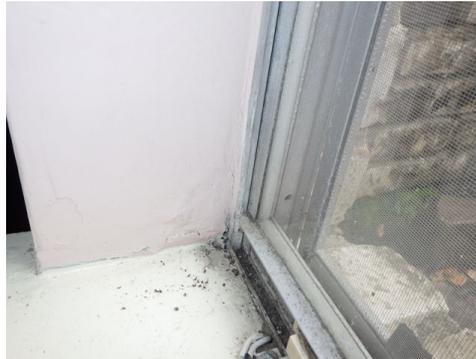
Observed water stains or damage on interior wall at sides of windows in some areas. Moisture detection equipment indicated that the area was not wet at time of inspection. This could be caused by condensation on aluminum window frames, windows left open during rain, or possible window leaks. We recommend refinish area, monitor for water penetration and repair as necessary.

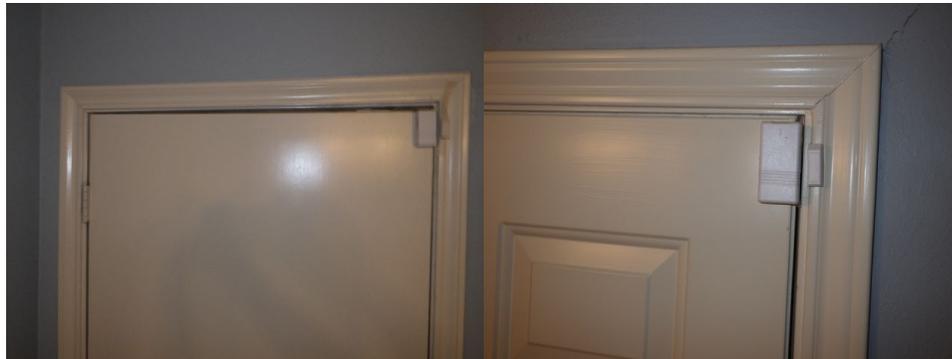
Multiple interior and exterior doors were not square in jamb, would not latch or rubbed frame. The living room rear exterior door would not lock and laundry room exterior door would not open. The laundry room interior door would not close. We recommend repair / adjustment to restore door(s) to a serviceable condition. This appears to be an indication of foundation movement or improper installation.

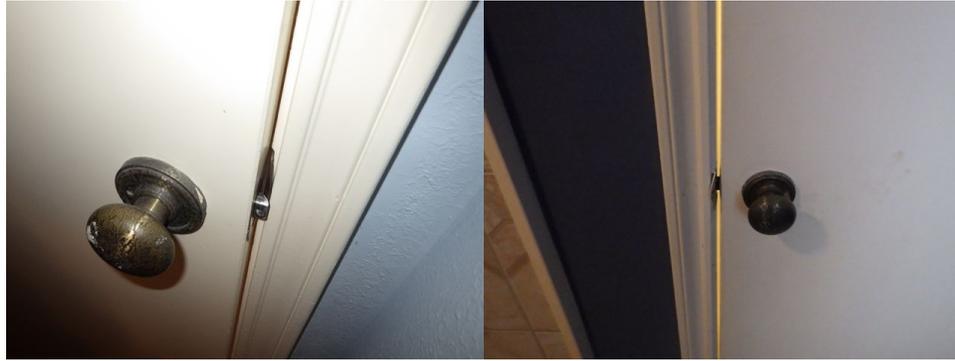
The door from house to garage was not square, had a gap at top, meaning it was not a fire resistant assembly as required to protect an opening between garage and dwelling (Ref: IRC R302.5.1). A solid core wood or honeycomb steel door 1 3/8" thick minimum or UL listed 20 minute fire rated door with self closer is required. We recommend install fire resistant door with self closer as required according to today's standards.

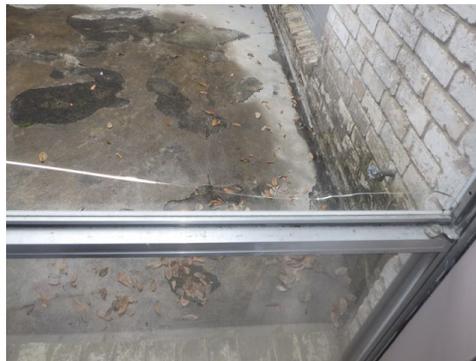
Broken or cracked glass was observed in one or more windows. We recommend all broken and/or cracked glass be replaced.

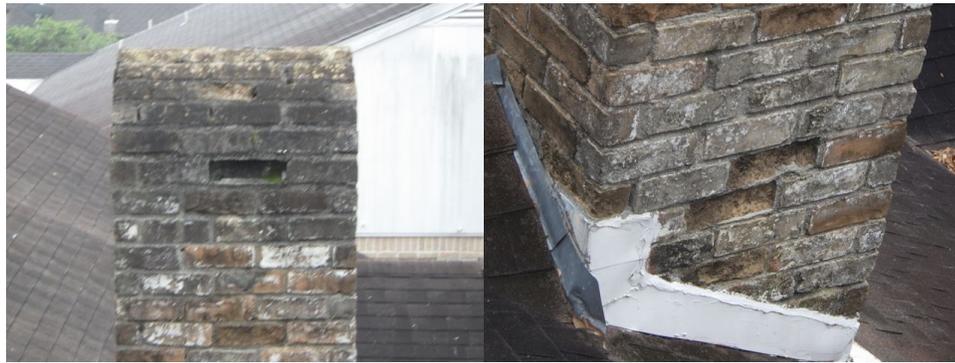
Observed loose or deteriorated bricks on chimney. (Photos are examples only and do not represent all instances of condition.) We recommend further inspection by a specialist contractor and repair as necessary.

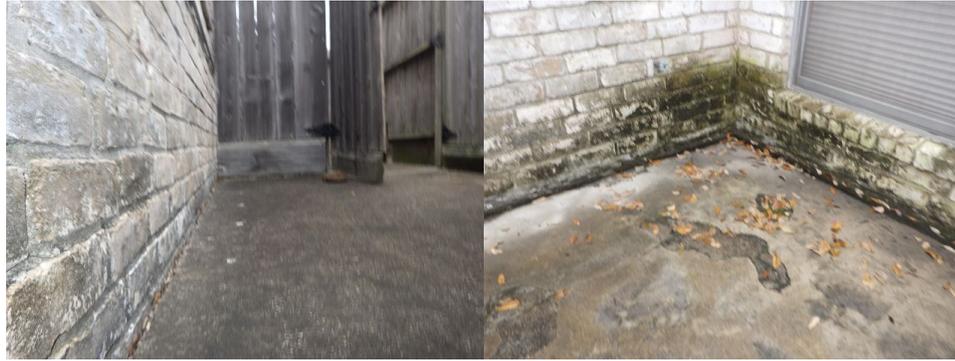
There are one or more trip hazards throughout the walkways / patio / driveway. A trip hazard is defined as an irregularity in a walking surface exceeding one inch in height. We recommend they be patched or repaired to provide an even walking surface.

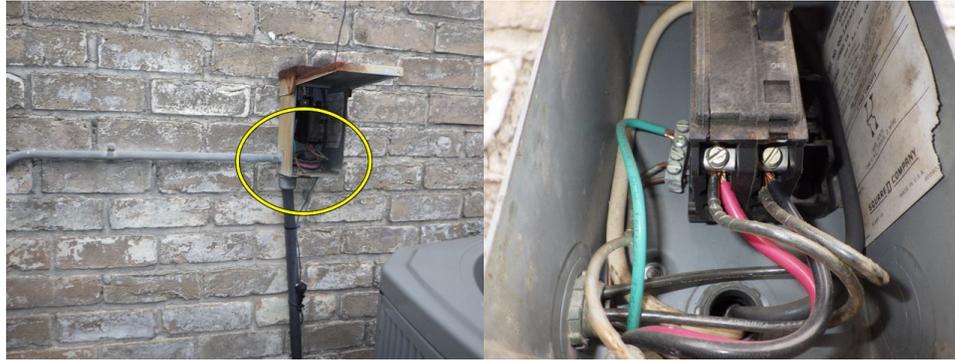
We found overfusing in the main electrical service panel, meaning the conductor was inadequate size to safely carry current allowed by the circuit breaker. This is a potential fire hazard. We recommend the circuit be equipped with a properly rated conductors and/or circuit breaker.

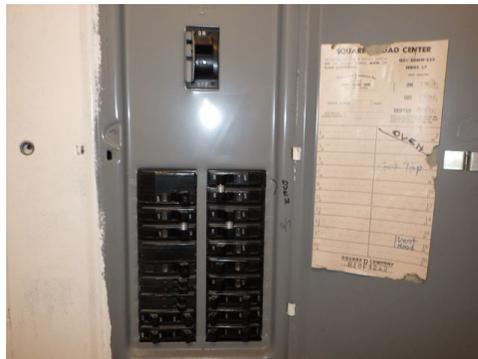
The circuitry in the electric service panel was not properly labeled. We recommend that every circuit be identified and labeled, allowing individuals unfamiliar with the system to recognize the locations of each circuit.

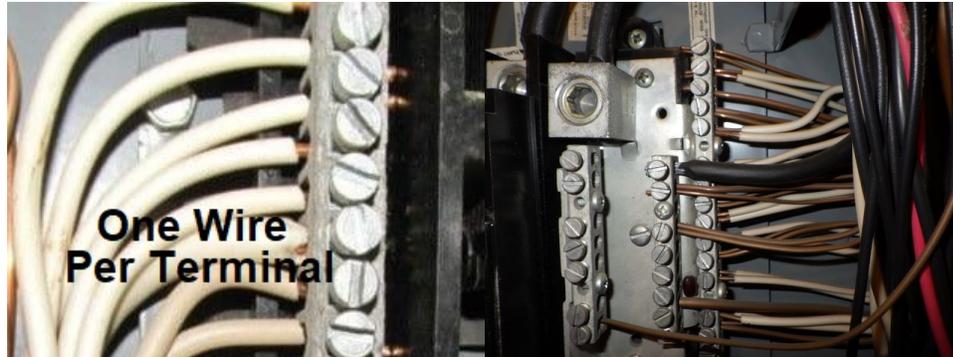
Multiple wires were improperly installed on individual neutral lugs on electric service panel bus bar. This is not permitted because a positive connection for each of the wires

can not be assured. Loose connections can cause overheating, a possible fire hazard. We recommend repair by a licensed electrician.

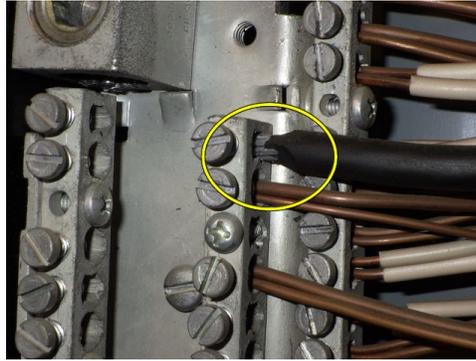
Observed improper wire colors in electric service panel. This can be hazardous for service personnel. Positive / hot conductors (to breakers) should only be black or red, Neutral are white, grounding are green or bare. We recommend use caution when working in panel and mark wires inside panel when possible.

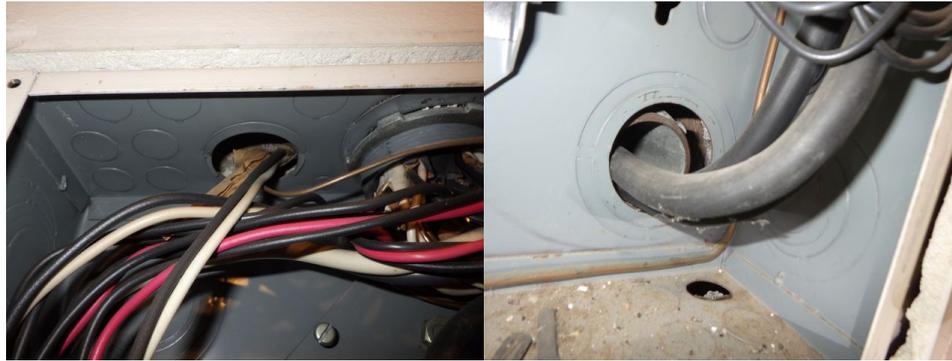
Multiple conductor cables were loose where entering the electric service panel. We recommend the cable be secured by installing an approved connector as required according to today's standards.

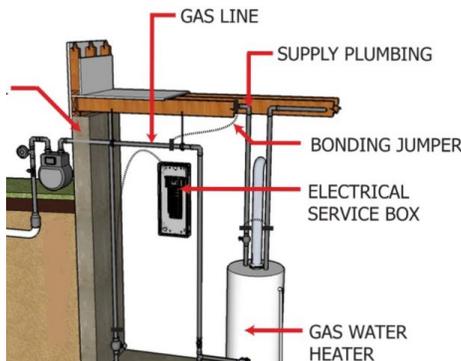
The hot & cold metallic water piping did not appear to be properly bonded to gas piping and the house grounded service at main panel as required according to today's standards. This may not have been required at time of construction, but to minimize shock hazard in case of ground fault, we recommend install bonding connections. (Ref: IRC E3509.7)

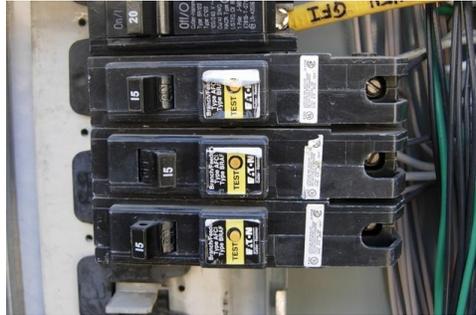
Did not observe AFCI (Arc Fault Circuit Interrupt) device protection as required by current building standards for all: family rooms, dining rooms, living rooms, parlors, libraries, dens, bedrooms, sunrooms, recreations rooms, closets, hallways, or similar rooms or areas (Ref: IRC E3902.11). AFCI devices are intended to protect against fires caused by electrical arcing faults in the home's wiring. Arc faults are a common cause of residential electrical fires. Arc faults can be created by damaged, deteriorated, or worn electrical plugs, cords, and/or branch circuit conductors. This was not required at the time of construction, but for enhanced safety, we recommend upgrading.

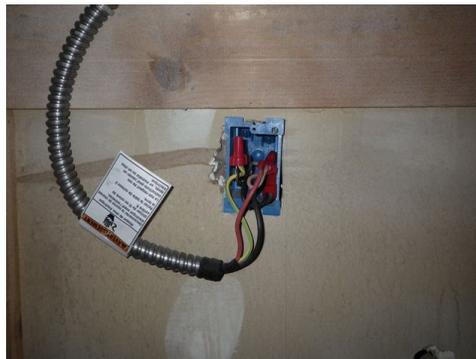
There was an uncovered junction box at kitchen cooktop. We recommend attach conduit to approved cover as required according to today's standards to protect the wiring from accidental contact and physical damage.

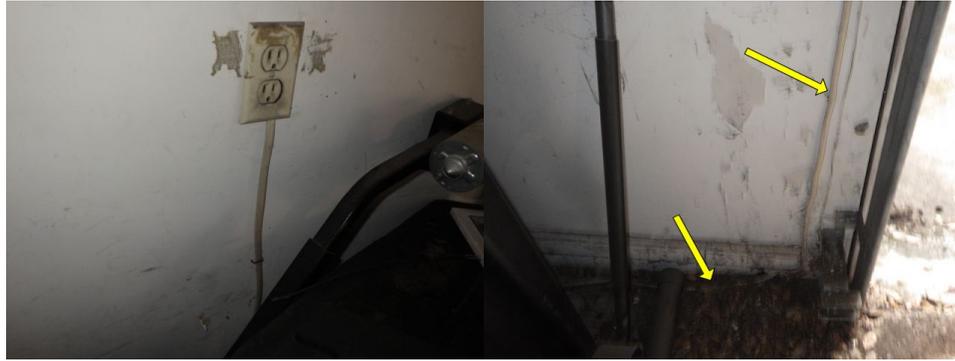
**Exposed and improper wiring was observed in garage. This is a potential shock and fire hazard. We recommend further inspection by a licensed electrician and repair or replace as necessary.**

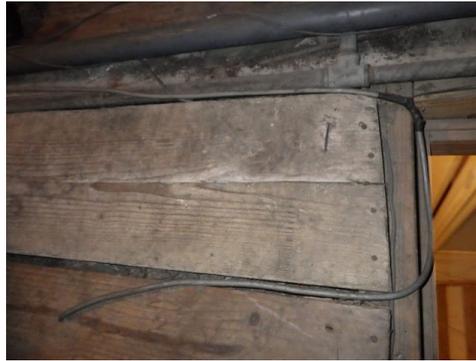
**Observed extension cord wiring in attic used improperly as permanent wiring in one or more areas. This is a possible fire hazard. We recommend further inspection by a licensed electrician and repair or replace as necessary.**

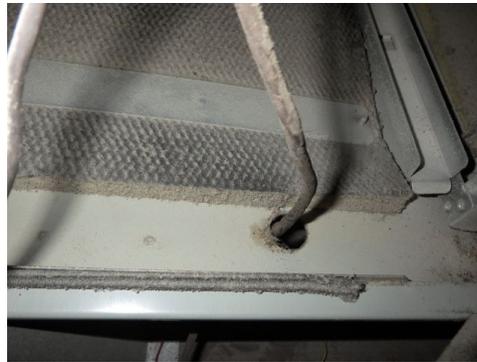
Thermostat wiring was missing clamp / bushing that secures wires to heater case. Loose wires can cause unit malfunction and/or damage. This also allows improper air infiltration. We recommend secure wires and seal hole.

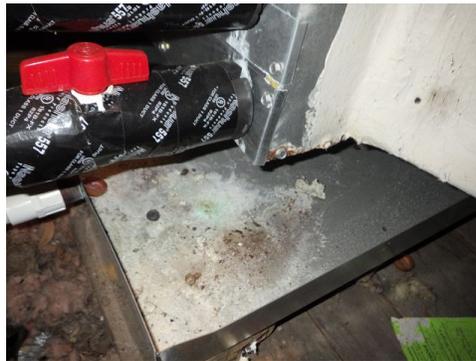
Observed corrosion or water stains below the air conditioner evaporator coil in the emergency drain pan. This is an indication of past or current leakage of condensation from evaporator coil or drain line. We recommend further inspection by a licensed HVAC technician and repair if/as necessary.

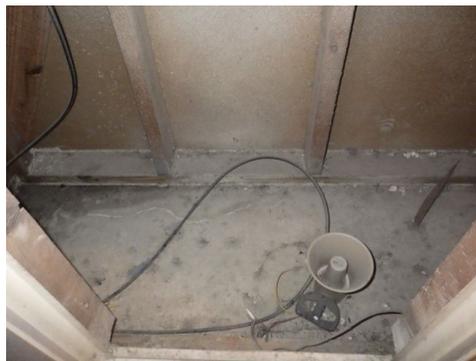
Observed 120 volt electrical wiring located in return air chase. According to today's standards (code) 120 volt wiring should not be located in, or pass through chases. In the event of an electrical fault / fire, this could promote spread of fire into attic. This may have been allowed at the time of construction, but for enhanced safety, we recommend alteration if possible.

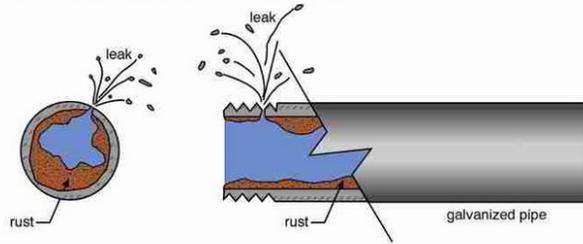
The water was very discolored at master bathroom shower. This is most likely iron from the mineral buildup inside of the older galvanized lines at fixtures not used on a regular basis. Often times allowing the water to run for a few moments helps it to run clearer.

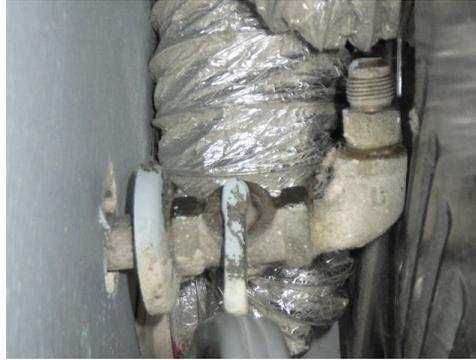
**A currently unused gas line was observed at the laundry room that lacked a cap. We recommend that an approved cap be installed if the gas line will not be used.**

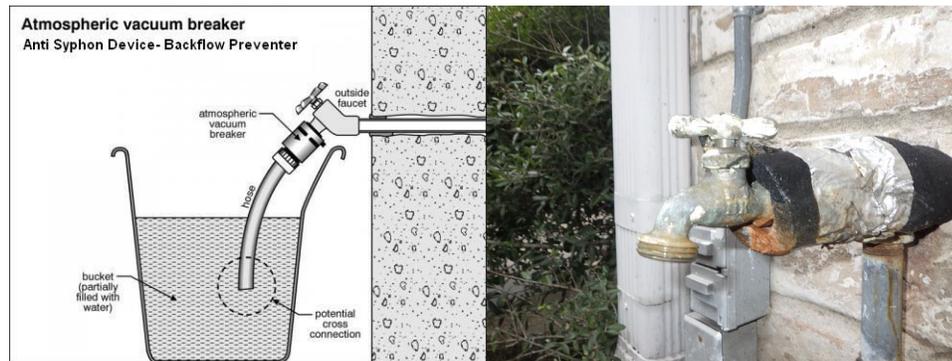
Hose bibs were missing backflow preventer devices as required according to today's standards (IRC P2902.3). This is a possible hazard. We recommend install approved backflow prevention devices at all exterior hose bibs.

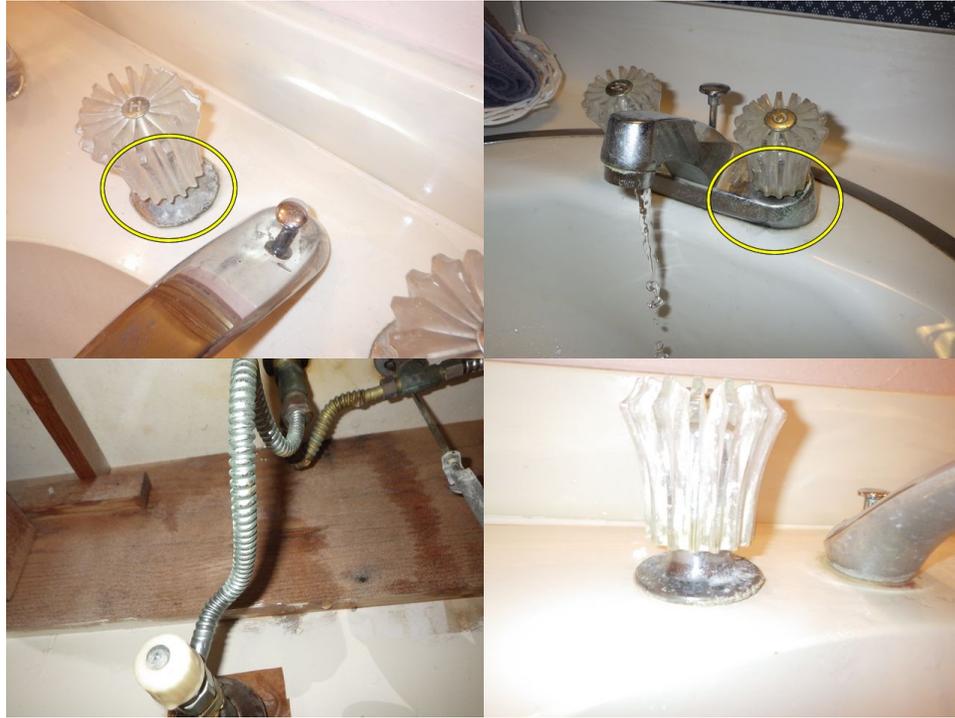
We observed leakage at three or more bathroom faucet handles / valve stems while faucet is turned on. The hall bathroom sink had significant leakage into cabinet below sink. We recommend further inspection by a licensed plumber and repair or replace as necessary.

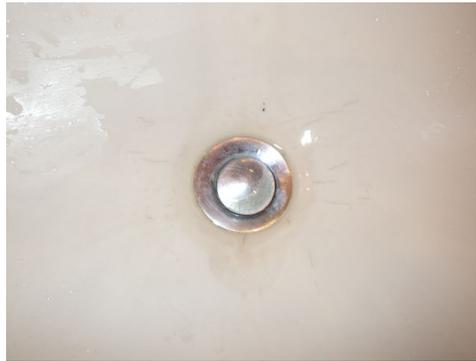
The cultured marble bathroom sink in one or more areas has surface deterioration / cracking. No leaking was visible. This is primarily a cosmetic concern that can be refinished for a better appearance.

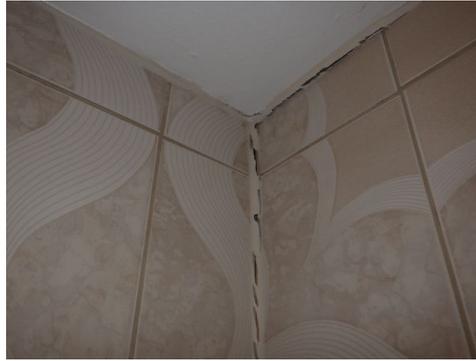
The hall bathroom shower corners had gaps in one or more areas. These can be re-grouted, but this condition is likely to return due to structural movement. We recommend a flexible sealant at this location.

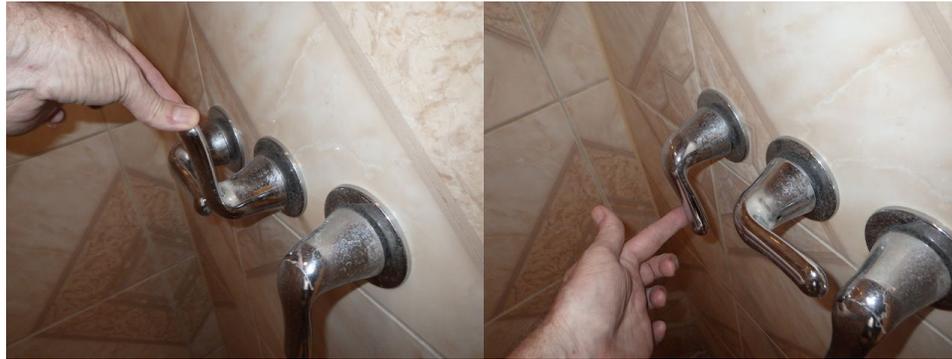
The master bathroom shower diverter faucet handle spun freely, failed to divert water from lower spout to shower head. There was no hot water flow to faucets. We recommend further inspection by a licensed plumber and repair or replace as necessary.

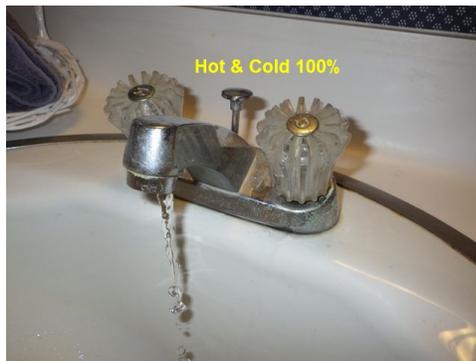
Observed low water pressure at half bathroom sink faucets. We recommend further inspection by a licensed plumber and repair or replace as necessary.

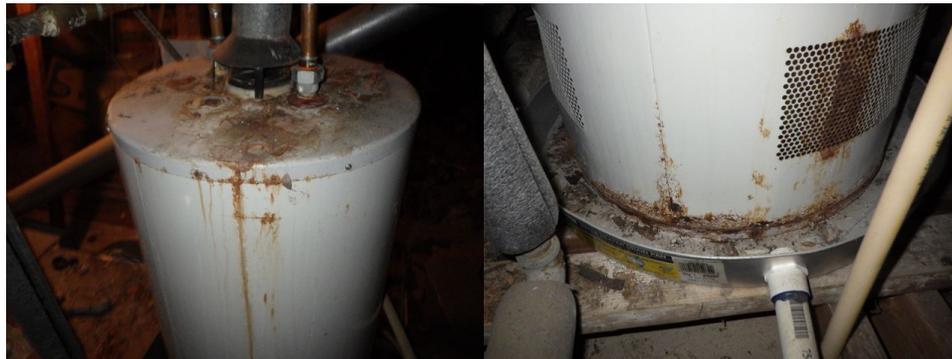
The water heater case was corroded at top and bottom. Typically this means tank is at end of service life, may have minor internal leaks. The water heater was later in its expected service life (12-15 years with service). We recommend further inspection by a licensed plumber, service Temperature & Pressure Relief Valve as required according to manufacturer and flush sediment from tank.

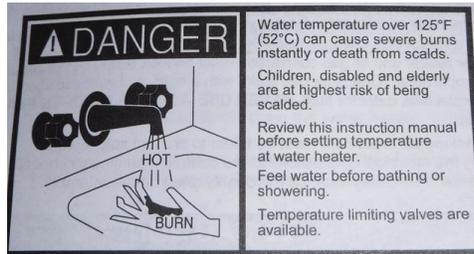
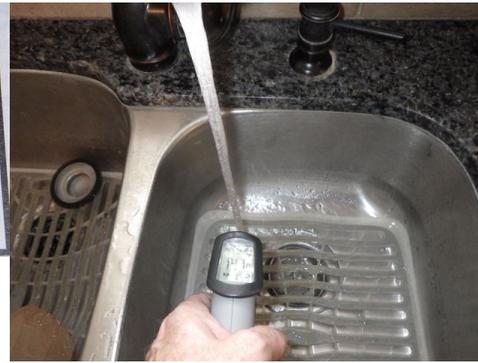
**The water heater temperature was set too high. Excessive temperature is a scalding hazard for children, and uses additional energy. The CPSC recommends the temperature setting be maximum 120 degrees for safer operation.**

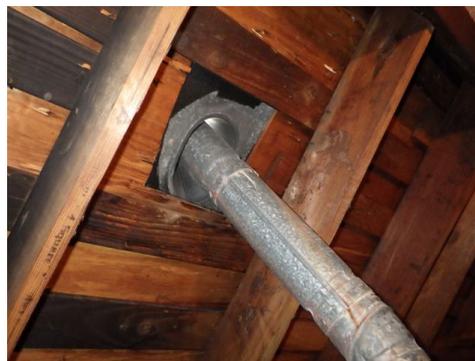
Observed water heater vent pipe(s) not properly secured (strapped) to roof rafters in attic. Strapping gas appliance vents is required to resist wind storm damage / disconnection of vent when wind pushes on vent and cap above roof line. We recommend repair as necessary.

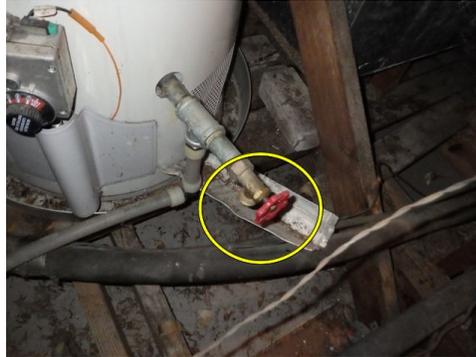
Improper water pipe alterations have caused drain valve to extend over edge of drain pan. If it leaks, water will not be contained. We recommend repair as required according to today's standards.

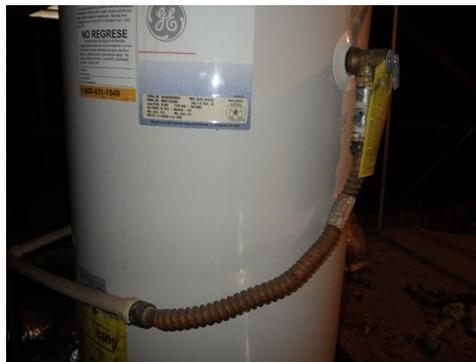
The water heater Temperature & Pressure relief valve drain line was not an approved material. Flex connectors reduce pipe diameter and can improperly restrict flow. We recommend replace drain line with material approved according to today's standards.

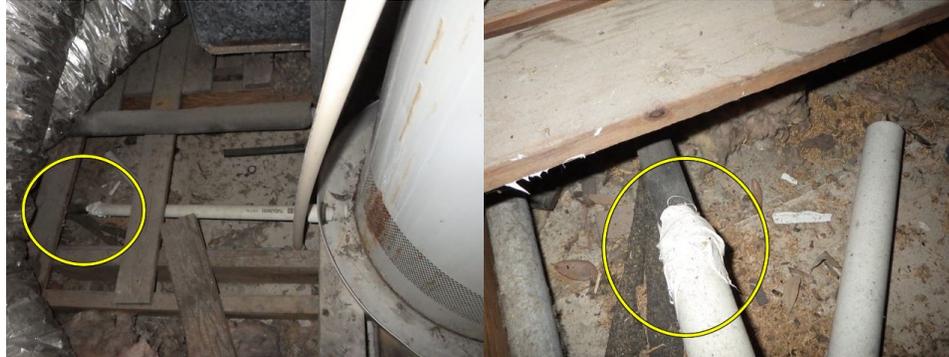
The drain line for water heater drain pan had improper connection. This may promote

leakage into ceiling if water heater has a leak. We recommend repair or replace as necessary.

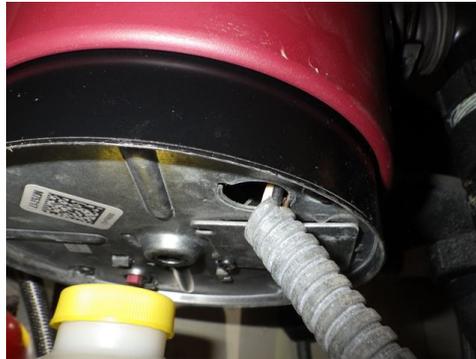
The metal flex conduit was not secured where it enters the bottom of the disposal, wire connections can come loose. This also will likely indicate unit is not grounded, a possible shock hazard. We recommend repair as necessary.

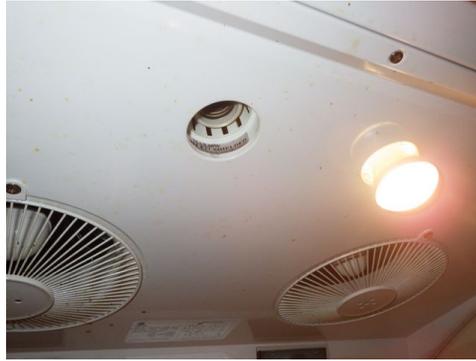
A cooktop hood light bulb was missing. We recommend repair or replace as necessary. did not operate.

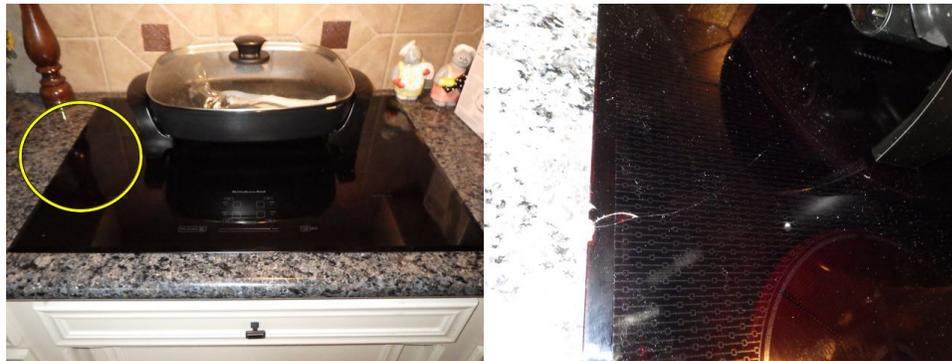
The cooktop glass surface was damaged. The power supply was off at time of inspection and unit not functional according to seller. We recommend repair or replace as necessary.

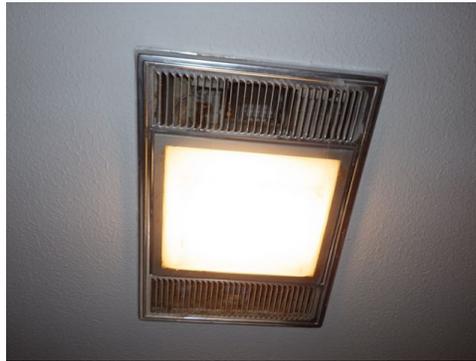
The resistance heater in the master bathroom made a burning smell when running. This may be caused by lack of use (dusty heating element) or damaged unit. We recommend further inspection by a specialist contractor and repair or replace as necessary.

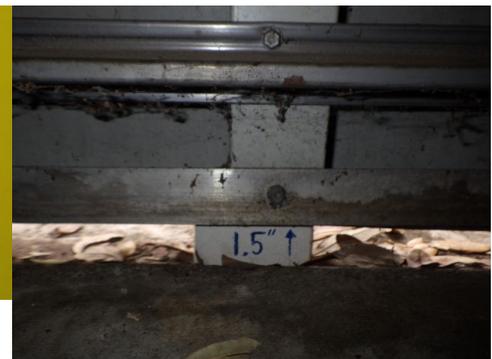
**The automatic garage door opener did not reverse properly when tested according to most manufacturer's recommendations with a 2x4 board laid flat on the floor. We recommend adjustment, repair or replacement to restore proper function and safety.**

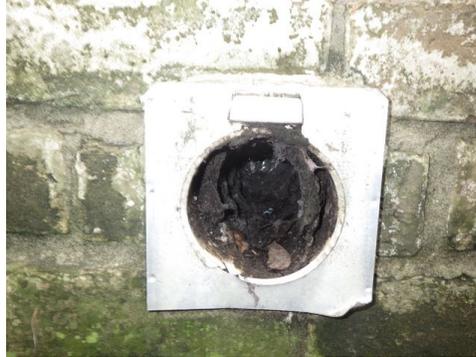
Clogged dryer ducts can be a fire hazard and, we recommend cleaning duct after moving in, and regularly as used. The dryer vent back draft damper was missing. We recommend replace to prevent water penetration and air infiltration.
