Solid Home Inspections

PROPERTY INSPECTION REPORT

Concerning: 2006 build - 3,611 sf, Houston, TX
(Address or Other Identification of Inspected Property)

By: David Gibbs, Lic #7406 TREC Professional Inspector 01/25/2021
(Name and License Number of Inspector) (Date)

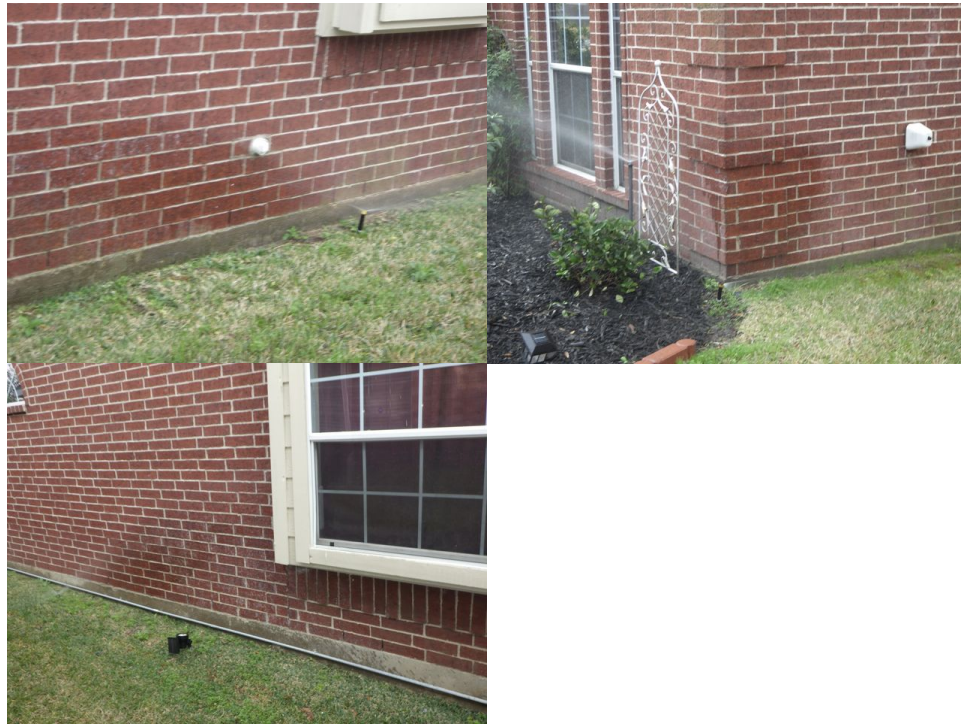
Observed multiple damages spray heads and/or buried water lines. We recommend repair or replace as necessary.
